**NEW CAR ASSESSMENT PROGRAM
LANE DEPARTURE WARNING CONFIRMATION TEST
NCAP-DRI-LDW-21-06**

2021 Honda Passport 2WD EX-L

DYNAMIC RESEARCH, INC.

Final Report

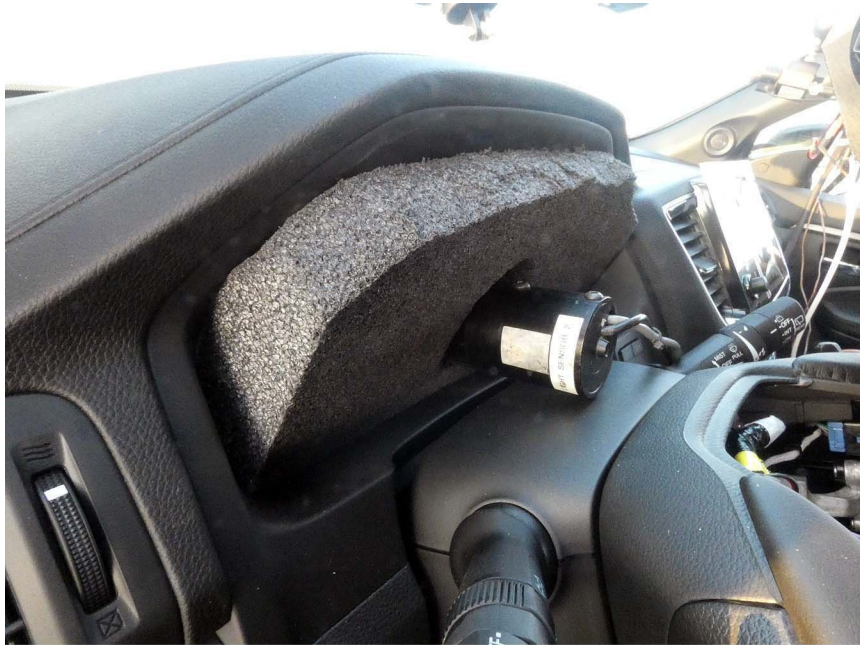
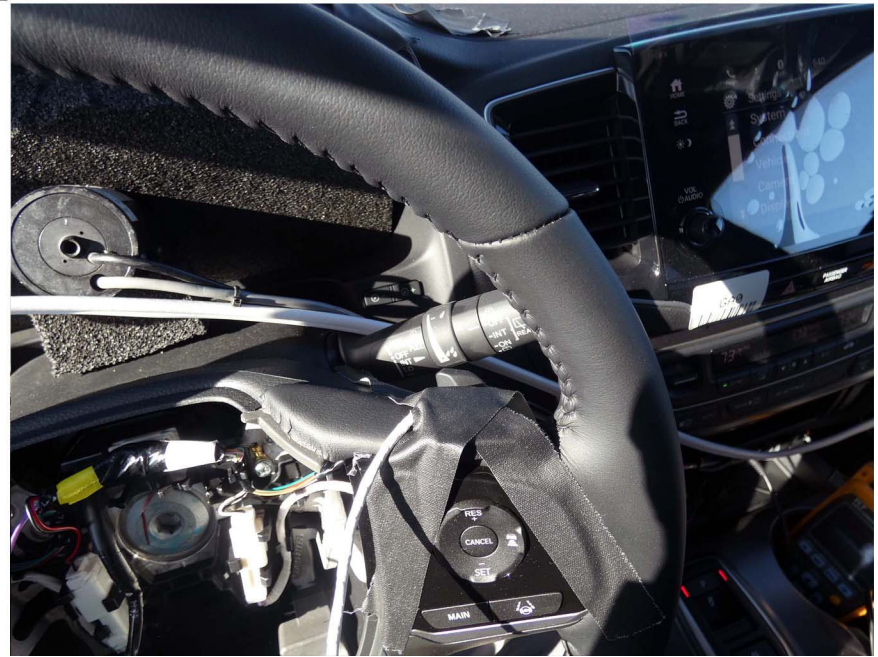
Figure A7. Sensors for Detecting Haptic and Visual Alerts

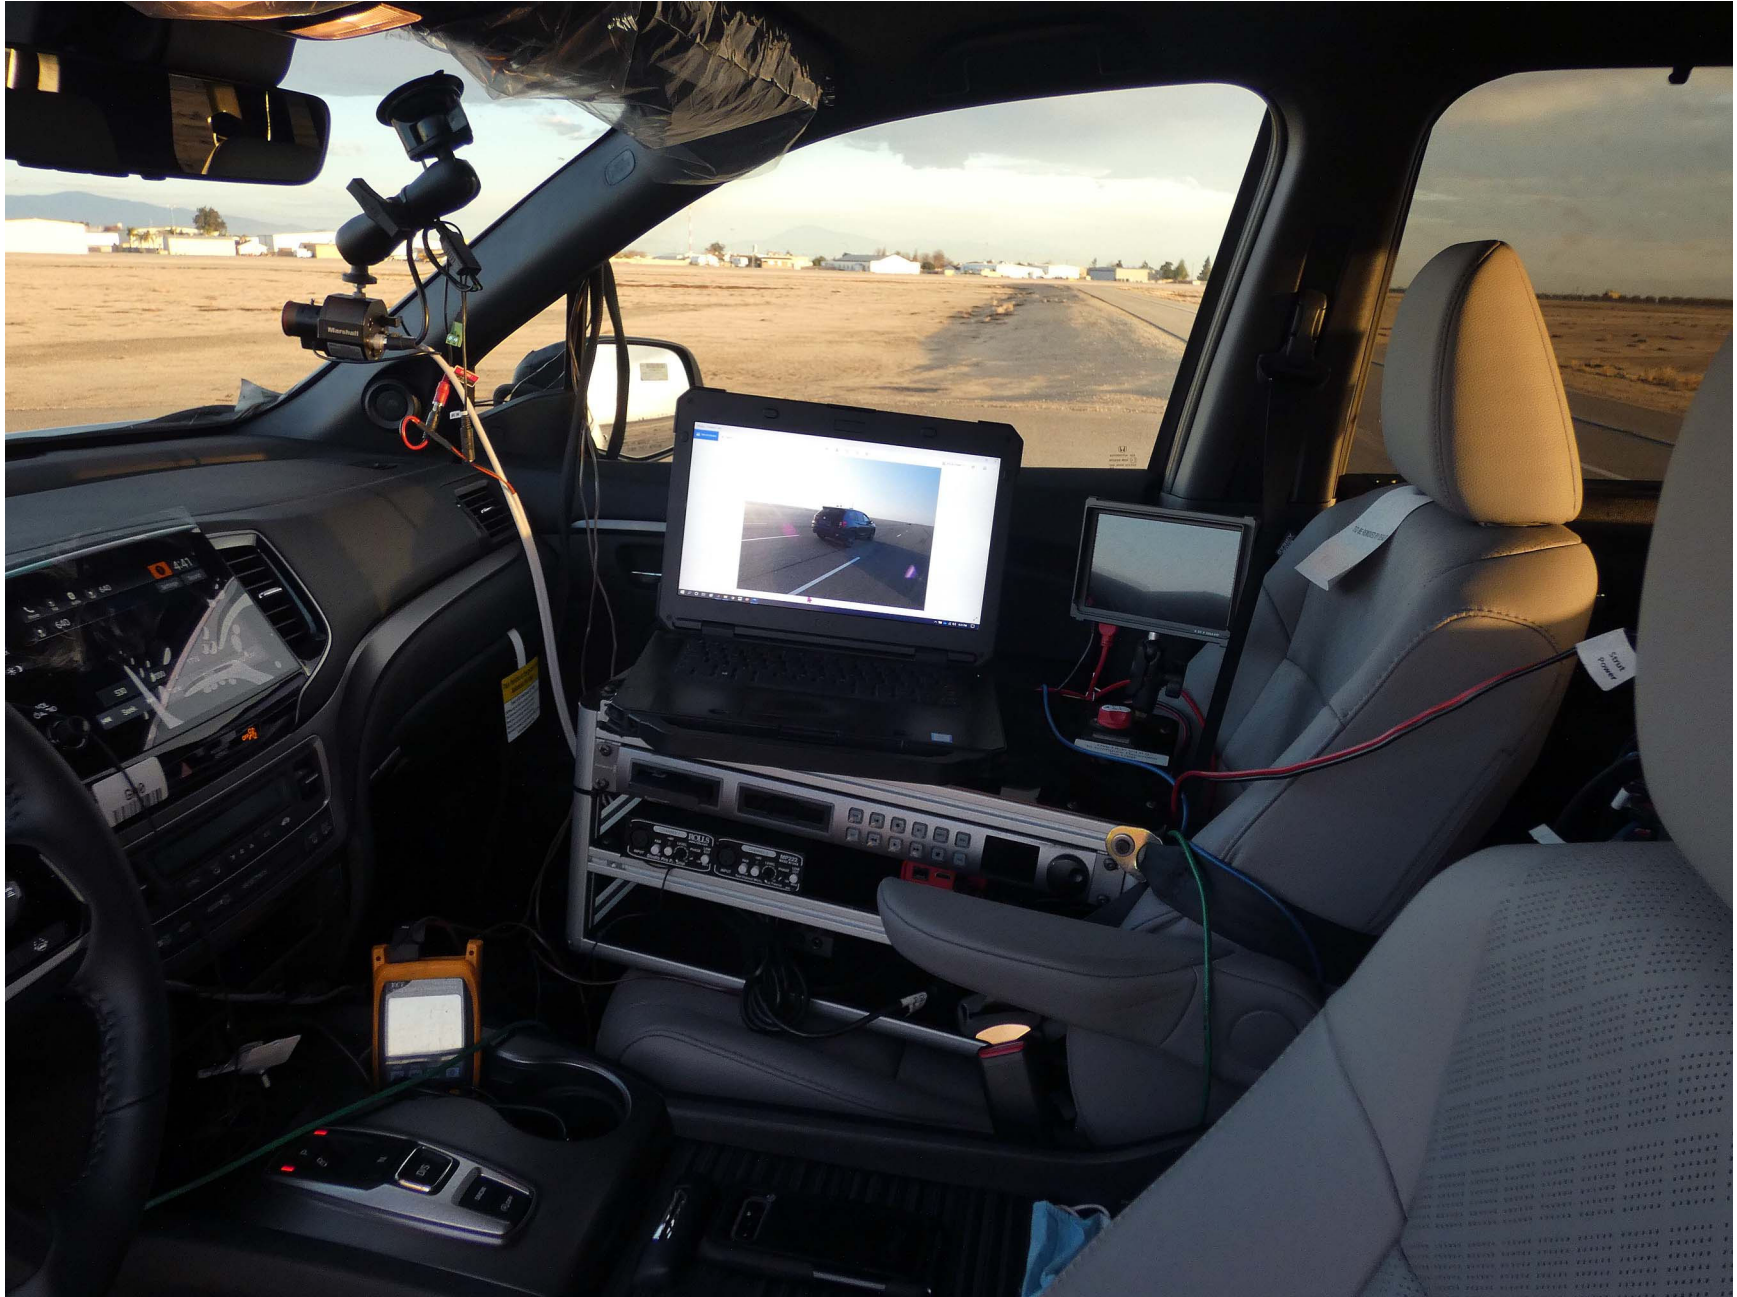
Figure A8. Computer Installed in Subject Vehicle

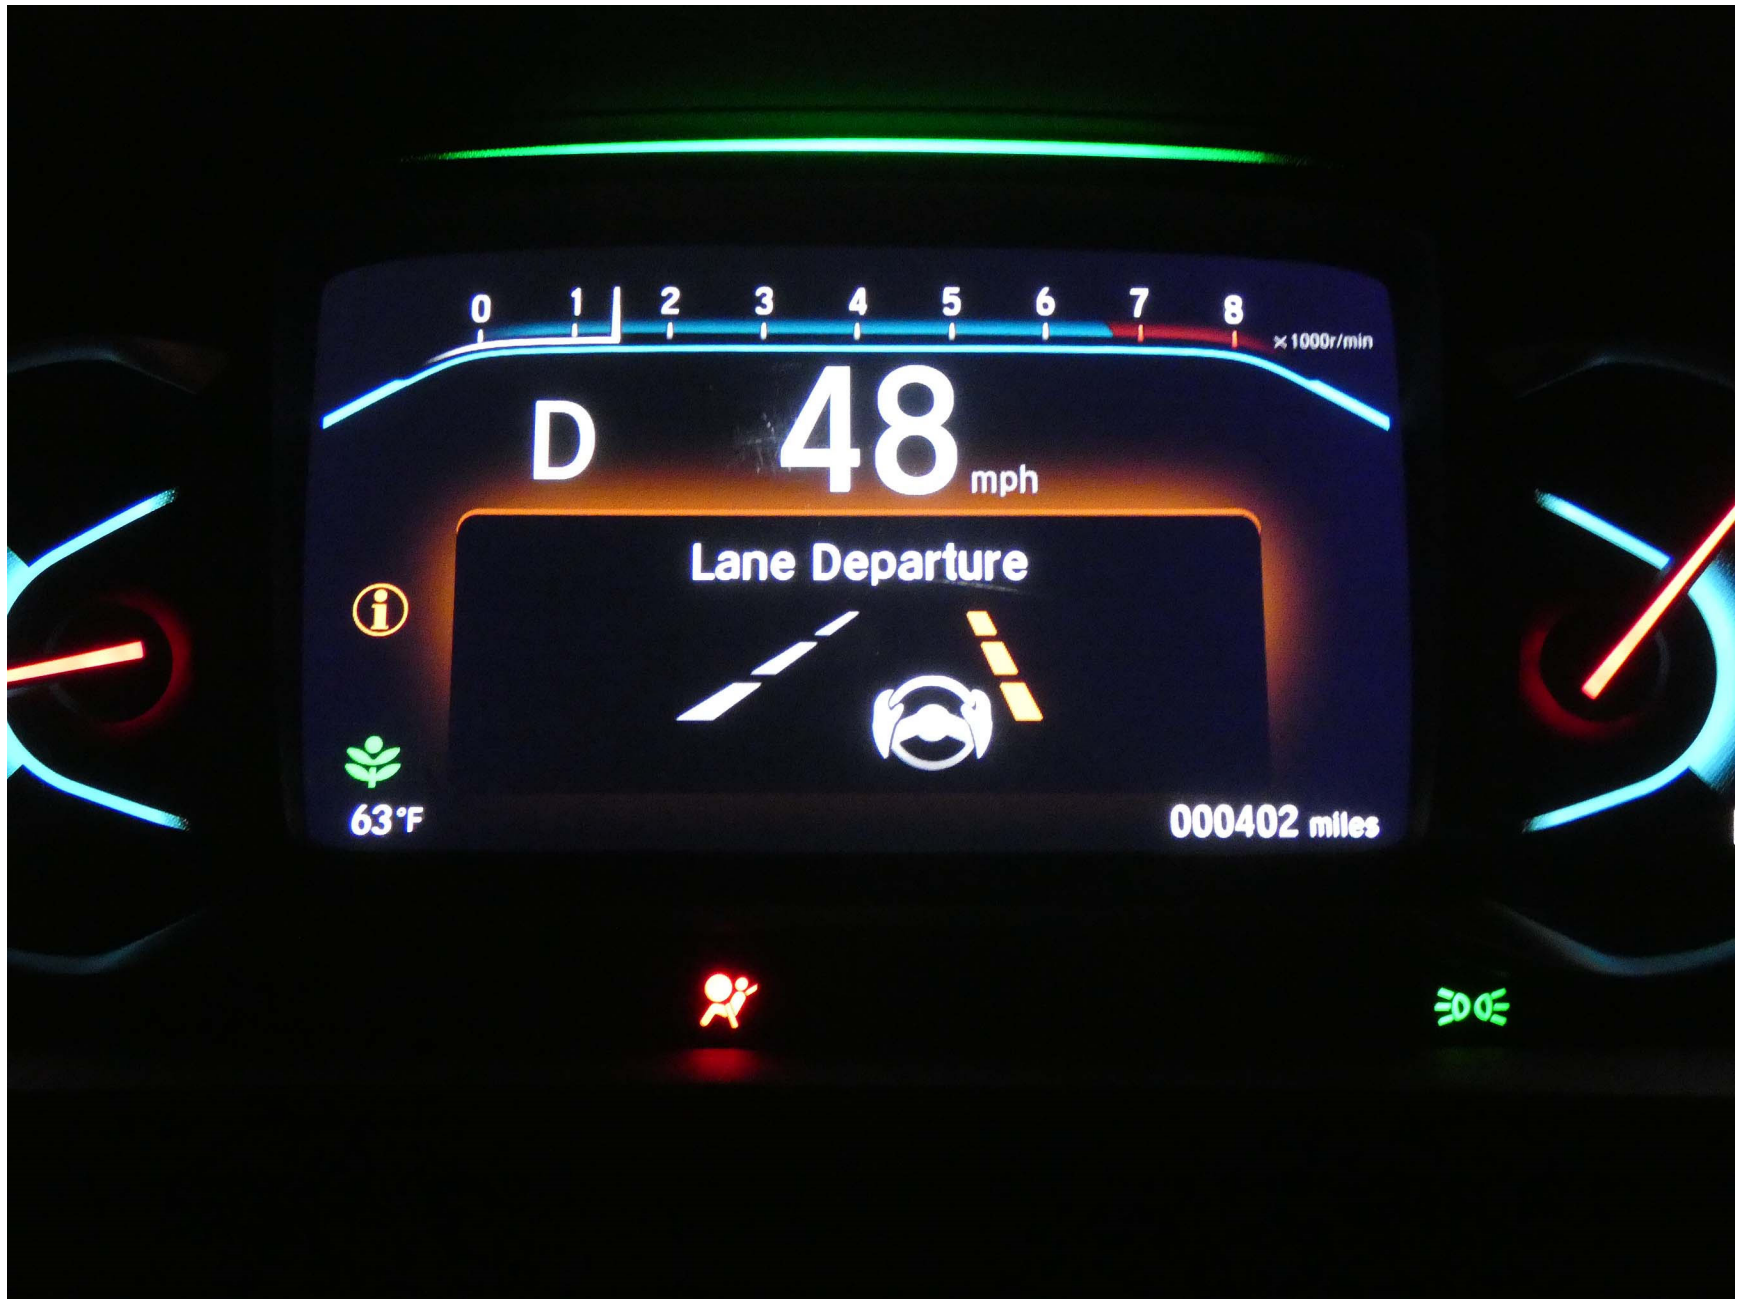
Figure A12. Visual Alert

The driver is alerted with a visual and haptic alert. The visual alert is a warning image displayed in the center of the instrument panel. The image consists of a steering wheel with lane lines on either side and the words "Lane Departure" above. The lane line in the warning image corresponding to the side the vehicle approached is illuminated yellow.

See Appendix A, Figure A12.
