**REPORT NUMBER: SPNCAP-KAR-20-029
NEW CAR ASSESSMENT PROGRAM (NCAP)
SIDE IMPACT POLE TEST**

**TESLA INC.
2020 TESLA MODEL Y 5-DOOR MPV**

**PREPARED BY:
APPLUS IDIADA KARCO ENGINEERING, LLC.
9270 HOLLY ROAD
ADELANTO, CA 92301**

FINAL REPORT

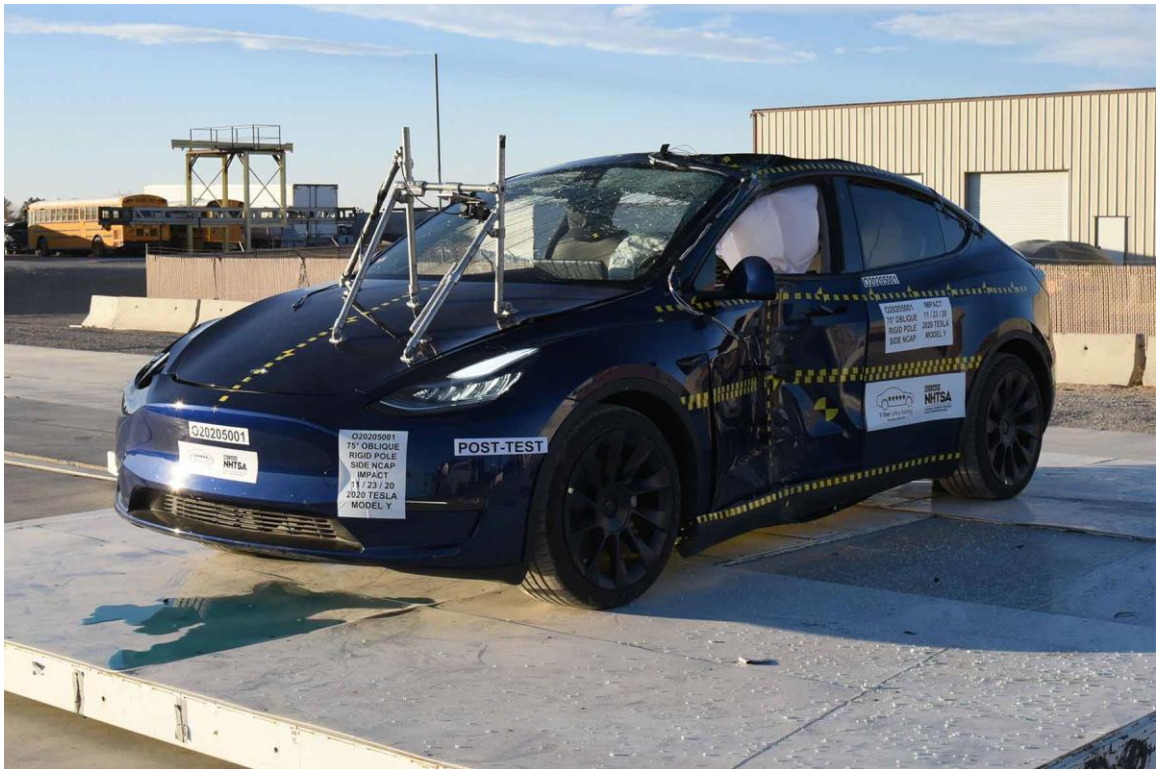
FIGURE 6. Post-Test Left Front $\frac{3}{4}$ View of Test Vehicle

The struck side door at the front of the vehicle was jammed shut. There was no separation at the hinges or latches. The remaining doors remained closed and latched. There were no ATD values that exceeded limits.

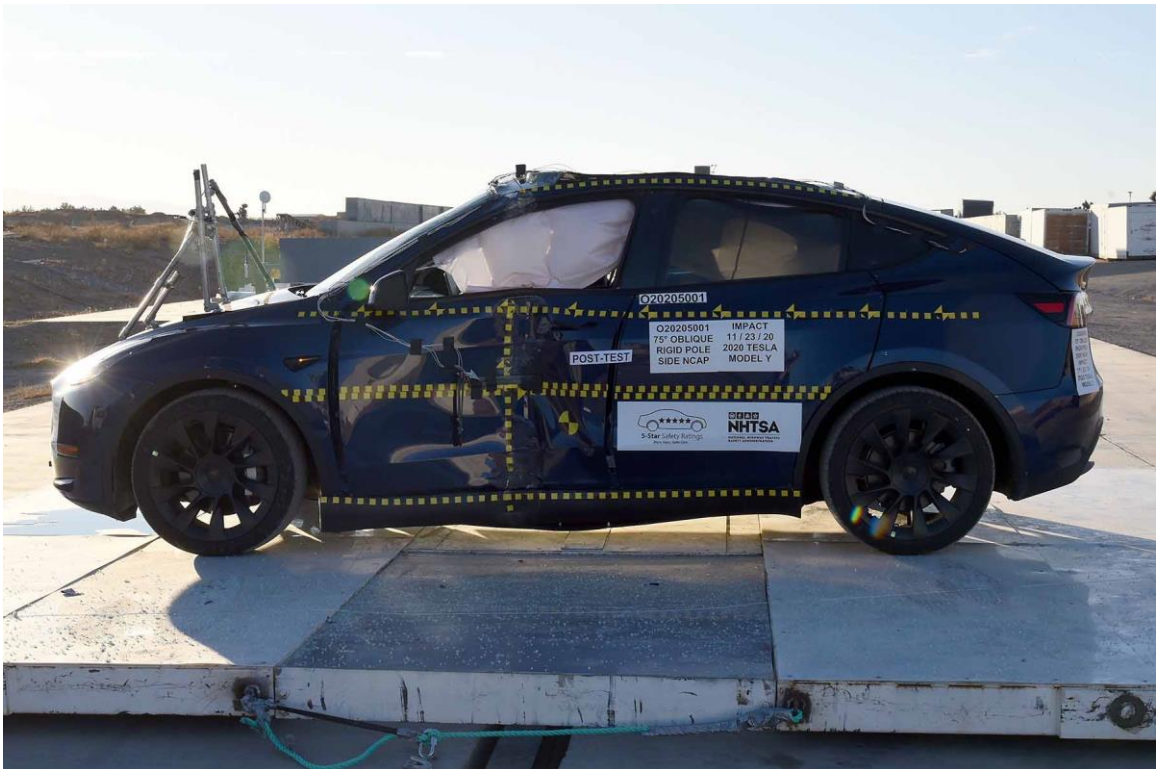
FIGURE 8. Post-Test Left Side View of Test Vehicle

Critical Areas of Performance	Observations and Conclusions
Pillar Performance	No separation occurred
Sill Separation	No separation occurred
Windshield Damage	Broken
Side Window Damage	Left front window broken
Other Notable Effects	Roof glass broken and separation occurred

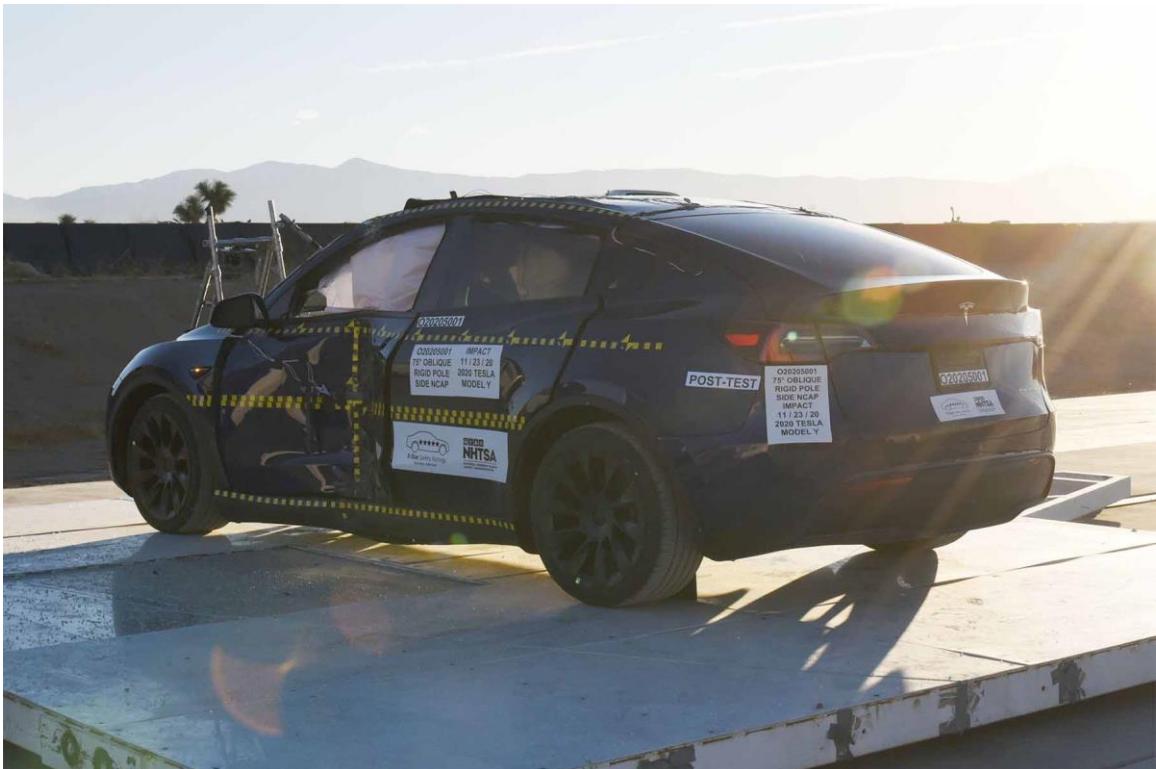
FIGURE 10. Post-Test Left Rear $\frac{3}{4}$ View of Test Vehicle

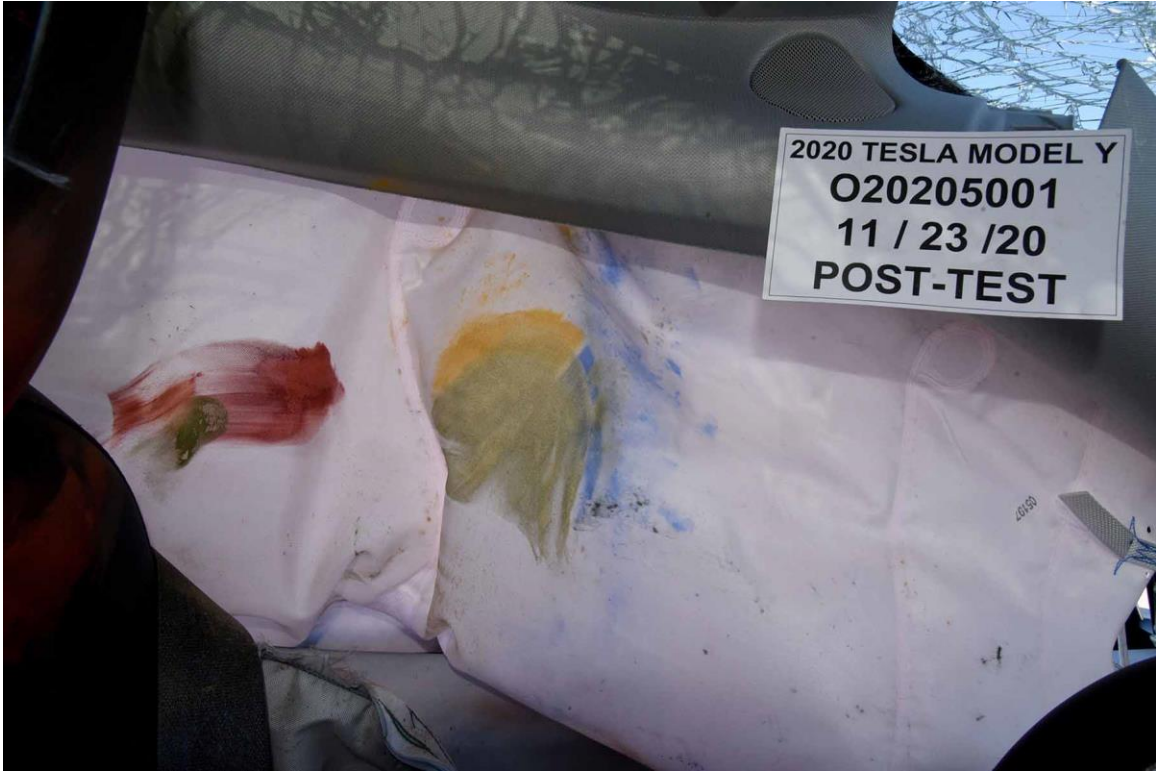
FIGURE 47. Post-Test Dummy Close-Up Head Contact With Side Airbag View

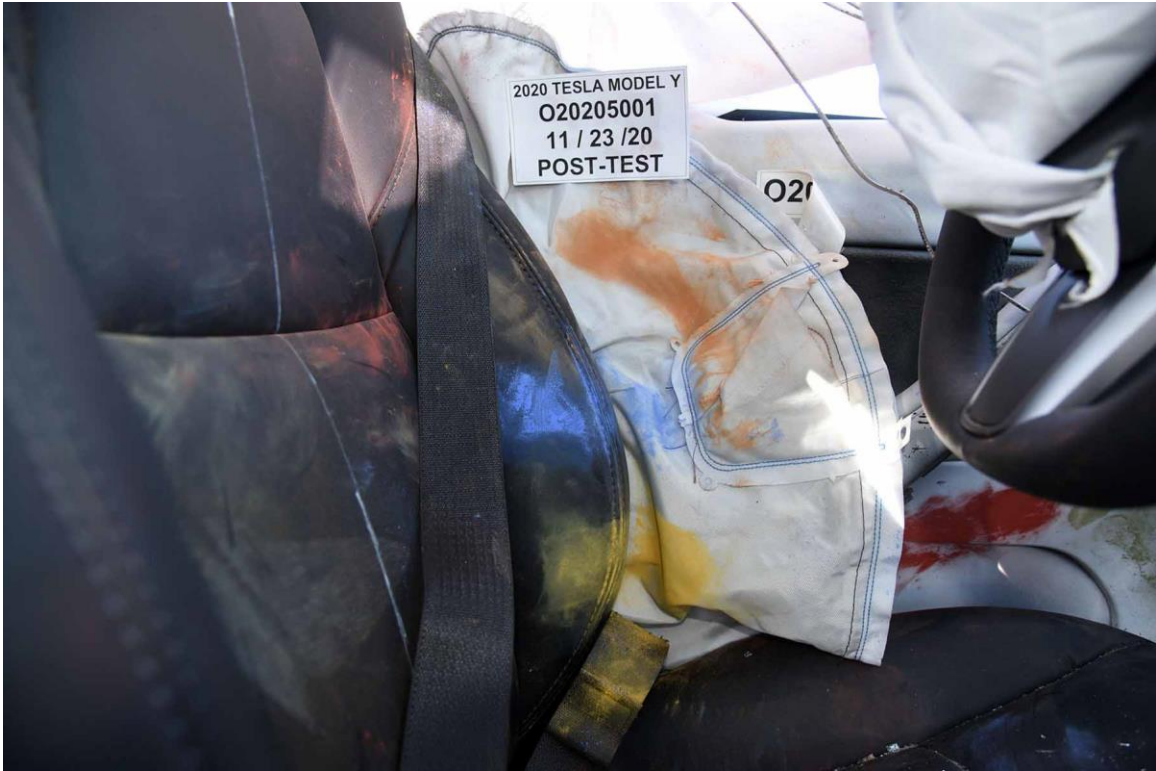
FIGURE 49. Post-Test Dummy Close-Up Torso Contact With Side Airbag View

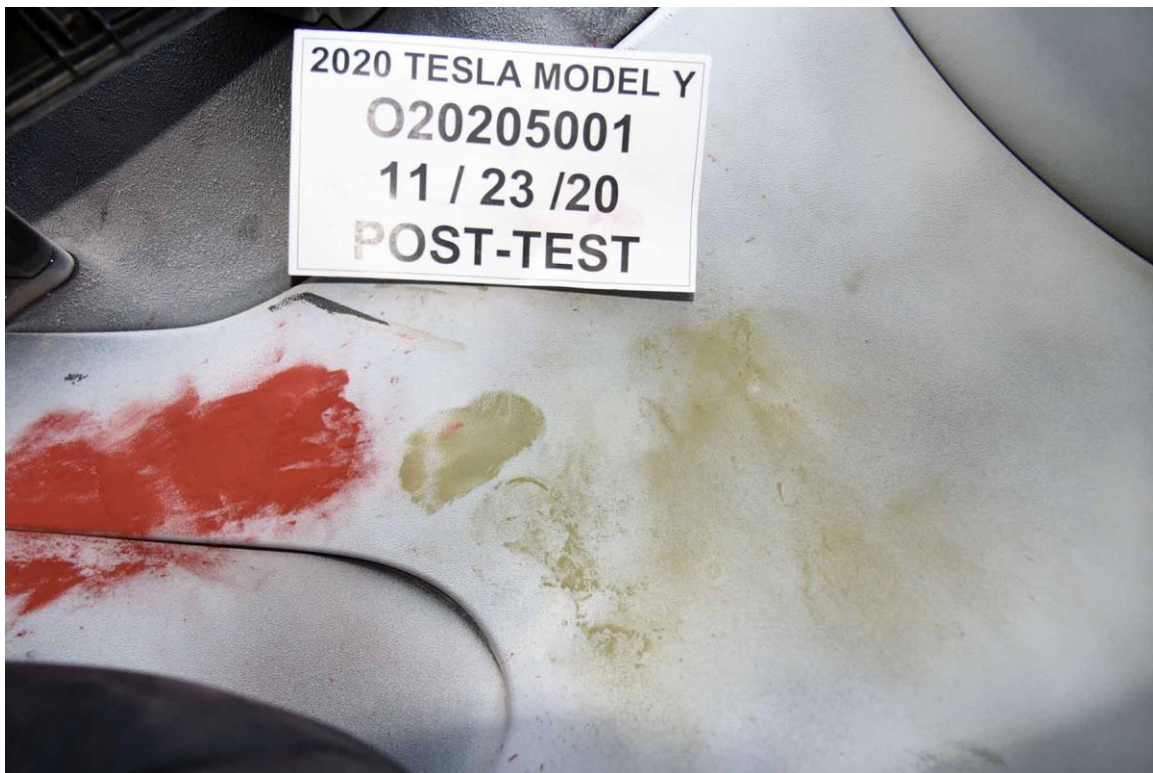
FIGURE 52. Post-Test Dummy Close-Up Knee Contact with Vehicle Interior View

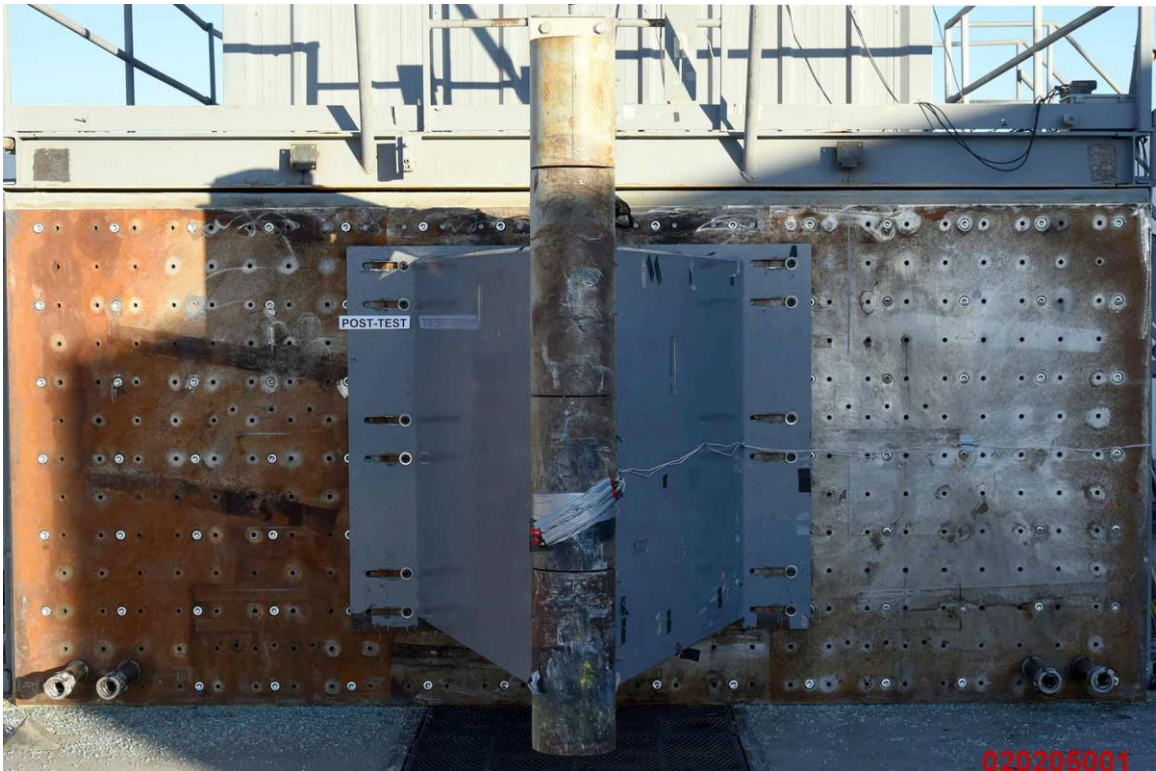
FIGURE 58. Post-Test Pole Barrier Front View

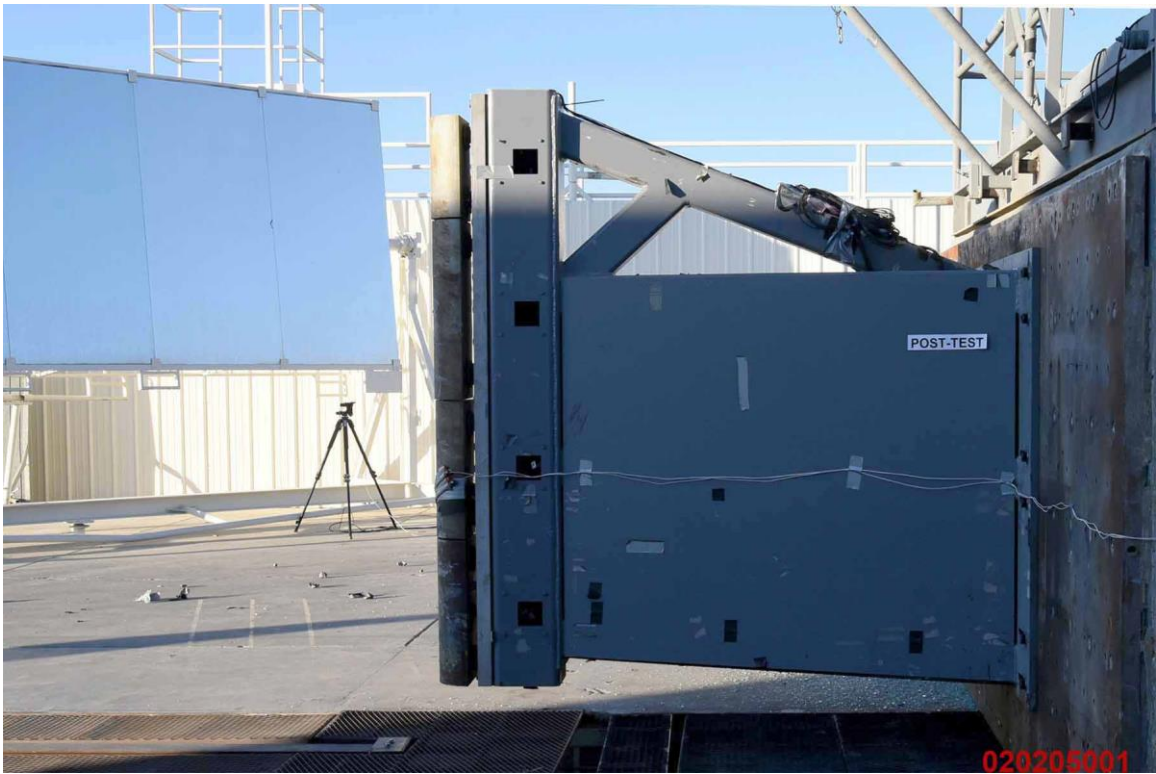
FIGURE 60. Post-Test Pole Barrier Side View
