**REPORT NUMBER: SINCAP-KAR-20-030**

**NEW CAR ASSESSMENT PROGRAM (NCAP)  
MOVING DEFORMABLE BARRIER SIDE IMPACT TEST**

**TESLA INC.  
2020 TESLA MODEL Y 5-DOOR MPV**

**NHTSA No: O20205002**

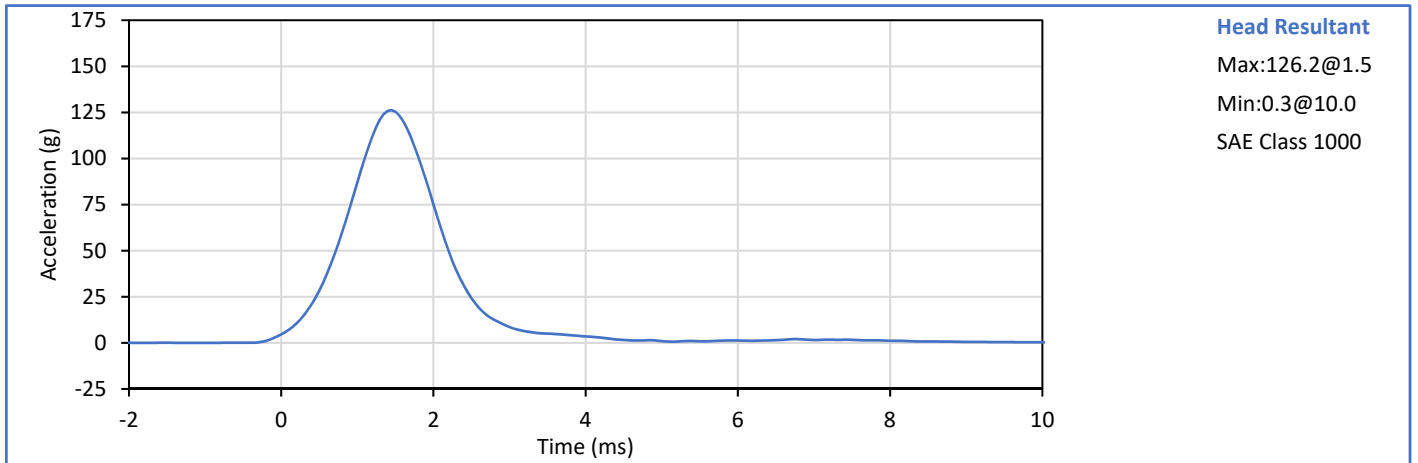
Tested Parameter	Units	Spec. Low	Spec. High	Result	Pass/Fail
Laboratory Temperature	°C	18.9	25.6	21.1	Pass
Laboratory Relative Humidity	%	10	70	28	Pass
Peak Resultant Acceleration	g	125.0	155.0	126.2	Pass
Peak Head Ax	g	-15.0	15.0	1.1	Pass
Oscillations After Main Pulse	%	0.0	15.0	1.6	Pass
Is Acceleration Unimodal?	Yes/No	Yes		Yes	Pass
Overall Test Results					Pass

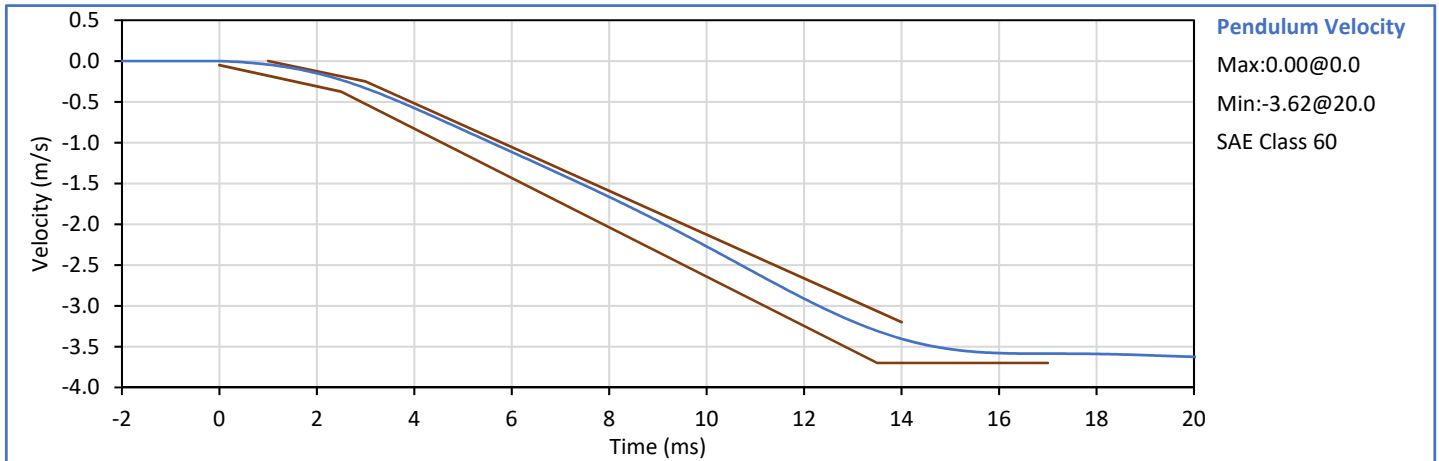
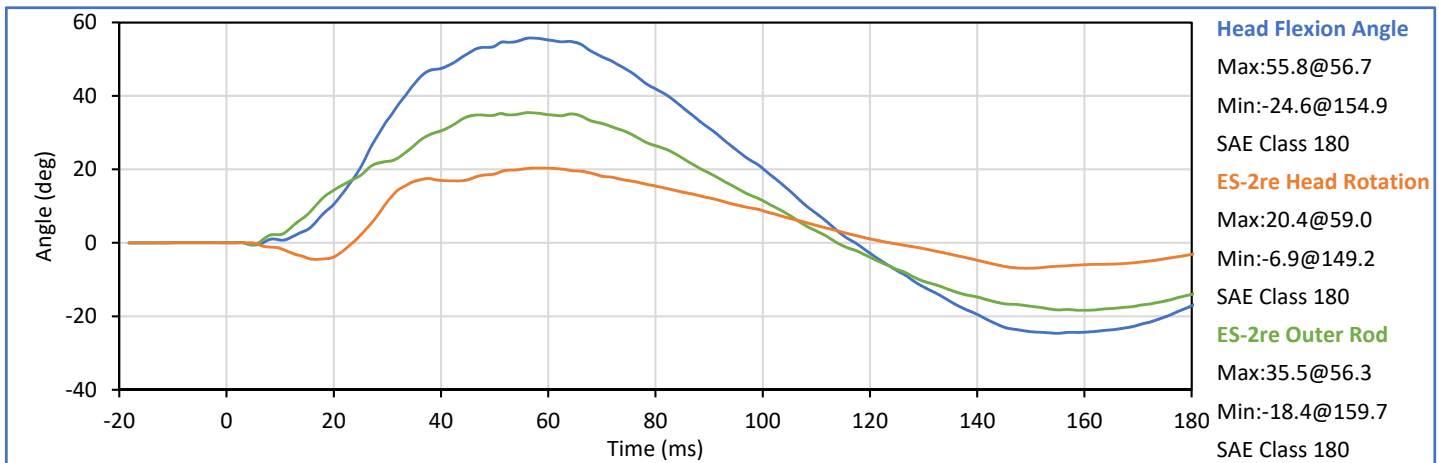
Tested Parameter	Units	Spec. Low	Spec. High	Result	Pass/Fail
Laboratory Temperature	°C	20.6	22.2	21.1	Pass
Laboratory Relative Humidity	%	10	70	19	Pass
Pendulum Velocity	m/s	3.30	3.50	3.47	Pass
Peak Headform Flexion	deg	49.0	59.0	55.8	Pass
Time of Peak Headform Flexion	ms	54.0	66.0	56.7	Pass
Flexion Decay (Peak to zero)	ms	53.0	88.0	60.6	Pass
Overall Test Results					Pass

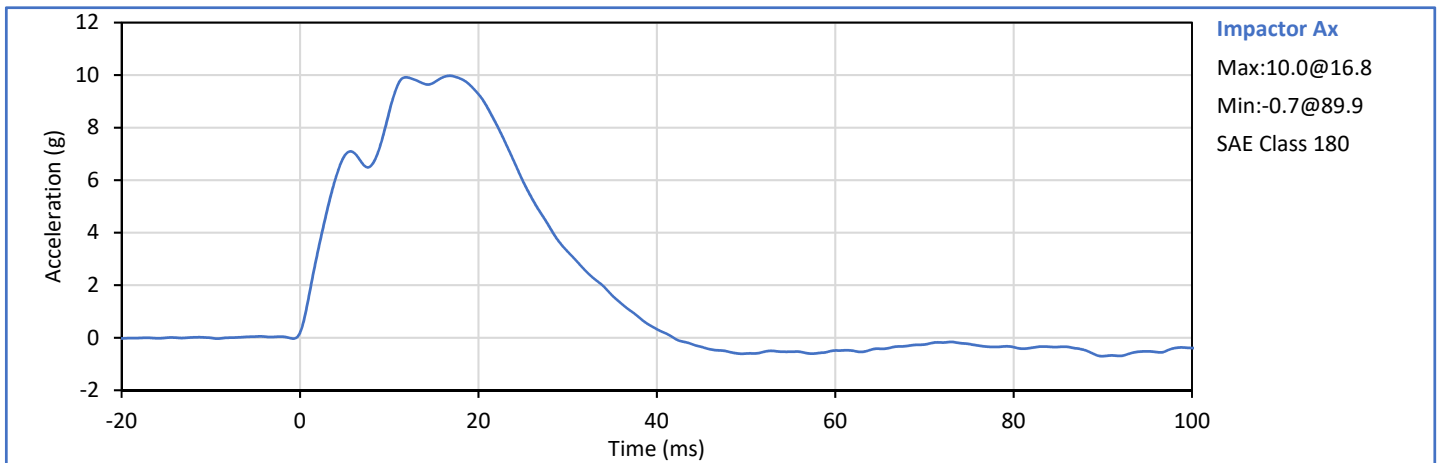
Tested Parameter	Units	Spec. Low	Spec. High	Result	Pass/Fail
Laboratory Temperature	°C	20.6	22.2	21.9	Pass
Laboratory Relative Humidity	%	10	70	22	Pass
Impactor Velocity	m/s	4.20	4.40	4.32	Pass
Peak Impactor Ax	g	7.5	10.5	10.0	Pass
Overall Test Results					Pass

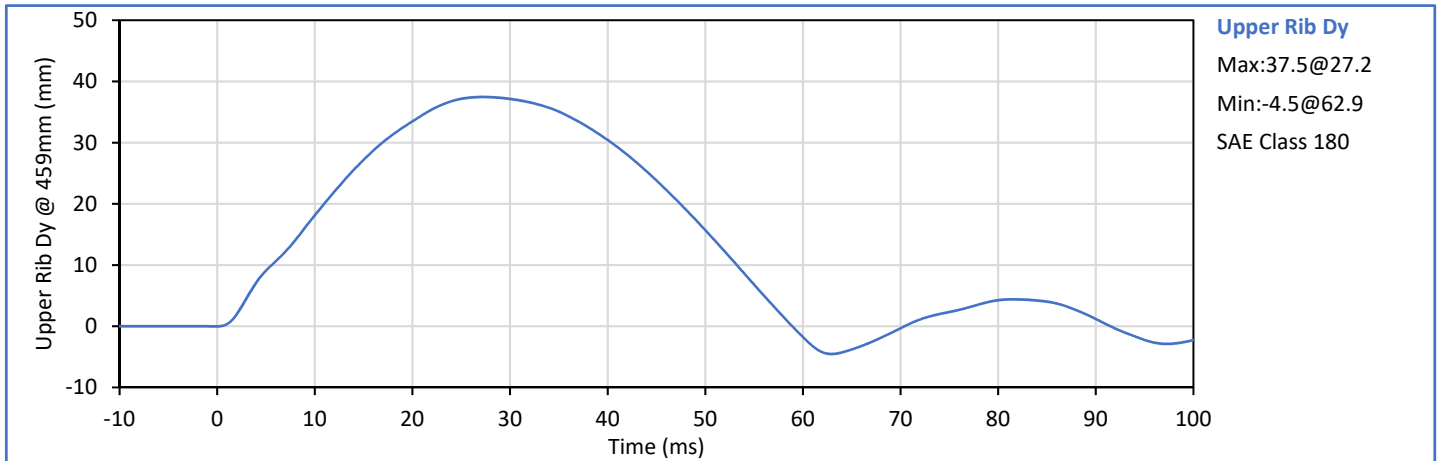
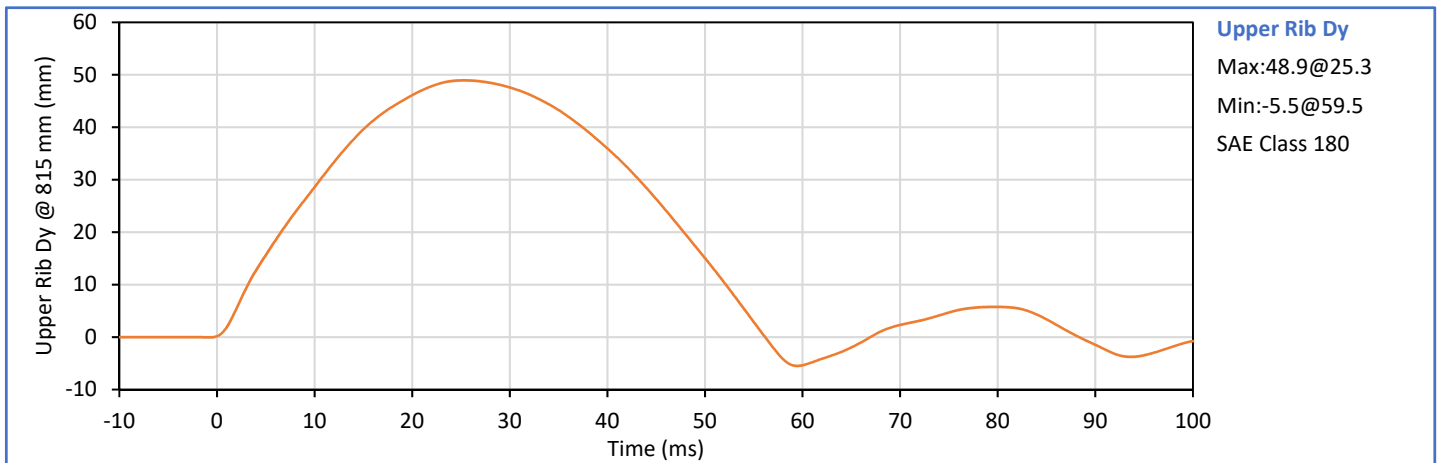
Tested Parameter	Units	Spec. Low	Spec. High	Result	Pass/Fail
Laboratory Temperature	°C	20.6	22.2	21.9	Pass
Laboratory Relative Humidity	%	10	70	19	Pass
Upper Rib Dy @ 459mm	mm	36.0	40.0	37.5	Pass
Upper Rib Dy @ 815mm	mm	46.0	51.0	48.9	Pass
Overall Test Results					Pass

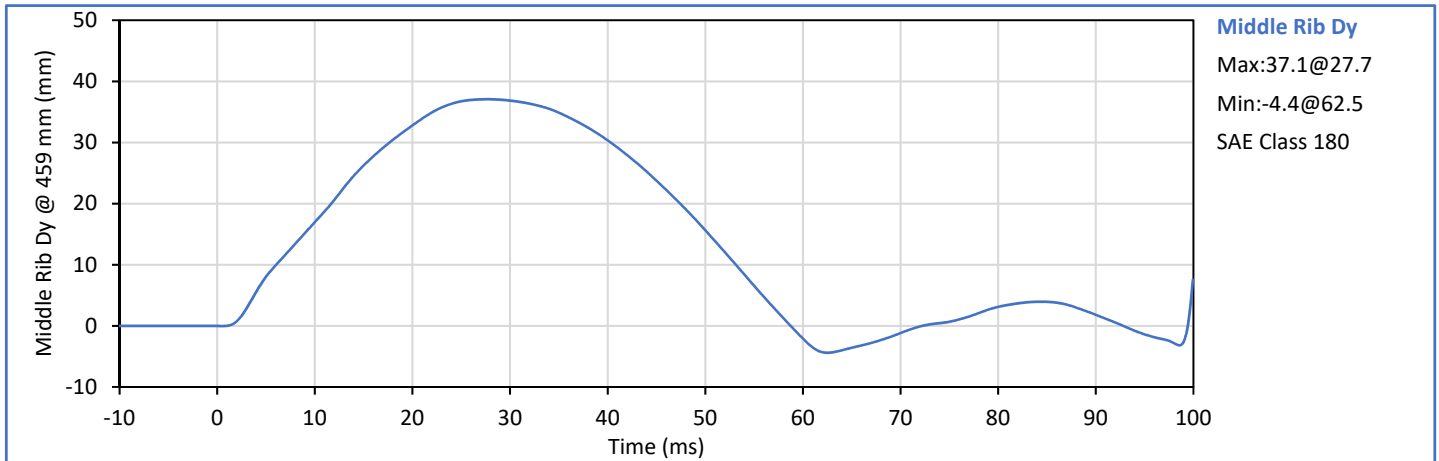
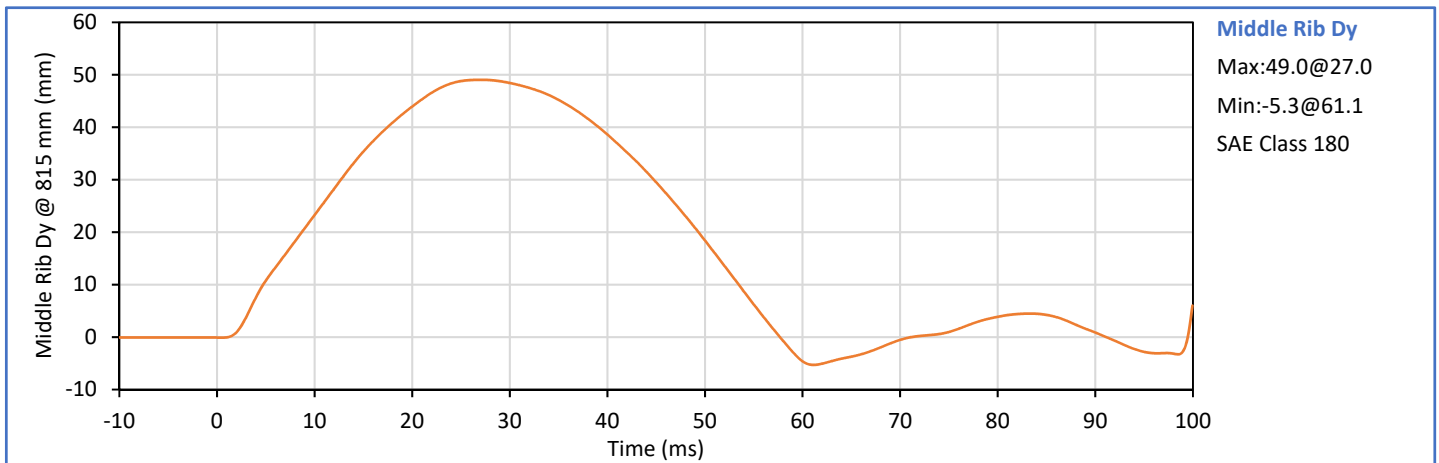
Tested Parameter	Units	Spec. Low	Spec. High	Result	Pass/Fail
Laboratory Temperature	°C	20.6	22.2	21.9	Pass
Laboratory Relative Humidity	%	10	70	20	Pass
Middle Rib Dy @ 459mm	mm	36.0	40.0	37.1	Pass
Middle Rib Dy @ 815mm	mm	46.0	51.0	49.0	Pass
Overall Test Results					Pass

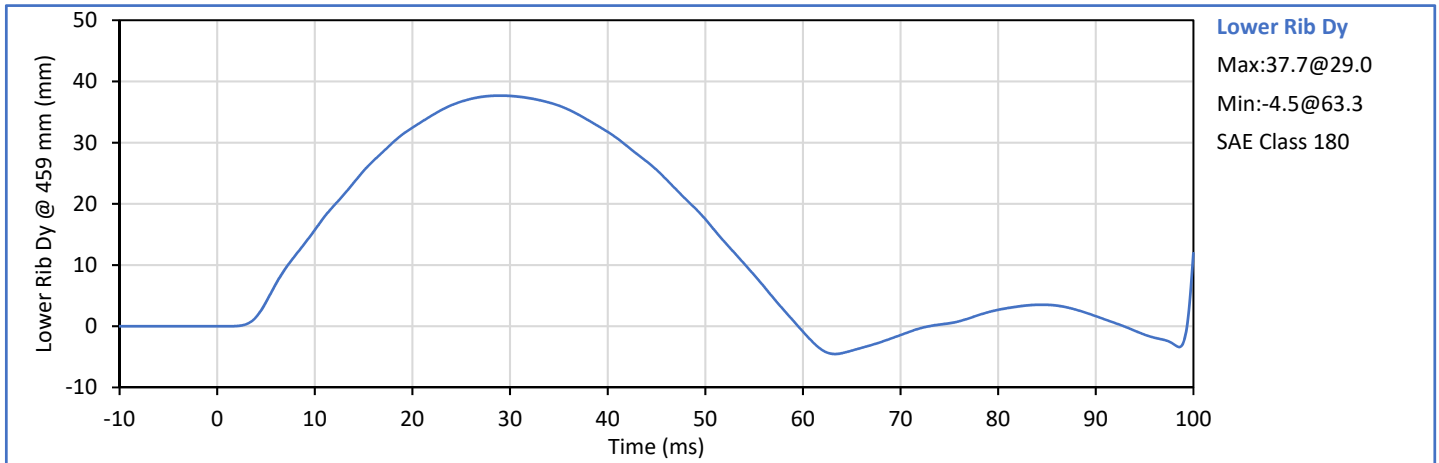
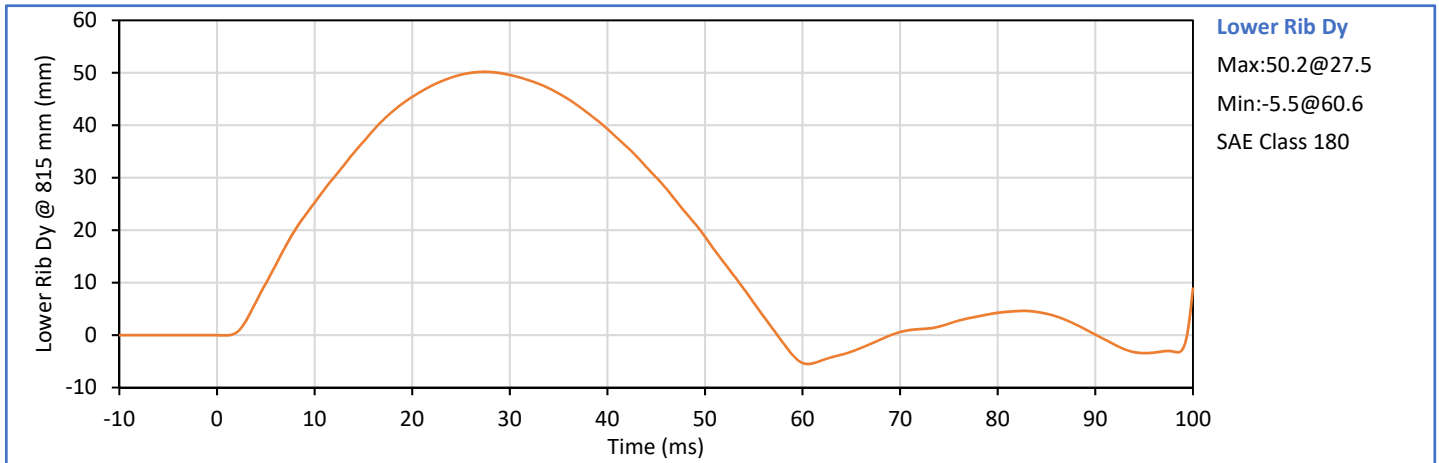
Tested Parameter	Units	Spec. Low	Spec. High	Result	Pass/Fail
Laboratory Temperature	°C	20.6	22.2	21.9	Pass
Laboratory Relative Humidity	%	10	70	20	Pass
Lower Rib Dy @ 459mm	mm	36.0	40.0	37.7	Pass
Lower Rib Dy @ 815mm	mm	46.0	51.0	50.2	Pass
Overall Test Results					Pass
