**REPORT NUMBER: SideNCAPMDB-MGA-20-031**

**NEW CAR ASSESSMENT PROGRAM (NCAP)  
Moving Deformable Barrier Side Impact Test**

**AUDI AG  
2020 Audi A6 45 TFSI quattro 4-Door Sedan  
NHTSA No.: O20205800**

**FINAL REPORT**

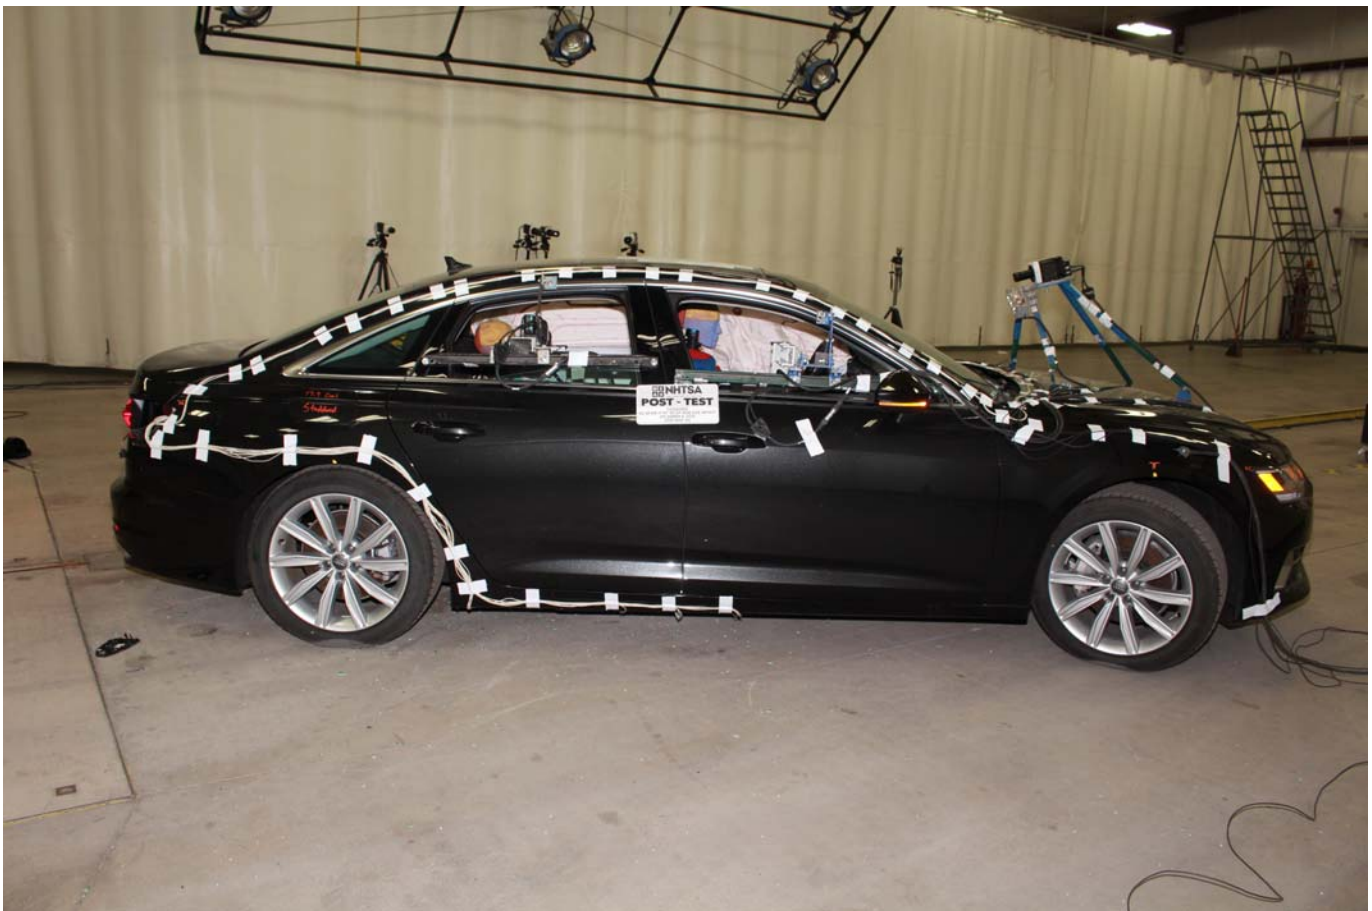
Photo No. 014 - Post-Test Right Side View of Test Vehicle

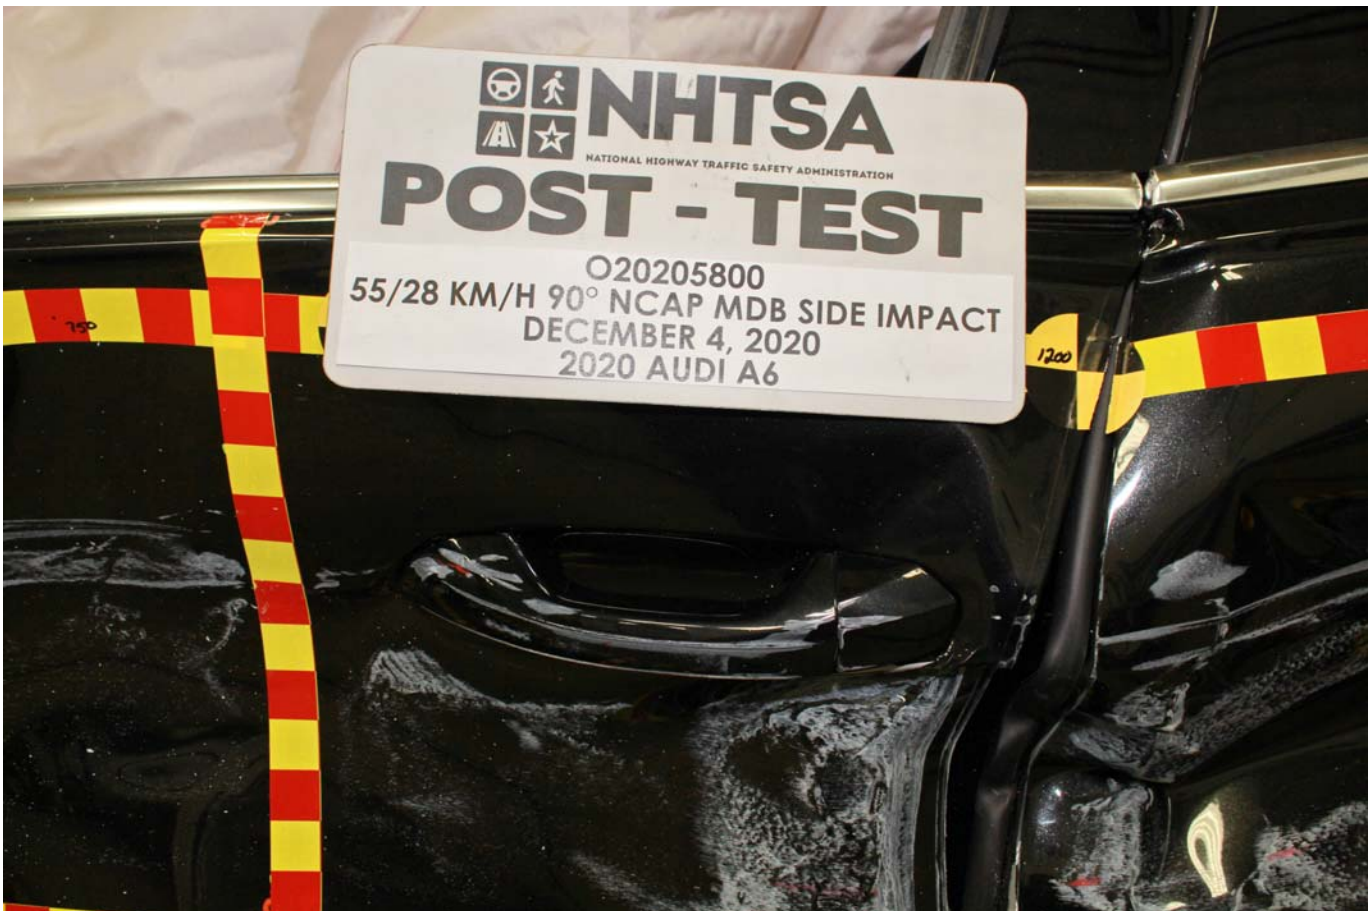
Photo No. 022 - Post-Test Left Front Door Latch Close-Up

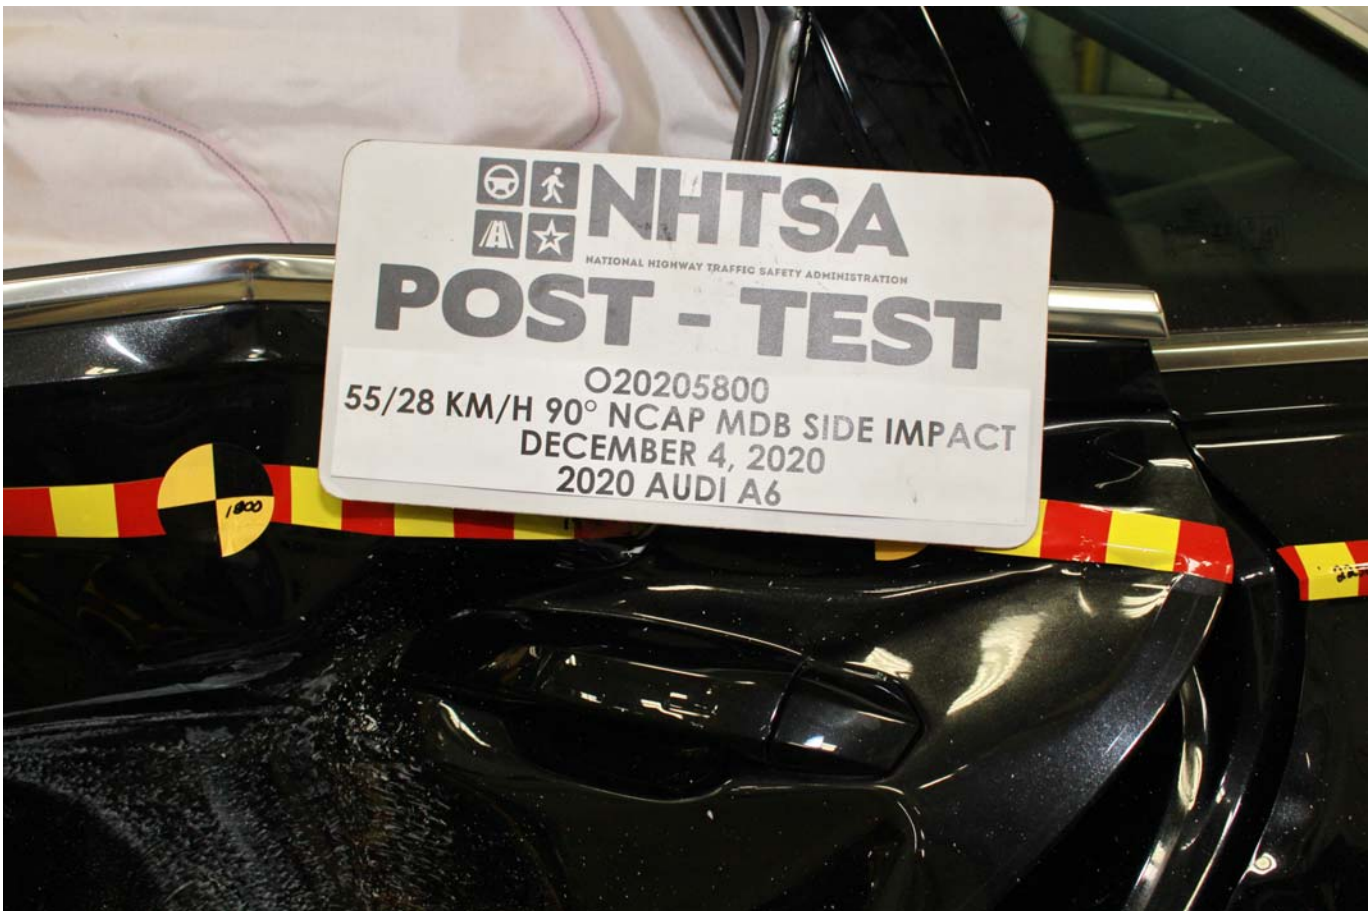
Photo No. 024 - Post-Test Left Rear Door Latch Close-Up

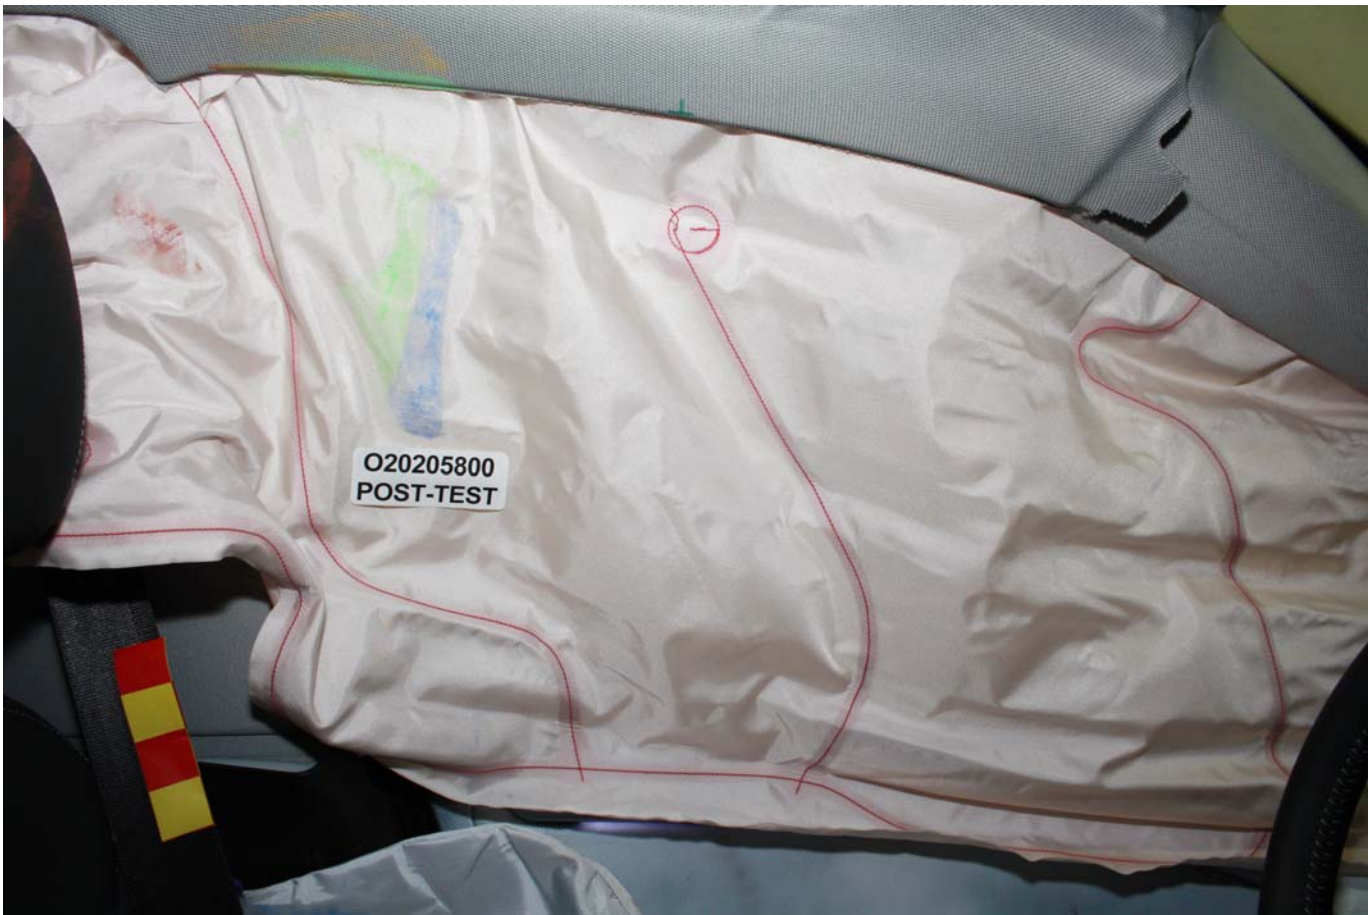
Photo No. 049 - Post-Test Driver Dummy Close-up Head Contact with Side Airbag View

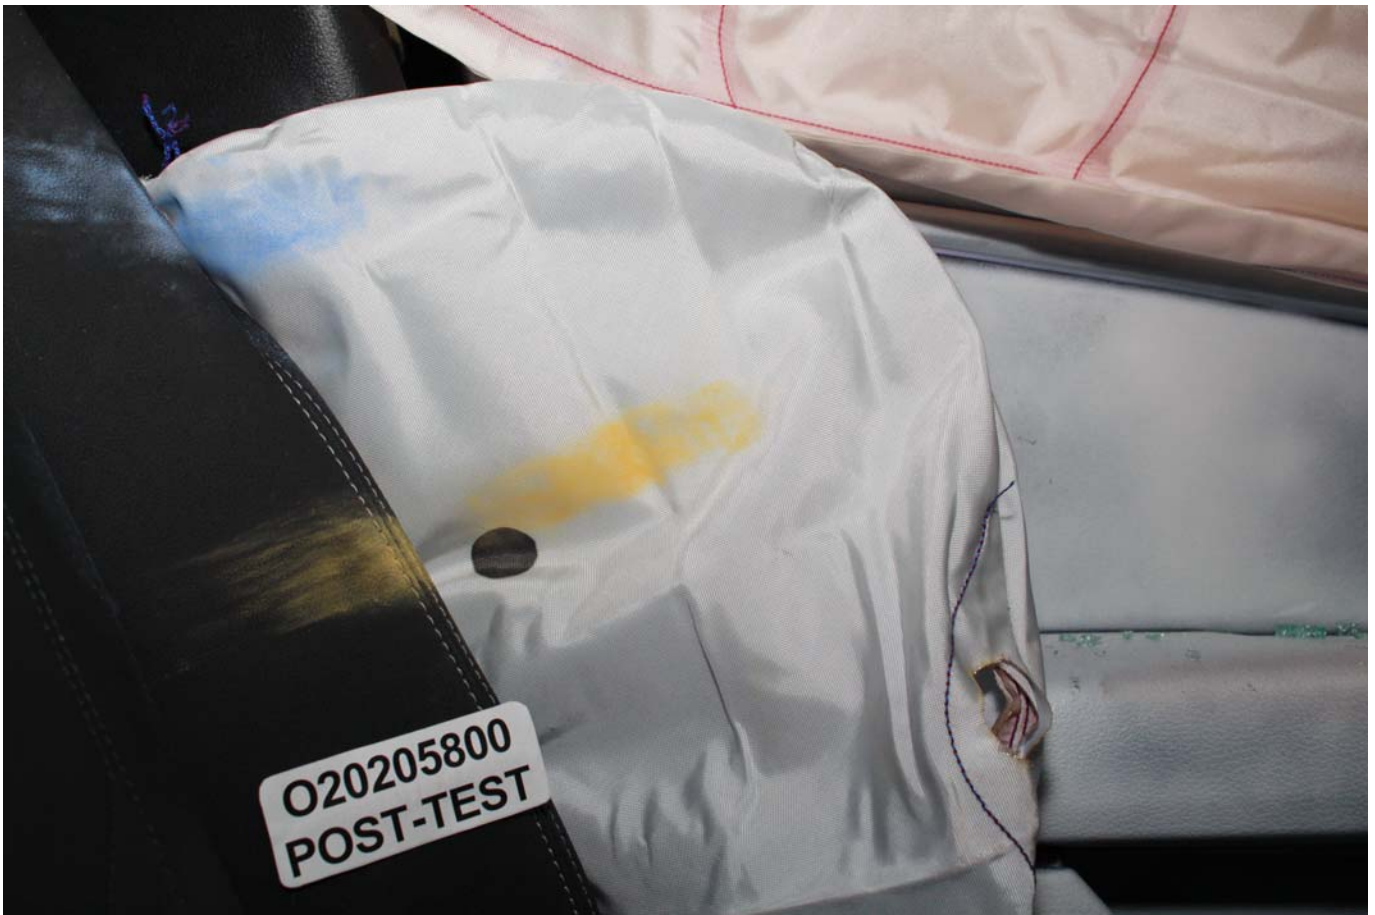
Photo No. 051 - Post-Test Driver Dummy Close-up Torso Contact with Side Airbag View

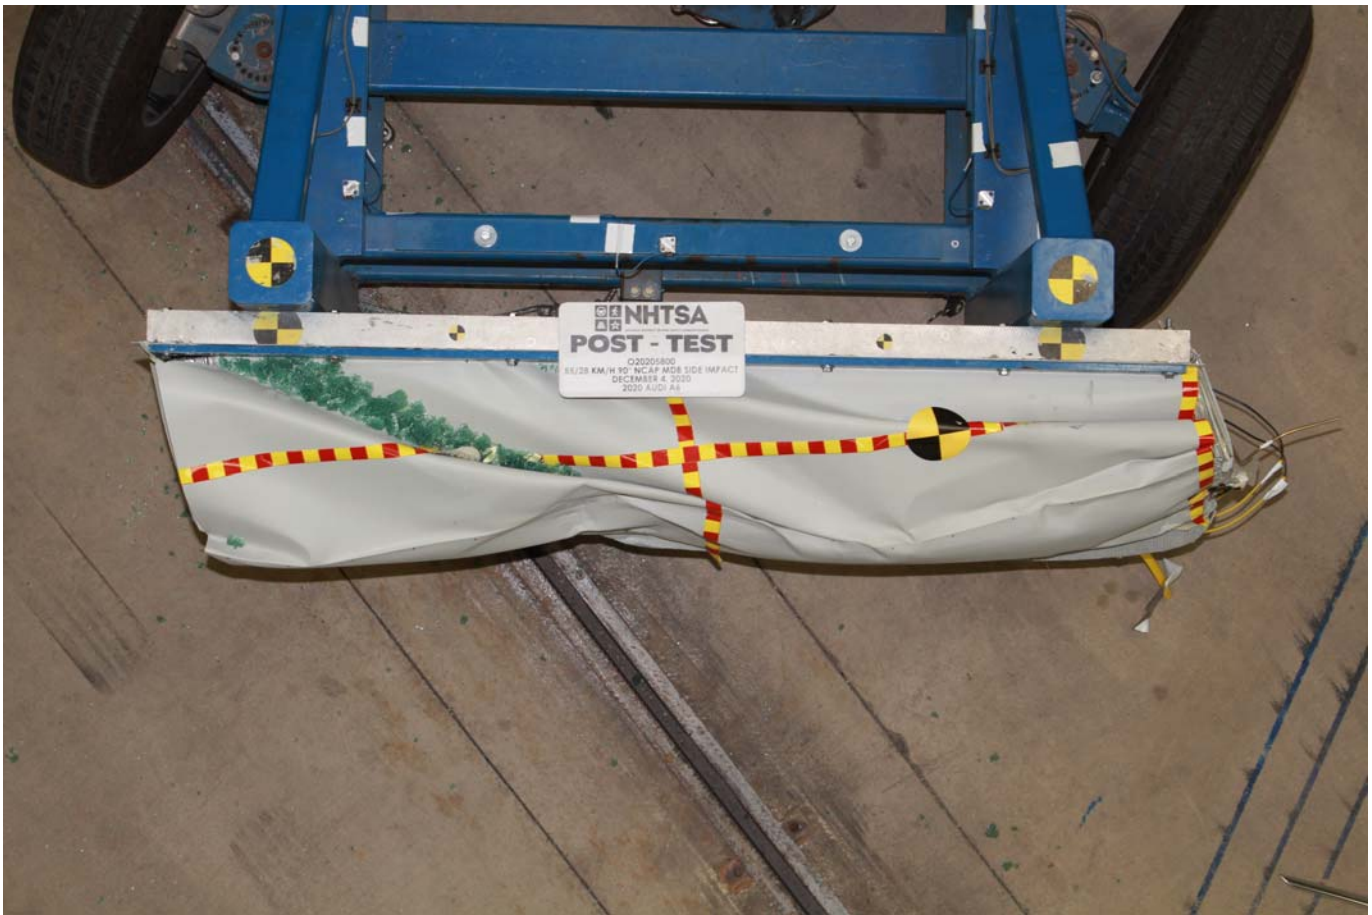
Photo No. 087 - Post-Test Top View of MDB Impactor Face

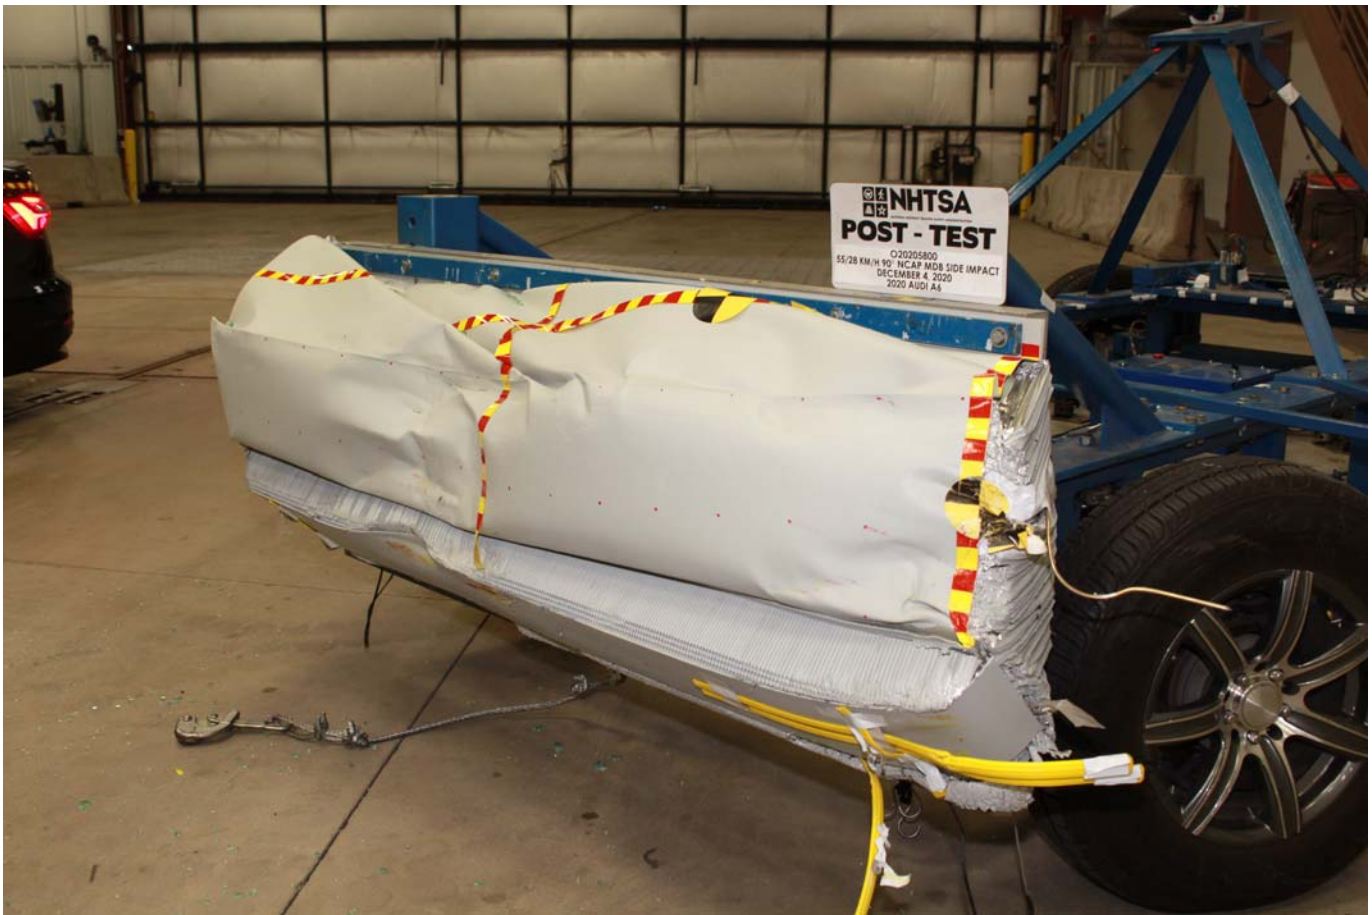
Photo No. 089 - Post-Test Left Side View of MDB Impactor Face

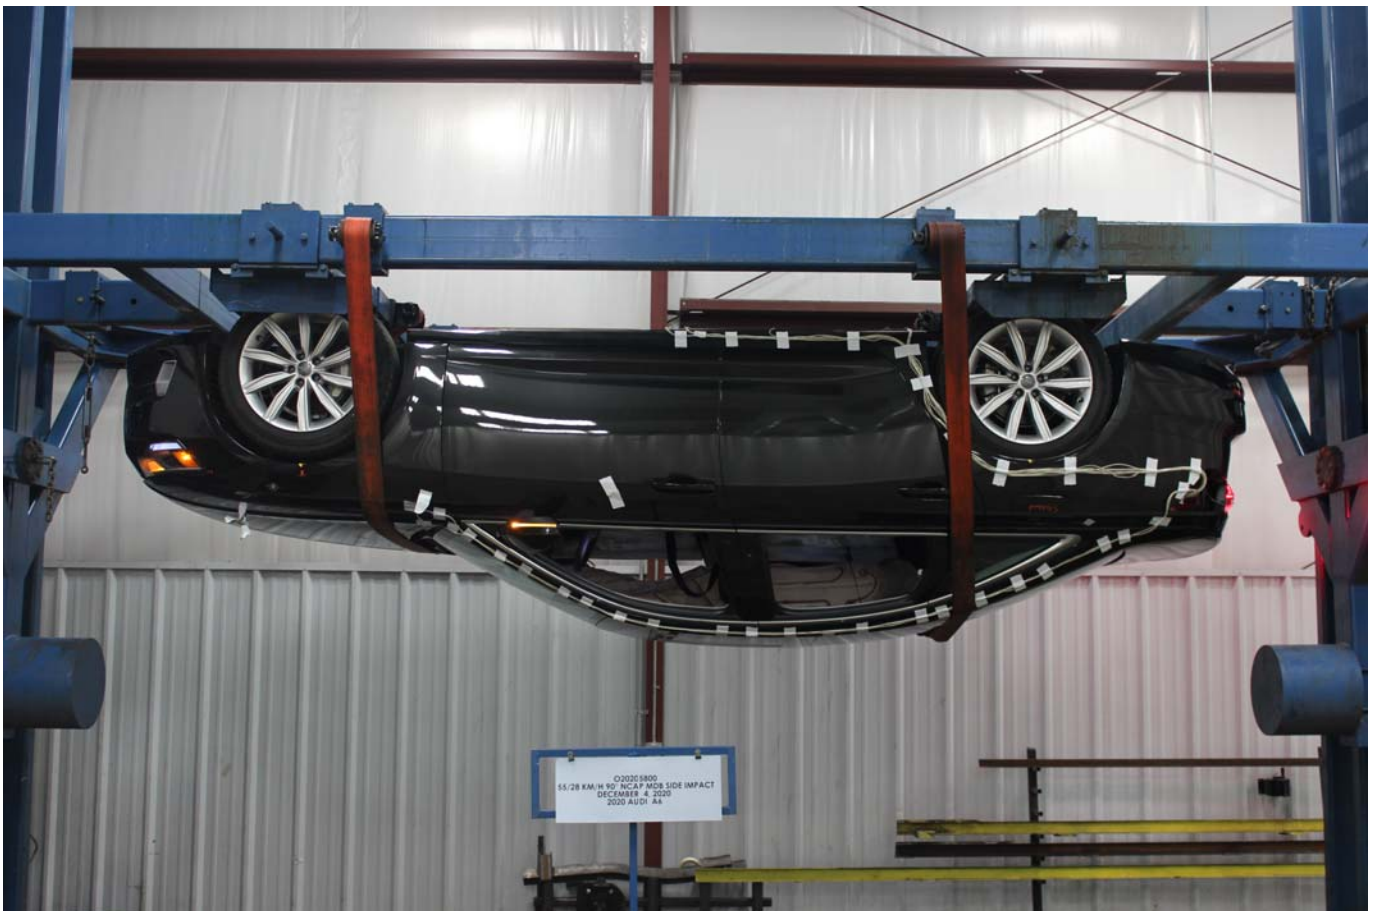
Photo No. 098 - FMVSS Photo No. 301 Static Rollover 180 Degrees

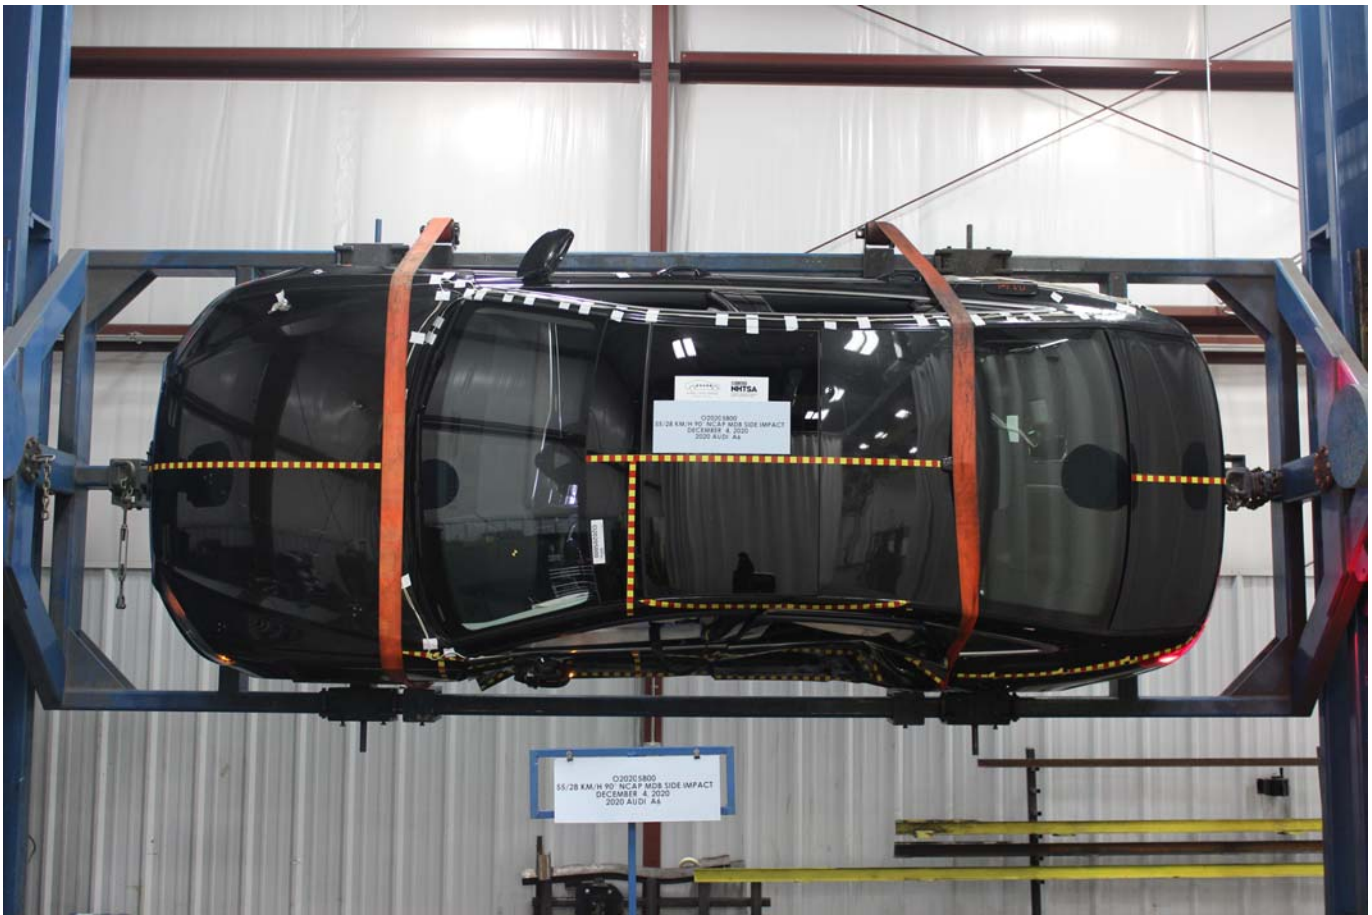
Photo No. 099 - FMVSS Photo No. 301 Static Rollover 270 Degrees

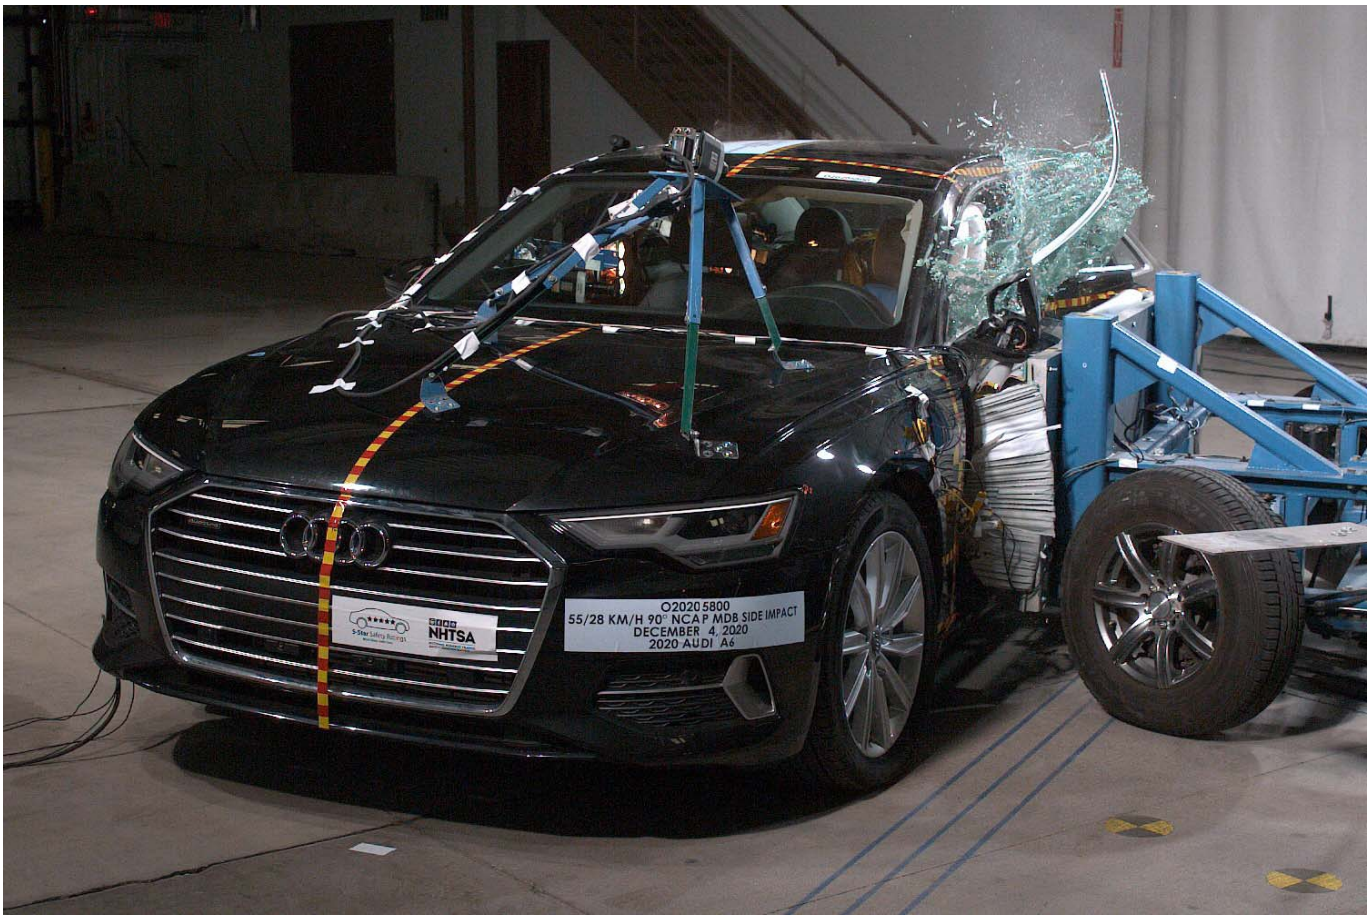
Photo No. 101 - Impact Event
