REPORT NUMBER: NCAP-CAL-21-002

NEW CAR ASSESSMENT PROGRAM (NCAP) FRONTAL BARRIER IMPACT TEST

Toyota Motor Manufacturing Canada Inc. 2021 Lexus RX350 SUV

NHTSA No: M20215102

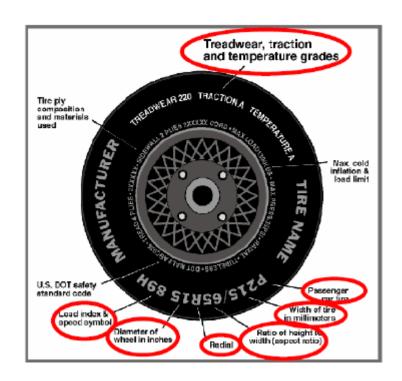
Collect items circled in red, tire manufacturer, and tire name.

VEHICLE TIRE INFORMATION

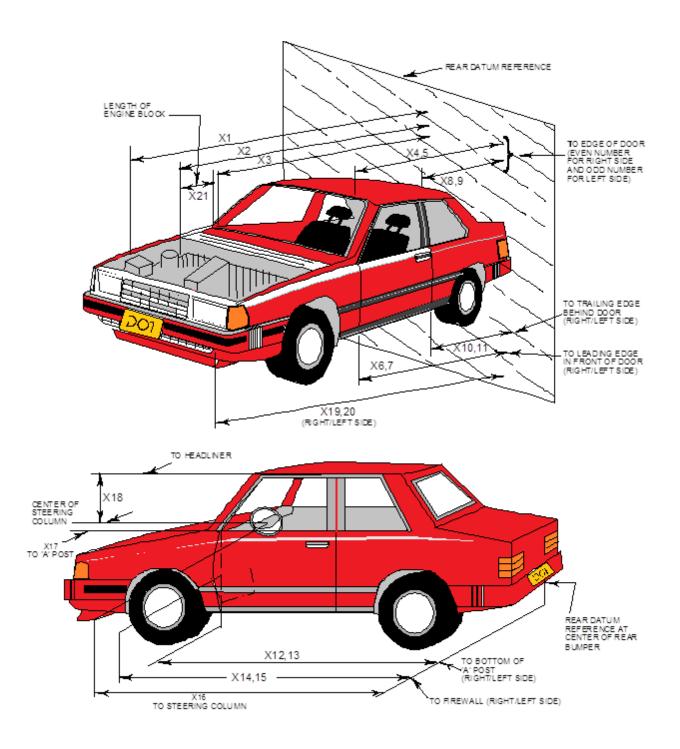
DATA SHEET NO. 12 ... (CONTINUED) VEHICLE PROFILE MEASUREMENTS

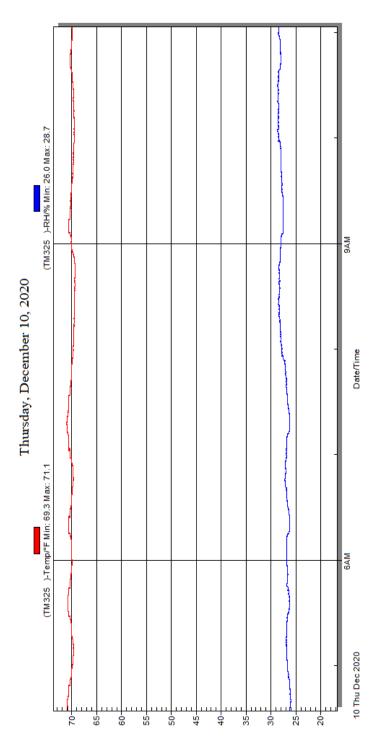
DATA SHEET NO. 17 DUMMY / VEHICLE TEMPERATURE STABILIZATION CHART

Temperature and Humidity Stabilization Chart/Data for Dummies and Test Vehicle

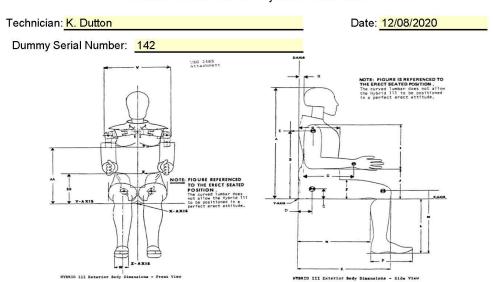
External Measurements - Hybrid 3 - 50th Male

Symbol	Description		ication n)	Result (in)	Pass/Fail
Α	Sitting Height	34.6	35.0	34.7	Pass
В	Shoulder Pivot Height	19.9	20.5	20.3	Pass
С	H-Point Height	3.3	3.5	3.4	Pass
D	H-Point from Backline	5.3	5.5	5.4	Pass
E	Shoulder Pivot from Backline	3.3	3.7	3.5	Pass
F	Thigh Clearance	5.5	6.1	5.9	Pass
G	Back of Elbow to Wrist Pivot	11.4	12.0	11.8	Pass
Н	Head Back to Backline	1.6	1.8	1.7	Pass
	Shoulder to Elbow Length	13.0	13.6	13.4	Pass
J	Elbow Rest Height	7.5	8.3	8.1	Pass
K	Buttock to Knee Length	22.8	23.8	23.1	Pass
L	Popliteal Height	16.9	17.9	17.4	Pass
М	Knee Pivot Height	19.1	19.7	19.5	Pass
N	Buttock Popliteal Length	17.8	18.8	18.3	Pass
0	Chest Depth without Jacket	8.4	9.0	8.6	Pass
Р	Foot Length (right)	9.9	10.5	10.1	Pass
٧	Shoulder Breadth	16.3	17.2	16.8	Pass
W	Foot Breadth	3.6	4.2	3.8	Pass
Υ	Chest Circumference with Jacket	38.2	39.4	38.8	Pass
Z	Waist Circumference	32.9	34.1	33.7	Pass
AA	Reference Location (Chest Circumference)	16.9	17.1	17.0	Pass

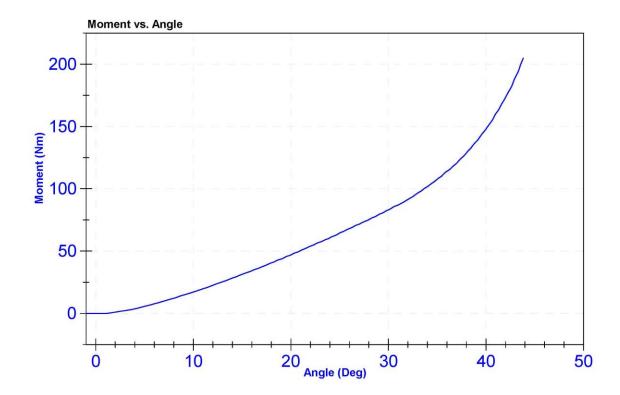
Certification Report Hybrid 3 - 50th Male Hip ROM Left - CFR 572

Test Parameter	Minimum Specification	Maximum Specification	Unit	Result	Pass/Fail
Temperature	18.9	25.6	°C	21.5	Pass
Humidity	10	70	%	32.2	Pass
Average Velocity	5	10	deg/s	7.2	Pass
Angle at 203Nm	40	50	deg	43.7	Pass
Moment at 30 degrees	0	94.9	Nm	83.1	Pass

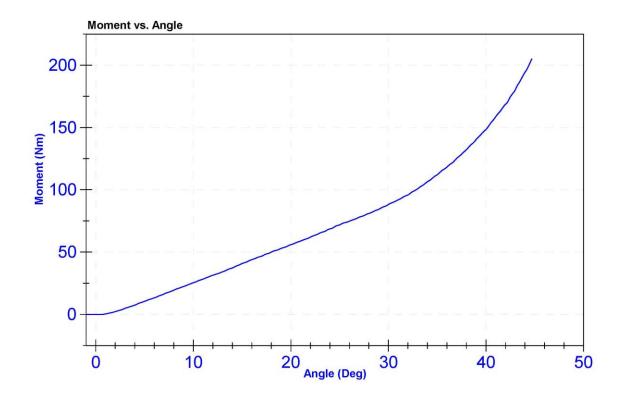
Certification Report Hybrid 3 - 50th Male Hip ROM Right - CFR 572

Test Parameter	Minimum Specification	Maximum Specification	Unit	Result	Pass/Fail
Temperature	18.9	25.6	°C	21.5	Pass
Humidity	10	70	%	32.2	Pass
Average Velocity	5	10	deg/s	7.3	Pass
Angle at 203Nm	40	50	deg	44.6	Pass
Moment at 30 degrees	0	94.9	Nm	88.3	Pass

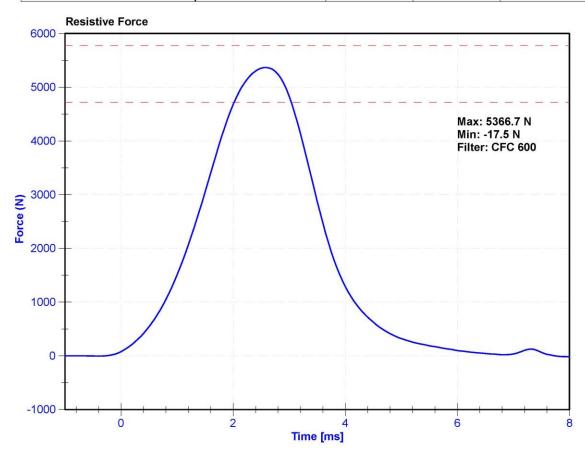
Certification Report Hybrid 3 - 50th Male Knee Impact Left - CFR 572

Test Parameter	Minimum Specification	Maximum Specification	Unit	Result	Pass/Fail
Temperature	18.9	25.6	°C	21.6	Pass
Humidity	10	70	%	34.2	Pass
Velocity	2.07	2.13	m/s	2.120	Pass
Maximum Resistive Force	4720	5780	N	5366.7	Pass

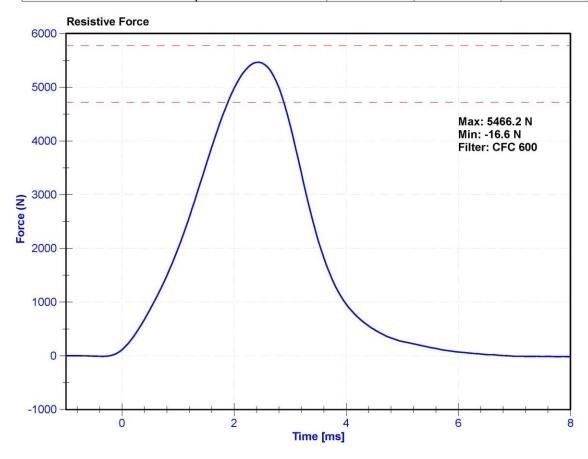
Certification Report Hybrid 3 - 50th Male Knee Impact Right - CFR 572

Test Parameter	Minimum Specification	Maximum Specification	Unit	Result	Pass/Fail
Temperature	18.9	25.6	°C	21.2	Pass
Humidity	10	70	%	35	Pass
Velocity	2.07	2.13	m/s	2.121	Pass
Maximum Resistive Force	4720	5780	N	5466.2	Pass

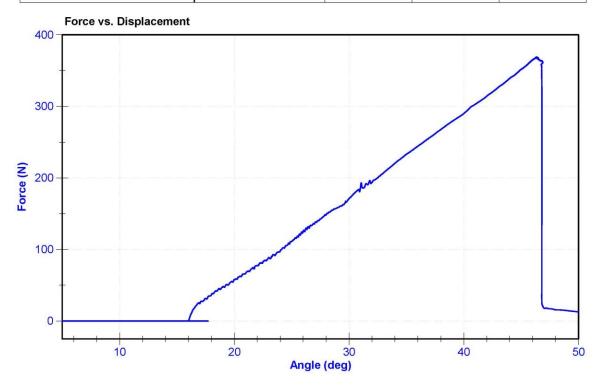
Certification Report Hybrid 3 - 5th Female Torso Flexion - CFR 572

Test Parameter	Minimum Specification	Maximum Specification	Unit	Result	Pass/Fail
Temperature	18.6	25.6	°C	21.5	Pass
Humidity	10	70	%	29.8	Pass
Initial Angle	0	20	deg	16.0	Pass
Force at 45 Degrees	320	390	N	369.1	Pass
Return Angle Relative to Initial	0	8	deg	2.4	Pass

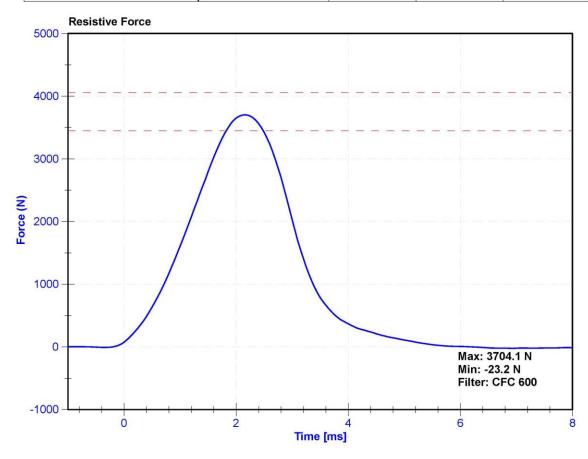
Certification Report Hybrid 3 - 5th Female Knee Impact Left - CFR 572

Test Parameter	Minimum Specification	Maximum Specification	Unit	Result	Pass/Fail
Temperature	18.9	25.6	°C	21.4	Pass
Humidity	10	70	%	21.0	Pass
Velocity	2.07	2.13	m/s	2.117	Pass
Resistive Force	3450	4060	N	3704.1	Pass

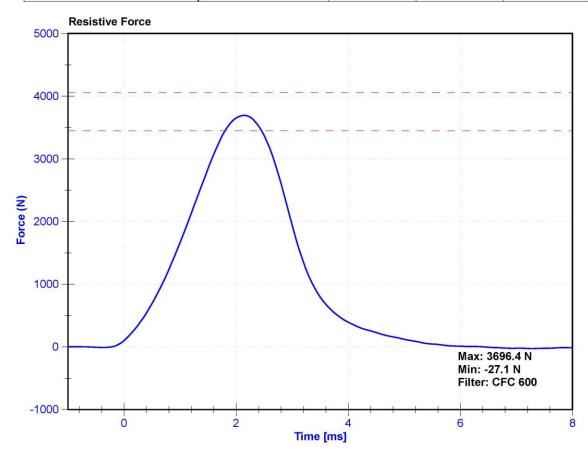
Certification Report Hybrid 3 - 5th Female Knee Impact Right - CFR 572

Test Parameter	Minimum Specification	Maximum Specification	Unit	Result	Pass/Fail
Temperature	18.9	25.6	°C	21.4	Pass
Humidity	10	70	%	21.0	Pass
Velocity	2.07	2.13	m/s	2.115	Pass
Resistive Force	3450	4060	N	3696.4	Pass
