REPORT NUMBER: NCAP-CAL-21-001

**NEW CAR ASSESSMENT PROGRAM (NCAP)
FRONTAL BARRIER IMPACT TEST**

**Mercedes-Benz AG Stuttgart
2021 Mercedes-Benz GLC 300 4 Matic
SUV**

NHTSA No: M20214306

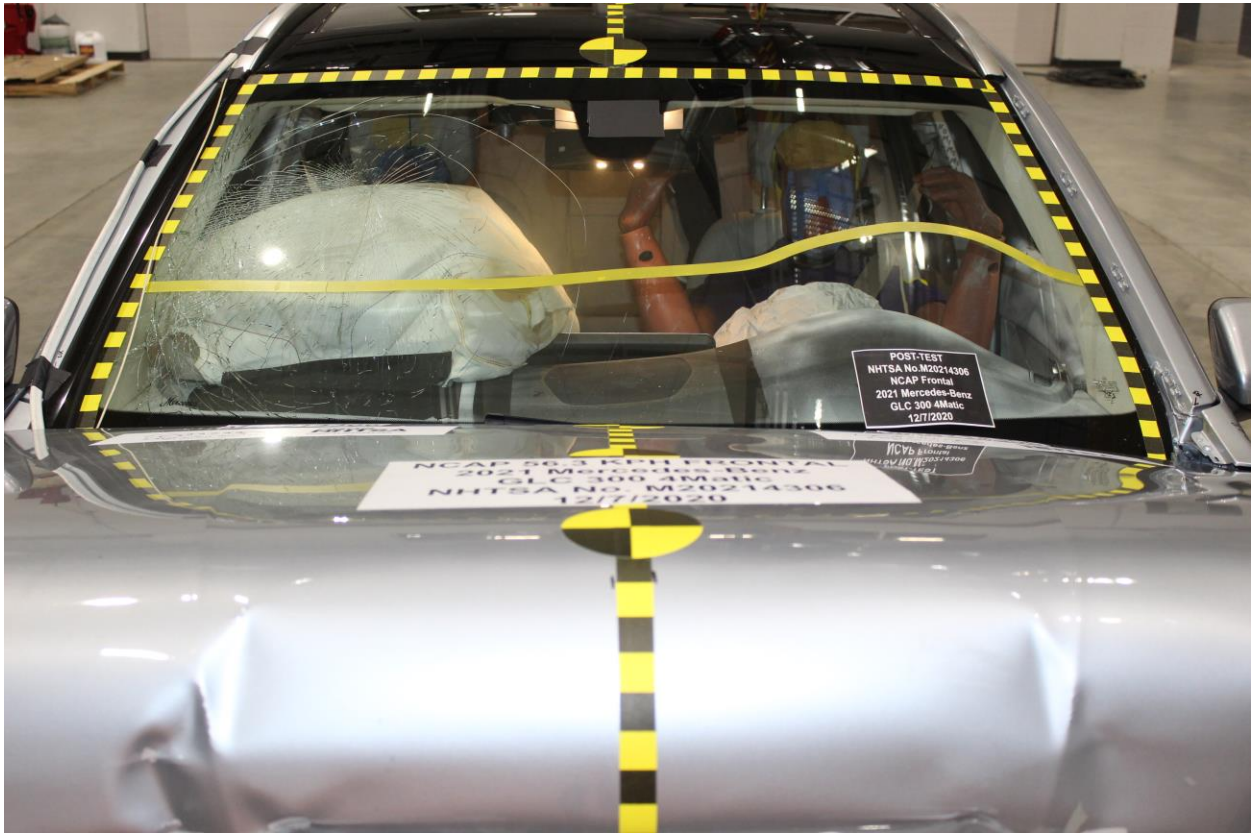
Figure A-19: Post-Test Windshield View

Critical Areas of Performance	Observations and Conclusions
Windshield Damage	Cracks along passenger side due to airbag deployment
Window Damage	None
Other	Both rear windows rolled down approximately 80 mm after the event
