**REPORT NUMBER: SideNCAPMDB-MGA-21-012**

**NEW CAR ASSESSMENT PROGRAM (NCAP)  
Moving Deformable Barrier Side Impact Test**

**FORD MOTOR CO.  
2021 Ford Transit Connect XLT Wagon LWB  
NHTSA No.: M20210220**

**MGA RESEARCH CORPORATION  
5000 Warren Road  
Burlington, WI 53105**

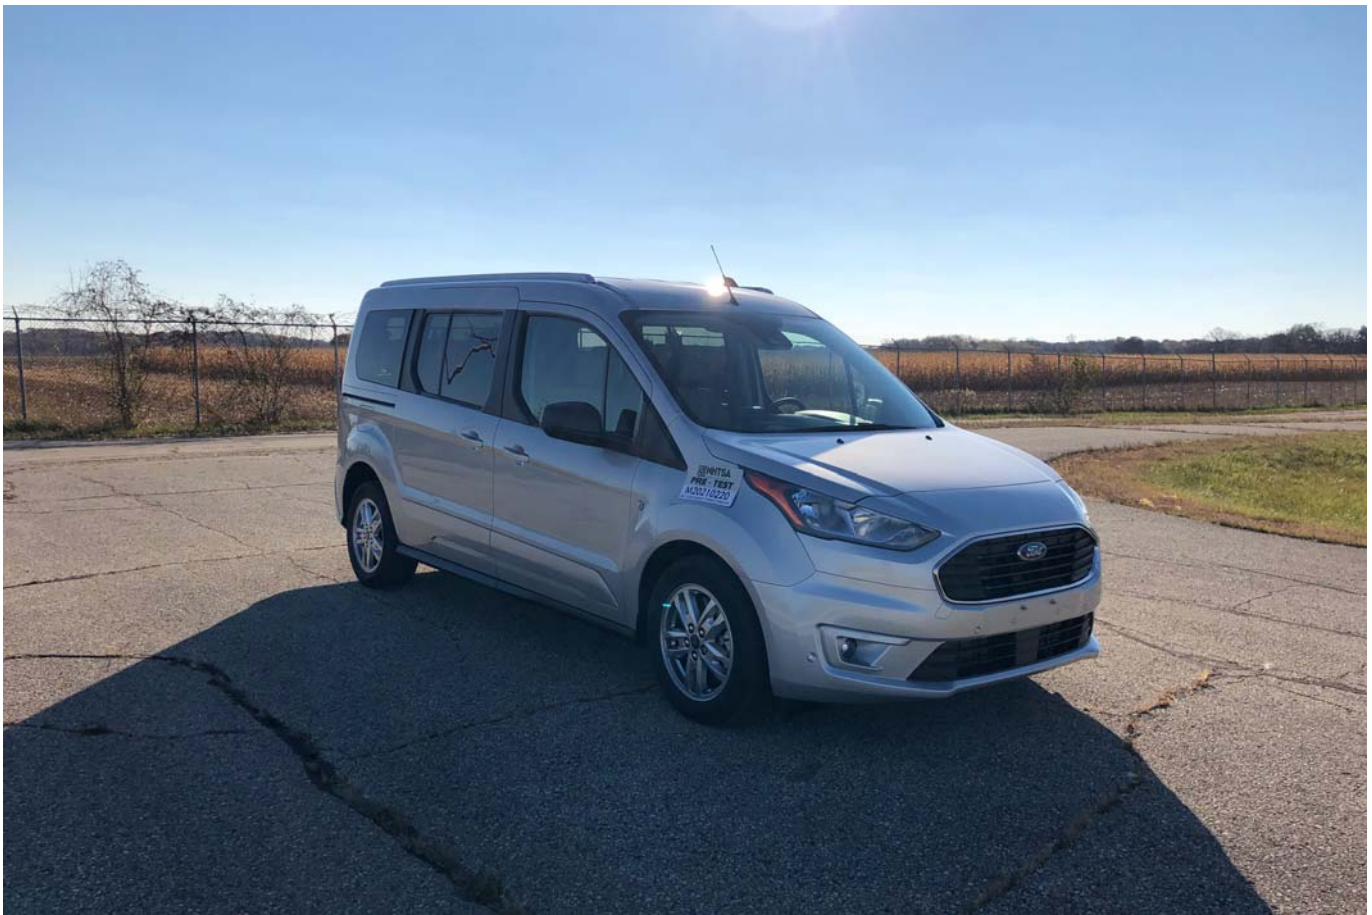
Photo No. 001 - As Delivered Right Front Three-Quarter View of Test Vehicle

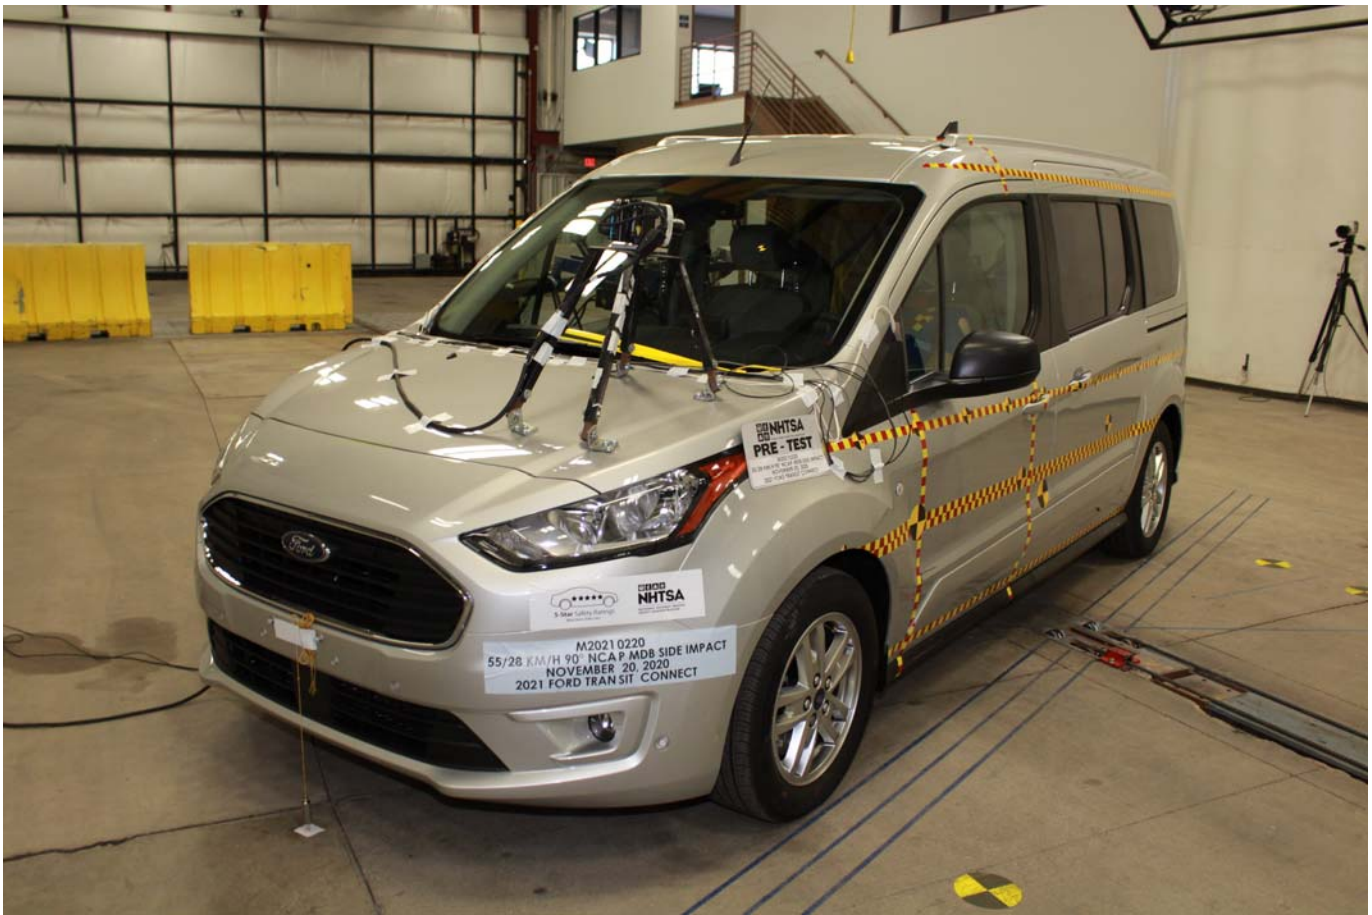
Photo No. 005 - Pre-Test Left Front Three-Quarter View of Test Vehicle

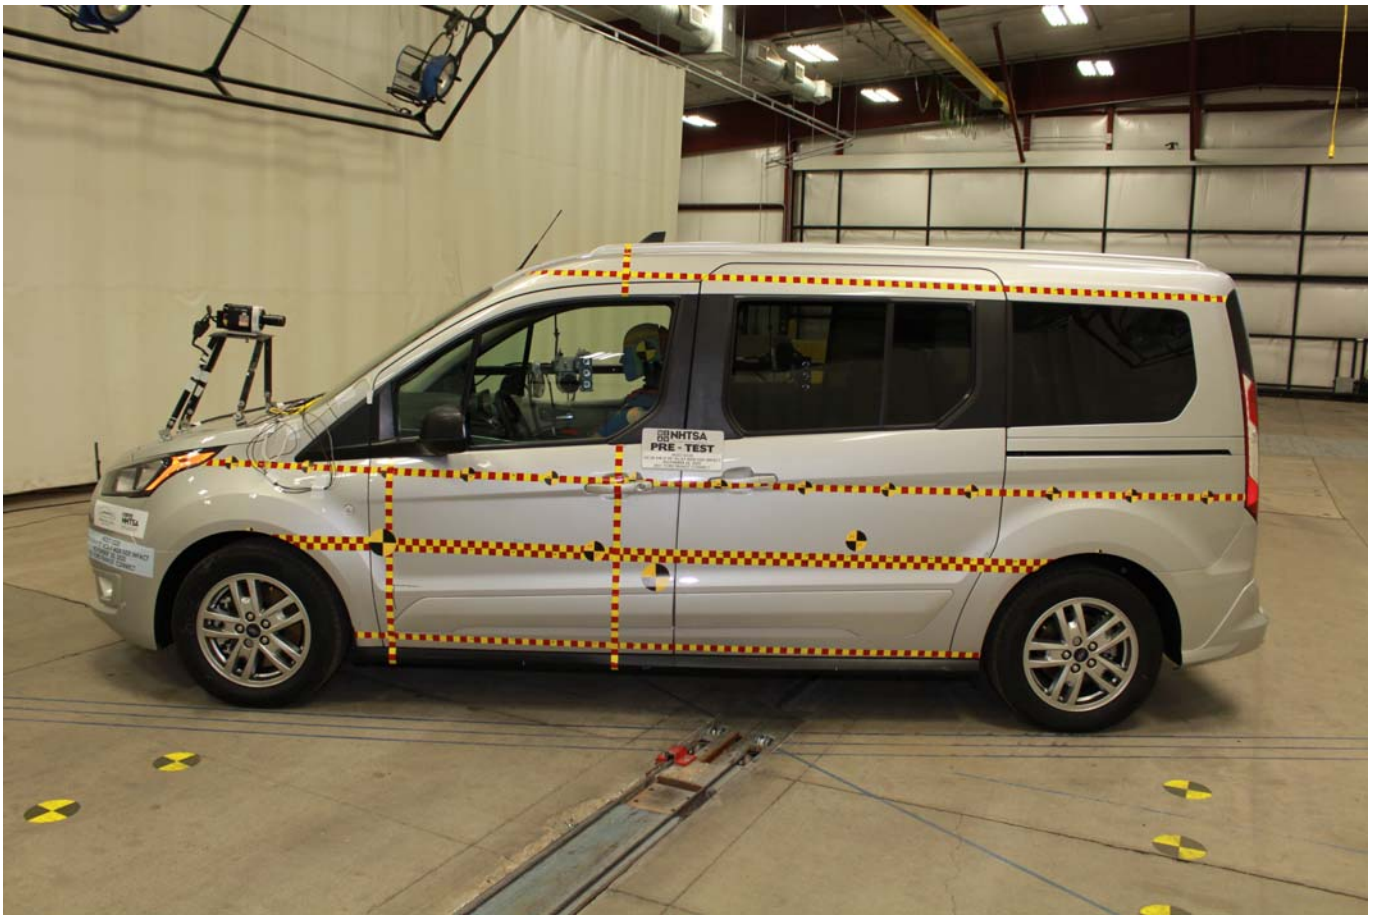
Photo No. 007 - Pre-Test Left Side View of Test Vehicle

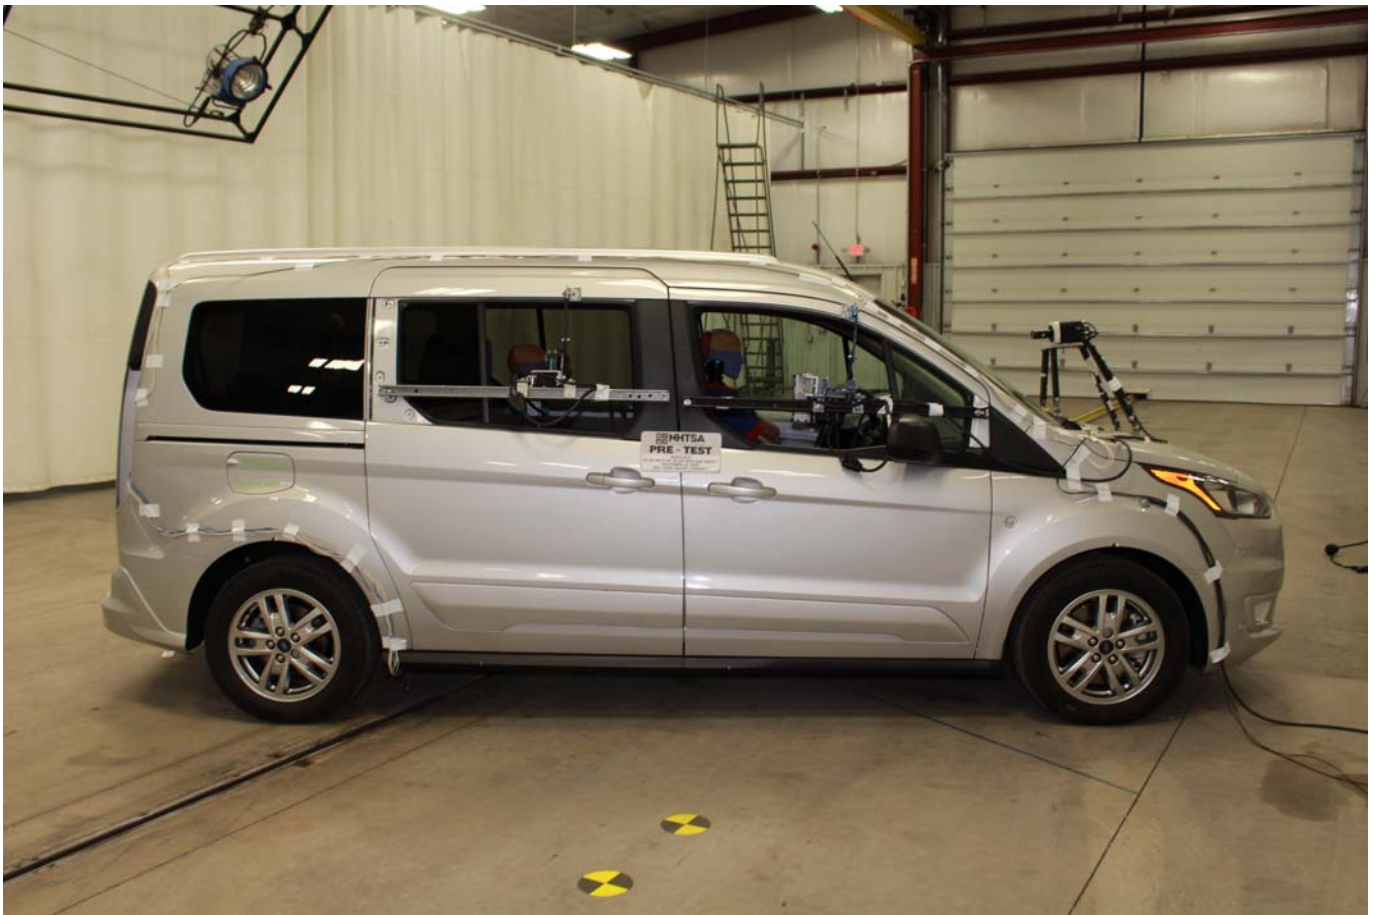
Photo No. 013 - Pre-Test Right Side View of Test Vehicle

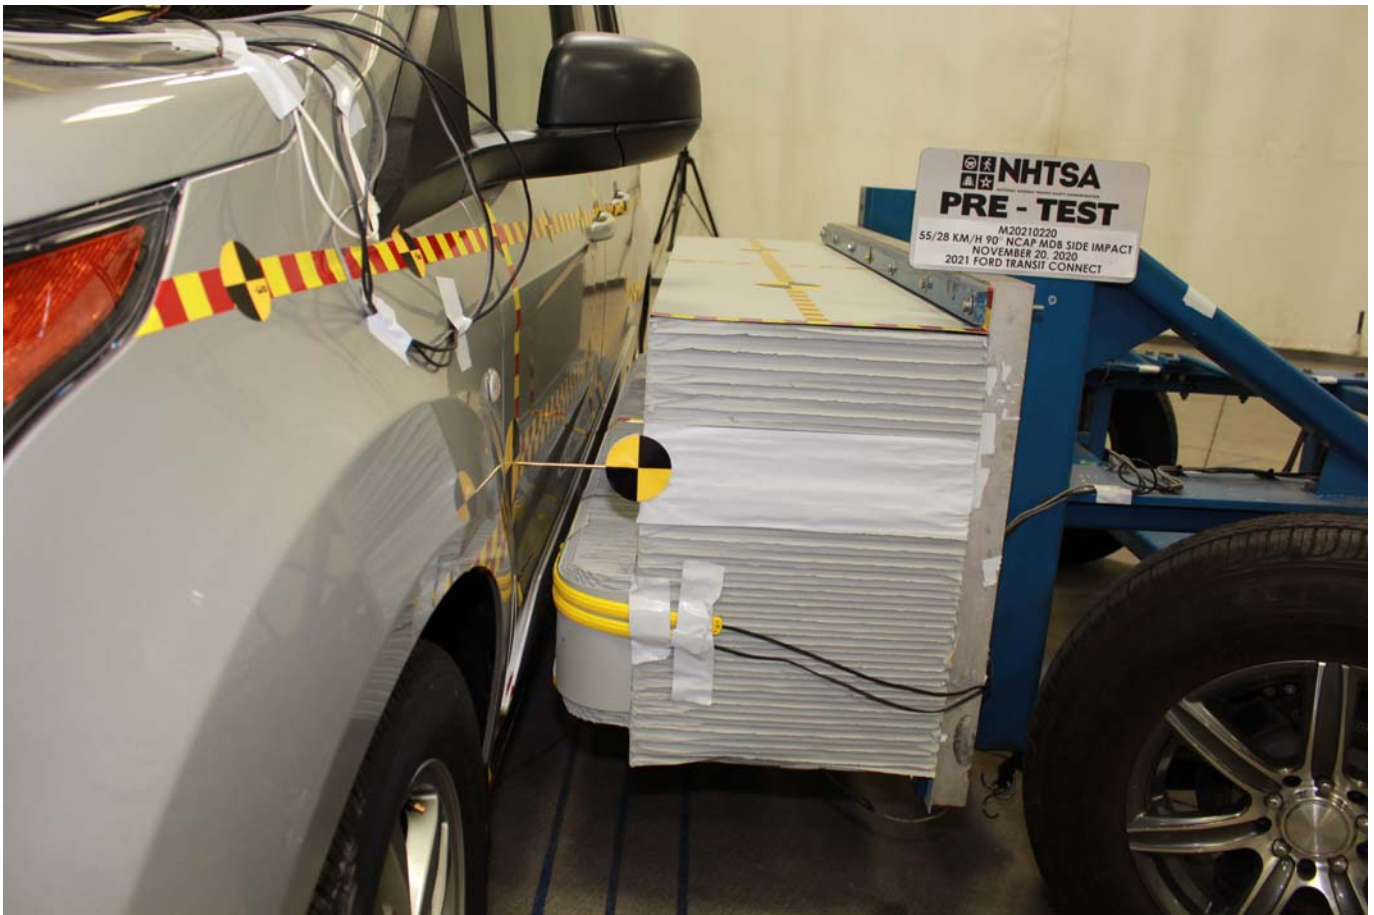
Photo No. 017 - Pre-Test Left Side View of MDB Positioned Against Side of Test Vehicle

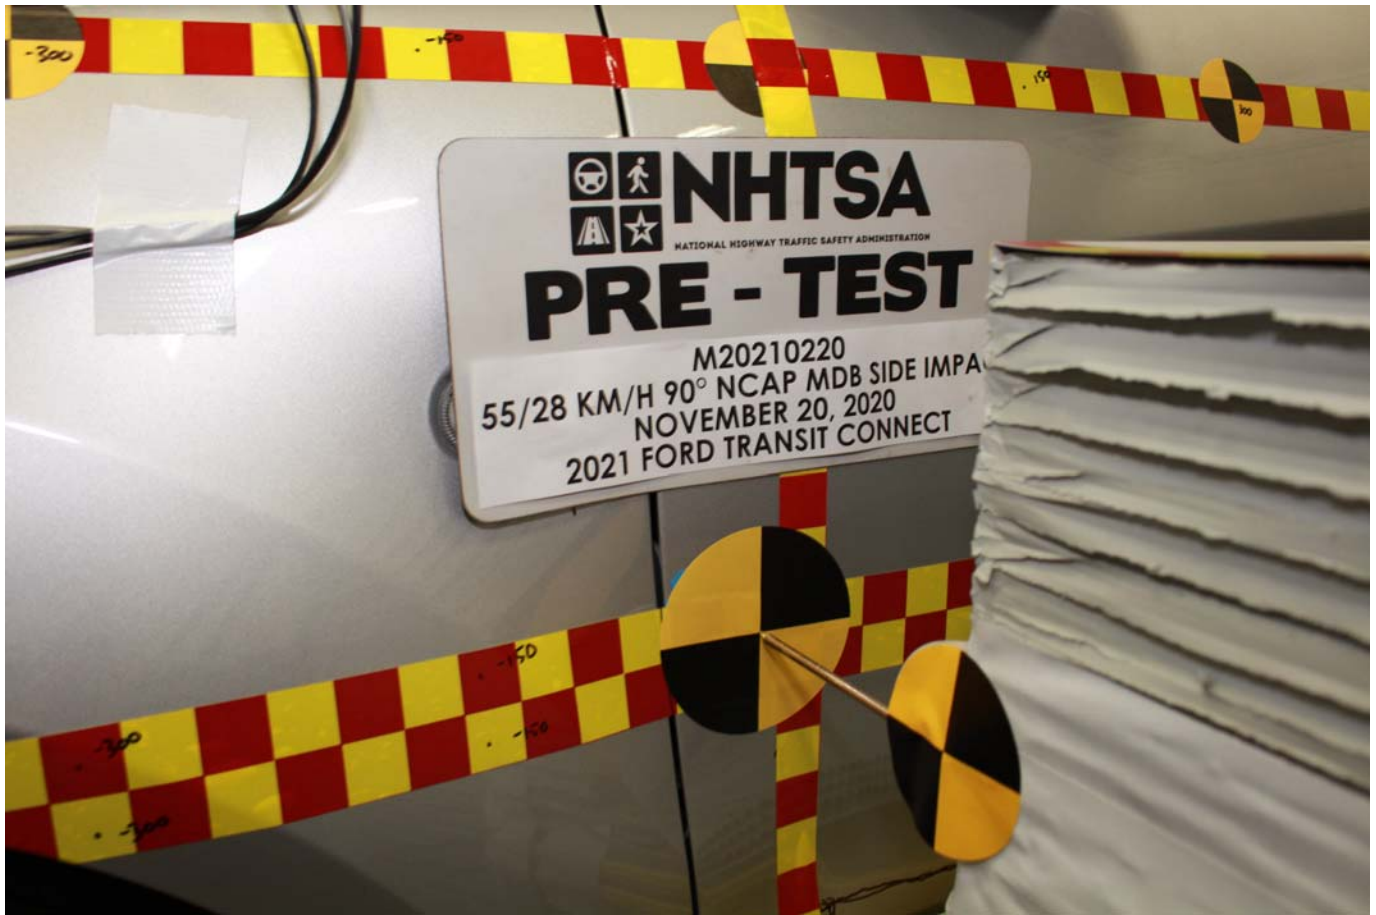
Photo No. 019 - Pre-Test Close-Up View of Impact Point Target

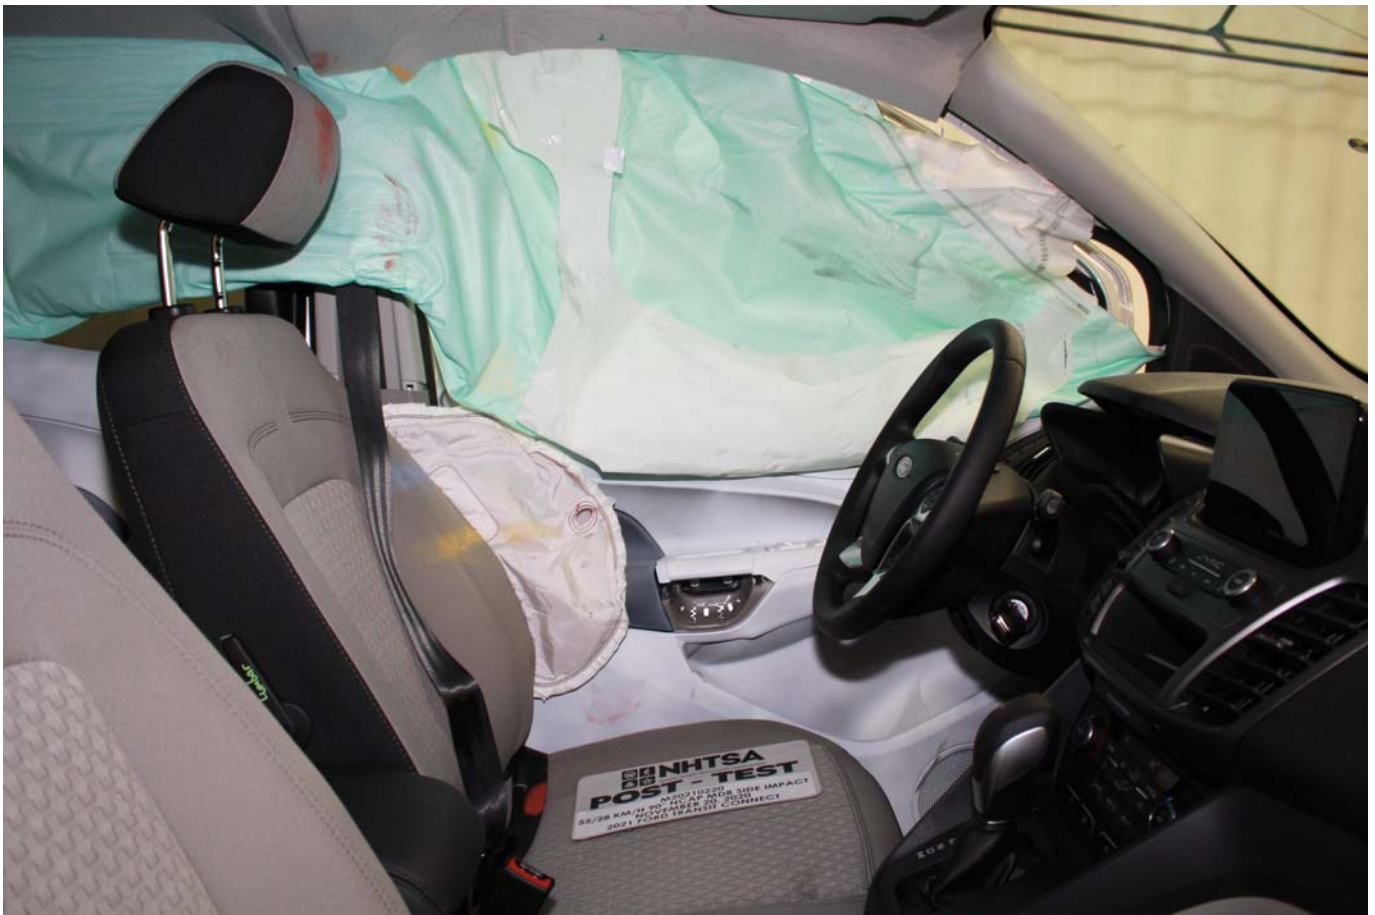
Photo No. 047 - Post-Test Driver Inner Door Panel View

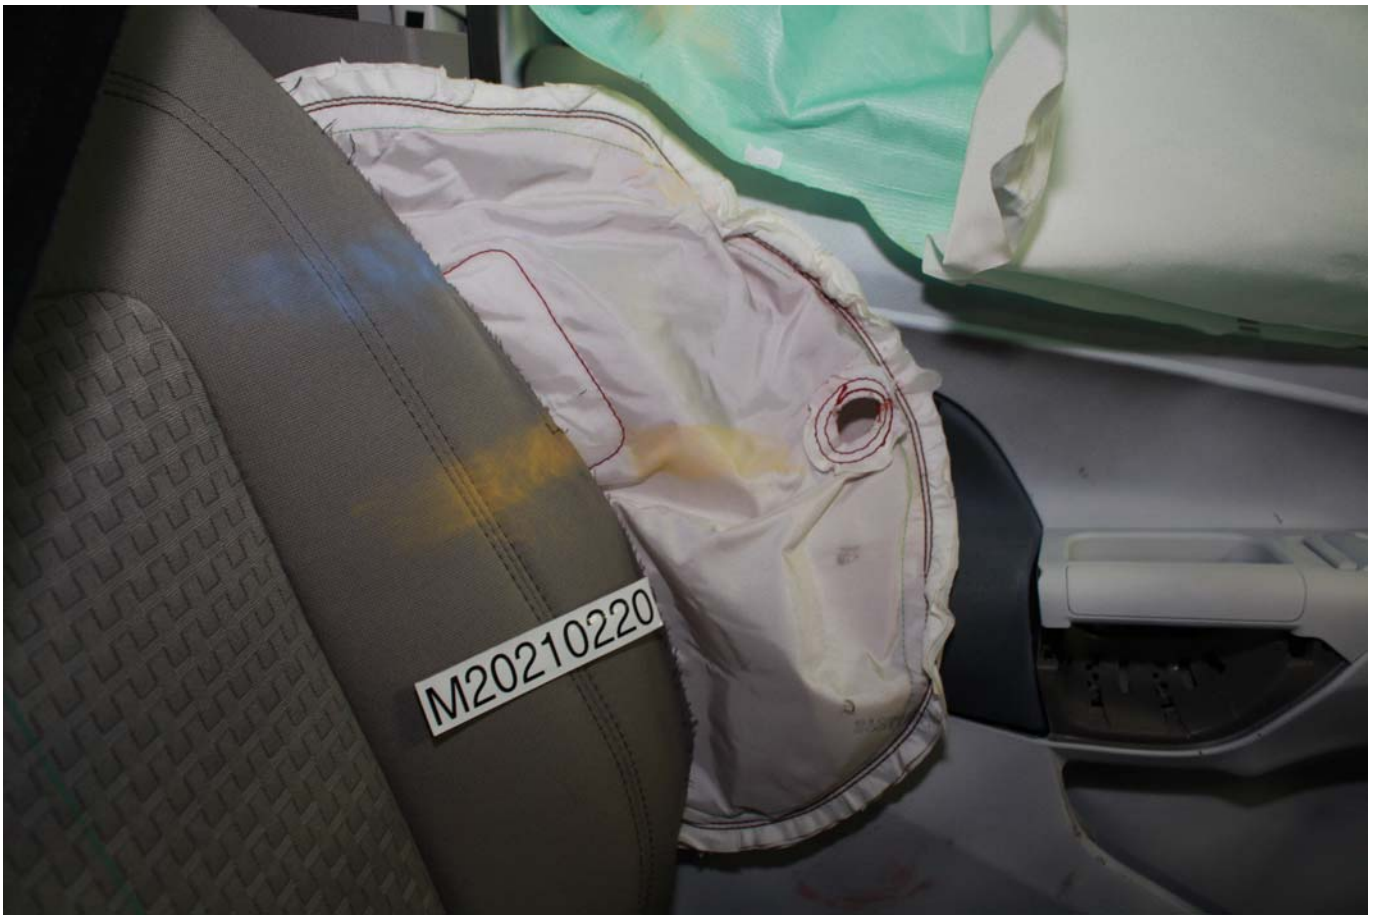
Photo No. 051 - Post-Test Driver Dummy Close-up Torso Contact with Side Airbag View

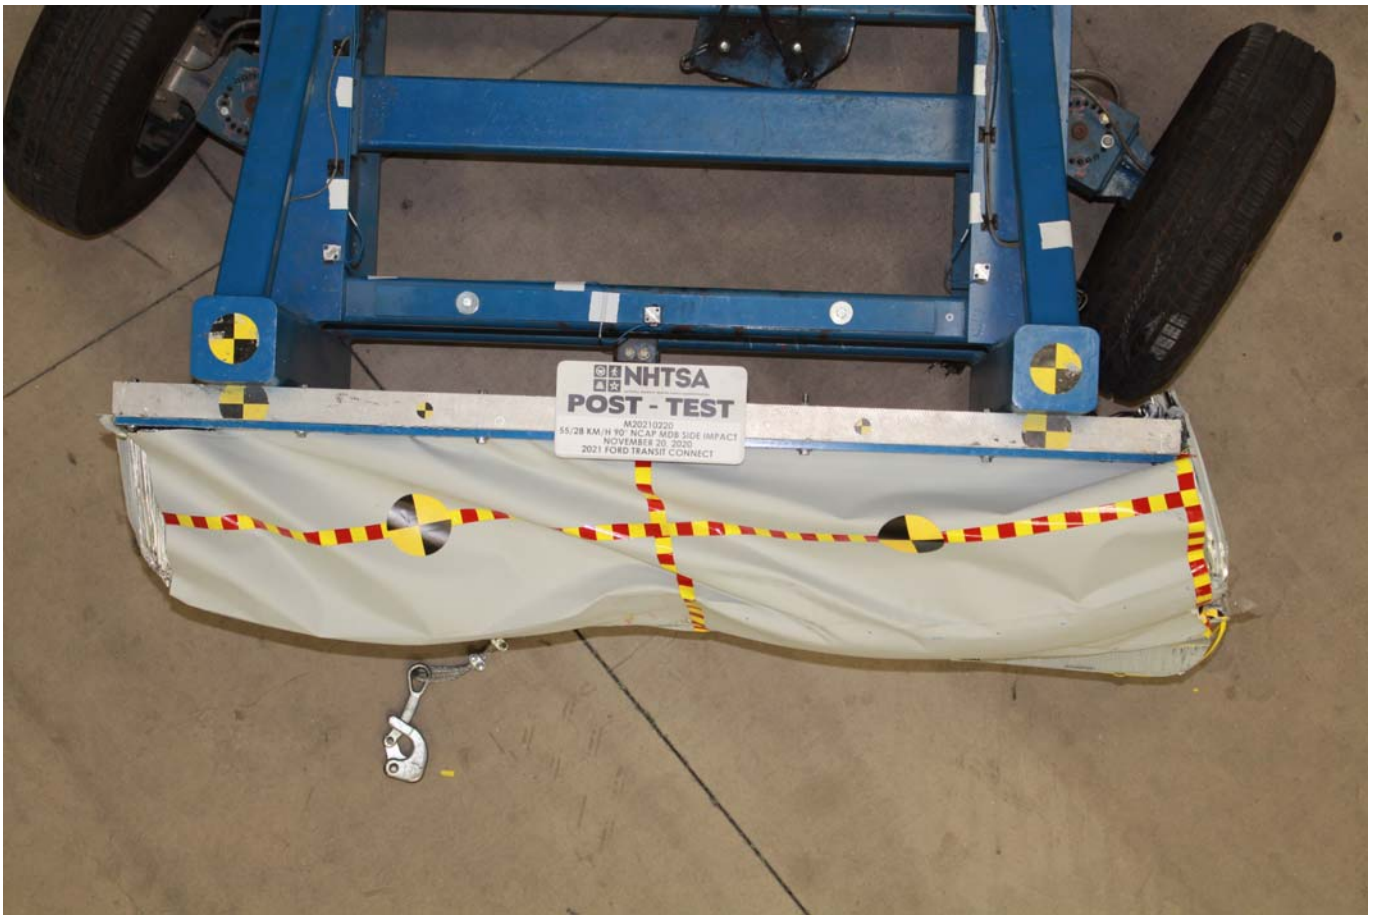
Photo No. 087 - Post-Test Top View of MDB Impactor Face

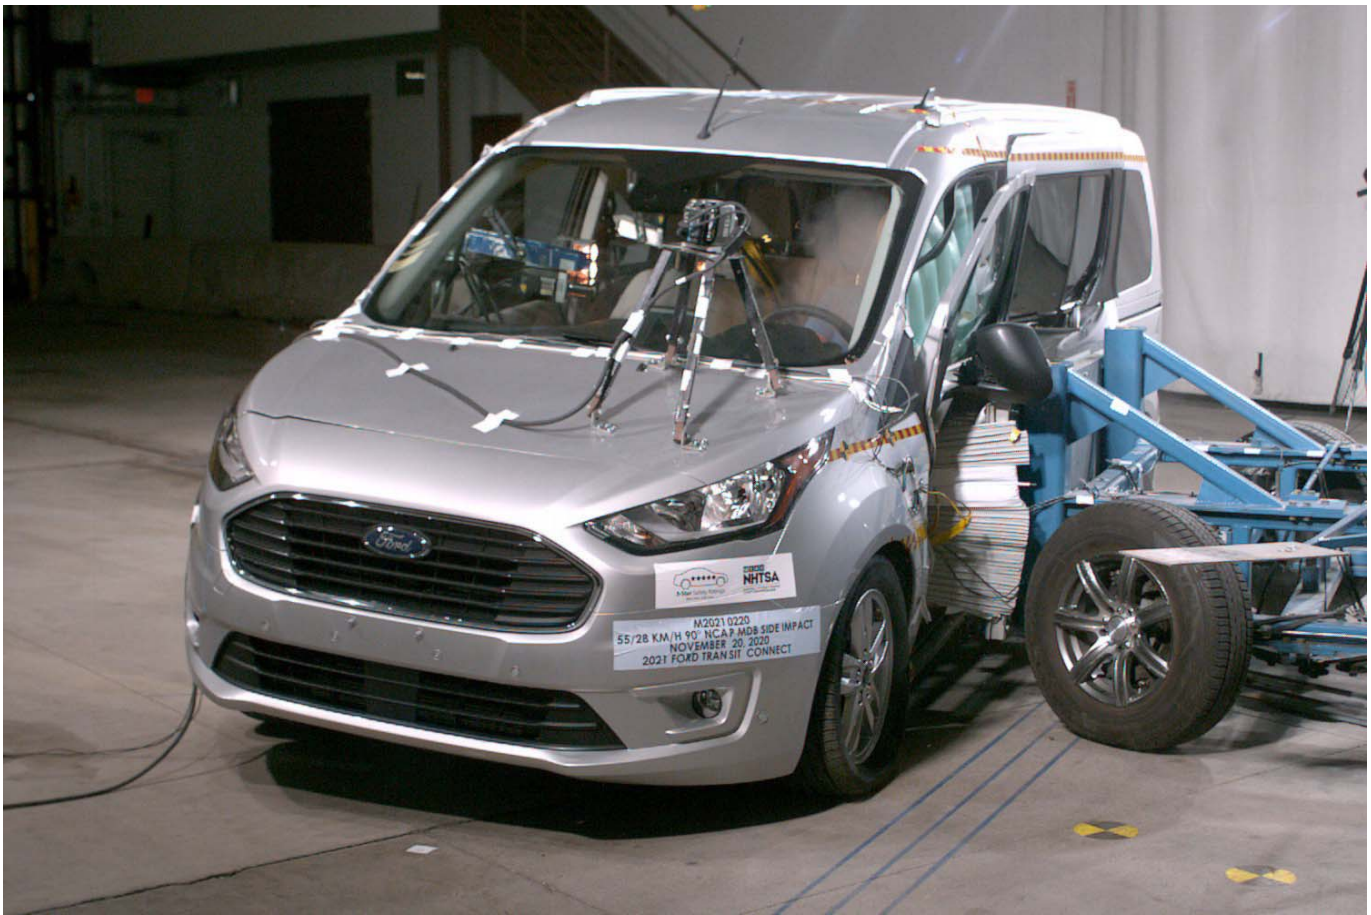
Photo No. 101 - Impact Event

A 55/28 km/h 90° Moving Deformable Barrier NCAP Side Impact Test was conducted on the subject 2021 Ford Transit Connect XLT Wagon LWB in accordance with the specifications of the Office of Crashworthiness Standards Side NCAP MDB Test Procedure for the generation of consumer information on vehicle side crash protection. The test was conducted at the MGA Research Corporation facility in Burlington, Wisconsin on November 20, 2020.

The impact velocity of the Moving Deformable Barrier (MDB) was 61.96 km/h, and the ambient temperature at the struck (driver's) side of the target vehicle at the time of impact was 21.4°C. The target vehicle post-test maximum crush was 214 mm at level 3. The test vehicle's performance was as follows:
