REPORT NUMBER: SideNCAPPole-MGA-21-010

**NEW CAR ASSESSMENT PROGRAM (NCAP)
Side Impact Pole Test**

**FORD MOTOR CO.
2021 Ford Transit Connect XLT Wagon LWB
NHTSA No.: M20210219**

**MGA RESEARCH CORPORATION
5000 Warren Road
Burlington, WI 53105**

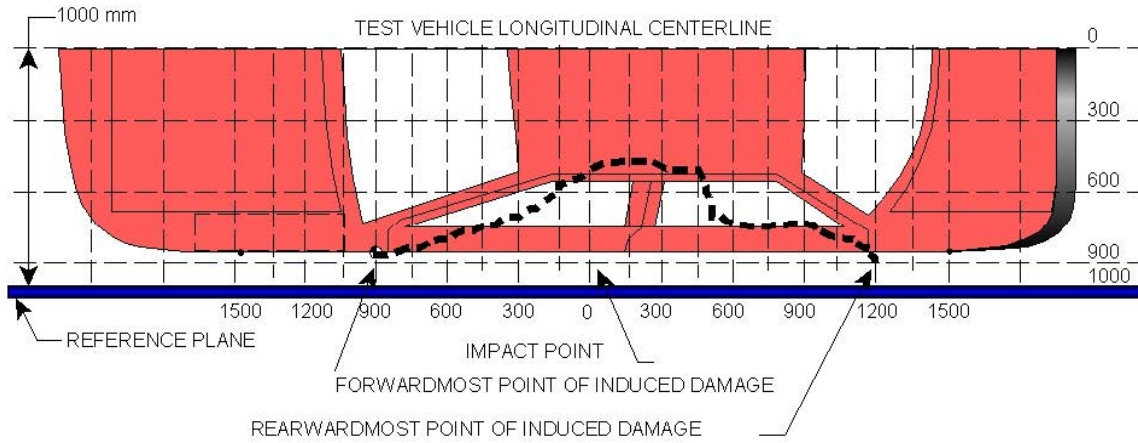
VEHICLE DAMAGE PROFILE DISTANCES

DPD	Distance from Impact Point (mm)	Level	Pre-Test (mm)	Post-Test (mm)	Max. Static Crush (mm)
1	455	3	212	307	95
2	234	3	212	433	221
3	13	3	213	513	300
4	-208	3	214	381	167
5	-429	3	218	251	33
6	-650	3	220	160	-60

Pre-test measurements are taken when the vehicle is in the "As Tested" weight condition. Vehicle measurements forward of the vertical impact reference line are negative. The crush profile grid is established prior to the test based on an estimated impact point.

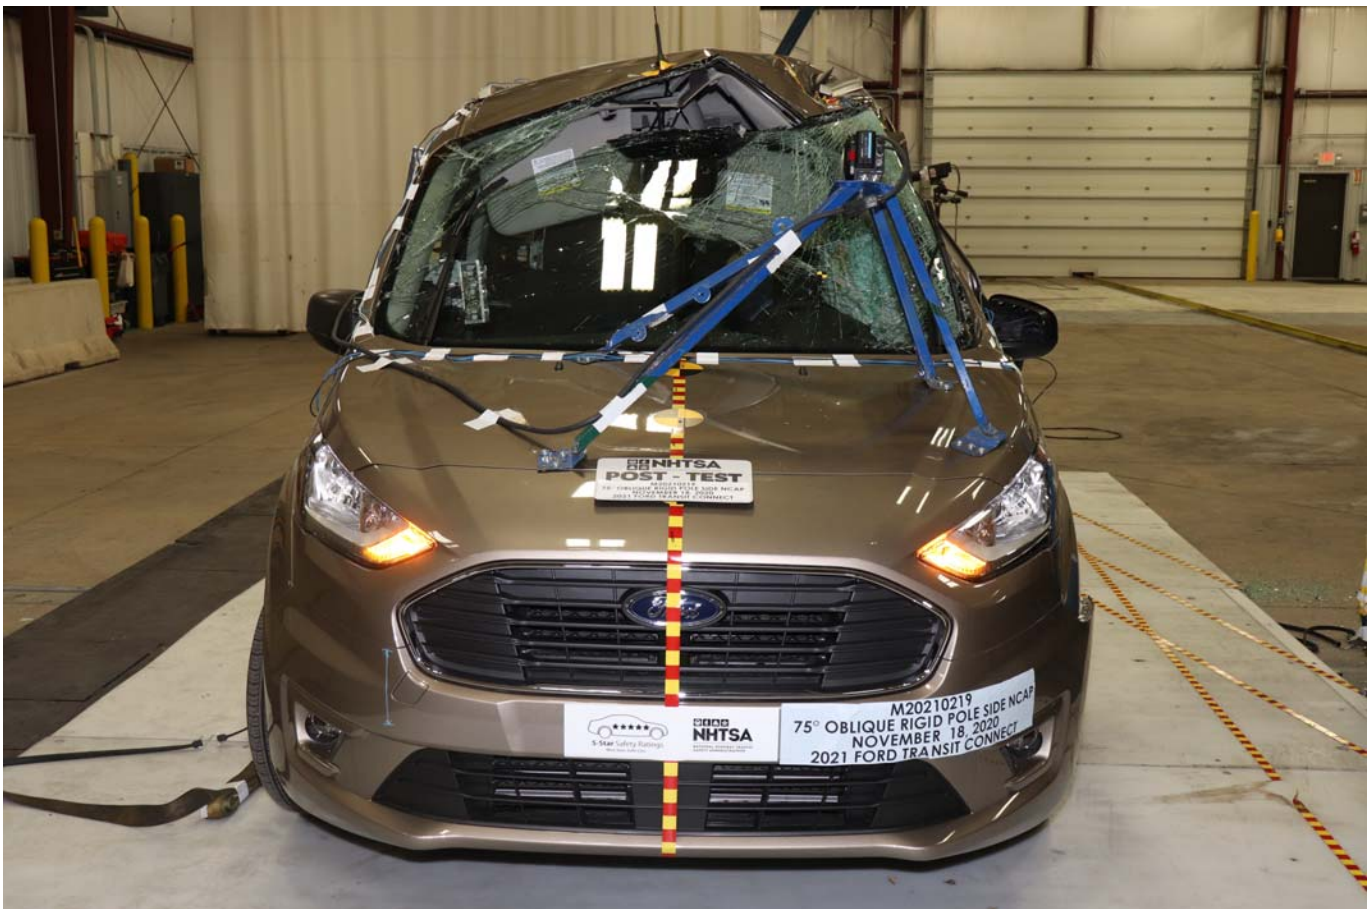
Photo No. 004 - Post-Test Frontal View of Test Vehicle

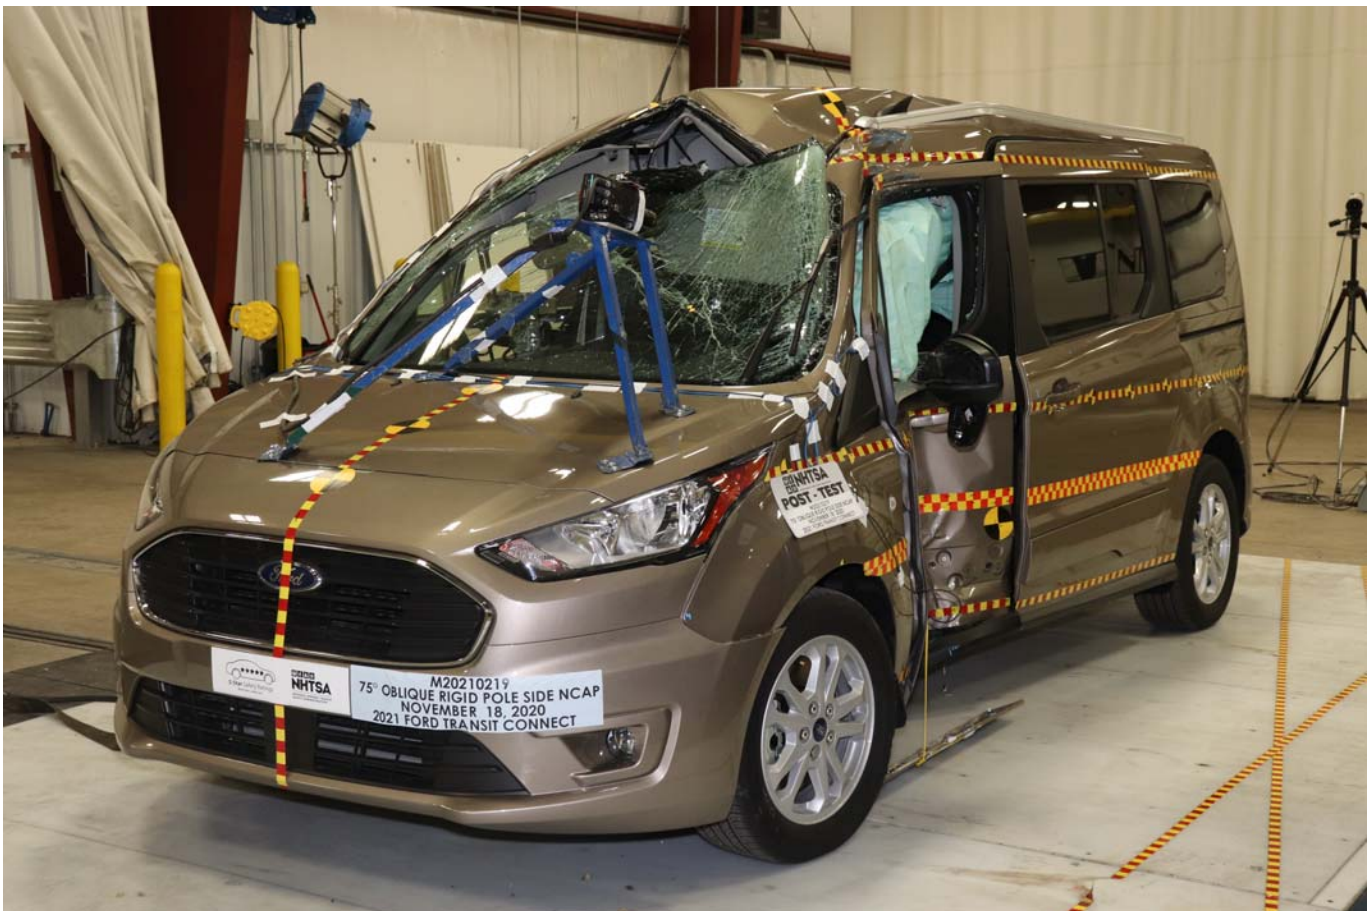
Photo No. 006 - Post-Test Left Front Three-Quarter View of Test Vehicle

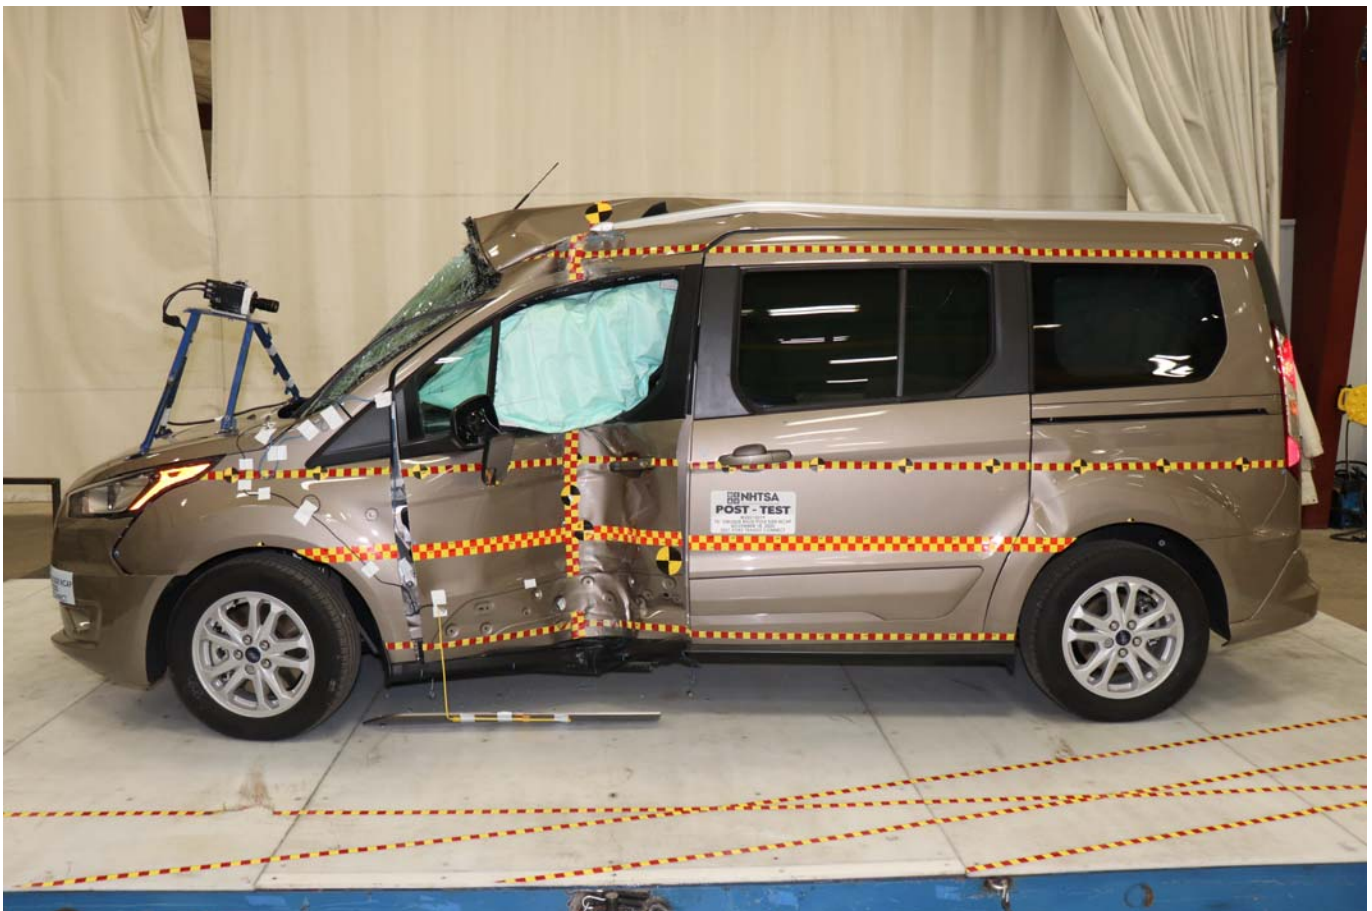
Photo No. 008 - Post-Test Left Side View of Test Vehicle

Critical Areas of Performance	Observations and Conclusions
Pillar Performance	No Separation
Sill Separation	No Separation
Windshield Damage	Broken
Side Window Damage	LF window broken
Other Notable Effects	Complete separation of windshield and roof

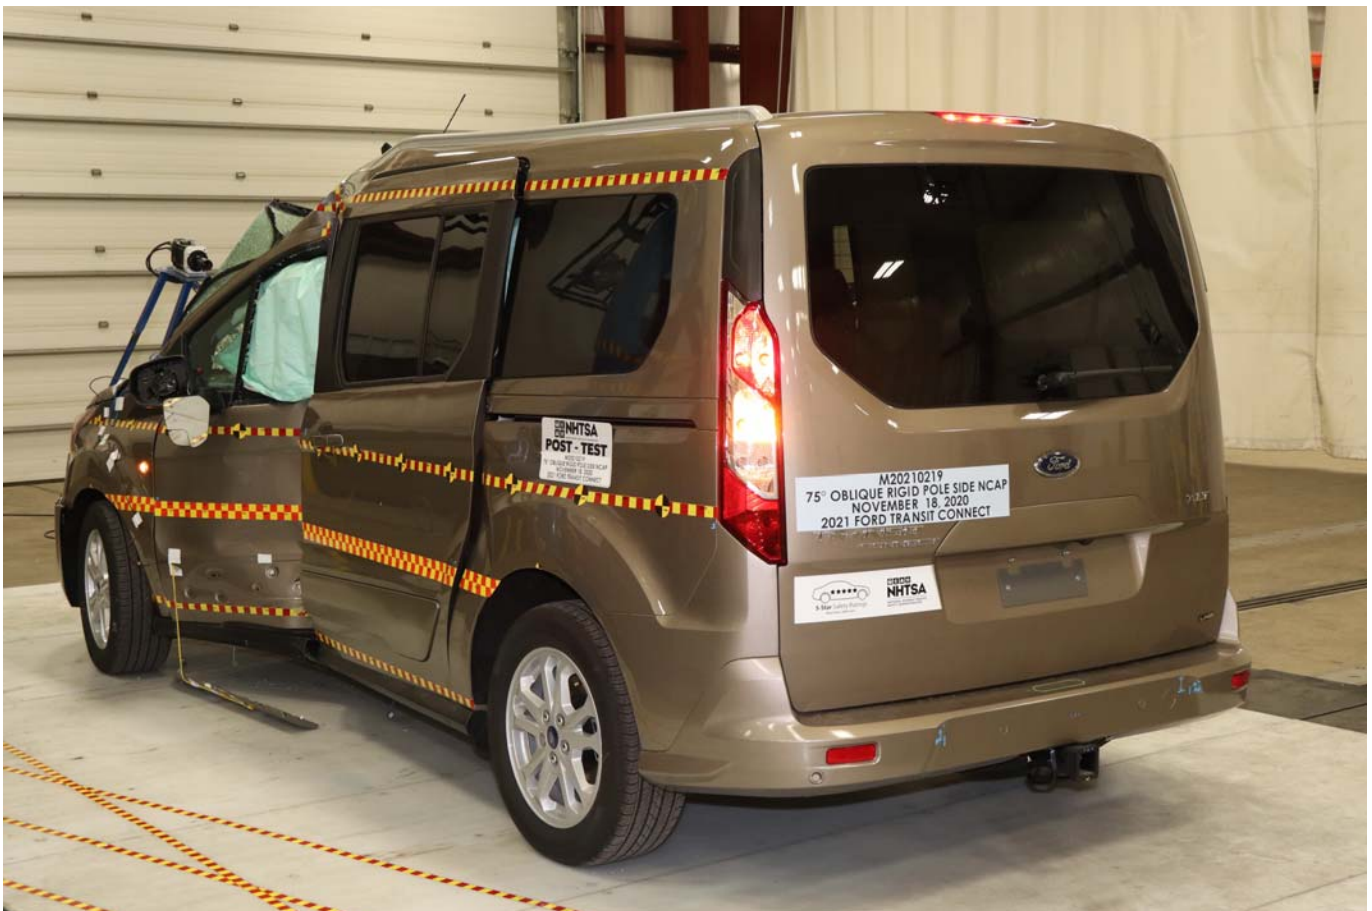
Photo No. 010 - Post-Test Left Rear Three-Quarter View of Test Vehicle

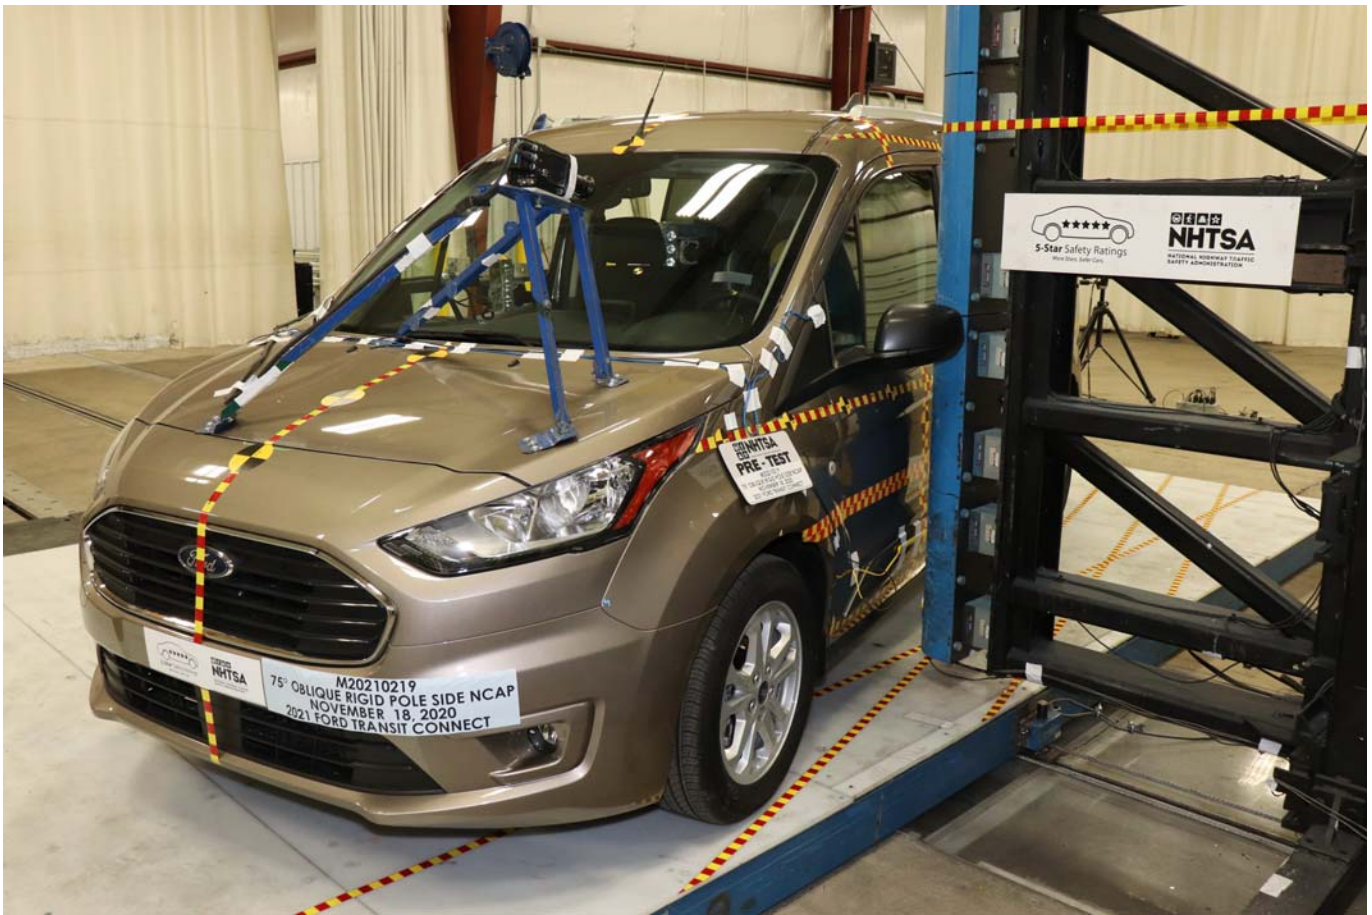
Photo No. 017 - Pre-Test Left Side View of Pole Positioned Against Side of Vehicle

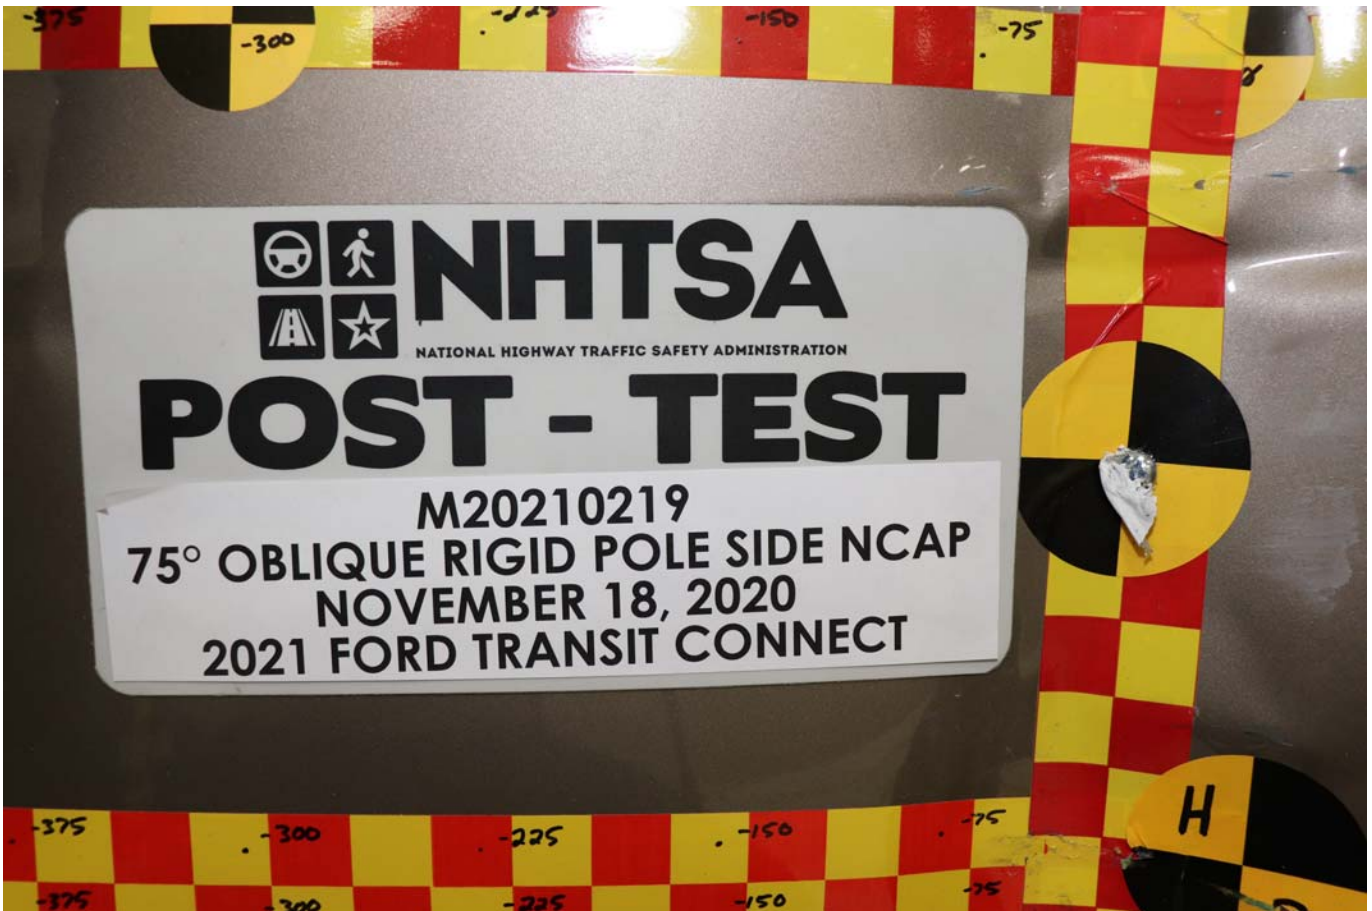
Photo No. 020 - Post-Test Close-Up View of Impact Point Target Showing Impact Location

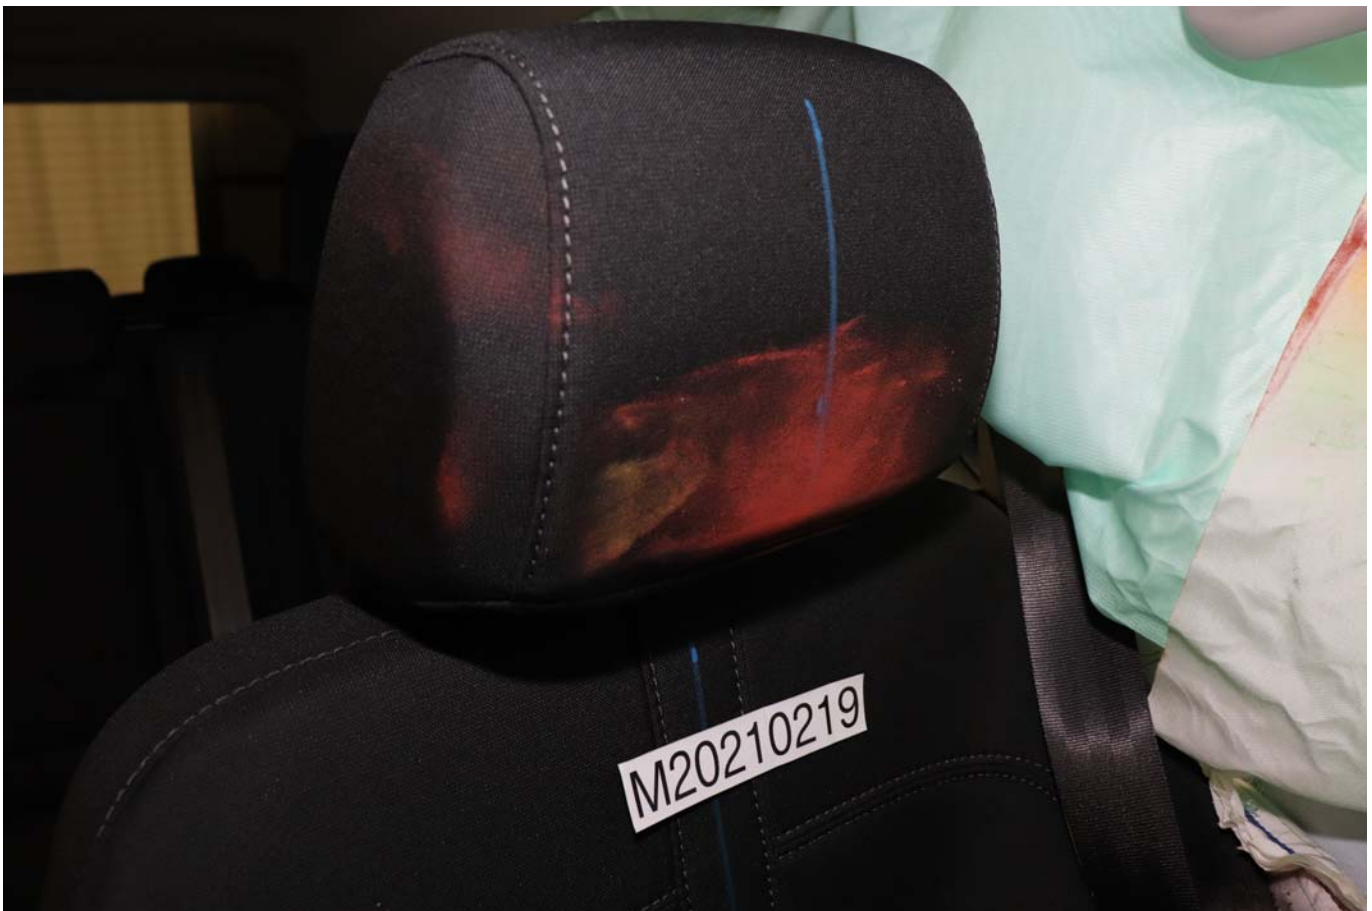
Photo No. 046 - Post-Test Dummy Close-Up Head Contact with Vehicle Interior View

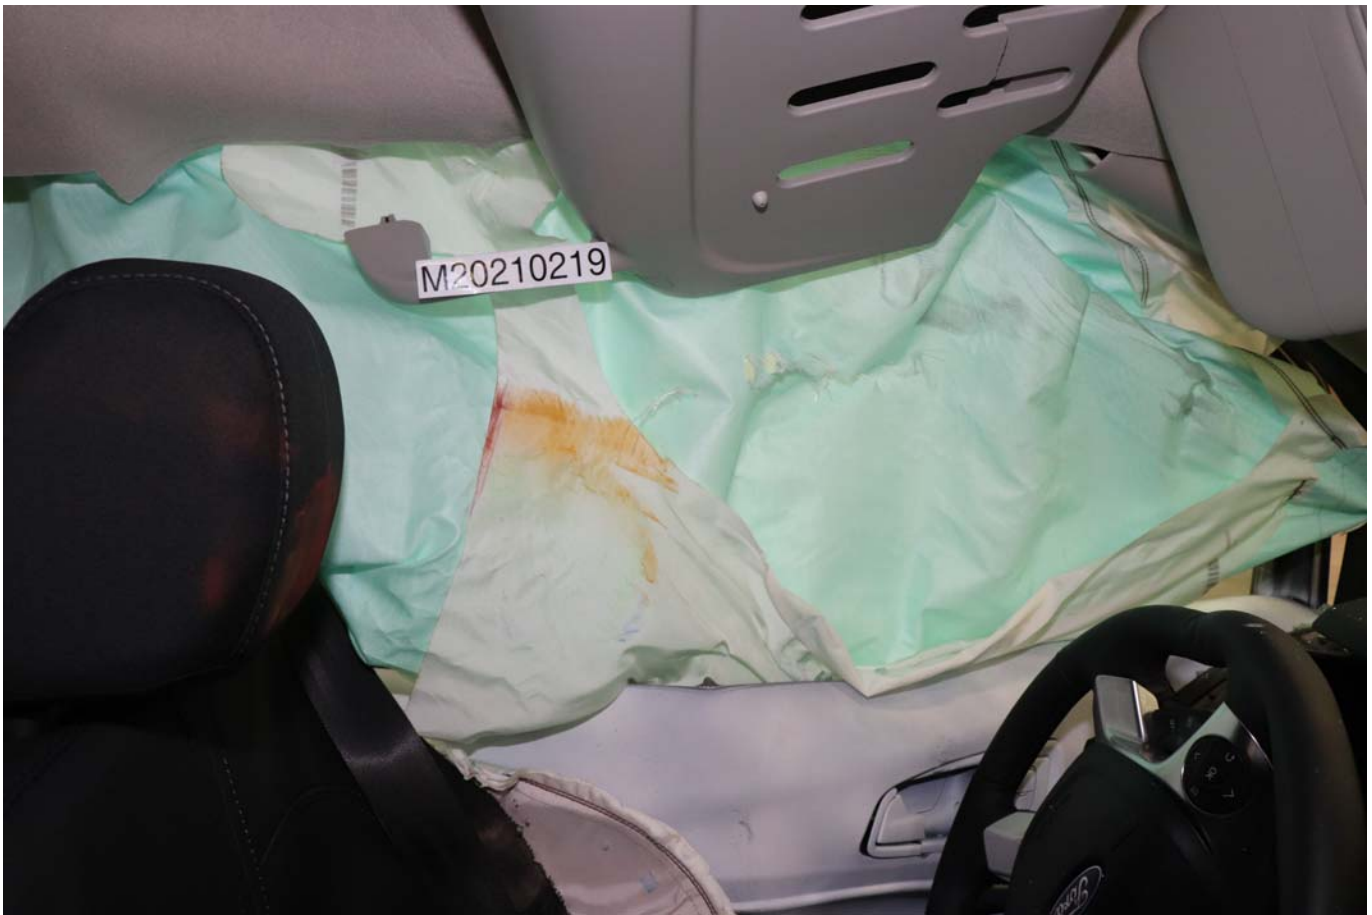
Photo No. 047 - Post-Test Dummy Close-Up Head Contact with Side Air Bag View

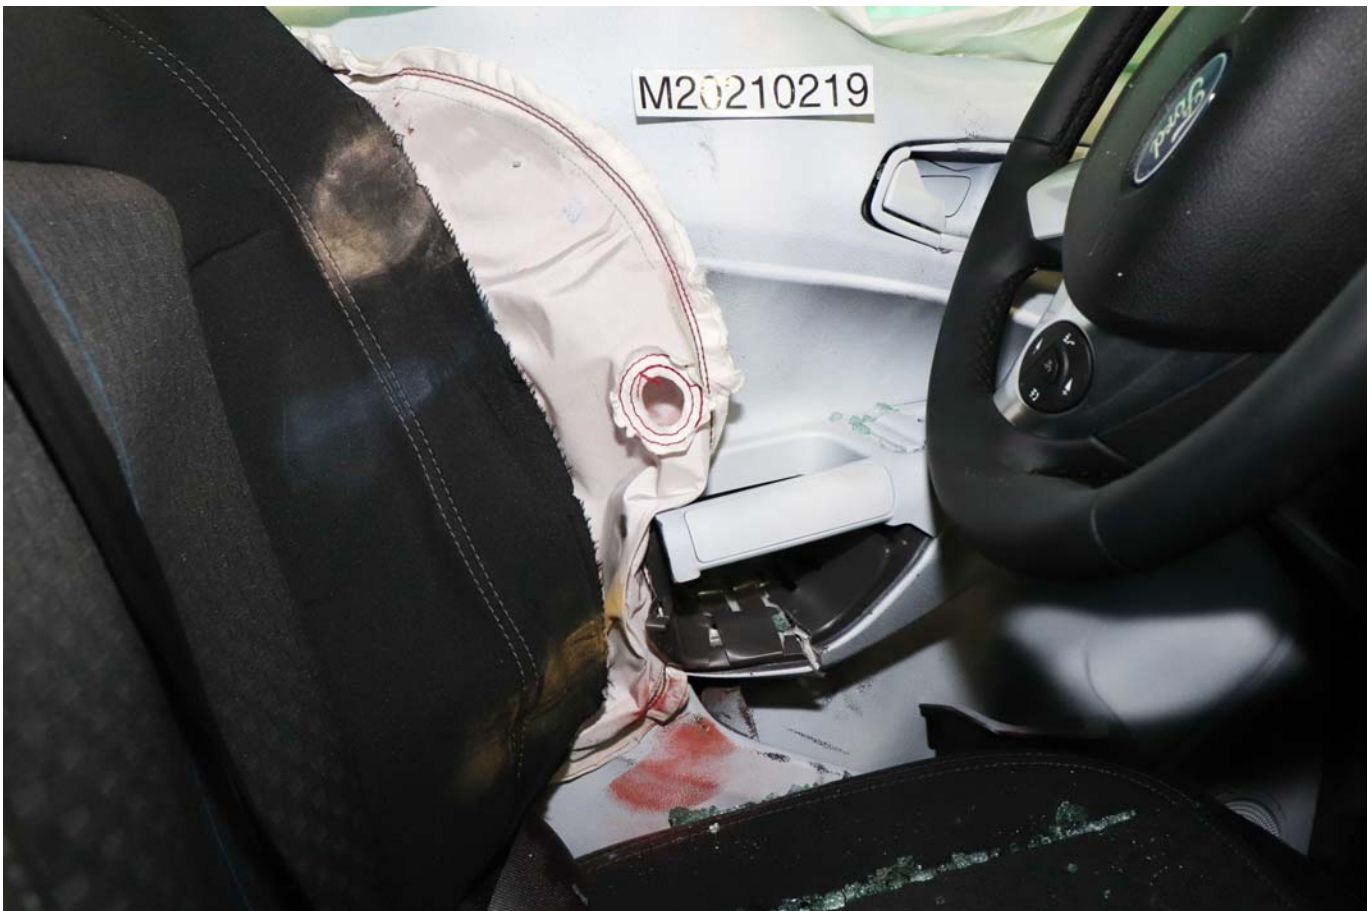
Photo No. 048 - Post-Test Dummy Close-Up Torso Contact with Vehicle Interior View

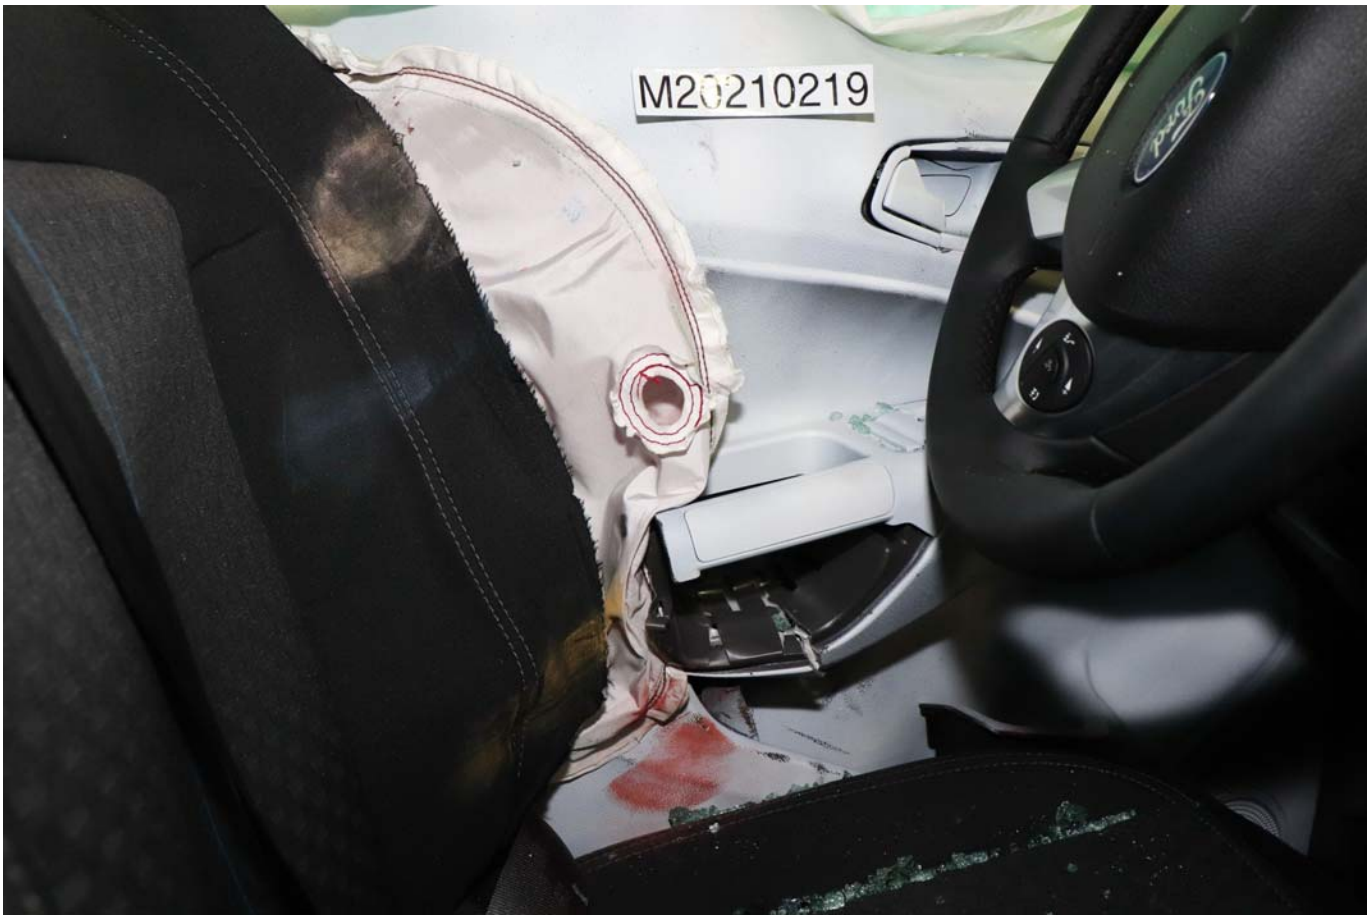
Photo No. 049 - Post-Test Dummy Close-Up Torso Contact with Side Air Bag View

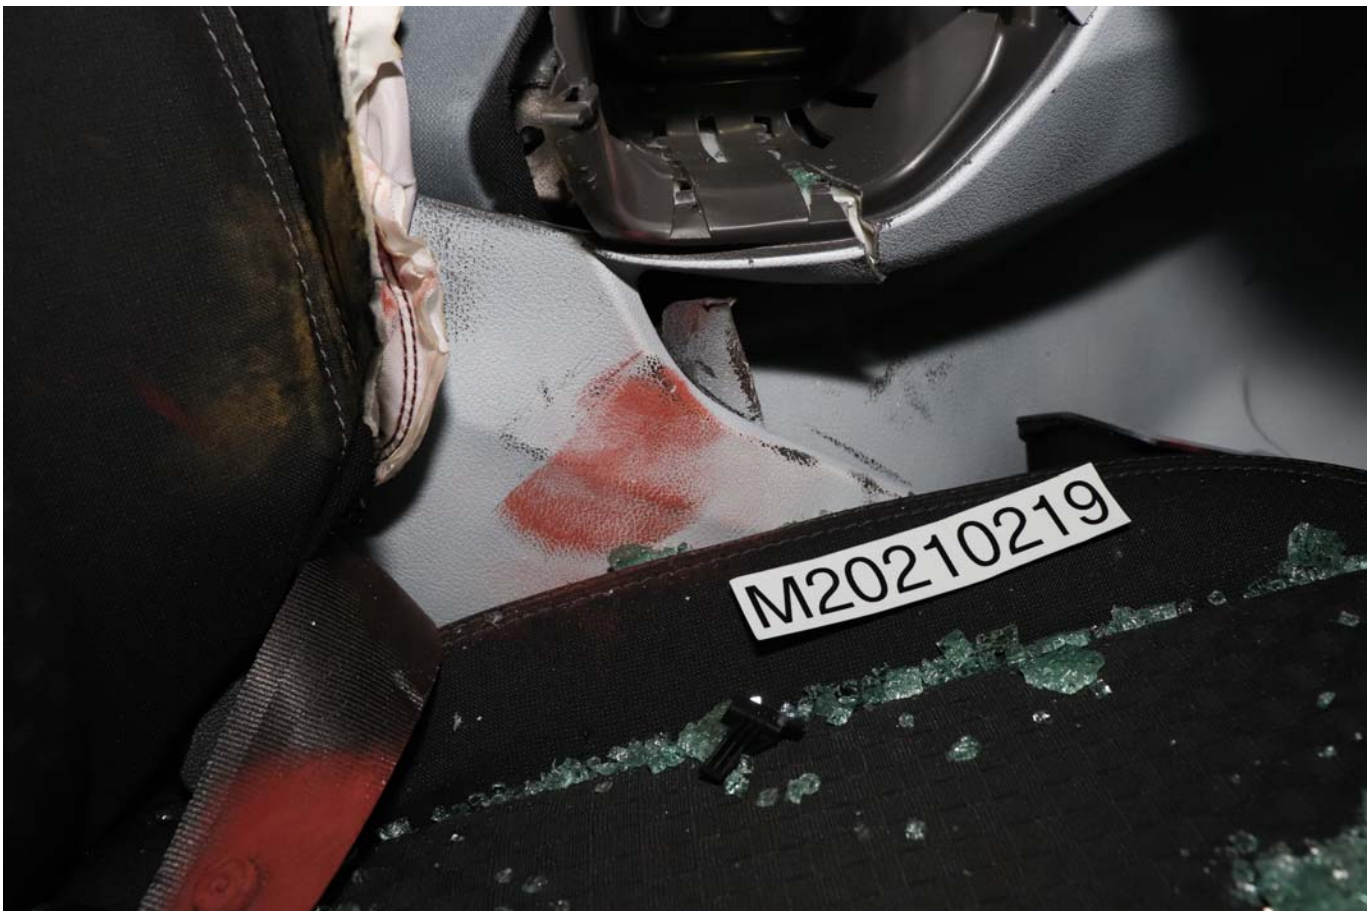
Photo No. 050 - Post-Test Dummy Close-Up Pelvis Contact with Vehicle Interior View

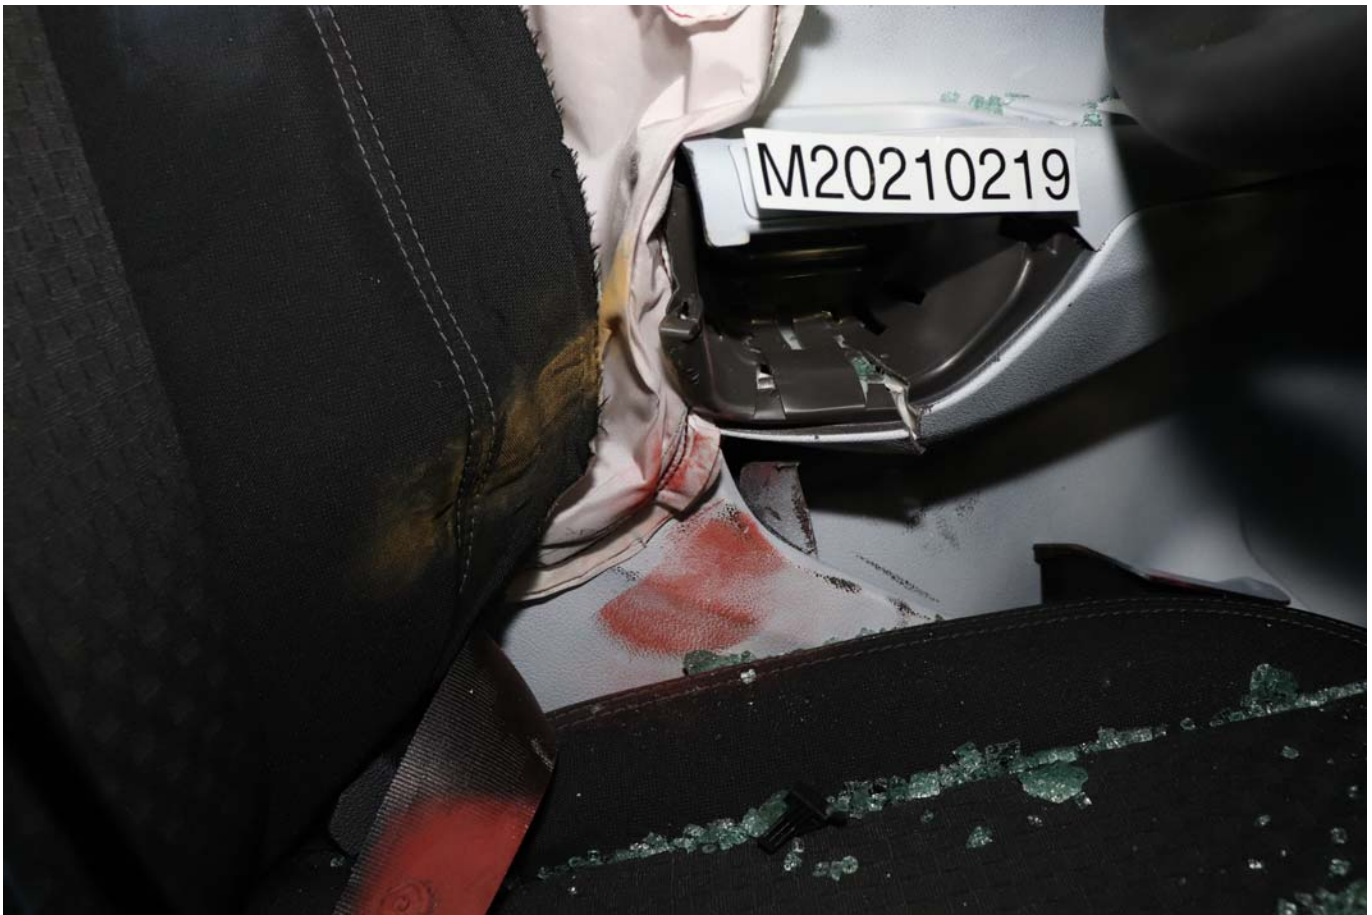
Photo No. 051 - Post-Test Dummy Close-Up Pelvis Contact with Side Air Bag View

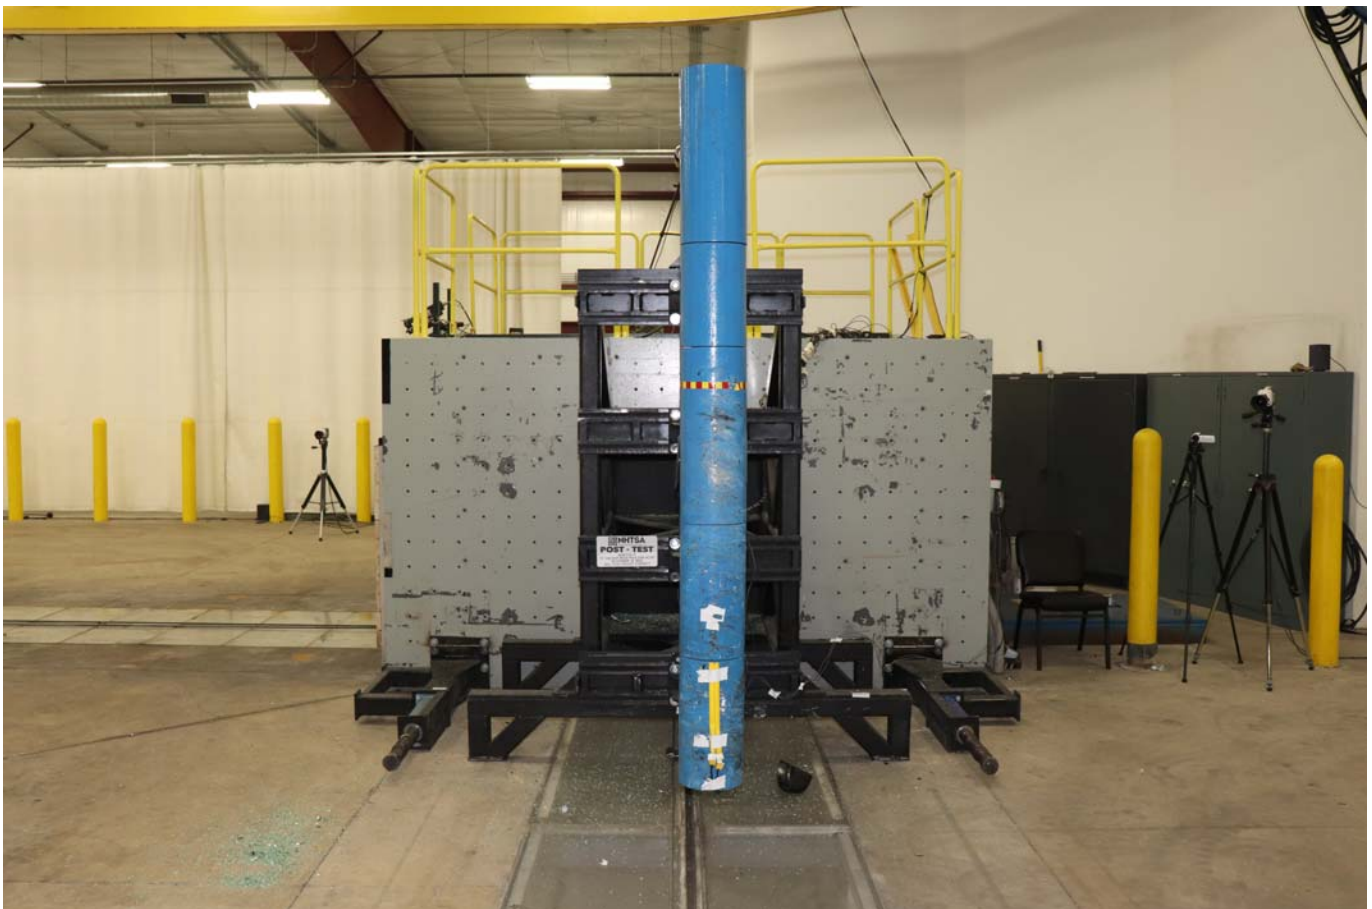
Photo No. 060 - Post-Test Pole Barrier Front View

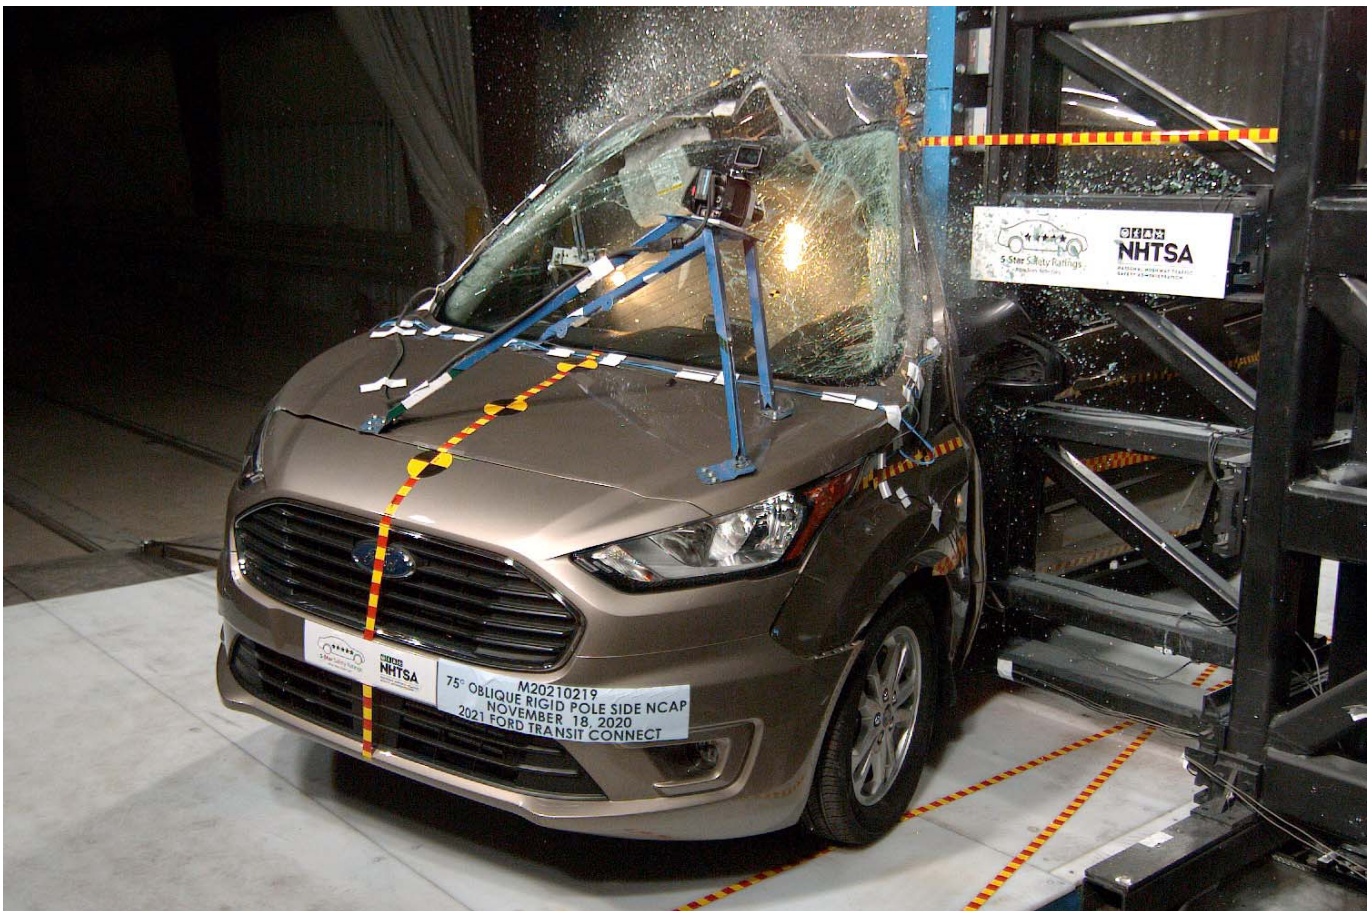
Photo No. 070 - Impact Event

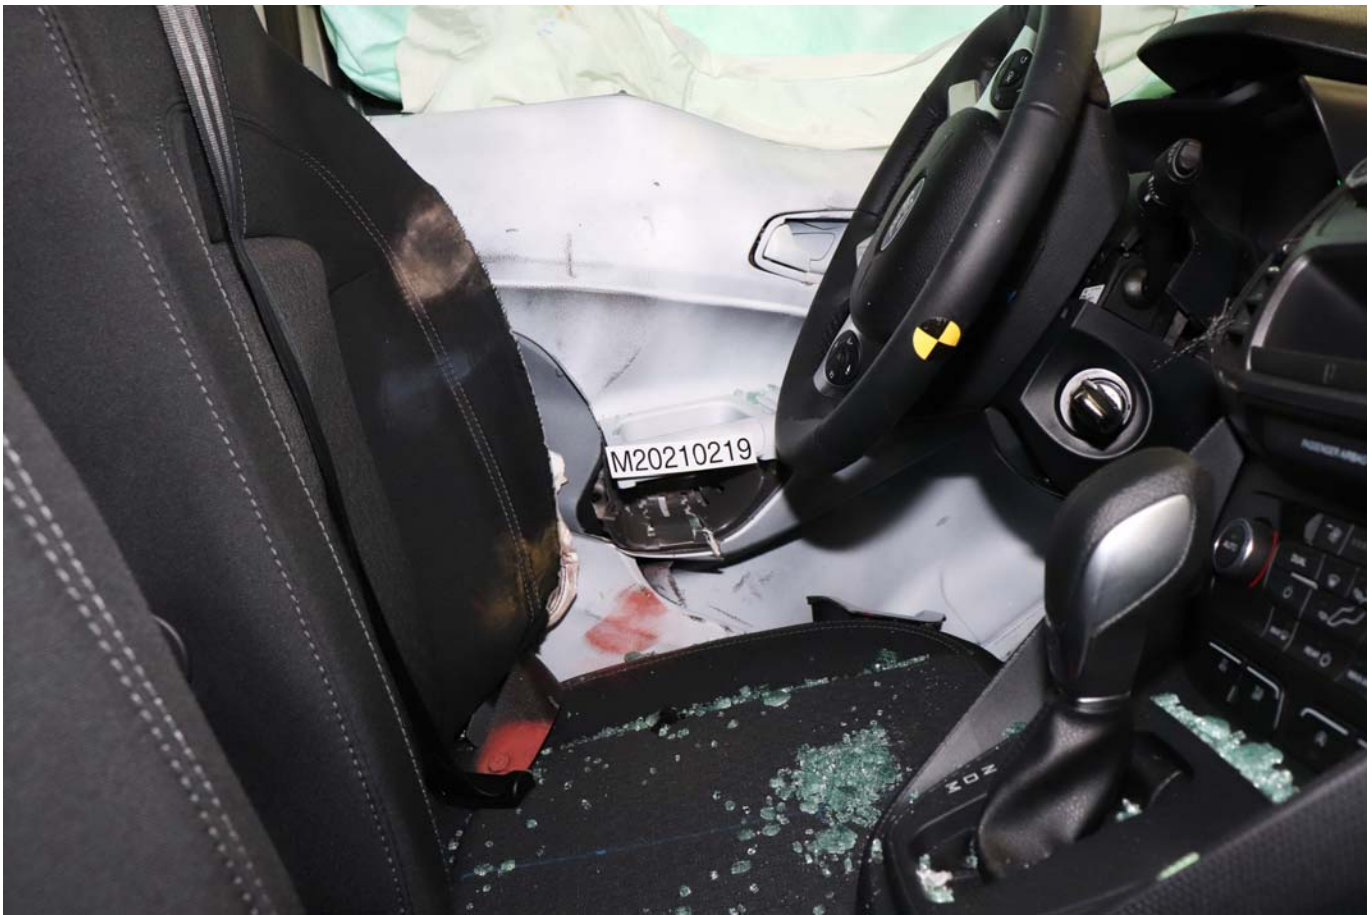
Photo No. 073 - Post-Test View of Shattered Vehicle Inner Door Panel
