REPORT NUMBER: SPNCAP-CAL-21-001

**NEW CAR ASSESSMENT PROGRAM (NCAP)
SIDE IMPACT POLE TEST**

**Nissan Motor Co., LTD.
2021 Nissan Rogue
SUV**

NHTSA No: M20215203

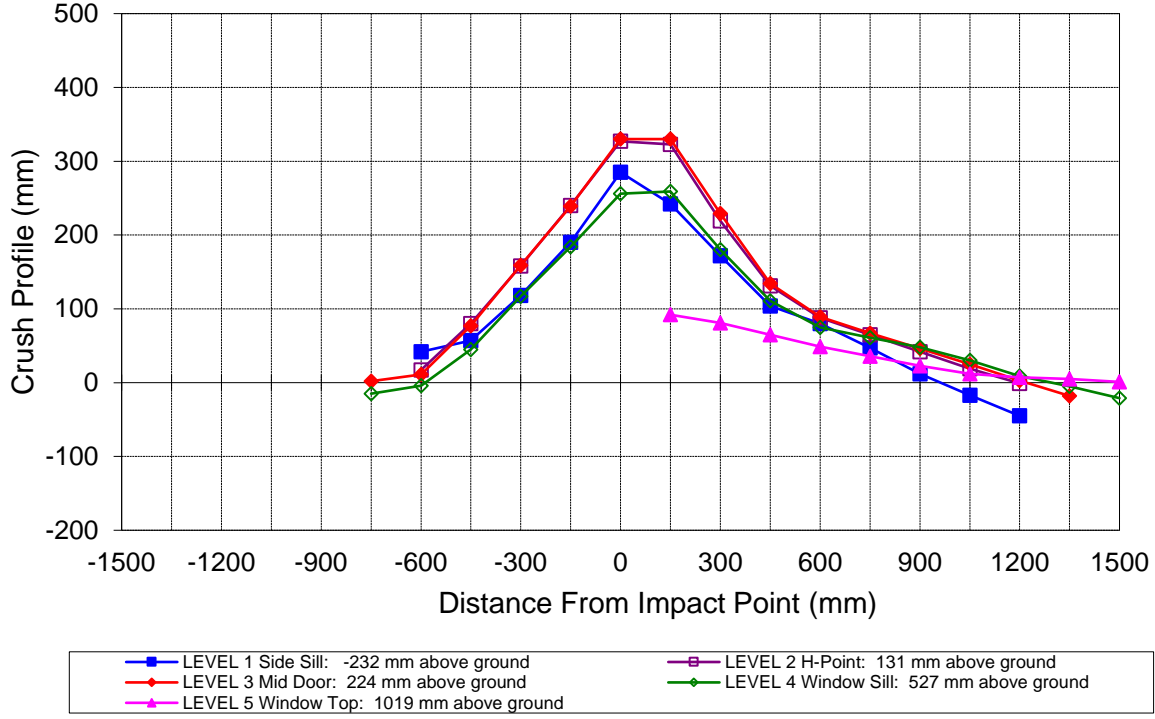
Vehicle Exterior Crush Measurements - Visual Representation

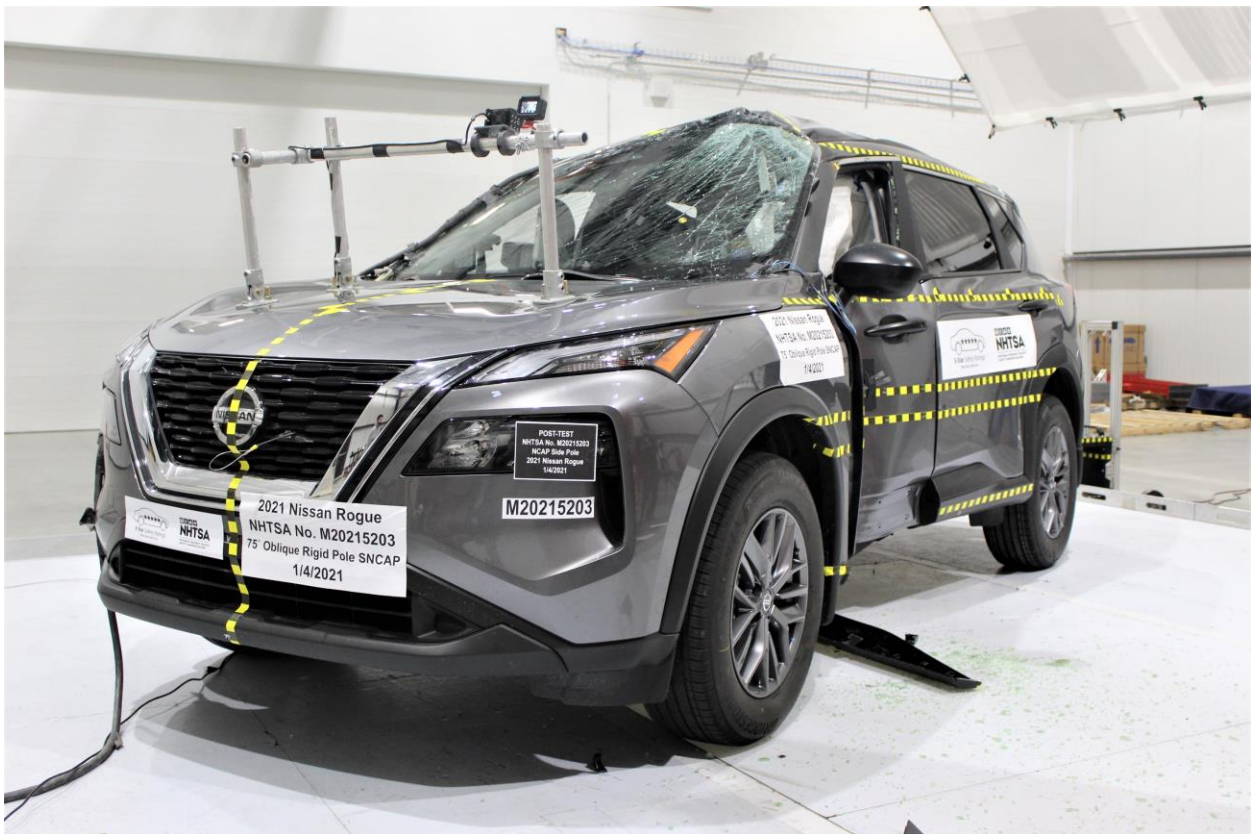
Figure A-6: Post-Test Left Front $\frac{3}{4}$ View of Test Vehicle

Critical Areas of Performance	Observations and Conclusions
Pillar Performance	A-Pillar buckled
Sill Separation	None
Windshield Damage	Cracks throughout and separation along A-pillar and roof
Side Window Damage	Driver window shattered
Other Notable Effects	None

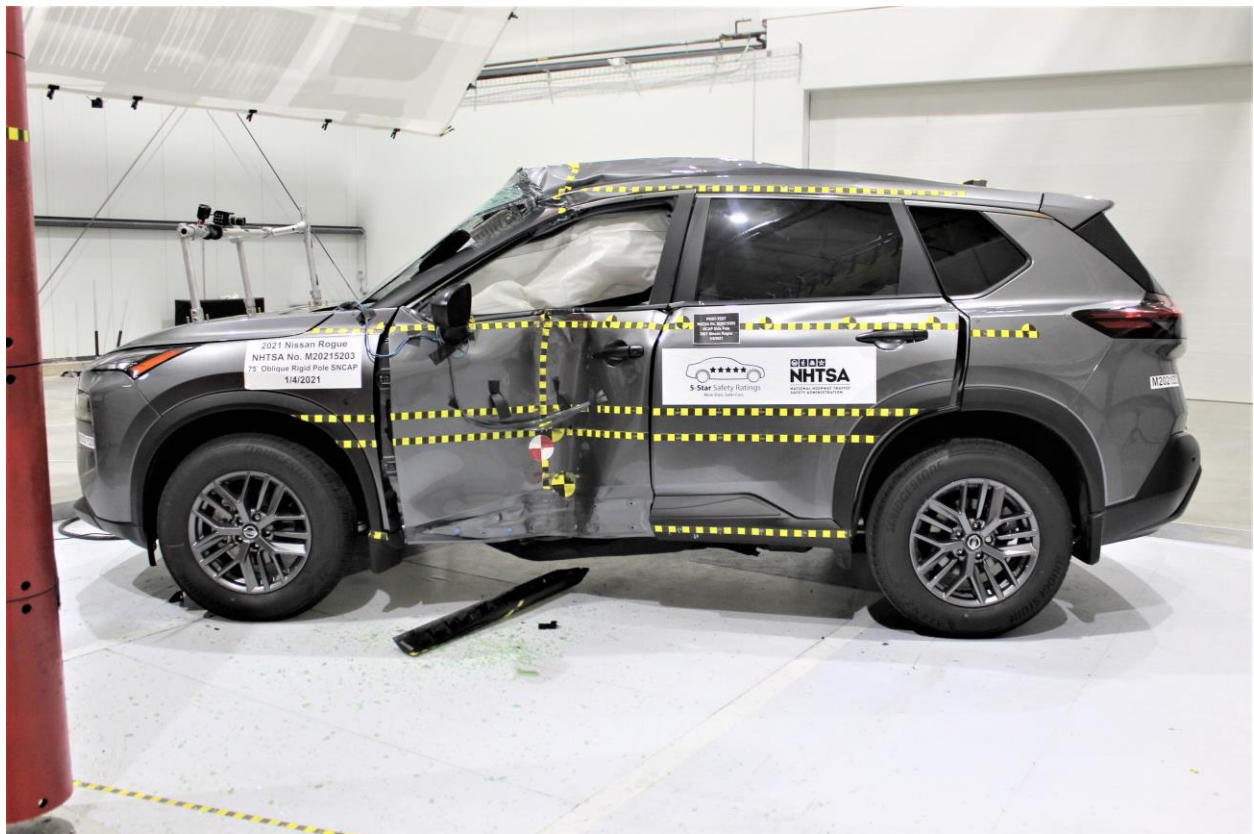
Figure A-8: Post-Test Left Side View of Test Vehicle

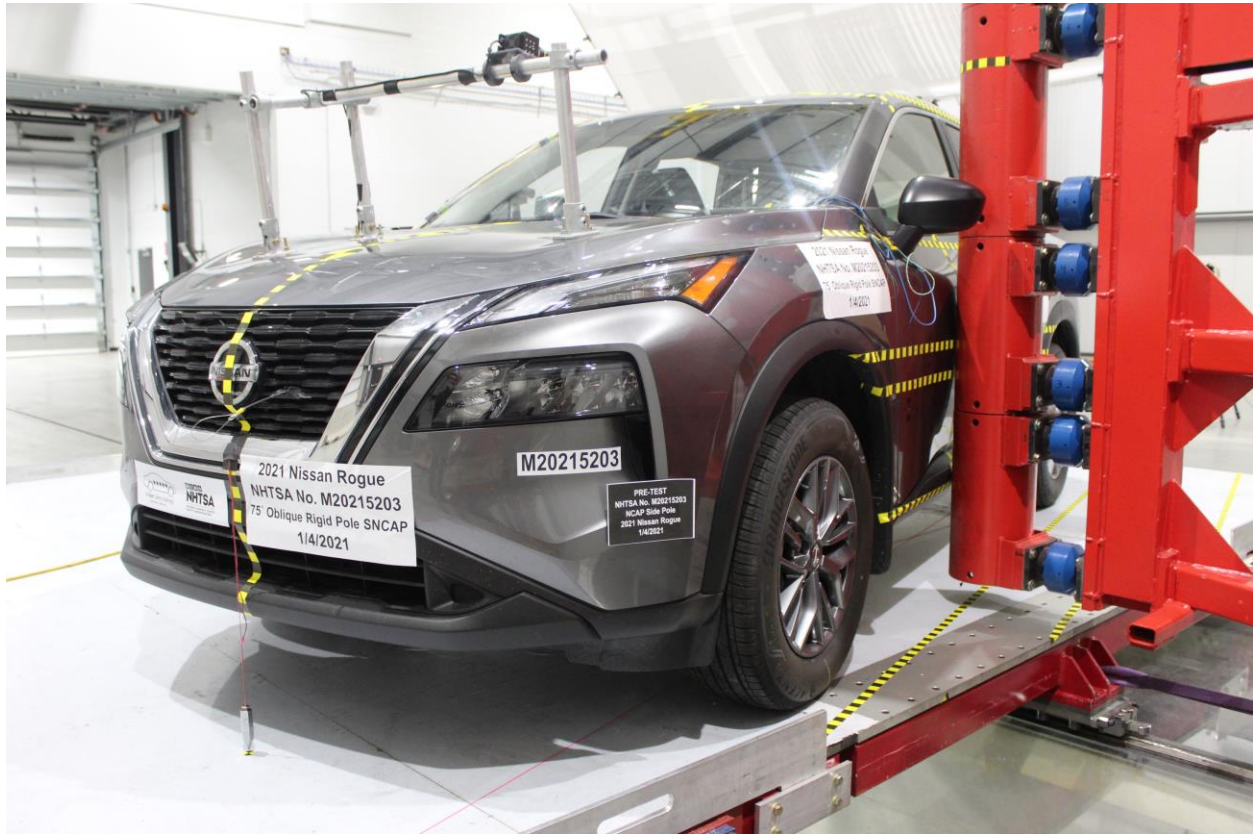
Figure A-17: Pre-Test Left Side View of Pole Positioned Against Side of Vehicle

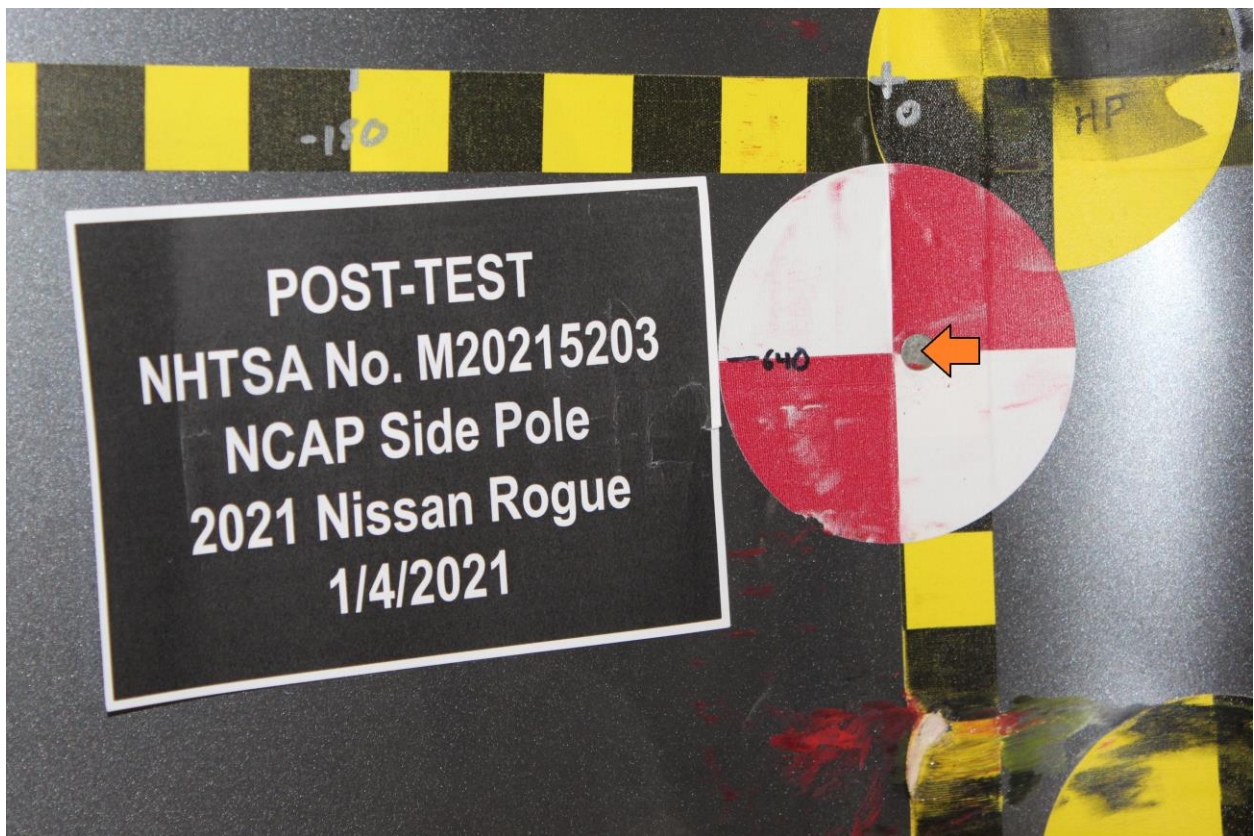
Figure A-20: Post-Test Close-Up View of Impact Point Target Showing Impact Location

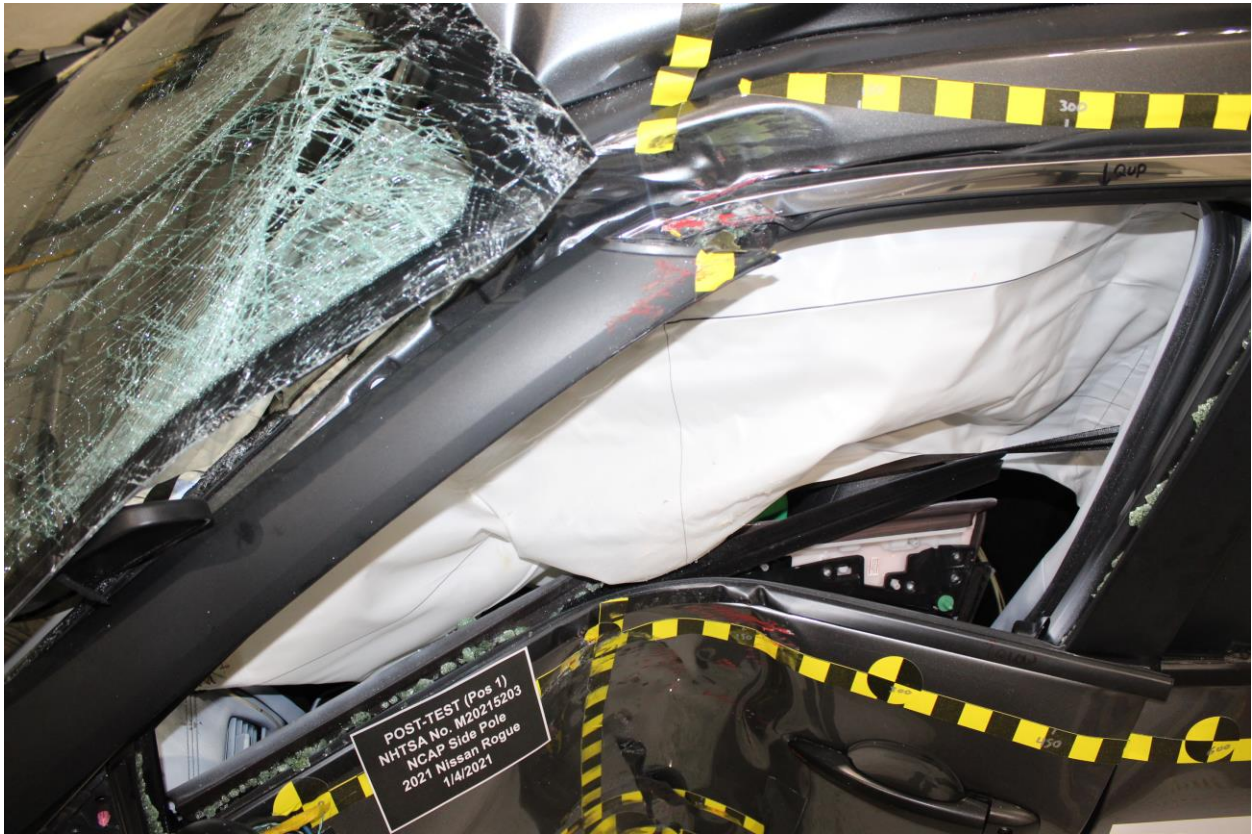
Figure A-41: Post-Test Dummy and Door Clearance View

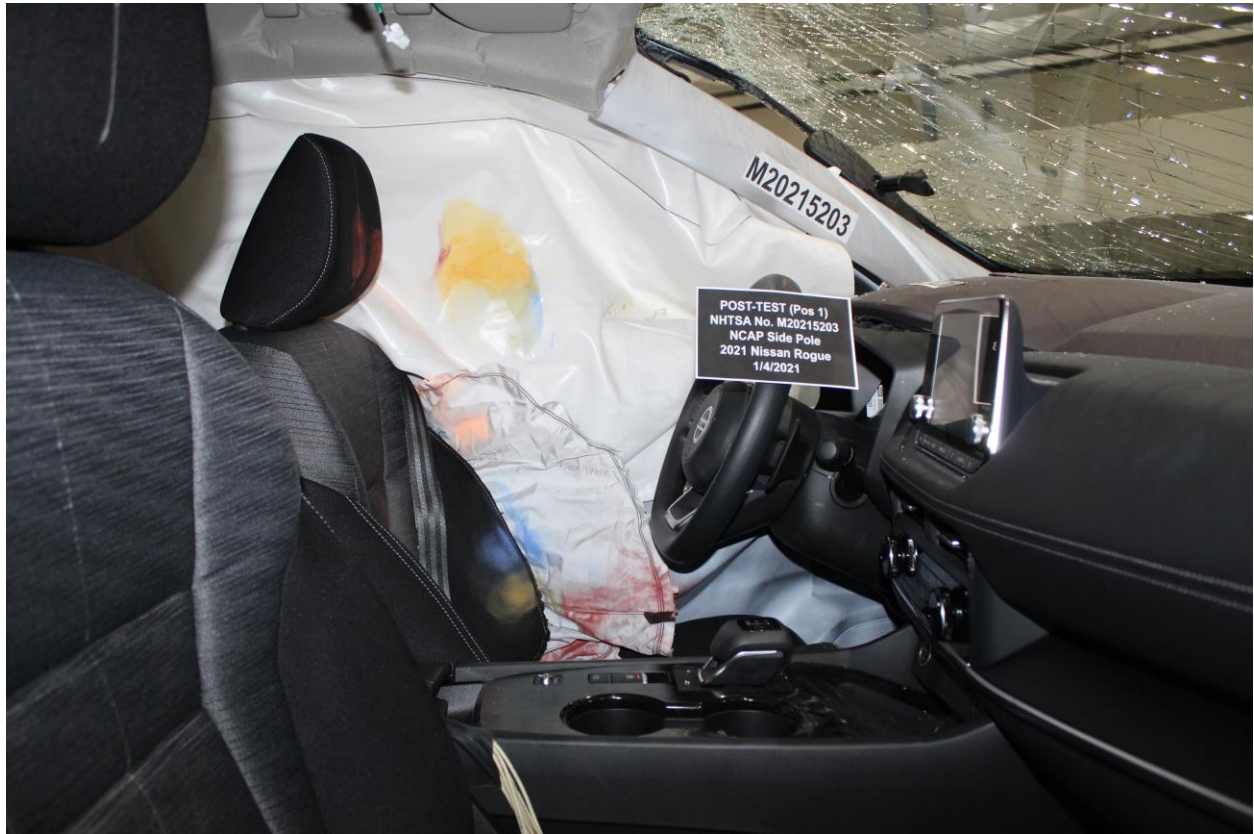
Figure A-45: Post-Test Inner Door Panel View Showing Dummy Contact Location

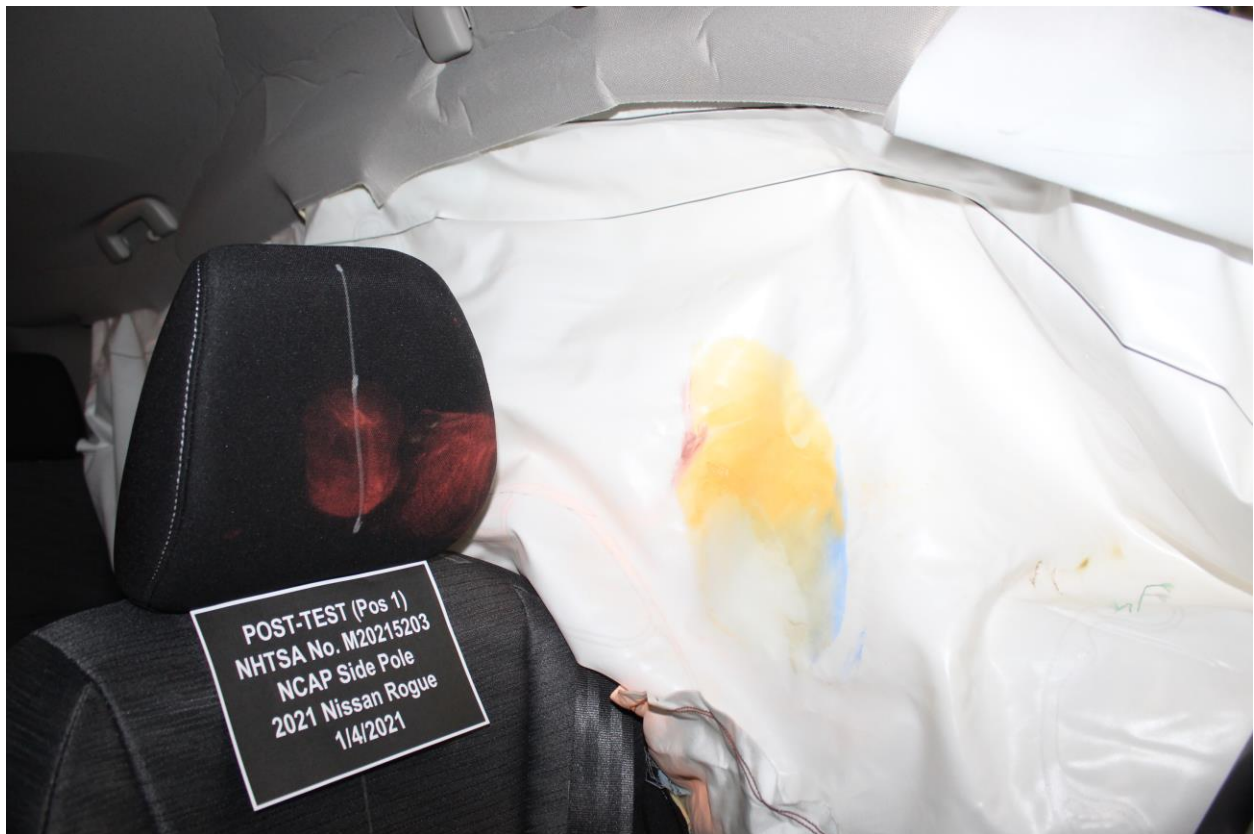
Figure A-46: Post-Test Dummy Close-Up Head Contact with Vehicle Interior View

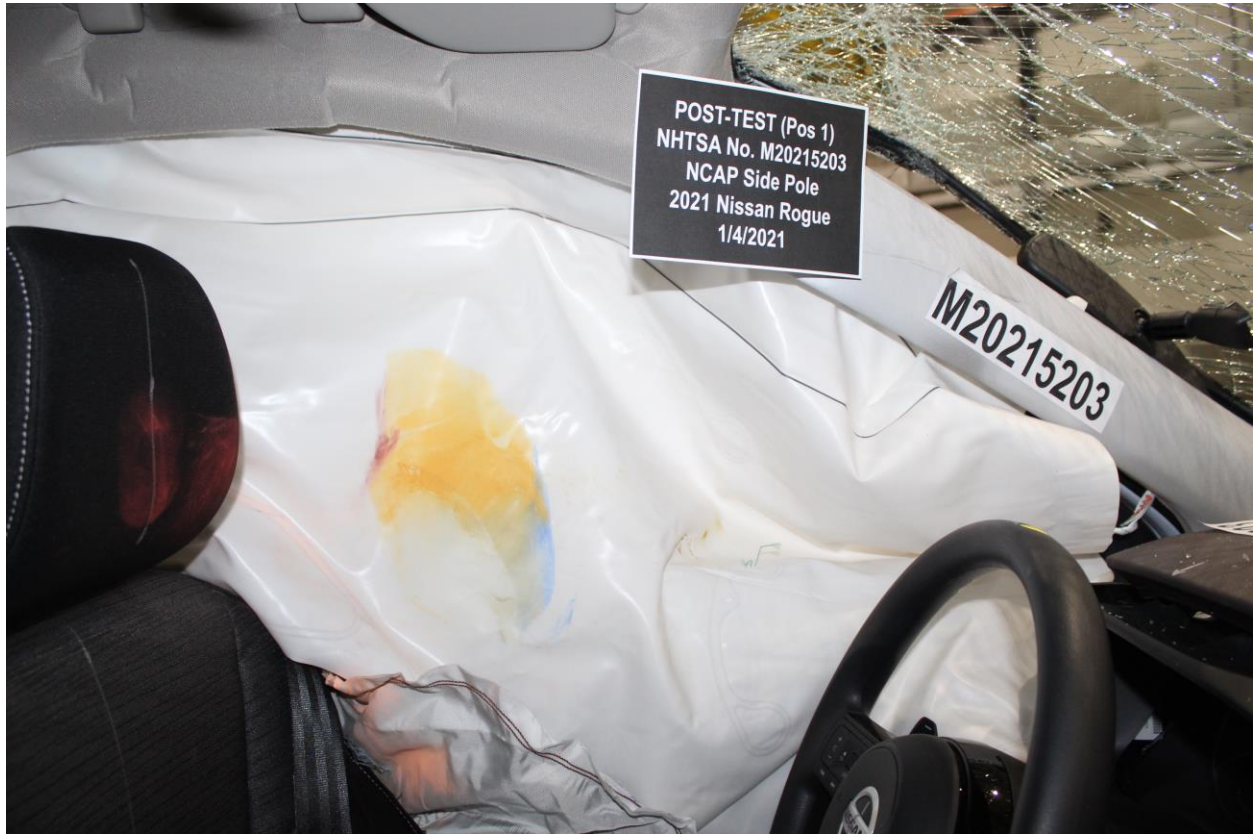
Figure A-47: Post-Test Dummy Close-Up Head Contact with Side Airbag View

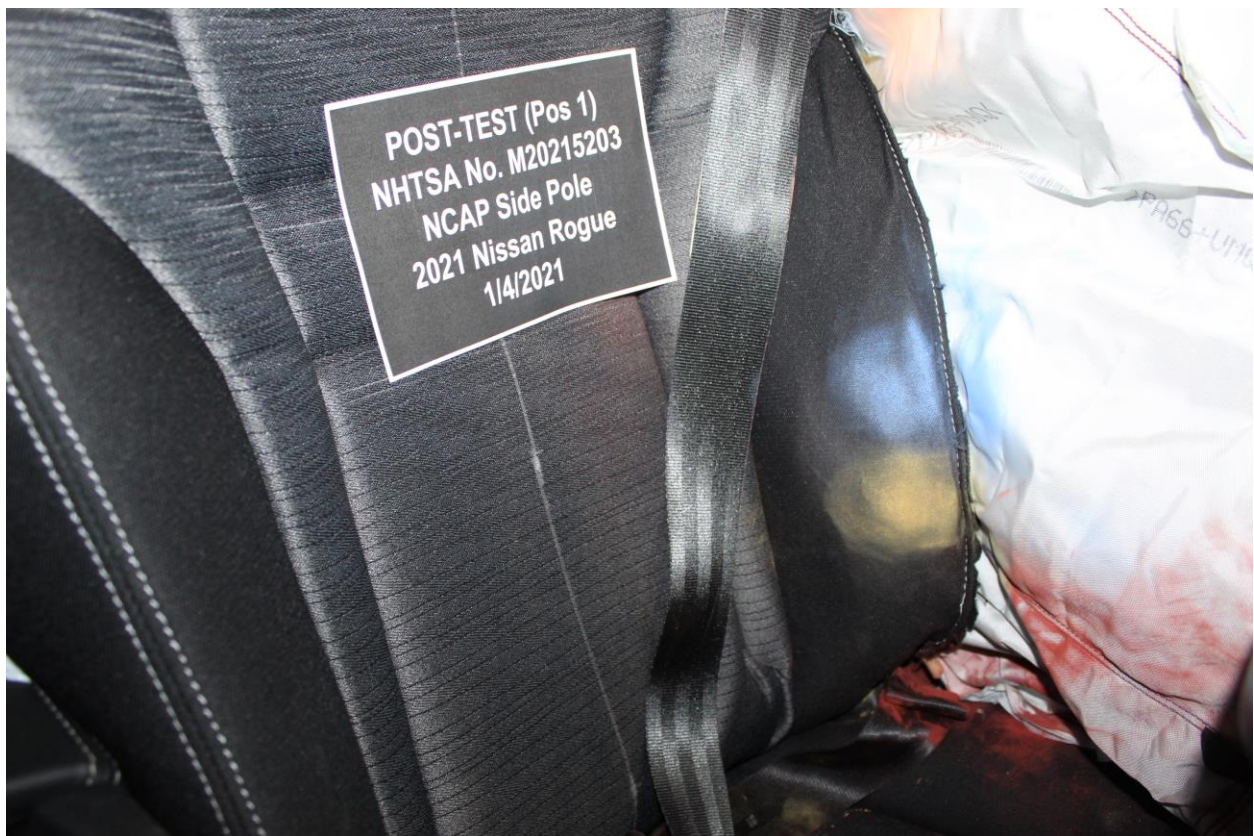
Figure A-48: Post-Test Dummy Close-Up Torso Contact with Vehicle Interior View

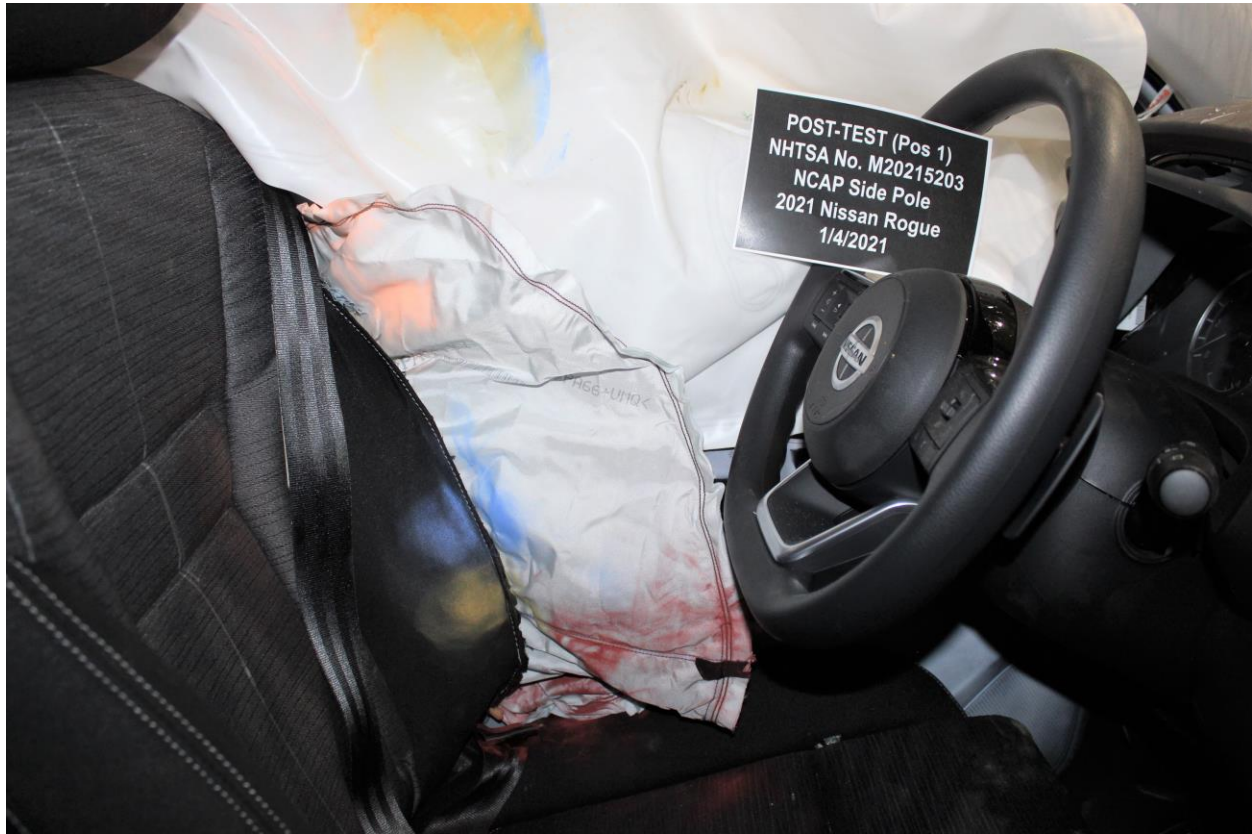
Figure A-49: Post-Test Dummy Close-Up Torso Contact with Side Airbag View

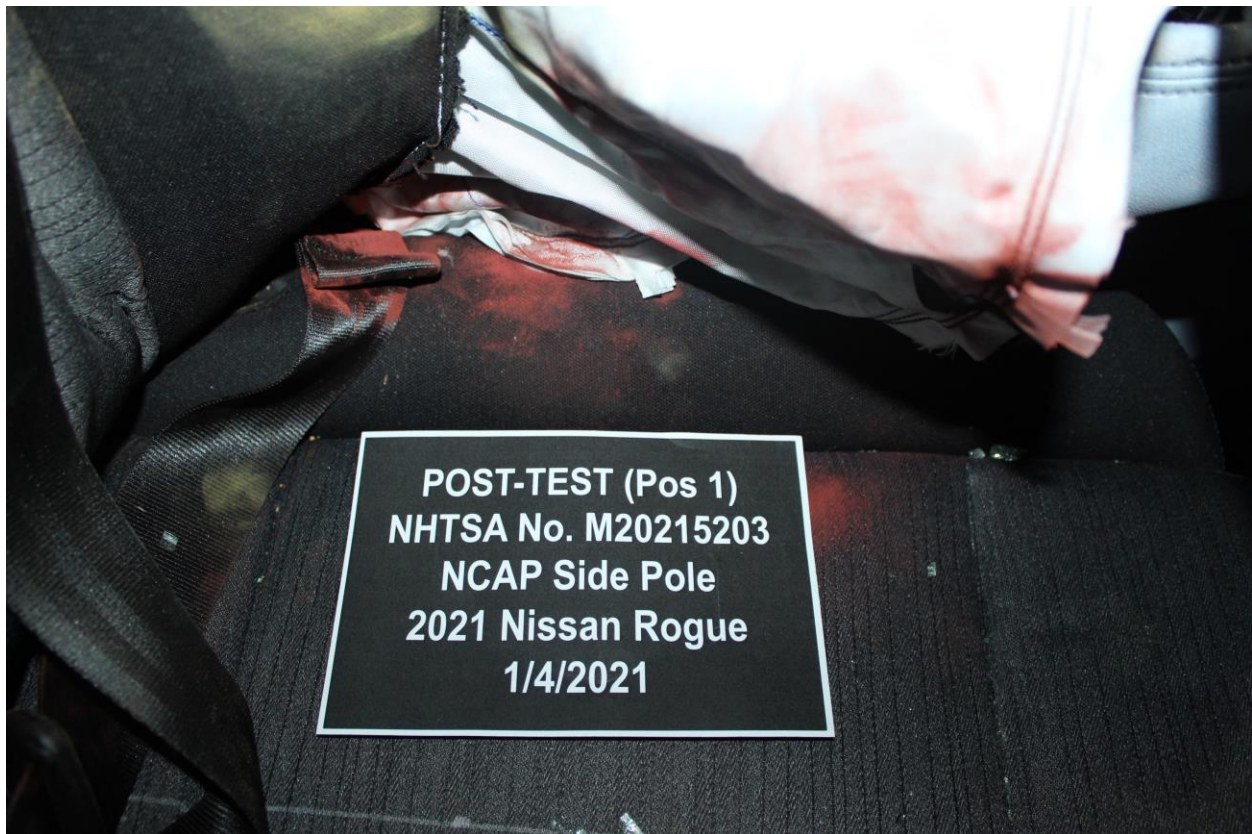
Figure A-50: Post-Test Dummy Close-Up Pelvis Contact with Vehicle Interior View

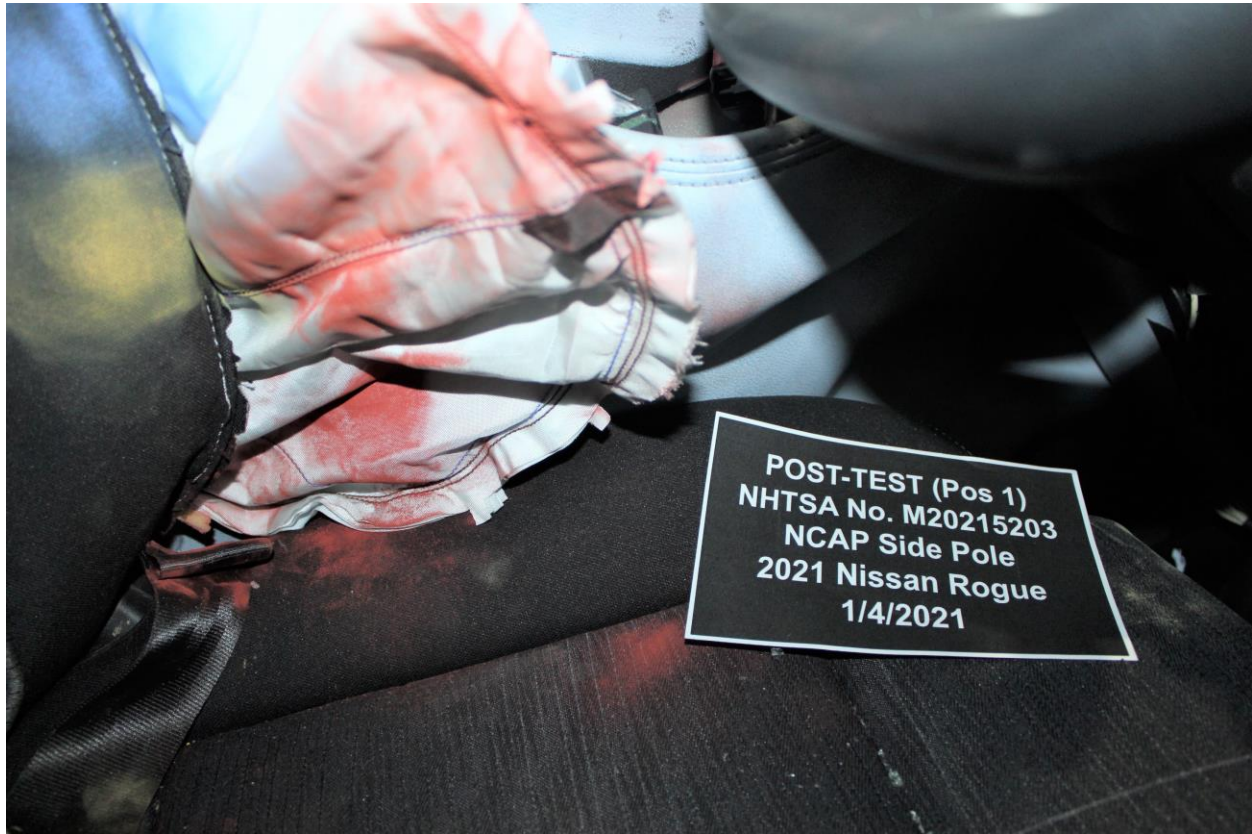
Figure A-51: Post-Test Dummy Close-Up Pelvis Contact with Side Airbag View

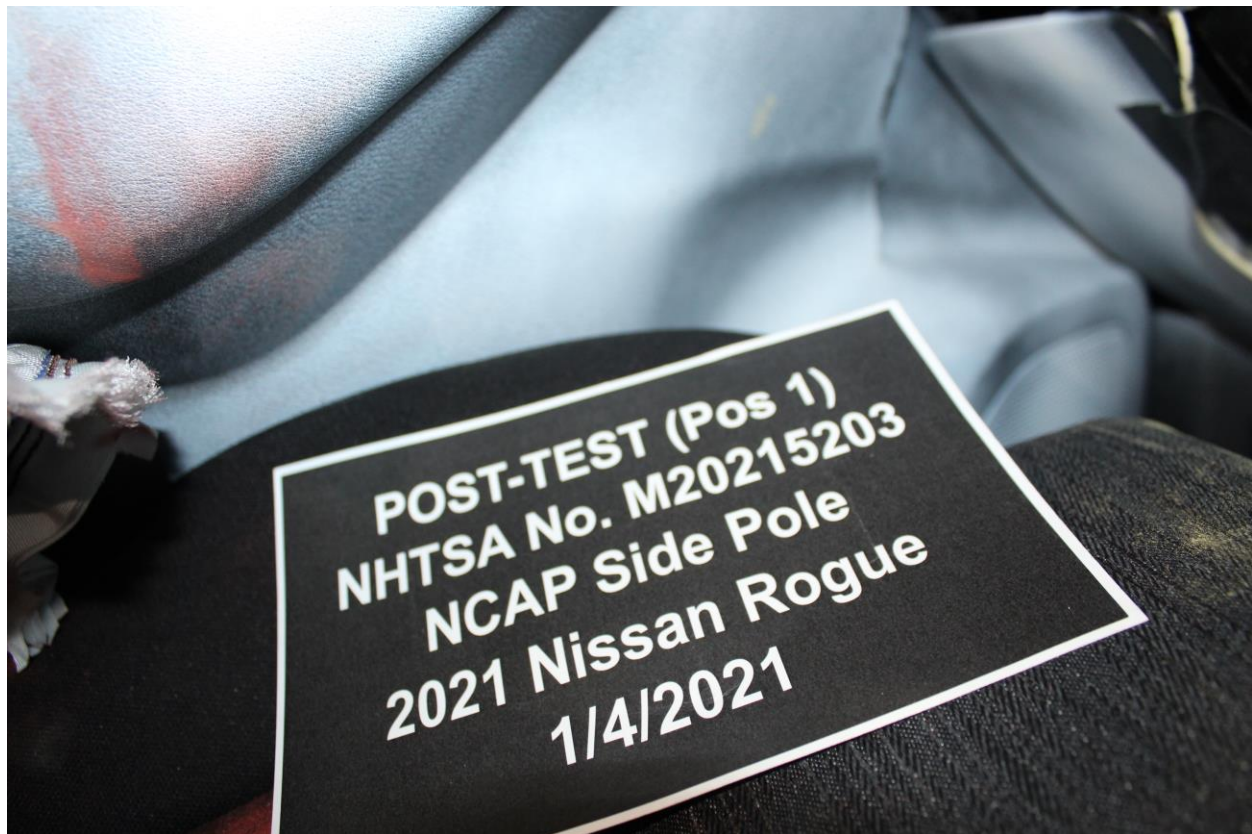
Figure A-52: Post-Test Dummy Close-Up Knee Contact with Vehicle Interior View

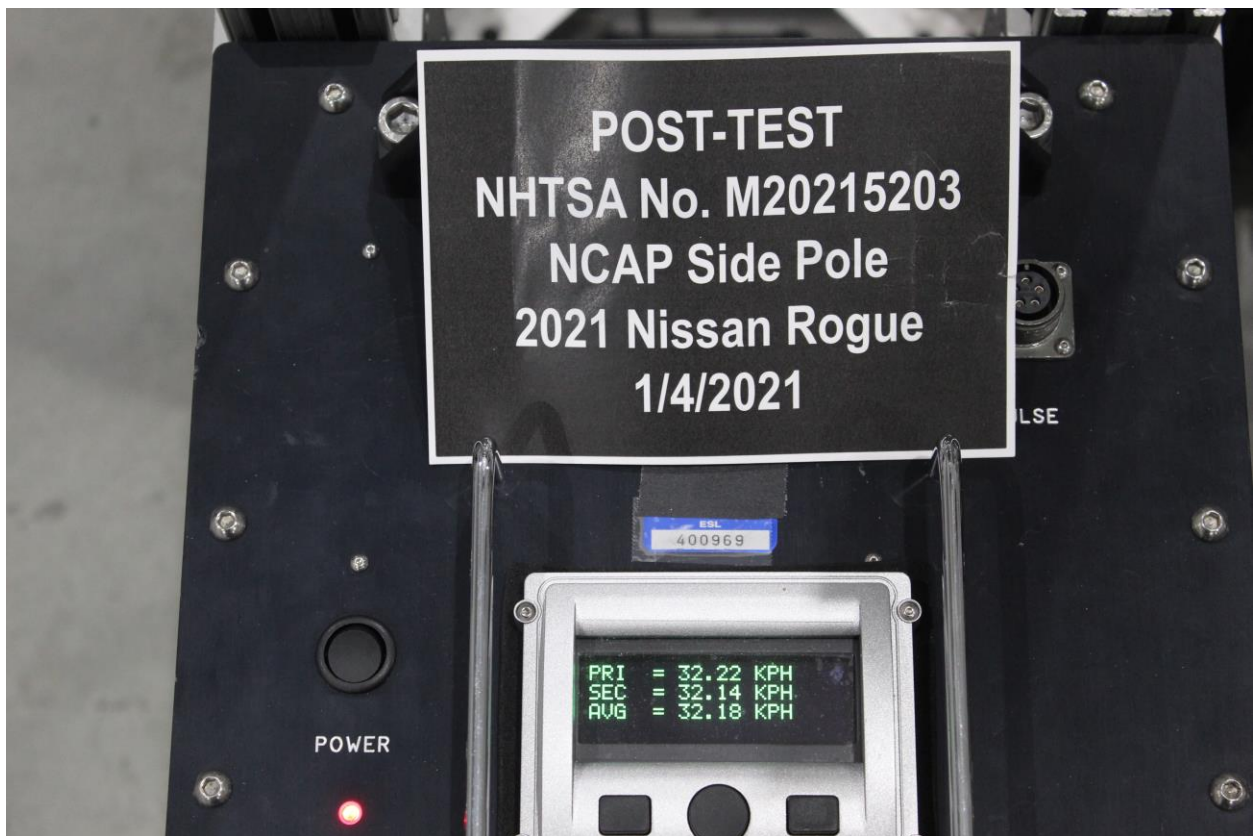
Figure A-62: Post-Test Primary and Redundant Speed Trap Read-Out

A rigid pole side impact test was conducted on a 2021 Nissan Rogue SUV. The subject vehicle was towed into the rigid pole at an angle of 75° and a velocity of 32.22 km/h. The test was conducted by Calspan Corporation's Transportation Test Operations facility in Buffalo, New York on January 4, 2021. Pre-test and post-test photographs of the test vehicle and side impact dummy (SID-IIs) are included in Appendix A of this report.

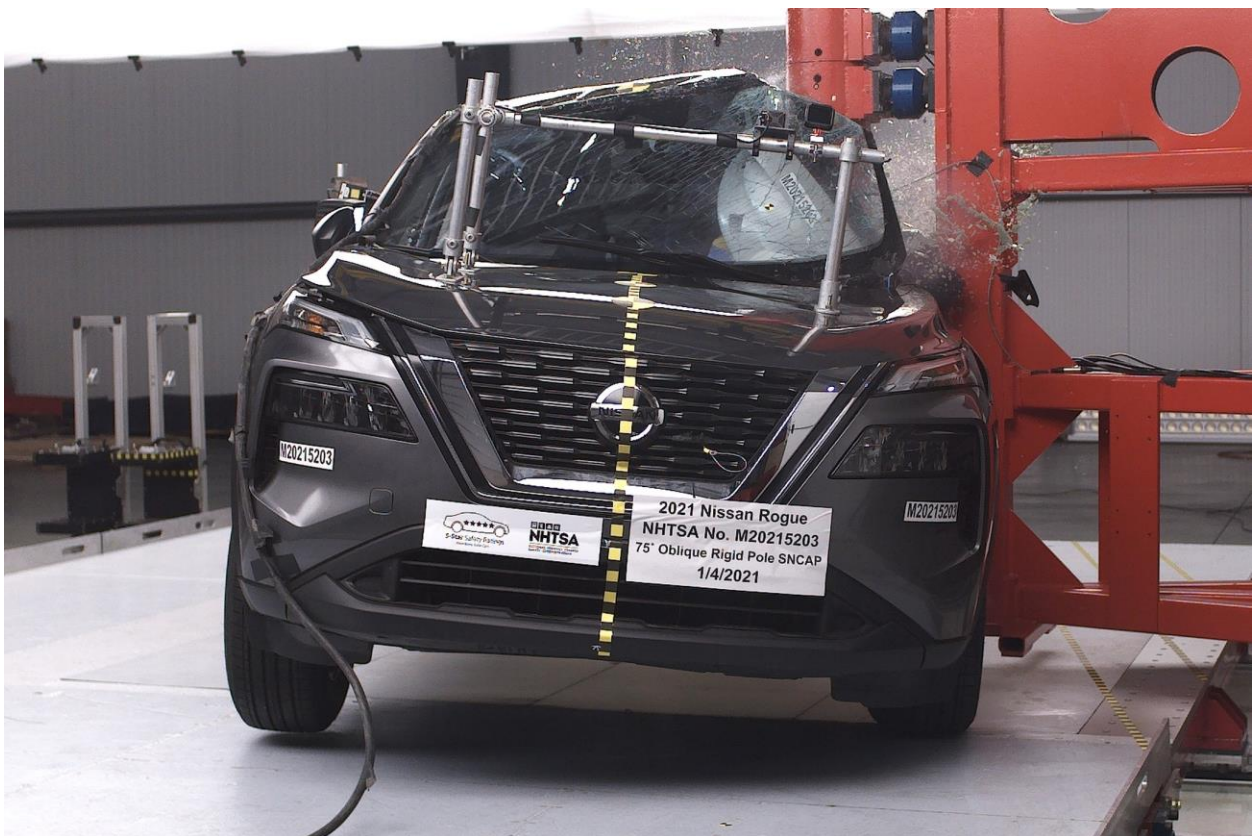
Figure A-68: Impact Event
