**NEW CAR ASSESSMENT PROGRAM (NCAP)  
Side Impact Pole Test**

**HONDA OF AMERICA MFG., INC.  
2021 Acura TLX 4-Door Sedan  
NHTSA No.: O20215301**

**MGA RESEARCH CORPORATION  
5000 Warren Road  
Burlington, WI 53105**

**FINAL REPORT**

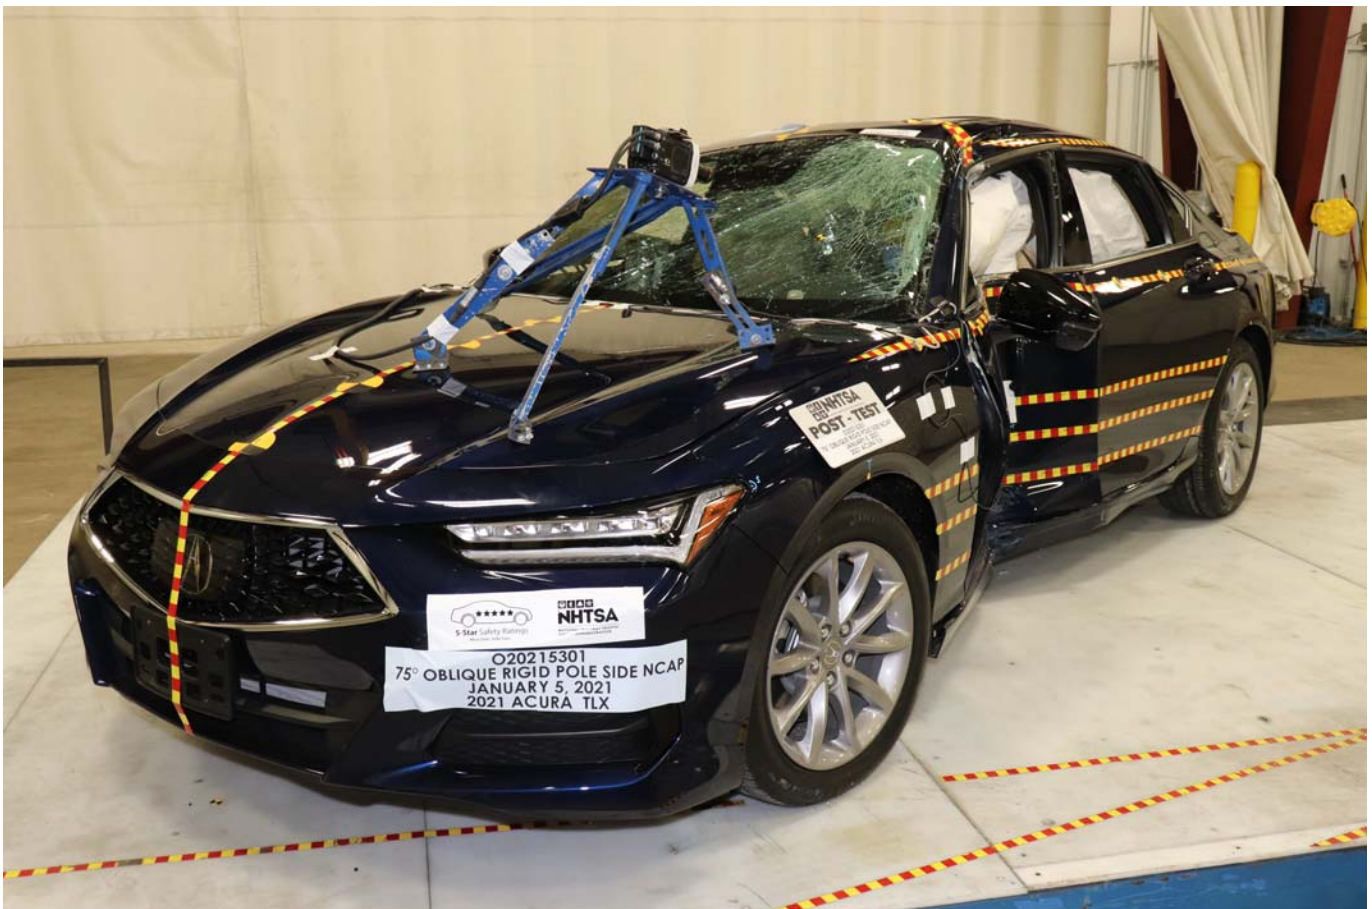
Photo No. 006 - Post-Test Left Front Three-Quarter View of Test Vehicle

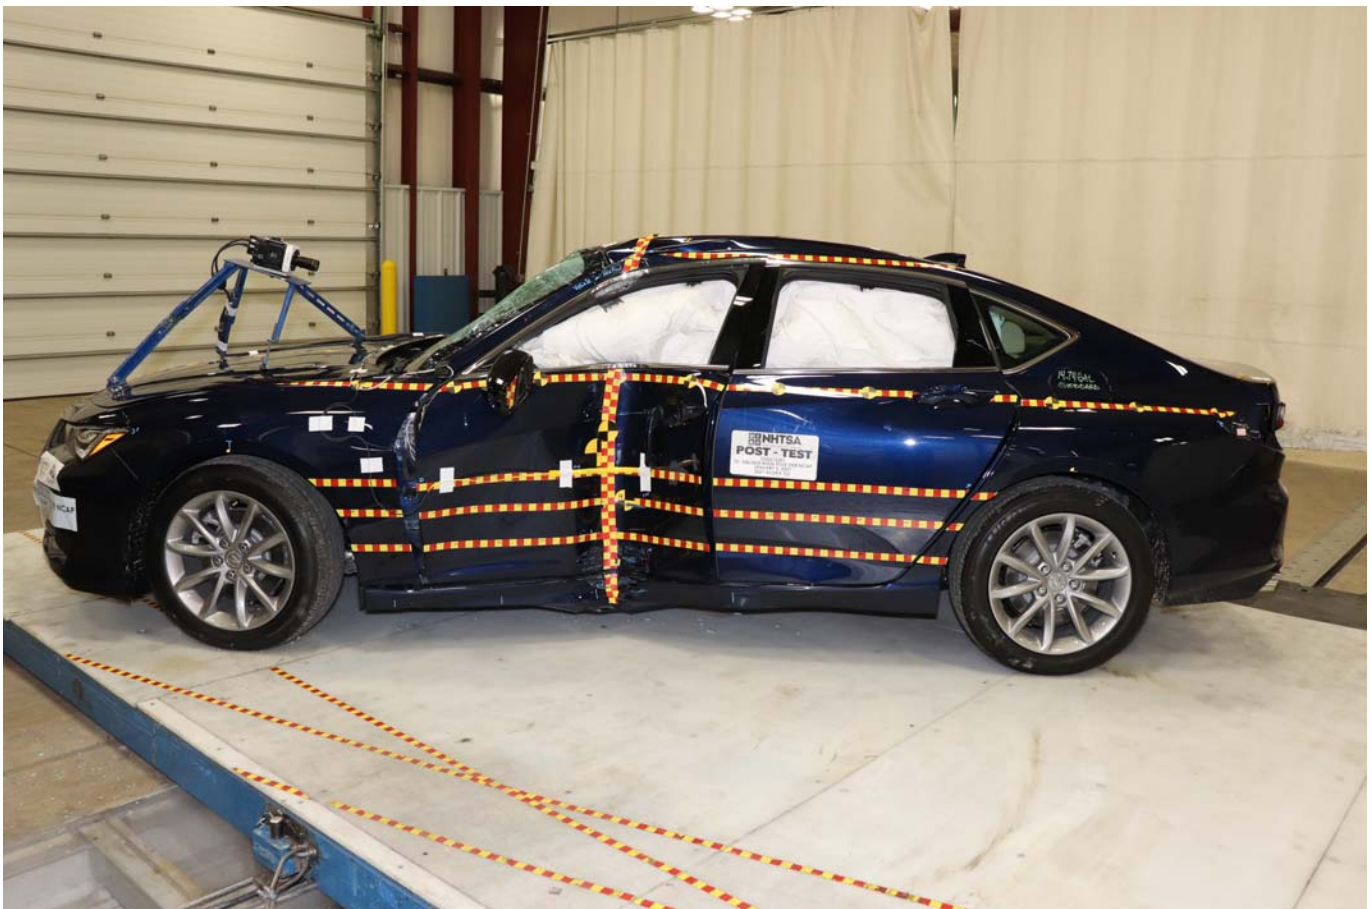
Photo No. 008 - Post-Test Left Side View of Test Vehicle

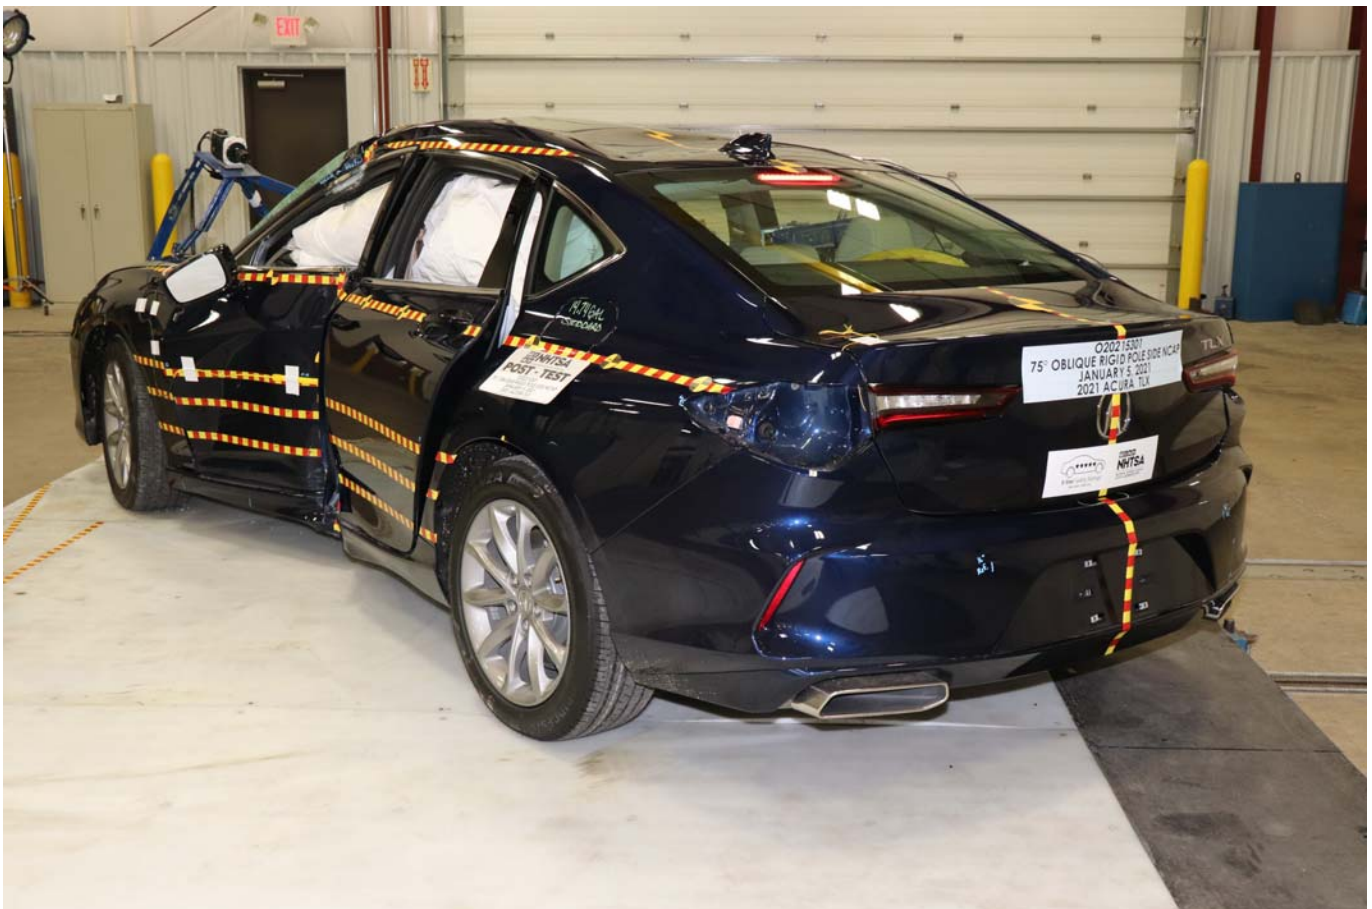
Photo No. 010 - Post-Test Left Rear Three-Quarter View of Test Vehicle

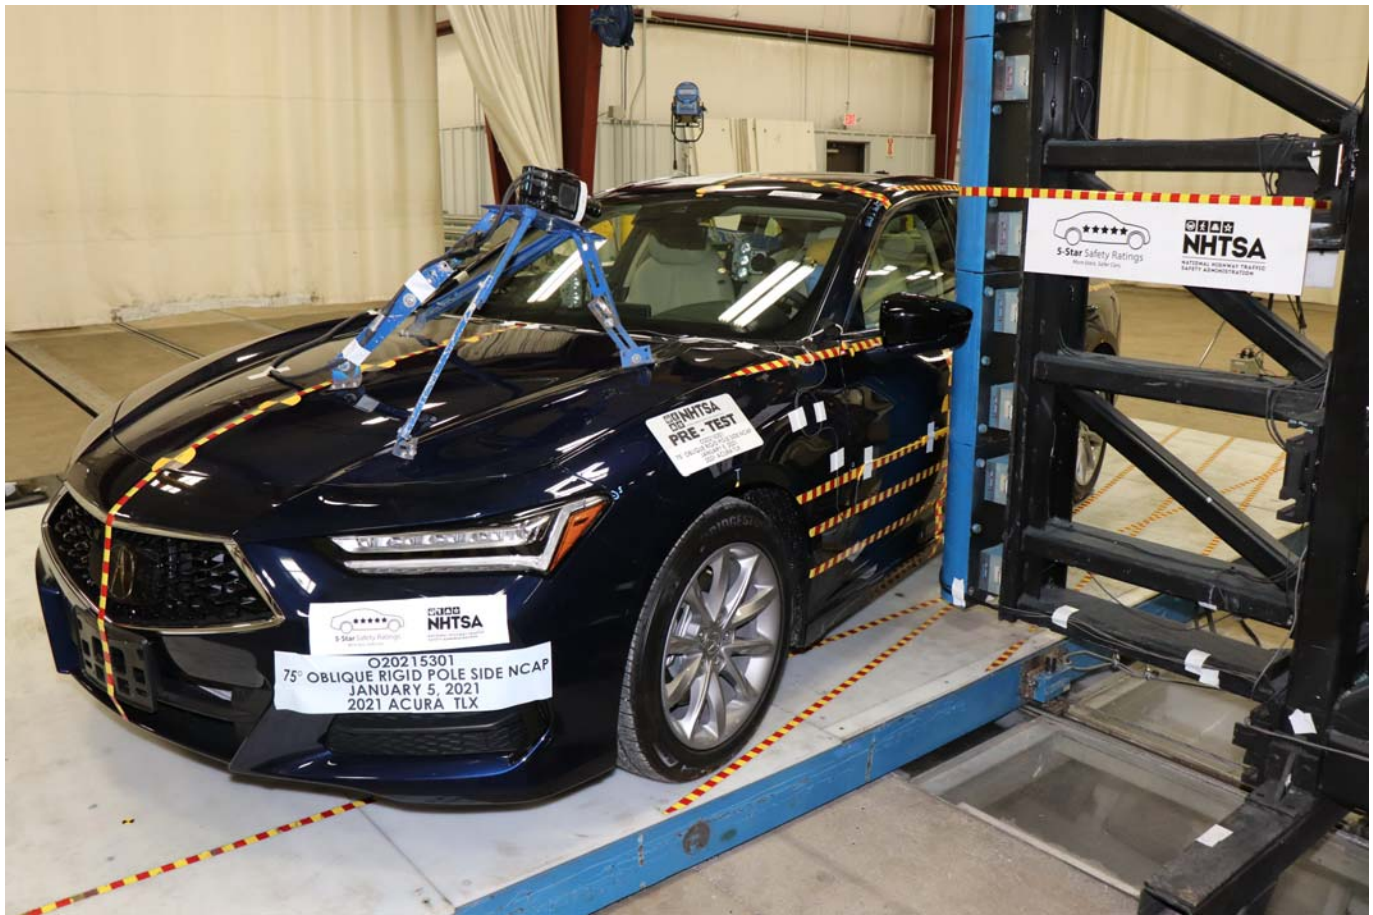
Photo No. 017 - Pre-Test Left Side View of Pole Positioned Against Side of Vehicle

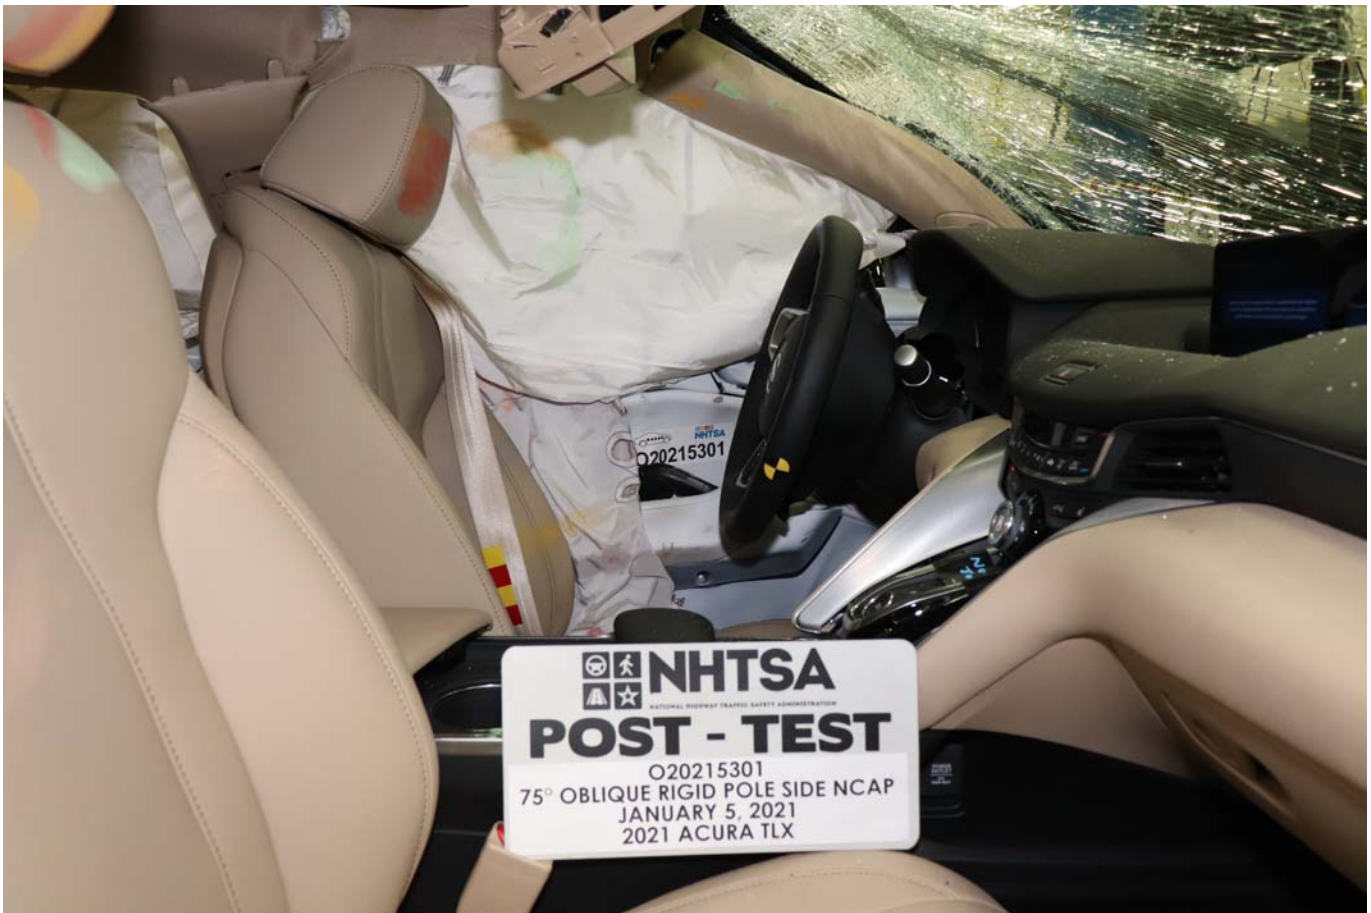
Photo No. 045 - Post-Test Inner Door Panel View Showing Dummy Contact Location

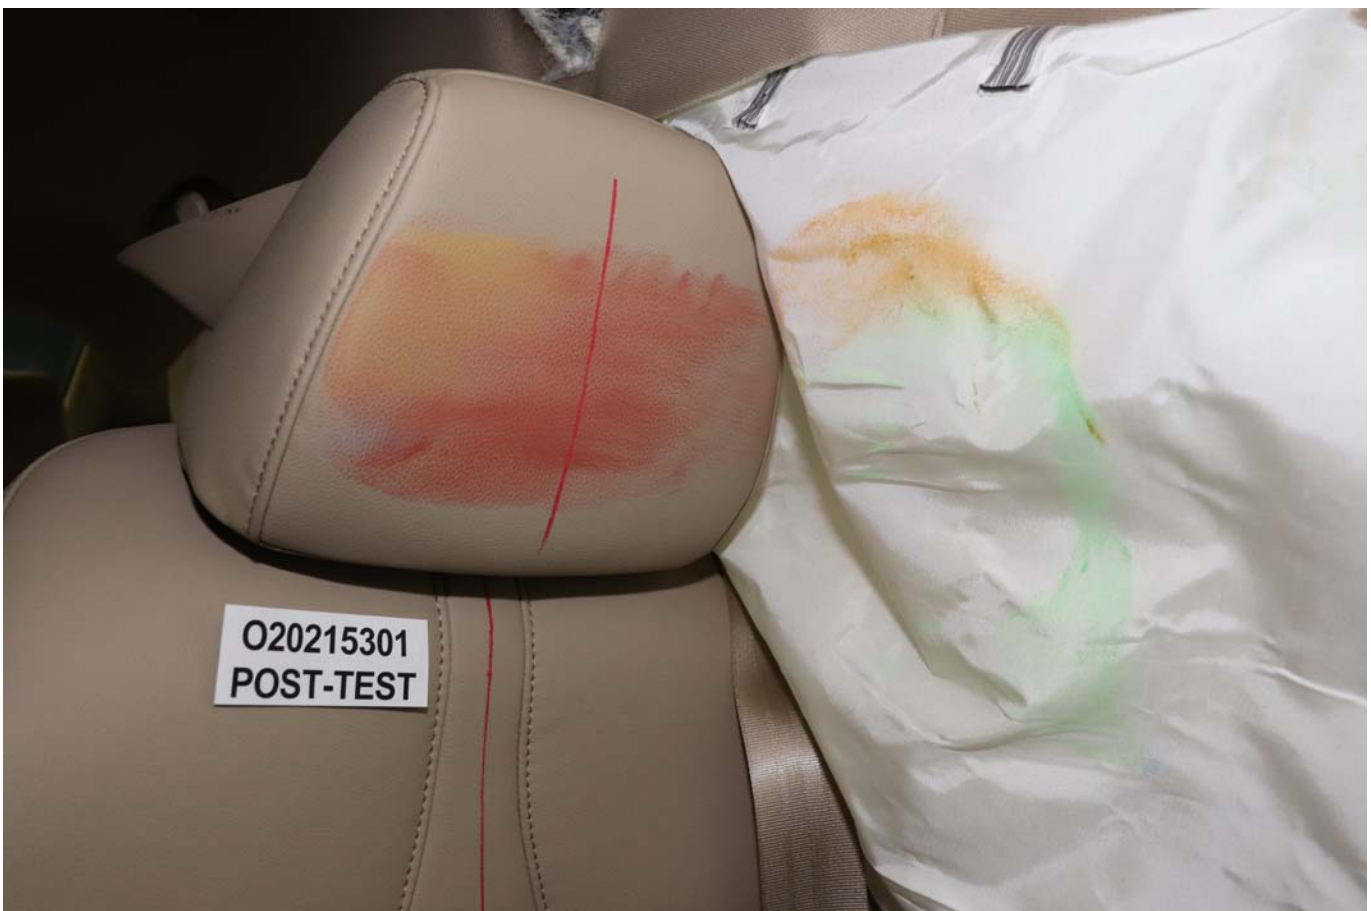
Photo No. 046 - Post-Test Dummy Close-Up Head Contact with Vehicle Interior View

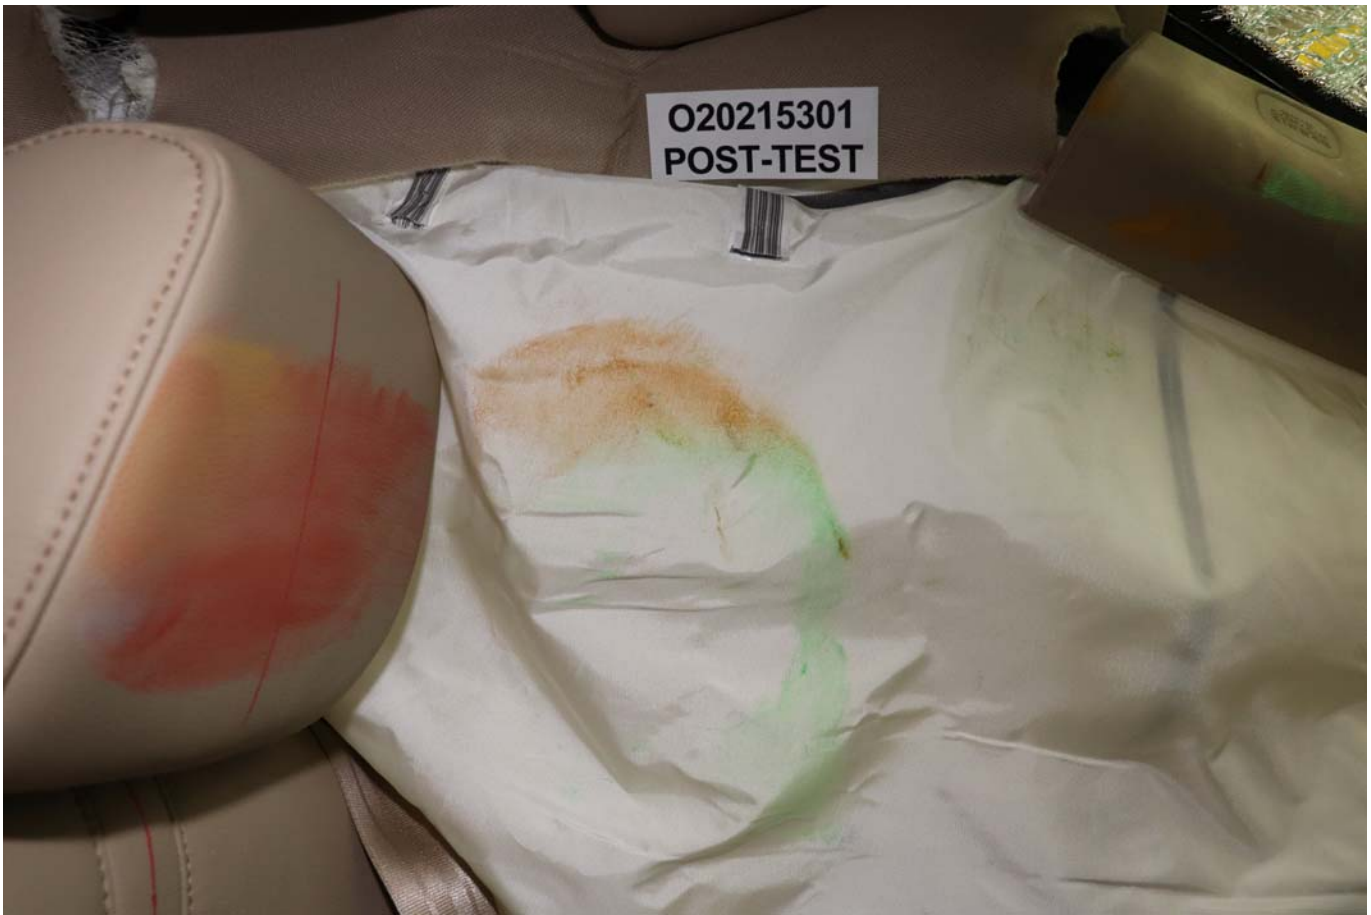
Photo No. 047 - Post-Test Dummy Close-Up Head Contact with Side Air Bag View

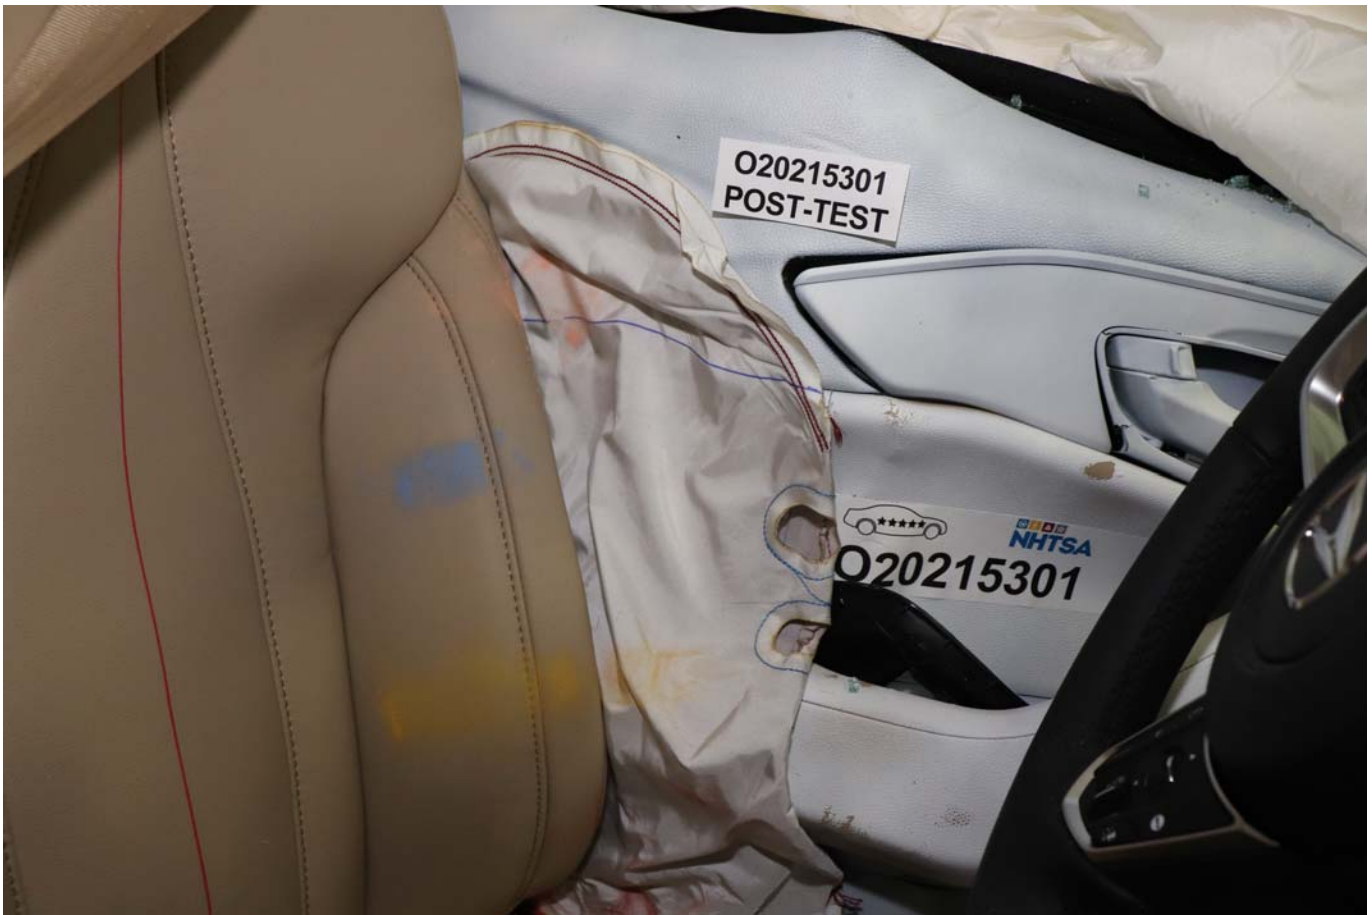
Photo No. 049 - Post-Test Dummy Close-Up Torso Contact with Side Air Bag View

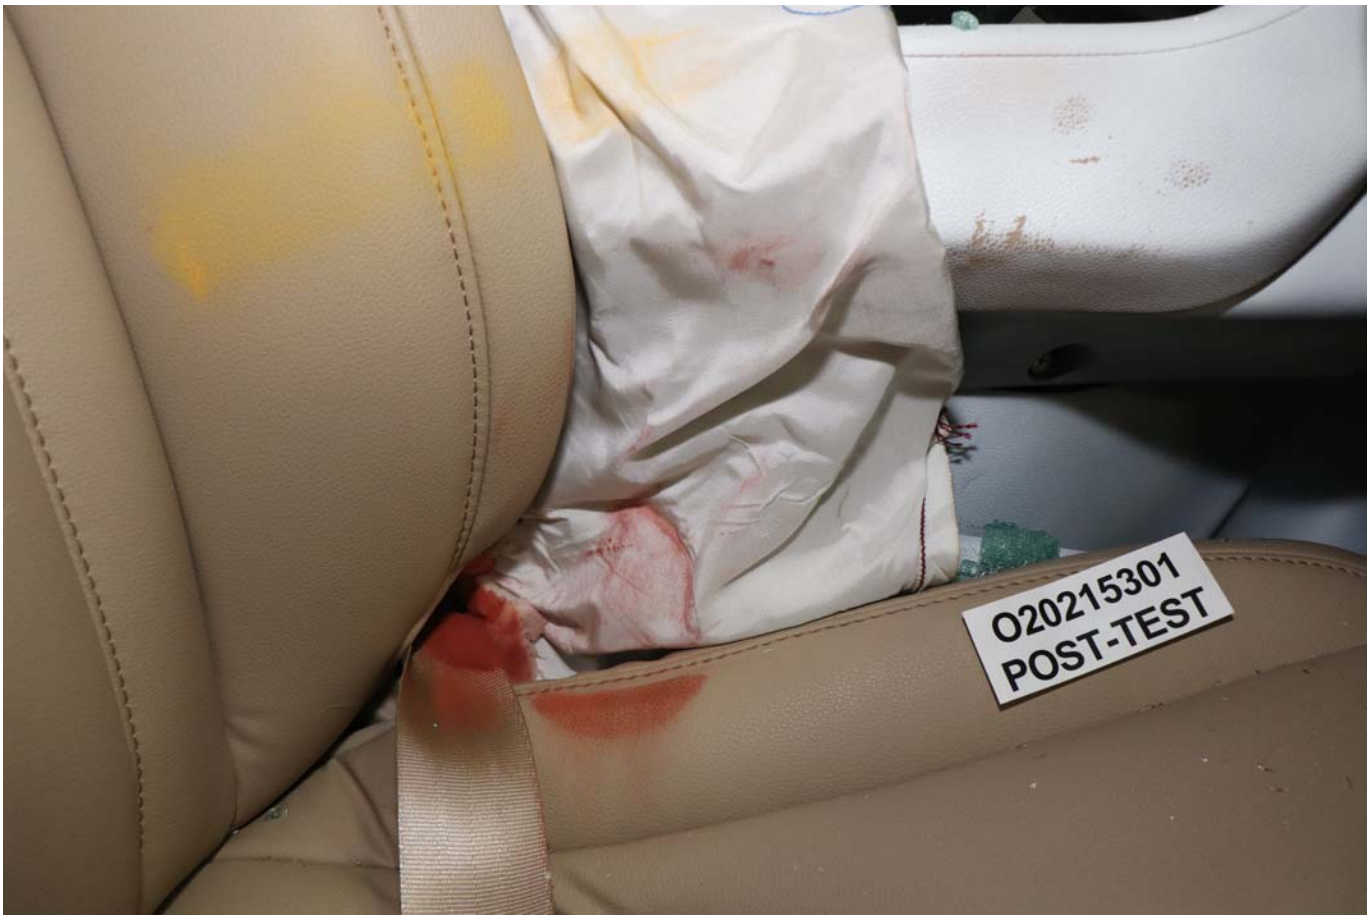
Photo No. 051 - Post-Test Dummy Close-Up Pelvis Contact with Side Air Bag View

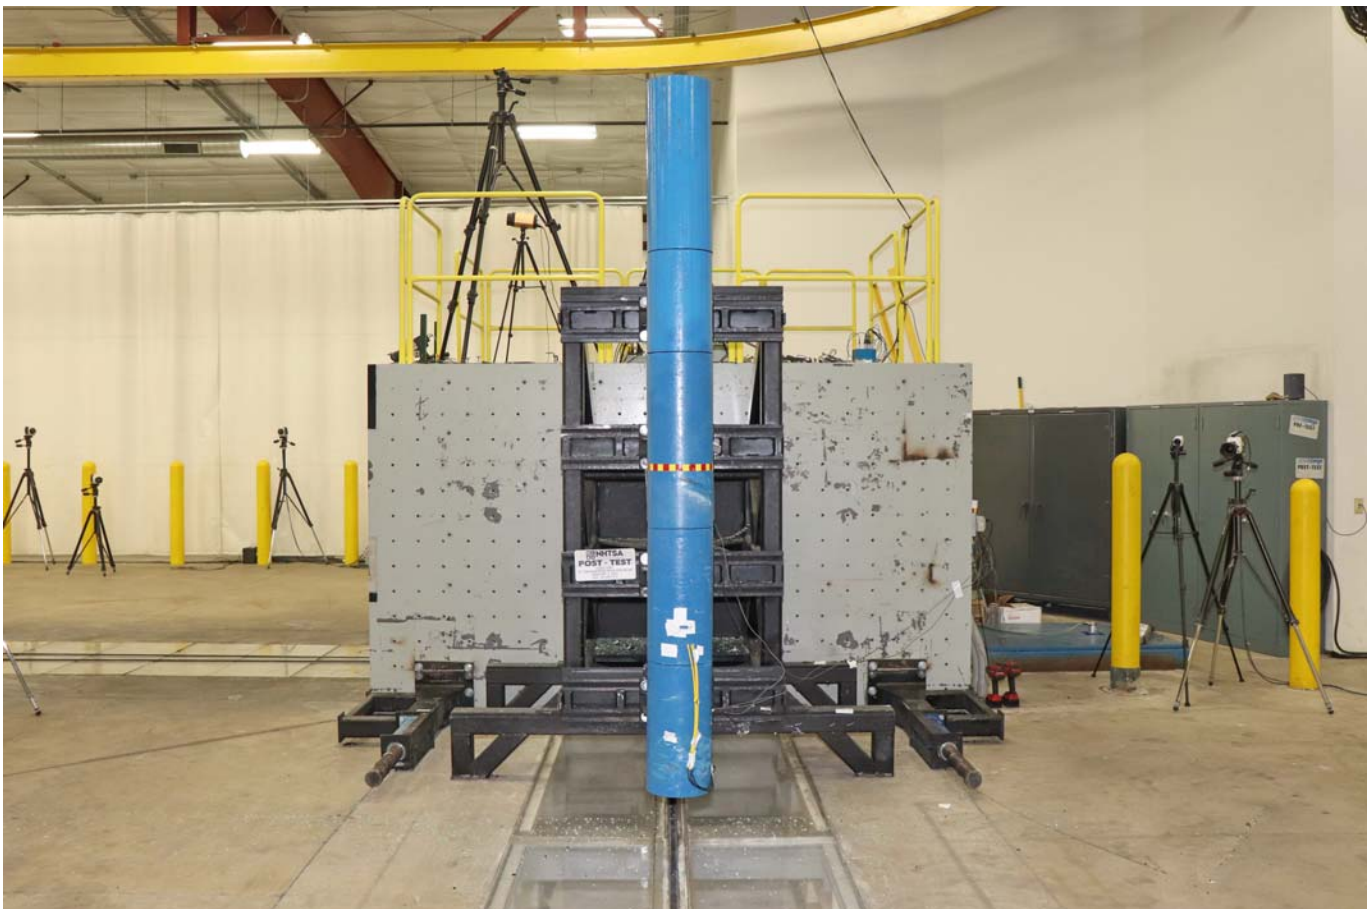
Photo No. 060 - Post-Test Pole Barrier Front View

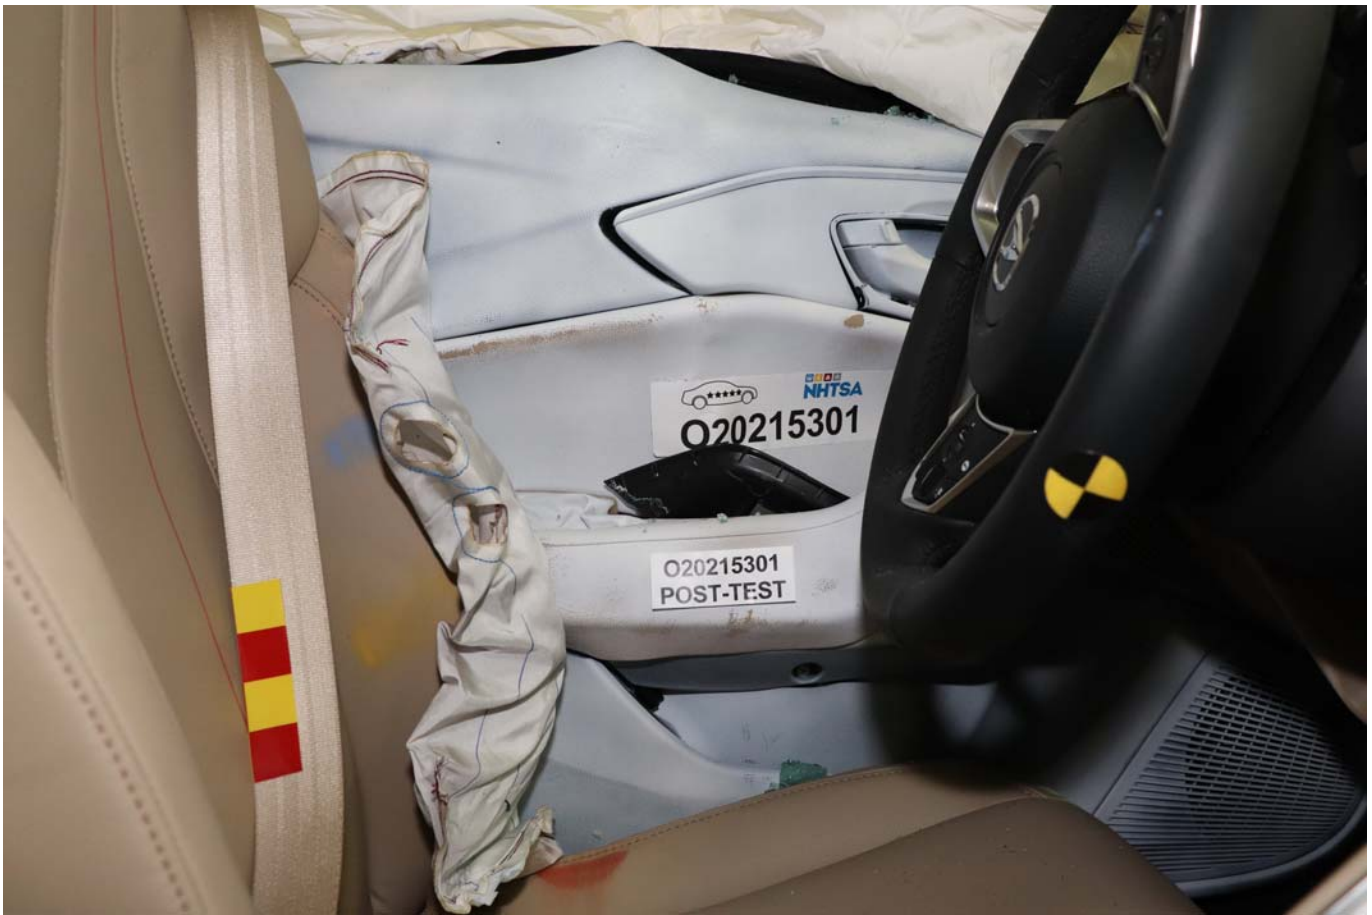
Photo No. 073 - Post-Test View of Shattered Vehicle Inner Door Panel
