**NEW CAR ASSESSMENT PROGRAM
LANE DEPARTURE WARNING CONFIRMATION TEST
NCAP-DRI-LDW-21-10**

2021 Mercedes-Benz E350 Sedan

DYNAMIC RESEARCH, INC.

Final Report

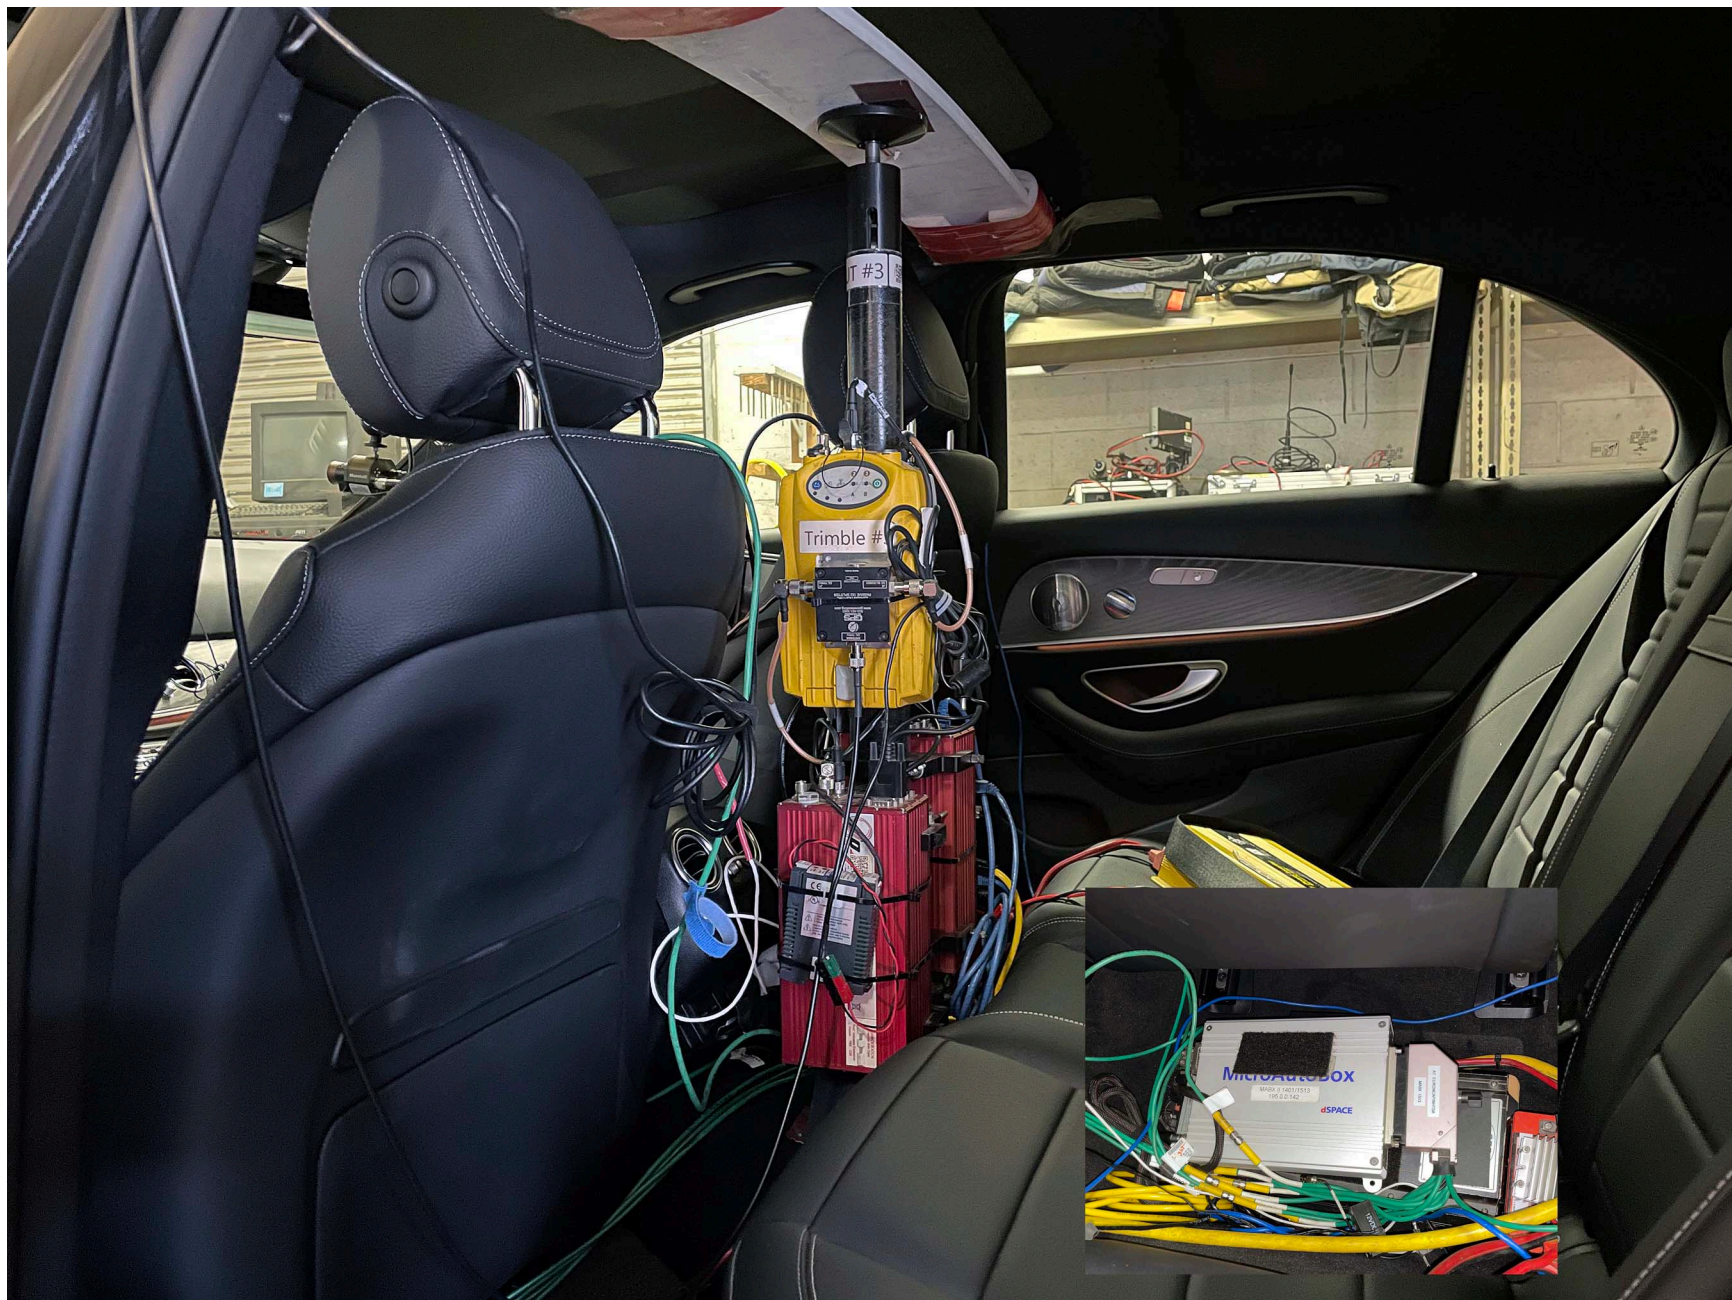
Figure A6. DGPS, Inertial Measurement Unit, and MicroAutoBox Installed in Subject Vehicle

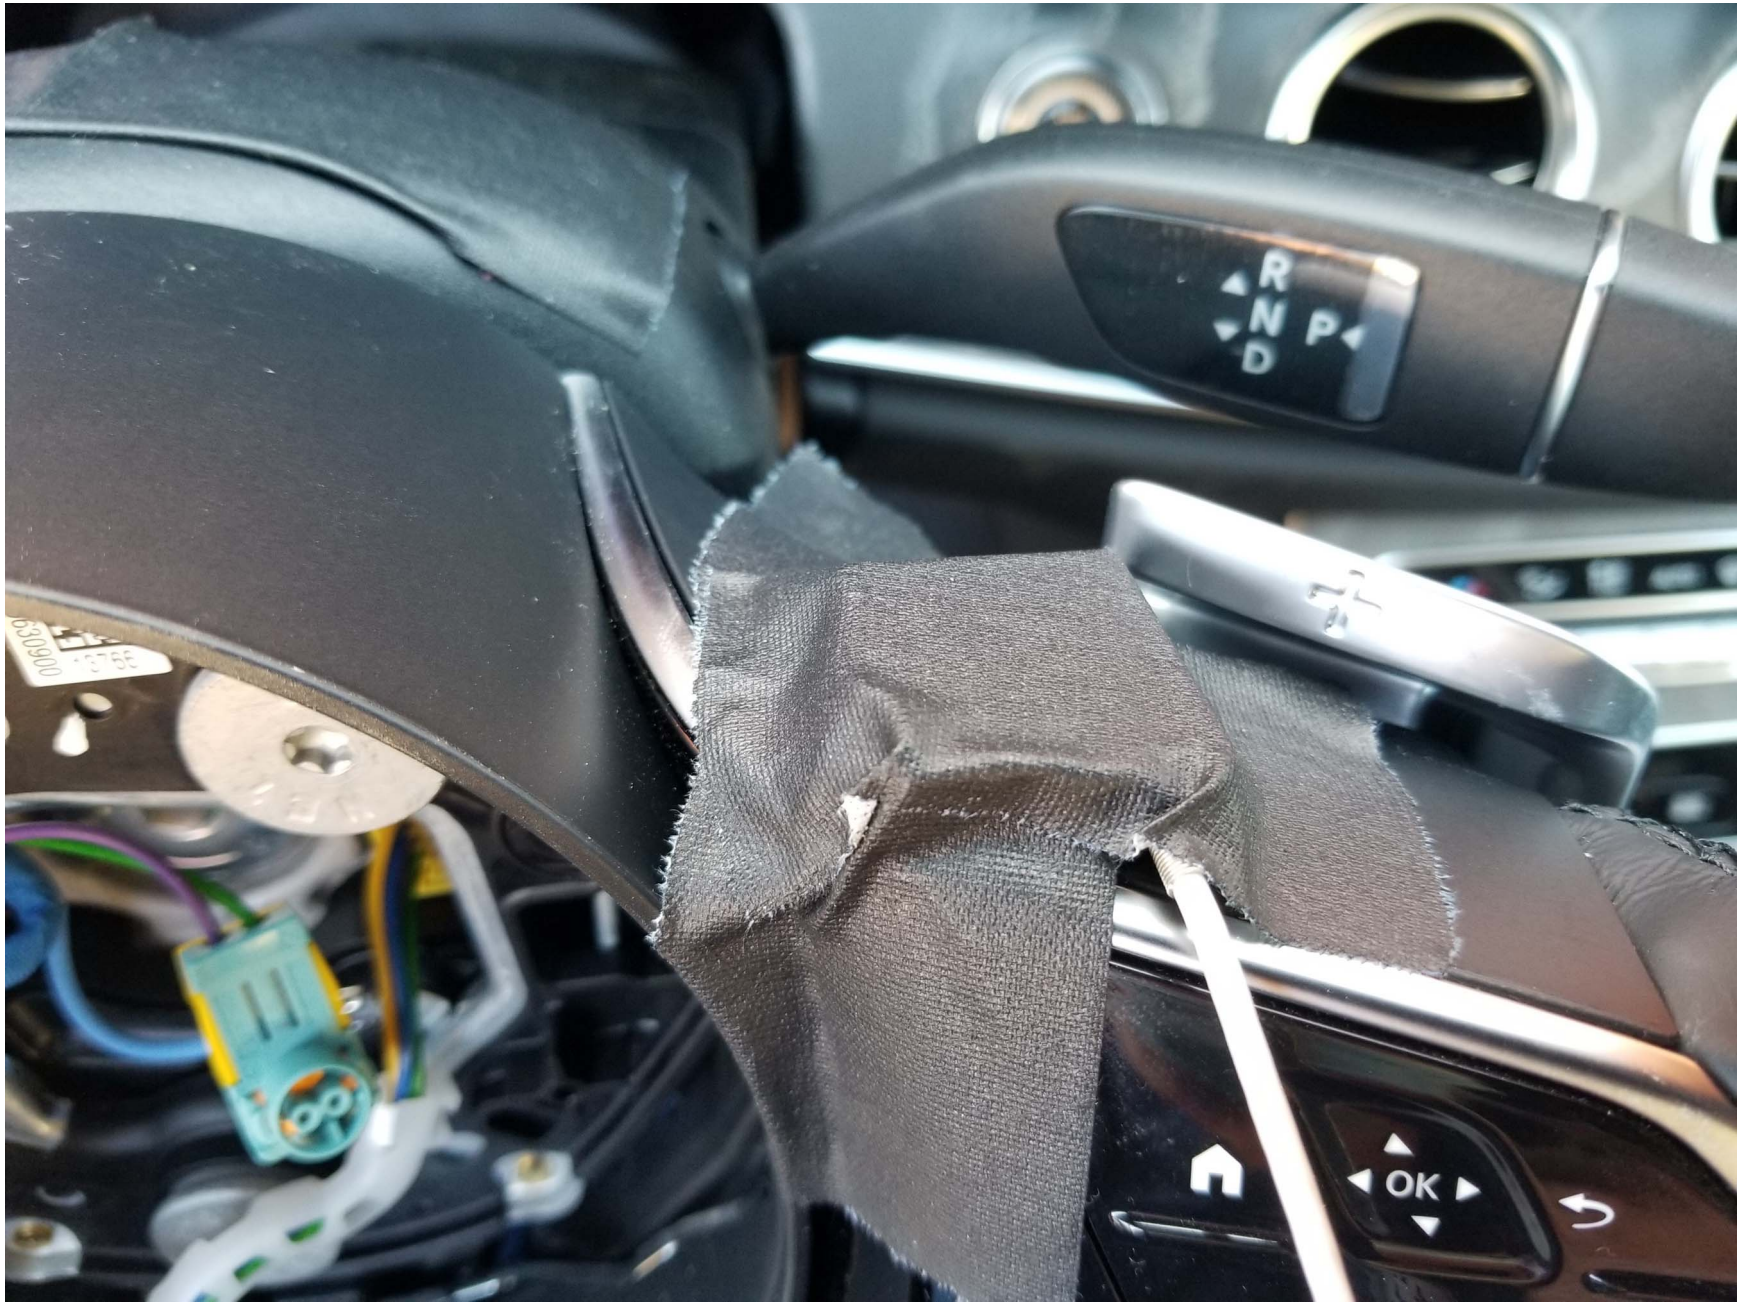
Figure A7. Sensor for Detecting Haptic Alerts

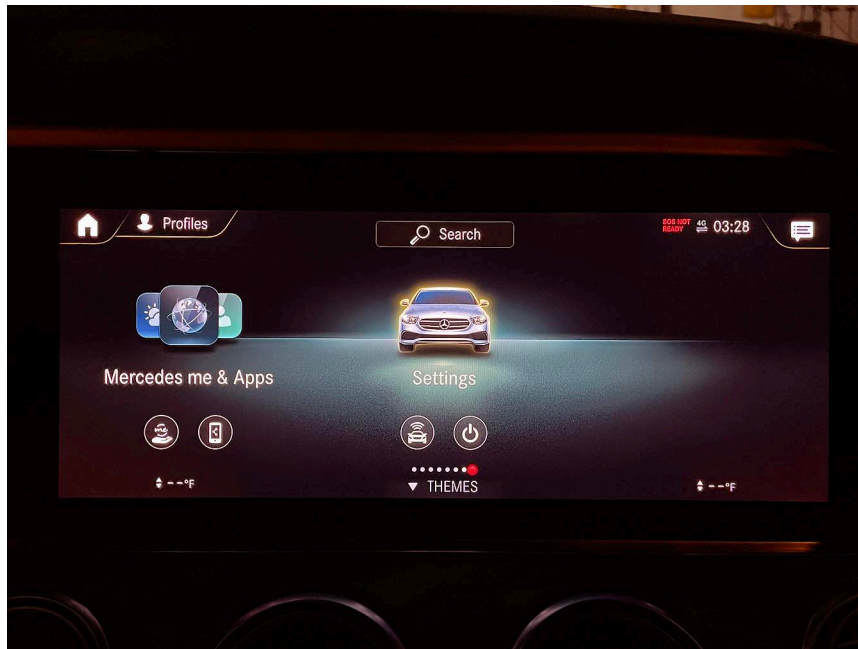
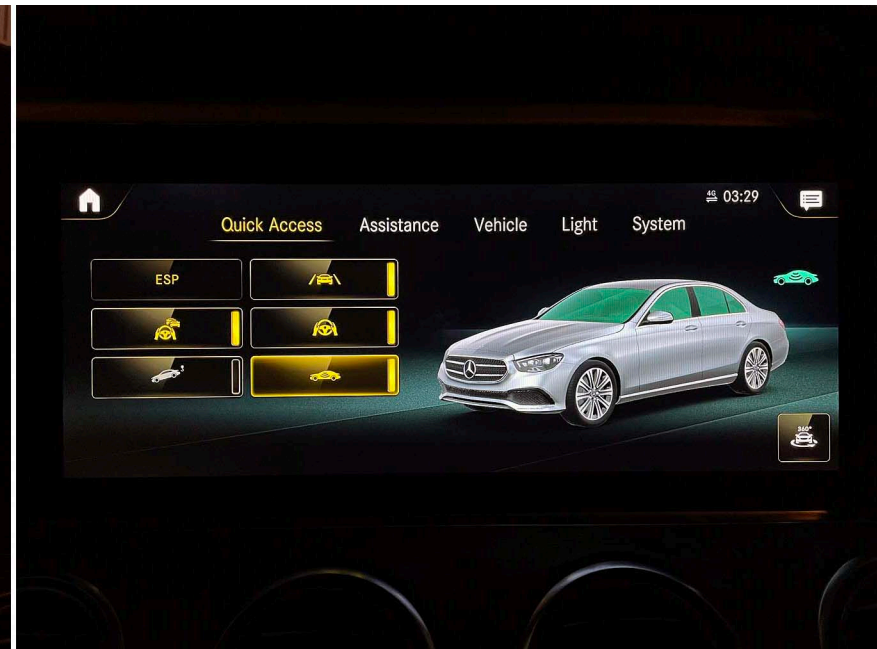
Figure A9. LDW Menus (1 of 2)

System menus can be accessed via the multimedia touch screen, buttons on the right side of the steering wheel, or a track pad located in the center console. The menu hierarchy for disabling the system is:

See Appendix A, Figures A9 – A11.

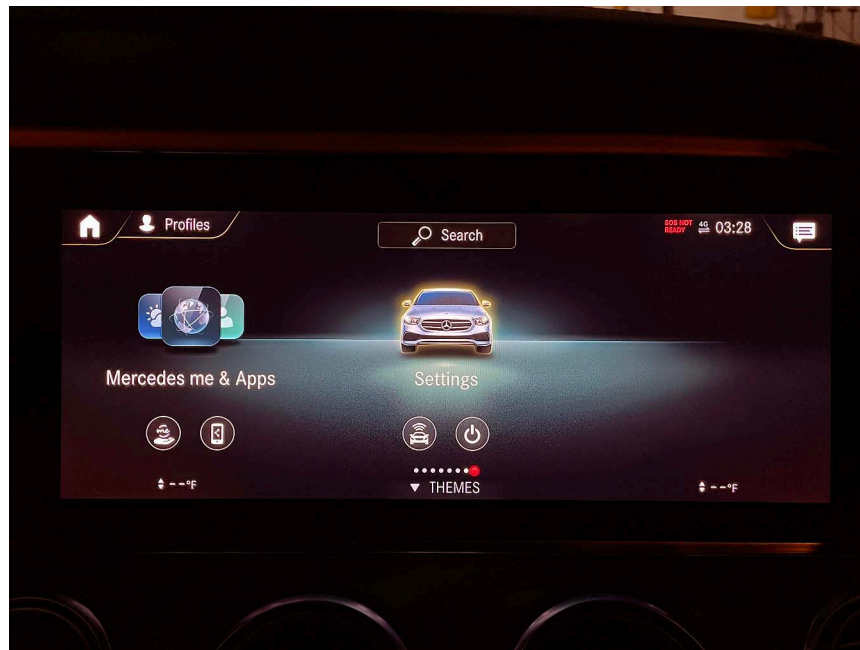
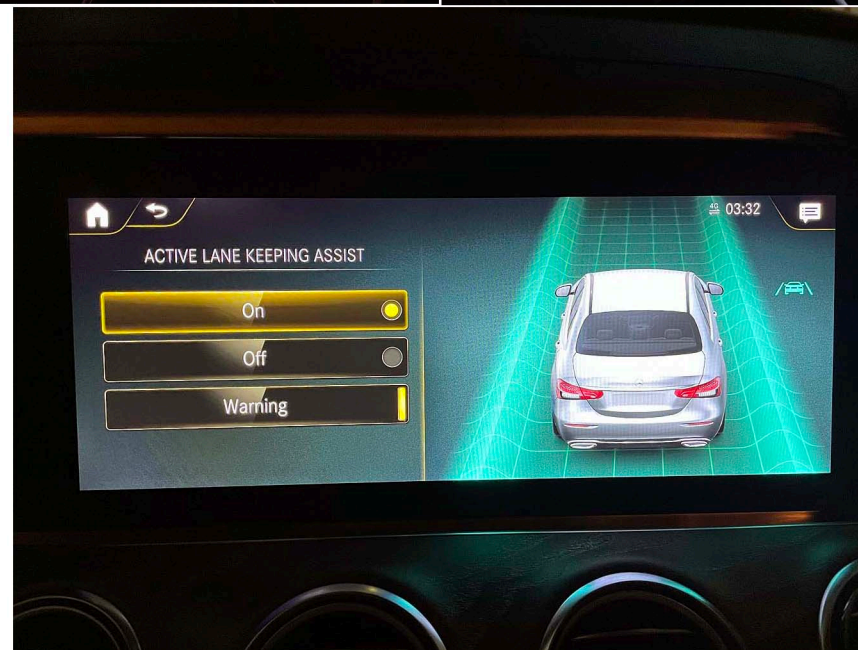
Figure A10. LDW Menus (2 of 2)

An alternate hierarchy is:

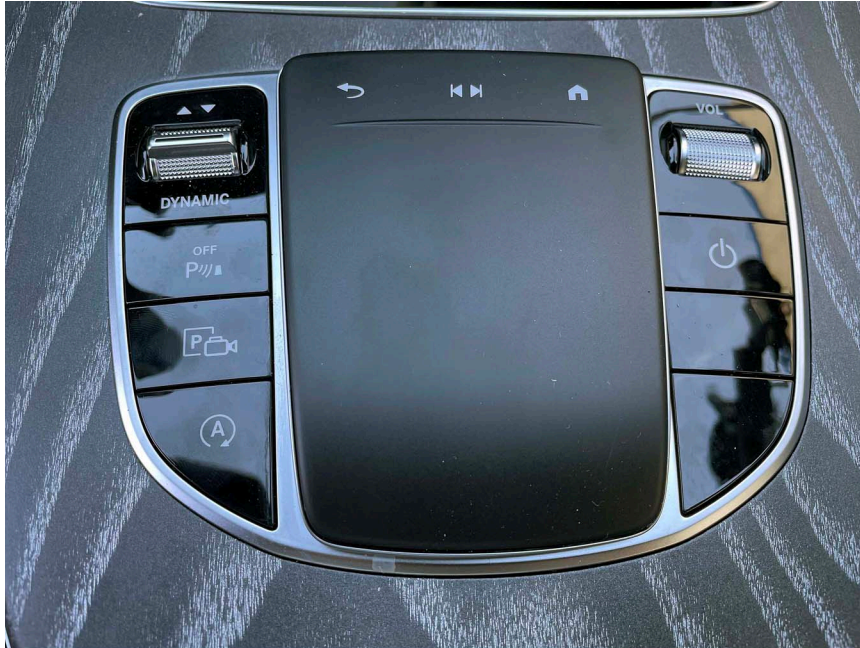
Figure A11. Controls for Interacting with System Menus

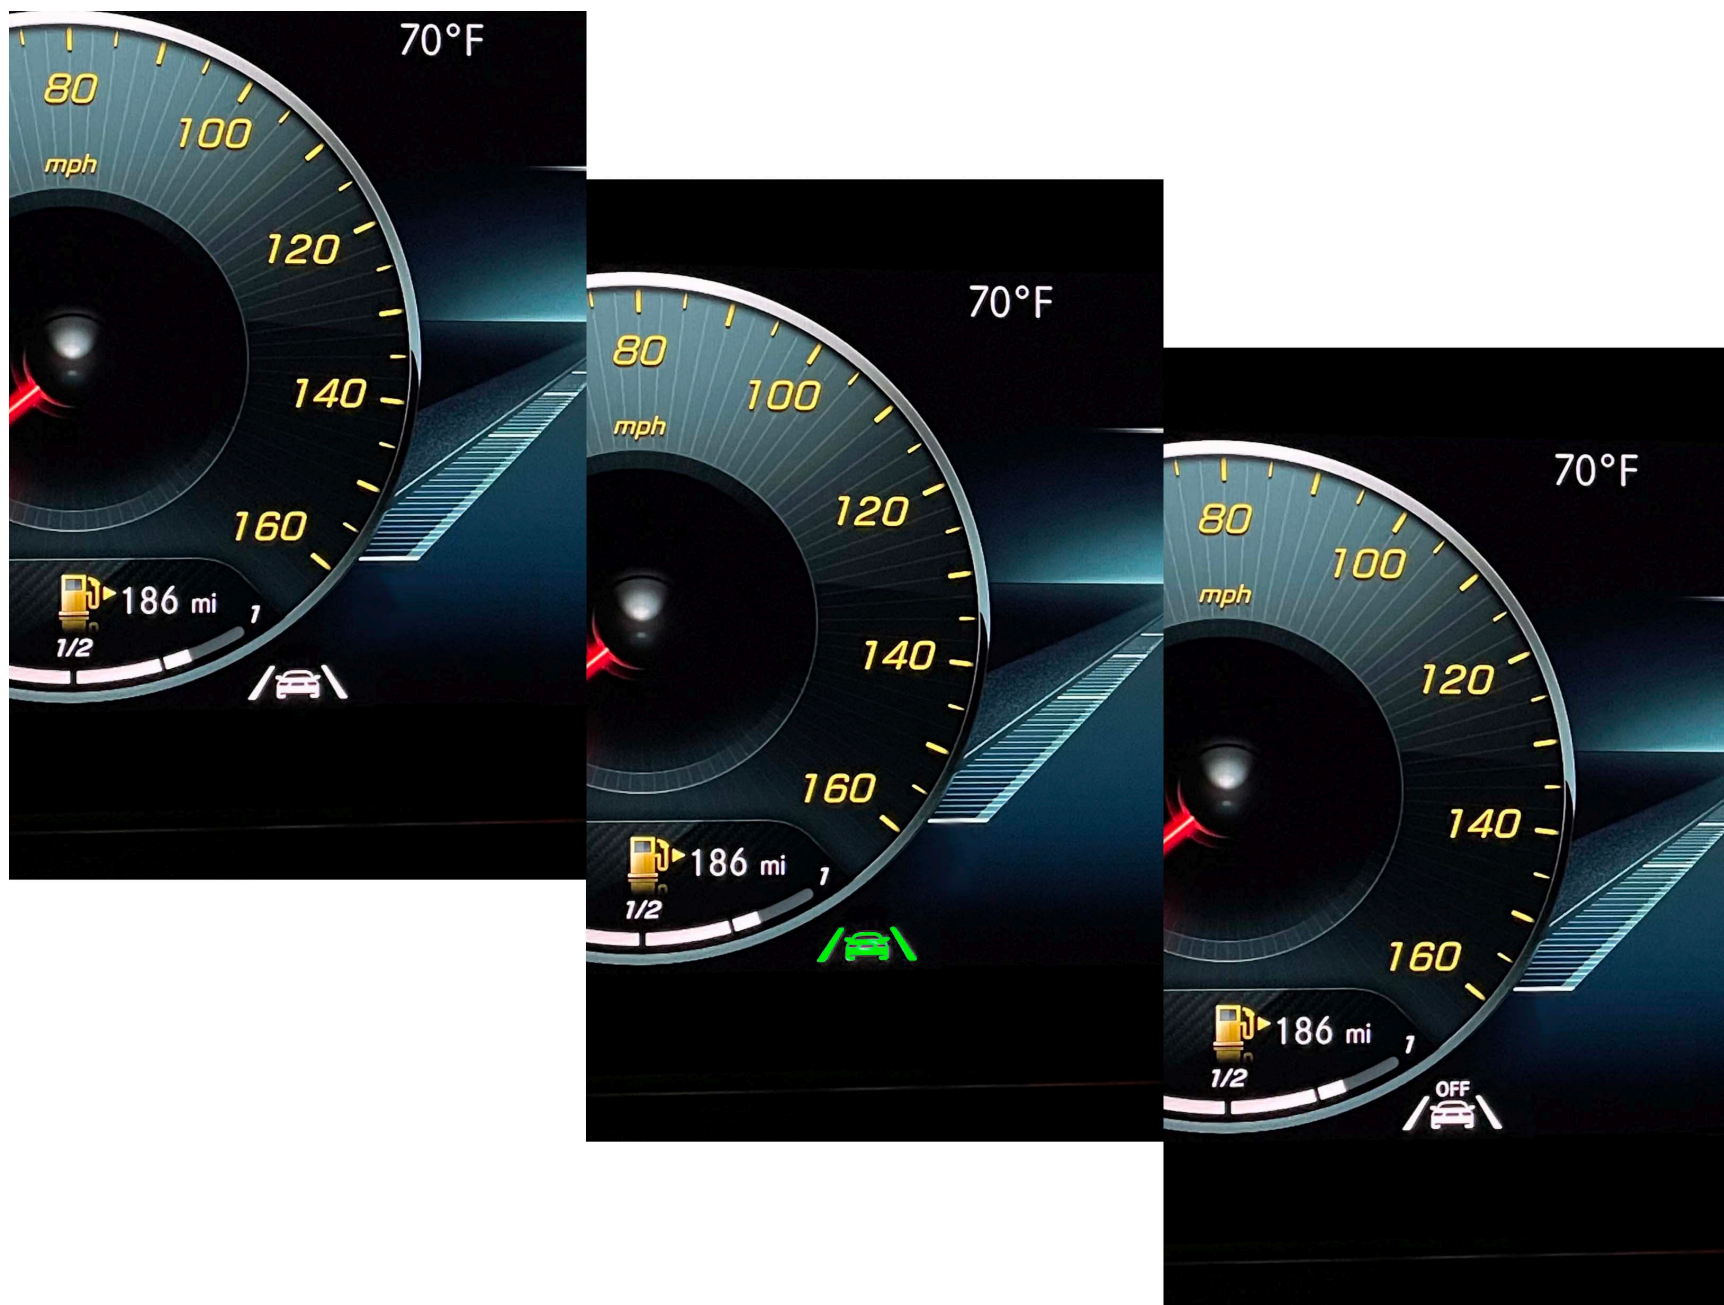
Figure A12. Visual Alert Showing (L-R): "Active, Not Operating", "Active, Operating", and "Deactivated or Malfunction"
