REPORT NUMBER: SINCAP-CAL-20-005

NEW CAR ASSESSMENT PROGRAM (NCAP) MOVING DEFORMABLE BARRIER SIDE IMPACT TEST

Volkswagen Group of America 2020 Volkswagen Passat Four Door Sedan

NHTSA No: M20205805

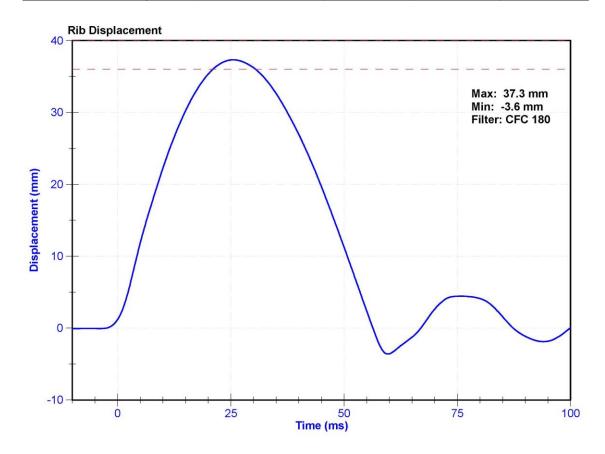
Certification Report ES-2re Upper Rib Drop 3 m/s - CFR 572

Test Parameter	Minimum Specification	Maximum Specification	Unit	Result	Pass/Fail
Temperature	20.6	22.2	°C	20.6	Pass
Humidity	10	70	%	22.7	Pass
Rib Displacement	36	40	mm	37.3	Pass

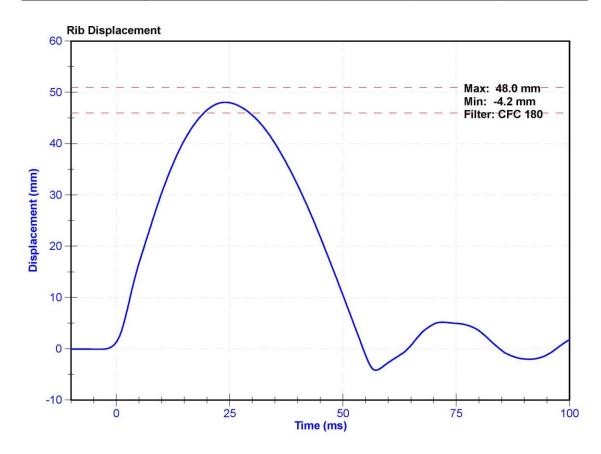
Certification Report ES-2re Upper Rib Drop 4 m/s - CFR 572

Test Parameter	Minimum Specification	Maximum Specification	Unit	Result	Pass/Fail
Temperature	20.6	22.2	°C	20.6	Pass
Humidity	10	70	%	22.7	Pass
Rib Displacement	46	51	mm	48.0	Pass

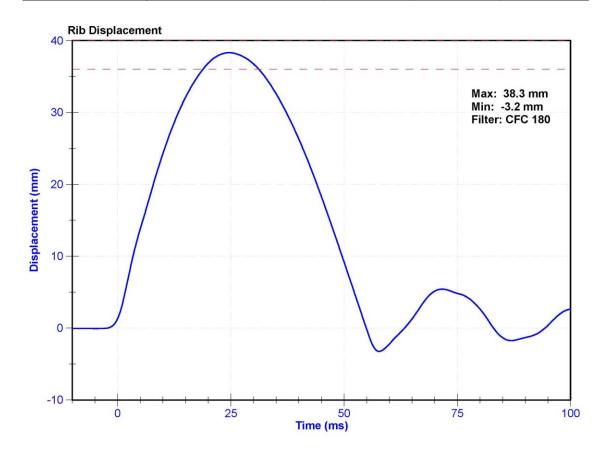
Certification Report ES-2re Middle Rib Drop 3 m/s - CFR 572

Test Parameter	Minimum Specification	Maximum Specification	Unit	Result	Pass/Fail
Temperature	20.6	22.2	°C	20.8	Pass
Humidity	10	70	%	23.2	Pass
Rib Displacement	36	40	mm	38.3	Pass

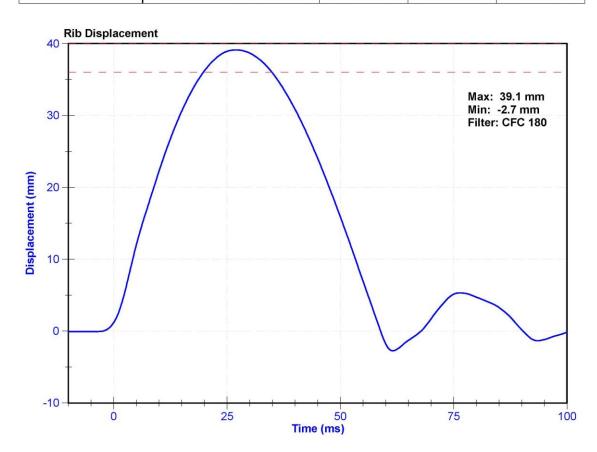
Certification Report ES-2re Lower Rib Drop 3 m/s - CFR 572

Test Parameter	Minimum Specification	Maximum Specification	Unit	Result	Pass/Fail
Temperature	20.6	22.2	°C	21.1	Pass
Humidity	10	70	%	23.5	Pass
Rib Displacement	36	40	mm	39.1	Pass
