**REPORT NUMBER: NCAP-CAL-20-009**

**NEW CAR ASSESSMENT PROGRAM (NCAP)  
FRONTAL BARRIER IMPACT TEST**

**Volkswagen Group of America  
2020 Volkswagen Passat  
Four Door Sedan**

**NHTSA No: M20205803**

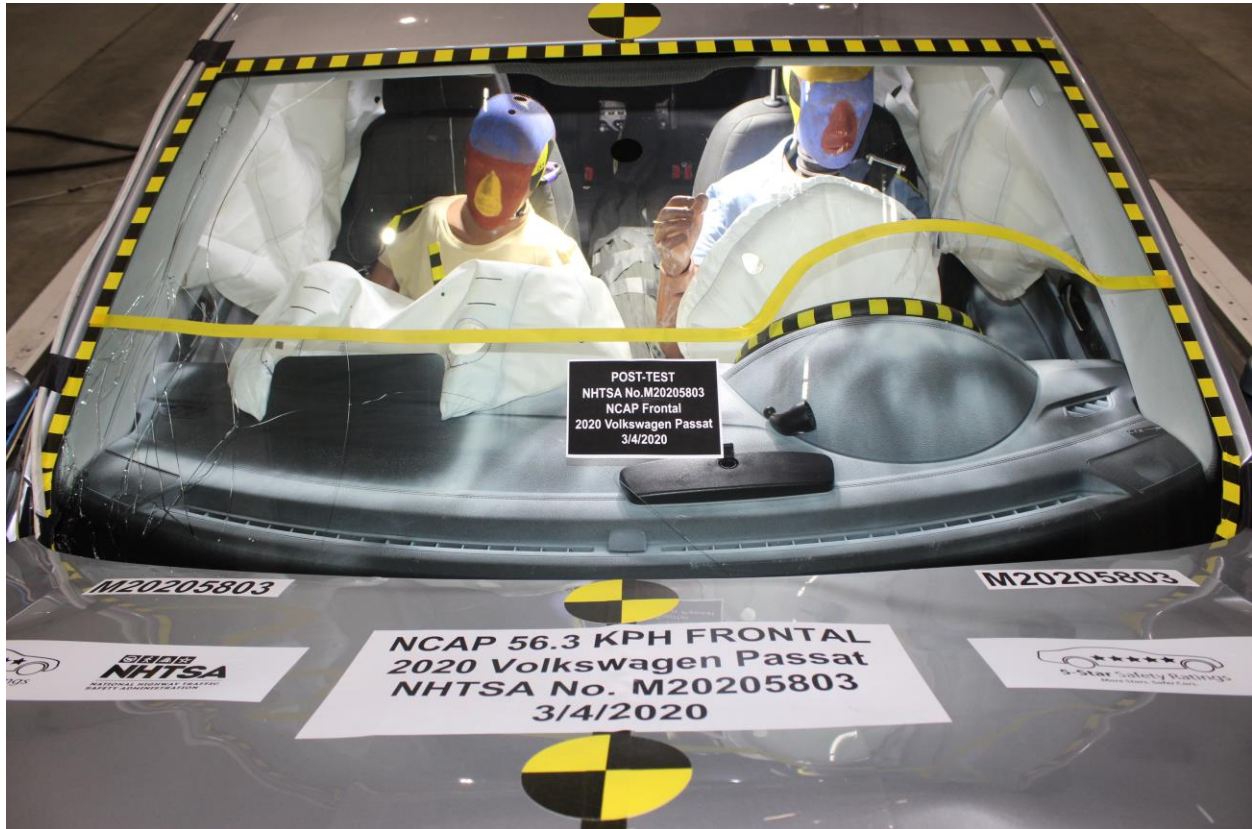
Figure A-19: Post-Test Windshield View

Critical Areas of Performance	Observations and Conclusions
Windshield Damage	Minor Cracks Along Passenger Side
Window Damage	None
Other	None

There was 100 percent windshield retention and no intrusion into the protected zone of the windshield during the event. There was a total of 0.0 grams of stoddard solvent leakage after the event or during any phase of the static rollover. The maximum static crush of the vehicle was 593 mm and both driver and passenger side doors remained closed during the impact event and were operable after the impact.

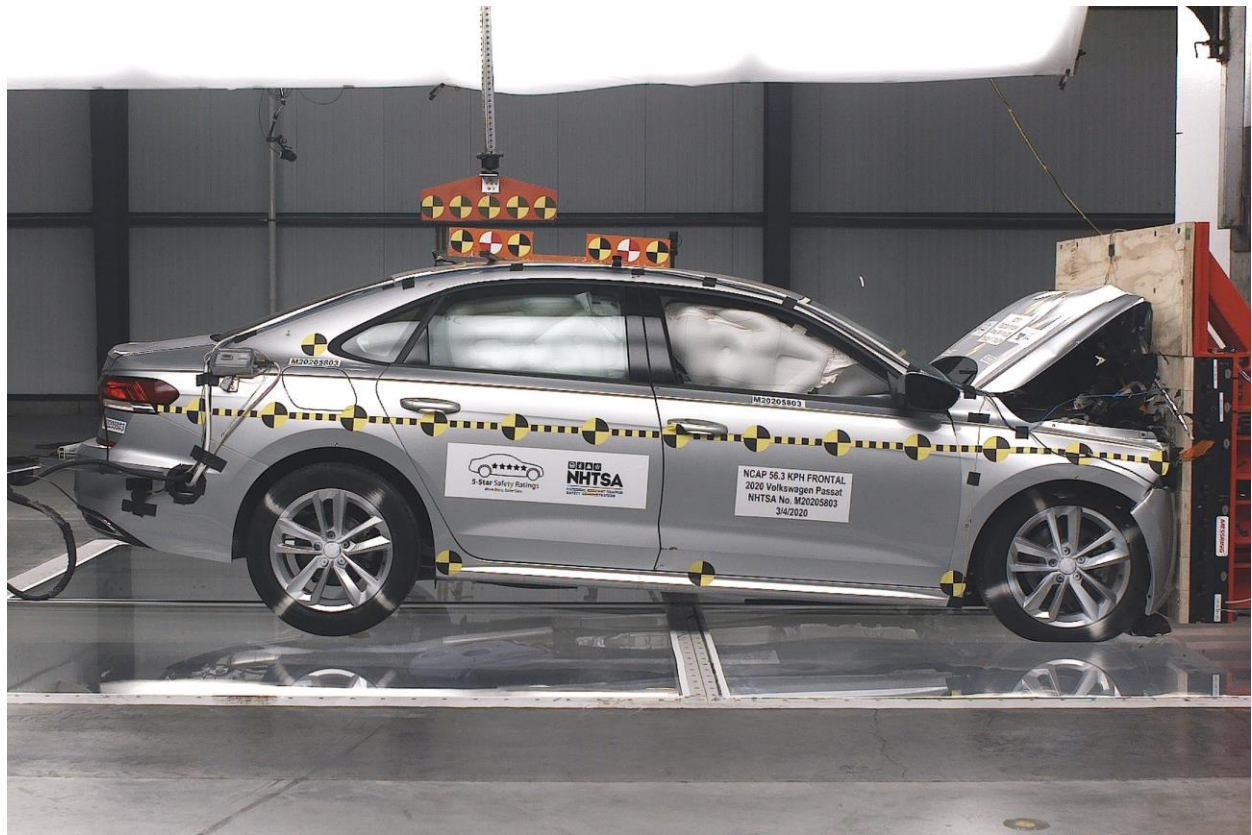
**Figure A-82: 2020 Volkswagen Passat Frontal Impact Event**

A load cell barrier consisting of 128 load cells was impacted by a 2020 Volkswagen Passat four door sedan at a velocity of 56.29 km/h. The test was performed at Calspan Corporation's Transportation Test Operations facility in Buffalo, New York on March 4, 2020. Pre- and post-test photographs of the vehicle and dummies to document the test can be found in Appendix A. One real-time camera and 16 high-speed cameras were used to document the frontal barrier impact event. Camera locations and other pertinent camera information can be found in Data Sheet 6 of this report.
