REPORT NUMBER: NCAP-KAR-21-003

**NEW CAR ASSESSMENT PROGRAM (NCAP)
FRONTAL BARRIER IMPACT TEST**

**MERCEDES-BENZ U.S. INTERNATIONAL INC.
2021 MERCEDES-BENZ GLE350 4MATIC 5-DOOR SUV**

NHTSA NUMBER: M20214307

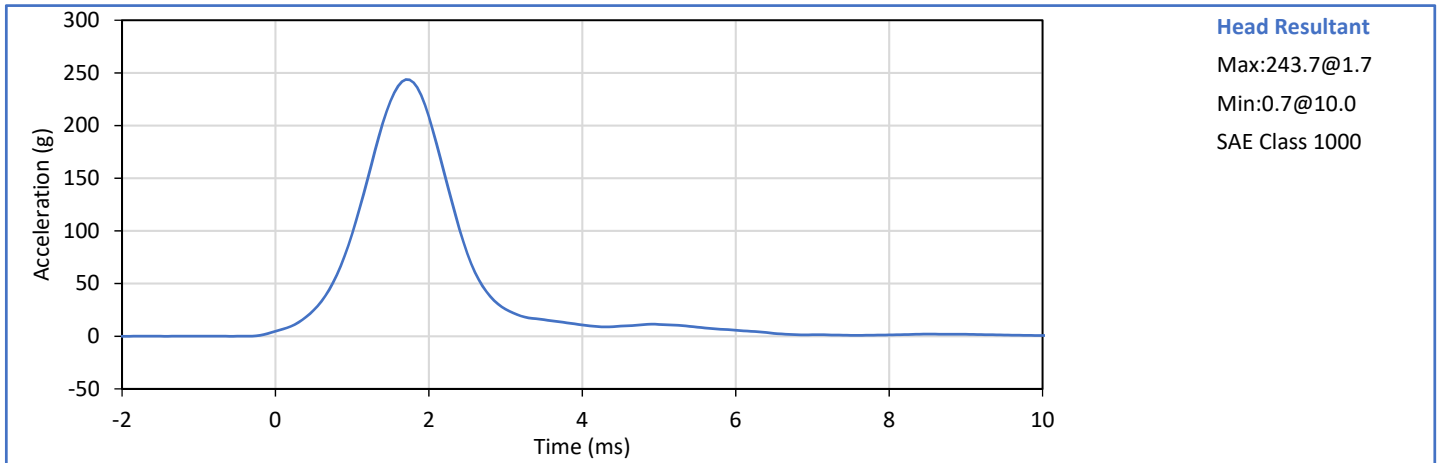
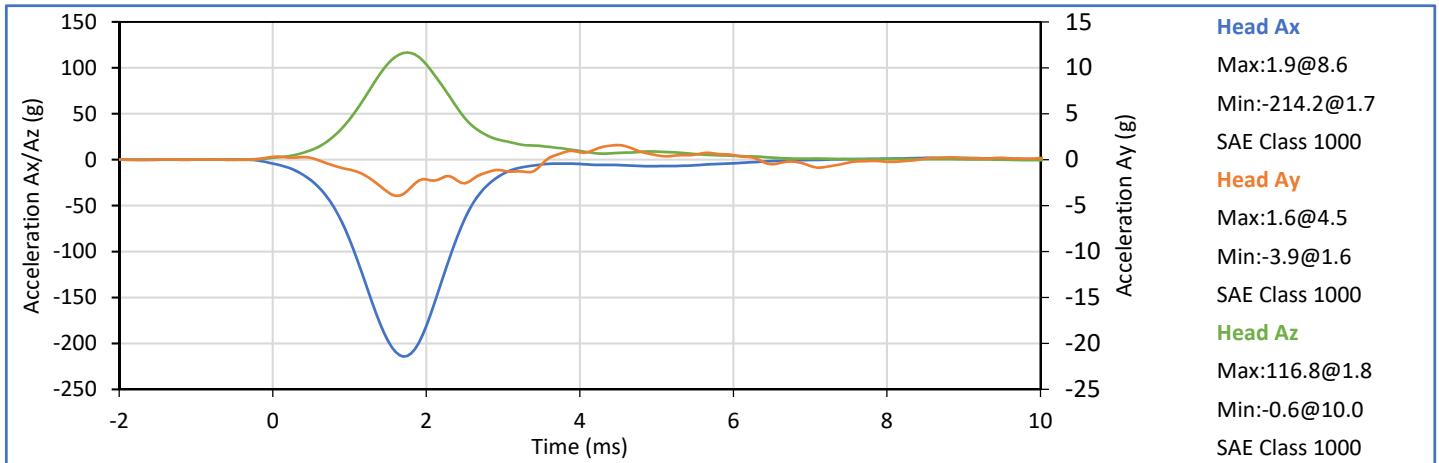
Tested Parameter	Units	Spec. Low	Spec. High	Result	Pass/Fail
Laboratory Temperature	°C	18.9	25.6	21.7	Pass
Laboratory Relative Humidity	%	10	70	22	Pass
Peak Resultant Acceleration	g	225.0	275.0	243.7	Pass
Peak Lateral Acceleration	g	-15.0	15.0	-3.9	Pass
Oscillations After Main Pulse	%	0.0	10.0	3.0	Pass
Is Acceleration Unimodal?	Yes/No	Yes		Yes	Pass
Overall Test Results					Pass

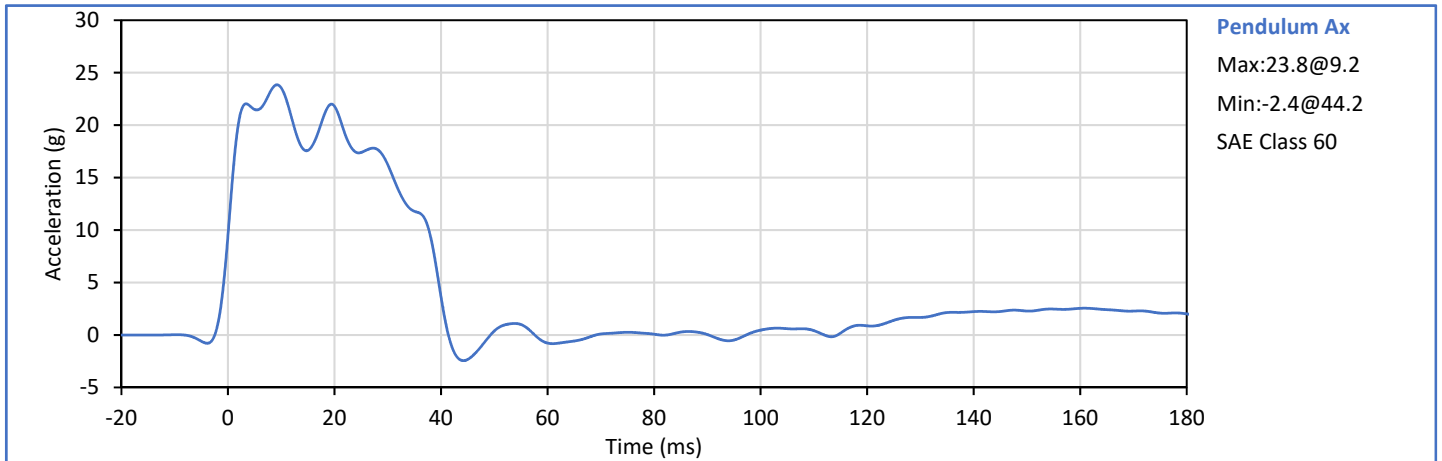
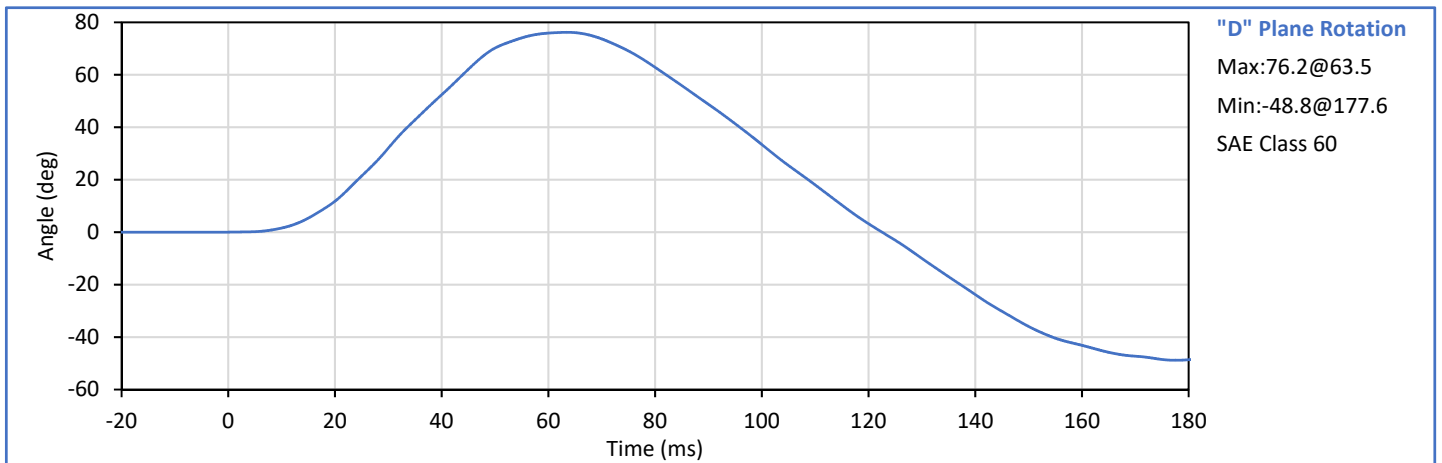
Tested Parameter	Units	Spec. Low	Spec. High	Result	Pass/Fail
Laboratory Temperature	°C	20.6	22.2	21.7	Pass
Laboratory Relative Humidity	%	10	70	25	Pass
Pendulum Velocity	m/s	6.89	7.13	7.00	Pass
Pendulum Deceleration at 10 ms	g	22.5	27.5	23.6	Pass
Pendulum Deceleration at 20 ms	g	17.6	22.6	21.8	Pass
Pendulum Deceleration at 30 ms	g	12.5	18.5	16.2	Pass
Peak Pendulum Decel. after 30 ms	g	0.0	29.0	16.2	Pass
Deceleration Decay to Cross 5 g	ms	34.0	42.0	39.6	Pass
"D" Plane Rotation peak	deg	64.0	78.0	76.2	Pass
	ms	57.0	64.0	63.5	Pass
"D" Plane Rotation Decay To Zero	ms	113.0	128.0	122.6	Pass
Moment About Occipital Condyle	Nm	88.1	108.5	92.6	Pass
	ms	47.0	58.0	54.4	Pass
Moment Decay, Peak to Zero	ms	97.0	107.0	100.8	Pass
Overall Test Results					Pass

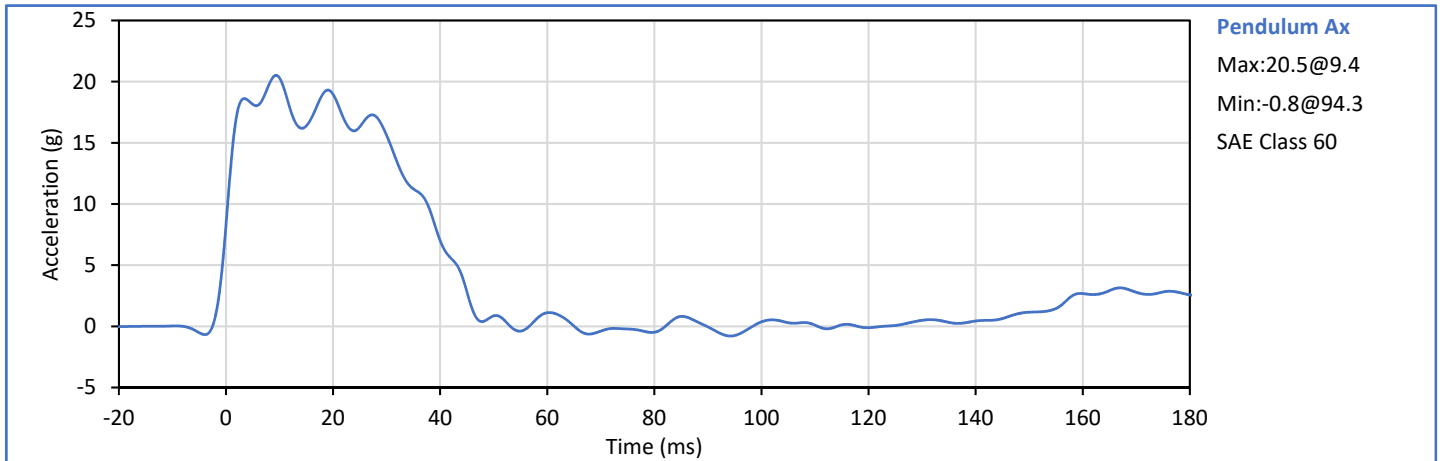
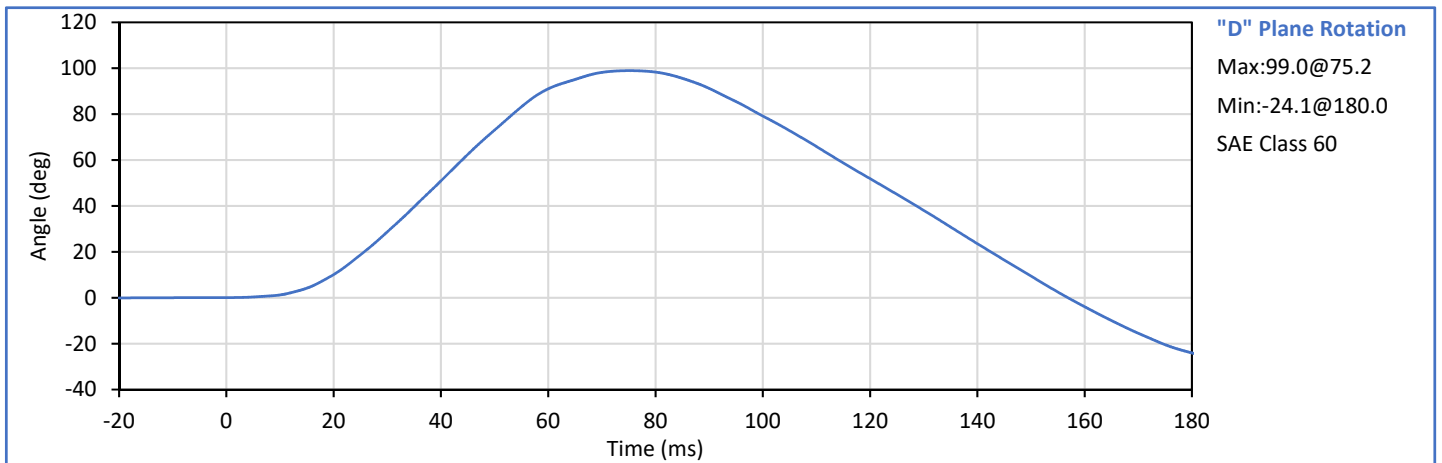
Tested Parameter	Units	Spec. Low	Spec. High	Result	Pass/Fail
Laboratory Temperature	°C	20.6	22.2	21.7	Pass
Laboratory Relative Humidity	%	10	70	25	Pass
Pendulum Velocity	m/s	5.94	6.19	6.09	Pass
Pendulum Deceleration at 10 ms	g	17.2	21.2	20.3	Pass
Pendulum Deceleration at 20 ms	g	14.0	19.0	19.0	Pass
Pendulum Deceleration at 30 ms	g	11.0	16.0	15.6	Pass
Peak Pendulum Decel. after 30 ms	g	0.0	22.0	15.6	Pass
Deceleration Decay to Cross 5 g	ms	38.0	46.0	43.1	Pass
"D" Plane Rotation peak	deg	81.0	106.0	99.0	Pass
	ms	72.0	82.0	75.2	Pass
"D" Plane Rotation Decay To Zero	ms	147.0	174.0	157.0	Pass
Moment About Occipital Condyle	Nm	-79.9	-52.9	-76.1	Pass
	ms	65.0	79.0	68.0	Pass
Moment Decay, Peak to Zero	ms	120.0	148.0	135.0	Pass
Overall Test Results					Pass

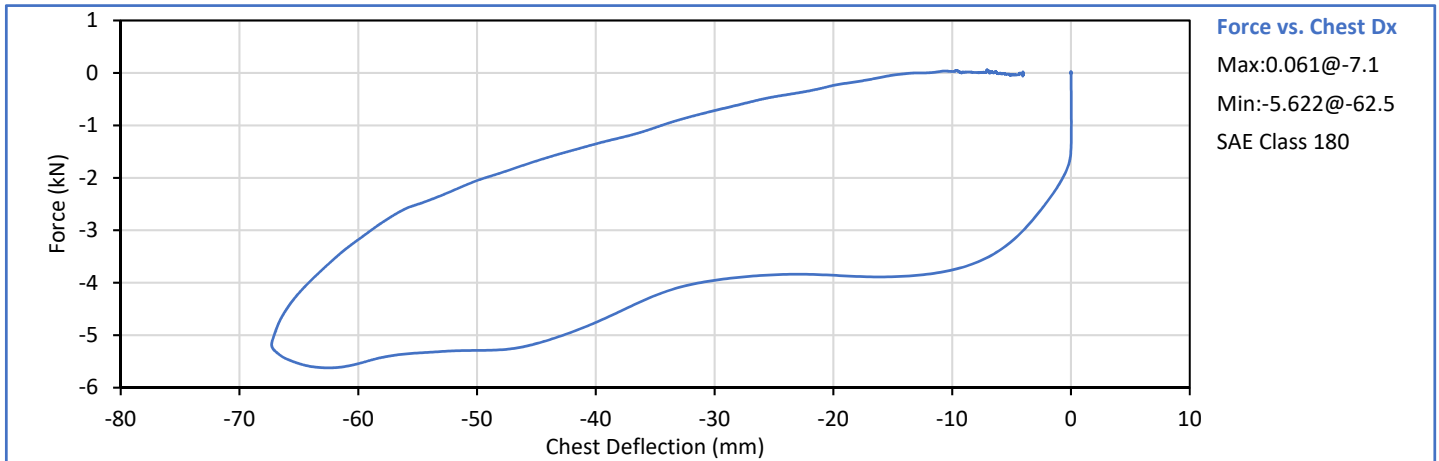
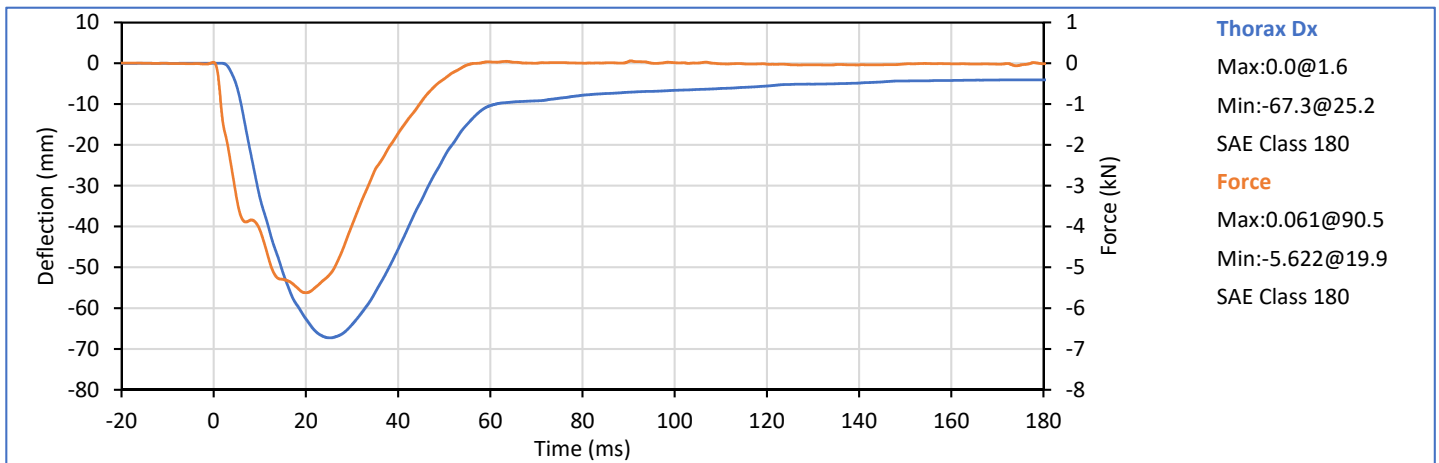
Tested Parameter	Units	Spec. Low	Spec. High	Result	Pass/Fail
Laboratory Temperature	°C	20.6	22.2	21.7	Pass
Laboratory Relative Humidity	%	10	70	19	Pass
Probe Velocity	m/s	6.58	6.82	6.78	Pass
Peak Chest Deflection	mm	-72.6	-63.5	-67.3	Pass
Peak Probe Force	kN	-5.893	-5.159	-5.622	Pass
Internal Hysterisis	%	69.0	85.0	70.6	Pass
Overall Test Results					Pass

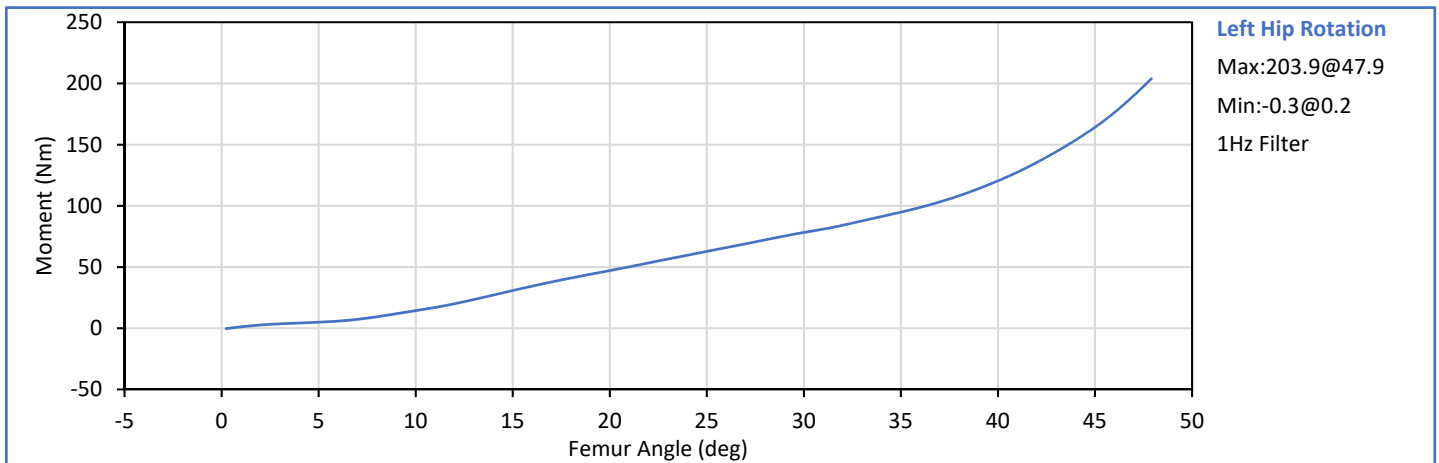
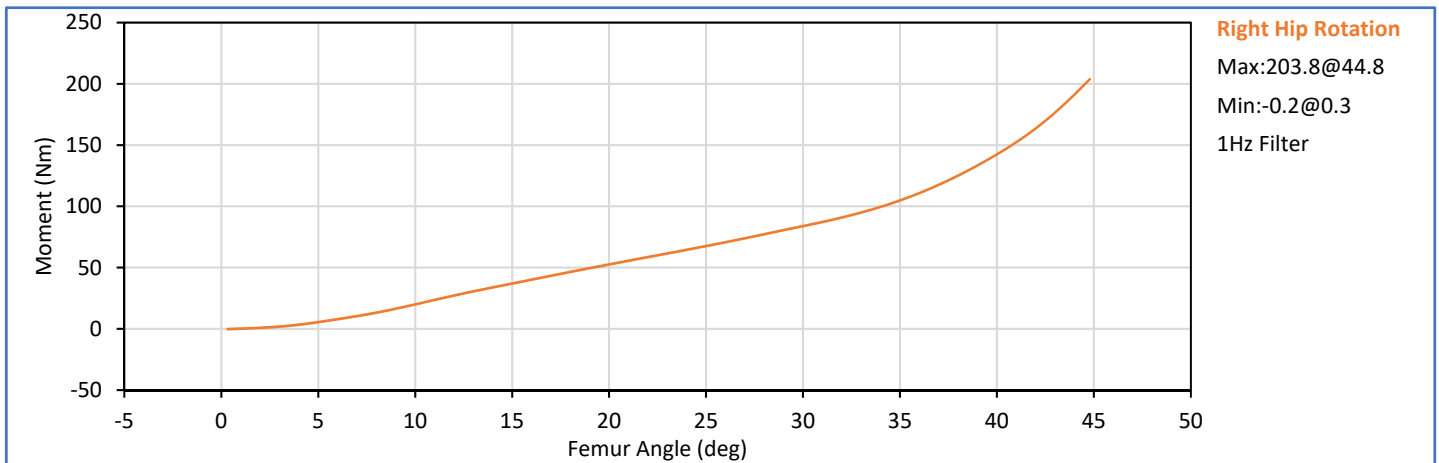
Tested Parameter	Units	Spec. Low	Spec. High	Result	Pass/Fail
	Laboratory Temperature	°C	18.9	25.6	21.7	Pass
	Laboratory Relative Humidity	%	10	70	19	Pass
Left Hip	Left Hip Rotation Rate	deg/s	5.0	10.0	6.0	Pass
	Left Femur Torque at 30°	Nm	0.0	95.0	78.3	Pass
	Left Hip Rotation at 203 Nm	deg	40.0	50.0	47.8	Pass
Right Hip	Right Hip Rotation Rate	deg/s	5.0	10.0	6.1	Pass
	Right Femur Torque at 30°	Nm	0.0	95.0	83.9	Pass
	Right Hip Rotation at 203 Nm	deg	40.0	50.0	44.7	Pass
Overall Test Results						Pass

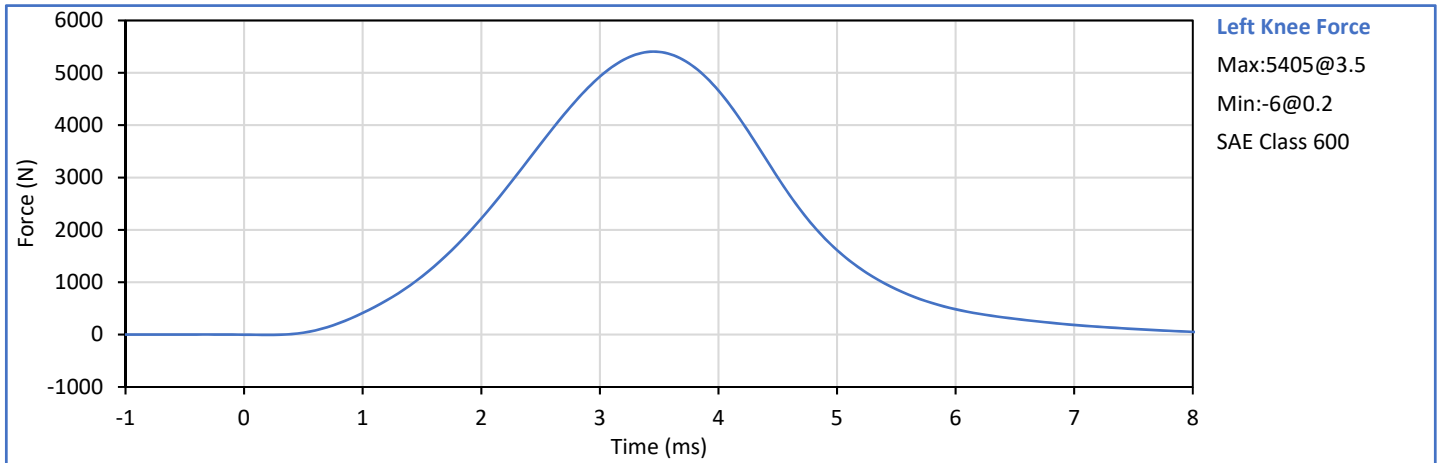
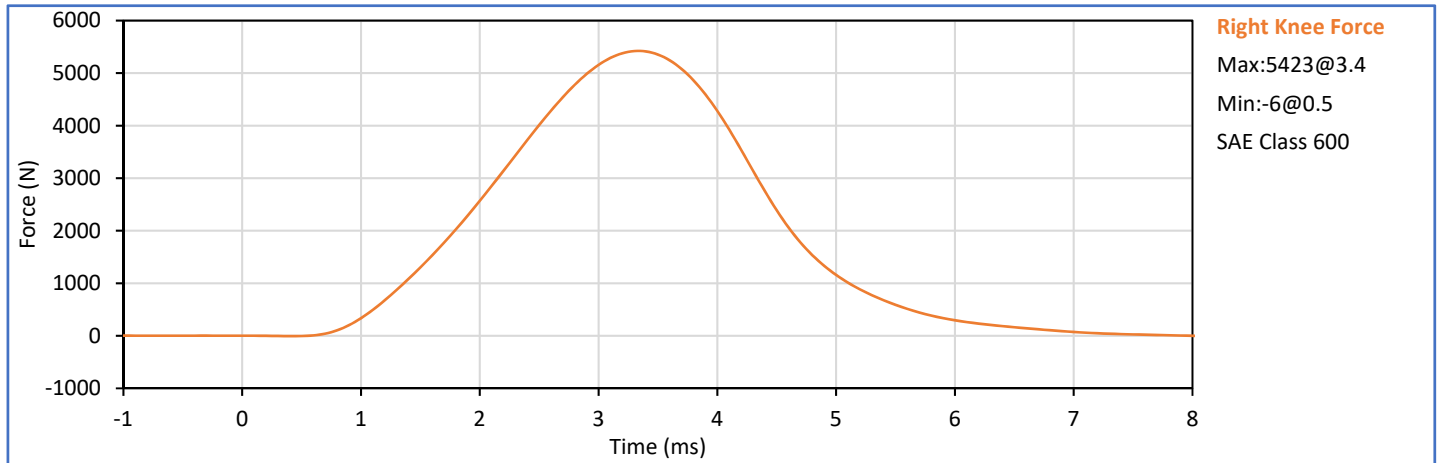
Tested Parameter	Units	Spec. Low	Spec. High	Result	Pass/Fail
	Laboratory Temperature	°C	18.9	25.6	21.7	Pass
	Laboratory Relative Humidity	%	10	70	23	Pass
Left	Probe Velocity	m/s	2.070	2.130	2.092	Pass
Knee	Peak Resistive Force	N	4715	5782	5405	Pass
Right	Probe Velocity	m/s	2.070	2.130	2.097	Pass
Knee	Peak Resistive Force	N	4715	5782	5423	Pass
Overall Test Results						Pass

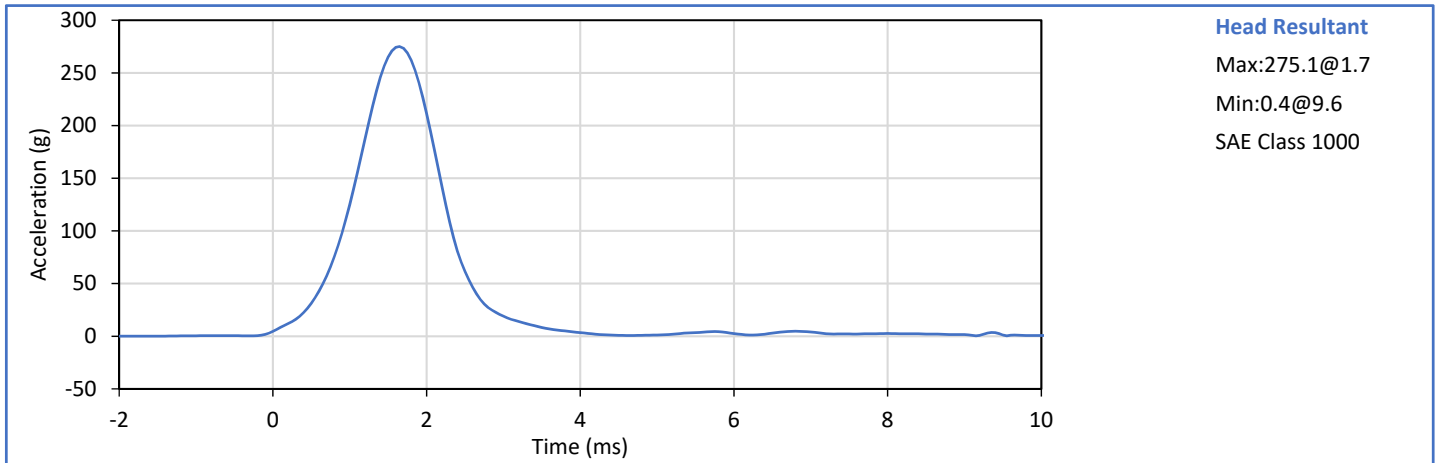
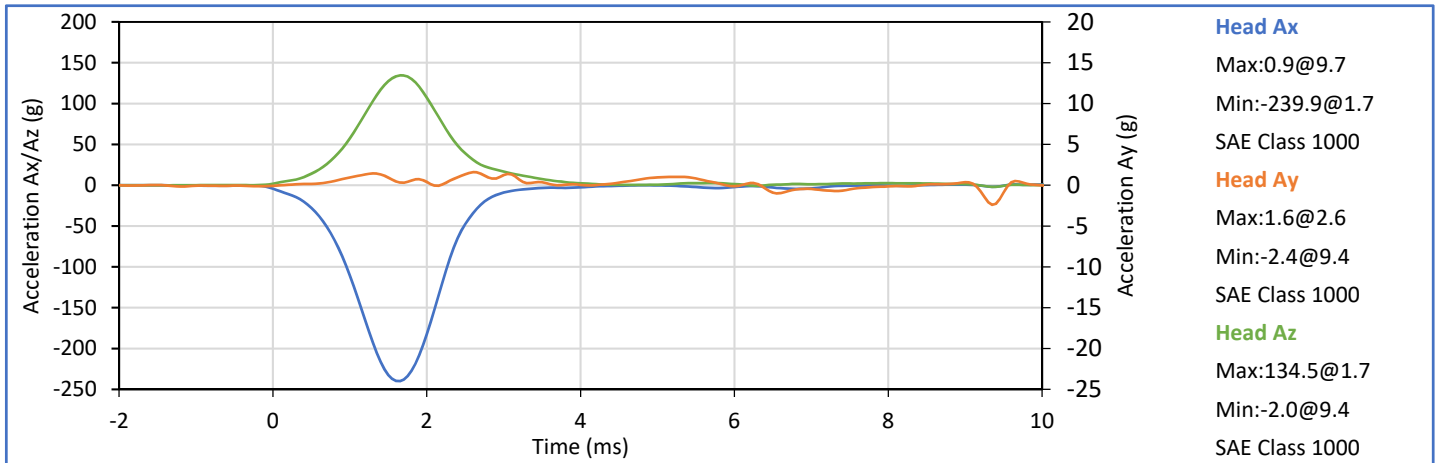
Tested Parameter	Units	Spec. Low	Spec. High	Result	Pass/Fail
Laboratory Temperature	°C	18.9	25.6	21.7	Pass
Laboratory Humidity	%	10	70	28	Pass
Peak Resultant Acceleration	g	250.0	300.0	275.1	Pass
Peak Lateral Acceleration	g	-15.0	15.0	-2.4	Pass
Oscillations After Main Pulse	%	0.0	10.0	1.7	Pass
Is Acceleration Unimodal?	Yes/No	Yes		Yes	Pass
Overall Test Results					Pass

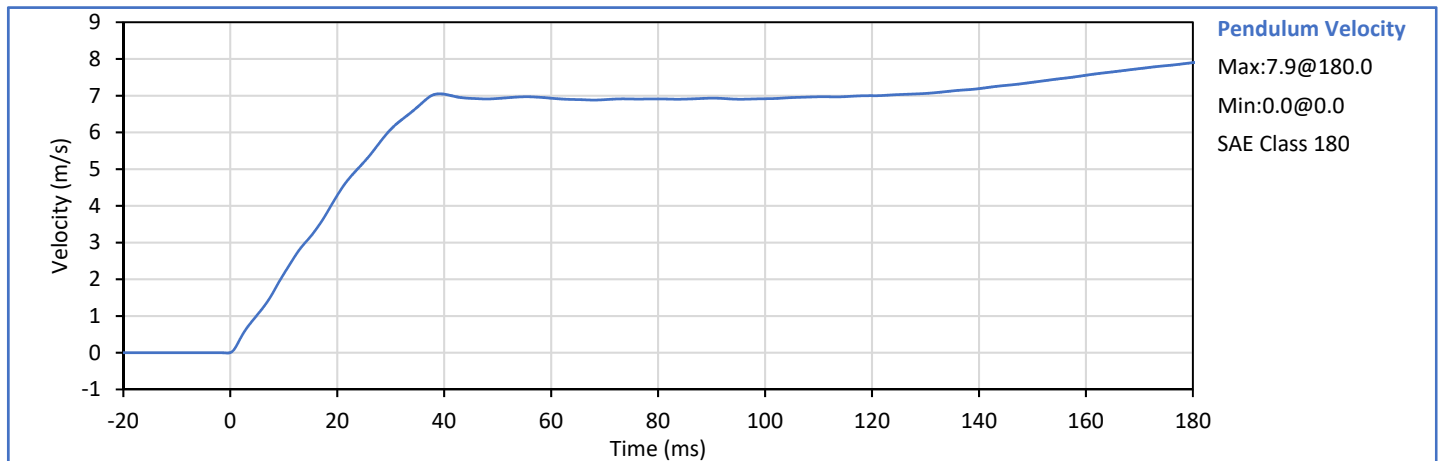
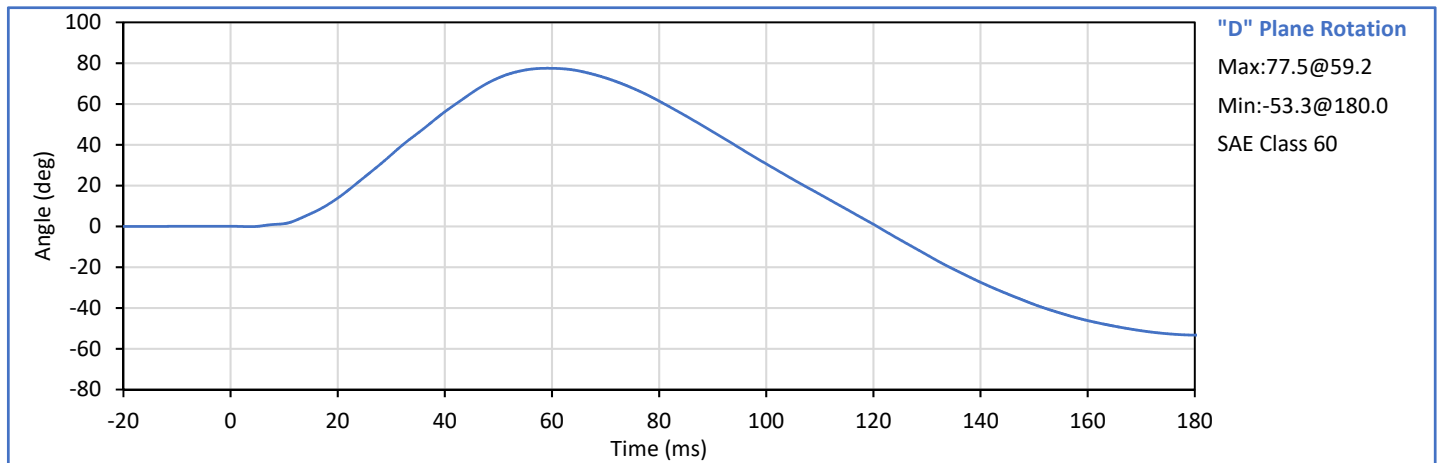
Tested Parameter	Units	Spec. Low	Spec. High	Result	Pass/Fail
Laboratory Temperature	°C	20.6	22.2	21.4	Pass
Laboratory Humidity	%	10	70	22	Pass
Pendulum Velocity	m/s	6.89	7.13	6.96	Pass
Pendulum Velocity at 10 ms	m/s	2.10	2.50	2.14	Pass
Pendulum Velocity at 20 ms	m/s	4.00	5.00	4.28	Pass
Pendulum Velocity at 30 ms	m/s	5.80	7.00	6.08	Pass
Peak "D" Plane Rotation	deg	77.0	91.0	77.5	Pass
Peak Moment in Rotation	Nm	69.0	83.0	73.2	Pass
Positive Moment Decay to 10 Nm	ms	80.0	100.0	87.7	Pass
Overall Test Results					Pass

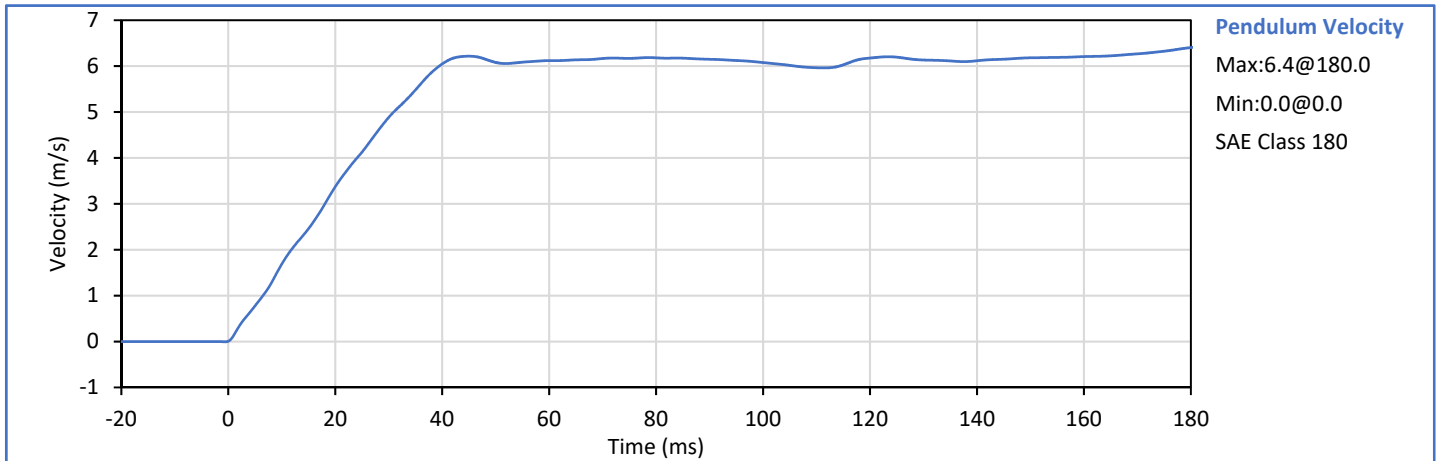
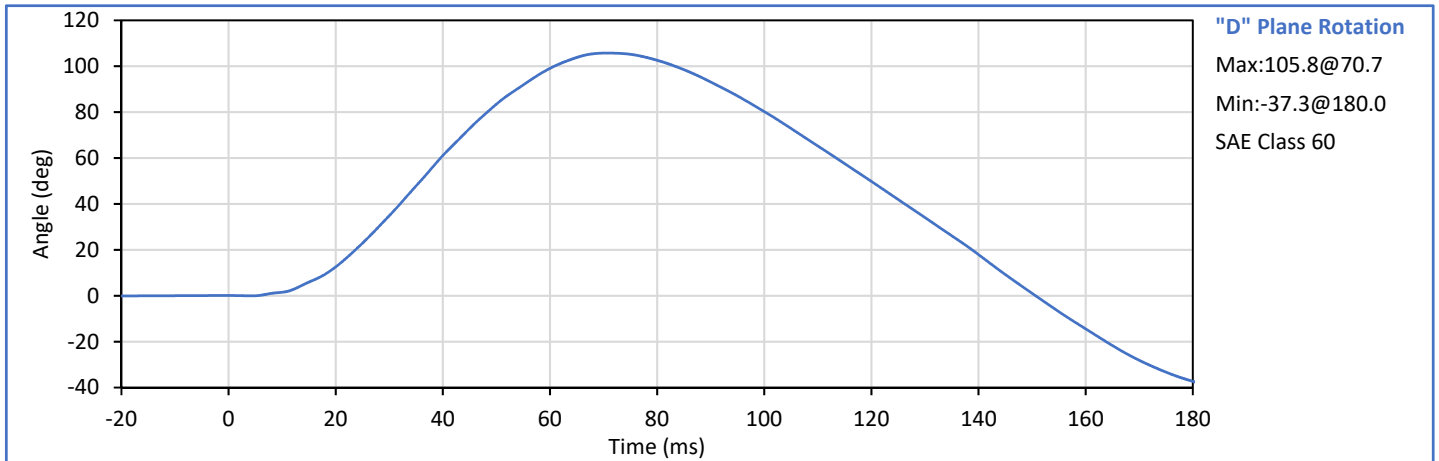
Tested Parameter	Units	Spec. Low	Spec. High	Result	Pass/Fail
Laboratory Temperature	°C	20.6	22.2	21.4	Pass
Laboratory Humidity	%	10	70	25	Pass
Pendulum Velocity	m/s	5.95	6.19	6.05	Pass
Pendulum Velocity at 10 ms	m/s	1.50	1.90	1.69	Pass
Pendulum Velocity at 20 ms	m/s	3.10	3.90	3.37	Pass
Pendulum Velocity at 30 ms	m/s	4.60	5.60	4.88	Pass
Peak "D" Plane Rotation	deg	99.0	114.0	105.8	Pass
Peak Moment in Rotation	Nm	-65.0	-53.0	-63.0	Pass
Negative Moment Decay to -10 Nm	ms	94.0	114.0	97.2	Pass
Overall Test Results					Pass

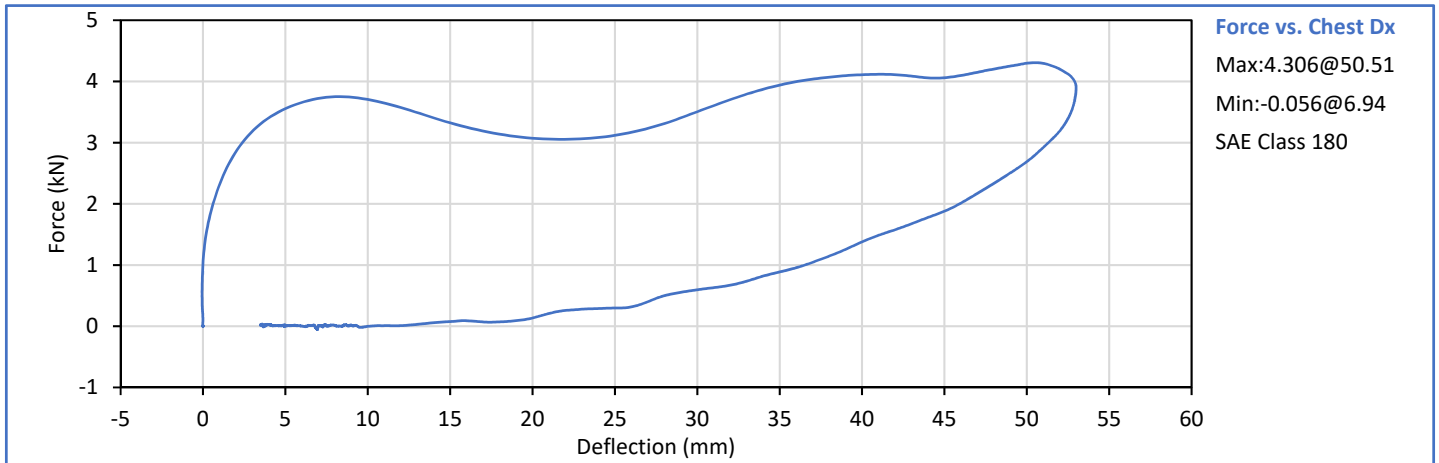
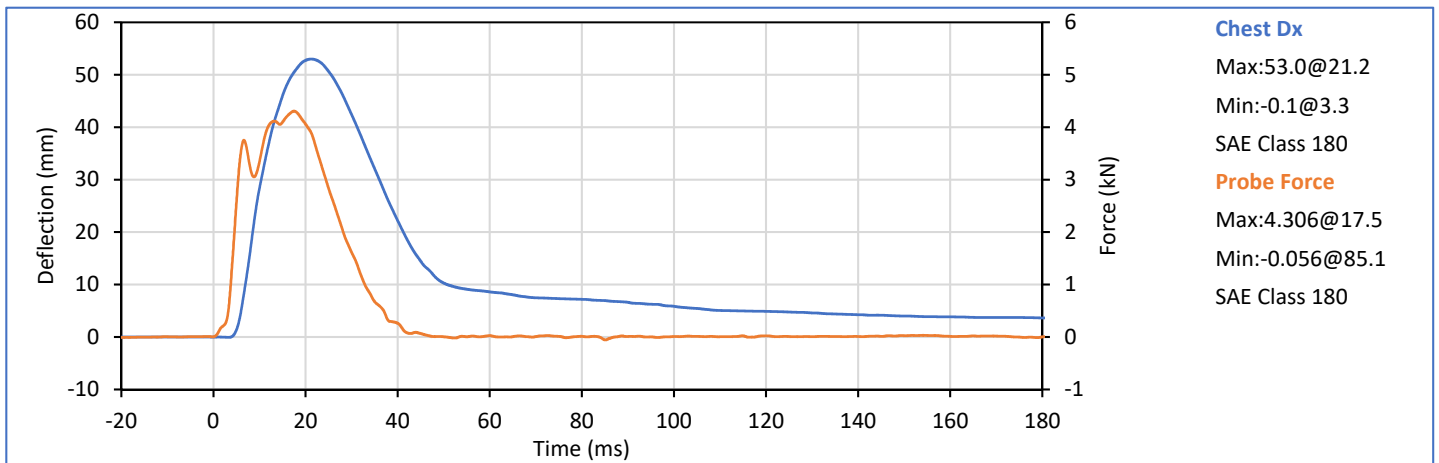
Tested Parameter	Units	Spec. Low	Spec. High	Result	Pass/Fail
Laboratory Temperature	°C	20.6	22.2	21.2	Pass
Laboratory Humidity	%	10	70	33	Pass
Probe Velocity	m/s	6.59	6.83	6.70	Pass
Peak Chest Deflection	mm	50.0	58.0	53.0	Pass
Peak Probe Force, 50 and 58 mm	kN	3.900	4.400	4.306	Pass
Peak Probe Force, 18 and 50 mm	kN	0.000	4.600	4.297	Pass
Internal Hysterisis	%	69.0	85.0	78.1	Pass
Overall Test Results					Pass

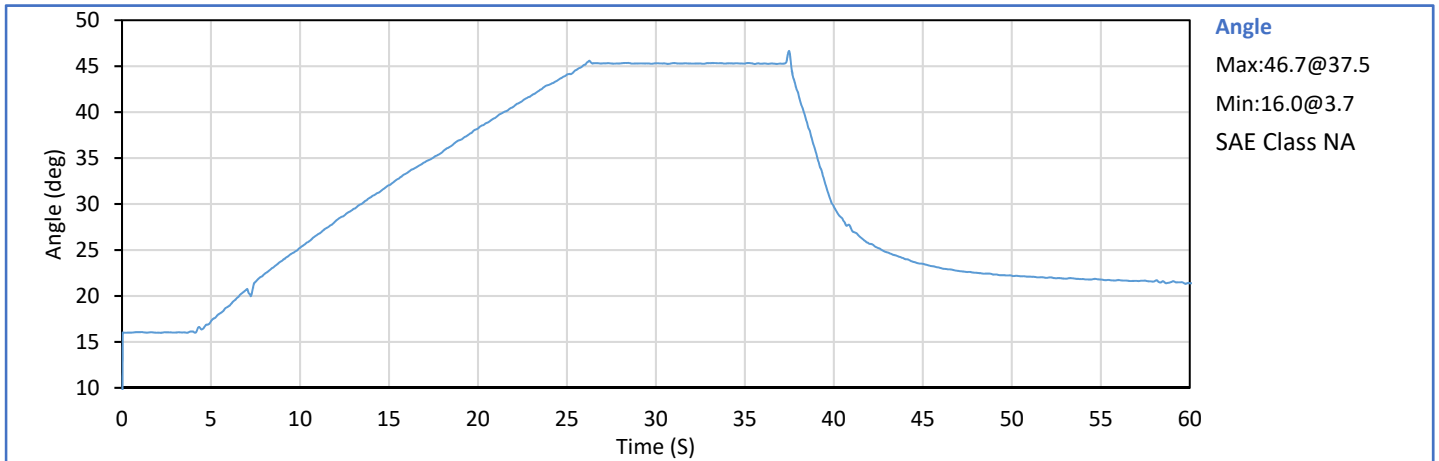
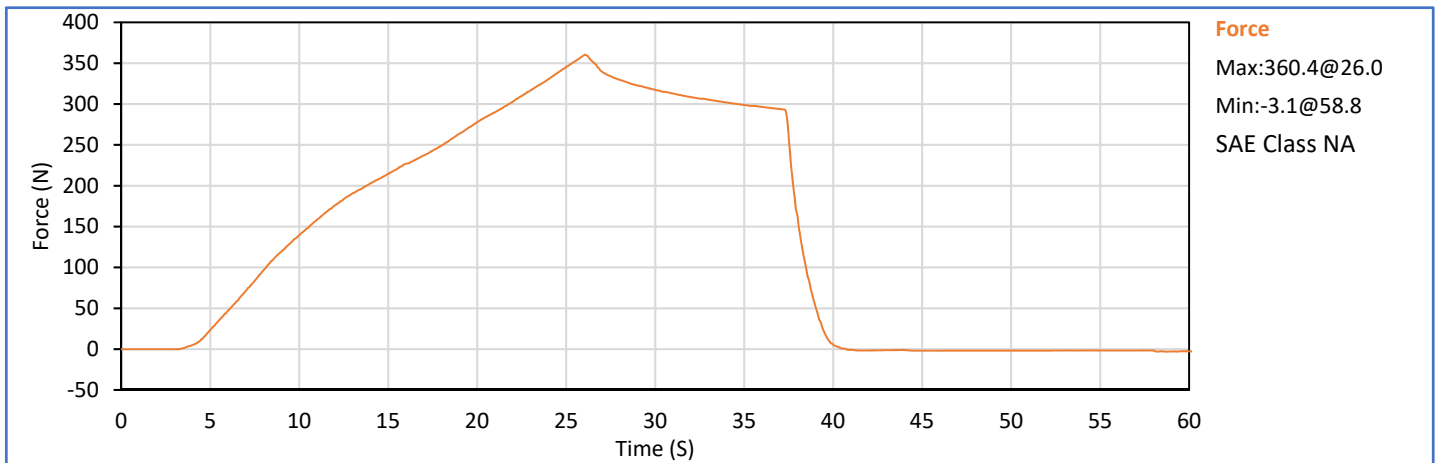
Tested Parameter	Units	Spec. Low	Spec. High	Result	Pass/Fail
Laboratory Temperature	°C	18.9	25.6	21.7	Pass
Laboratory Humidity	%	10	70	25	Pass
Orientation Angle	deg	0.0	20.0	15.7	Pass
Test Initial Angle	deg	11.0	19.0	16.0	Pass
Peak Force at 45° (+/-0.5°)	N	320.0	390.0	358.8	Pass
Torso Flexion Rate	deg/s	0.50	1.50	1.34	Pass
Final Reference Plane Angle	deg	-8.0	8.0	3.9	Pass
Overall Test Results					Pass

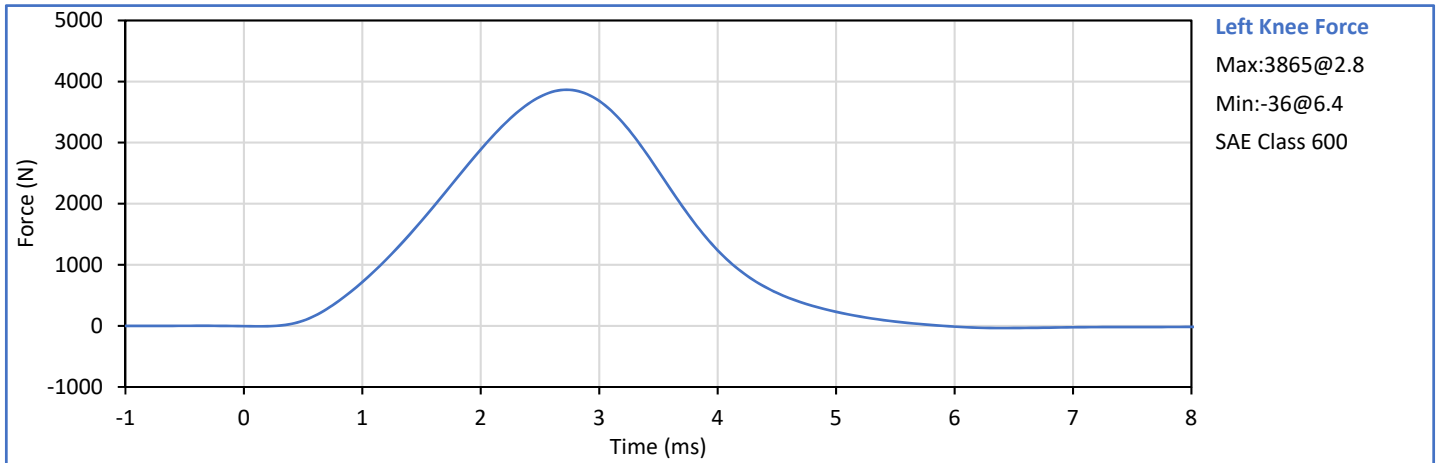
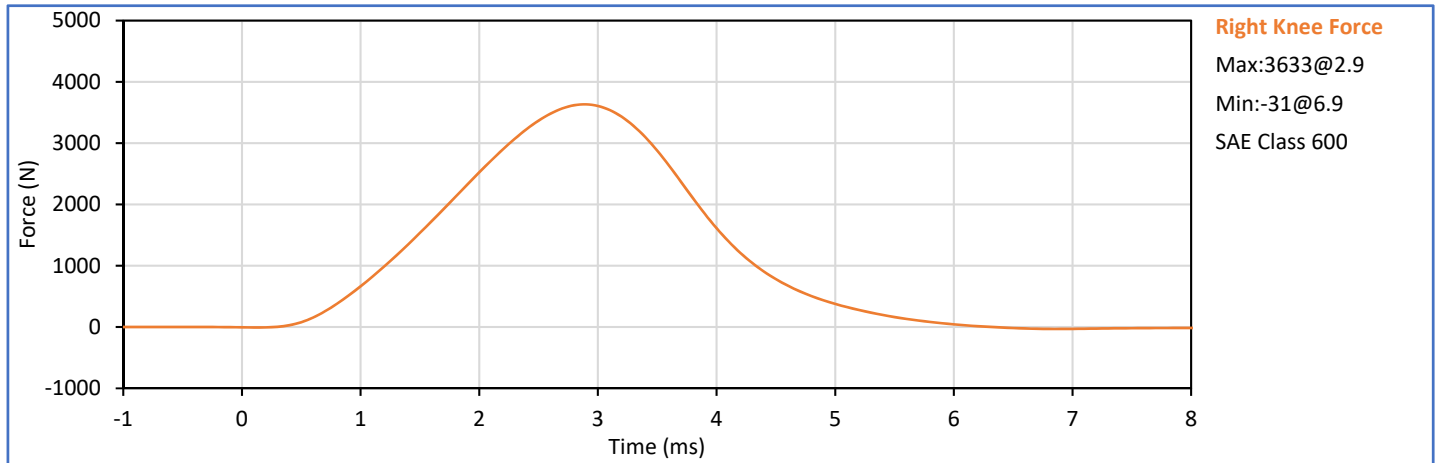
Tested Parameter	Units	Spec. Low	Spec. High	Result	Pass/Fail
	Laboratory Temperature	°C	18.9	25.6	21.7	Pass
	Laboratory Humidity	%	10	70	20	Pass
Left	Probe Velocity	m/s	2.070	2.130	2.110	Pass
Knee	Peak Resistive Force	N	3450	4060	3865	Pass
Right	Probe Velocity	m/s	2.070	2.130	2.112	Pass
Knee	Peak Resistive Force	N	3450	4060	3633	Pass
Overall Test Results						Pass
