# NEW CAR ASSESSMENT PROGRAM CRASH IMMINENT BRAKING SYSTEM CONFIRMATION TEST NCAP-DRI-CIB-21-05

2021 Dodge Durango GT Blacktop RWD

## DYNAMIC RESEARCH, INC.

#### **Final Report**

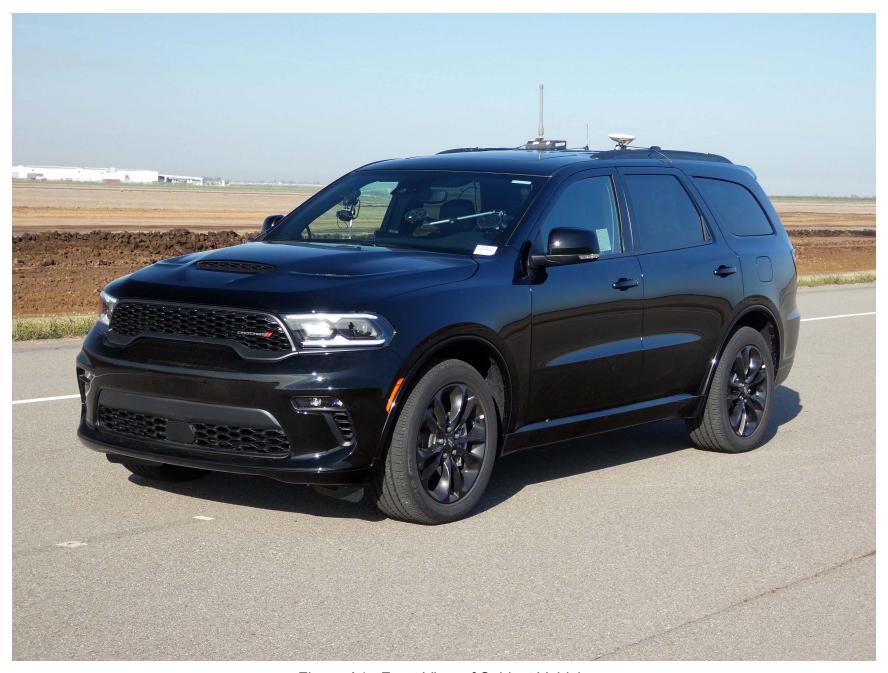
Figure A1. Front View of Subject Vehicle

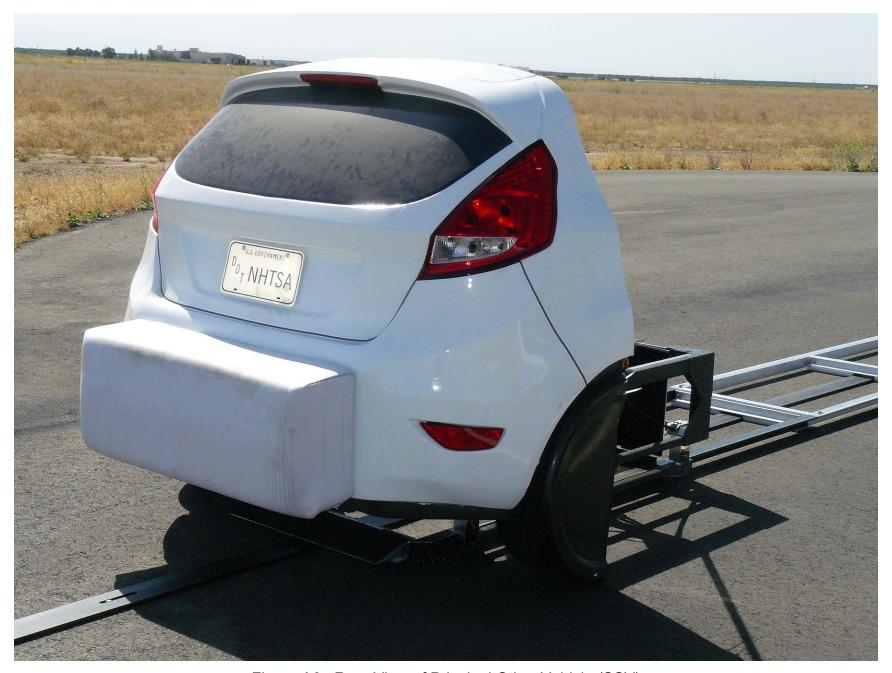
Figure A6. Rear View of Principal Other Vehicle (SSV)

CIB testing requires a POV that realistically represents typical vehicles, does not suffer damage or cause damage to a test vehicle in the event of collision, and can be accurately positioned and moved during the tests. The tests reported herein made use of the NHTSA developed Strikeable Surrogate Vehicle (SSV).

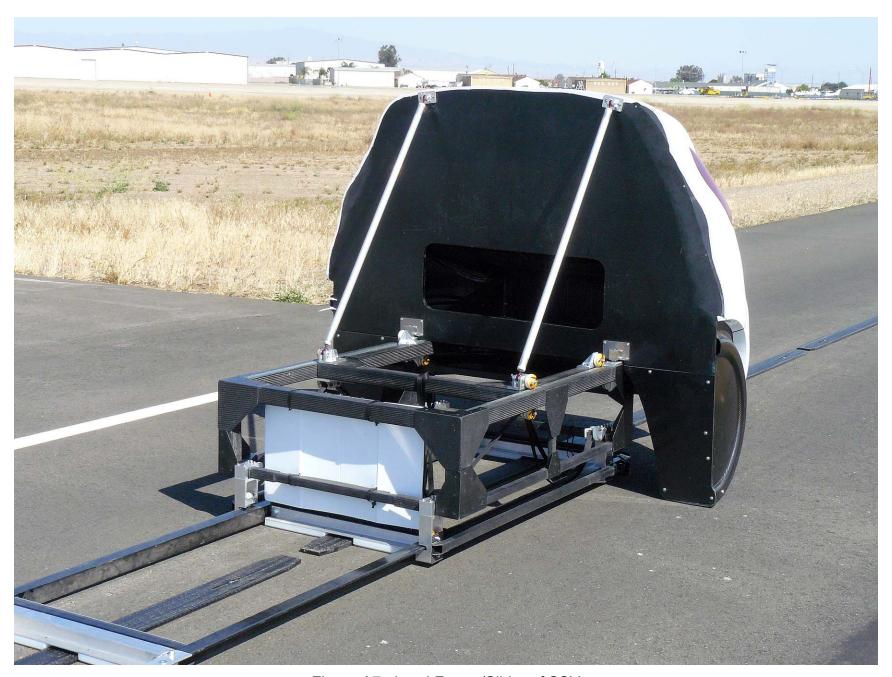
Figure A7. Load Frame/Slider of SSV

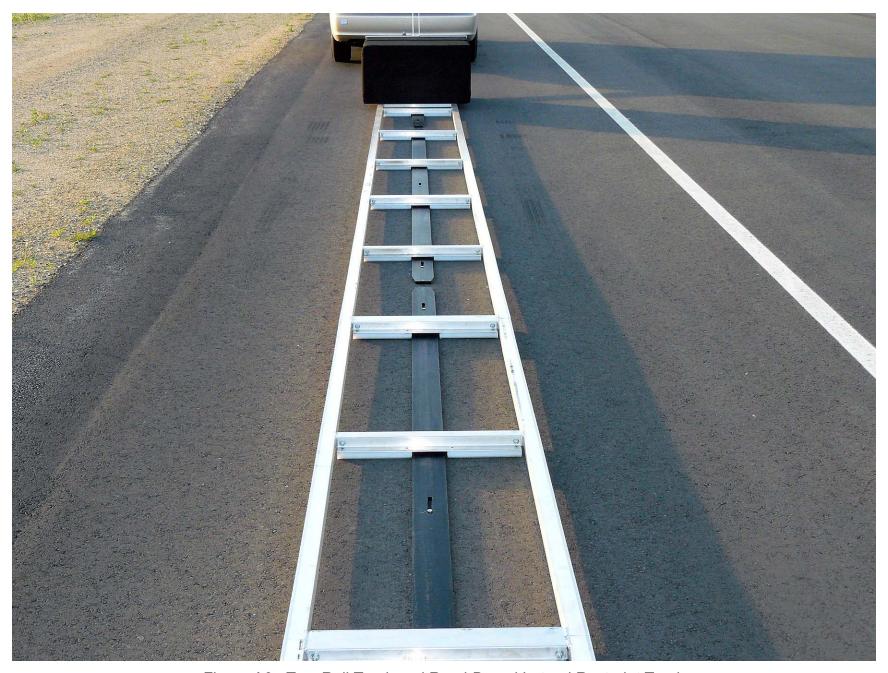
Figure A8. Two-Rail Track and Road-Based Lateral Restraint Track

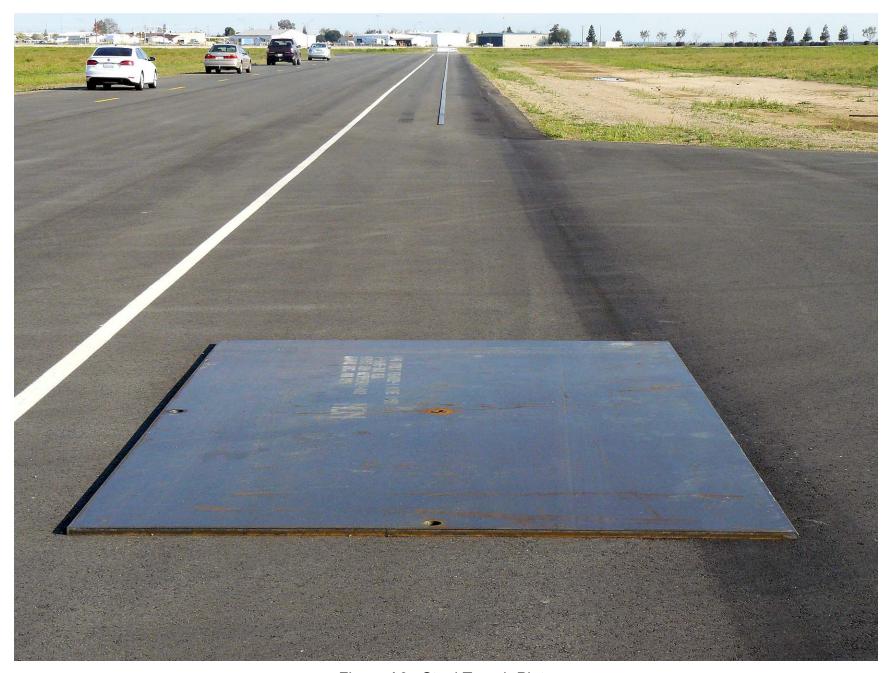
Figure A9. Steel Trench Plate

The false positive suppression test series evaluates the ability of a CIB system to differentiate a steel trench plate (STP) from an object presenting a genuine safety risk to the SV. Although the STP is large and metallic, it is designed to be driven over without risk of injury to the driver or damage to the SV. Therefore, in this scenario, the automatic braking available from CIB is not necessary and should be suppressed. The test condition is nearly equivalent to that previously defined for Test 1, the stopped POV condition, but with an STP in the SV forward path in lieu of a POV.

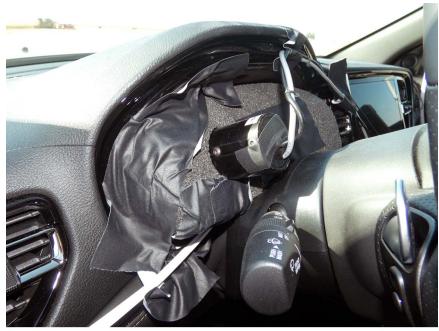
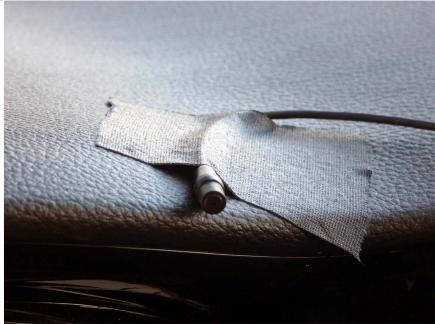
Figure A11. Sensors for Detecting Auditory and Visual Alerts

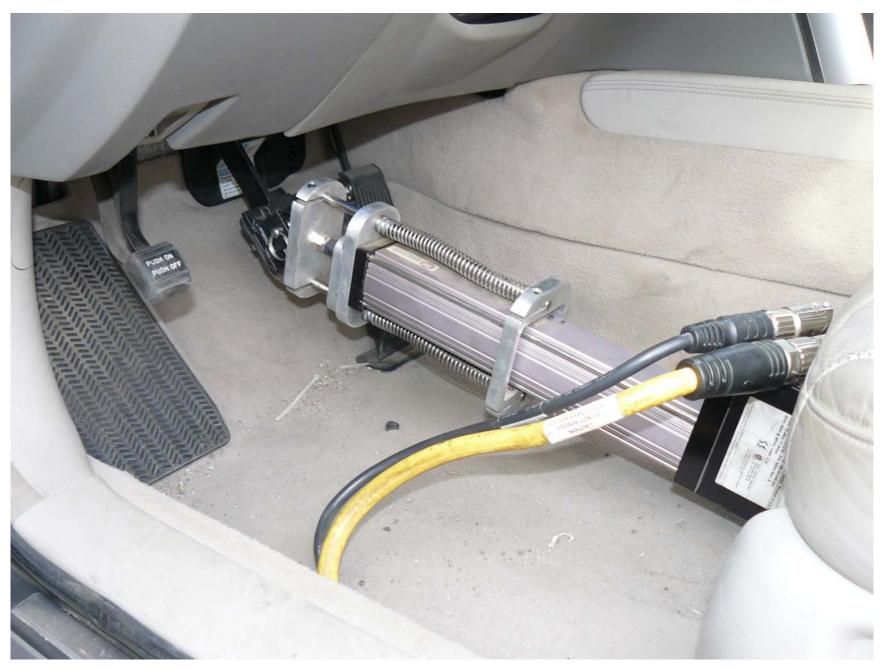
Figure A13. Brake Actuator Installed in POV System

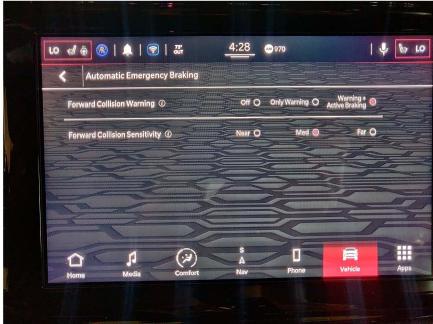
Figure A14. AEB Setup Menus

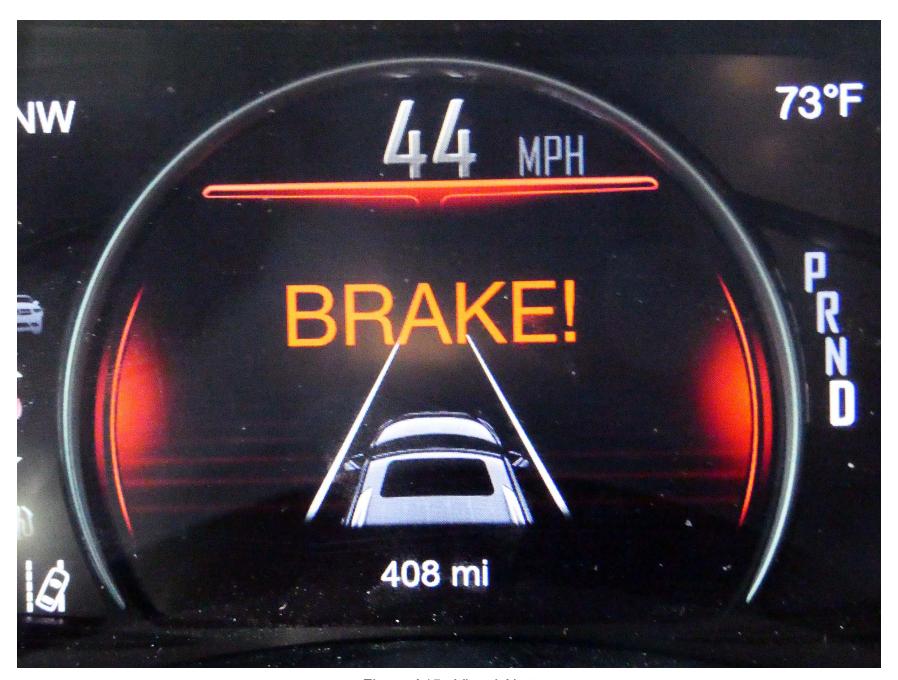
Figure A15. Visual Alert

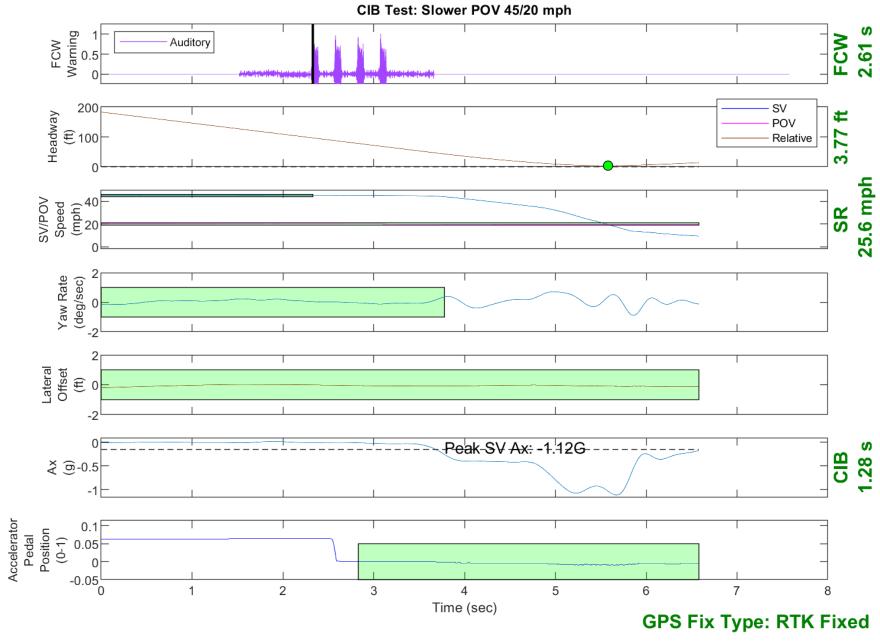
Figure D3. Example Time History for Slower POV 45 vs. 20, Passing

Examples of time history plots for each test type (including passing, failing and invalid runs) are shown in Figure D1 through Figure D9. Figures D1 through D6 show passing runs for each of the 6 test types. Figures D7 and D8 show examples of invalid runs. Figure D9 shows an example of a valid test that failed the CIB requirements.
