**NEW CAR ASSESSMENT PROGRAM
LANE DEPARTURE WARNING CONFIRMATION TEST
NCAP-DRI-LDW-21-02**

2021 Chevrolet Tahoe 2WD High Country

Final Report

1. Report No. NCAP-DRI-LDW-21-02	2. Government Accession No.	3. Recipient's Catalog No.	
4. Title and Subtitle Final Report of Lane Departure Warning Confirmation Test of a 2021 Chevrolet Tahoe 2WD High Country.		5. Report Date 15 March 2021

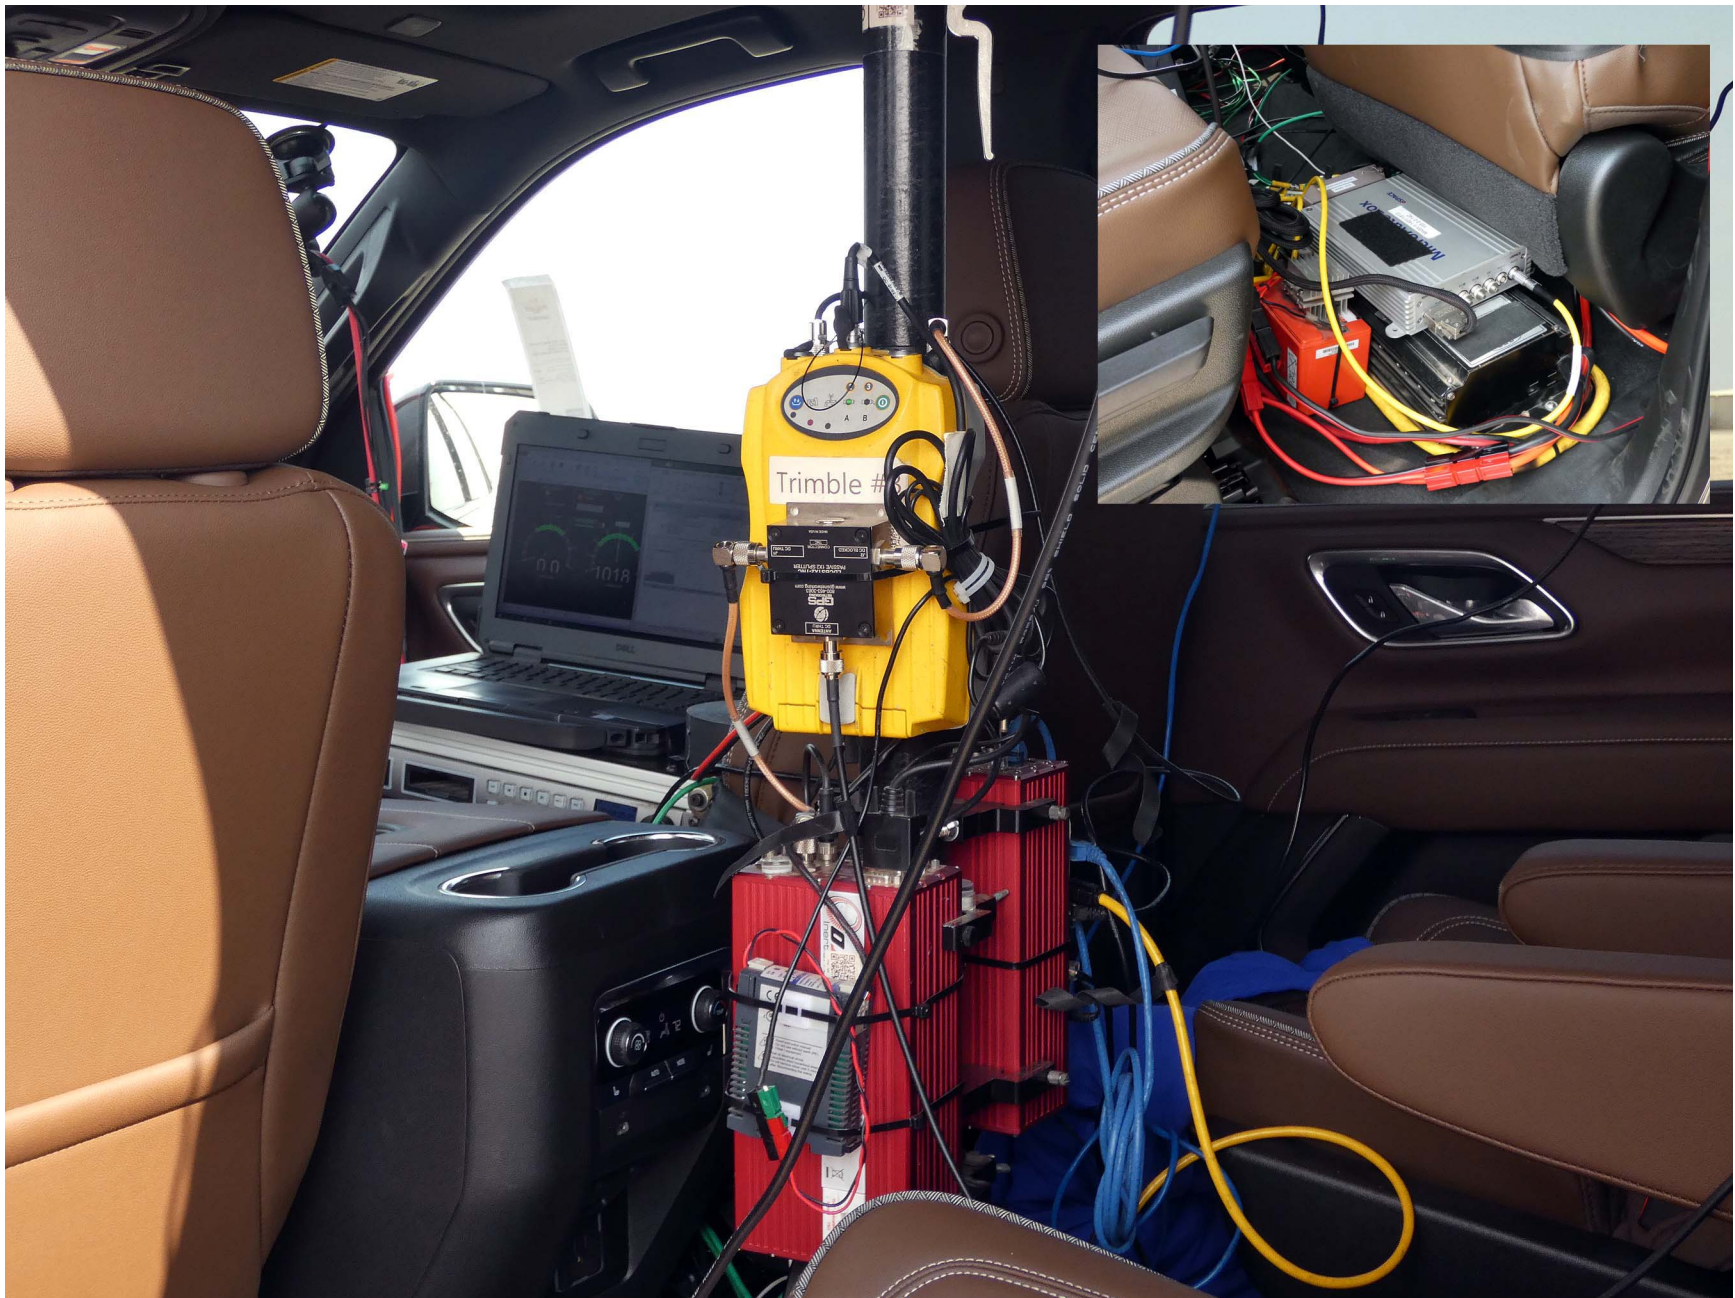
Figure A6. DGPS, Inertial Measurement Unit, and MicroAutoBox Installed in Subject Vehicle

Table 2 lists the sensors, signal conditioning, and data acquisition equipment used for these tests.

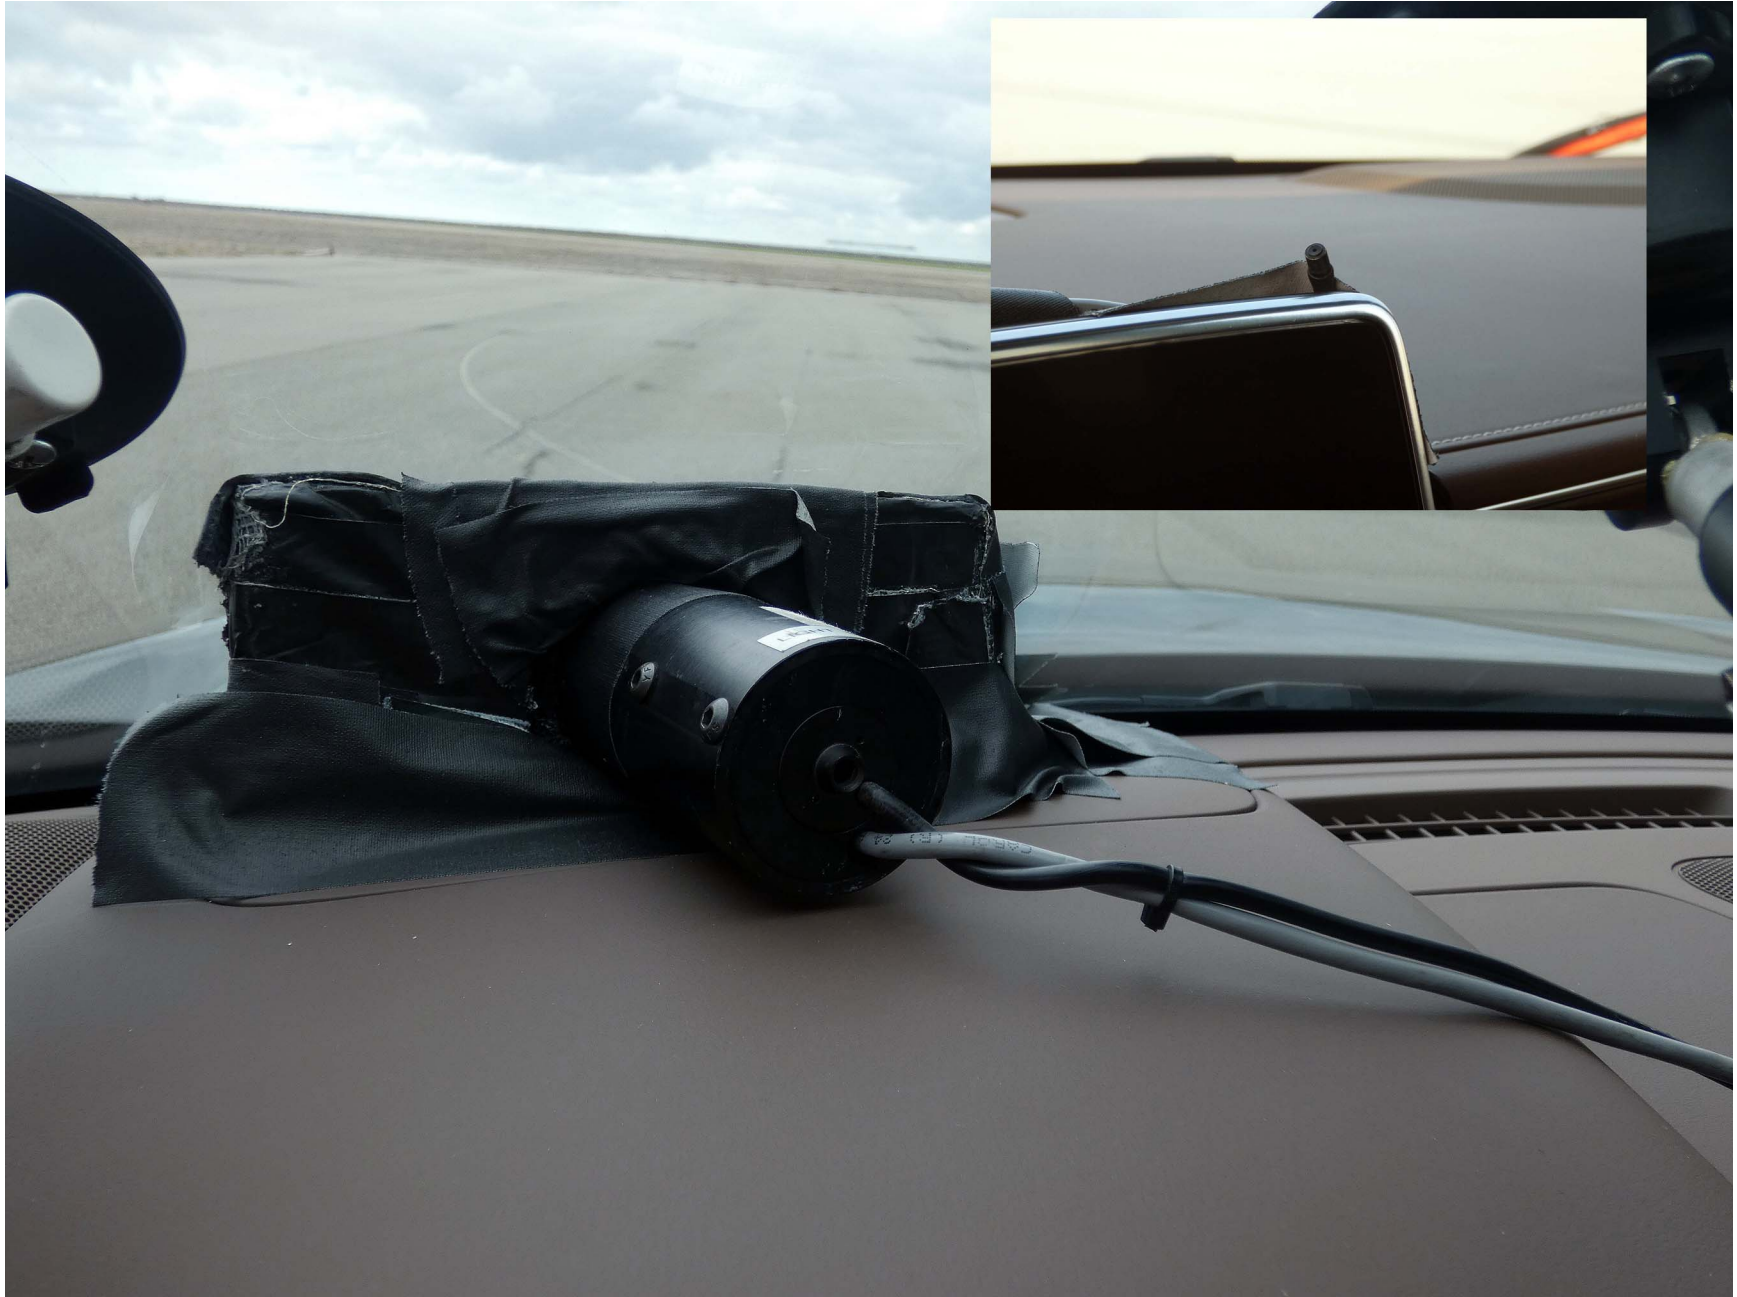
Figure A7. Sensors for Detecting Visual and Auditory Alerts

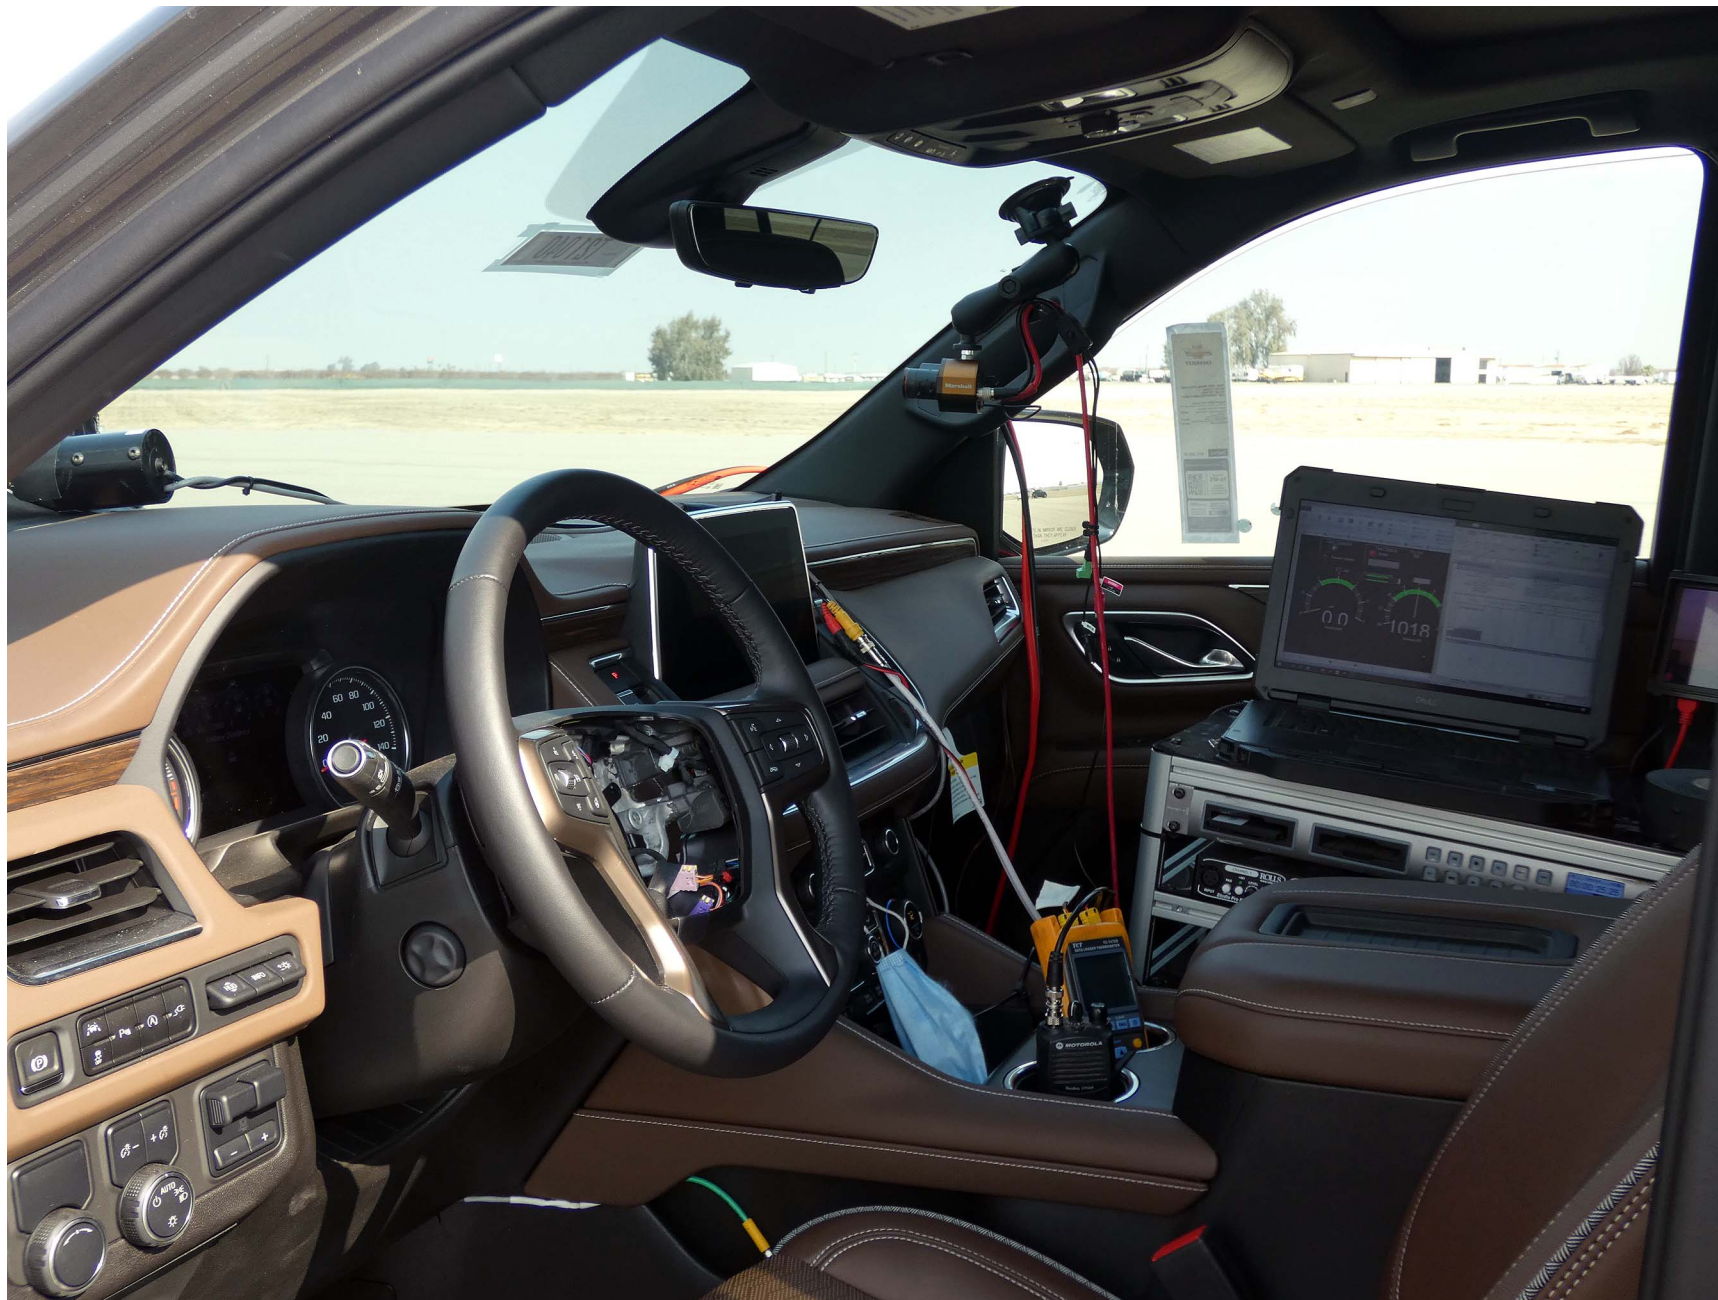
Figure A8. Computer Installed in Subject Vehicle

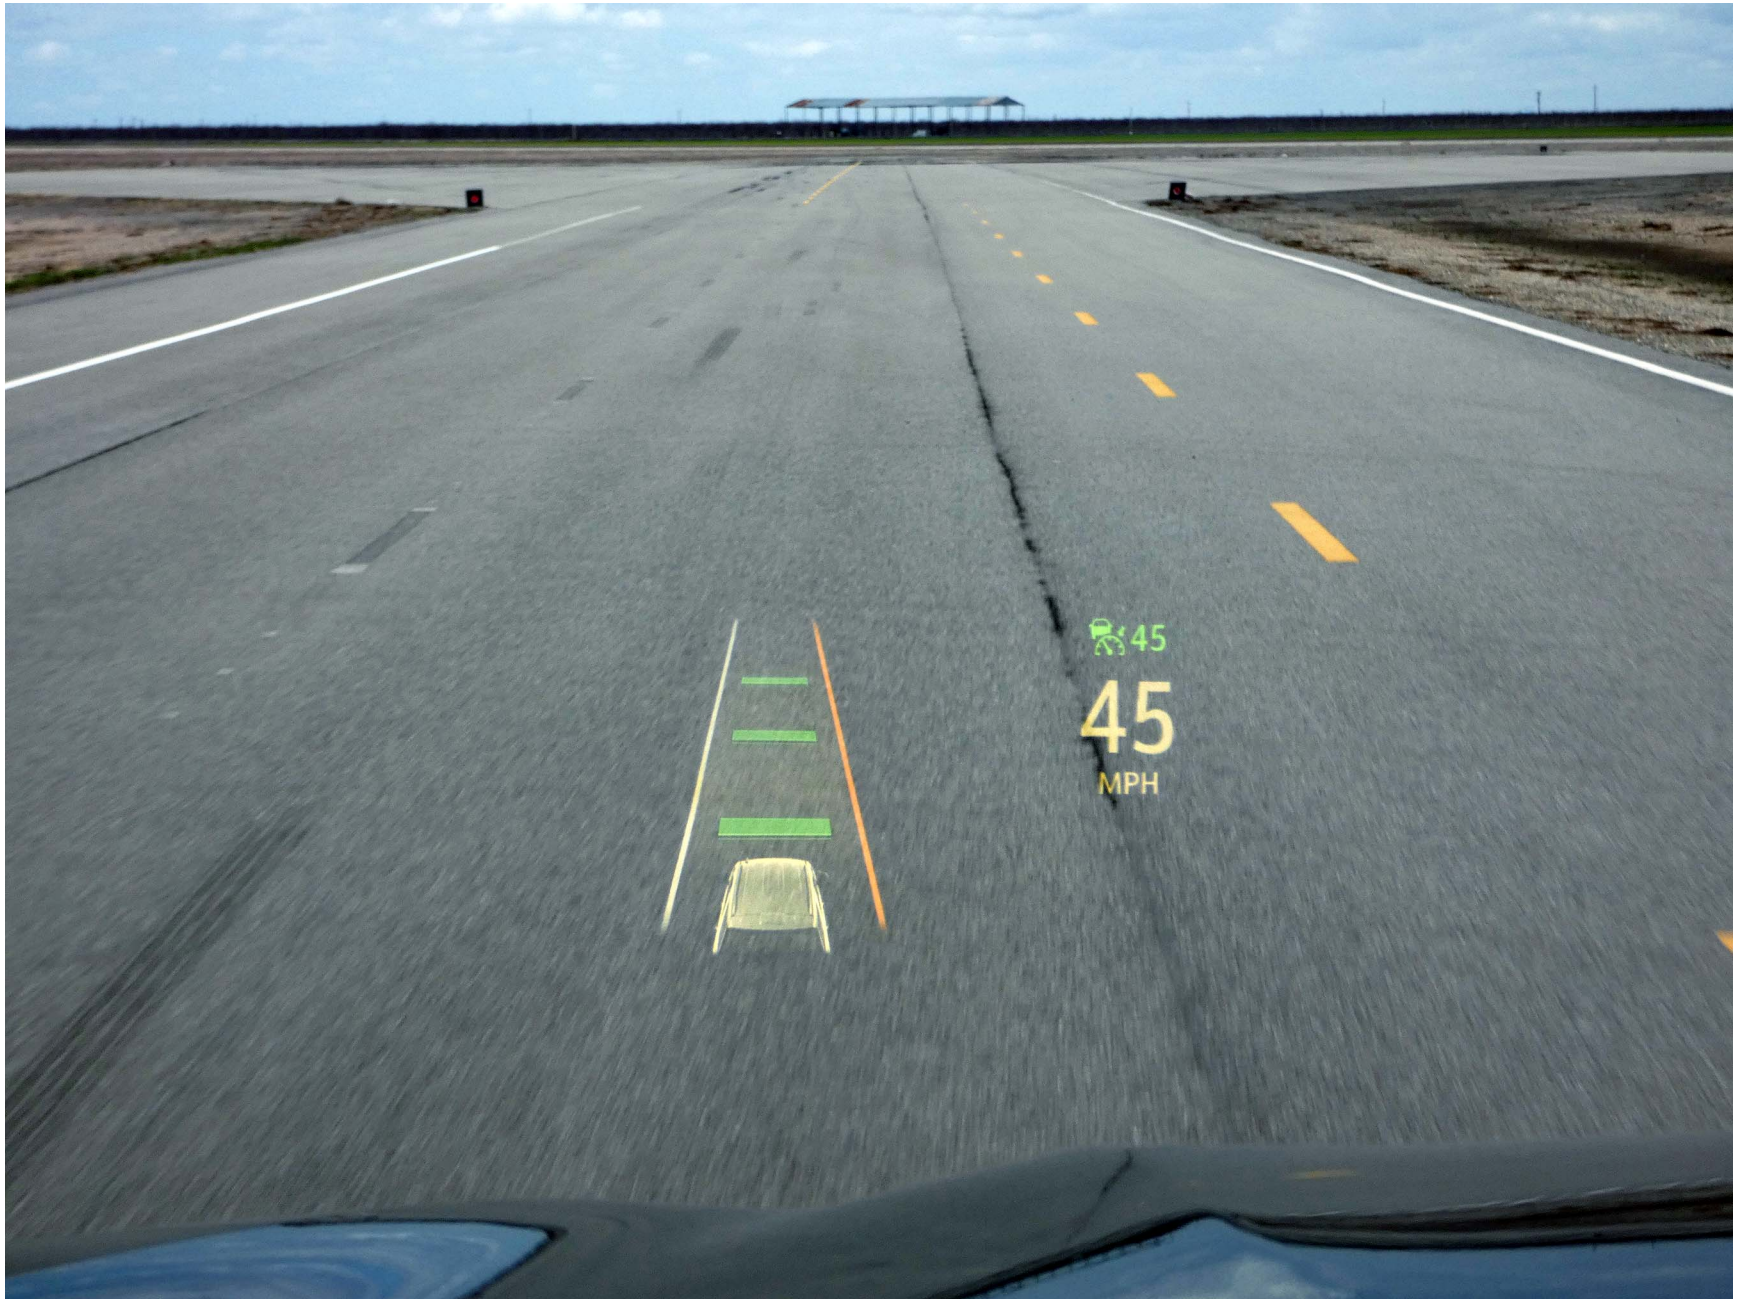
Figure A10. Visual Alert
