**NEW CAR ASSESSMENT PROGRAM  
FORWARD COLLISION WARNING CONFIRMATION TEST  
NCAP-DRI-FCW-21-04**

**2021 Ford Bronco Sport Badlands 4x4**

**DYNAMIC RESEARCH, INC.**

**5 April 2021**

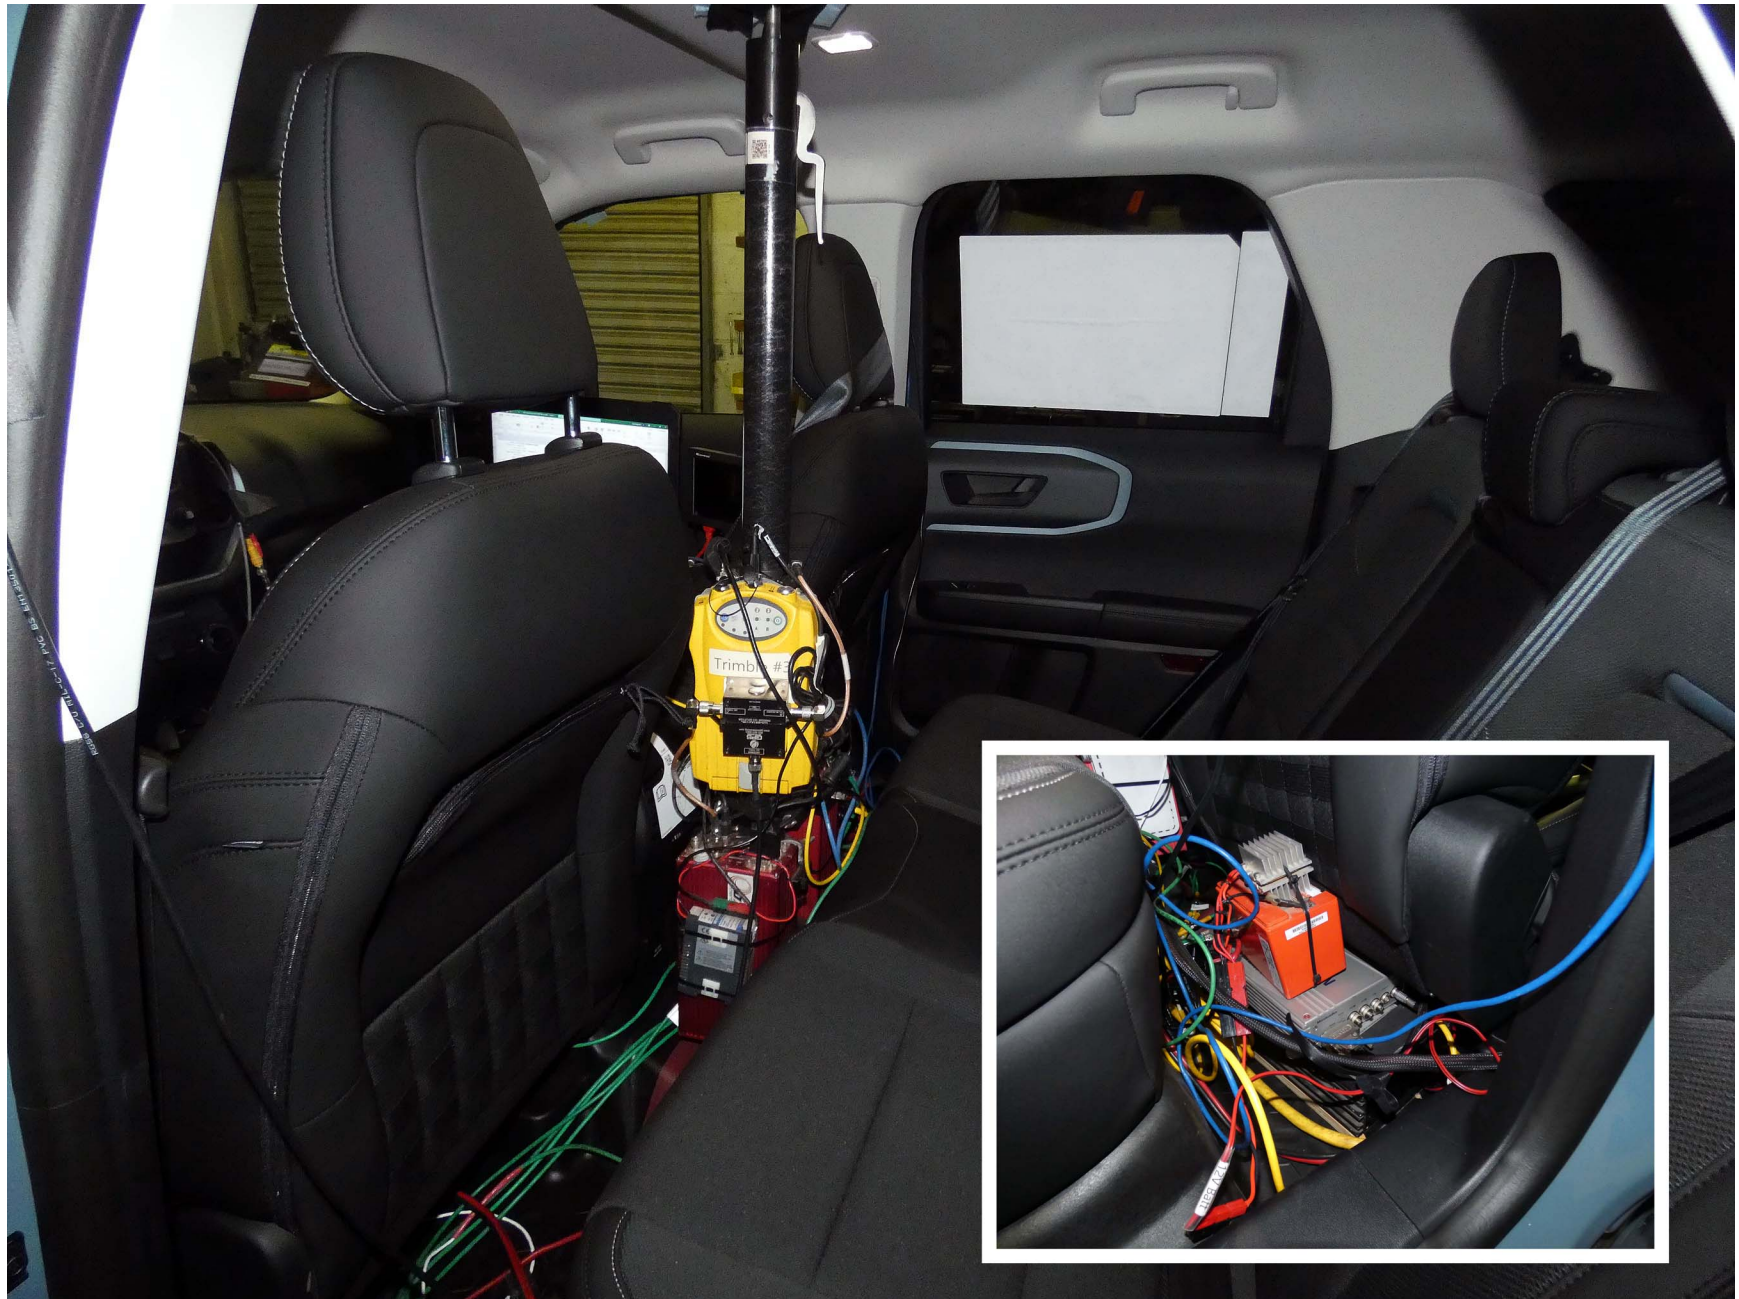
Figure A8. DGPS and Inertial Measurement Unit Installed in Subject Vehicle

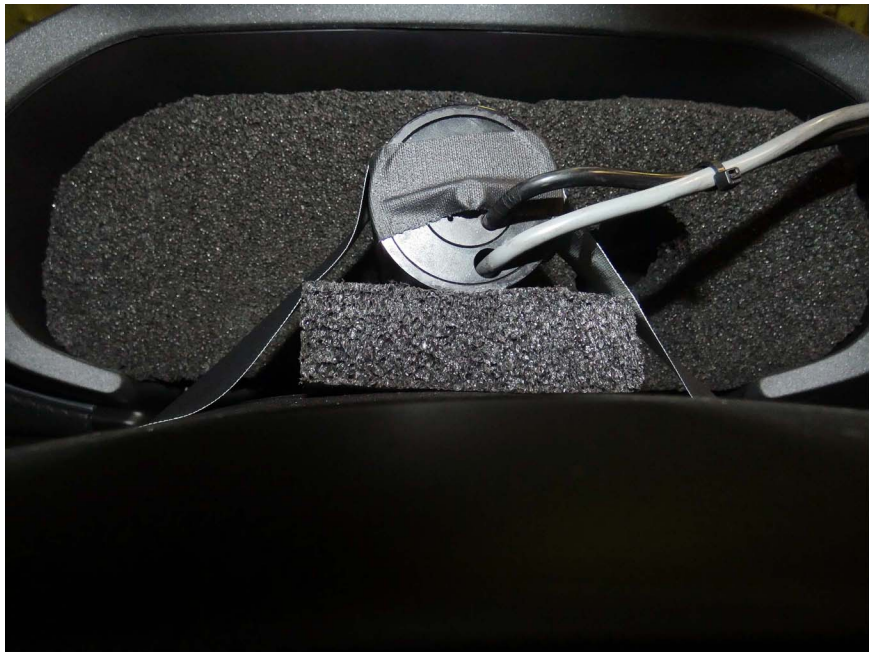
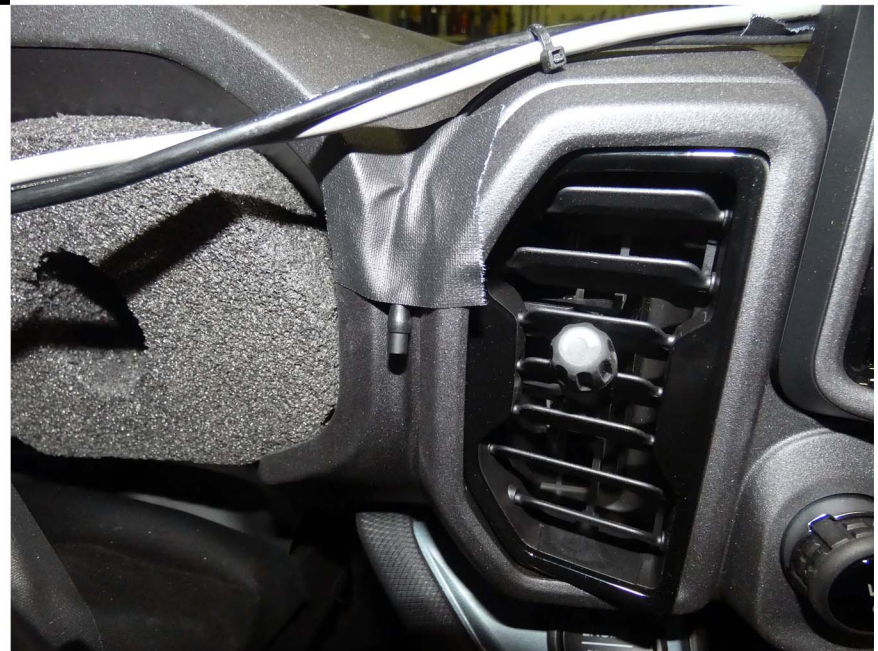
Figure A9. Sensors for Detecting Auditory and Visual Alerts

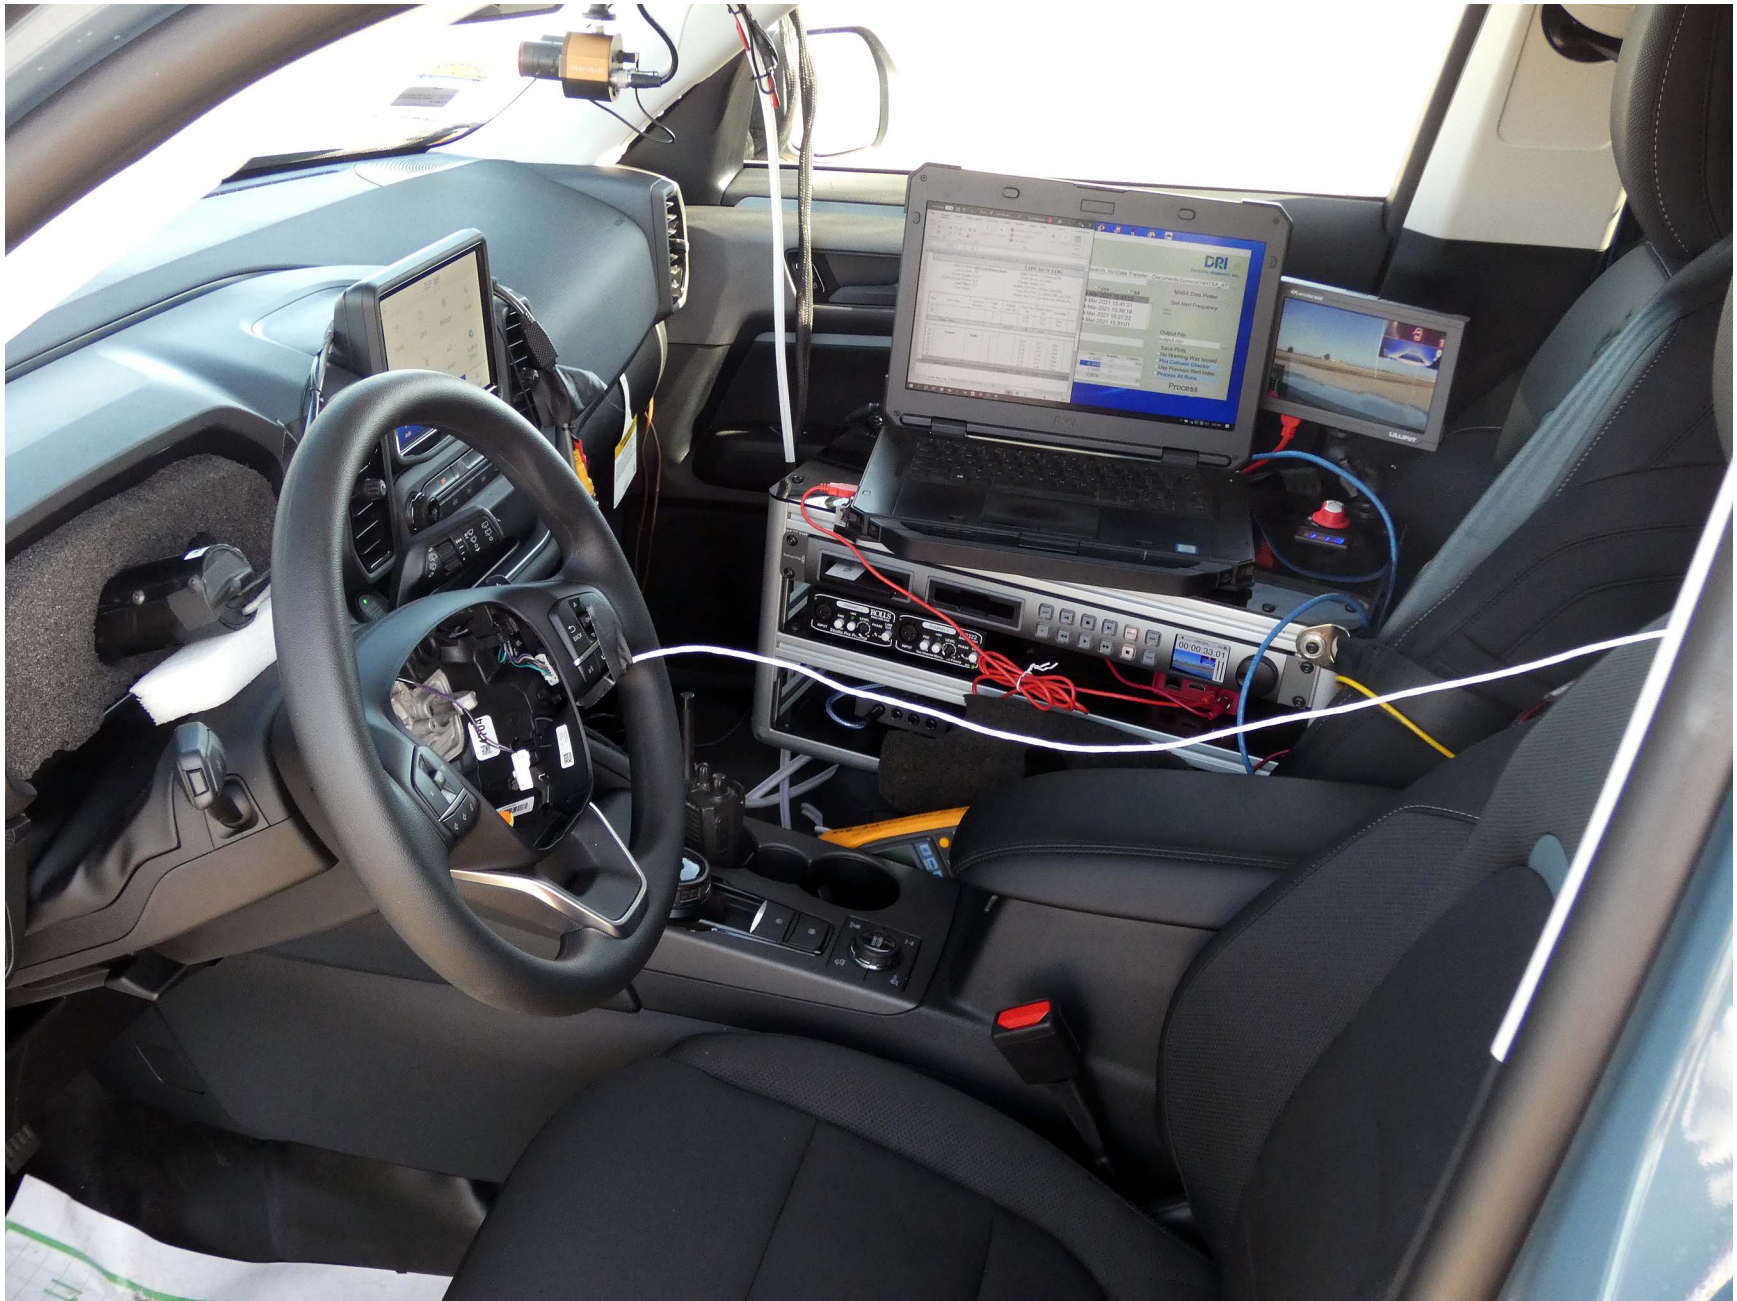
Figure A10. Computer Installed in Subject Vehicle

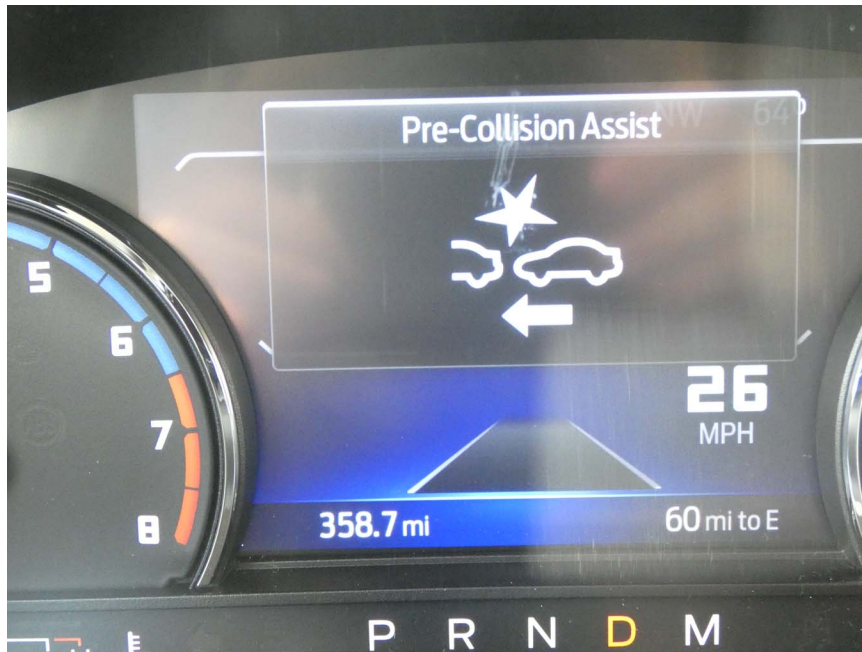
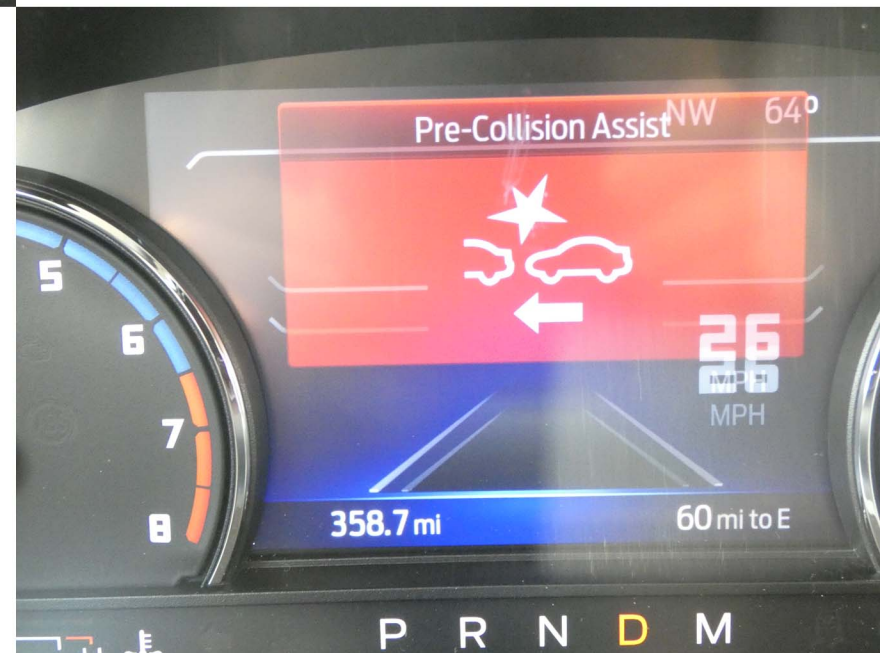
Figure A13. FCW Visual Alert
