**NEW CAR ASSESSMENT PROGRAM  
CRASH IMMINENT BRAKING SYSTEM CONFIRMATION TEST  
NCAP-DRI-CIB-21-09**

**2021 Hyundai Santa Fe 2.5L FWD**

**16 April 2021**

**Final Report**

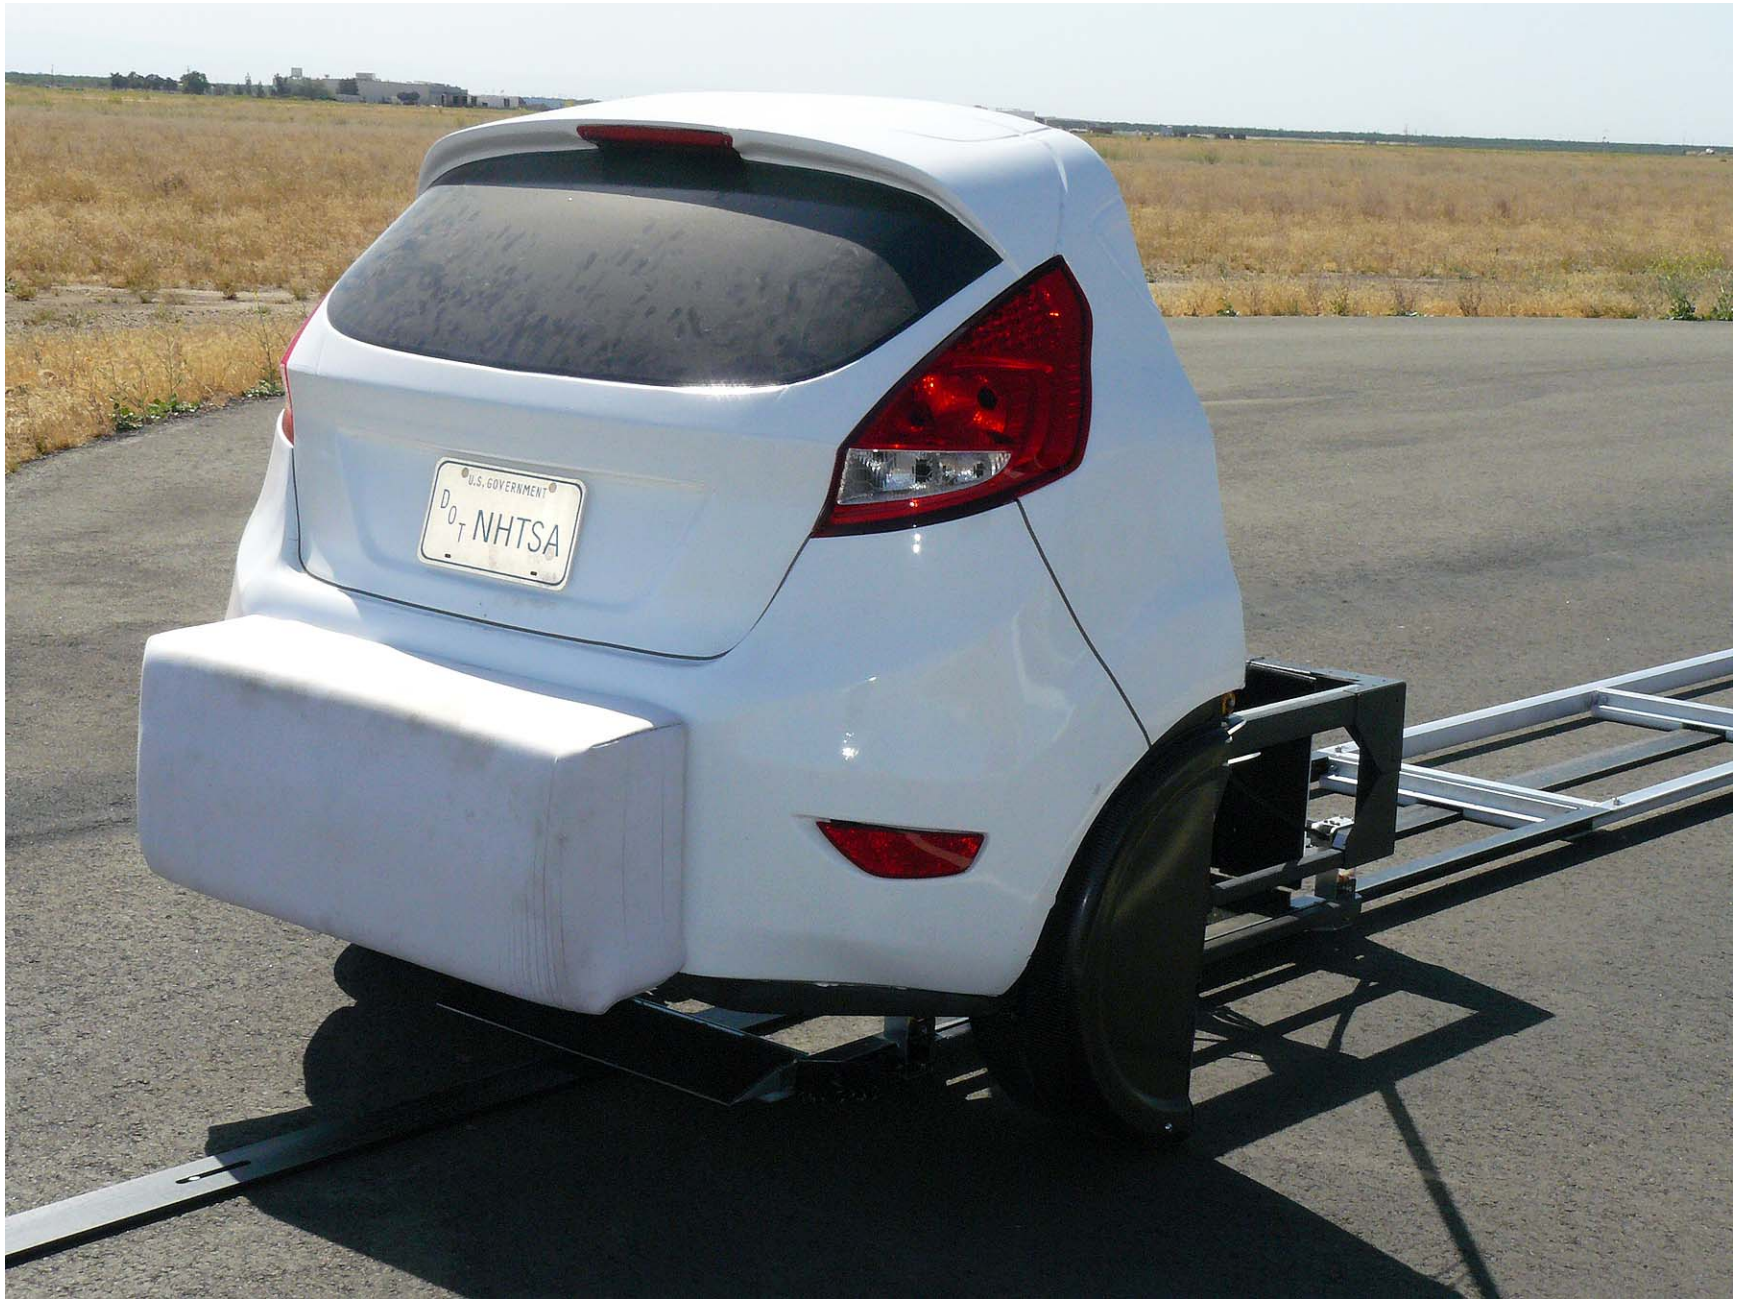
Figure A6. Rear View of Principal Other Vehicle (SSV)

CIB testing requires a POV that realistically represents typical vehicles, does not suffer damage or cause damage to a test vehicle in the event of collision, and can be accurately positioned and moved during the tests. The tests reported herein made use of the NHTSA developed Strikeable Surrogate Vehicle (SSV).

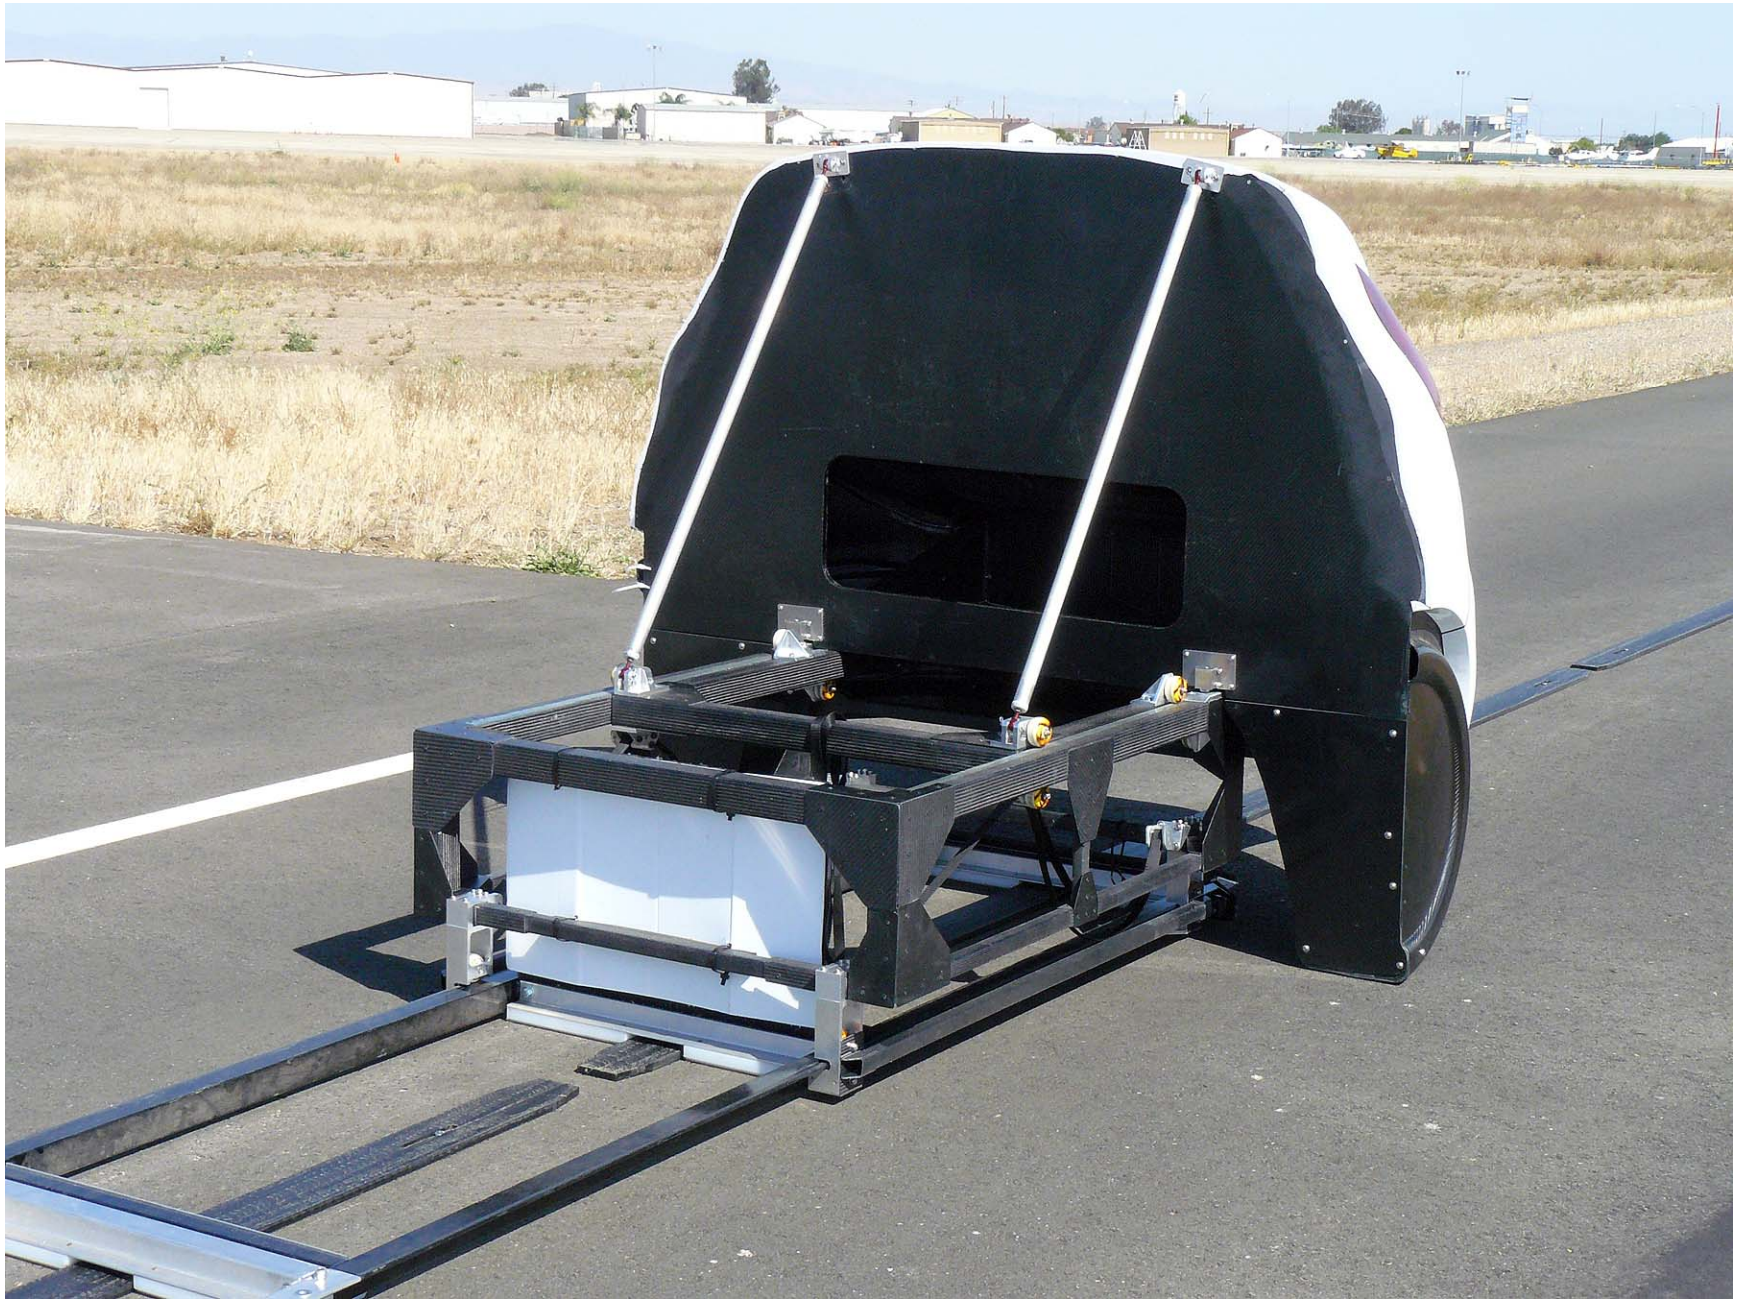
Figure A7. Load Frame/Slider of SSV

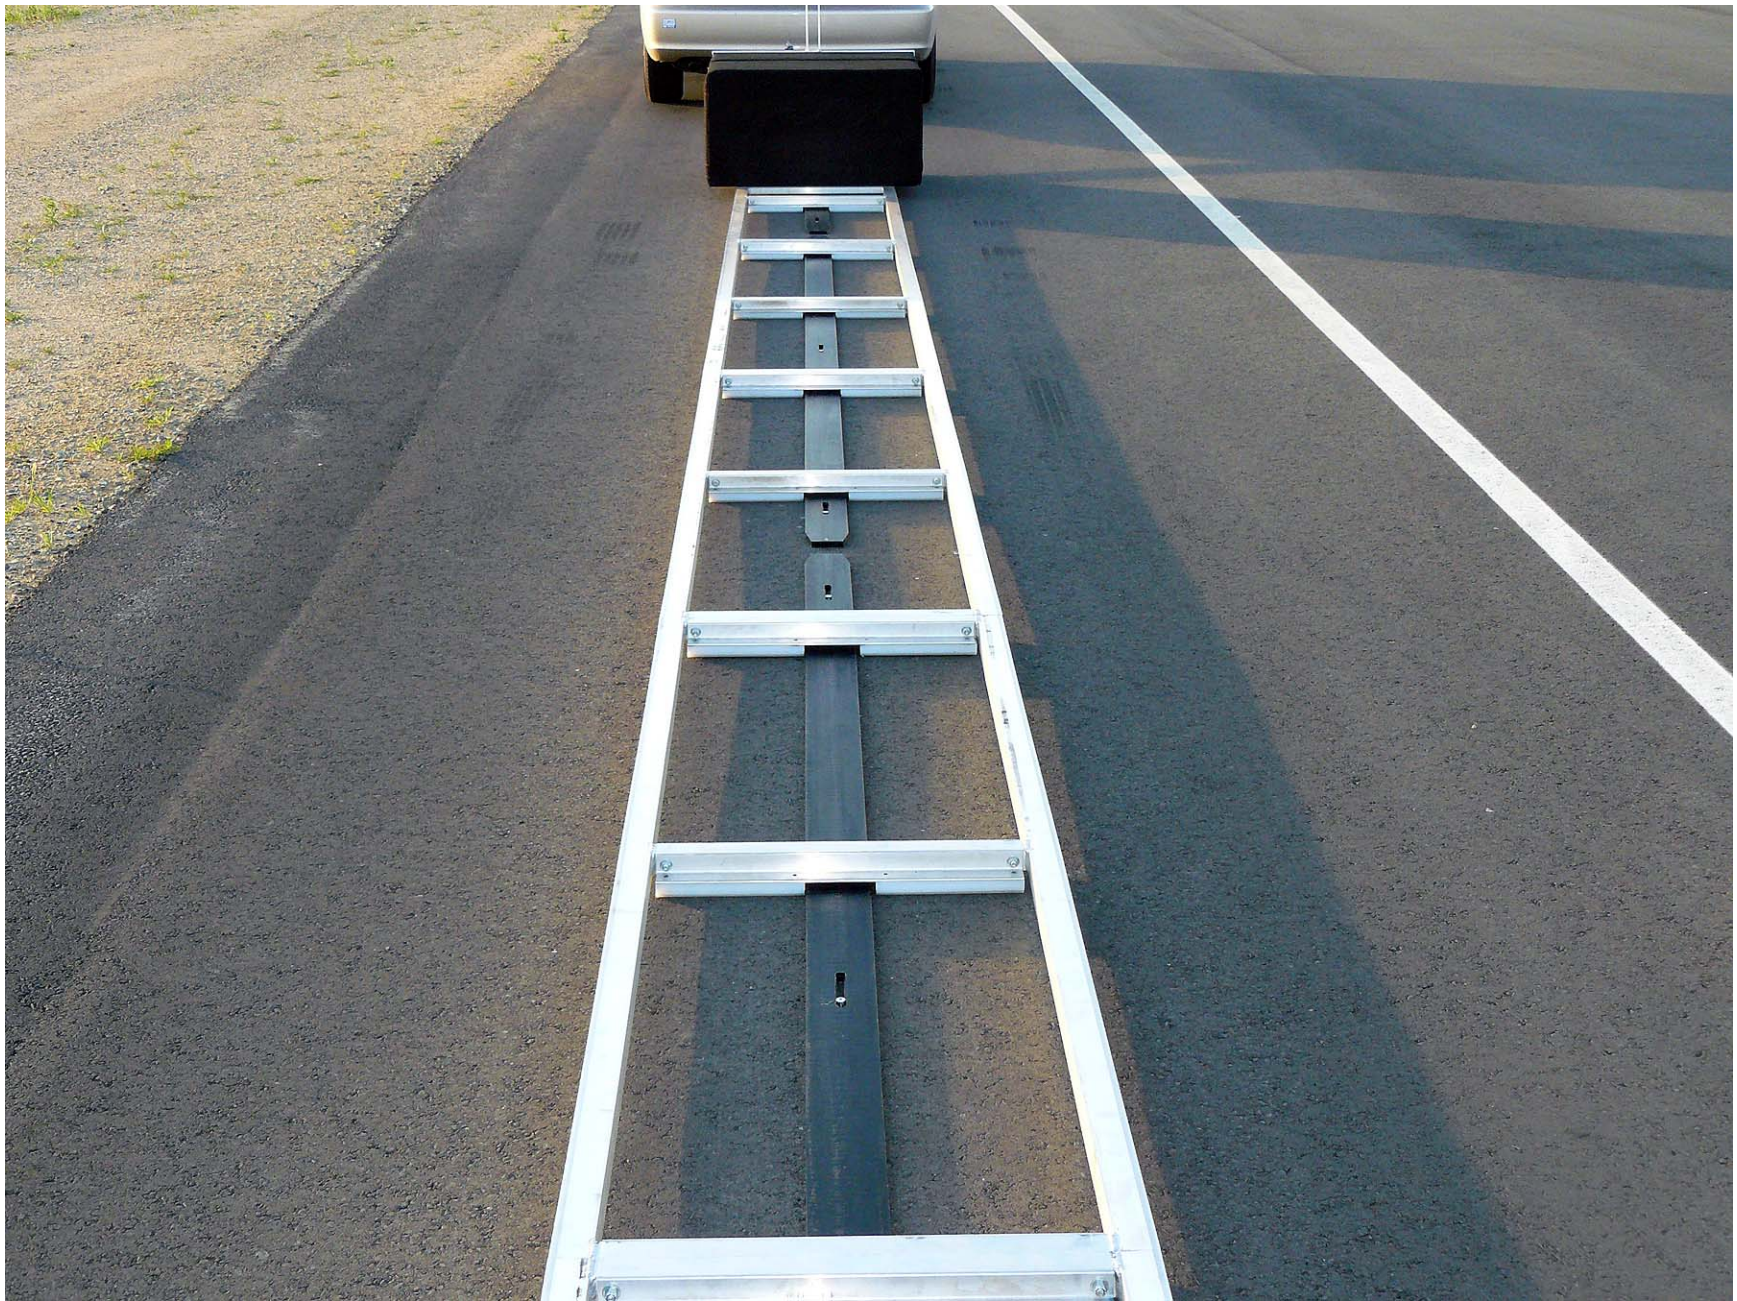
Figure A8. Two-Rail Track and Road-Based Lateral Restraint Track

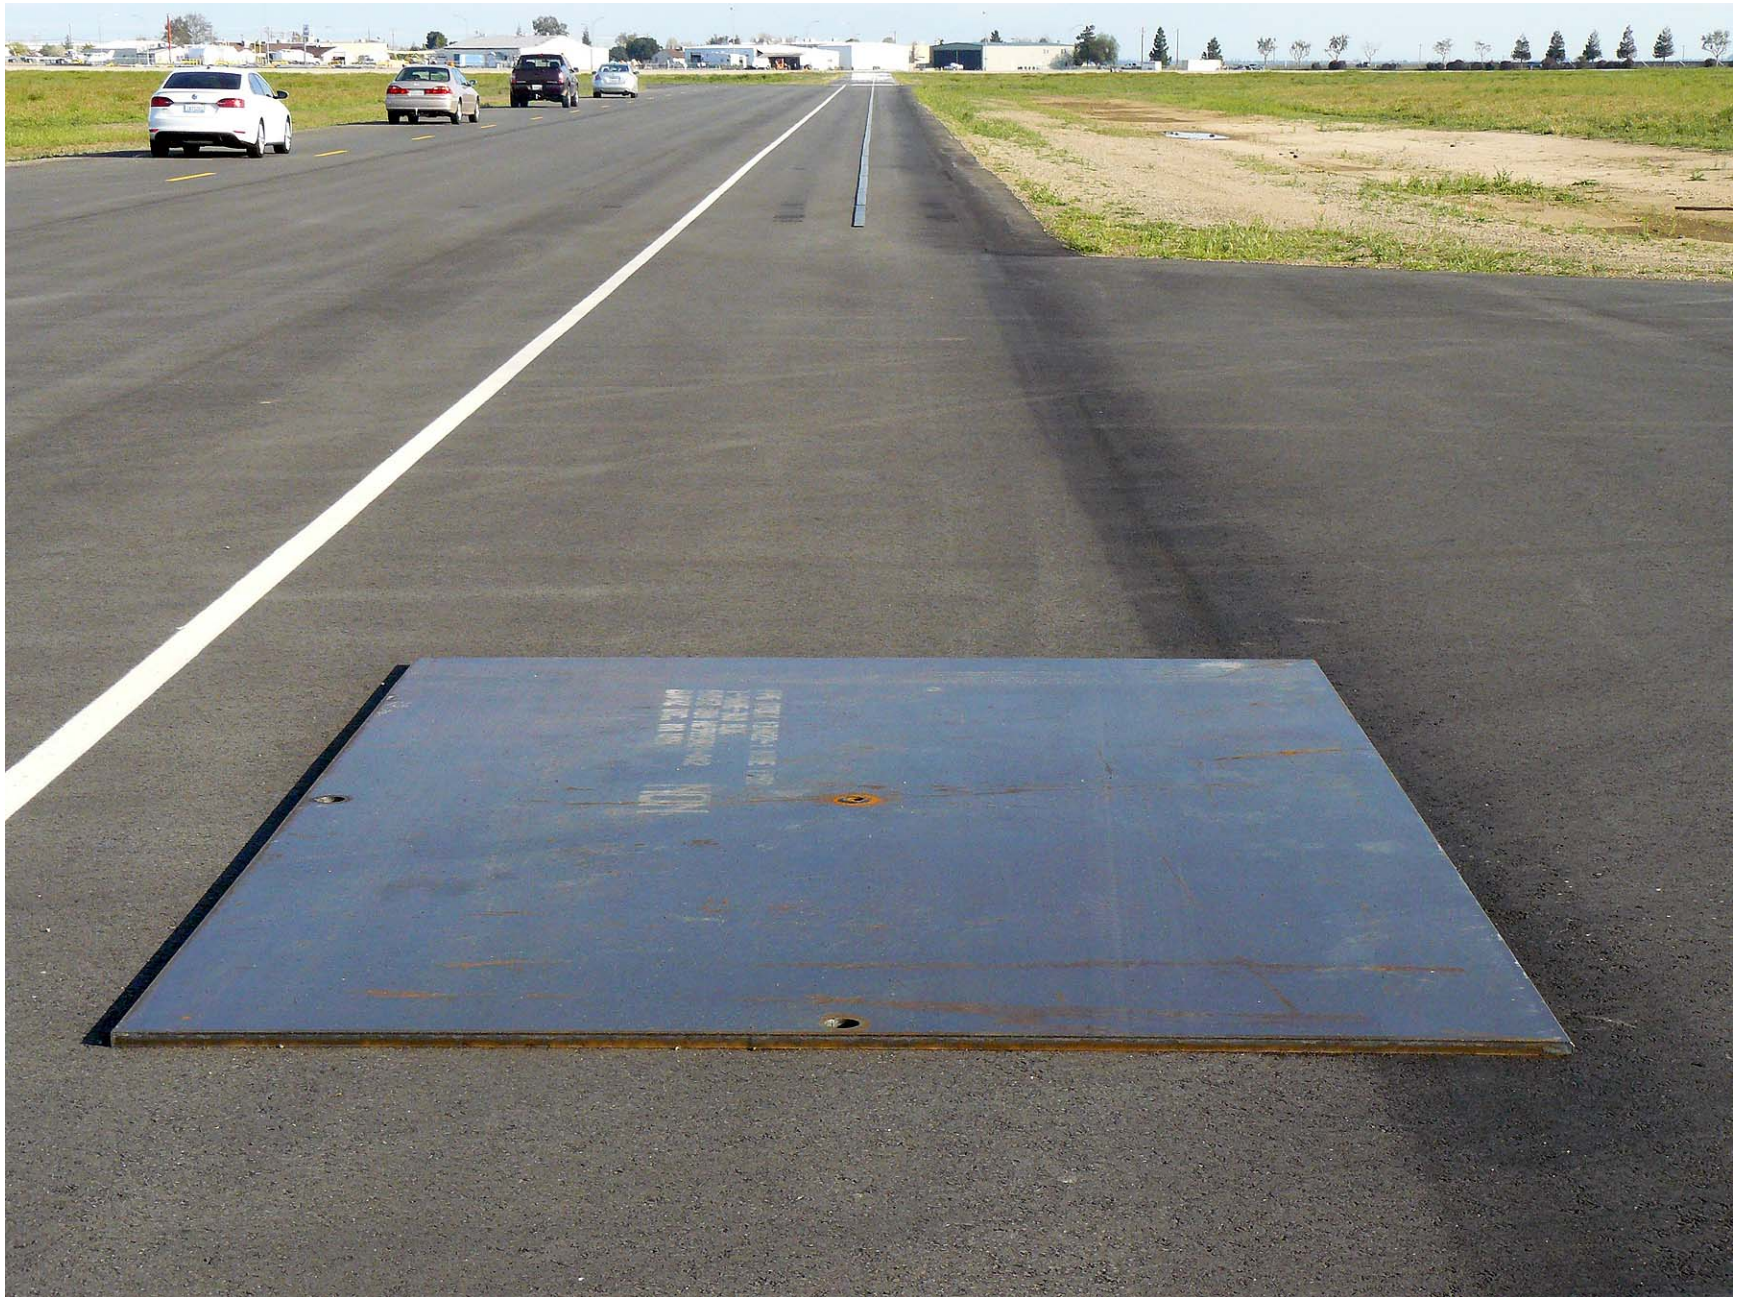
Figure A9. Steel Trench Plate

The false positive suppression test series evaluates the ability of a CIB system to differentiate a steel trench plate (STP) from an object presenting a genuine safety risk to the SV. Although the STP is large and metallic, it is designed to be driven over without risk of injury to the driver or damage to the SV. Therefore, in this scenario, the automatic braking available from CIB is not necessary and should be suppressed. The test condition is nearly equivalent to that previously defined for Test 1, the stopped POV condition, but with an STP in the SV forward path in lieu of a POV.

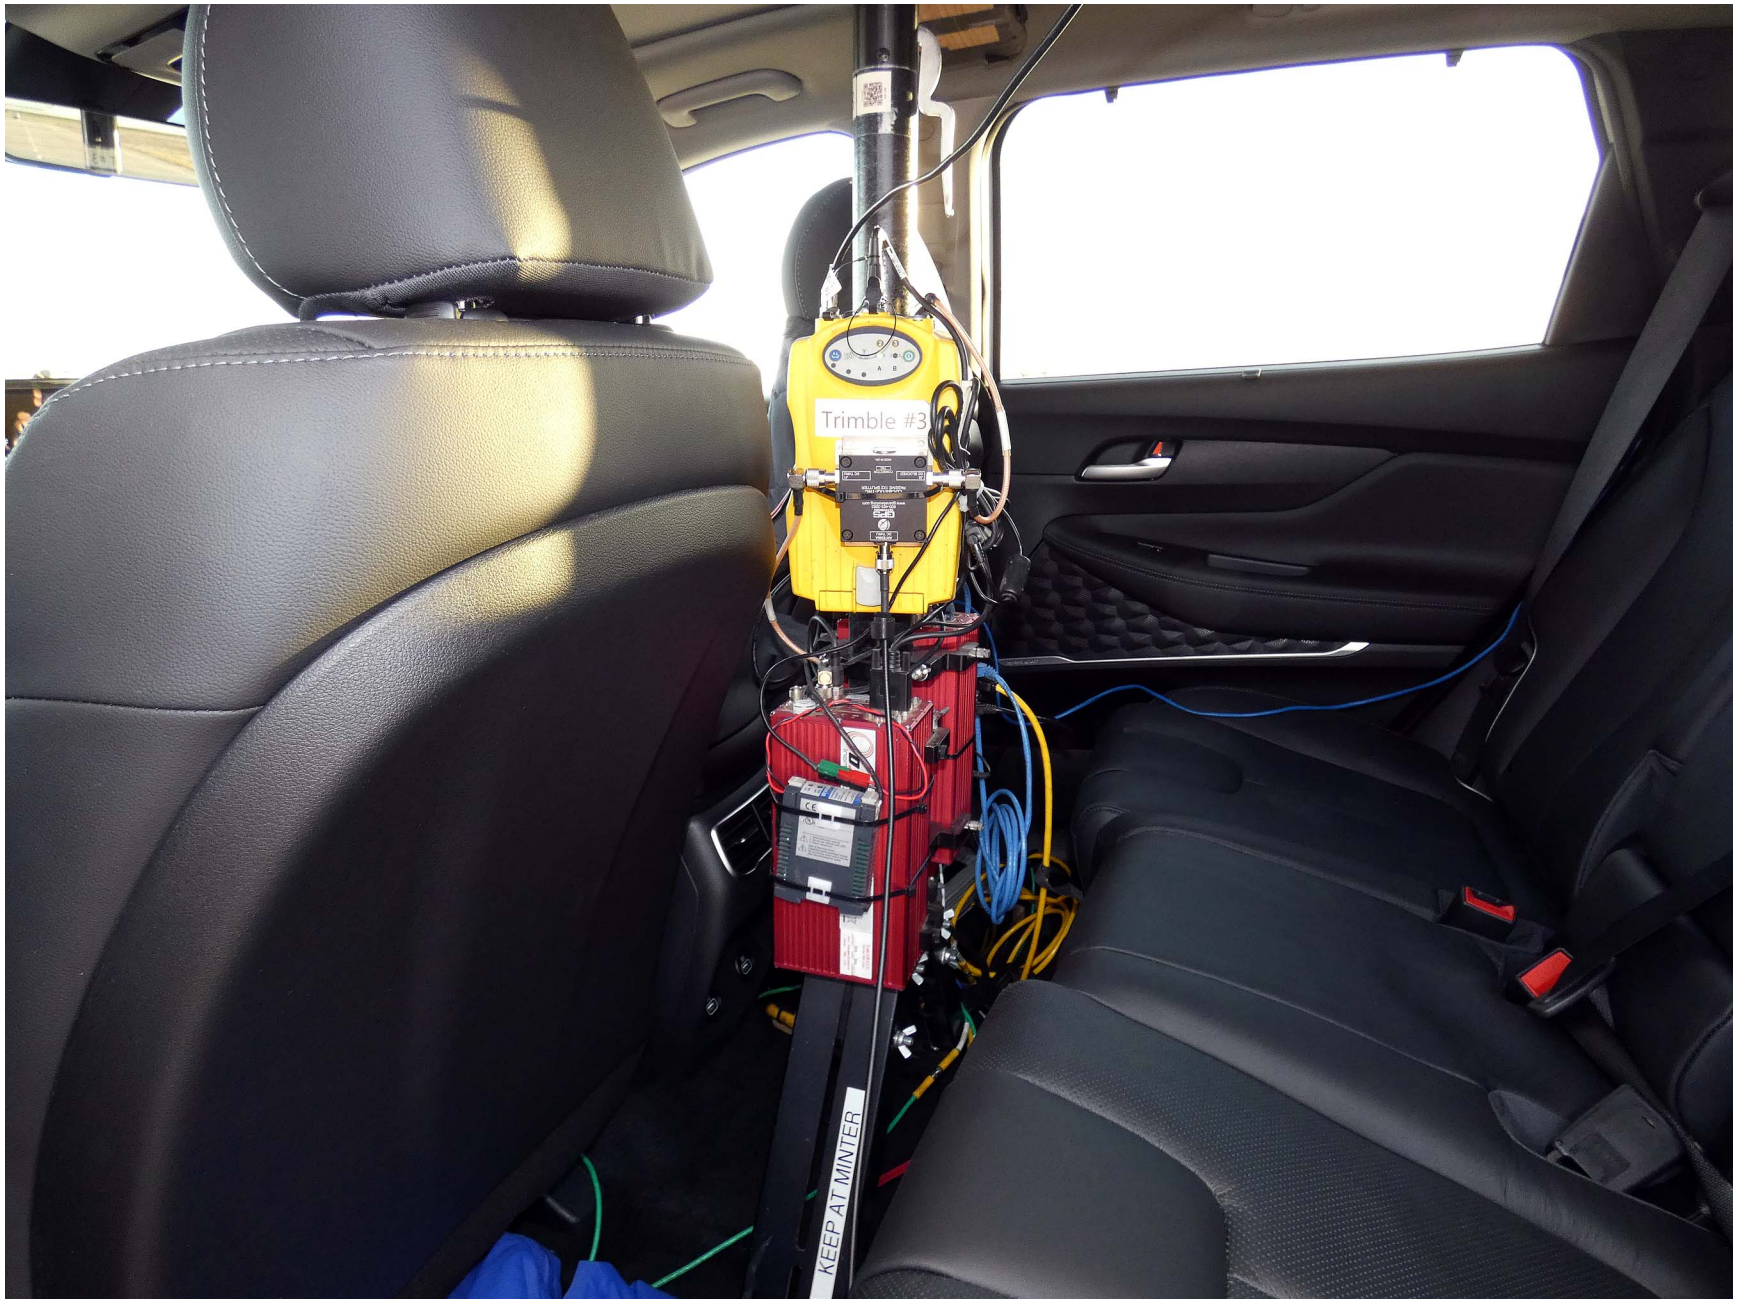
Figure A10. DGPS and Inertial Measurement Unit Installed in Subject Vehicle

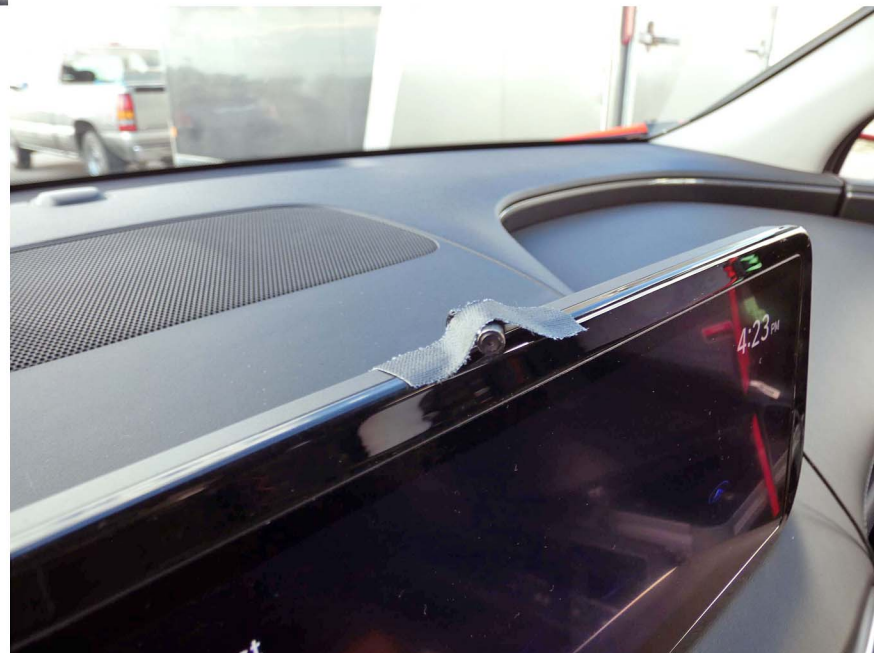
Figure A11. Sensors for Detecting Auditory and Visual Alerts

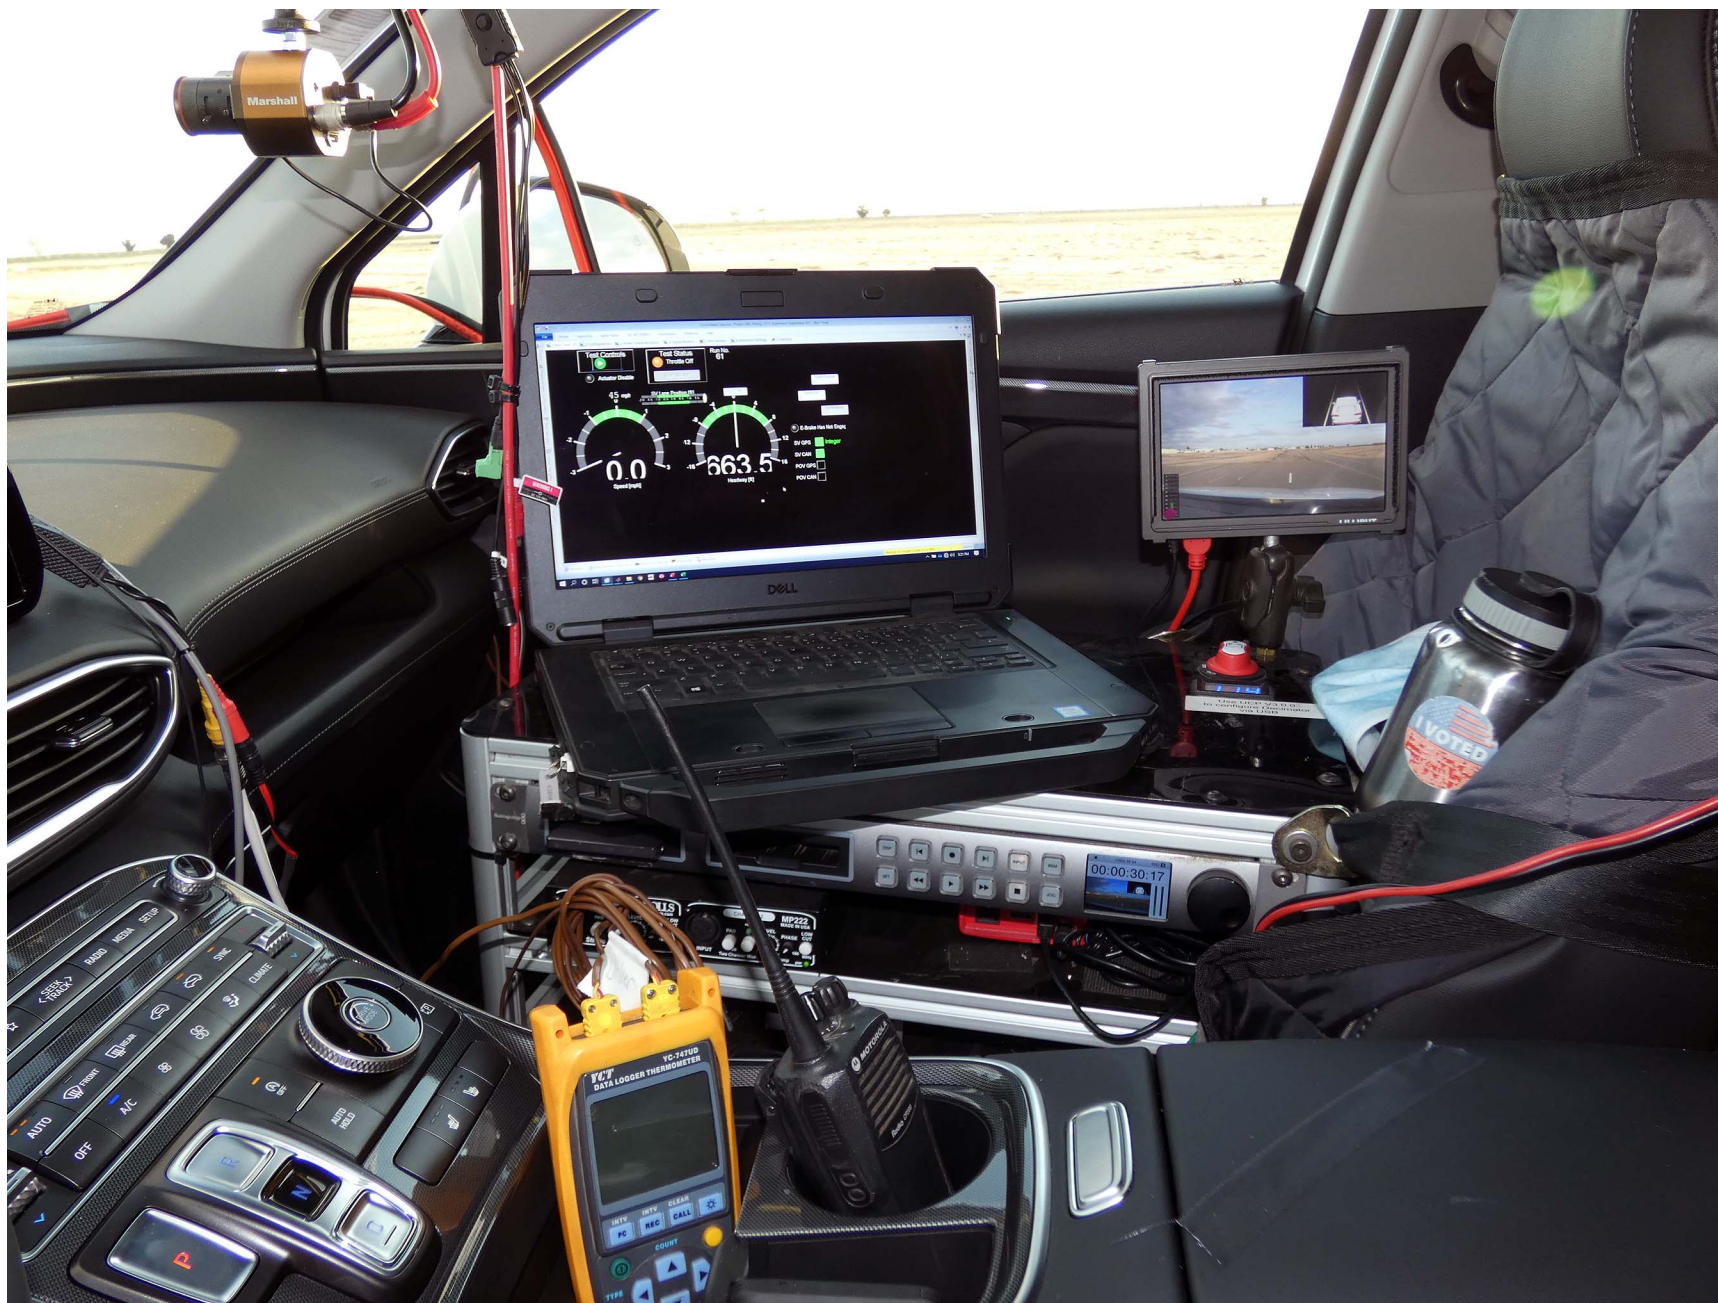
Figure A12. Computer Installed in Subject Vehicle

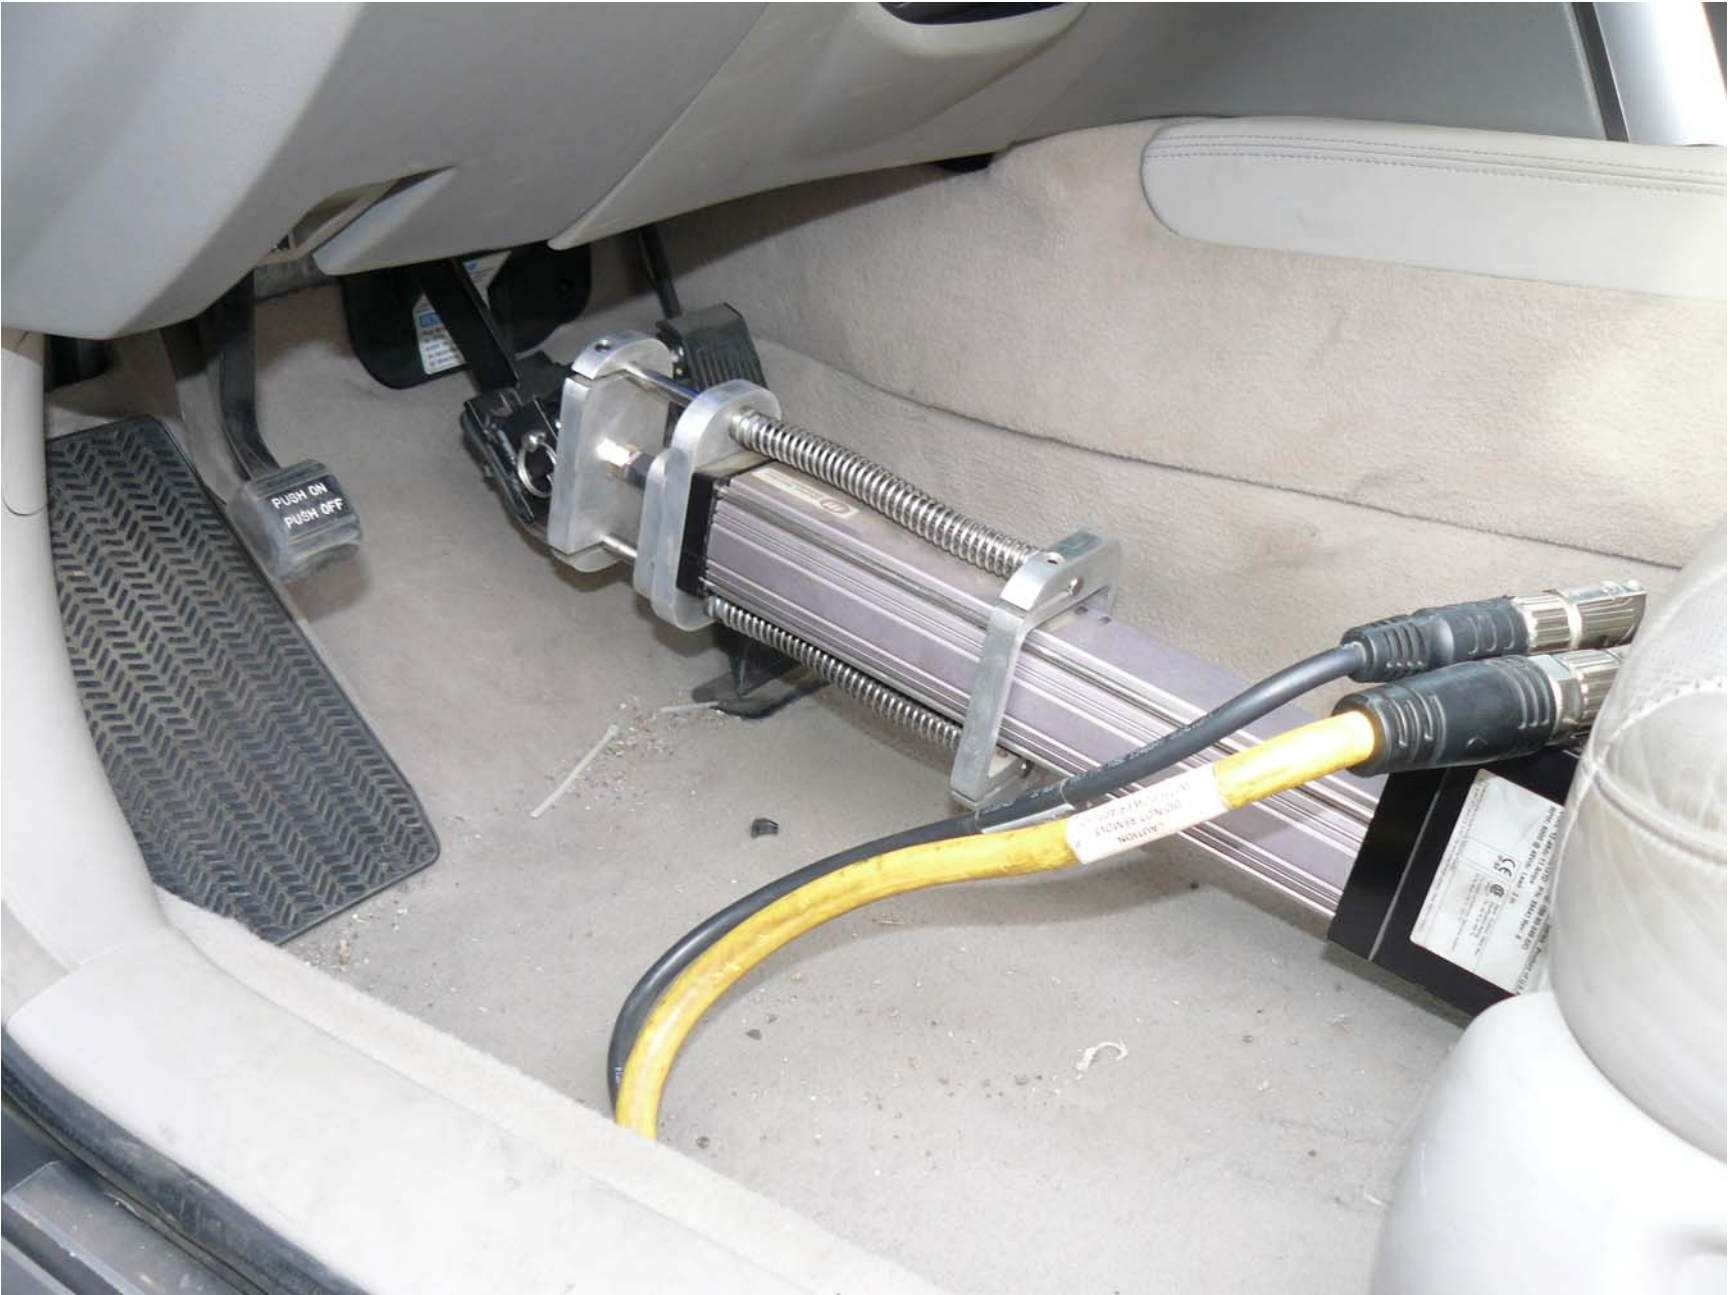
Figure A13. Brake Actuator Installed in POV System

likely to fail a test. The system fires when TTC is below 0.7 sec. It is typically enabled when an SV has already impacted the SSV one or two times.

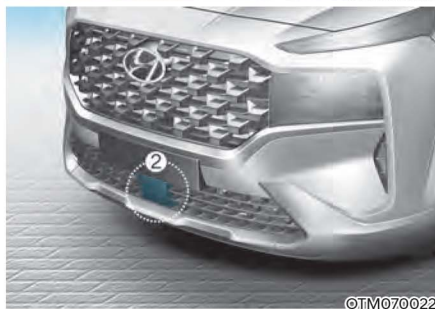
- [1] : Front view camera,
- [2] : Front radar

Refer to the picture above for the detailed location of the detecting sensors.

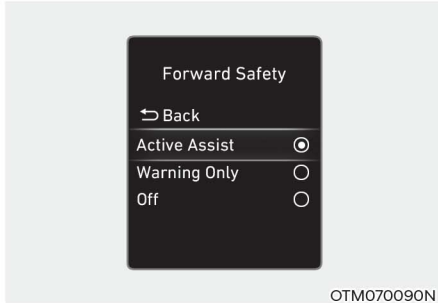
#### Forward Safety

With the engine on, select 'Driver Assistance → Forward Safety' from the Settings menu to set whether or not to use each function.

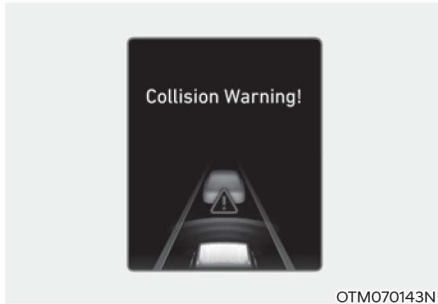
#### Collision Warning

- To warn the driver of a collision, the 'Collision Warning' warning message will appear on the cluster and an audible warning will sound.
- If a vehicle is detected in front, the system will operate when your vehicle speed is between approximately 6~112 mph (10~180 km/h).
- If a pedestrian or cyclist is detected in front, the system will operate when your vehicle speed is between approximately 6~53 mph (10~85 km/h).
- If 'Active Assist' is selected, braking may be assisted.

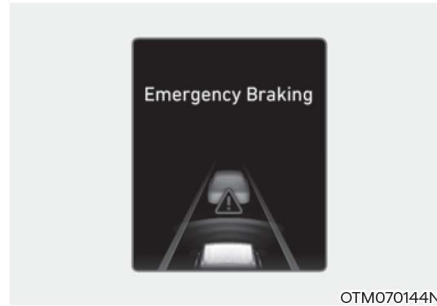
#### Emergency Braking

- To warn the driver that emergency braking will be assisted, the 'Emergency Braking' warning message will appear on the cluster and an audible warning will sound.
- If a vehicle is detected in front, the system will operate when your vehicle speed is between approximately 6~47 mph (10~75 km/h).
- If a pedestrian or cyclist is detected in front, the system will operate when your vehicle speed is between approximately 6~40 mph (10~65 km/h).
- In emergency braking situation, braking is assisted with strong braking power by the system to help prevent collision with the vehicle, pedestrian or cyclist ahead.

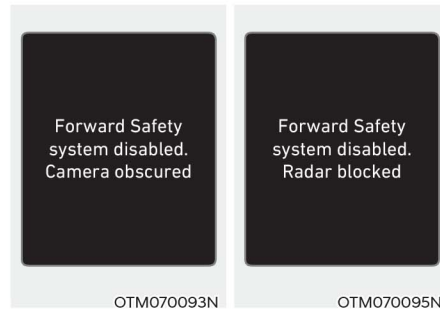
### System disabled

When the front windshield where the front view camera is located, front radar cover or sensor is covered with foreign material, such as snow or rain, it can reduce the detecting performance and temporarily limit or disable Forward Collision-Avoidance Assist.

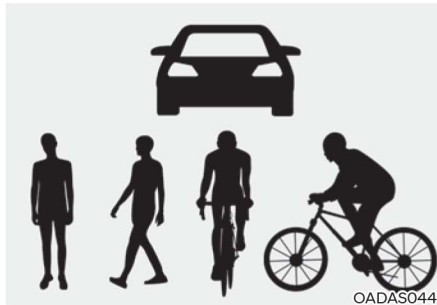
The illustration above shows the image the front view camera is capable of detecting as a vehicle, pedestrian and cyclist.

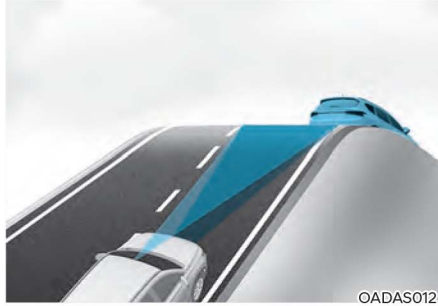
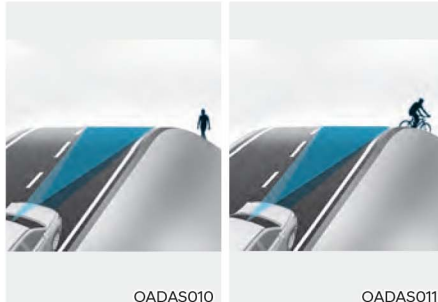
**Forward Collision-Avoidance Assist may not detect other vehicles, pedestrians or cyclists in front of you while driving uphill or downhill adversely affecting the performance of the sensors.**

This may result in unnecessary warning or braking assist, or no warning or braking assist when necessary.

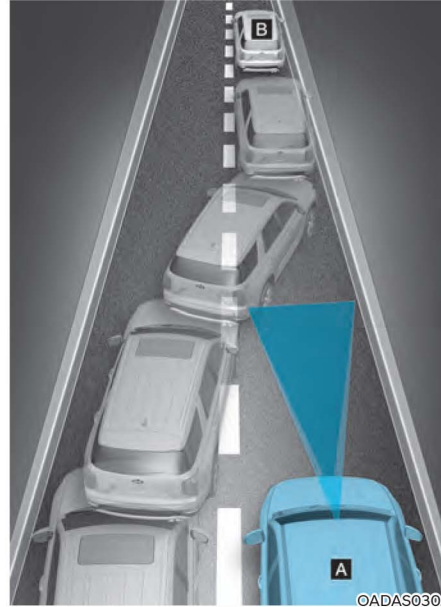
[A] : Your vehicle,  
[B] : Lane changing vehicle

**When a vehicle moves into your lane from an adjacent lane, it cannot be detected by the sensor until it is in the sensor's detection range. Forward Collision-Avoidance Assist may not immediately detect the vehicle when the vehicle changes lanes abruptly. In this case, you must maintain a safe braking distance, and if necessary, steer your vehicle and depress the brake pedal to reduce your driving speed in order to maintain a safe distance.**

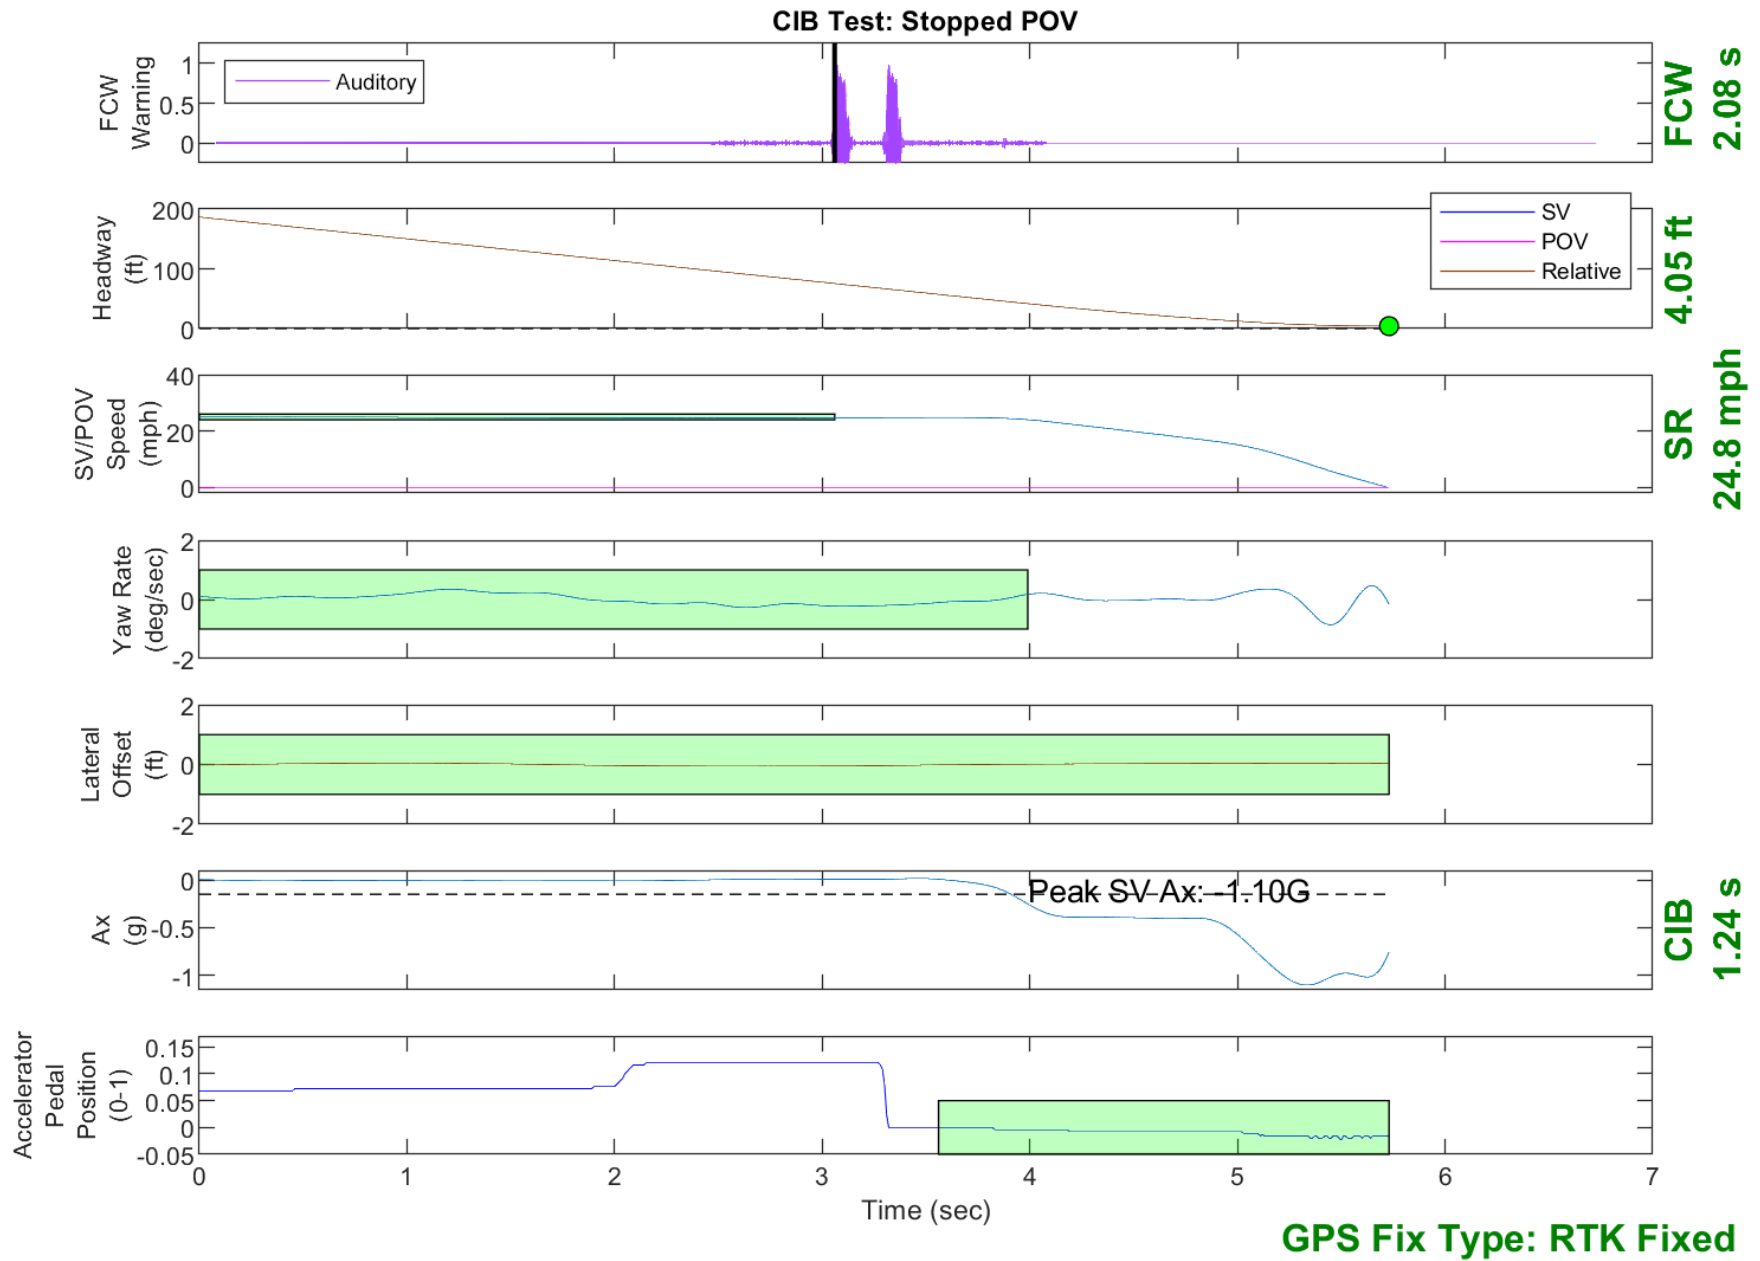
Figure D1. Example Time History for Stopped POV, Passing

Some of the time history plot figures contain either green or yellow envelopes and/or black threshold lines. These envelopes and thresholds are used to programmatically and visually determine the validity of a given test run. Envelope and threshold exceedances are indicated with either red shading or red asterisks, and red text is placed to the right side of the plot indicating the type of exceedance. Such exceedances indicate either that the test was invalid or that the requirements of the test were not met (i.e., failure of the AEB system).

Examples of time history plots for each test type (including passing, failing and invalid runs) are shown in Figure D1 through Figure D9. Figures D1 through D6 show passing runs for each of the 6 test types. Figures D7 and D8 show examples of invalid runs. Figure D9 shows an example of a valid test that failed the CIB requirements.
