**NEW CAR ASSESSMENT PROGRAM  
CRASH IMMINENT BRAKING SYSTEM CONFIRMATION TEST  
NCAP-DRI-CIB-21-09**

**2021 Hyundai Santa Fe 2.5L FWD**

**16 April 2021**

**Final Report**

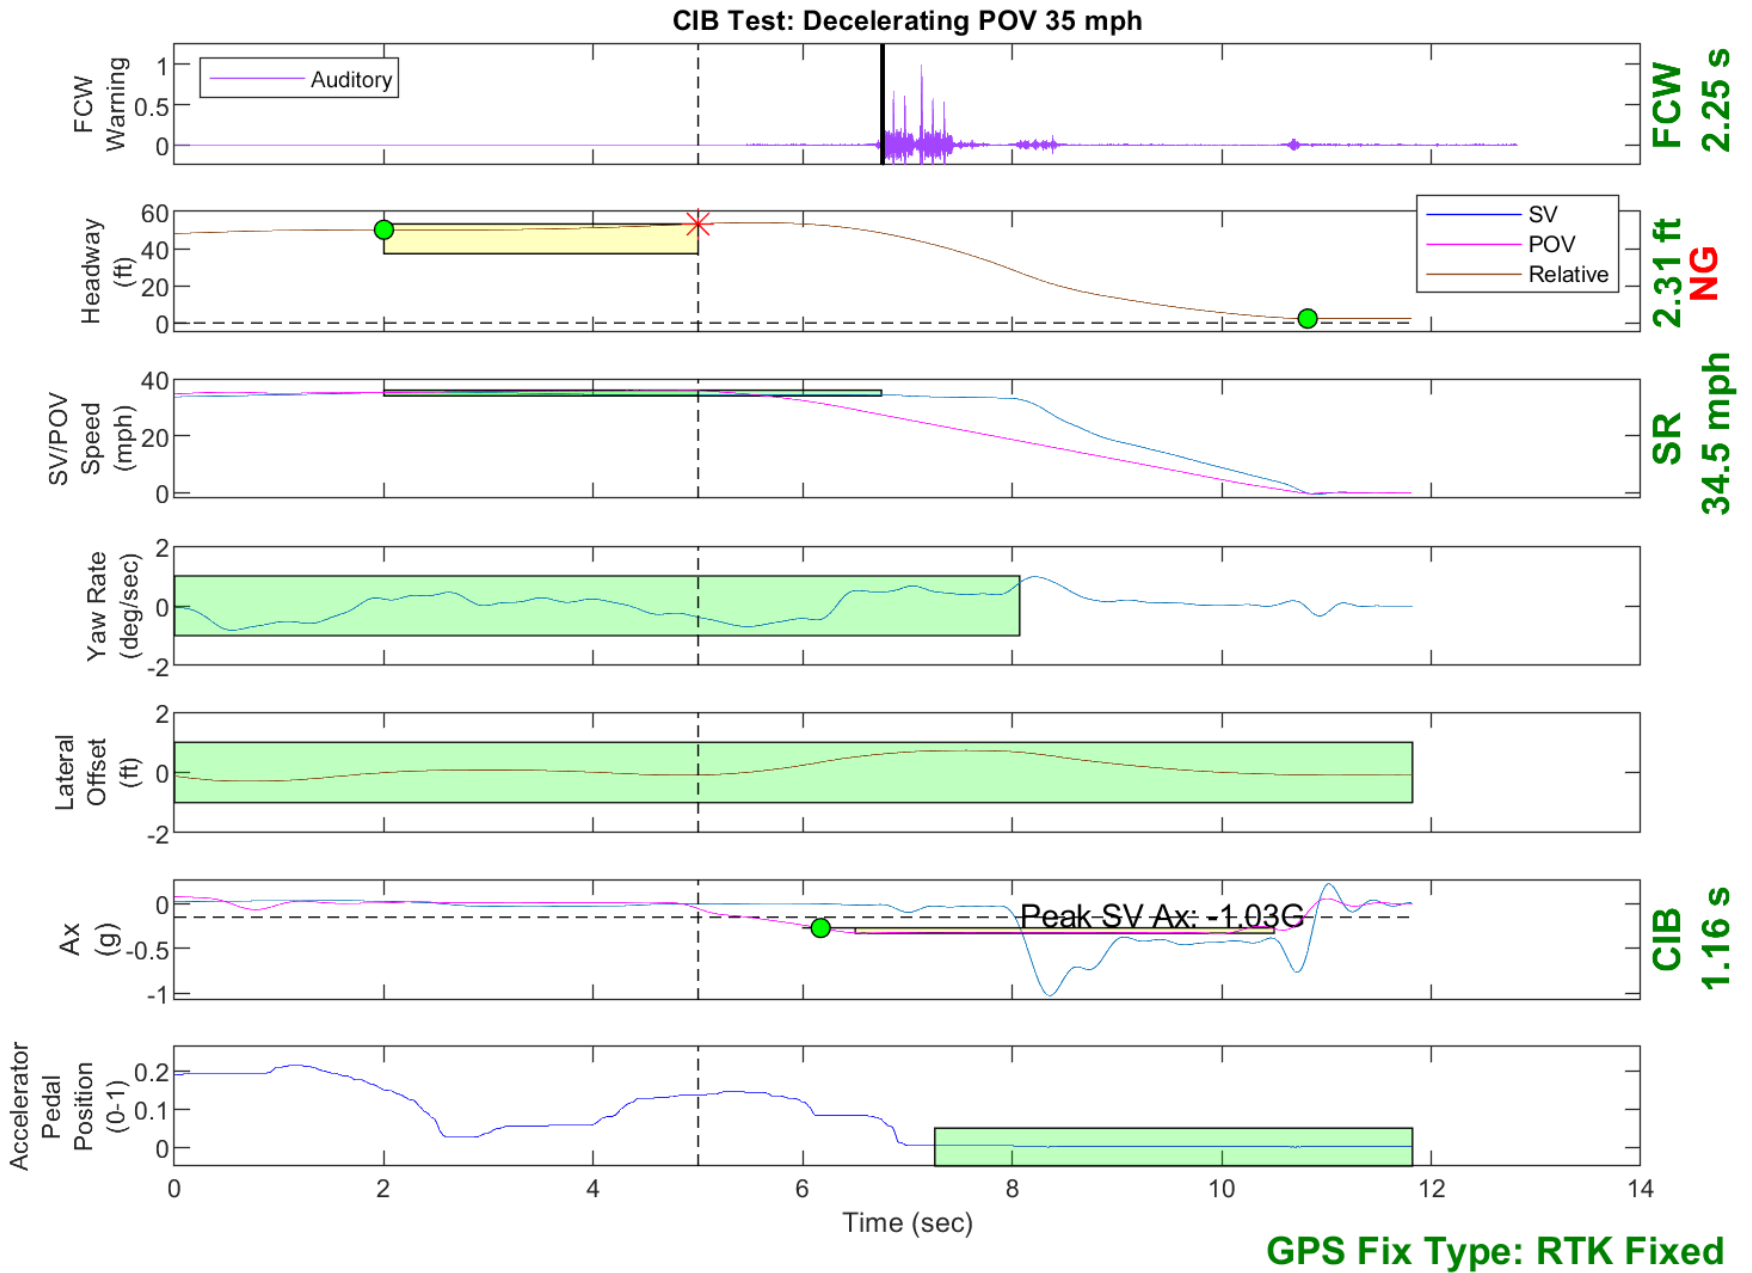
Figure D7. Example Time History Displaying Invalid Headway Criteria

Some of the time history plot figures contain either green or yellow envelopes and/or black threshold lines. These envelopes and thresholds are used to programmatically and visually determine the validity of a given test run. Envelope and threshold exceedances are indicated with either red shading or red asterisks, and red text is placed to the right side of the plot indicating the type of exceedance. Such exceedances indicate either that the test was invalid or that the requirements of the test were not met (i.e., failure of the AEB system).

Examples of time history plots for each test type (including passing, failing and invalid runs) are shown in Figure D1 through Figure D9. Figures D1 through D6 show passing runs for each of the 6 test types. Figures D7 and D8 show examples of invalid runs. Figure D9 shows an example of a valid test that failed the CIB requirements.

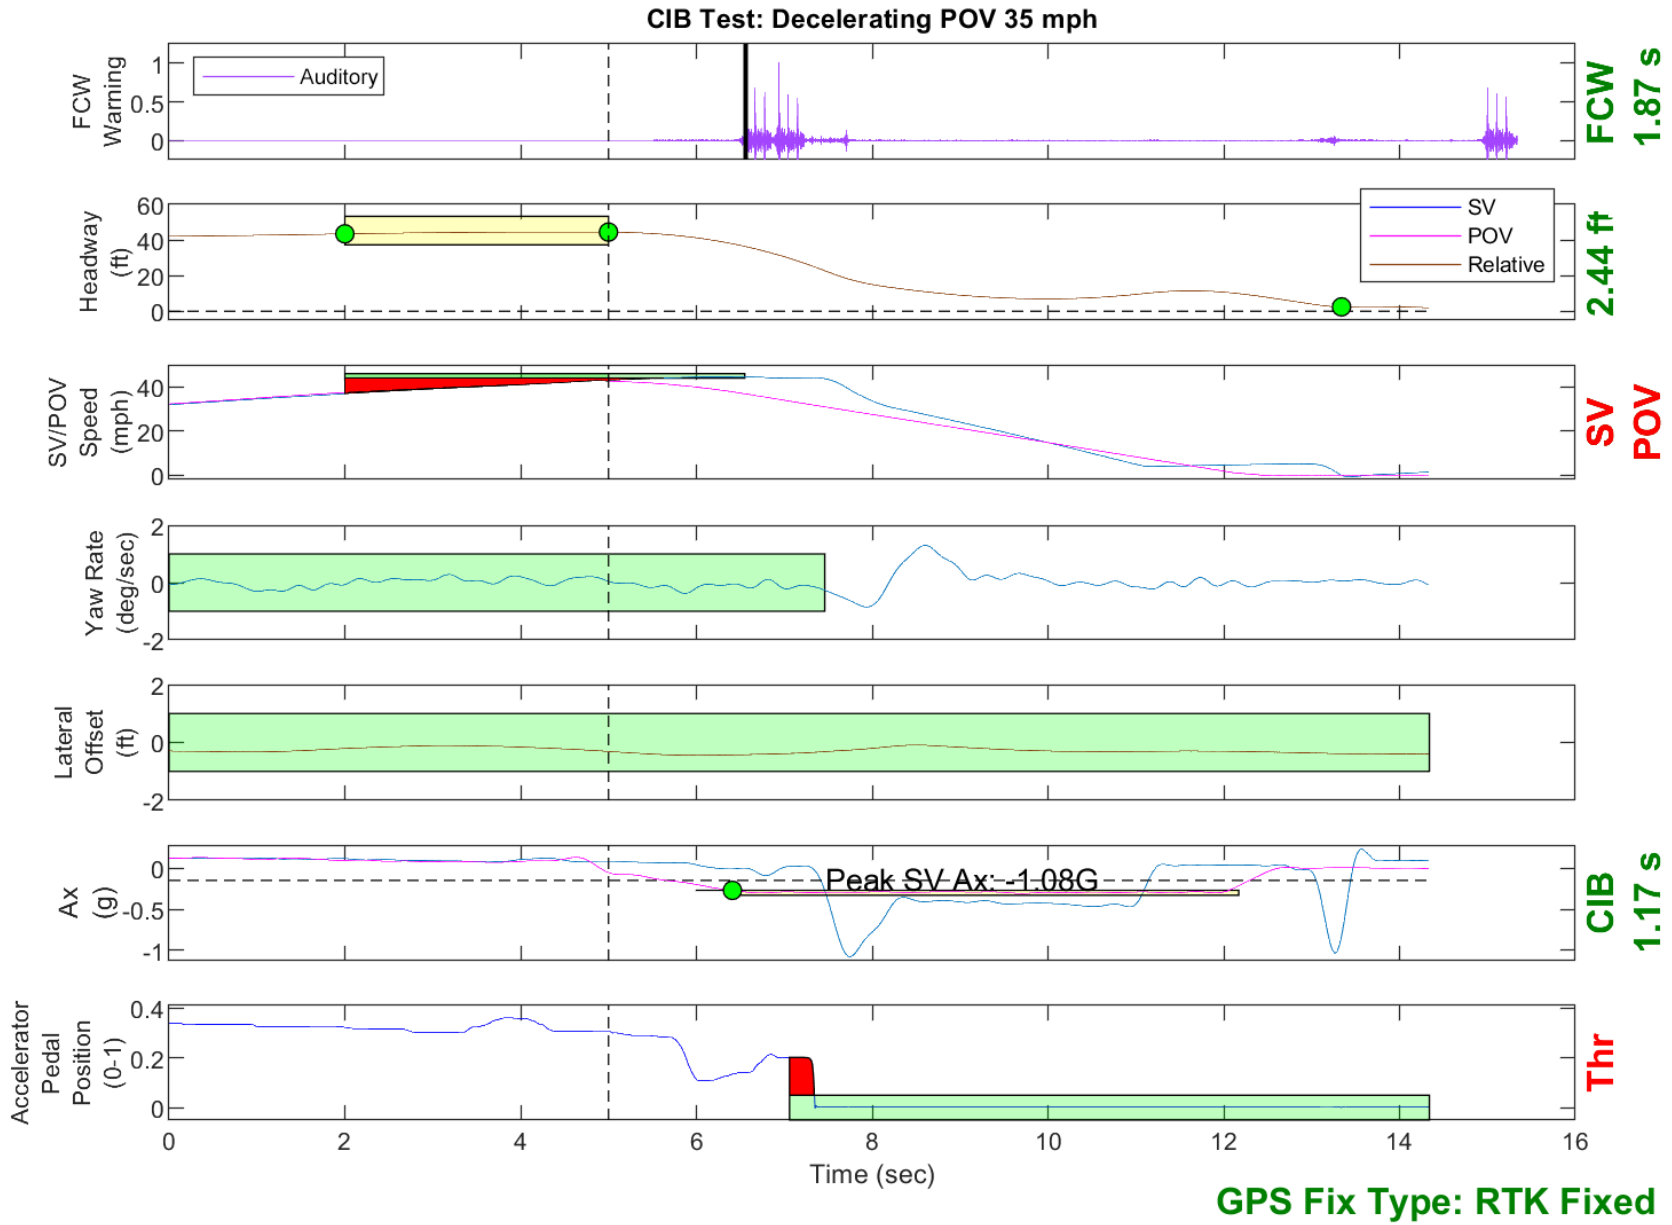
Figure D8. Example Time History Displaying Various Invalid Criteria

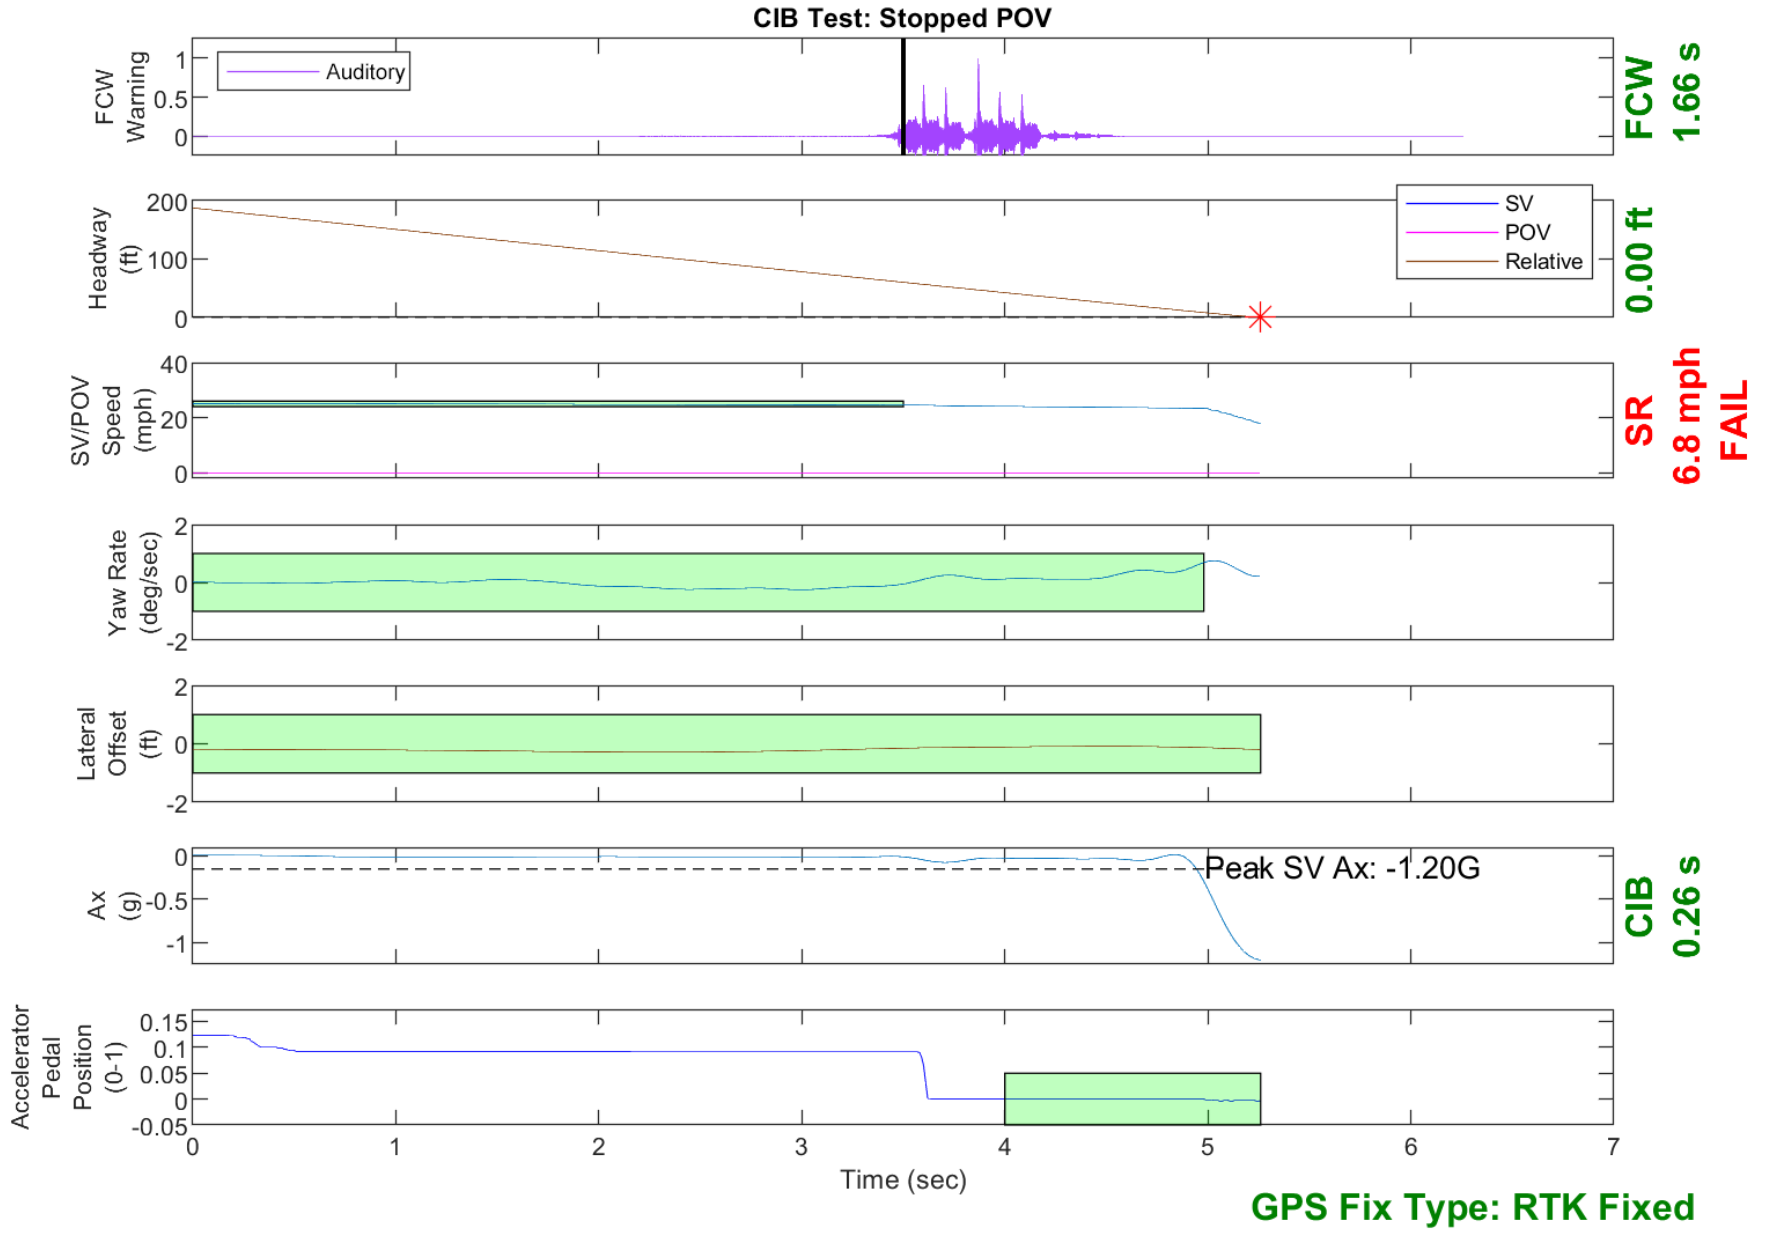
Figure D9. Example Time History for a Failed Run

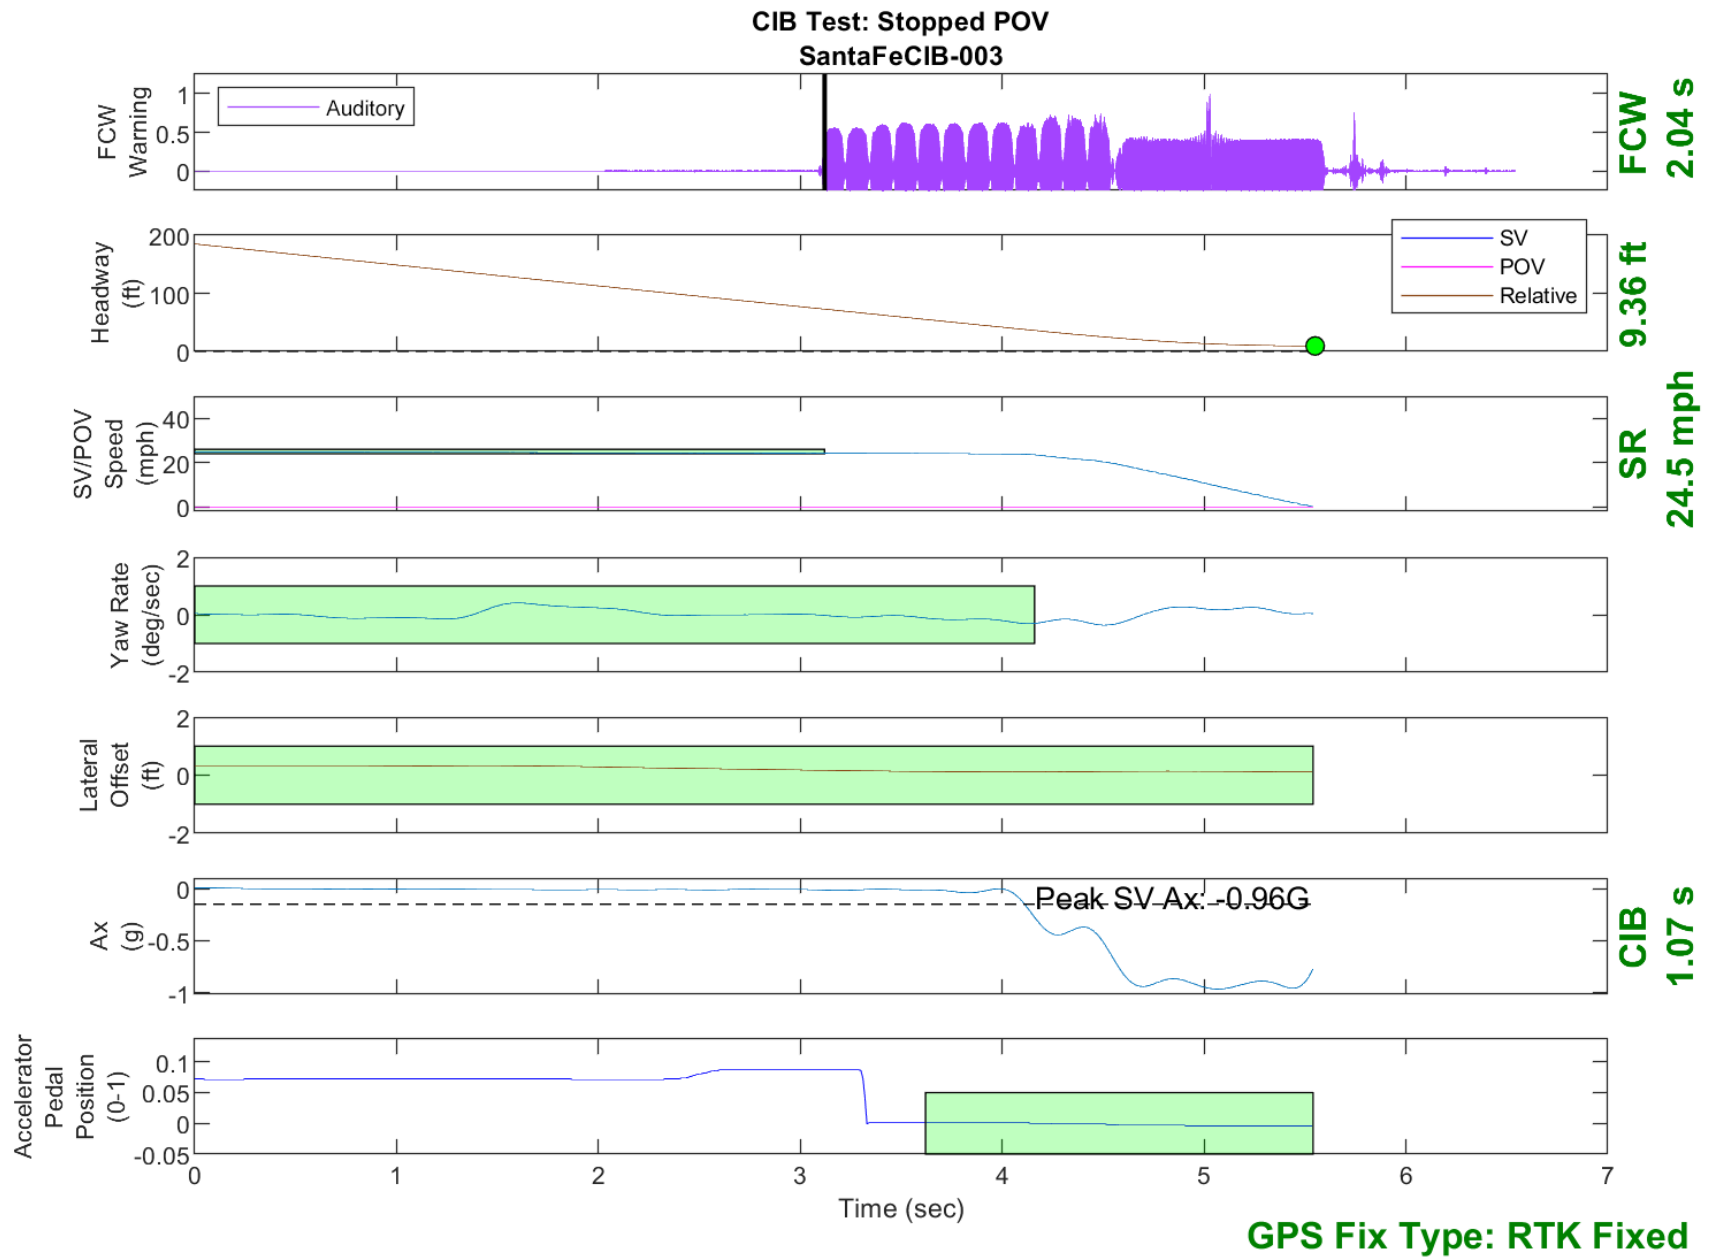
Figure D10. Time History for CIB Run 3, SV Encounters Stopped POV

Run	Test Type	Valid Run?	FCW TTC (s)	Min. Distance (ft)	Speed Reduction (mph)	Peak Decel. (g)	CIB TTC (s)	Pass/Fail	Notes
1	Static Run								Zero SV front bumper to SSV rear bumper and collect data
2	<b>Stopped POV</b>	N							Throttle
3		Y	2.04	9.36	24.5	0.96	1.07	Pass	
4		Y	1.99	9.77	24.5	1.05	1.11	Pass	
5		Y	2.07	9.66	24.8	0.96	1.10	Pass	
6		Y	2.01	8.94	24.5	1.00	1.08	Pass	
7		Y	2.03	9.85	24.2	0.99	1.08	Pass	
8		Y	2.08	9.82	24.8	1.00	1.09	Pass	
9		Y	2.07	9.86	25.5	1.06	1.11	Pass	
10	Static Run								
11	<b>Slower POV, 25 vs 10</b>	Y	1.81	9.30	14.8	0.97	0.88	Pass	
12		Y	1.79	9.45	13.9	0.97	0.90	Pass	
13		Y	1.80	10.55	14.8	0.91	0.94	Pass	
14		Y	1.78	10.30	14.3	0.95	0.93	Pass	
15		Y	1.82	9.25	15.1	0.98	0.88	Pass	
16		Y	1.80	9.77	15.7	1.02	0.91	Pass

Time history data plots for the tests of the vehicle under consideration herein are provided beginning with Figure D10.

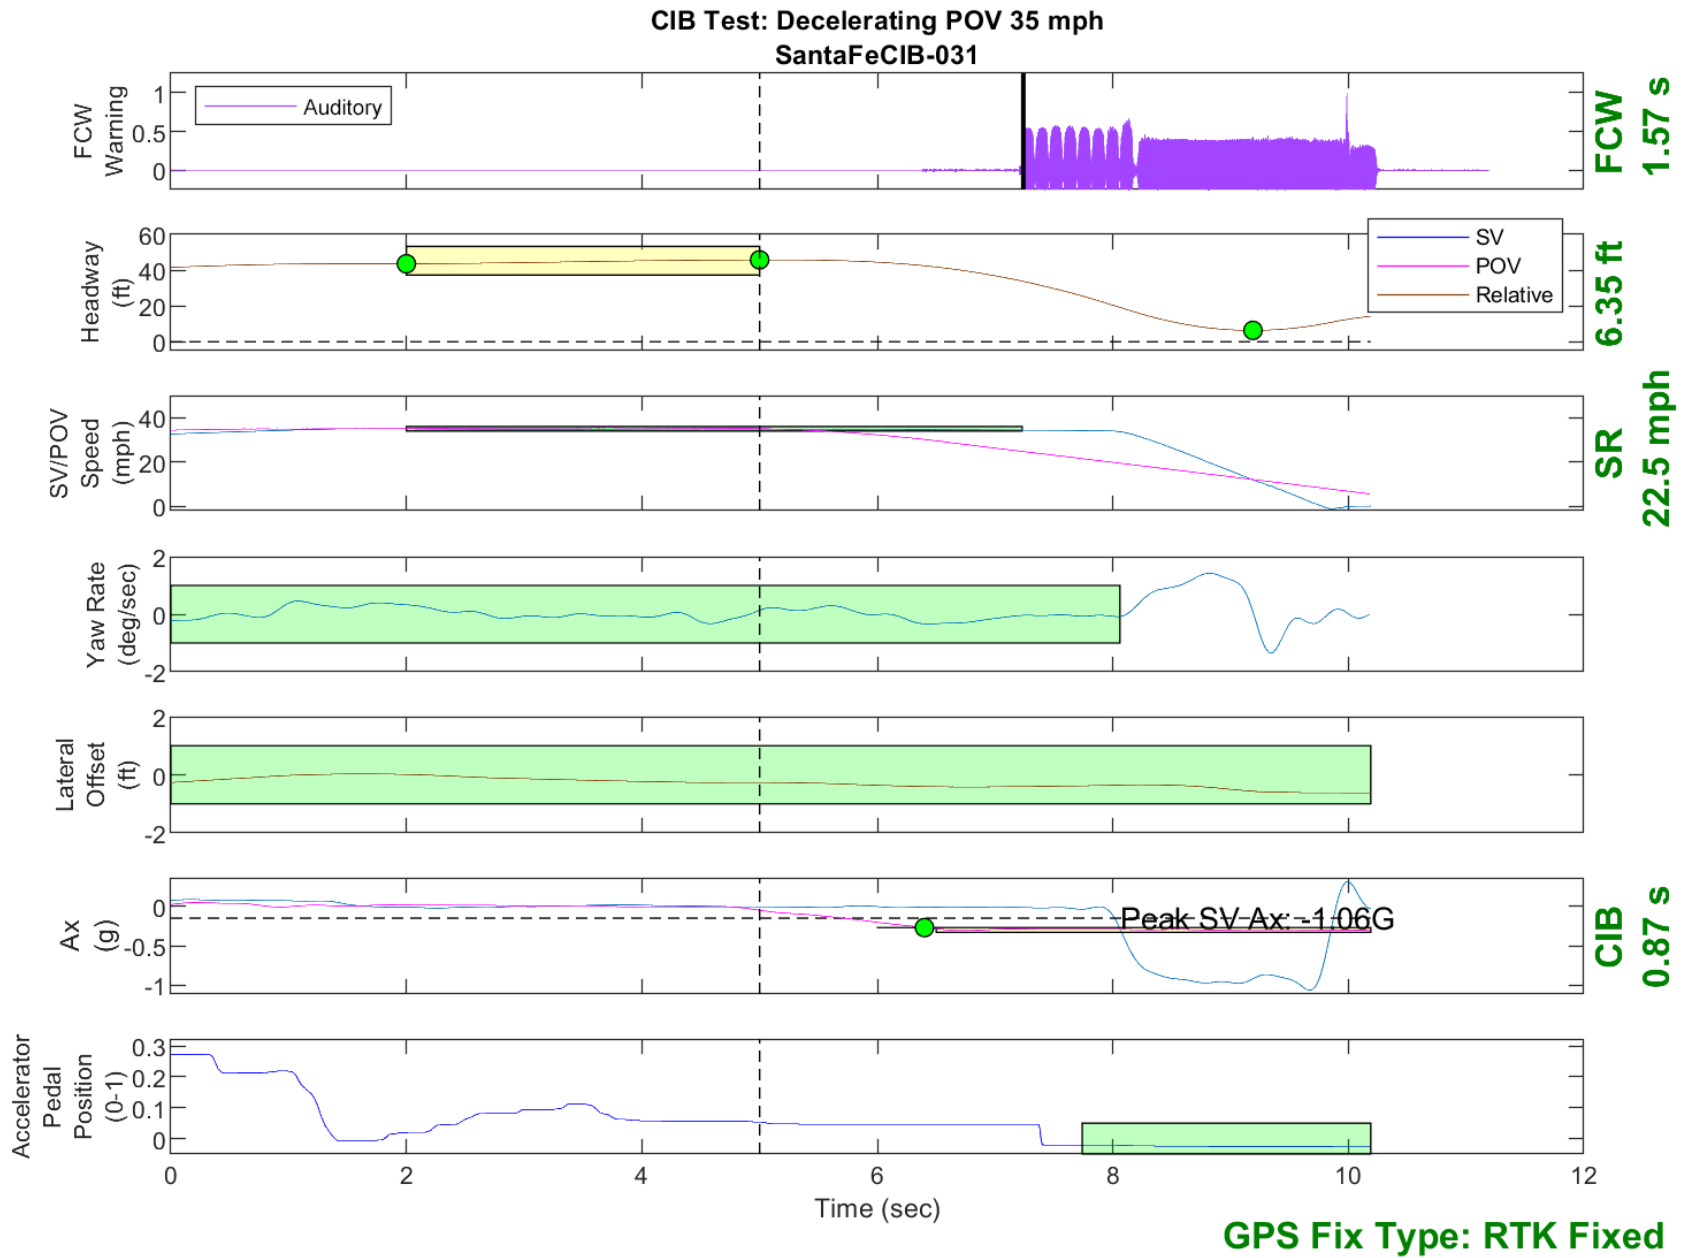
Figure D31. Time History for CIB Run 31, SV Encounters Decelerating POV, SV 35 mph, POV 35 mph

The SV ignition was cycled prior to each test run. For this test scenario, both the POV and SV were driven at a constant 35.0 mph (56.3 km/h) in the center of the lane, with a headway of 45.3 ft (13.8 m) ± 8 ft (2.4 m). Once these conditions were met, the POV tow vehicle brakes were applied to achieve  $0.3 \pm 0.03$  g of deceleration. The test concluded when either:

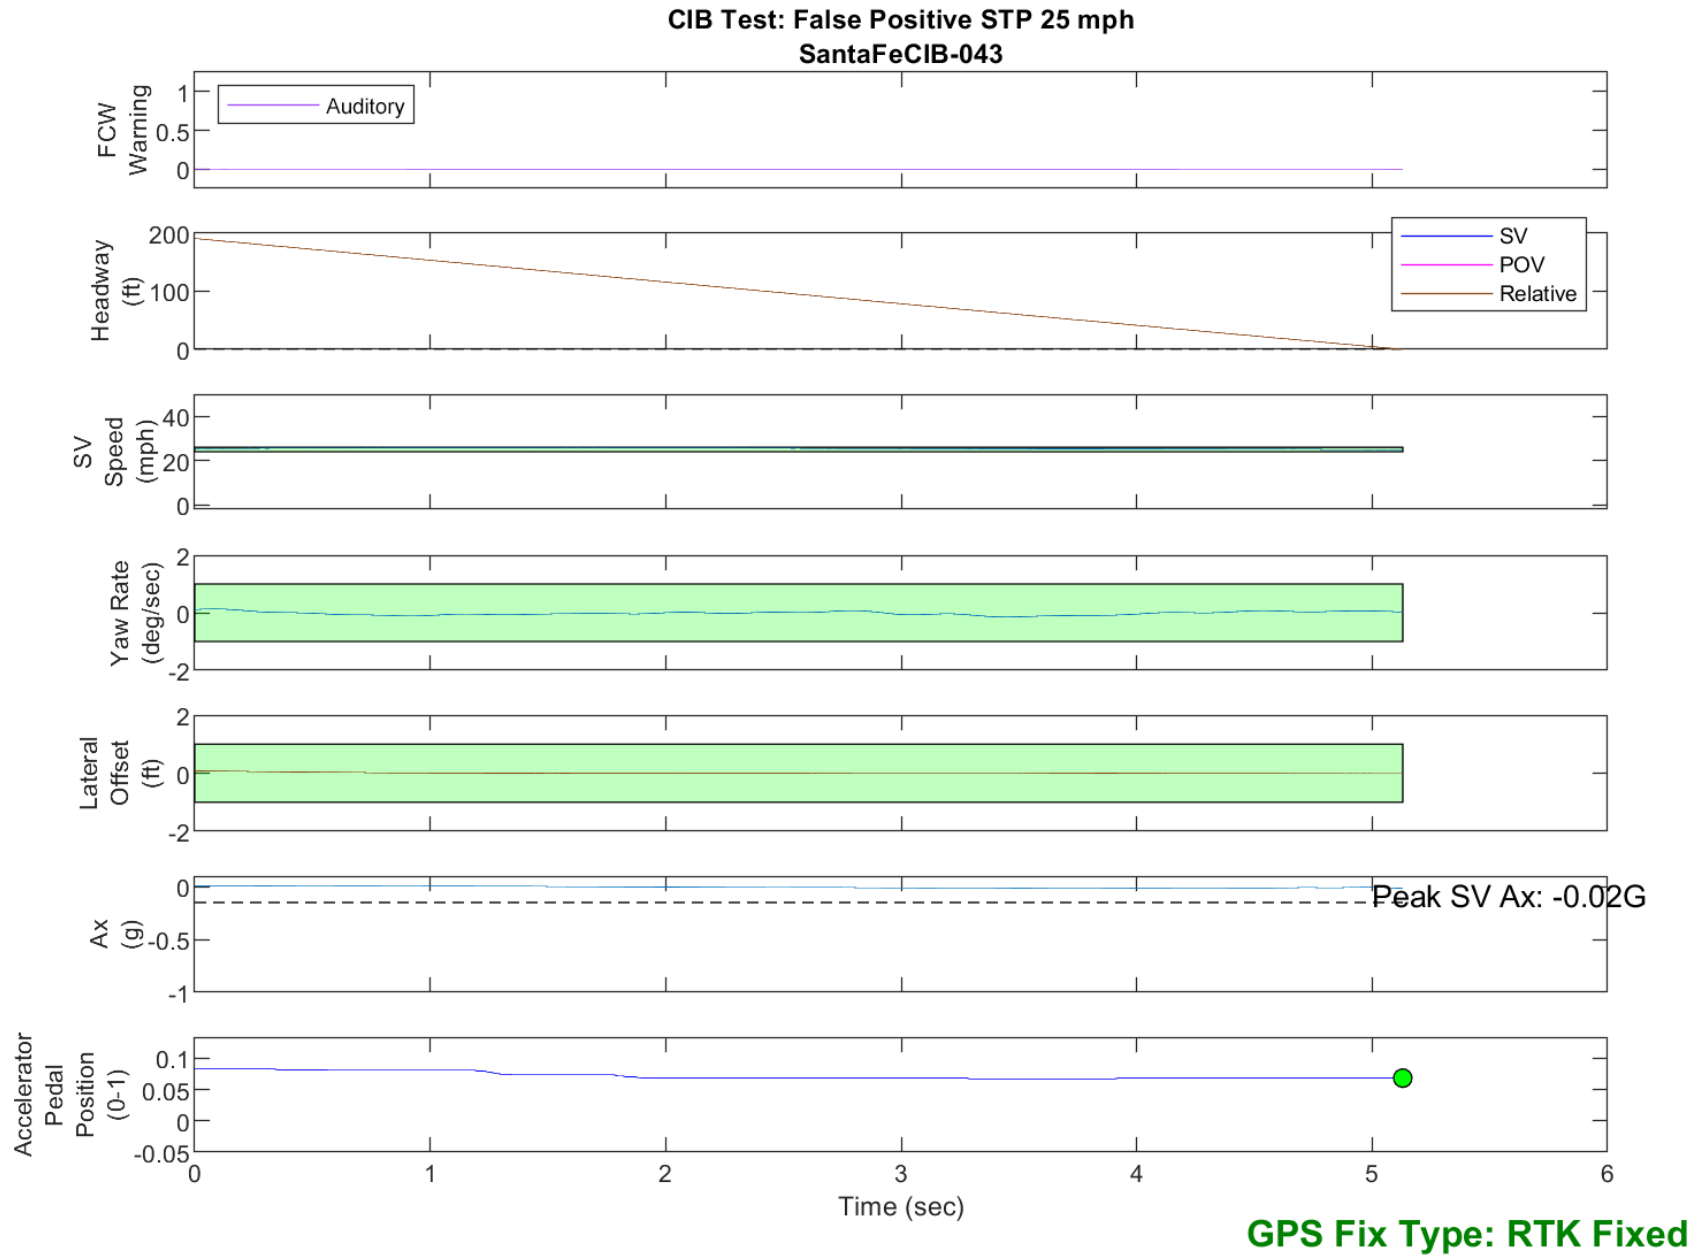
Figure D38. Time History for CIB Run 43, SV Encounters Steel Trench Plate, SV 25 mph

The false positive suppression test series evaluates the ability of a CIB system to differentiate a steel trench plate (STP) from an object presenting a genuine safety risk to the SV. Although the STP is large and metallic, it is designed to be driven over without risk of injury to the driver or damage to the SV. Therefore, in this scenario, the automatic braking available from CIB is not necessary and should be suppressed. The test condition is nearly equivalent to that previously defined for Test 1, the stopped POV condition, but with an STP in the SV forward path in lieu of a POV.
