**NEW CAR ASSESSMENT PROGRAM  
LANE DEPARTURE WARNING CONFIRMATION TEST  
NCAP-DRI-LDW-21-05**

**2021 Ford Bronco Sport Badlands 4x4**

**DYNAMIC RESEARCH, INC.**

**Final Report**

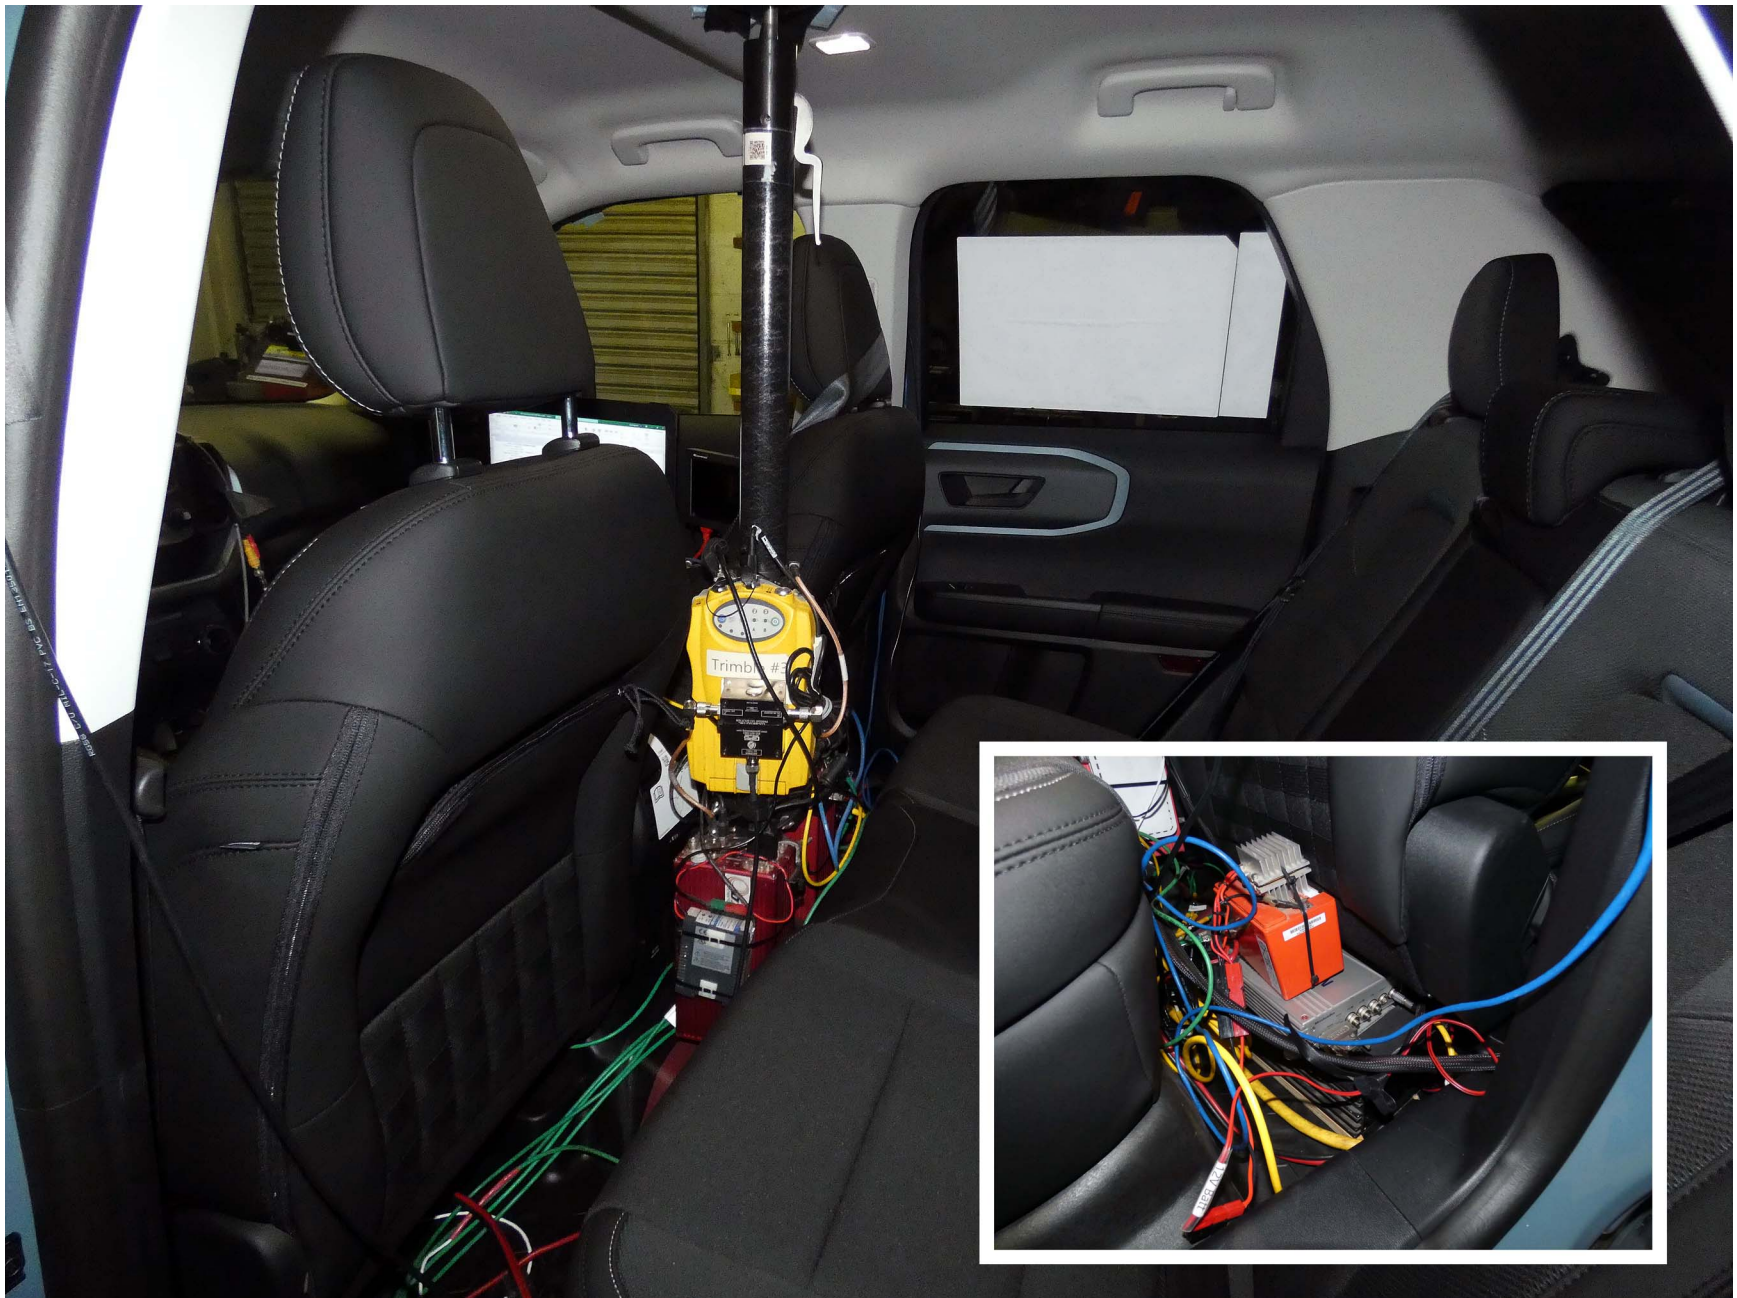
Figure A6. DGPS, Inertial Measurement Unit, and MicroAutoBox Installed in Subject Vehicle

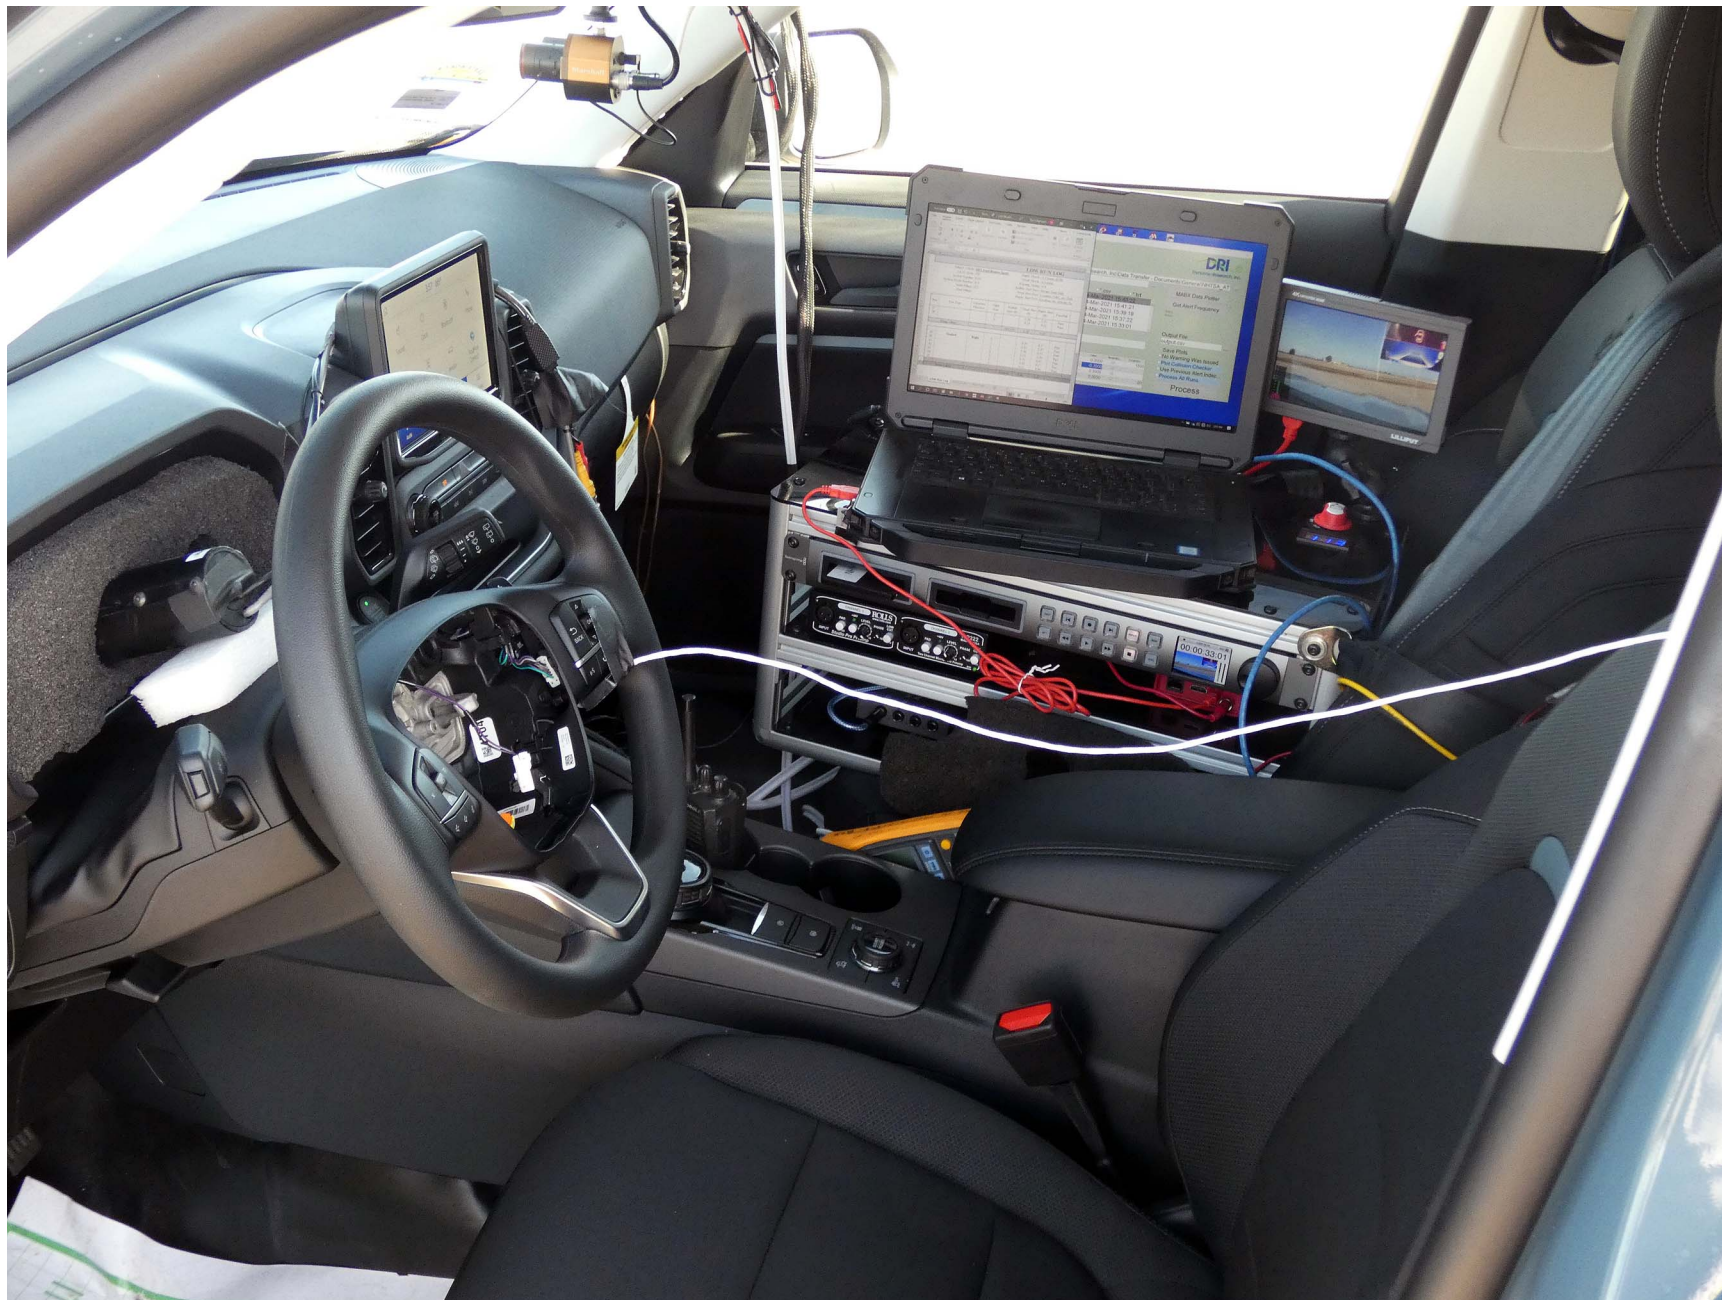
Figure A8. Computer Installed in Subject Vehicle

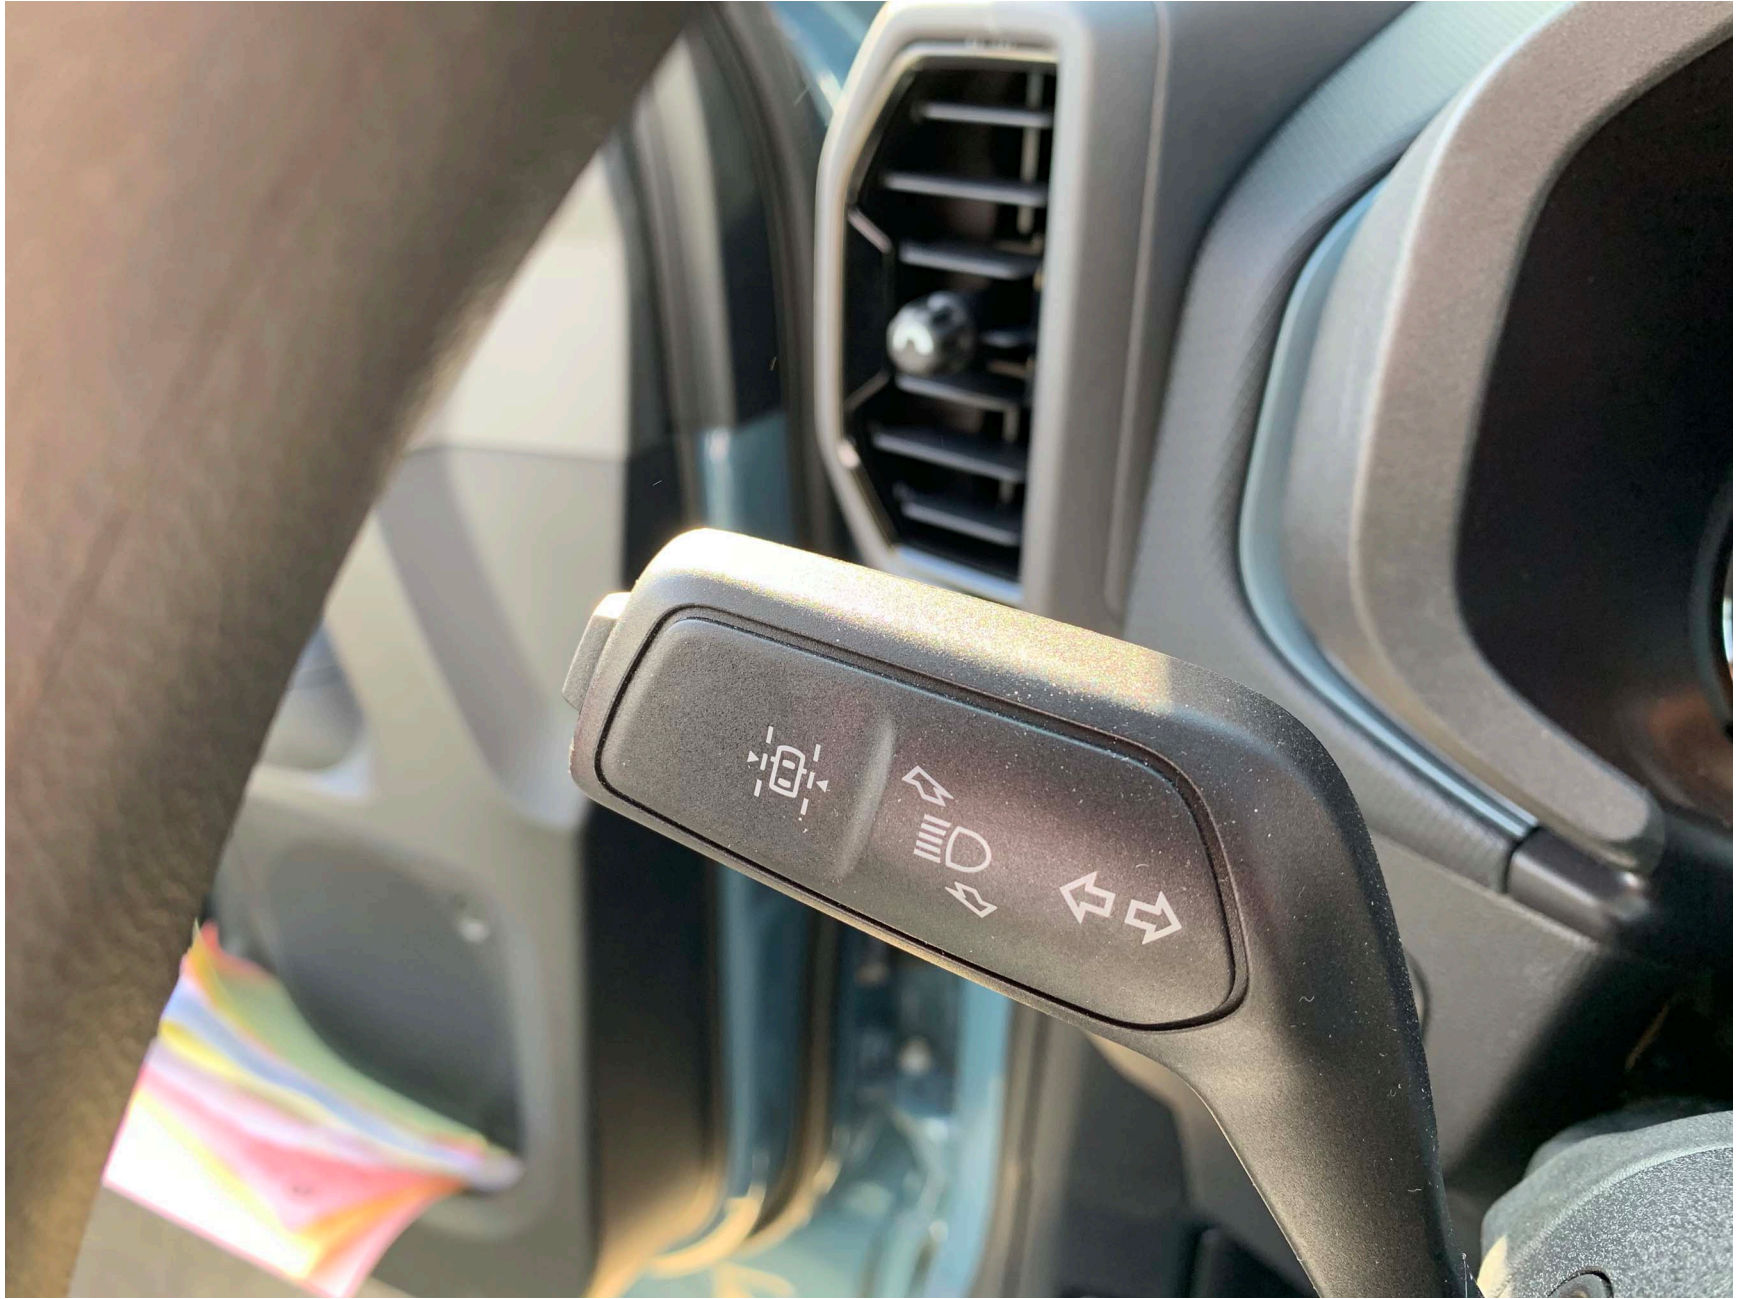
Figure A10. LDW On/Off Switch

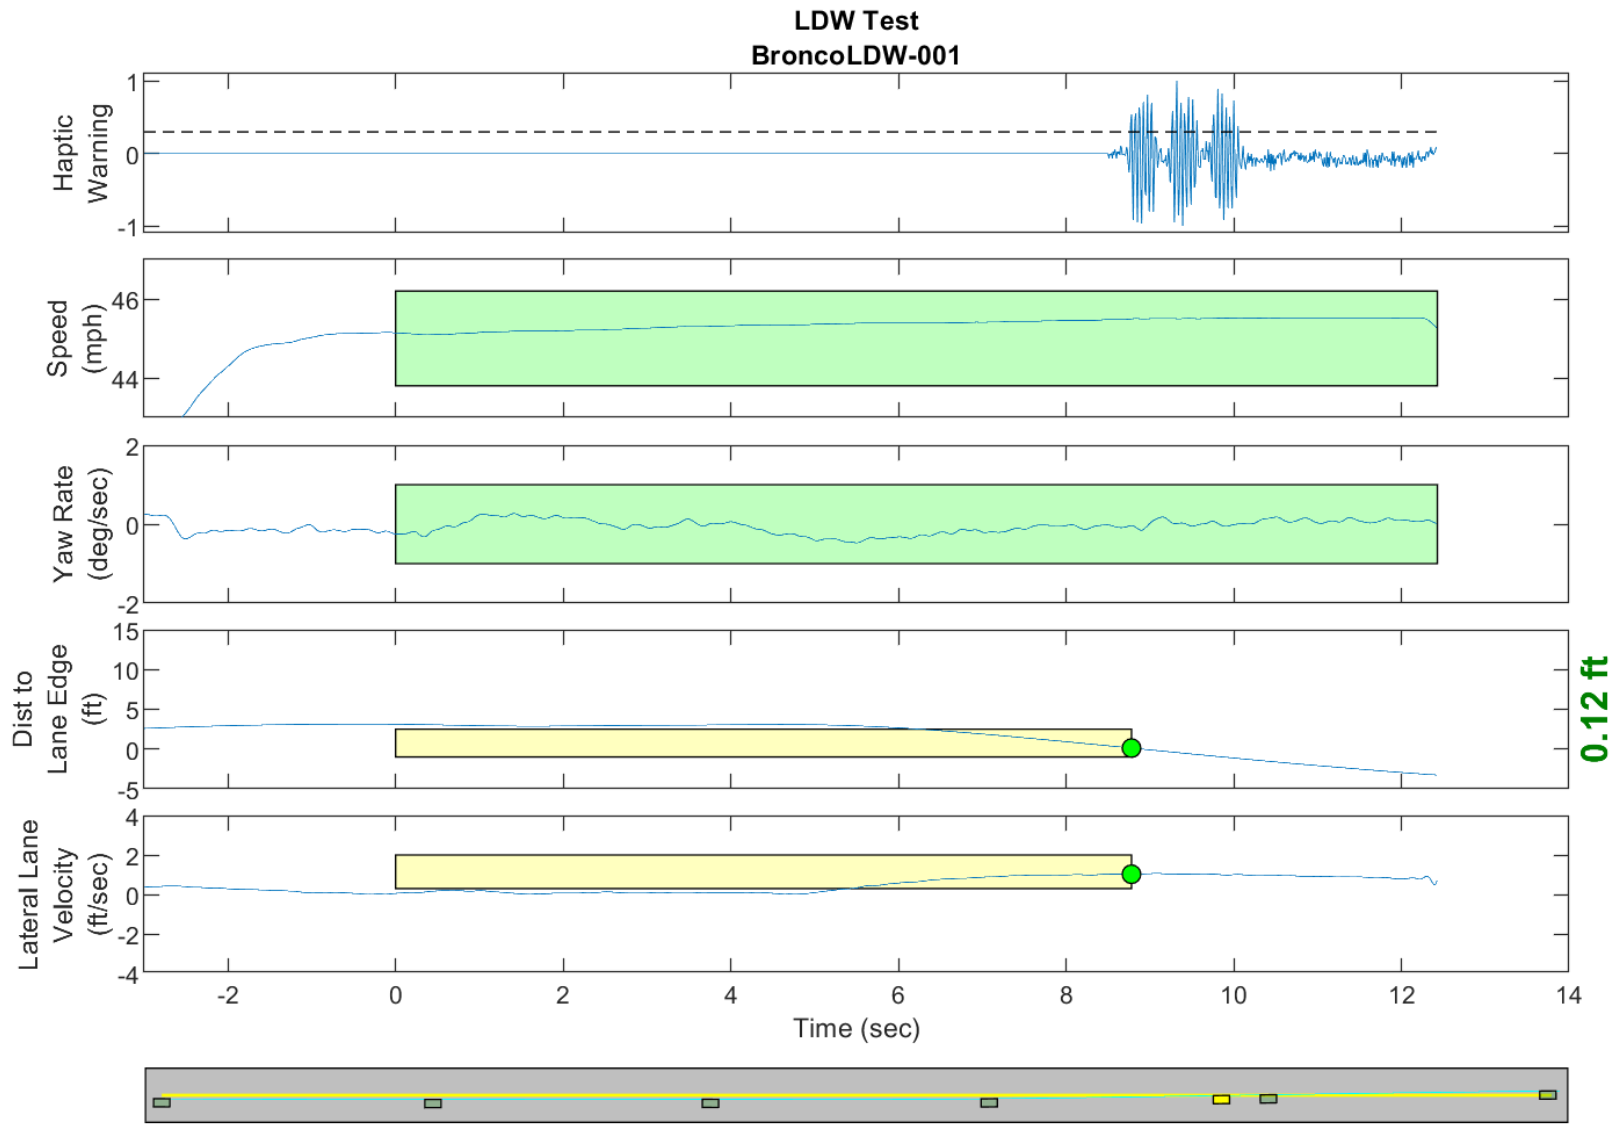
Figure D4. Time History for Run 01, Solid Line, Left Departure, Haptic Warning
