**NEW CAR ASSESSMENT PROGRAM
LANE DEPARTURE WARNING CONFIRMATION TEST
NCAP-DRI-LDW-21-01**

2021 Buick Envision Preferred AWD

DYNAMIC RESEARCH, INC.

Final Report

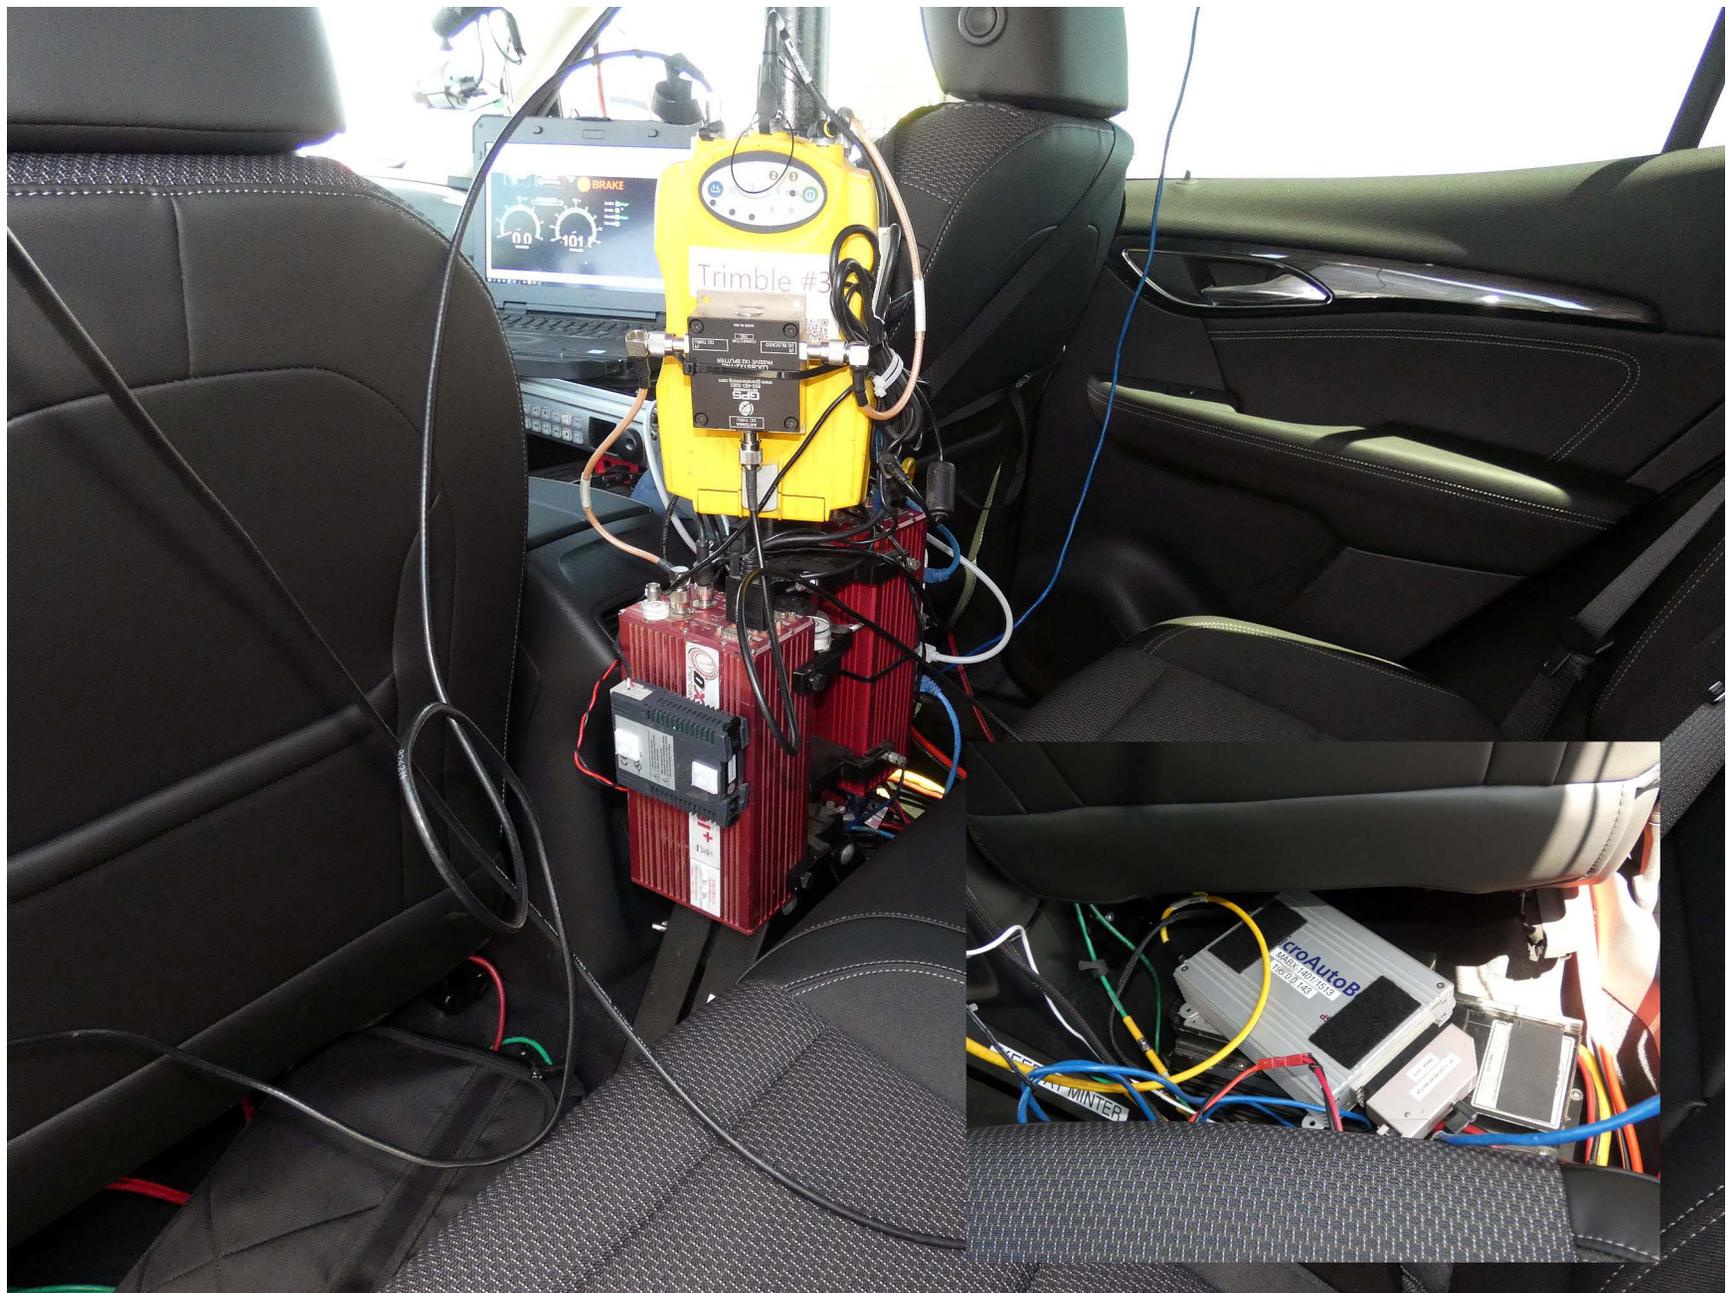
Figure A6. DGPS, Inertial Measurement Unit, and MicroAutoBox Installed in Subject Vehicle

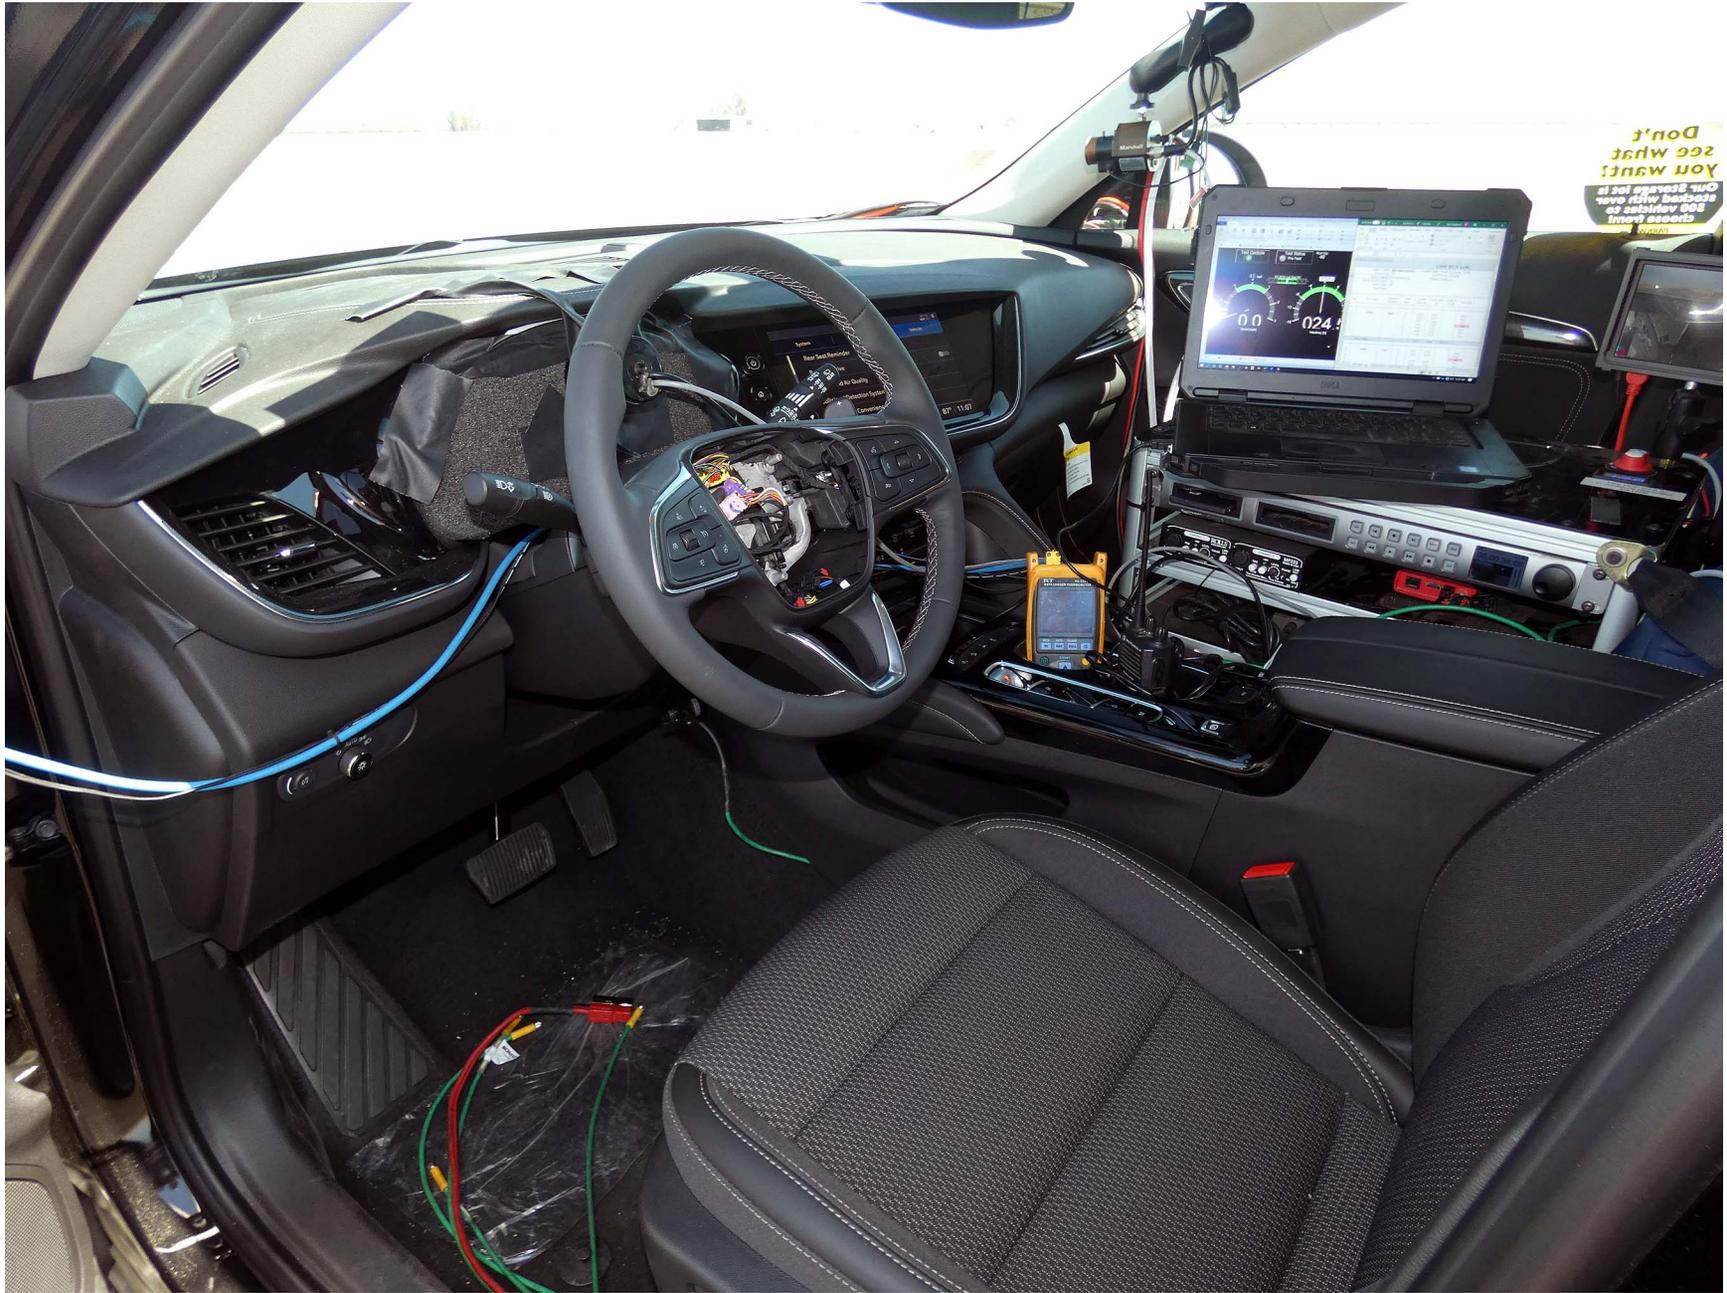
Figure A8. Computer Installed in Subject Vehicle

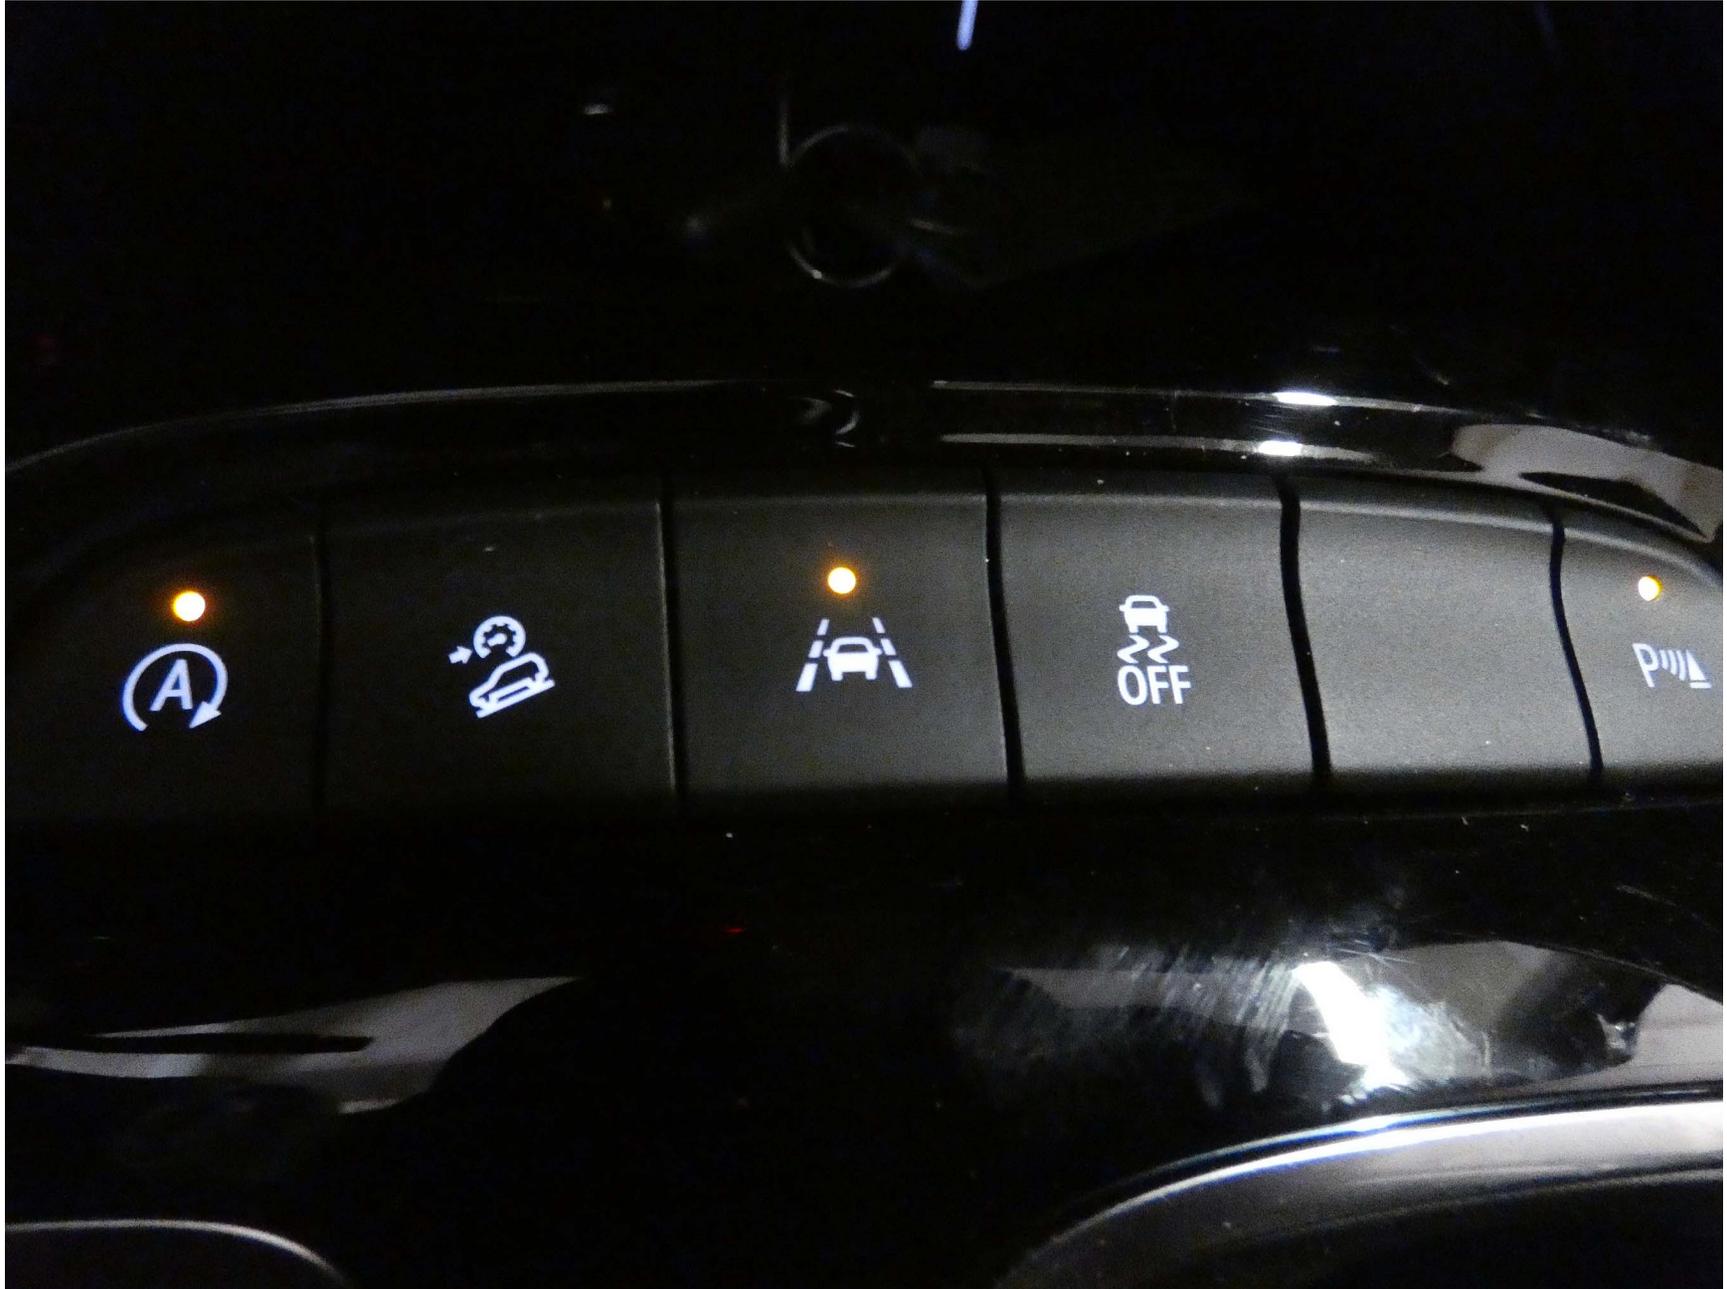
Figure A9. LDW On/Off Switch

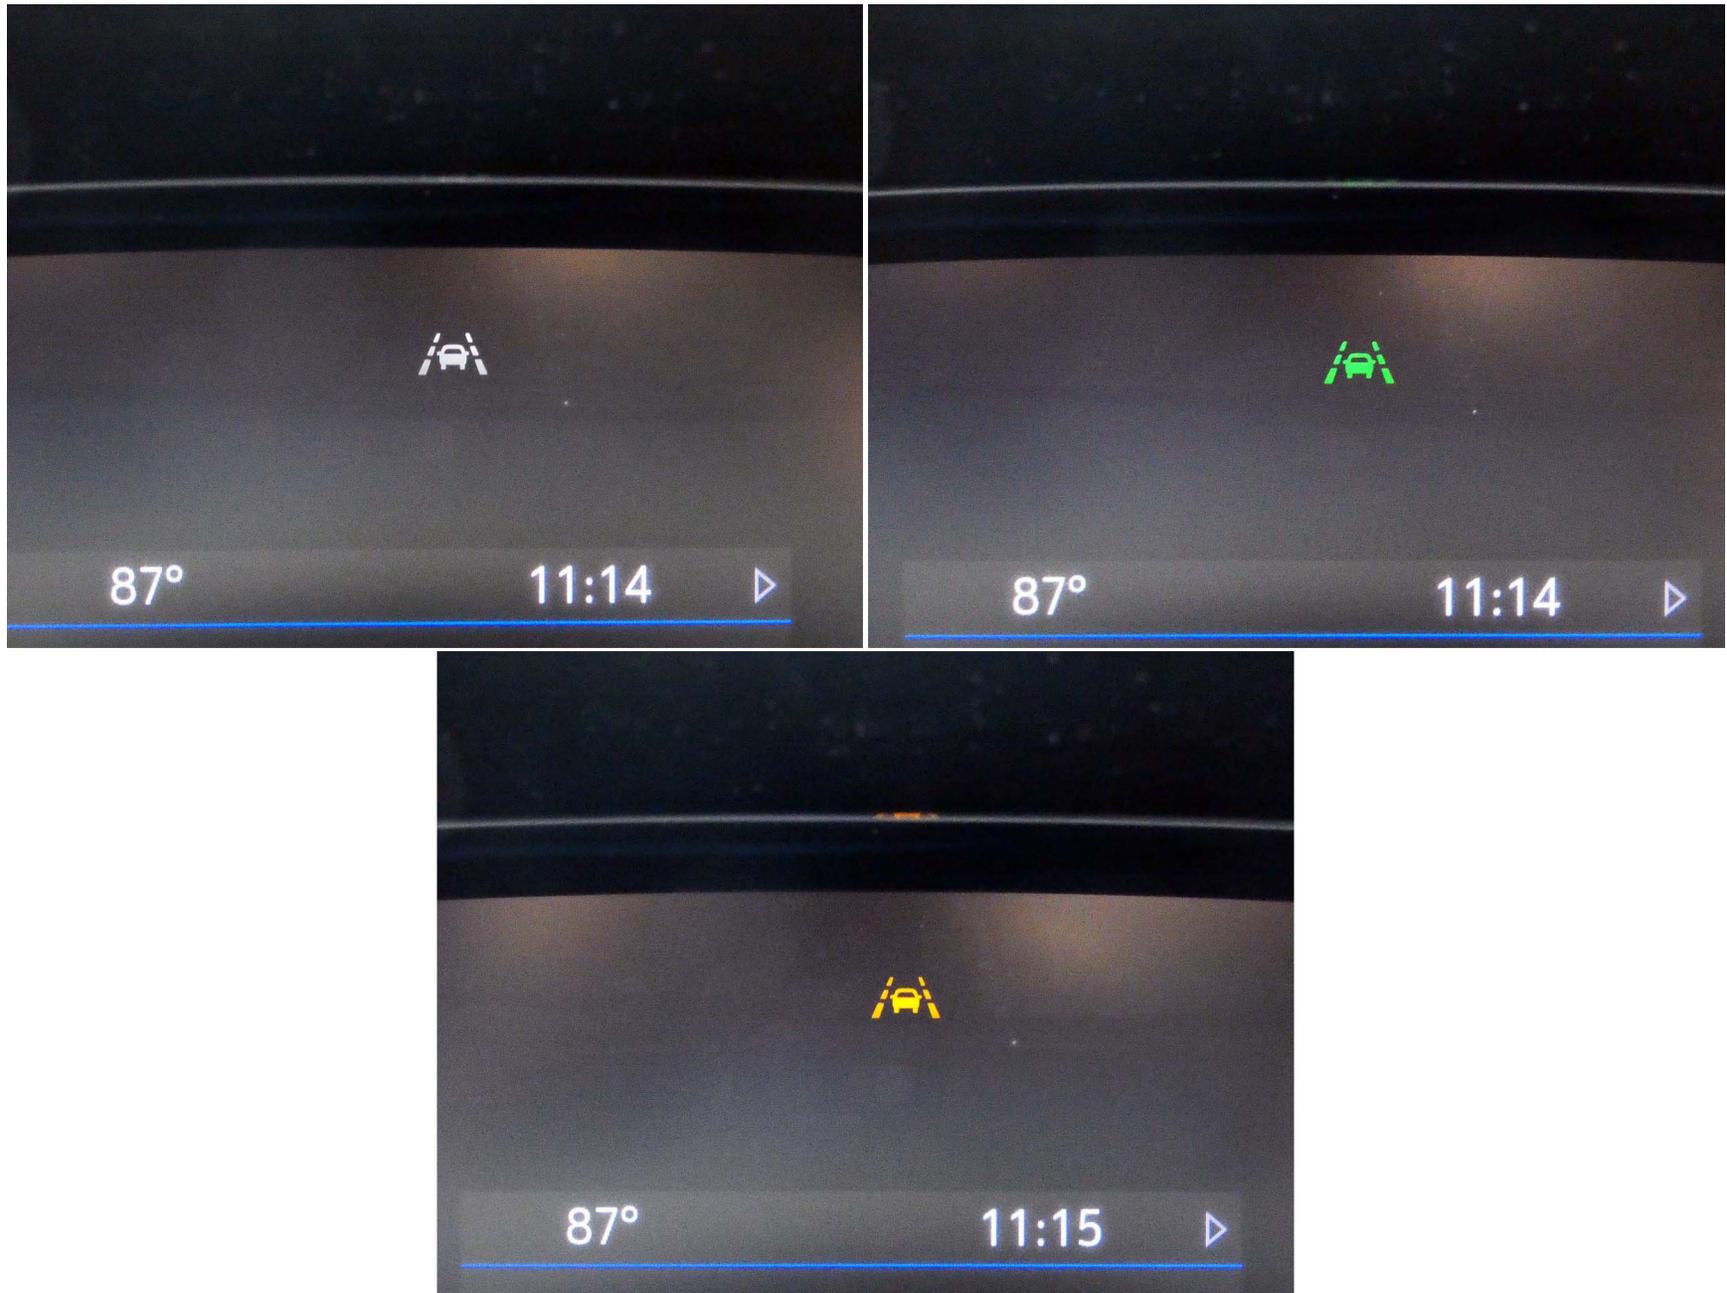
Figure A10. LDW Status Indicator/Visual Alert

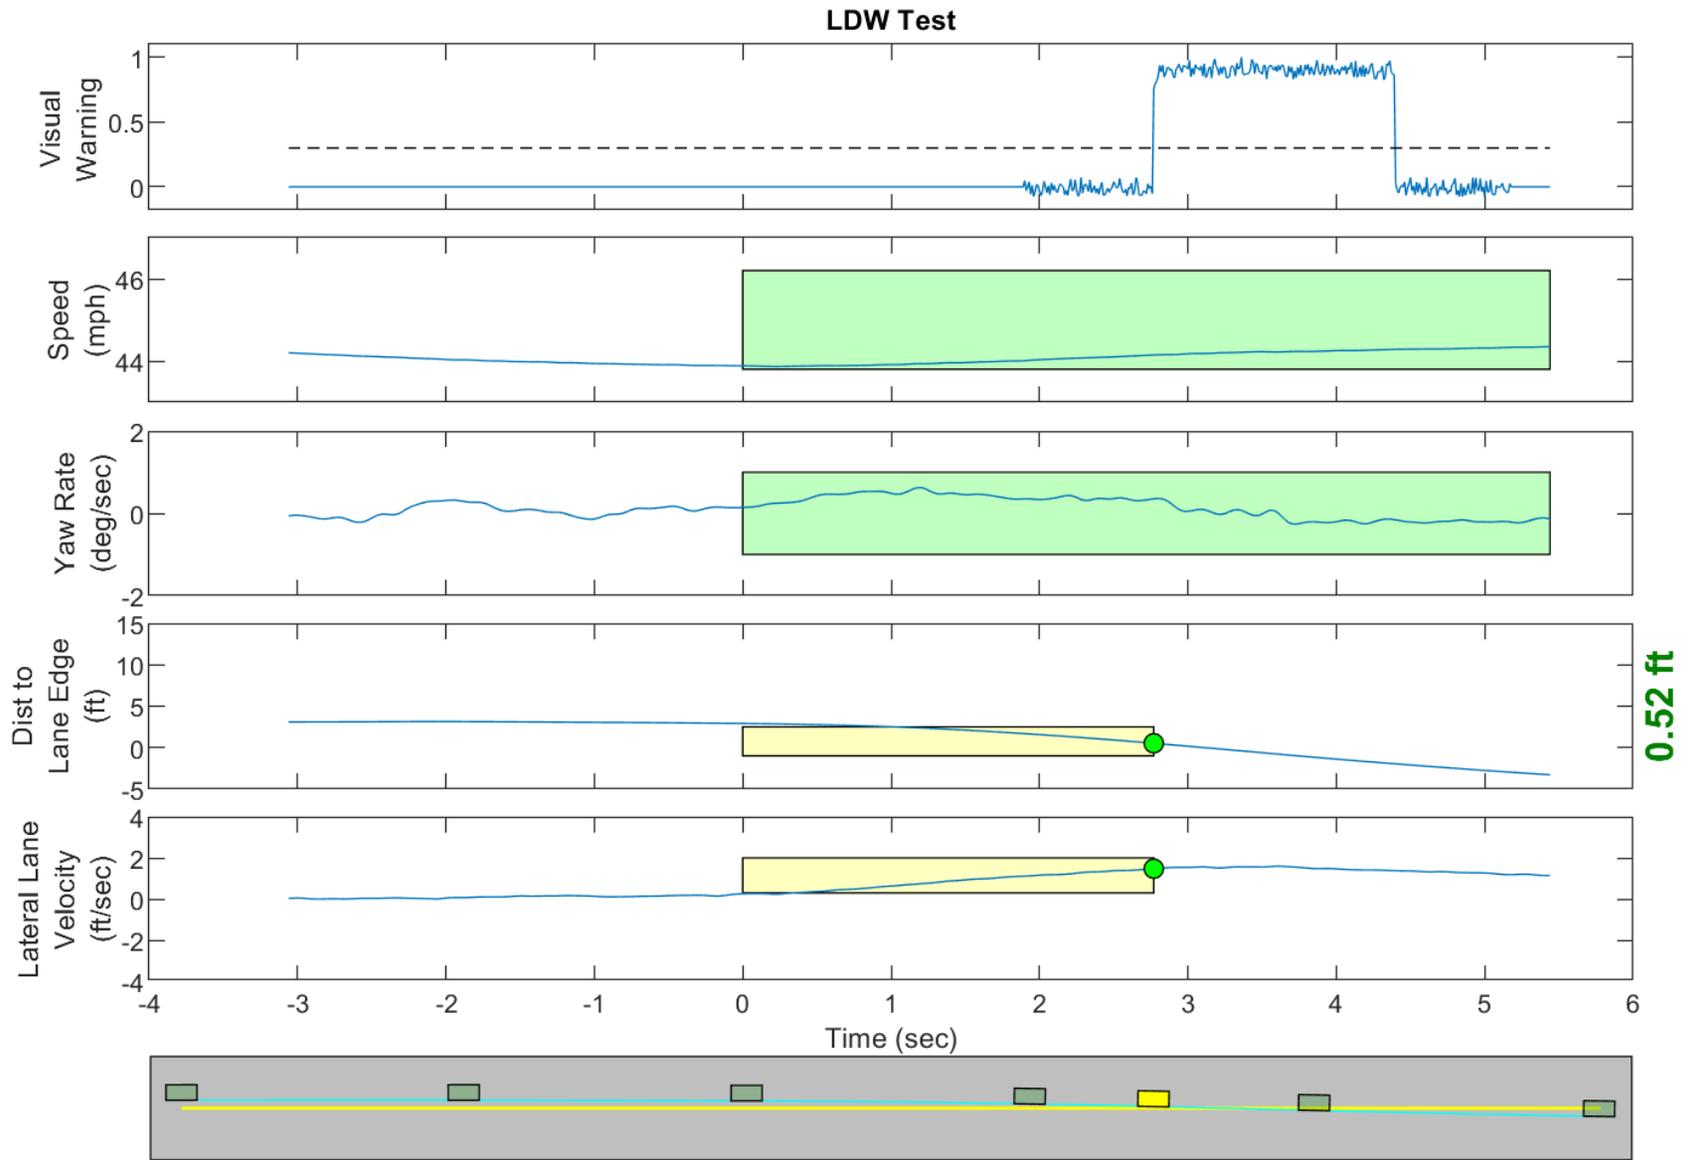
GPS Fix Type: RTK Fixed

Figure D1. Example Time History for Lane Departure Warning Test, Passing

A set of time history plots is provided for each valid run in the test series. Each set of plots comprises time varying data from the Subject Vehicle, as well as pass/fail envelopes and thresholds. The following is a description of data types shown in the time history plots, as well as a description of the color code for data envelopes.

Examples of time history plots (including passing, failing and invalid runs) are shown in Figure D1 through Figure D3. Actual time history data plots for the vehicle under consideration are provided subsequently.

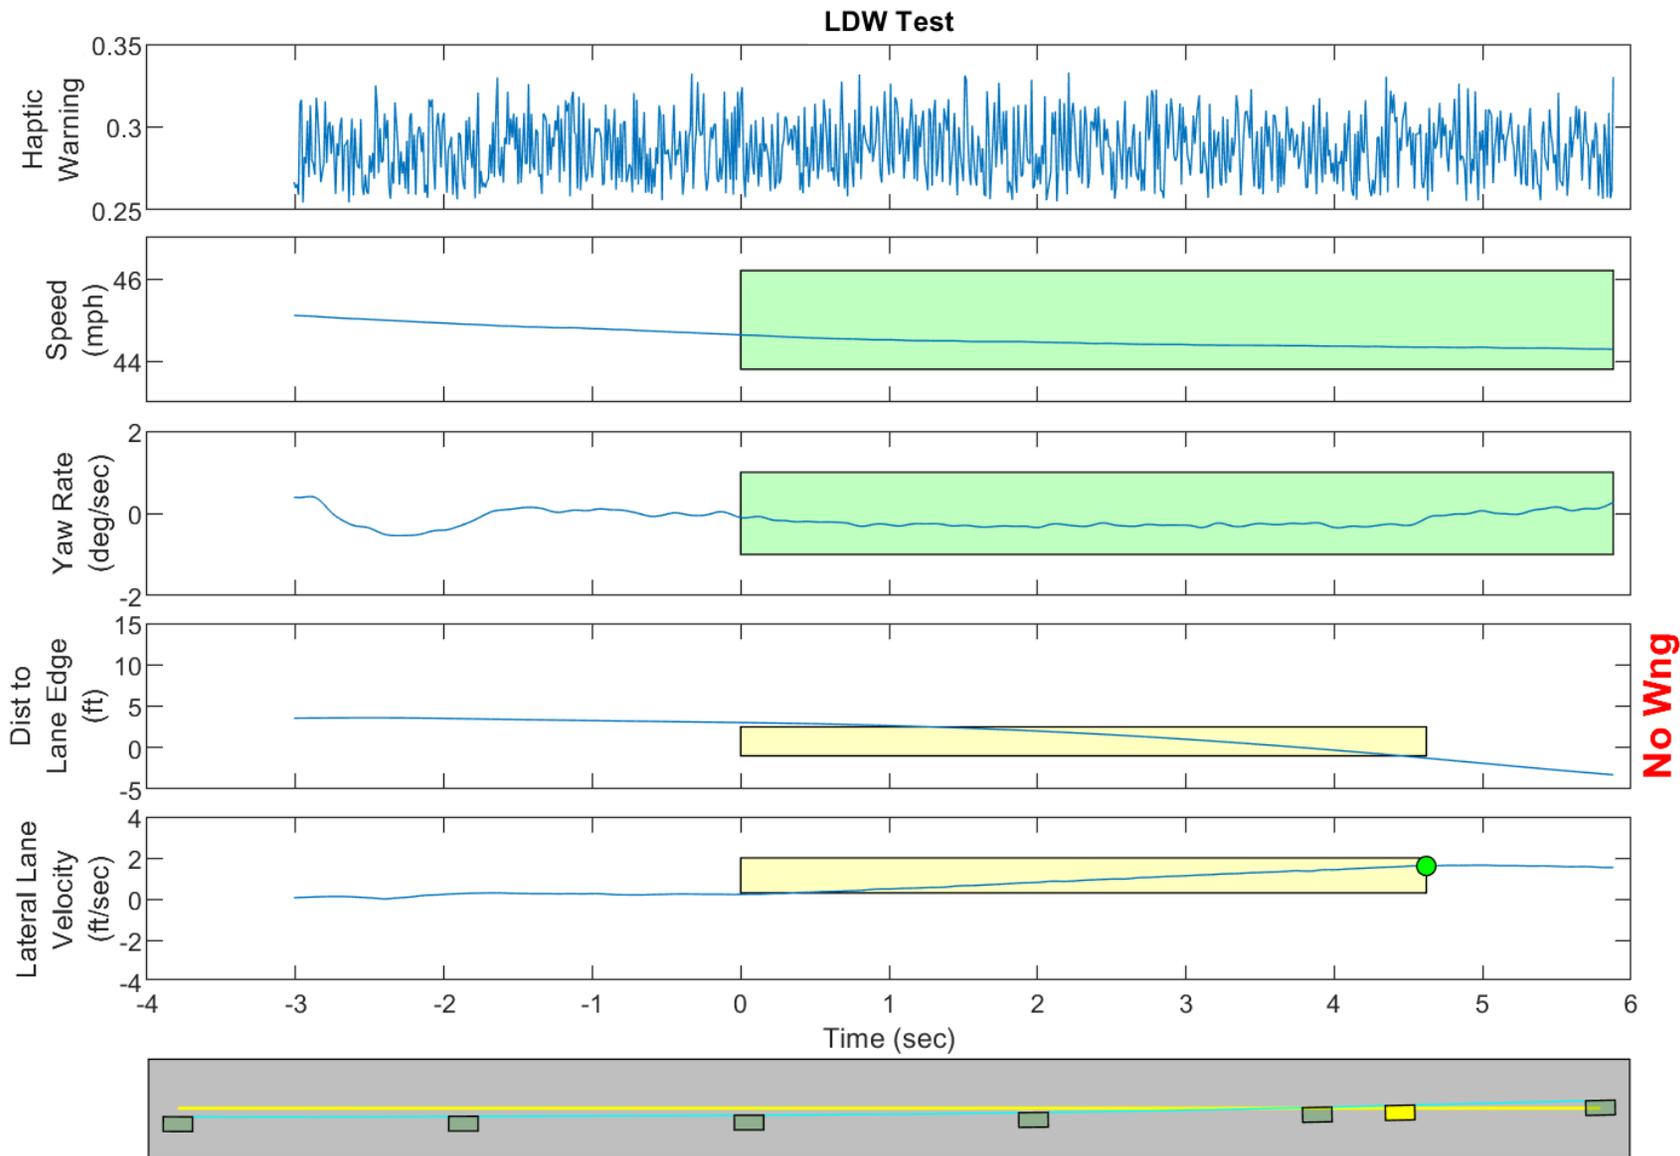
Figure D2. Example Time History for Lane Departure Warning Test, Failing, No Warning Issued

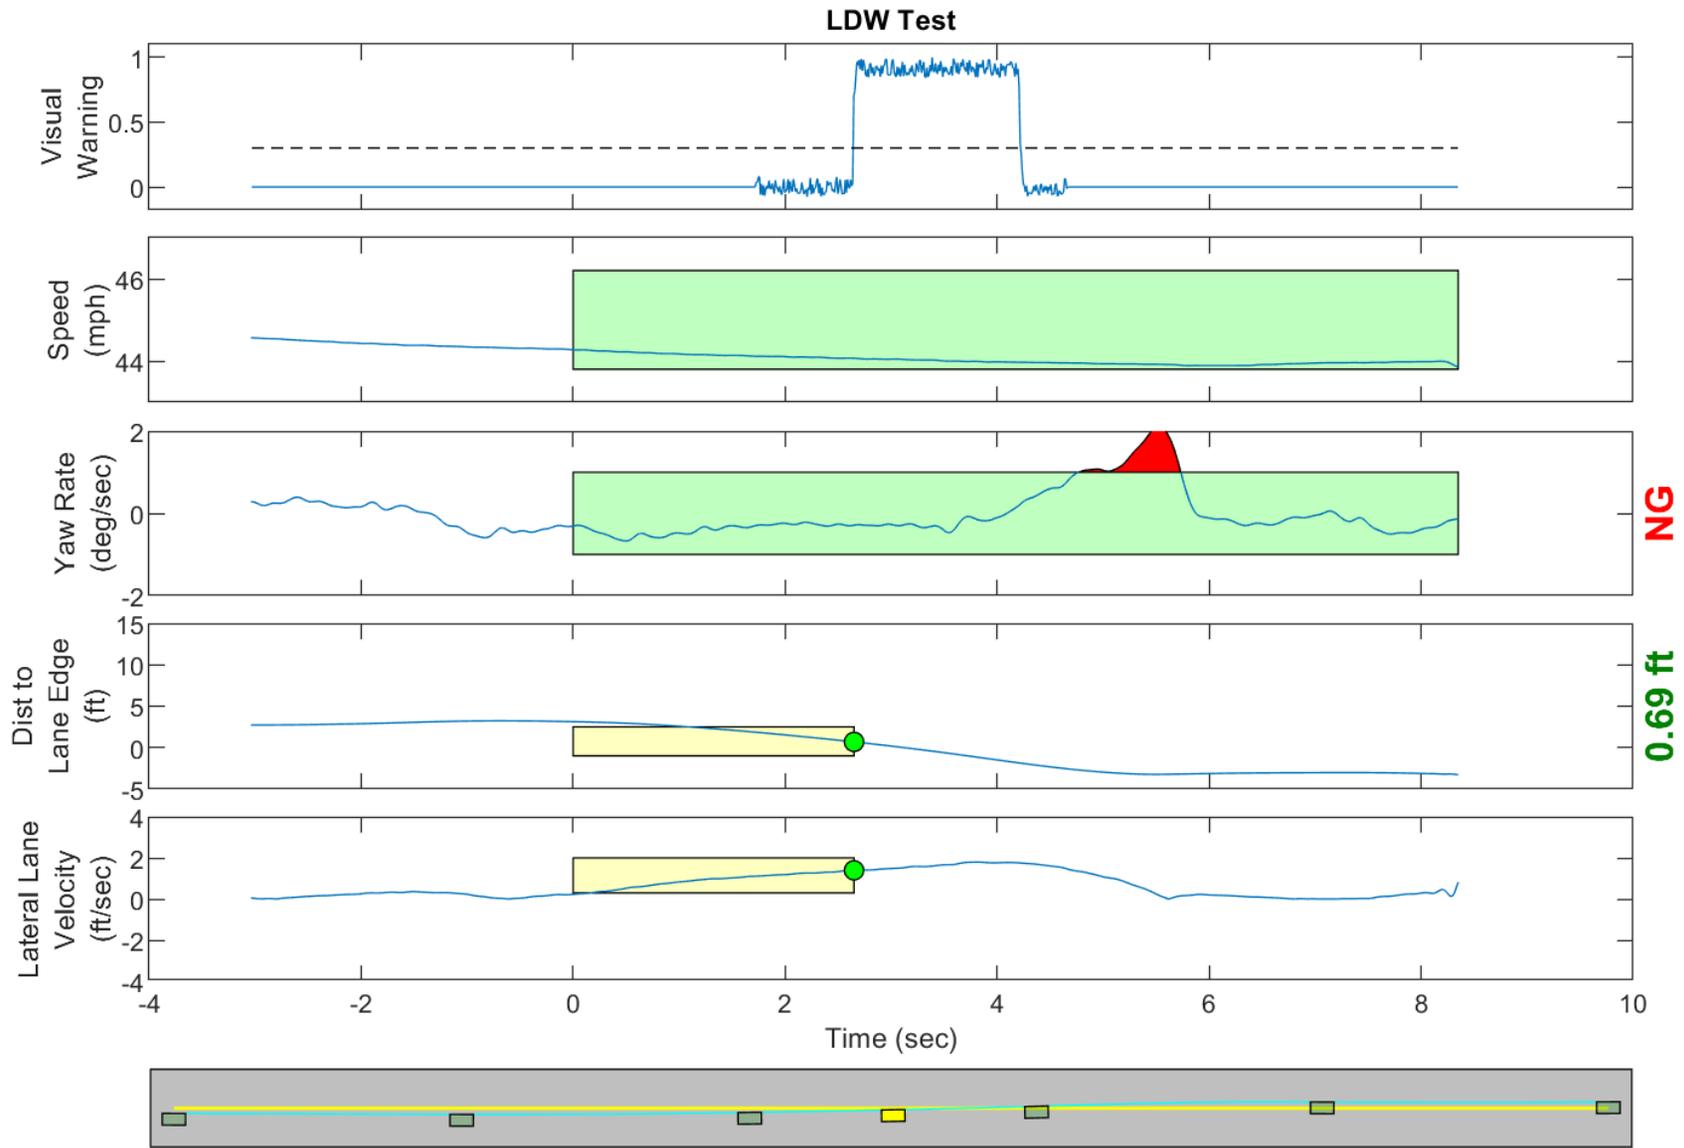
Figure D3. Example Time History for Lane Departure Warning Test, Invalid Run Due to Subject Vehicle Yaw Rate

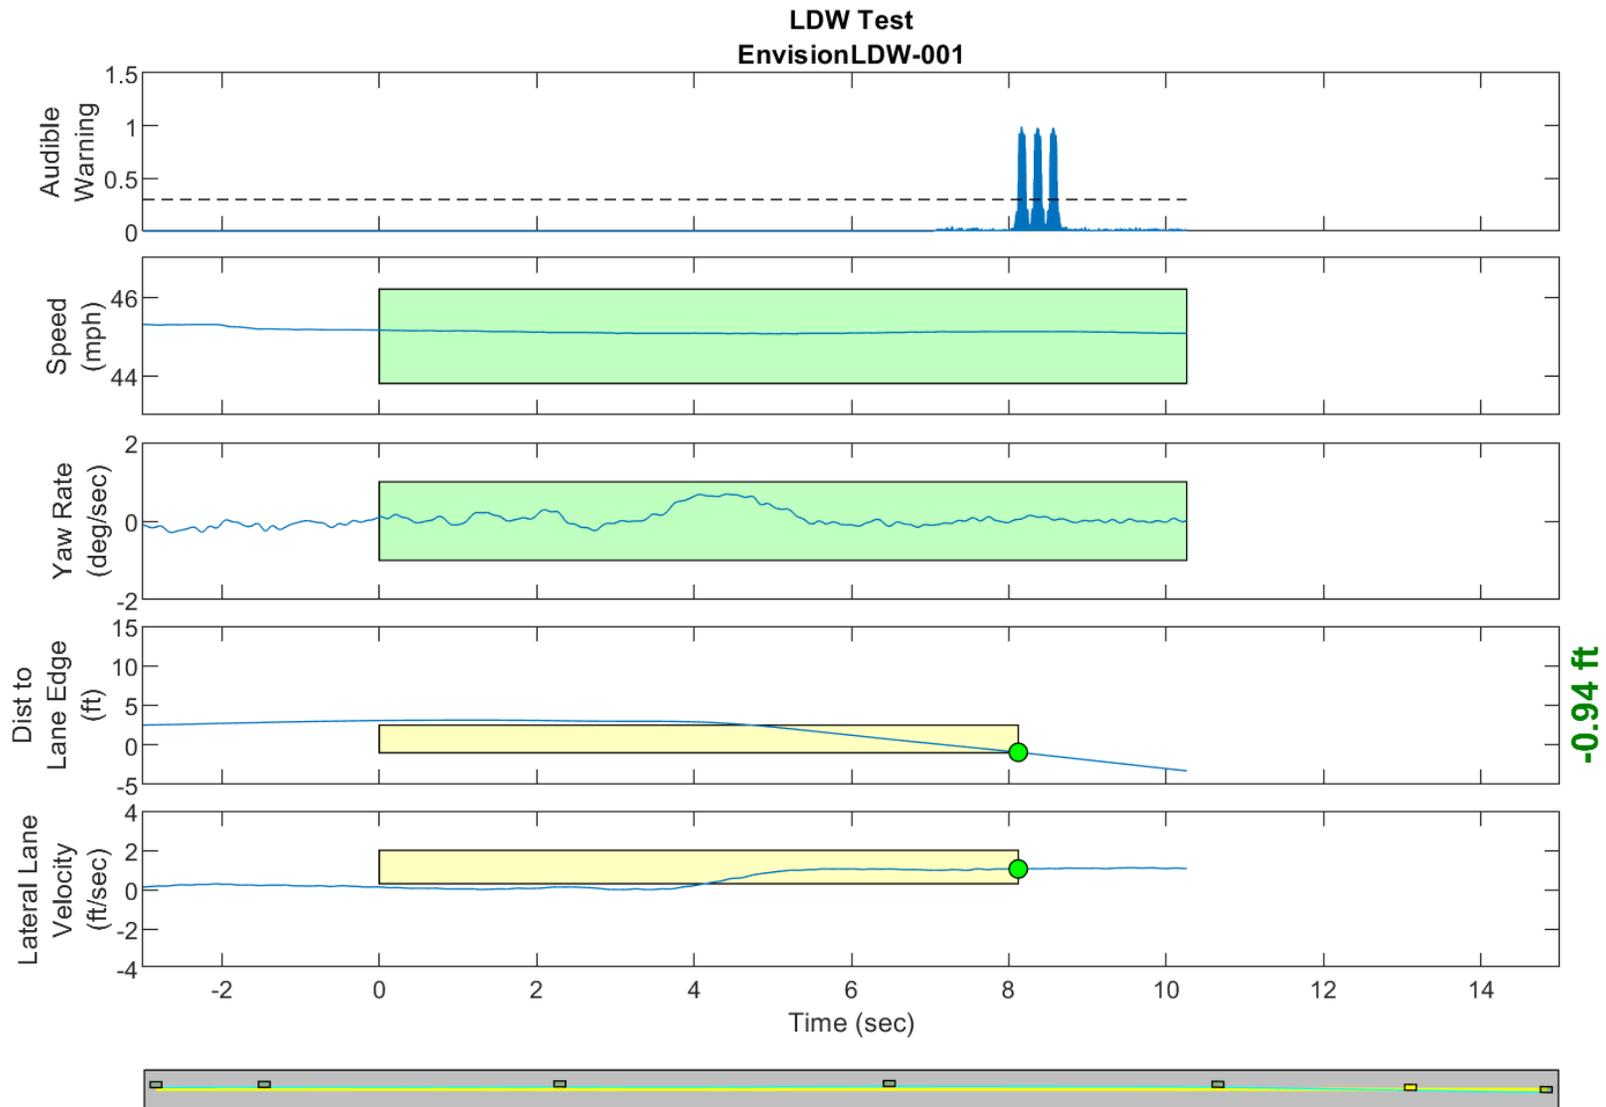
Figure D4. Time History for Run 01, Solid Line, Right Departure, Auditory Warning

Run	Lane Marking Type	Departure Direction	Valid Run?	Distance at Auditory Alert (ft)	Distance at Visual Alert (ft)	Pass/Fail	Notes
1	Solid	Right	Y	-0.94	1.78	Pass	
2			Y	-0.94	1.38	Pass	
3			Y	-0.97	0.93	Pass	
4			Y	-1.01	1.65	Pass	
5			Y	-0.92	1.33	Pass	
6			Y	-0.96	1.43	Pass	
7			Y	-0.90	1.27	Pass	
8	Solid	Left	Y	-0.72	1.85	Pass	
9			Y	-0.68	1.73	Pass	
10			Y			Fail	No warning
11			Y	-0.78	1.38	Pass	
12			Y	-0.88	0.92	Pass	
13			Y	-0.59	1.30	Pass	
14			Y	-0.58	0.92	Pass	
15	Dashed	Left	Y	-0.95	0.31	Pass	
16			Y	-1.02	0.32	Pass	
17			Y	-0.98	0.53	Pass

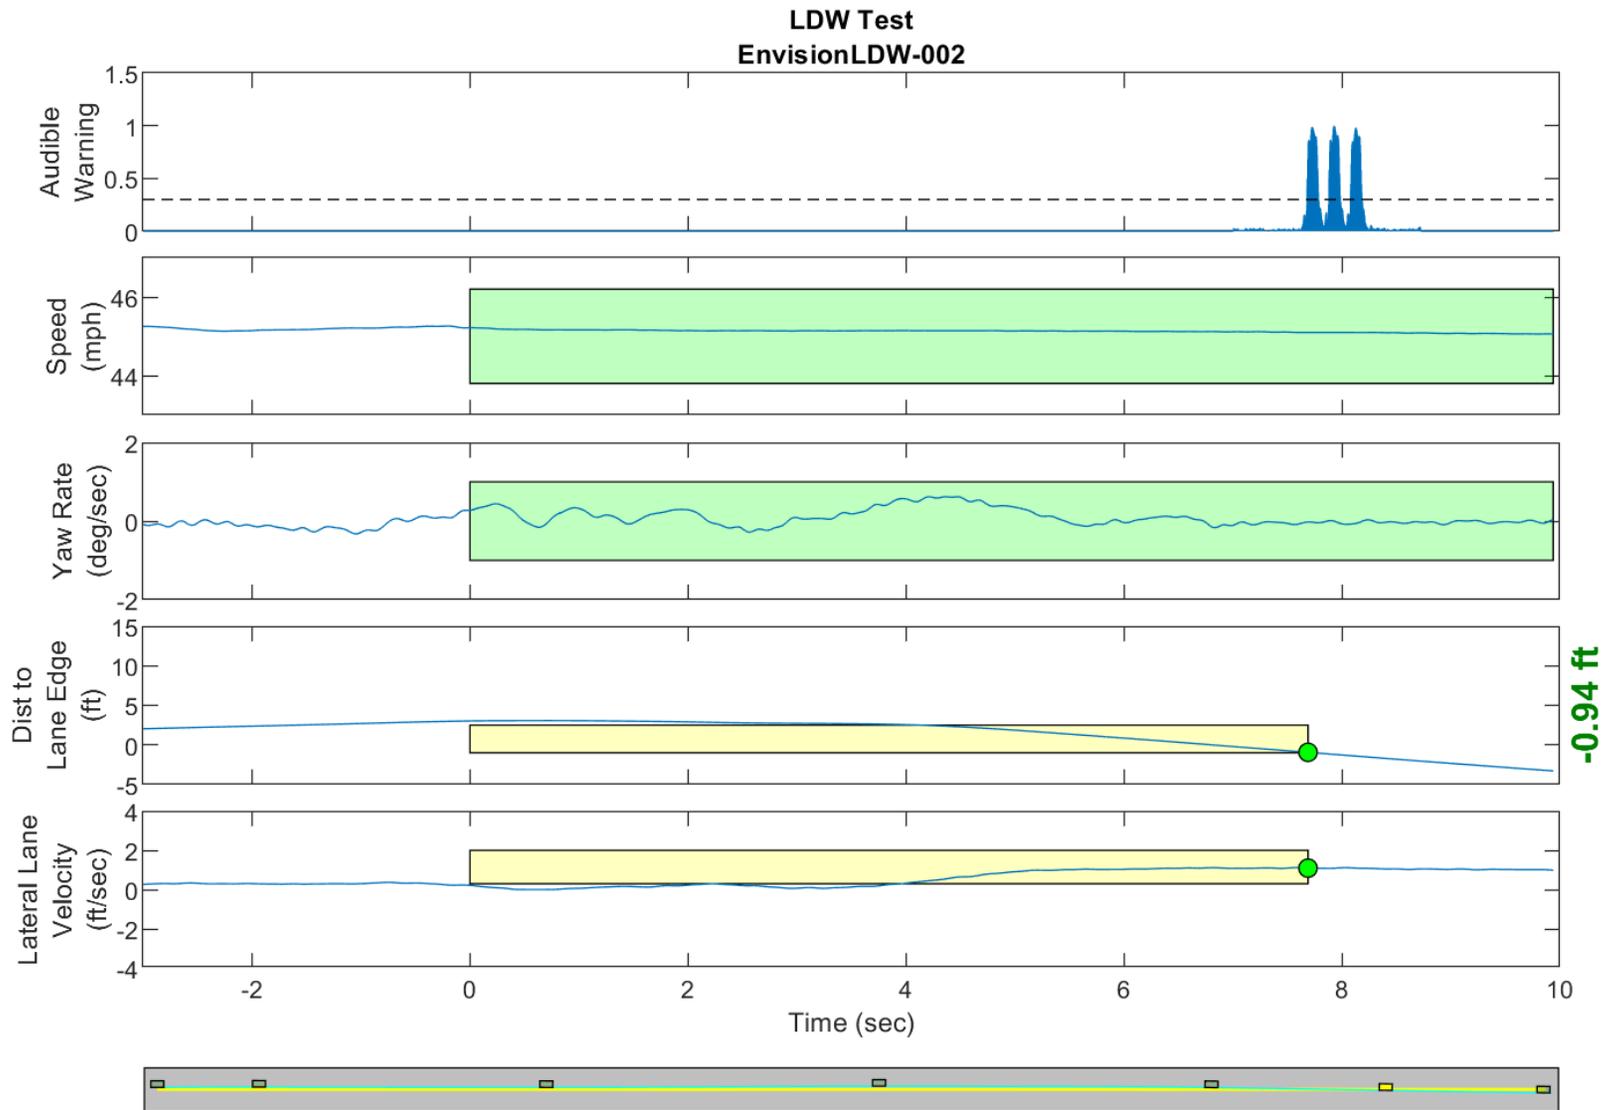
Figure D6. Time History for Run 02, Solid Line, Right Departure, Auditory Warning

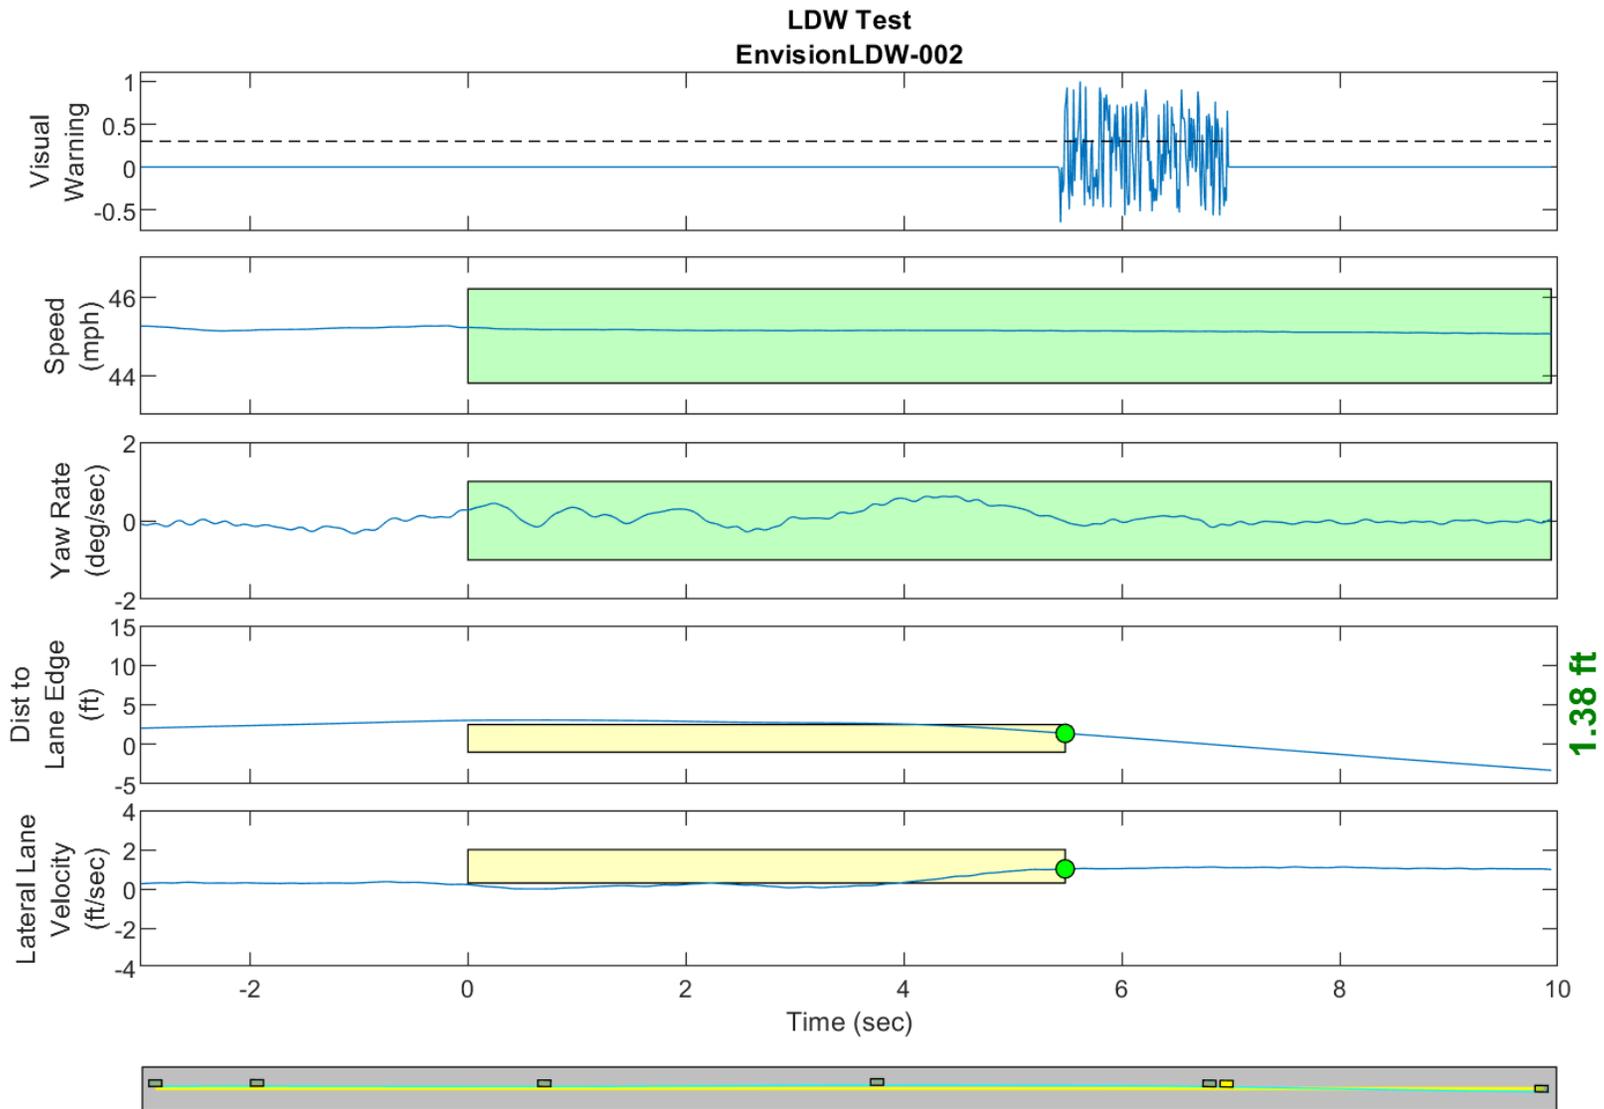
Figure D7. Time History for Run 02, Solid Line, Right Departure, Visual Warning

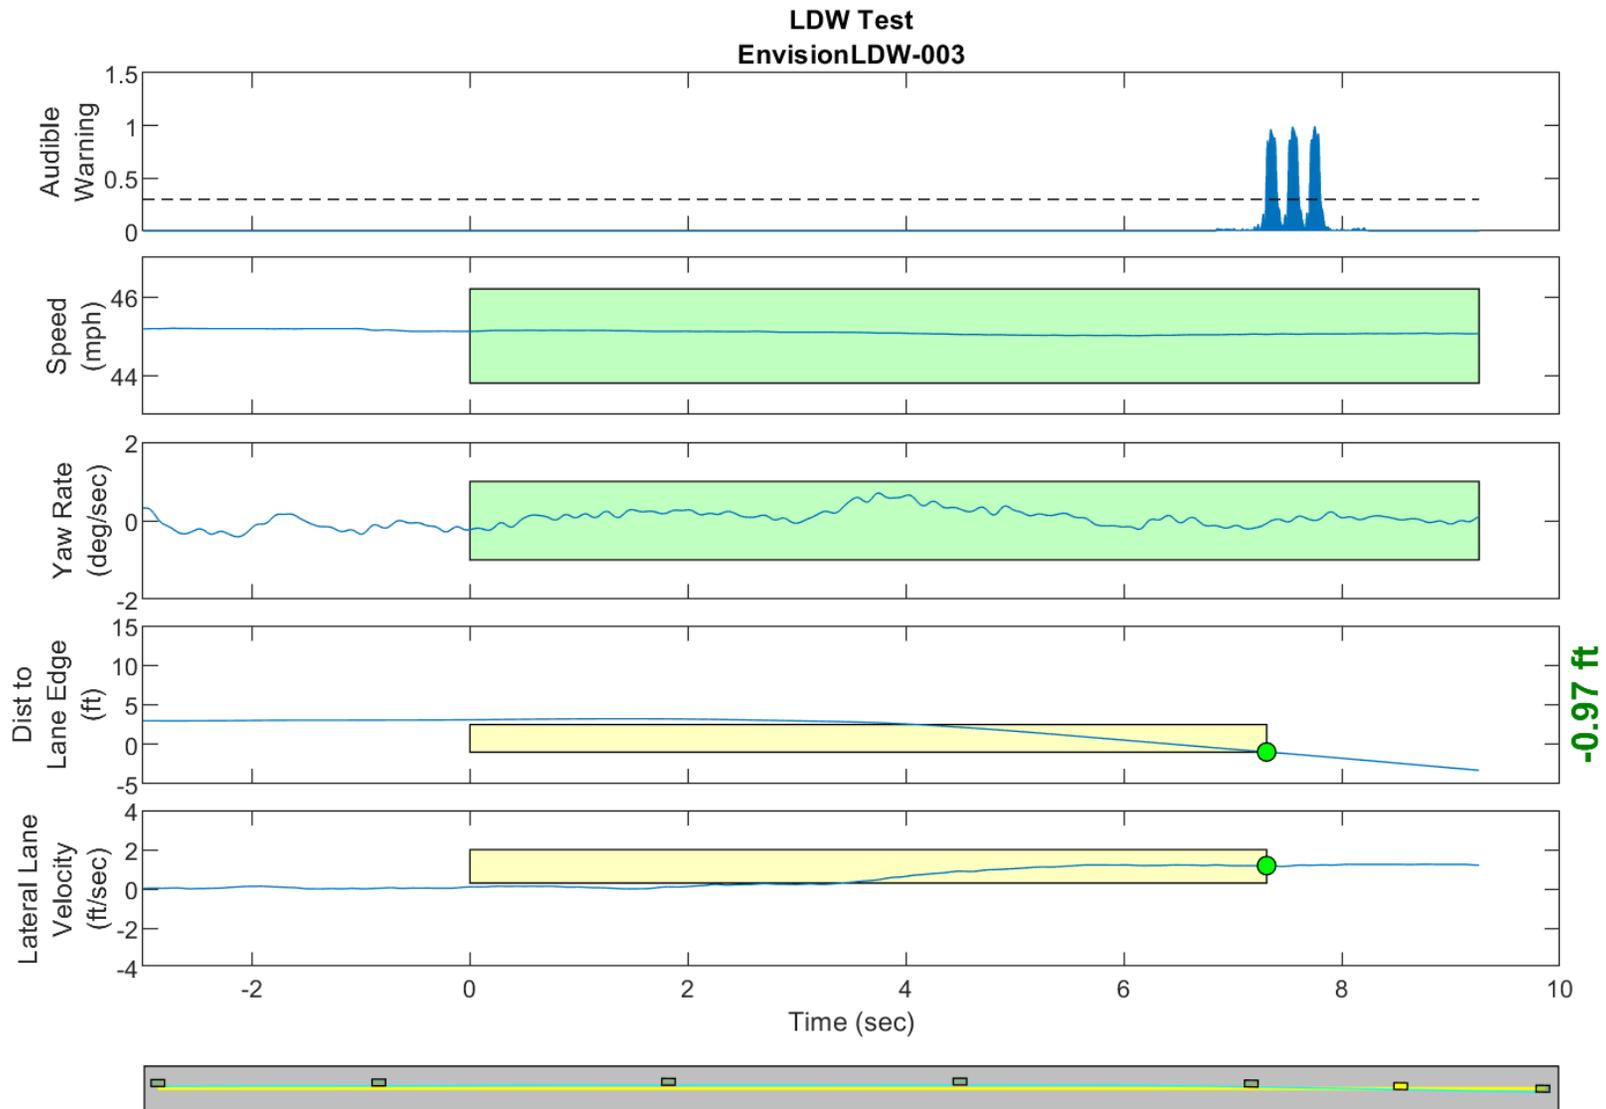
Figure D8. Time History for Run 03, Solid Line, Right Departure, Auditory Warning
