**NEW CAR ASSESSMENT PROGRAM
LANE DEPARTURE WARNING CONFIRMATION TEST
NCAP-DRI-LDW-21-01**

2021 Buick Envision Preferred AWD

DYNAMIC RESEARCH, INC.

Final Report

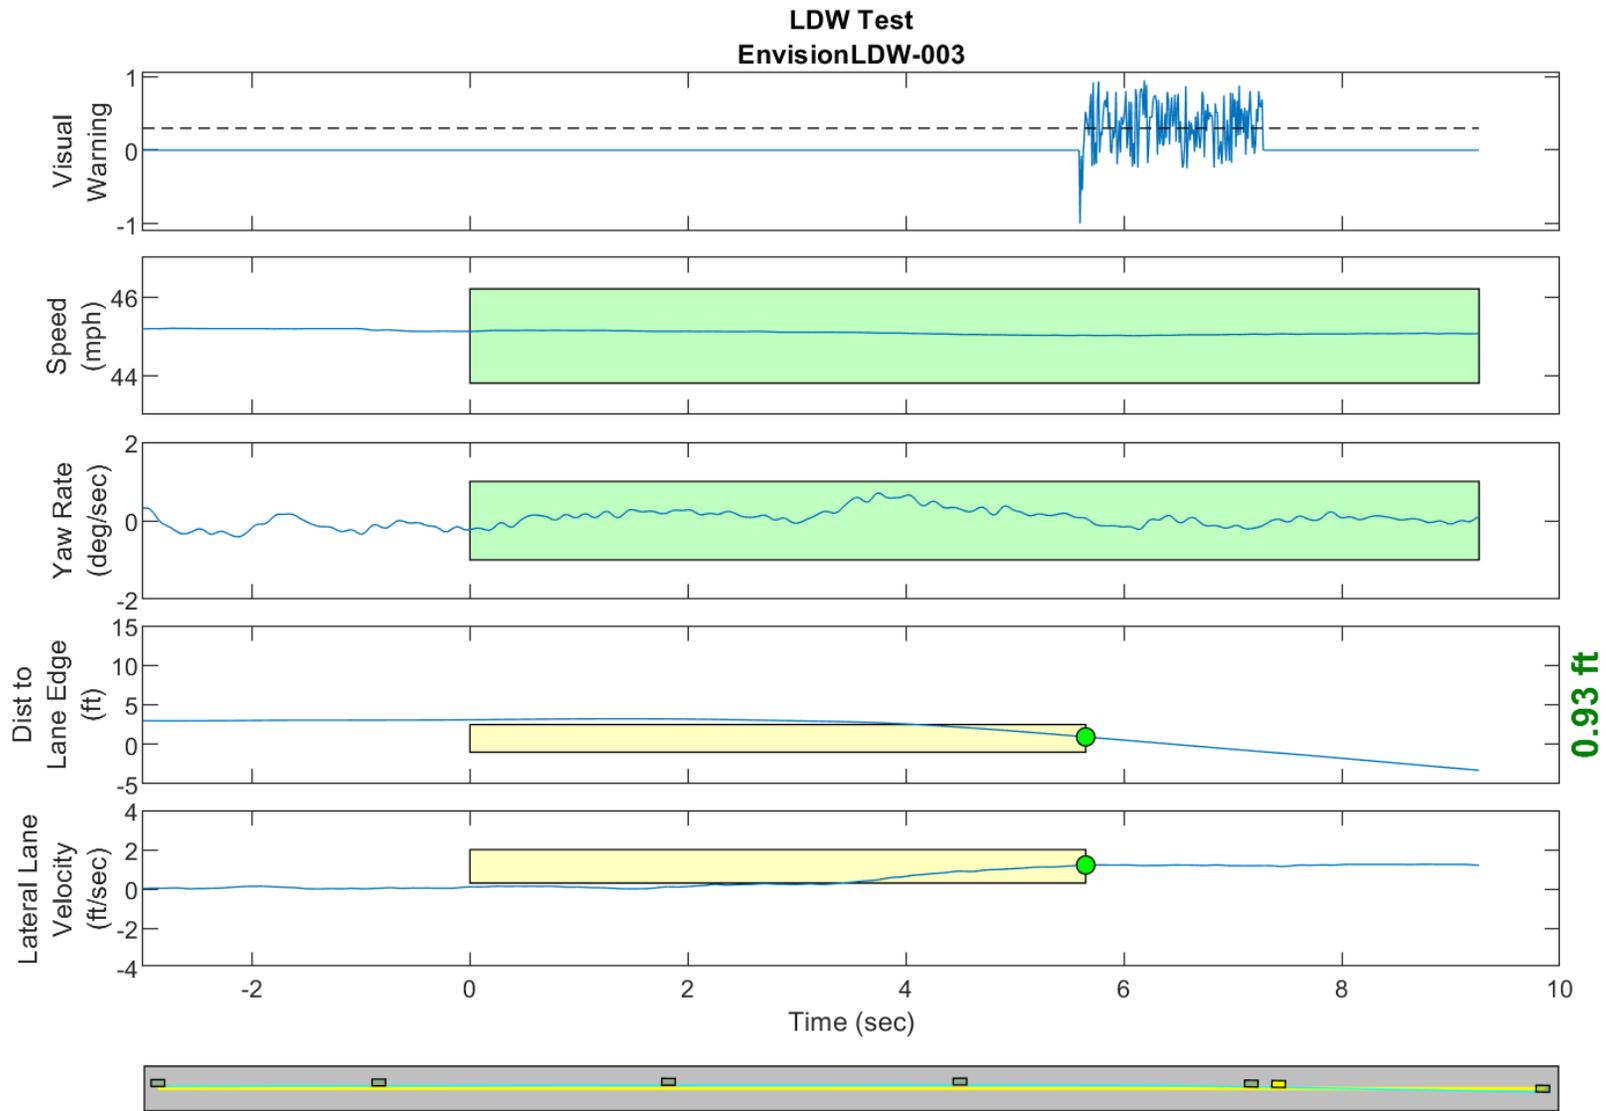
Figure D9. Time History for Run 03, Solid Line, Right Departure, Visual Warning

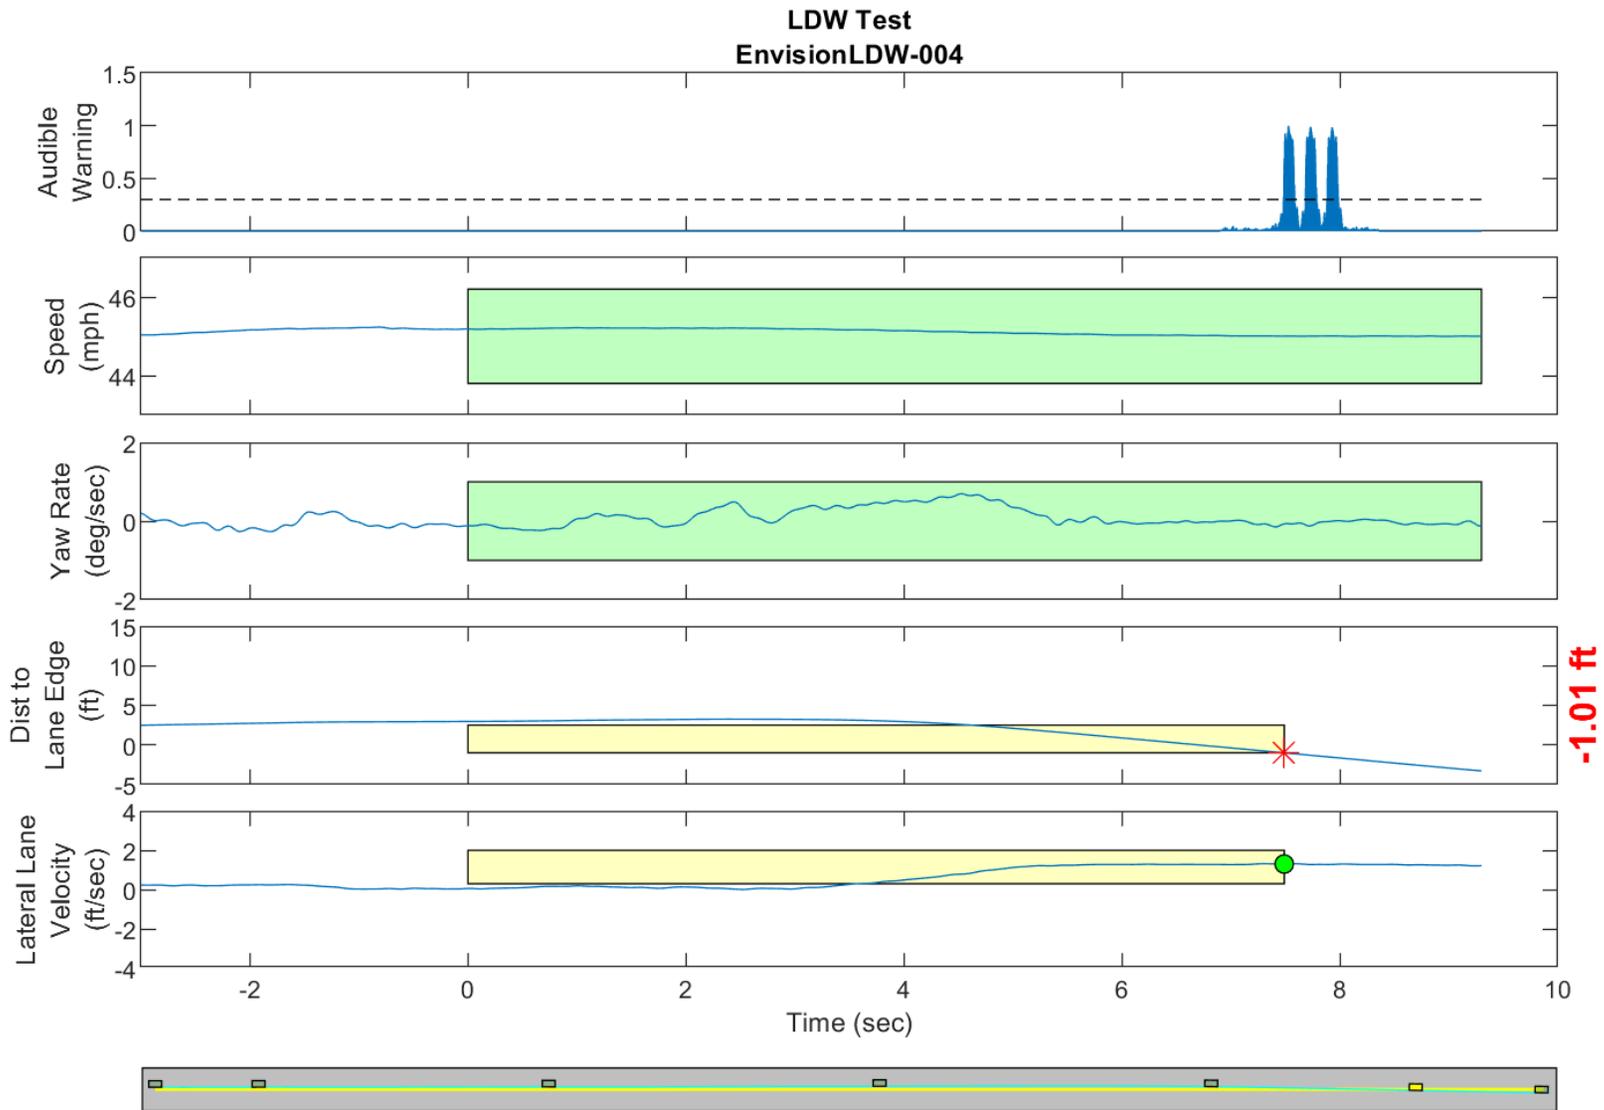
Figure D10. Time History for Run 04, Solid Line, Right Departure, Auditory Warning

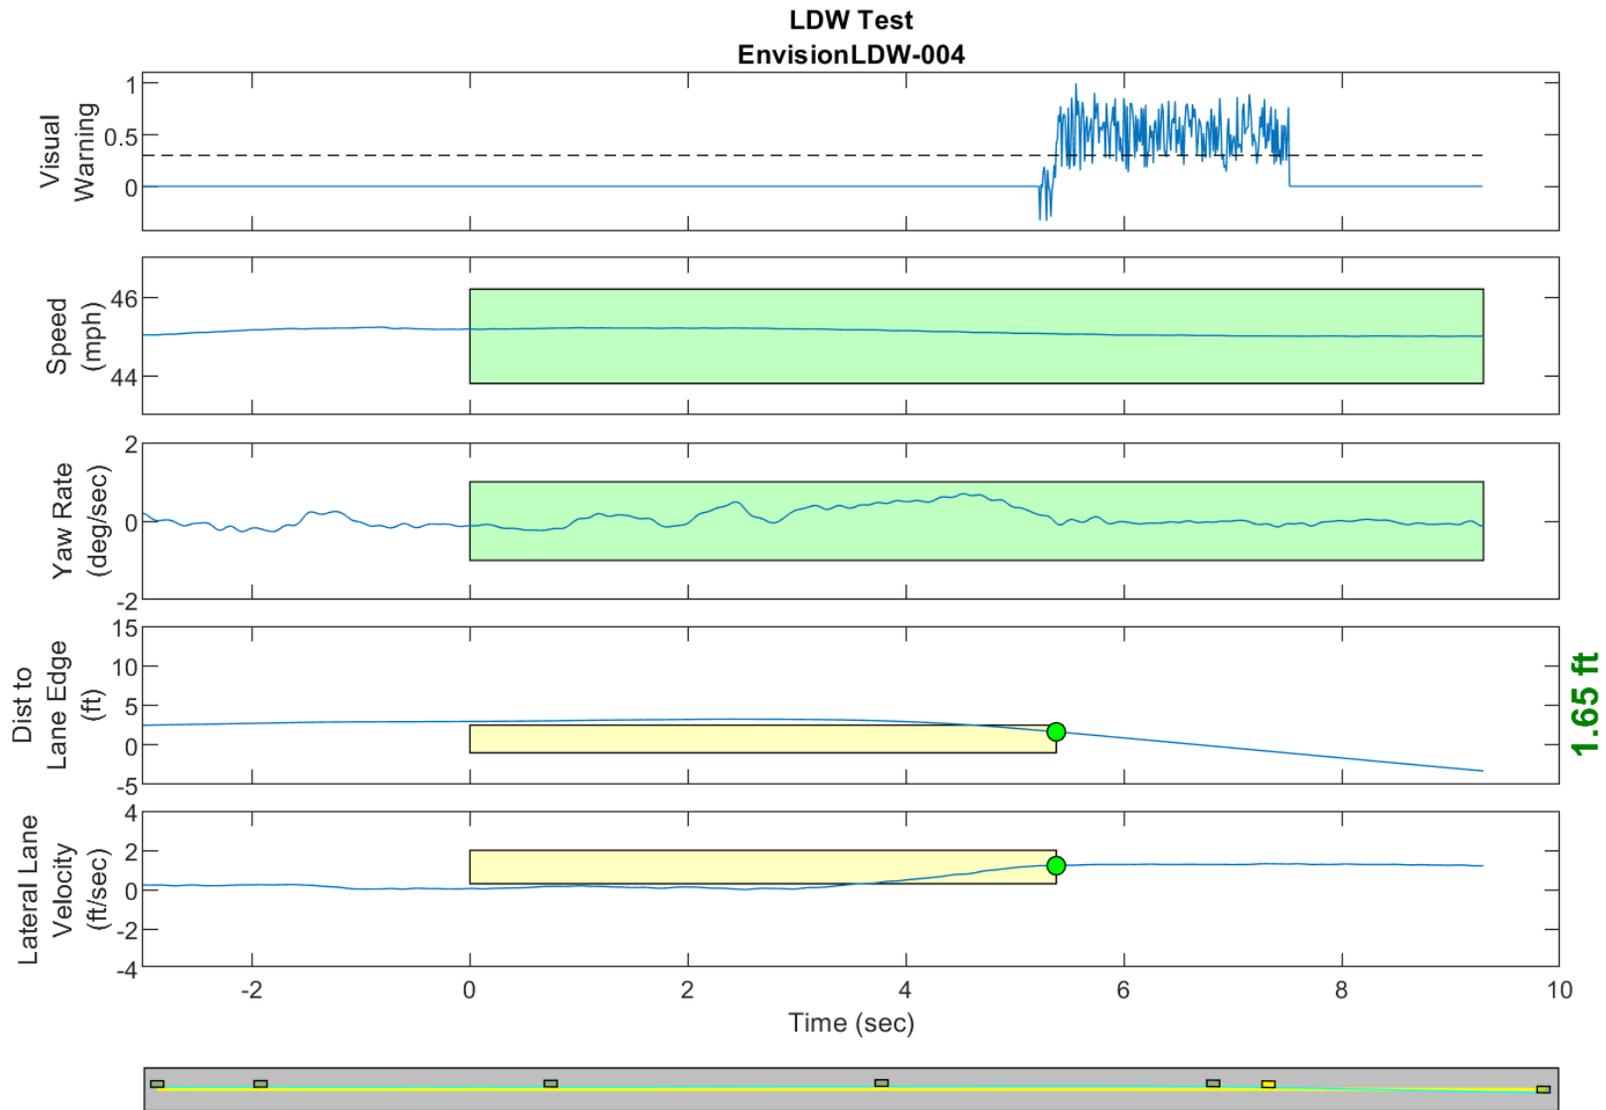
Figure D11. Time History for Run 04, Solid Line, Right Departure, Visual Warning

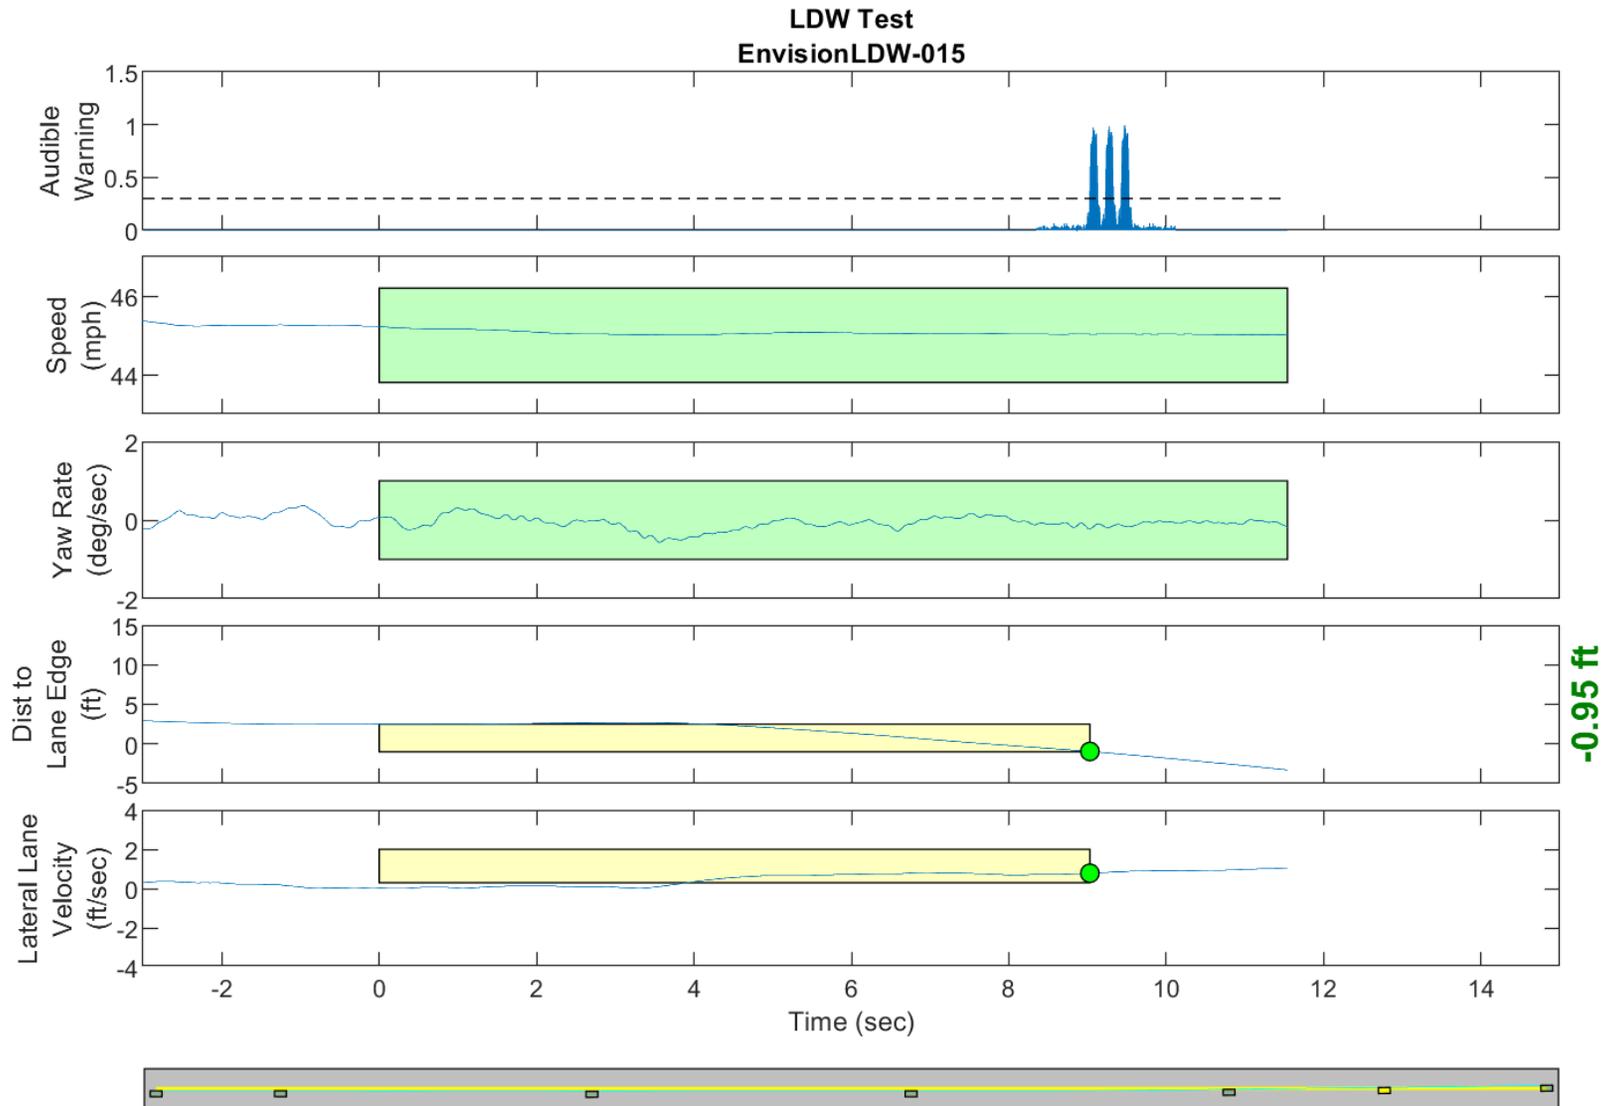
Figure D32. Time History for Run 15, Dashed Line, Left Departure, Auditory Warning

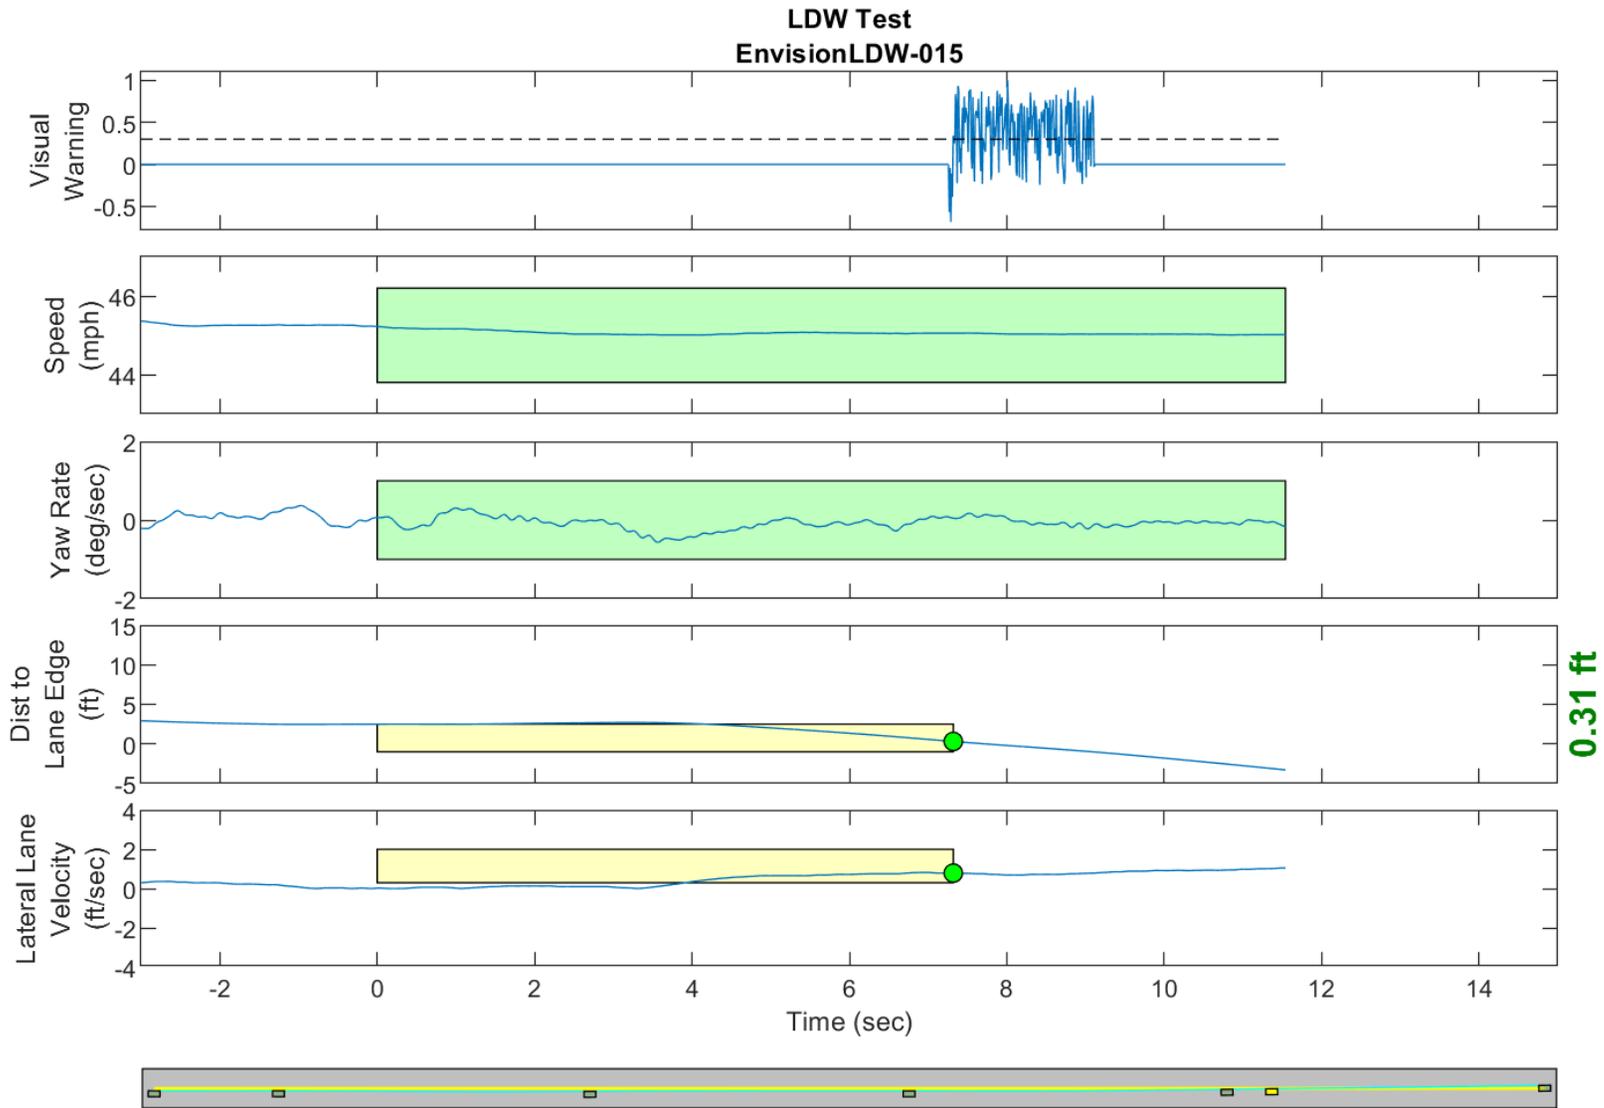
Figure D33. Time History for Run 15, Dashed Line, Left Departure, Visual Warning

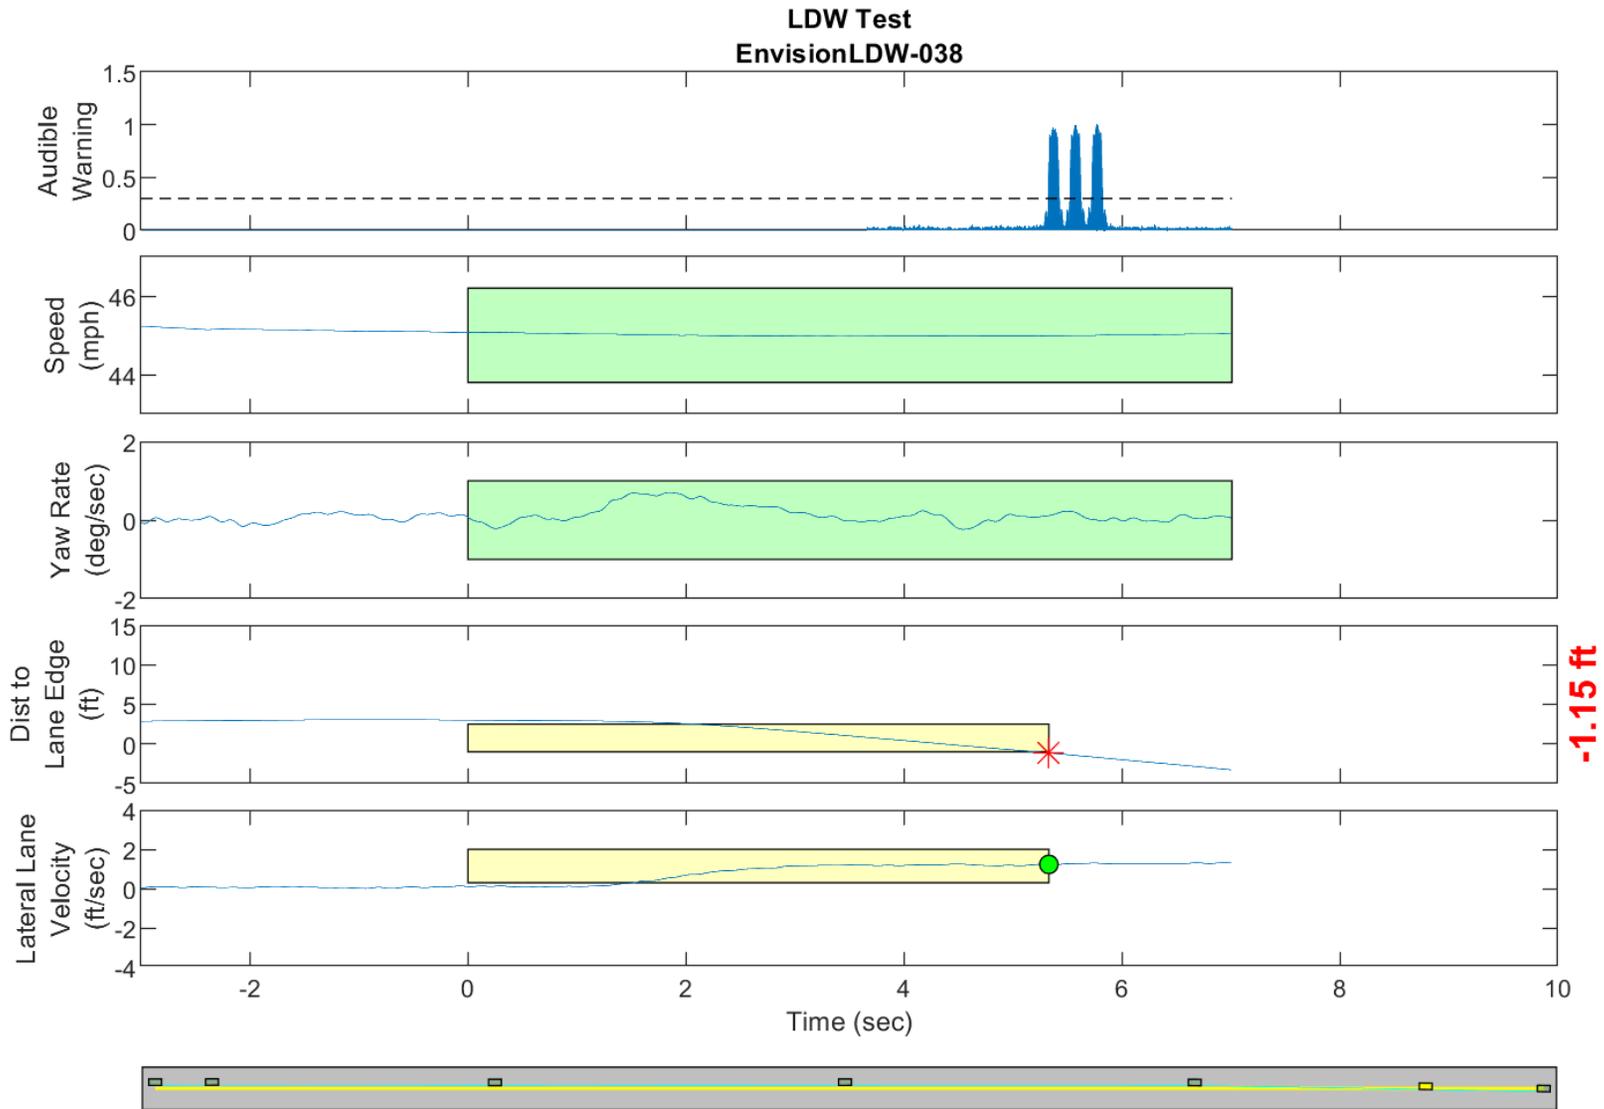
-1.15 ft

Figure D72. Time History for Run 38, Botts Dots, Left Departure, Auditory Warning

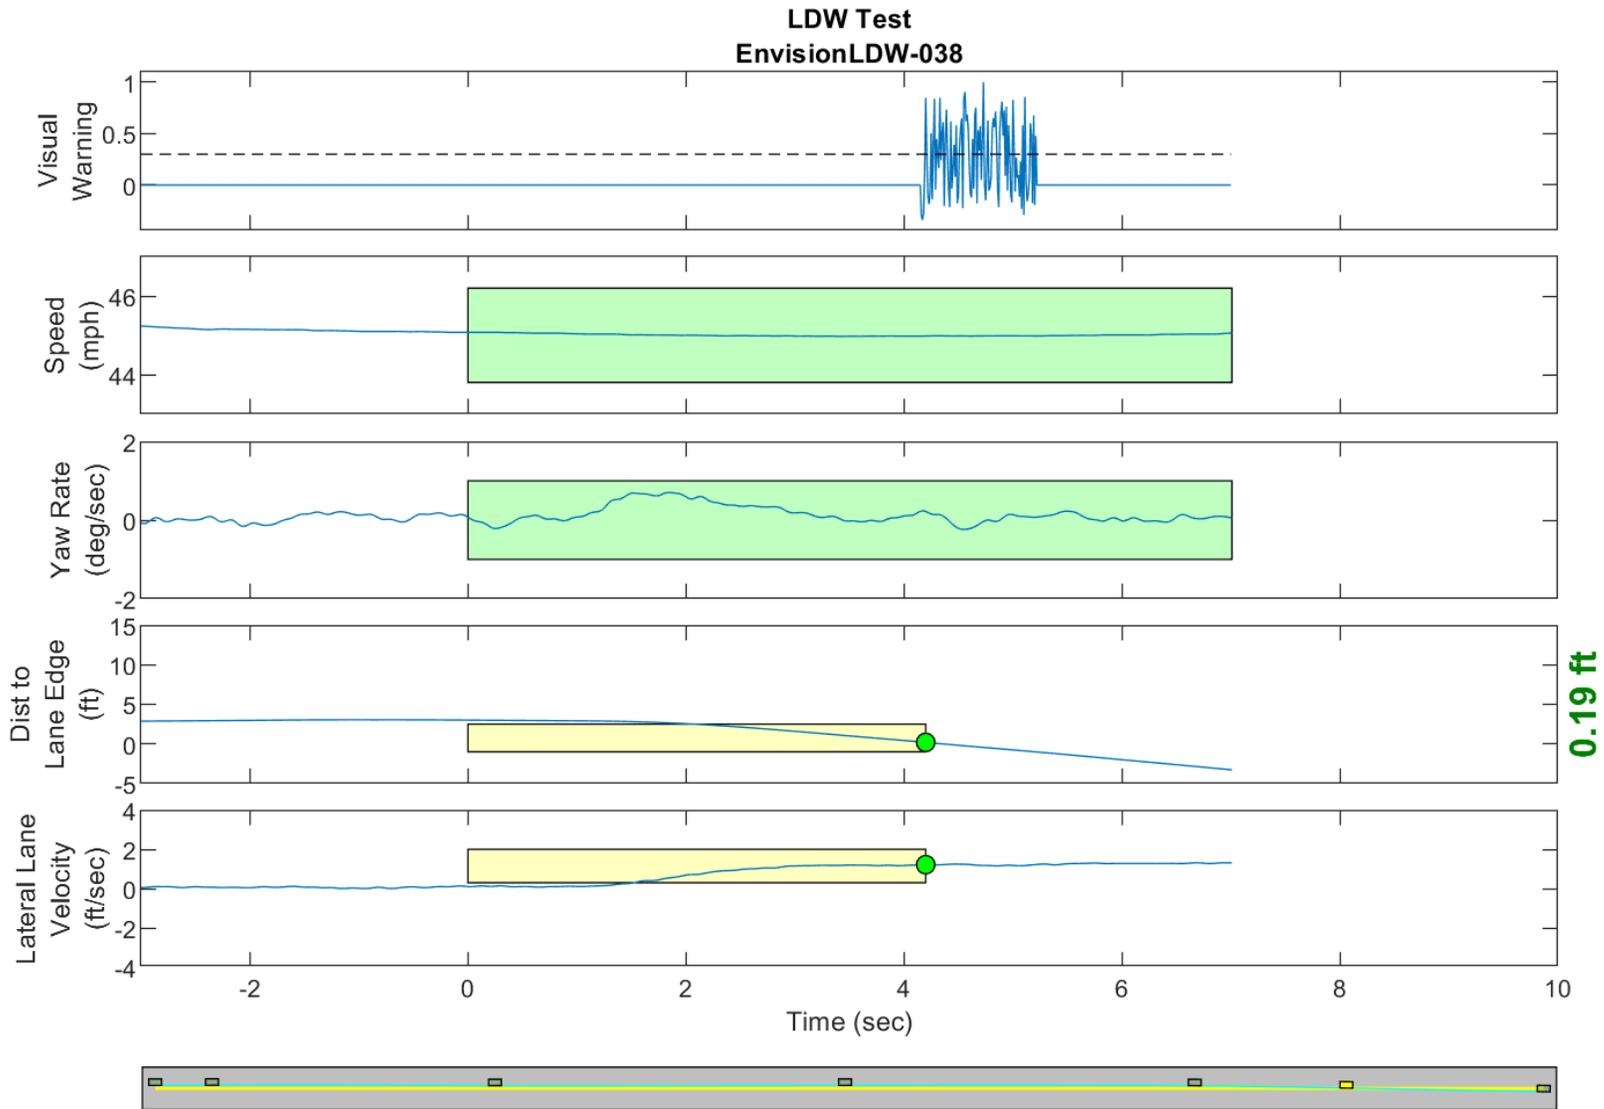
Figure D73. Time History for Run 38, Botts Dots, Left Departure, Visual Warning

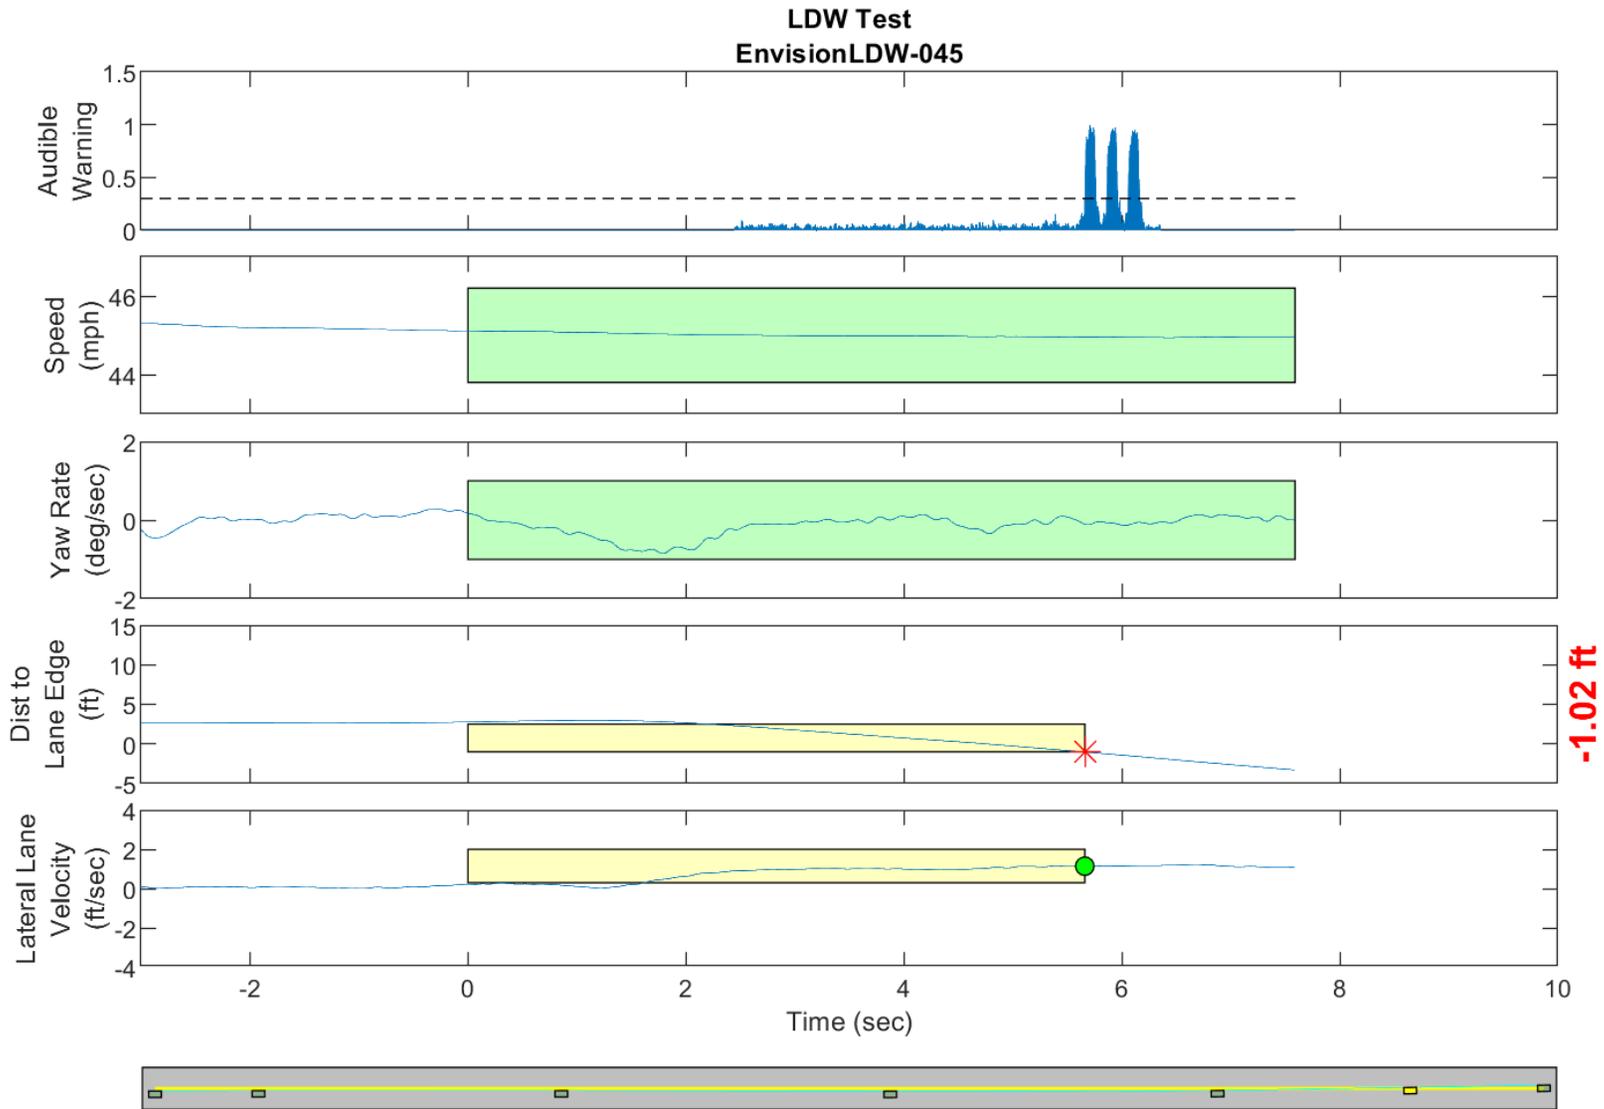
Figure D86. Time History for Run 45, Botts Dots, Right Departure, Auditory Warning

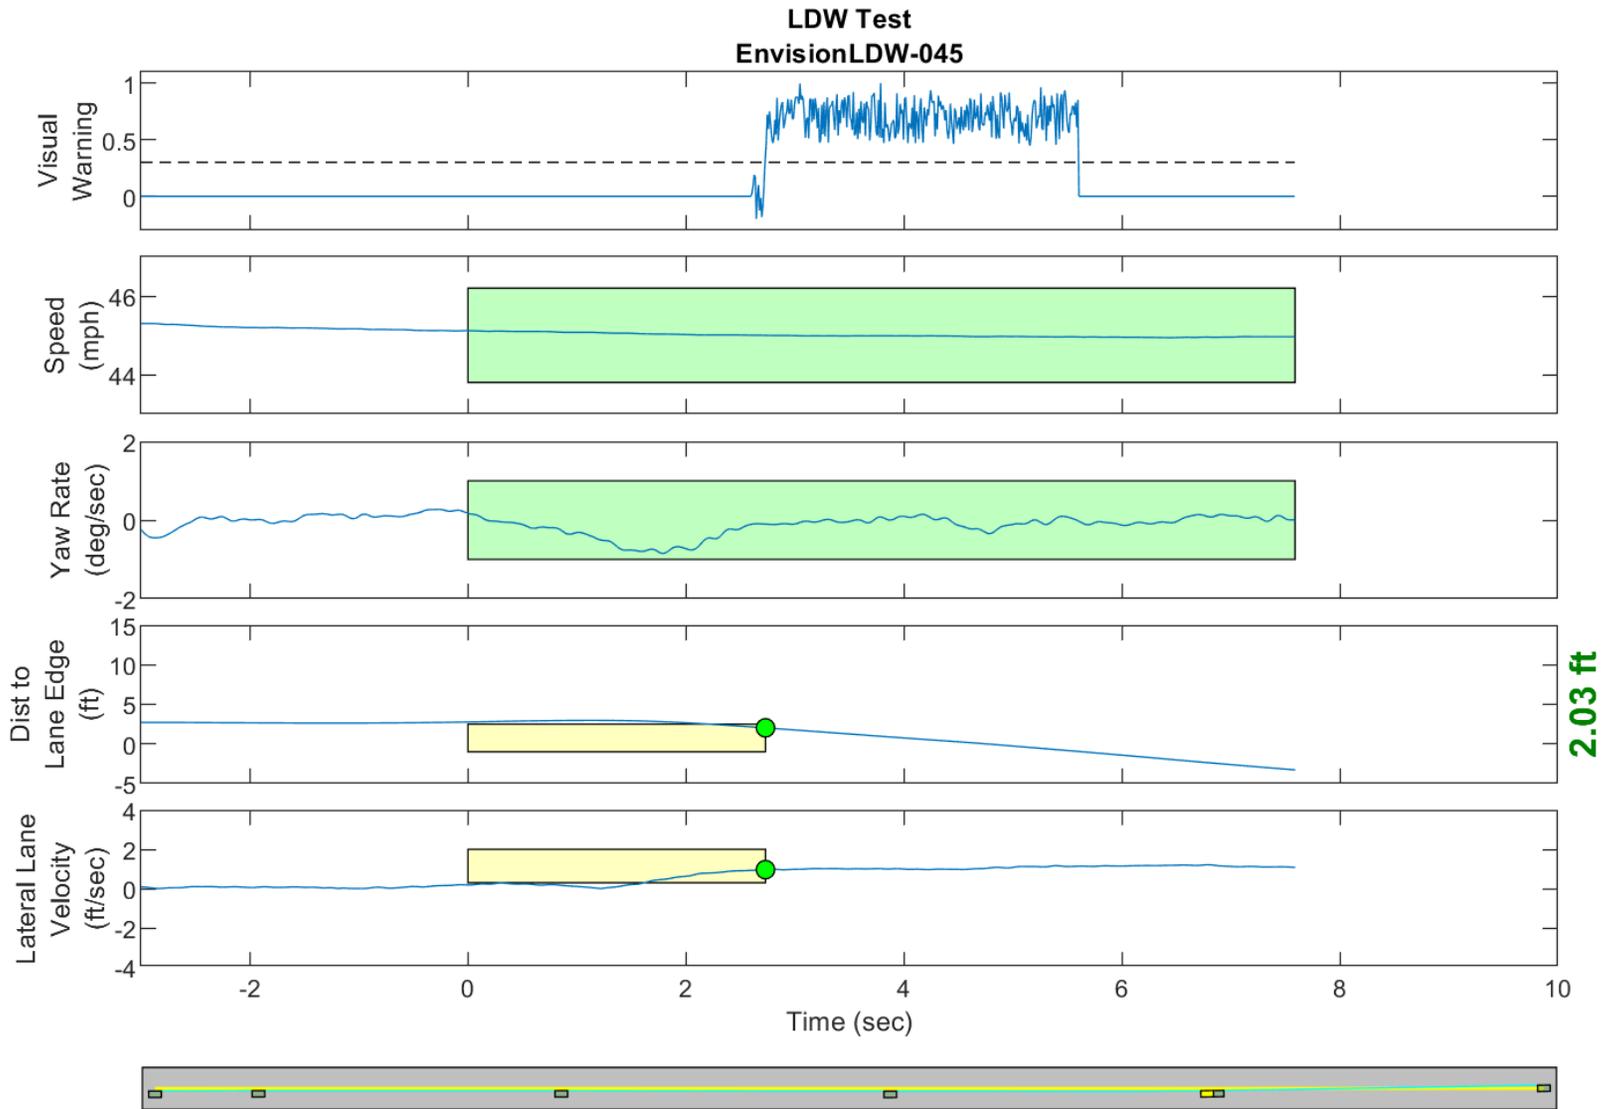
Figure D87. Time History for Run 45, Botts Dots, Right Departure, Visual Warning
