**NEW CAR ASSESSMENT PROGRAM (NCAP)
Side Impact Pole Test**

**TOYOTA MOTOR CORPORATION
2021 Lexus IS 300 4-Door Sedan
NHTSA No.: O20215100**

FINAL REPORT

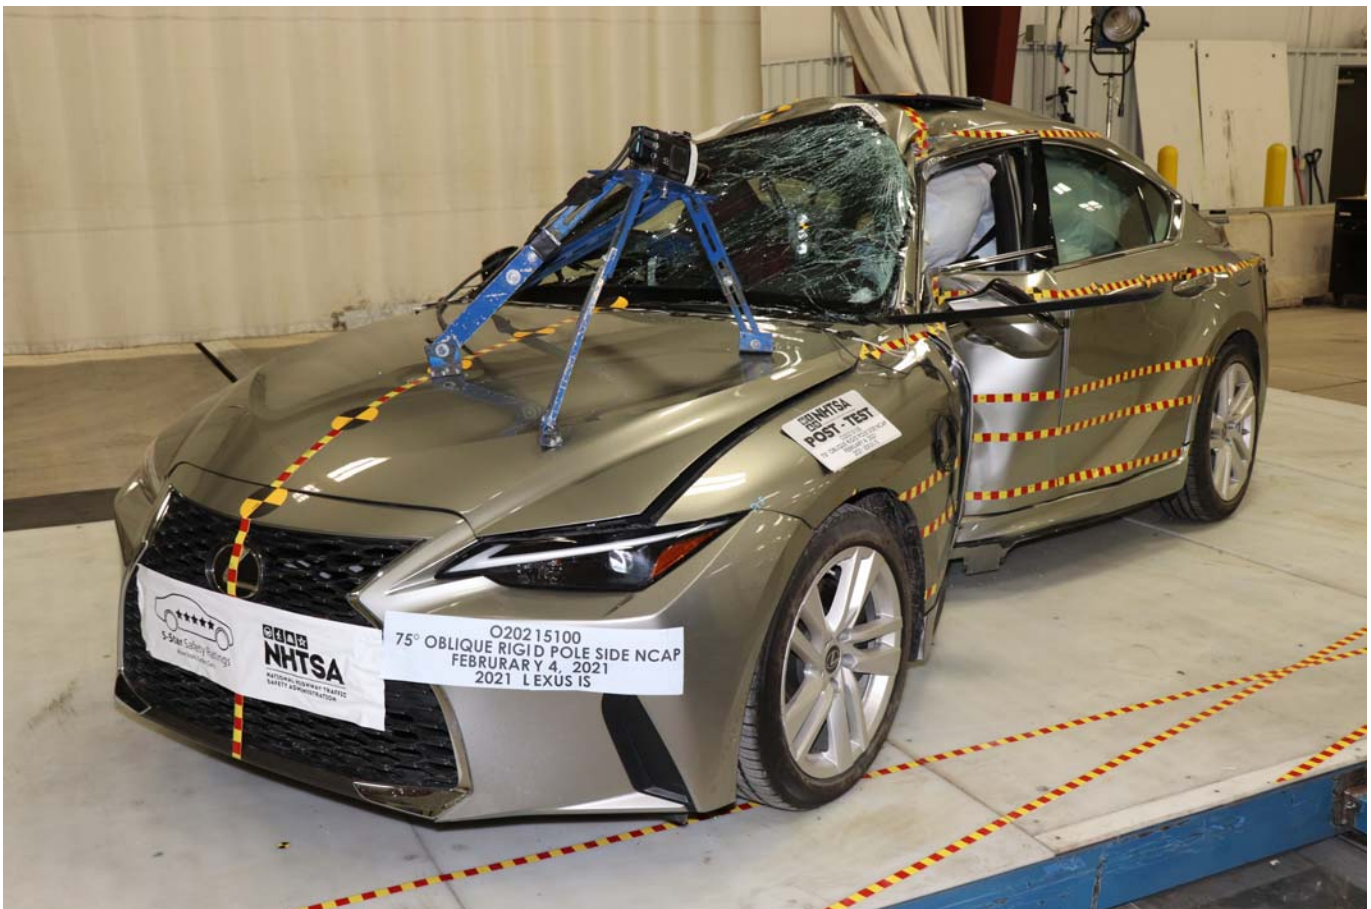
Photo No. 006 - Post-Test Left Front Three-Quarter View of Test Vehicle

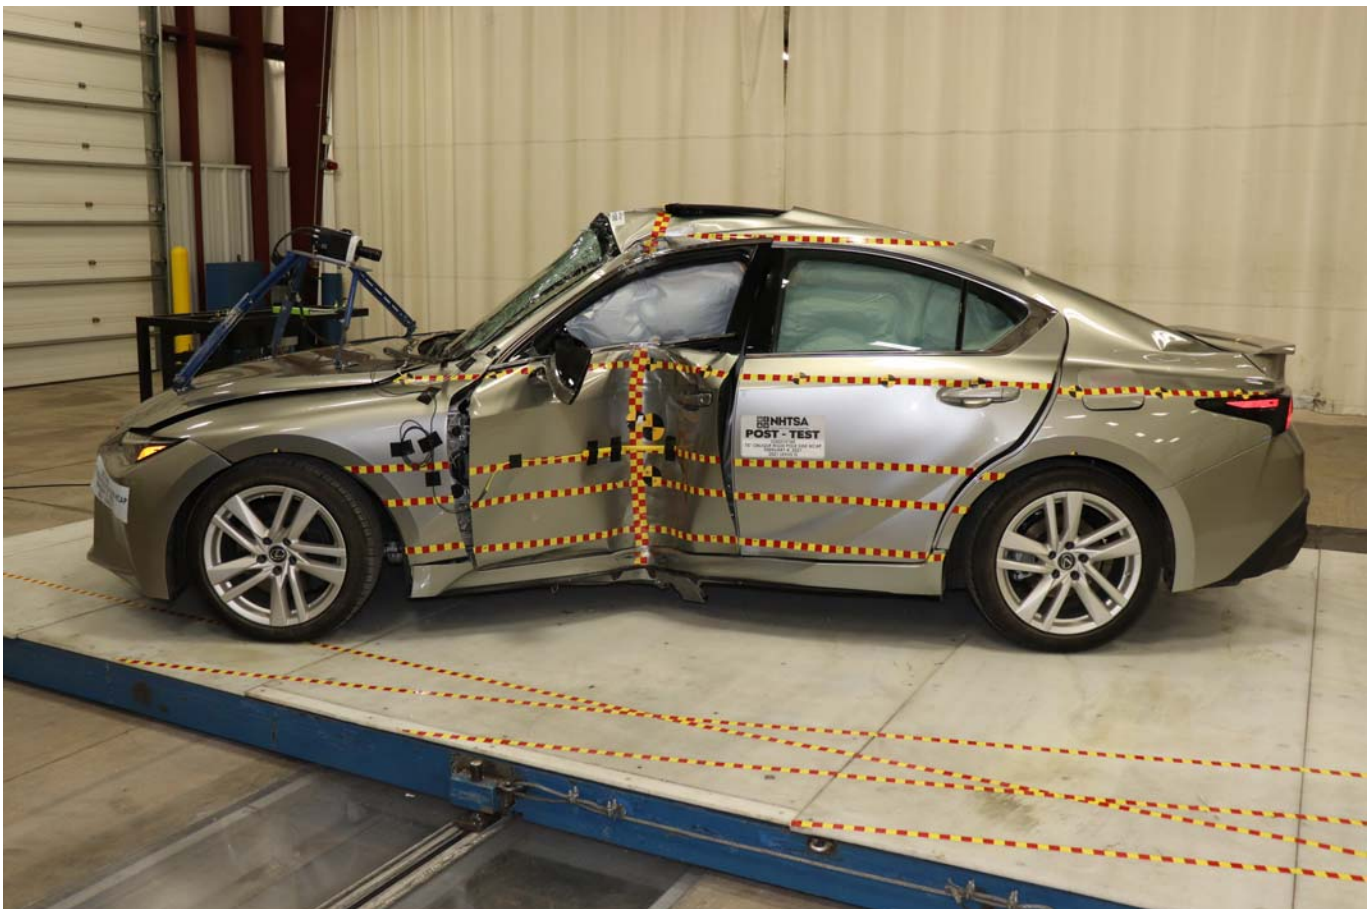
Photo No. 008 - Post-Test Left Side View of Test Vehicle

Critical Areas of Performance	Observations and Conclusions
Pillar Performance	No Separation
Sill Separation	No Separation
Windshield Damage	Cracked
Side Window Damage	LF window broken
Other Notable Effects	None

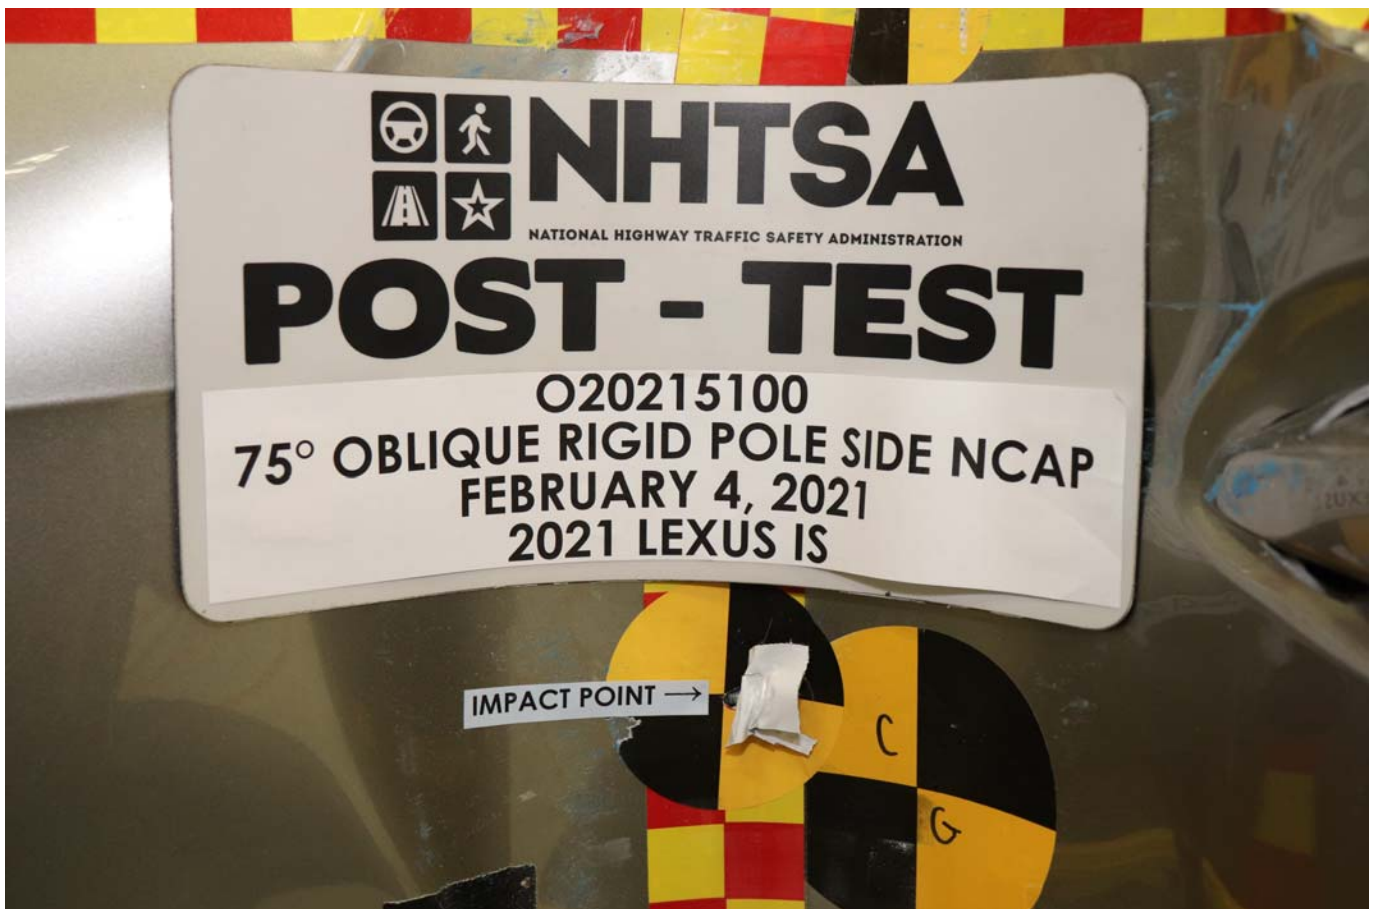
Photo No. 020 - Post-Test Close-Up View of Impact Point Target Showing Impact Location

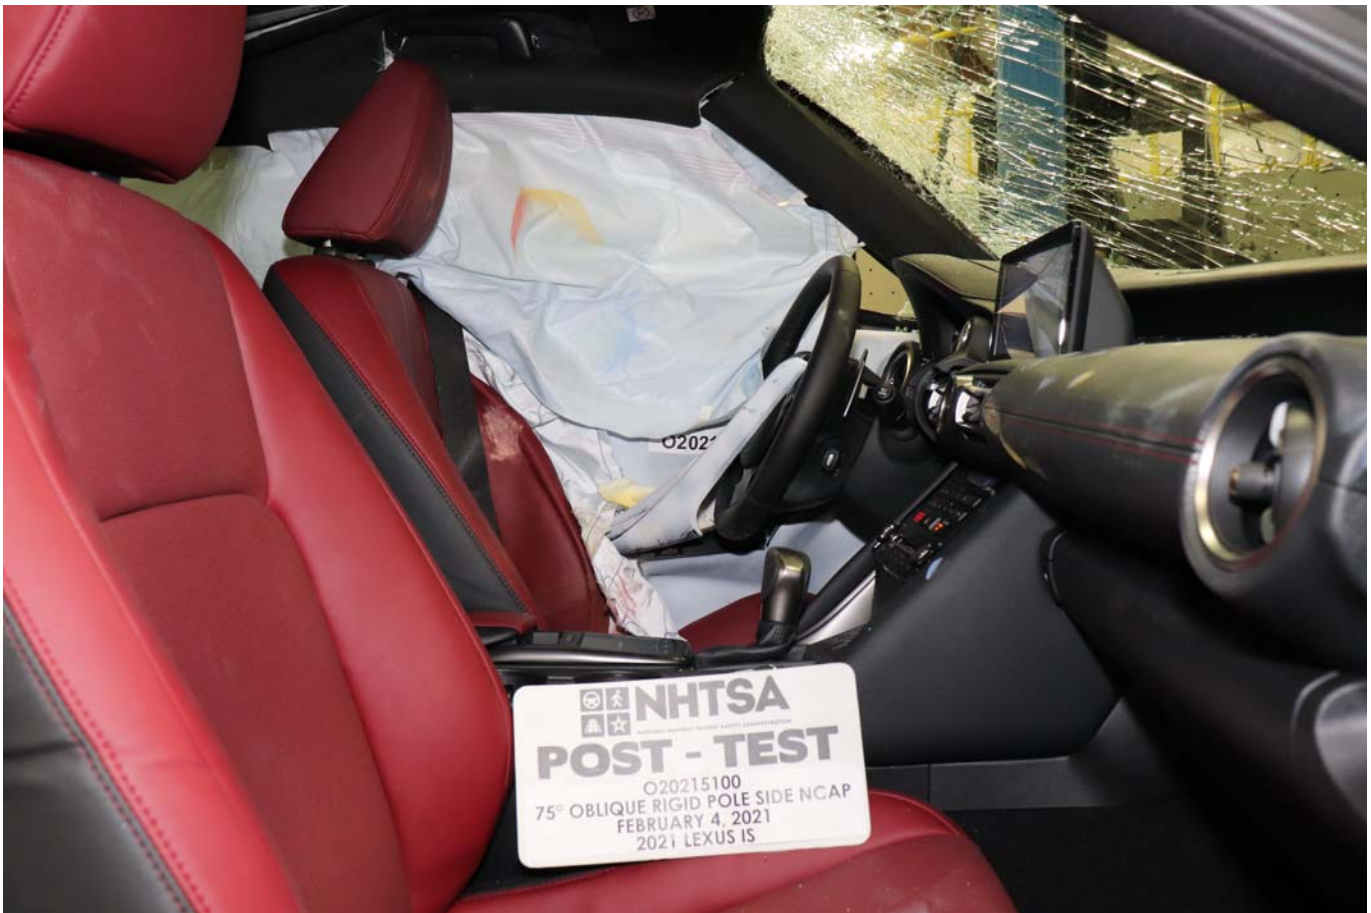
Photo No. 045 - Post-Test Inner Door Panel View Showing Dummy Contact Location

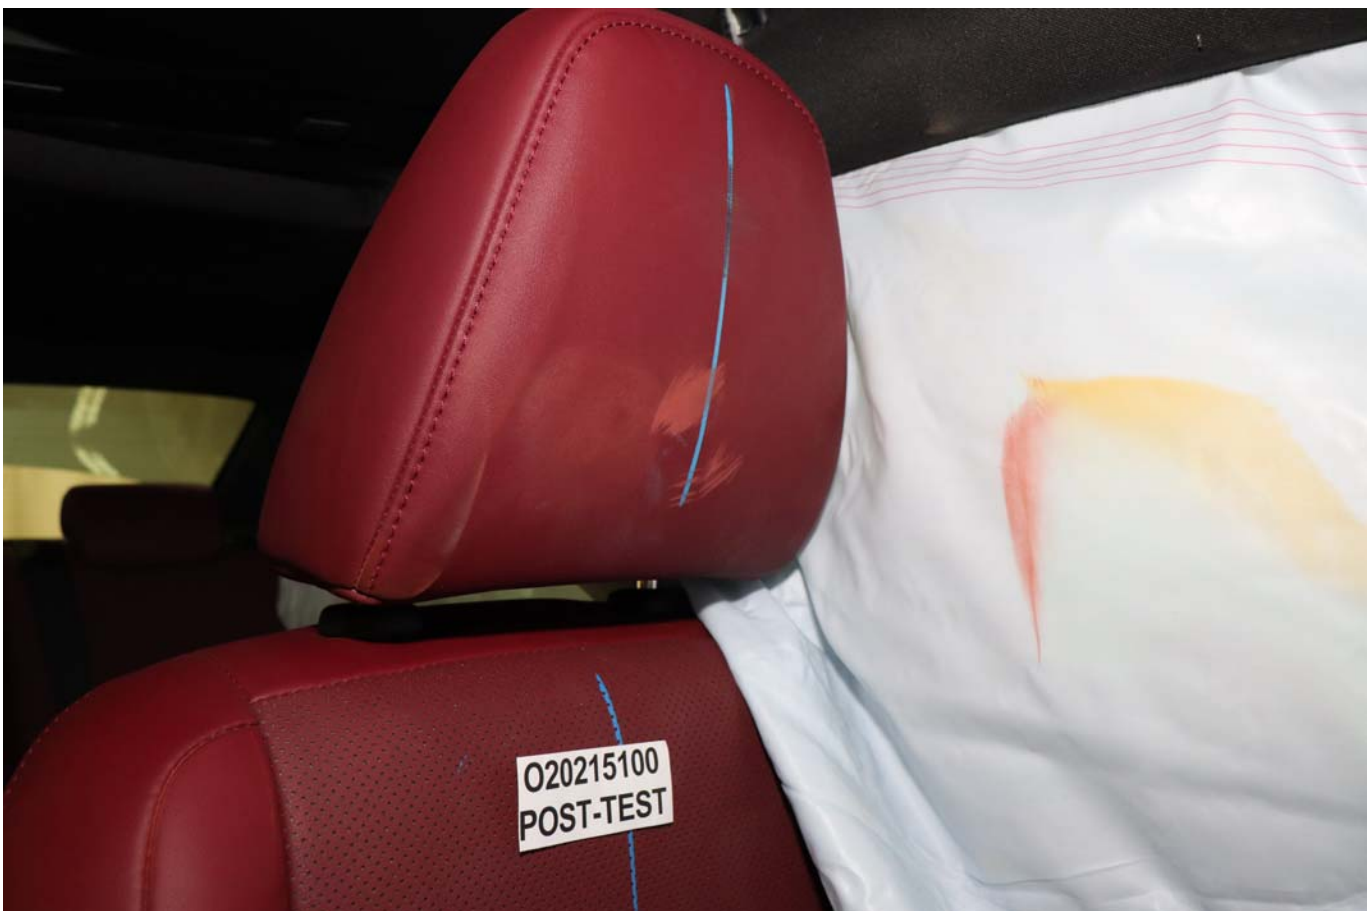
Photo No. 046 - Post-Test Dummy Close-Up Head Contact with Vehicle Interior View

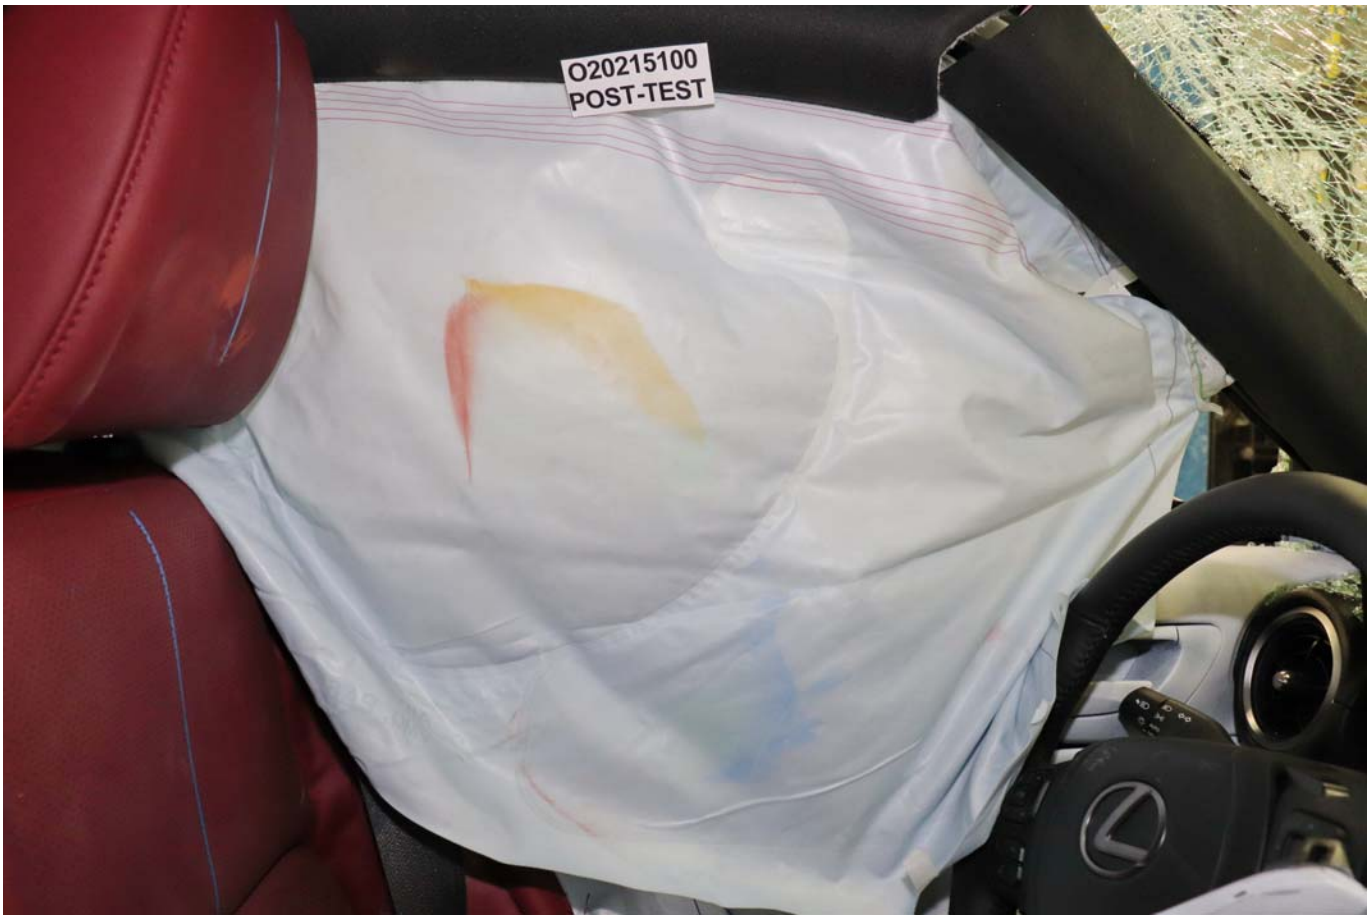
Photo No. 047 - Post-Test Dummy Close-Up Head Contact with Side Air Bag View

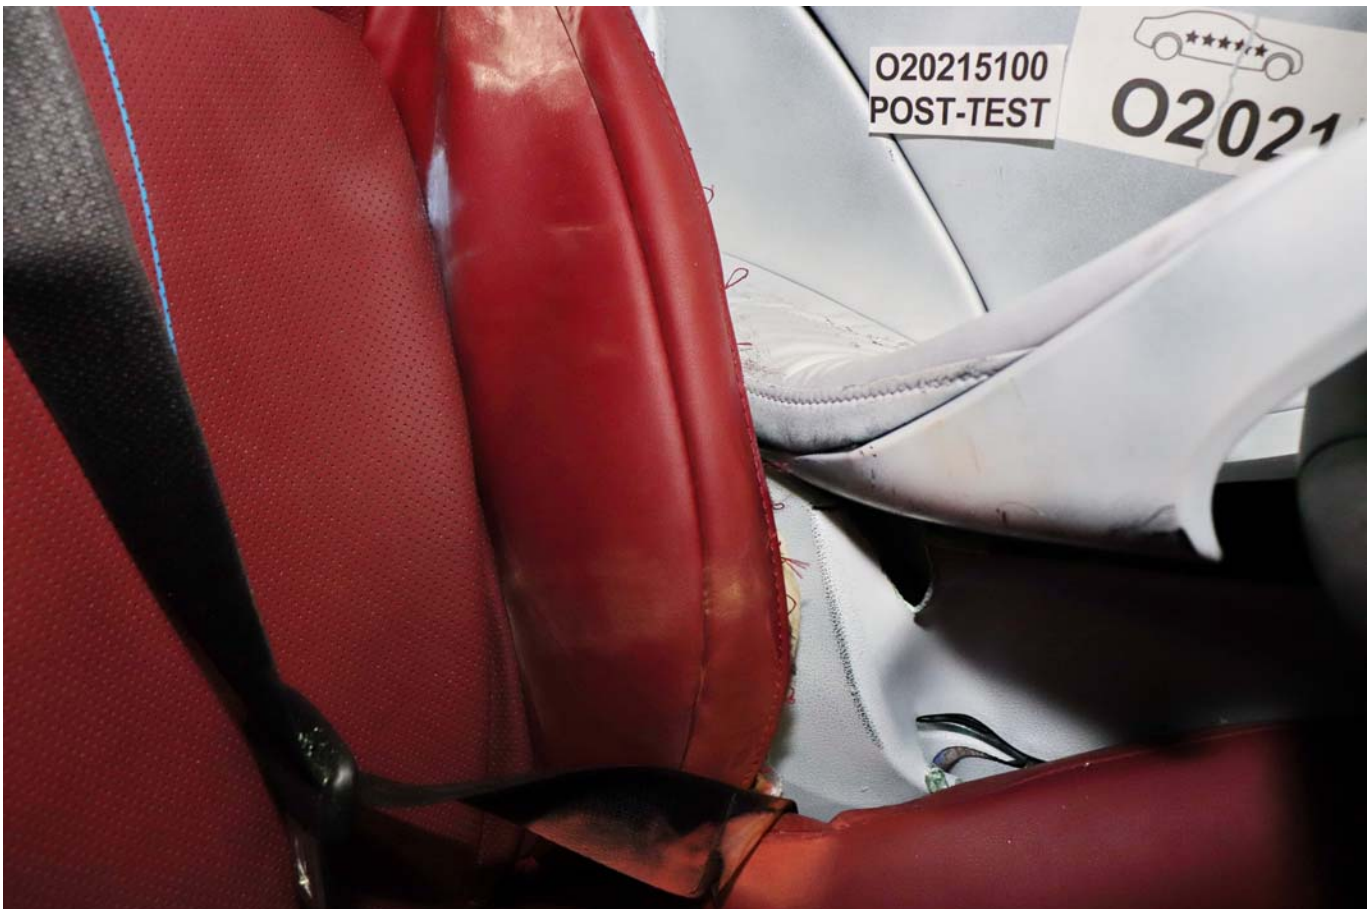
Photo No. 048 - Post-Test Dummy Close-Up Torso Contact with Vehicle Interior View

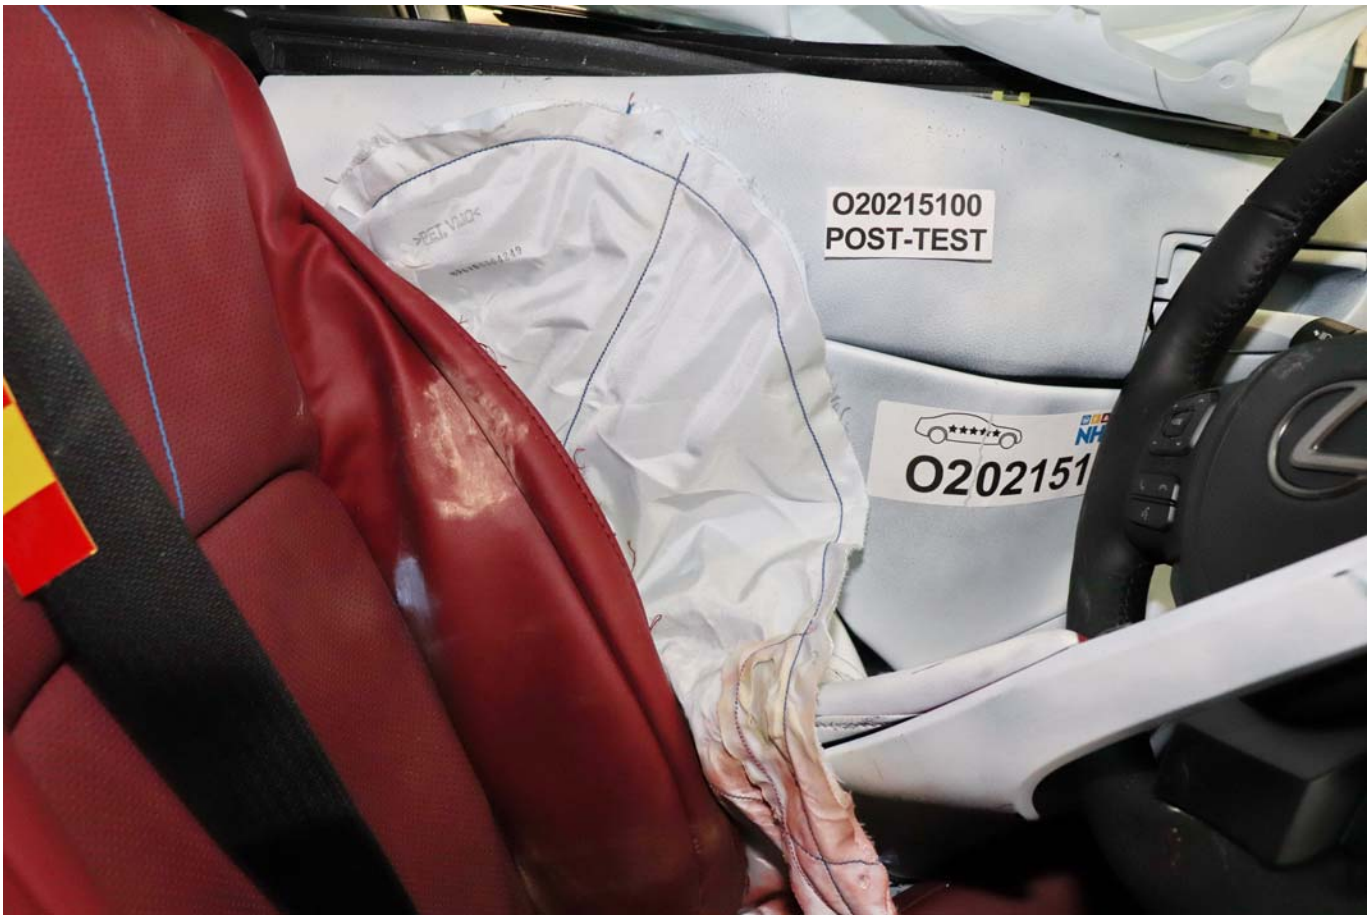
Photo No. 049 - Post-Test Dummy Close-Up Torso Contact with Side Air Bag View

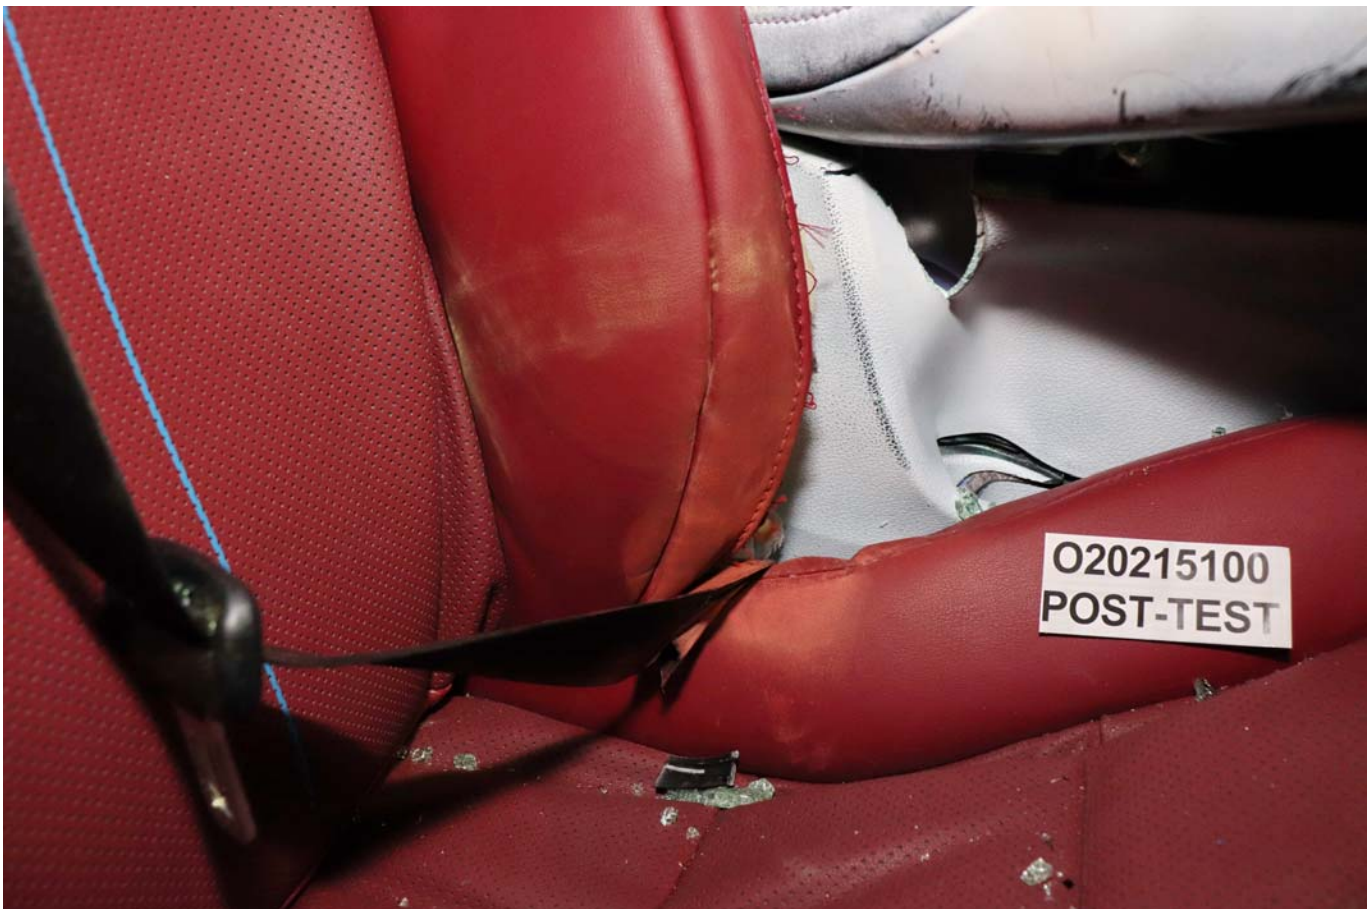
Photo No. 050 - Post-Test Dummy Close-Up Pelvis Contact with Vehicle Interior View

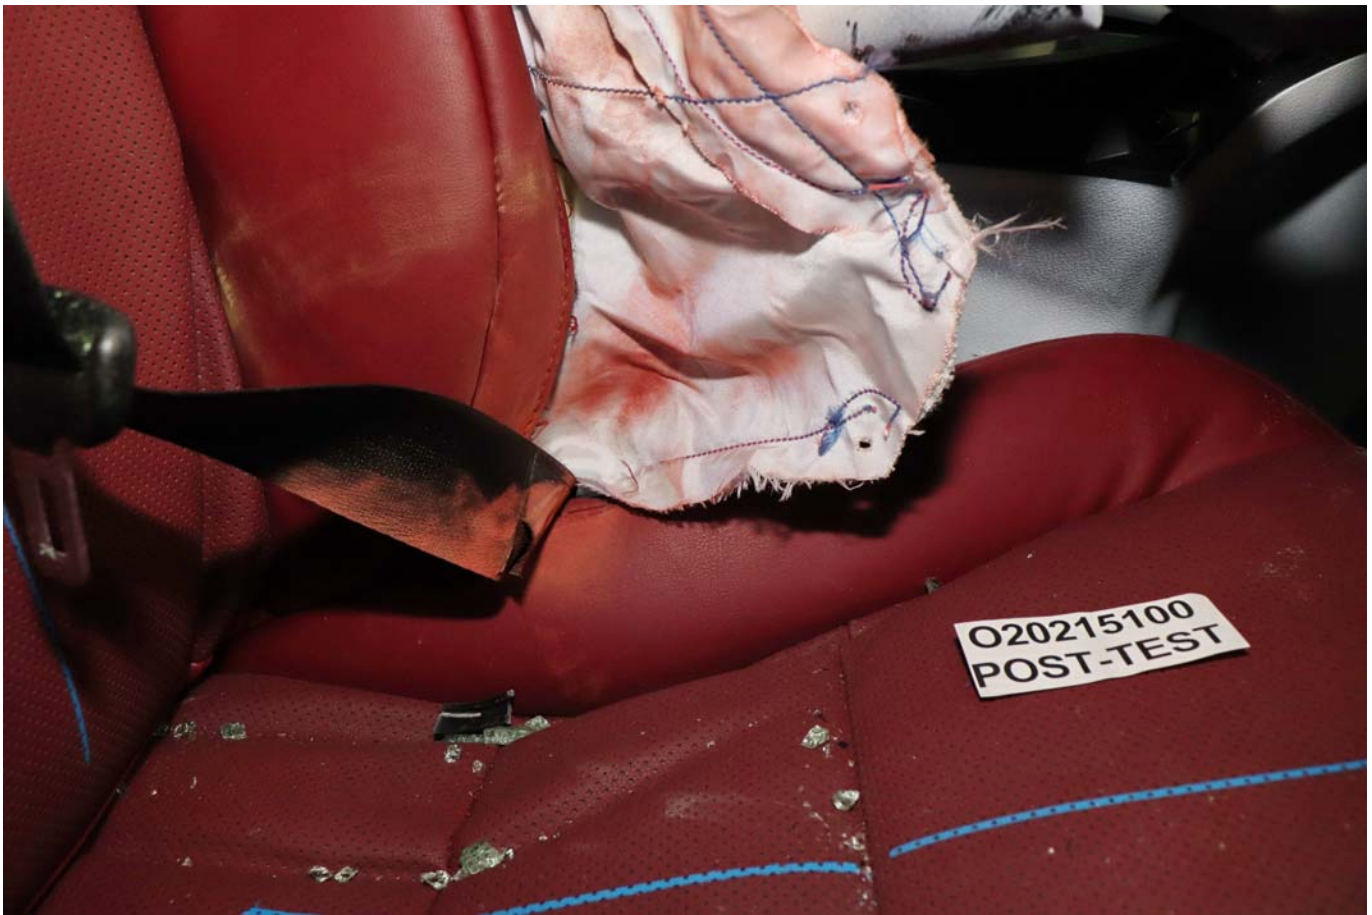
Photo No. 051 - Post-Test Dummy Close-Up Pelvis Contact with Side Air Bag View

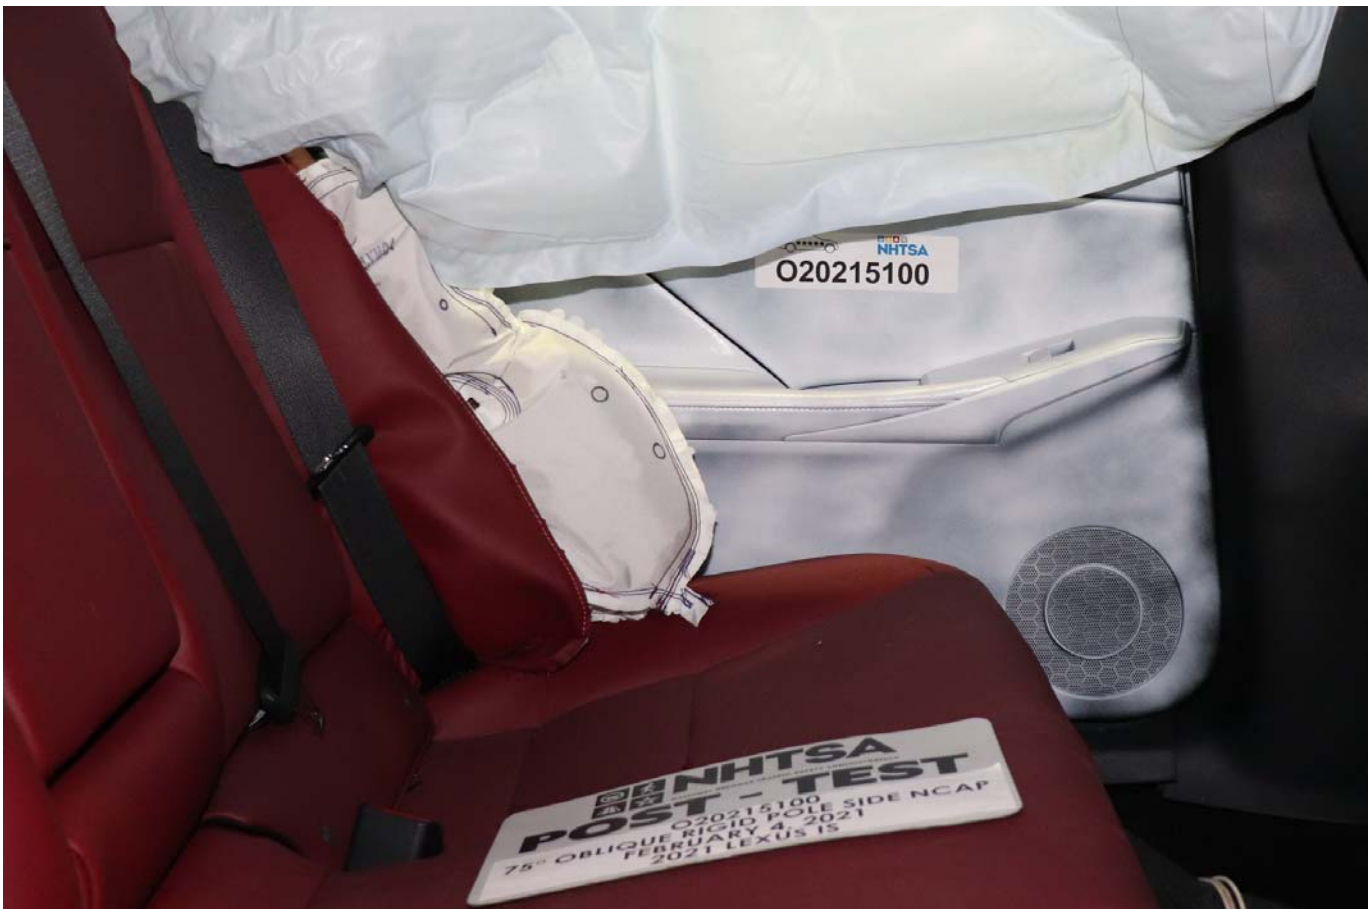
Photo No. 054 - Post-Test Inner Rear Passenger Torso Air Bag Deployment View

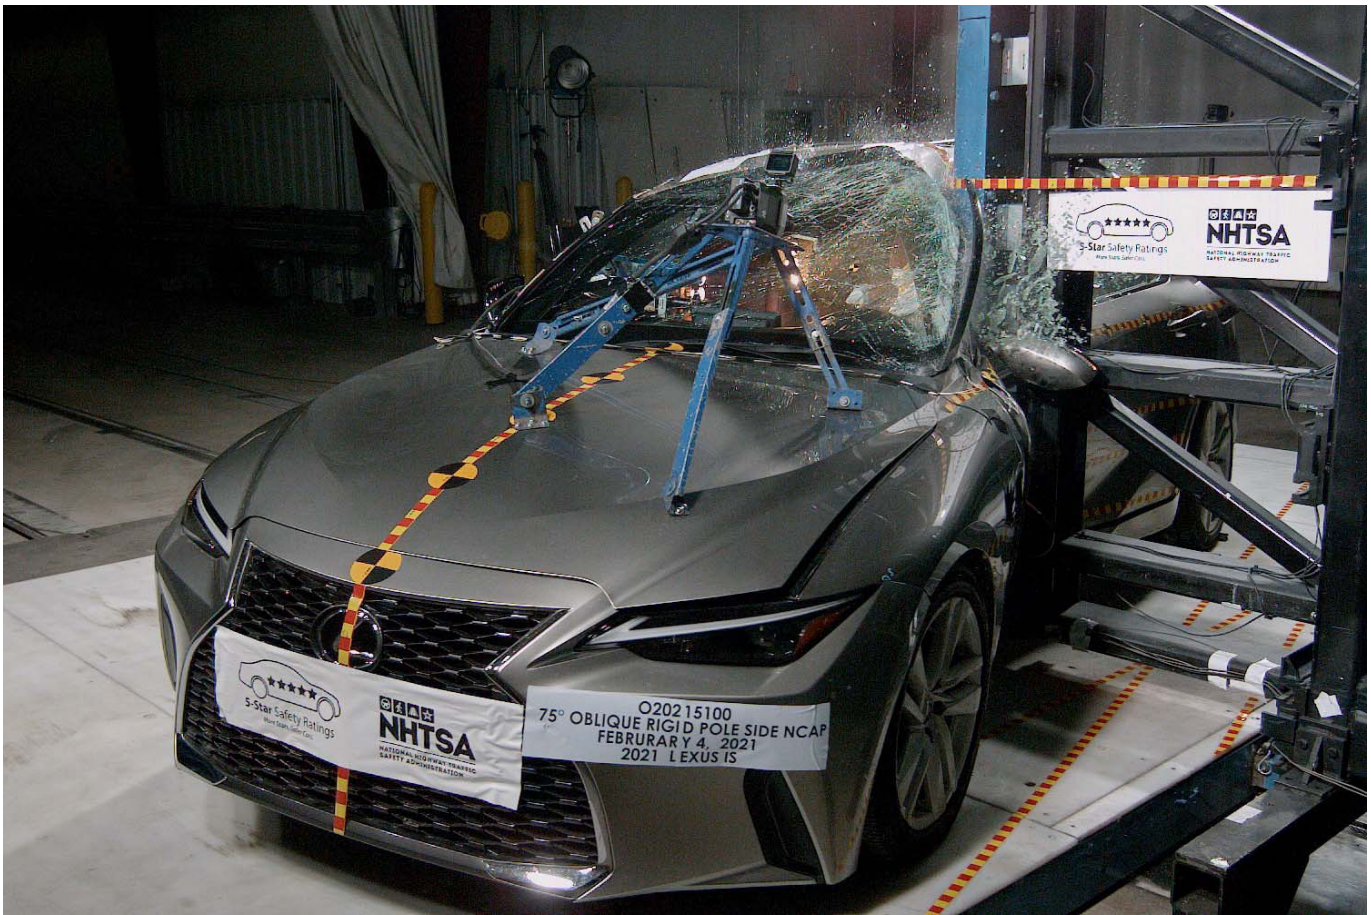
Photo No. 070 - Impact Event

A rigid pole side impact test was conducted on a 2021 Lexus IS 300 4-Door Sedan. The subject vehicle was towed into the rigid pole at an angle of 75° and a velocity of 32.27 km/h. The test was conducted by MGA Research Corporation in Burlington, Wisconsin on February 4, 2021. Pre-test and post-test photographs of the test vehicle and side impact dummy (SID-IIs) are included in Appendix A of this report.

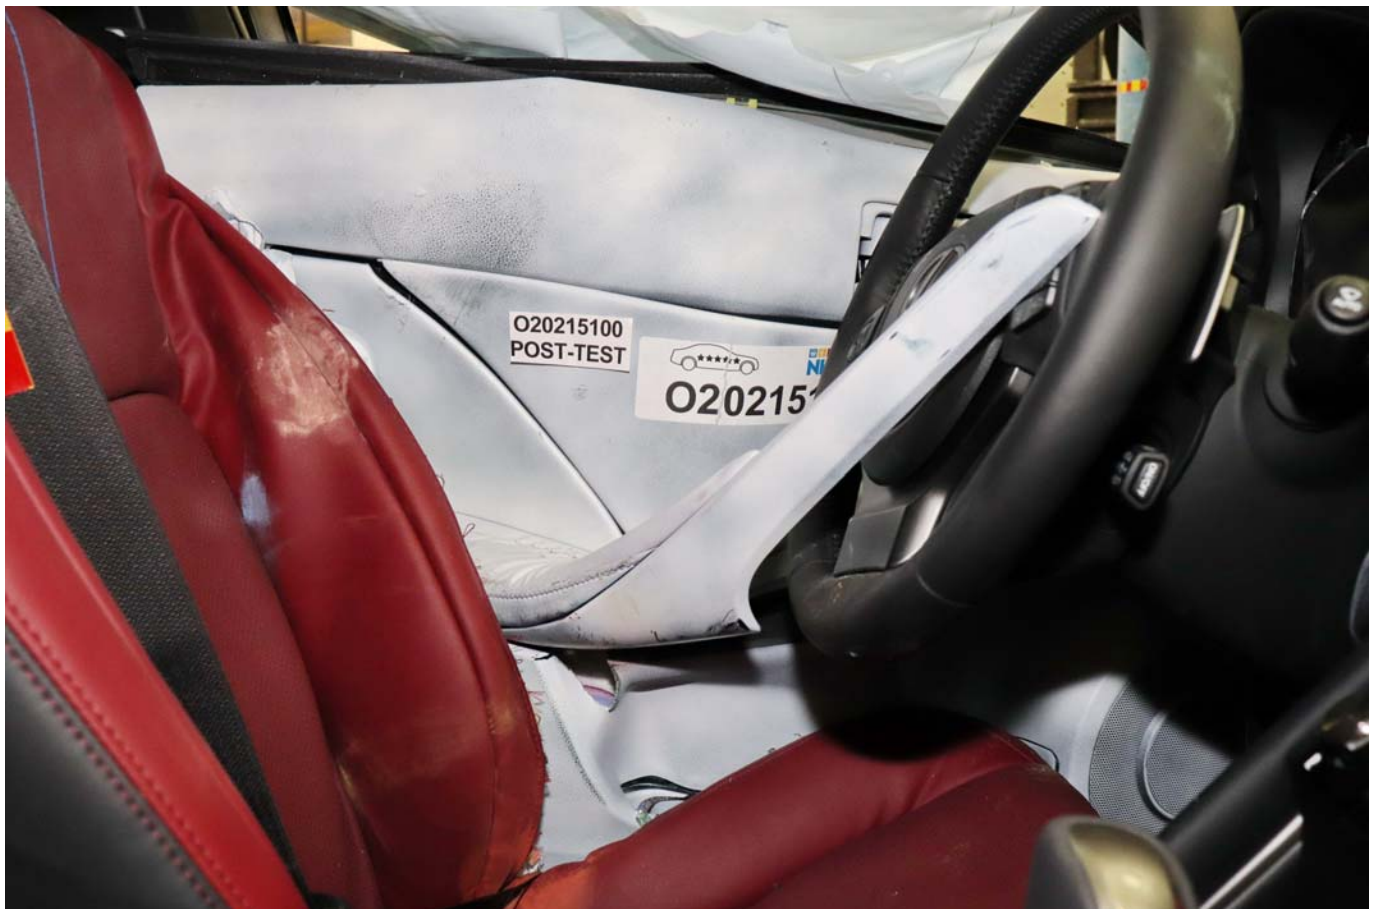
Photo No. 073 - Post-Test View of Shattered Vehicle Inner Door Panel
