REPORT NUMBER: NCAP-MGA-21-023

**NEW CAR ASSESSMENT PROGRAM (NCAP)
Frontal Barrier Impact Test**

**FCA USA LLC
2021 Ram 2500 Crew Cab 4x4
NHTSA No.: M20210301**

**MGA RESEARCH CORPORATION
5000 Warren Road
Burlington, WI 53105**

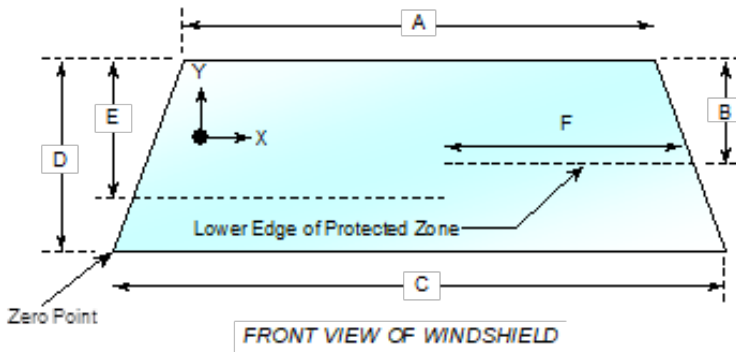
WINDSHIELD PERIPHERY MEASUREMENTS

Measurement	Pre-Test (mm)	Post-Test (mm)	% of Retention
Left Side	2265	2265	100
Right Side	2265	2265	100
Total	4530	4530	100

Item	Units	Value
A	mm	1388
B	mm	445
C	mm	1568
D	mm	787
E	mm	505
F	mm	453

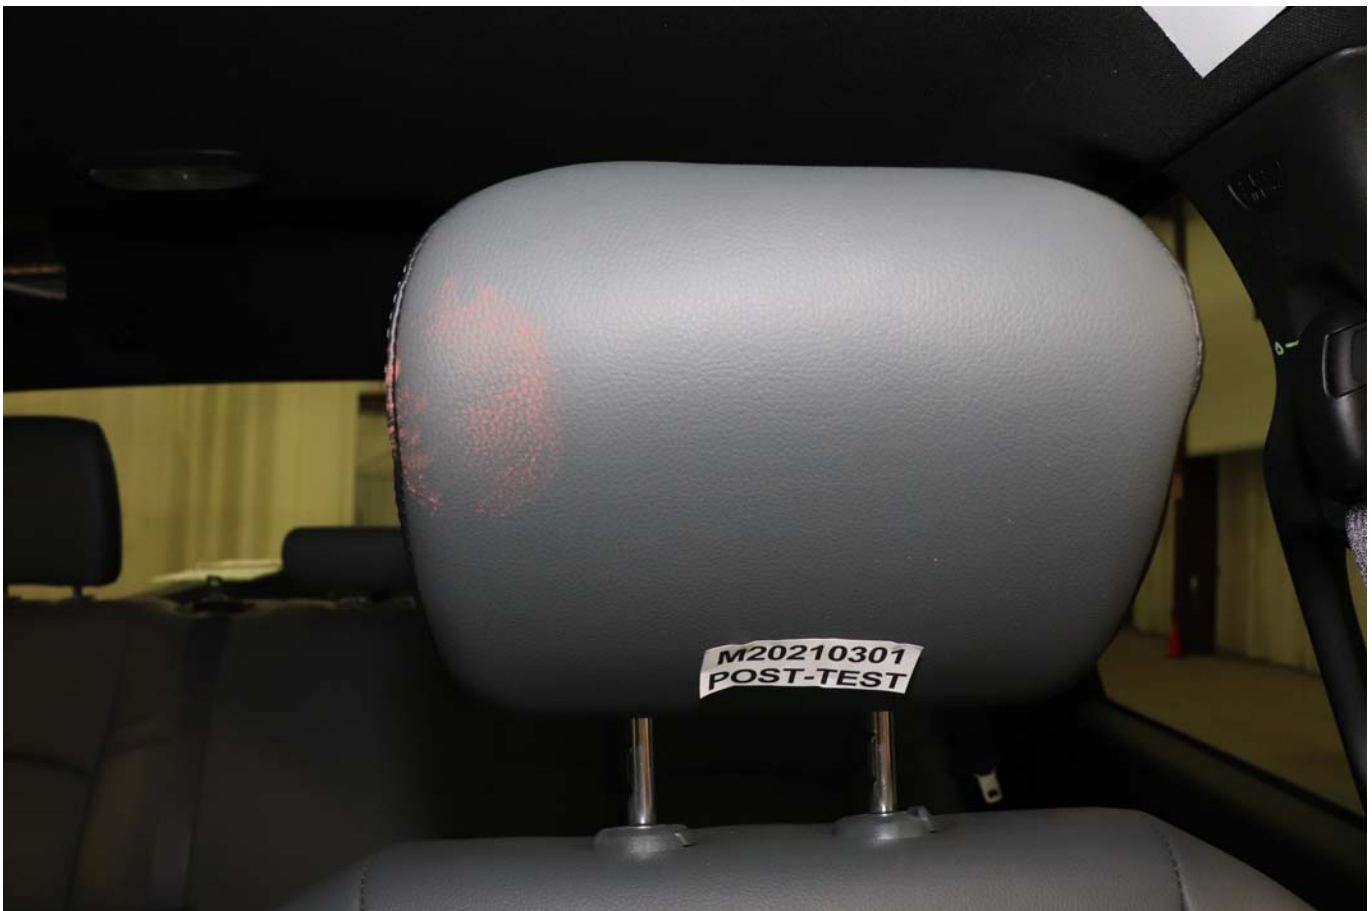
Photo No. 049 - Post-Test Driver Dummy Contact with Airbag

The driver's visible contact points were as follows: The driver's head contacted the airbag. The driver's head also contacted the headrest. The driver's knees contacted the knee bolster.

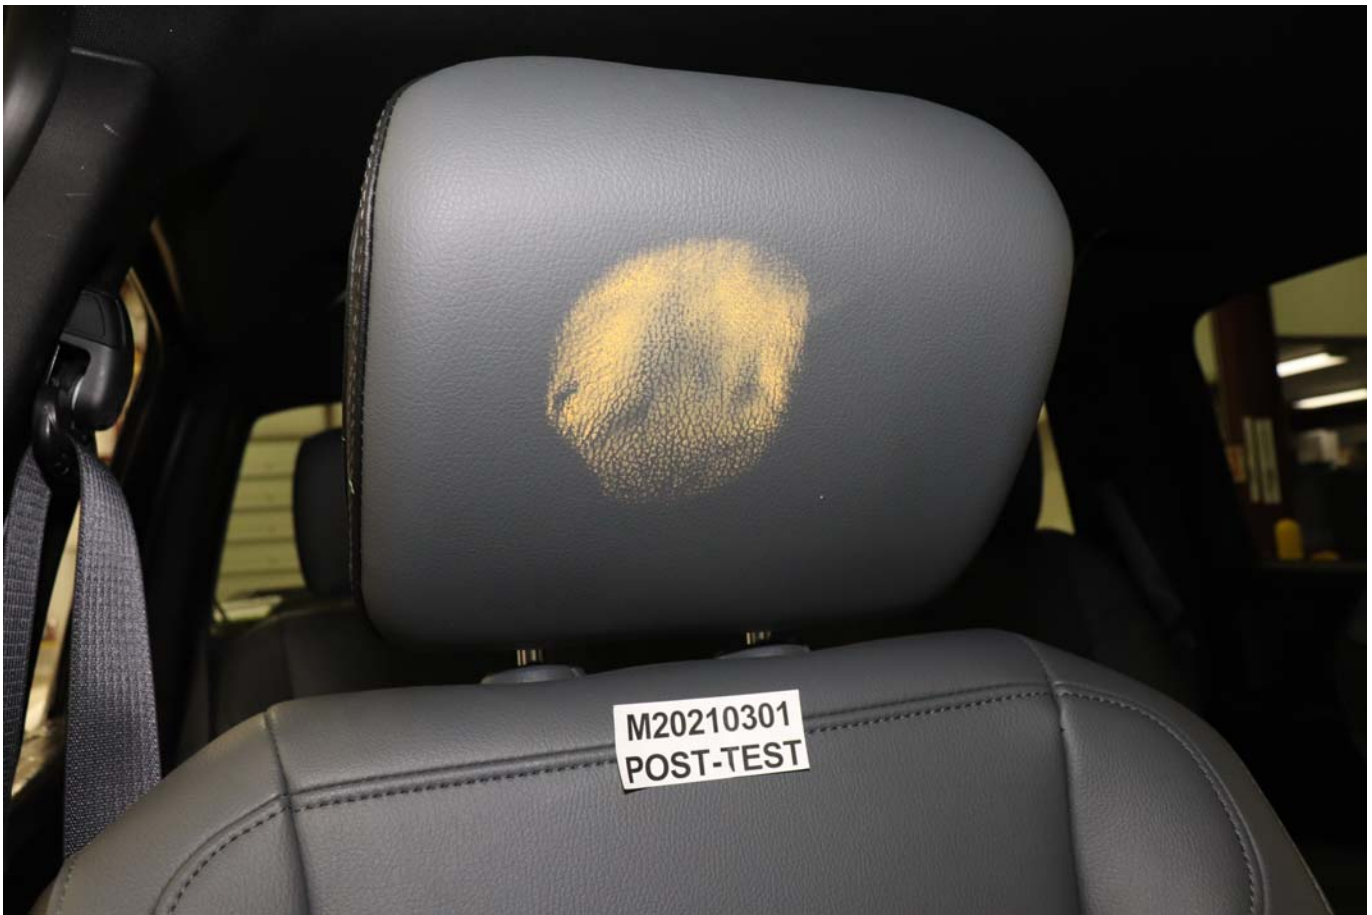
Photo No. 072 - Post-Test Passenger Dummy Contact with Airbag

The passenger's visible contact points were as follows: The passenger's head contacted the airbag. The passenger's head also contacted the headrest. The passenger's knees contacted the glove box.
