**REPORT NUMBER: SideNCAPMDB-MGA-21-021**

**NEW CAR ASSESSMENT PROGRAM (NCAP) Moving  
Deformable Barrier Side Impact Test**

**TOYOTA MOTOR CORPORATION  
2021 Toyota Prius Prime Hybrid LE 5-Door Hatchback  
NHTSA No.: O20215107**

**MGA RESEARCH CORPORATION  
5000 Warren Road  
Burlington, WI 53105**

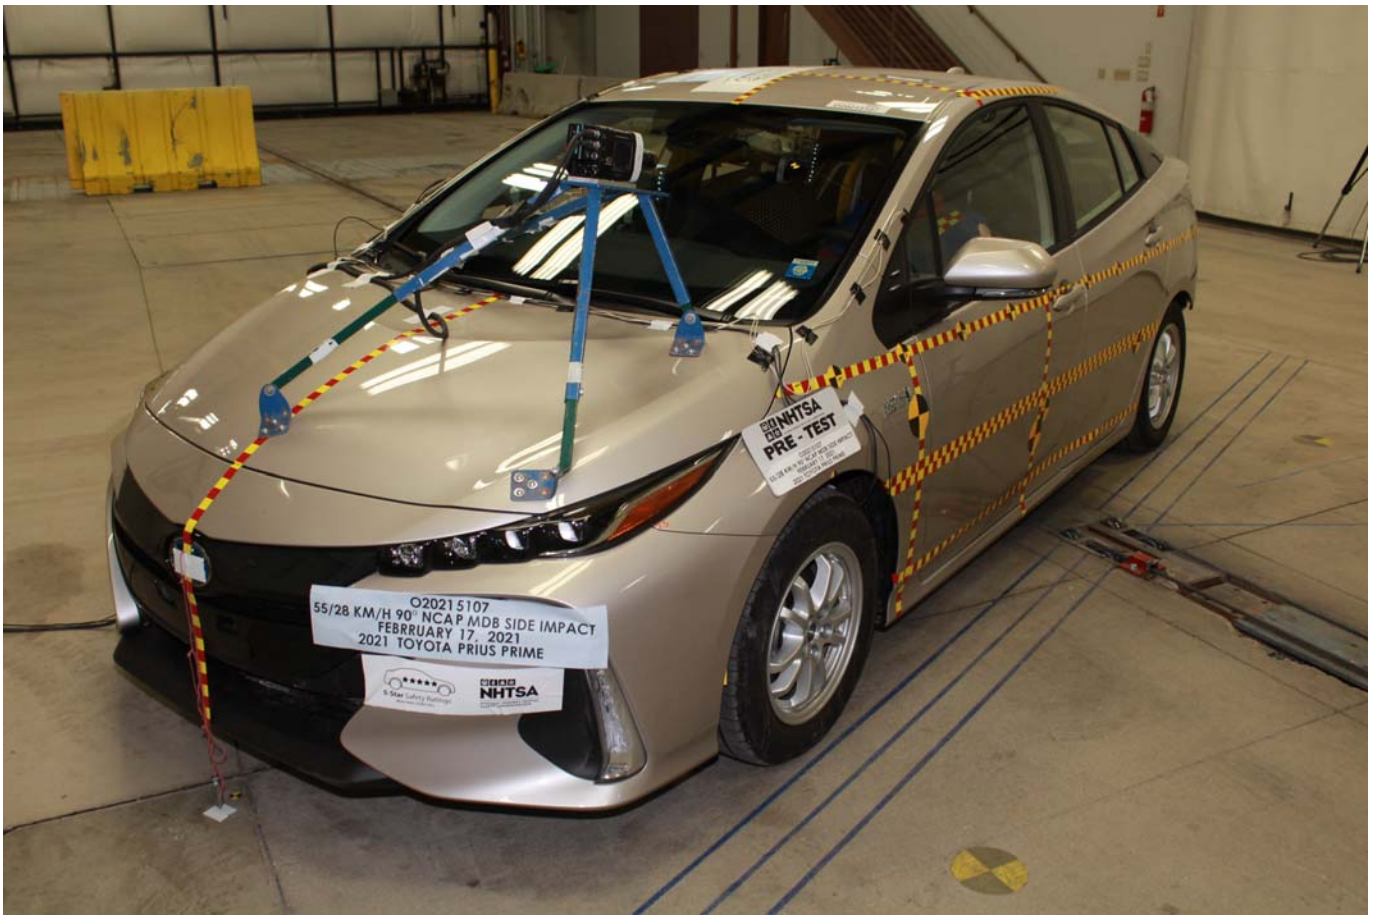
Photo No. 004 - Post-Test Frontal View of Test Vehicle

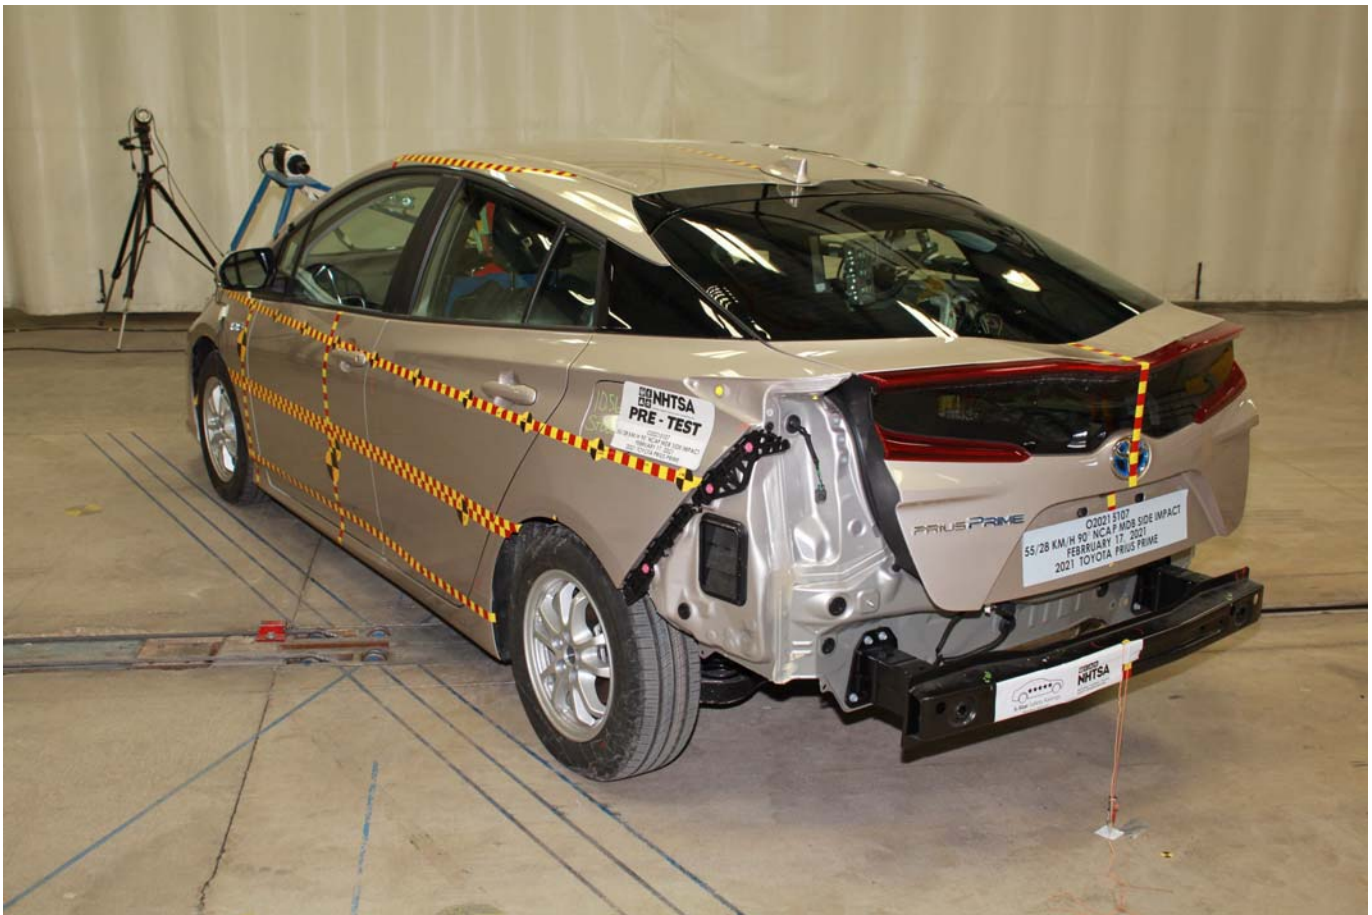
Photo No. 008 - Post-Test Left Side View of Test Vehicle

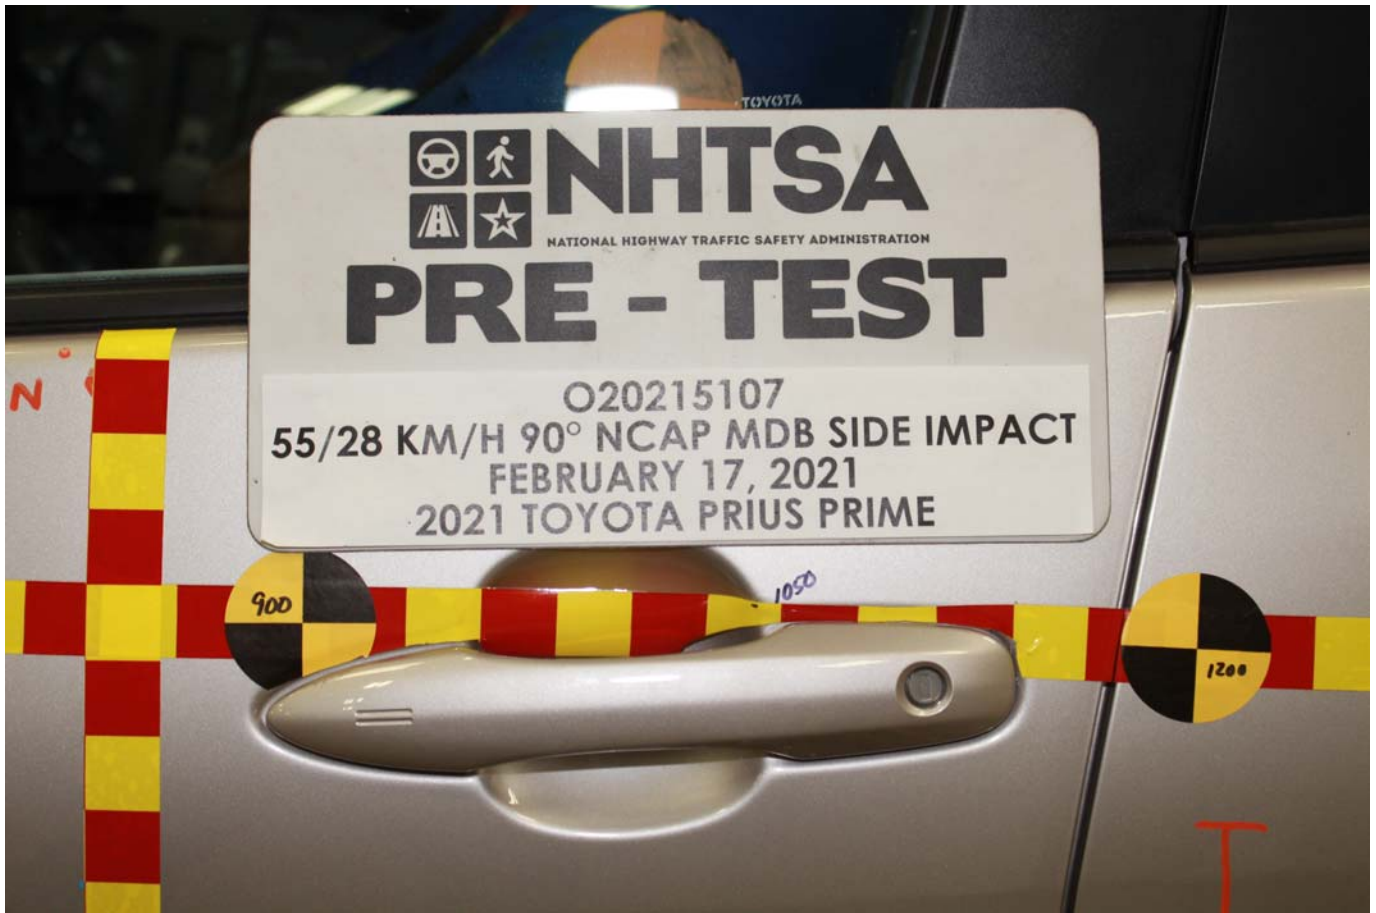
Photo No. 020 - Post-Test Close-Up View of Impact Point Target

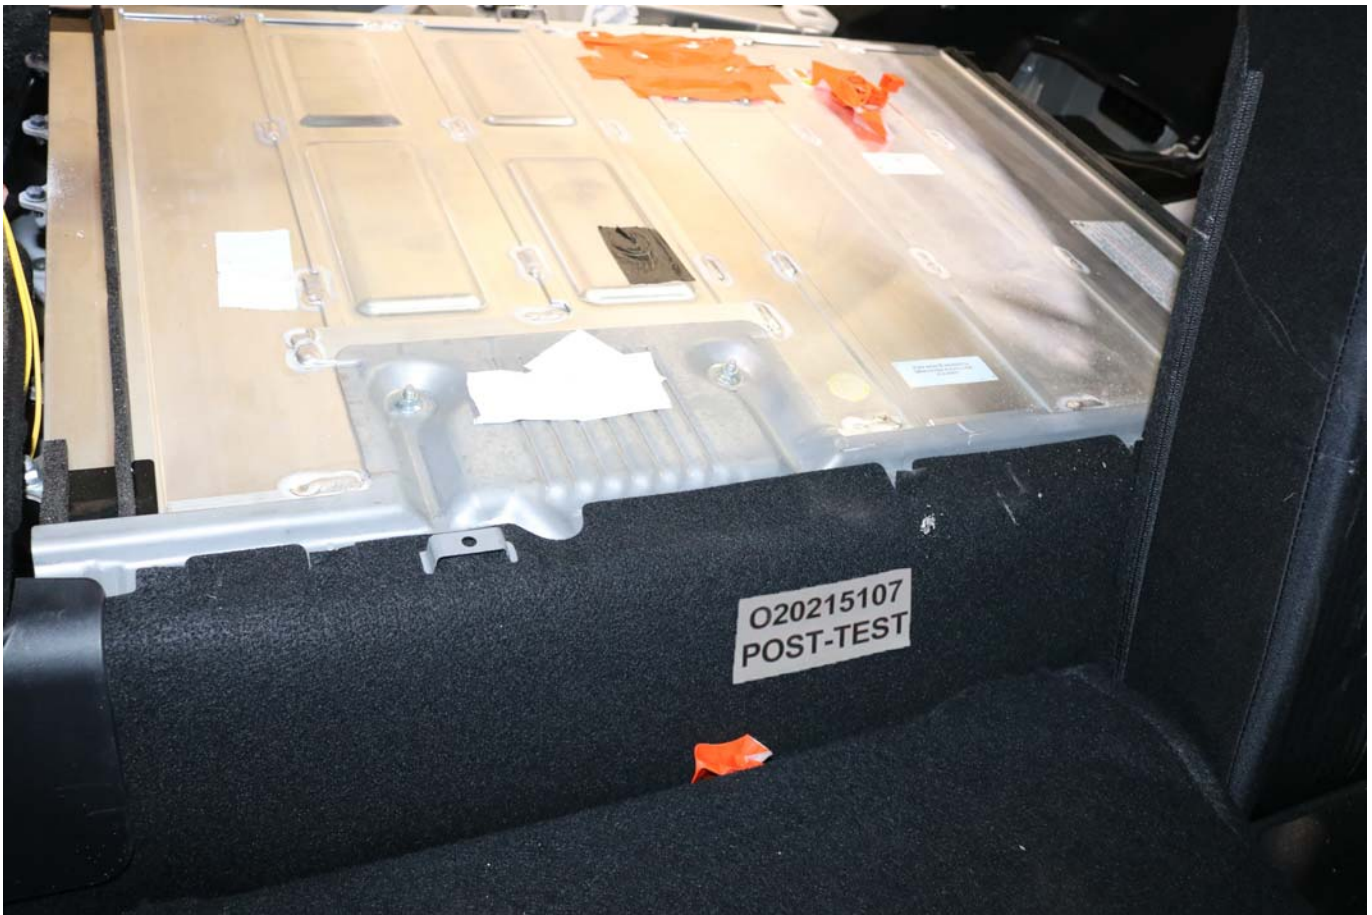
Photo No. 305-09 - Pre-Impact View of Propulsion Battery
