**REPORT NUMBER: NCAP-MGA-21-024**

**NEW CAR ASSESSMENT PROGRAM (NCAP)  
Frontal Barrier Impact Test**

**TOYOTA MOTOR MANUFACTURING, INDIANA, INC.  
2021 Toyota Sienna Hybrid XLE AWD Minivan  
NHTSA No.: O20215108**

**FINAL REPORT**

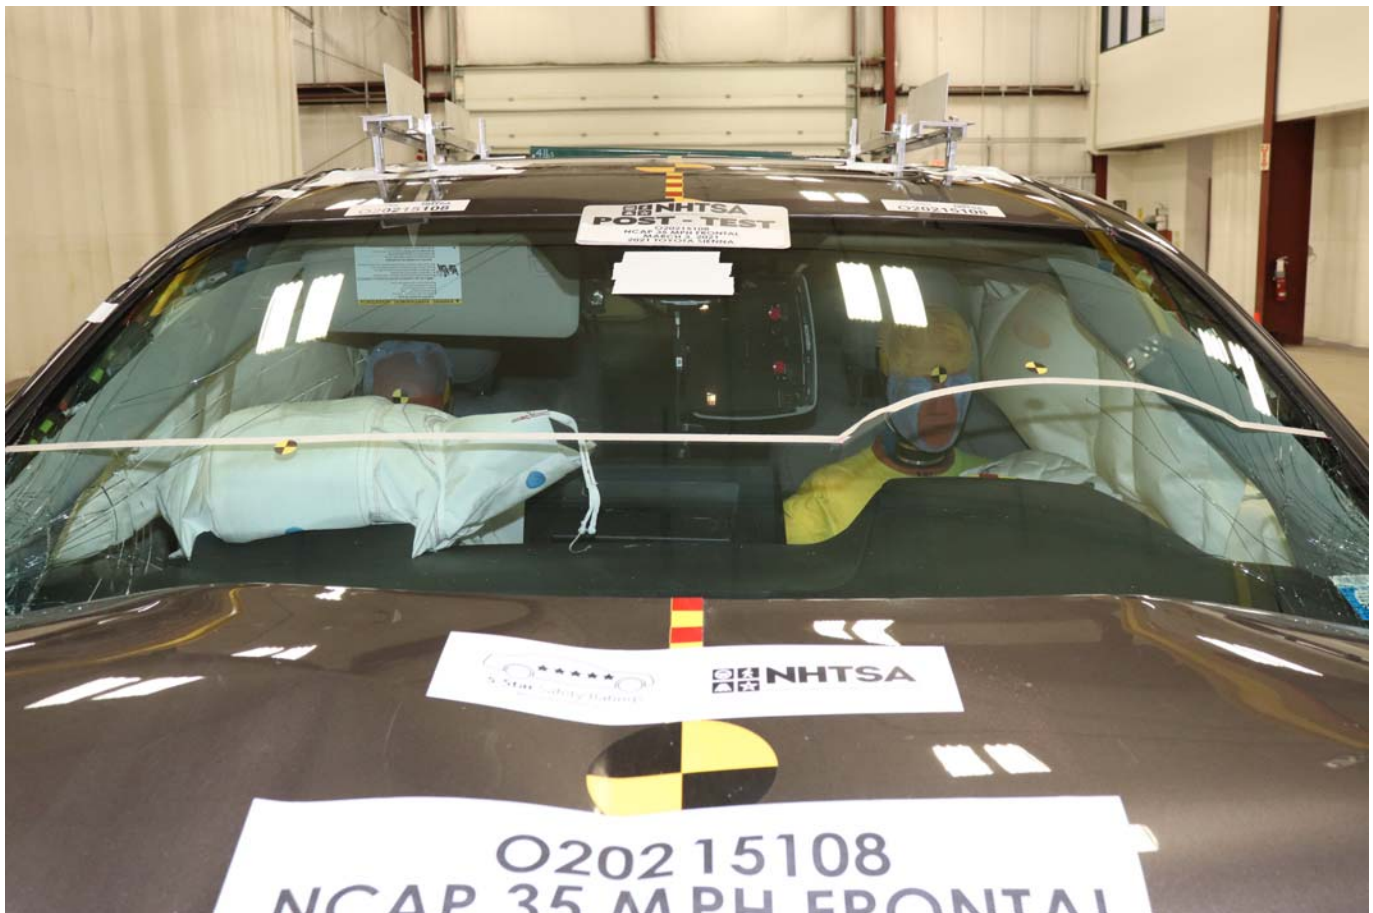
Critical Areas of Performance	Observations and Conclusions
Windshield Damage	Cracked at lower corners
Window Damage	None
Other Notable Effects	Hood unlatched during event.

Photo No. 019 - Post-Test Windshield View

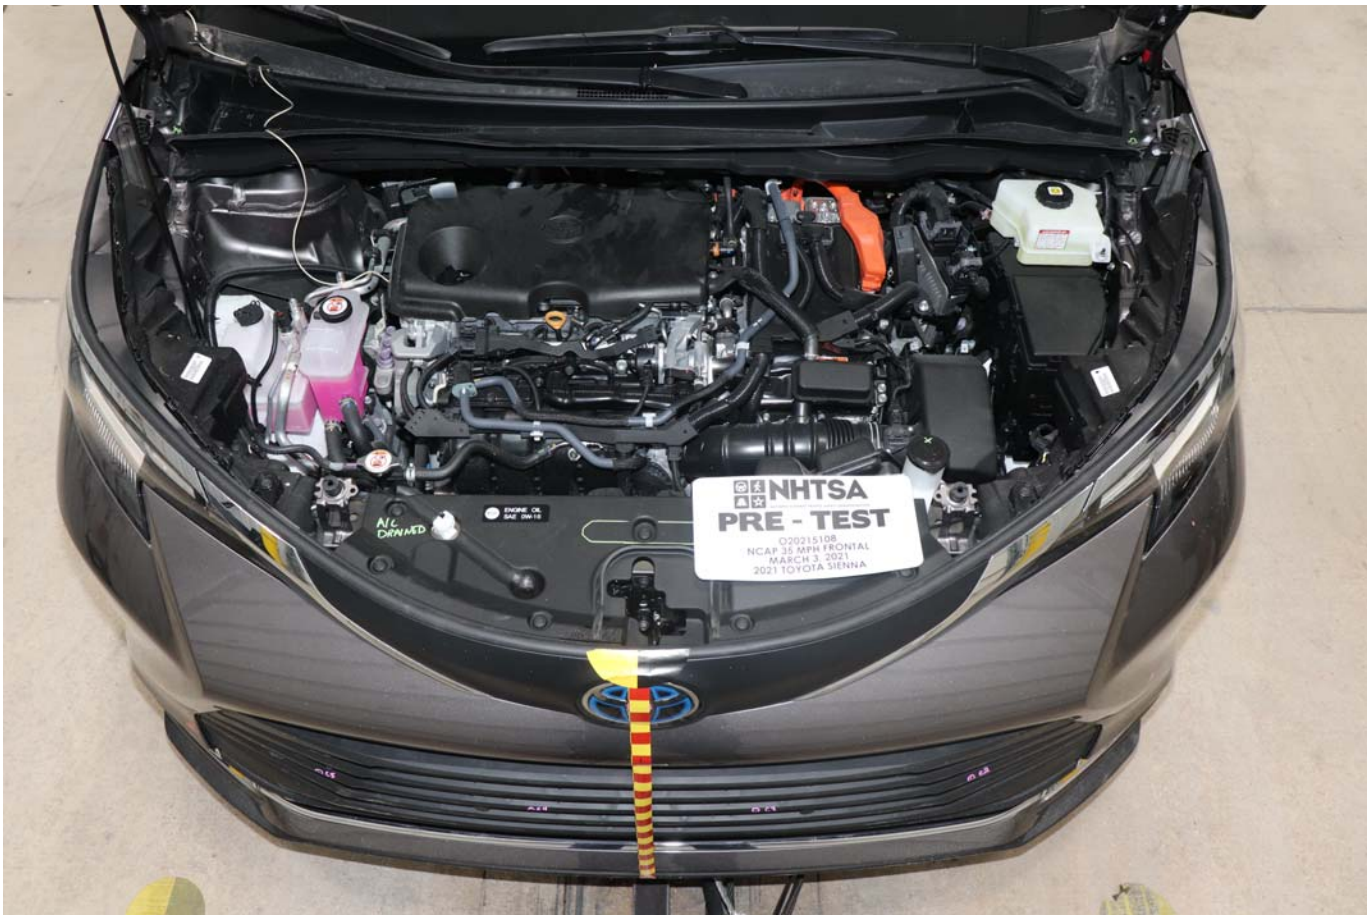
Photo No. 020 - Pre-Test Engine Compartment View

Photo No. 021 - Post-Test Engine Compartment View
