**REPORT NUMBER: SINCAP-CAL-21-004**

# NEW CAR ASSESSMENT PROGRAM (NCAP) MOVING DEFORMABLE BARRIER SIDE IMPACT TEST

Mercedes-Benz AG Stuttgart 2021 Mercedes C300 Four Door Sedan

NHTSA No: M20214301

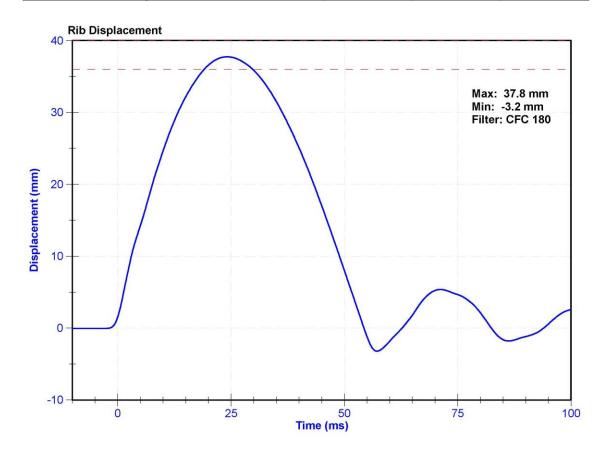
# Certification Report ES-2re Middle Rib Drop 3 m/s - CFR 572

Test Parameter	Minimum Specification	Maximum Specification	Unit	Result	Pass/Fail
Temperature	20.6	22.2	°C	21.0	Pass
Humidity	10	70	%	23.4	Pass
Rib Displacement	36	40	mm	37.8	Pass

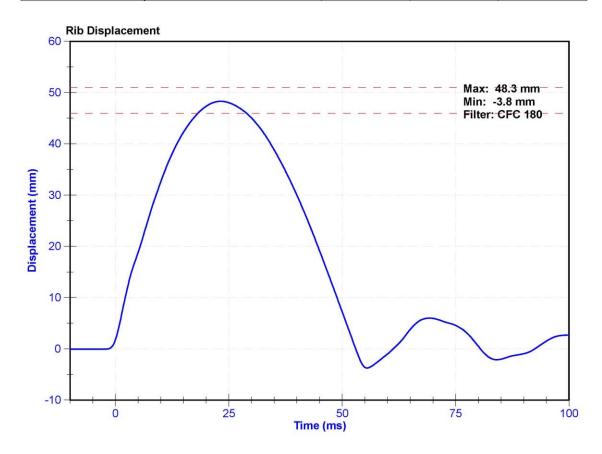
# Certification Report ES-2re Middle Rib Drop 4 m/s - CFR 572

Test Parameter	Minimum Specification	Maximum Specification	Unit	Result	Pass/Fail
Temperature	20.6	22.2	°C	21.2	Pass
Humidity	10	70	%	22.1	Pass
Rib Displacement	46	51	mm	48.3	Pass

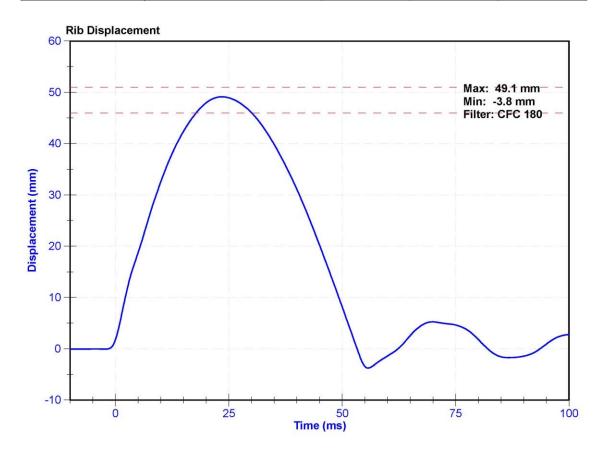
# Certification Report ES-2re Lower Rib Drop 4 m/s - CFR 572

Test Parameter	Minimum Specification	Maximum Specification	Unit	Result	Pass/Fail
Temperature	20.6	22.2	°C	21.0	Pass
Humidity	10	70	%	23.4	Pass
Rib Displacement	46	51	mm	49.1	Pass
