**REPORT NUMBER: SideNCAPPole-KAR-21-008**  
**NEW CAR ASSESSMENT PROGRAM (NCAP)**  
**SIDE IMPACT POLE TEST**

**BAYERISCHE MOTOREN WERKE AG**  
**2021 BMW 330i 4-DOOR SEDAN**

**NHTSA No: M20214101**

**FINAL REPORT**

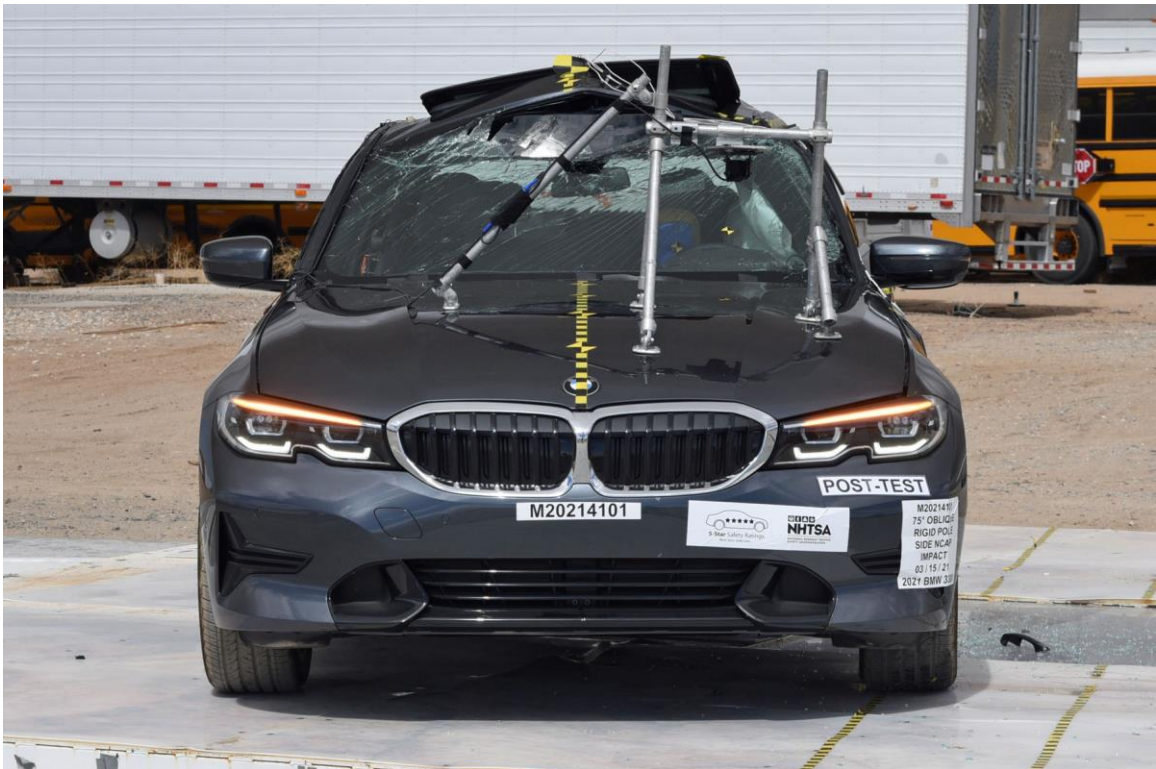
FIGURE 4. Post-Test Frontal View of Test Vehicle

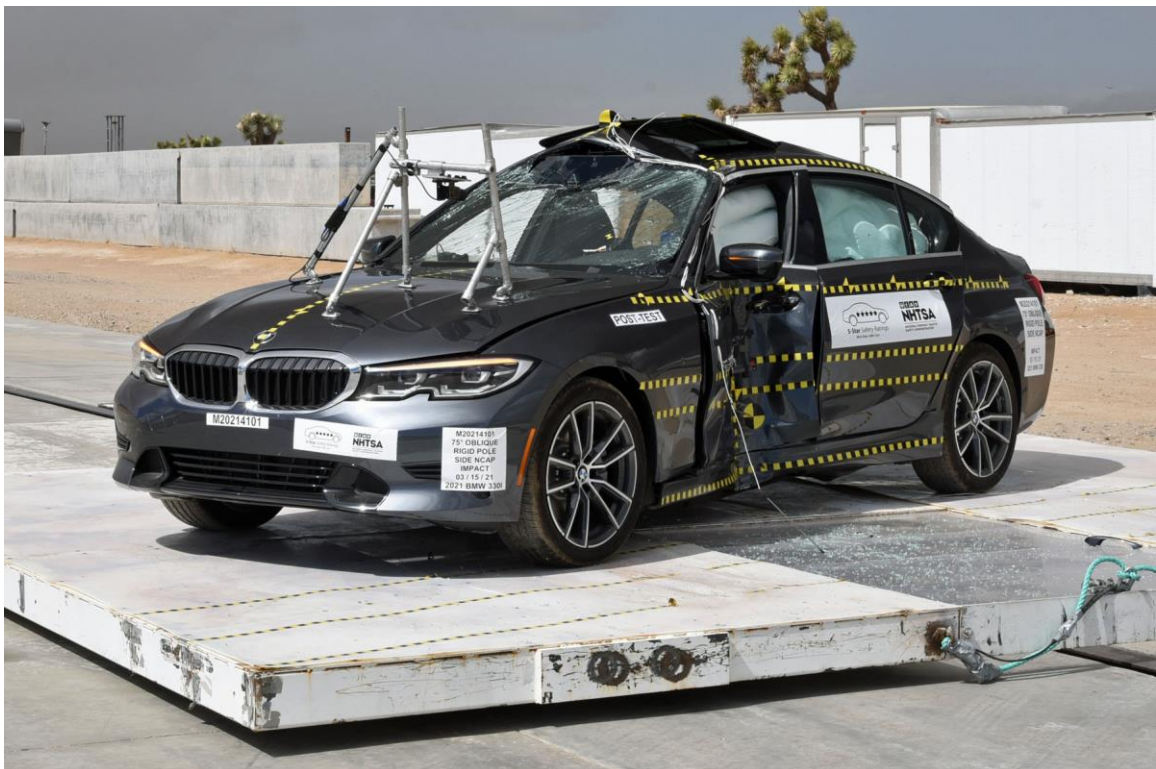
FIGURE 6. Post-Test Left Front  $\frac{3}{4}$  View of Test Vehicle

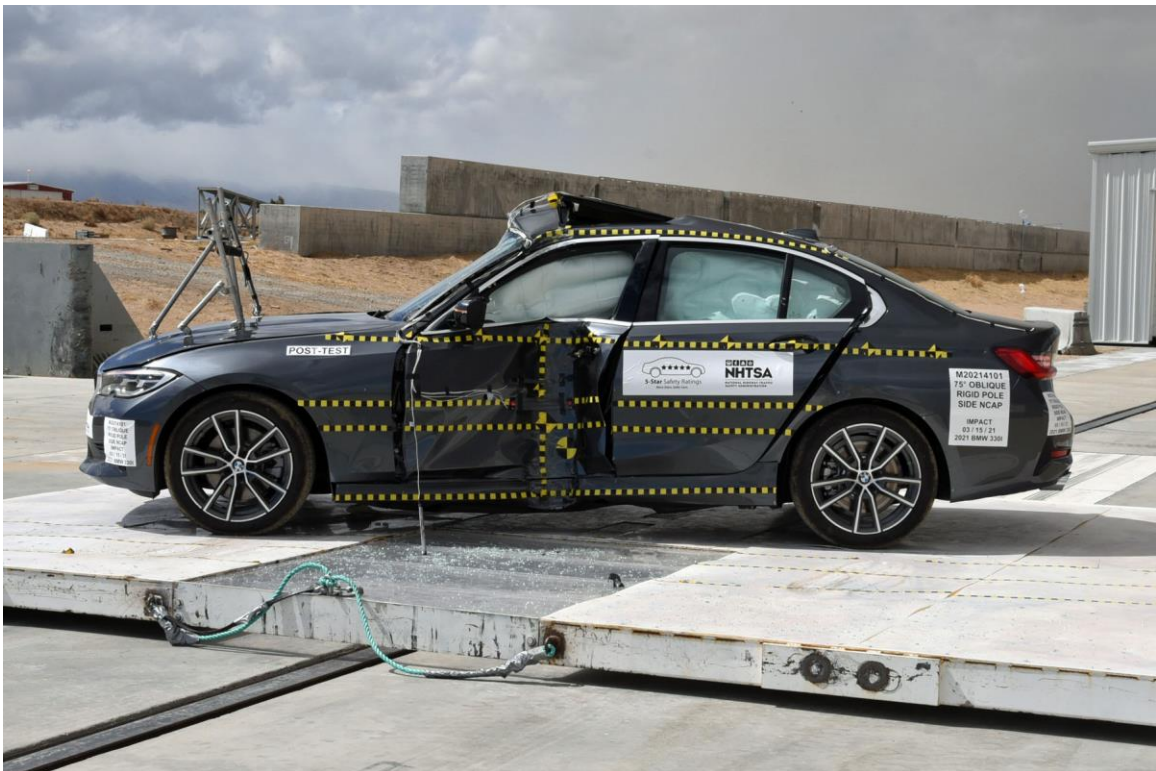
FIGURE 8. Post-Test Left Side View of Test Vehicle

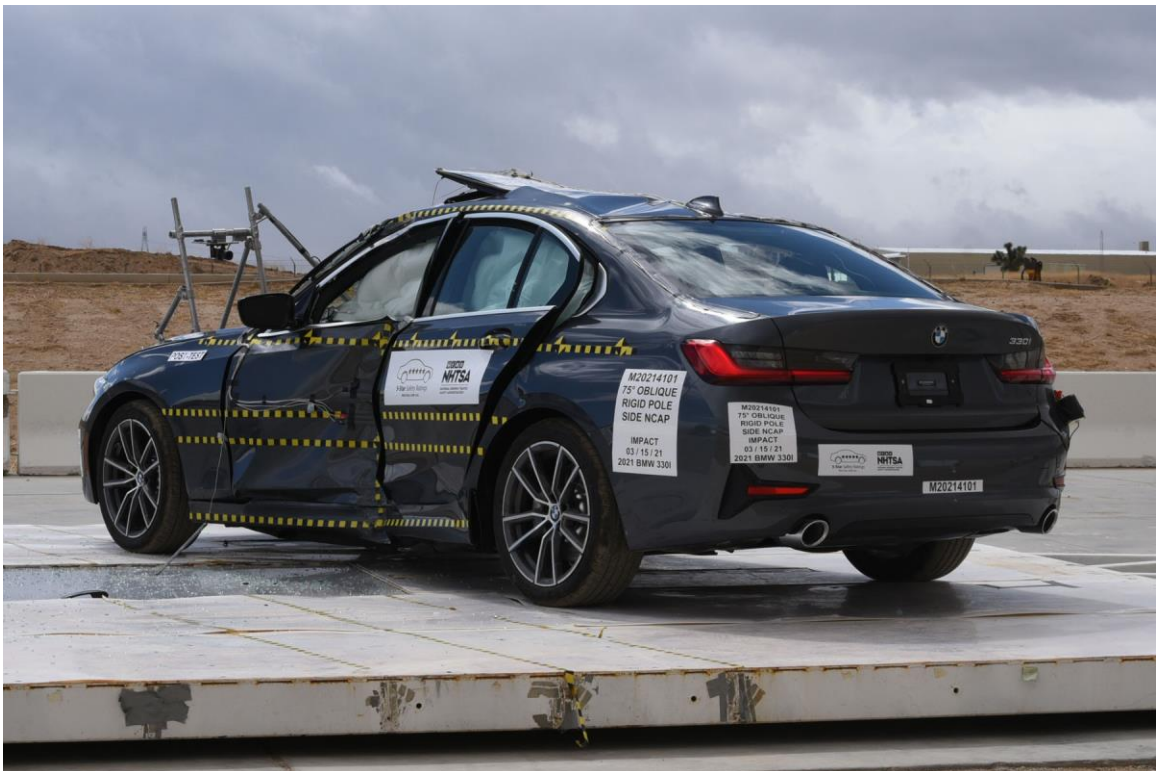
FIGURE 10. Post-Test Left Rear  $\frac{3}{4}$  View of Test Vehicle

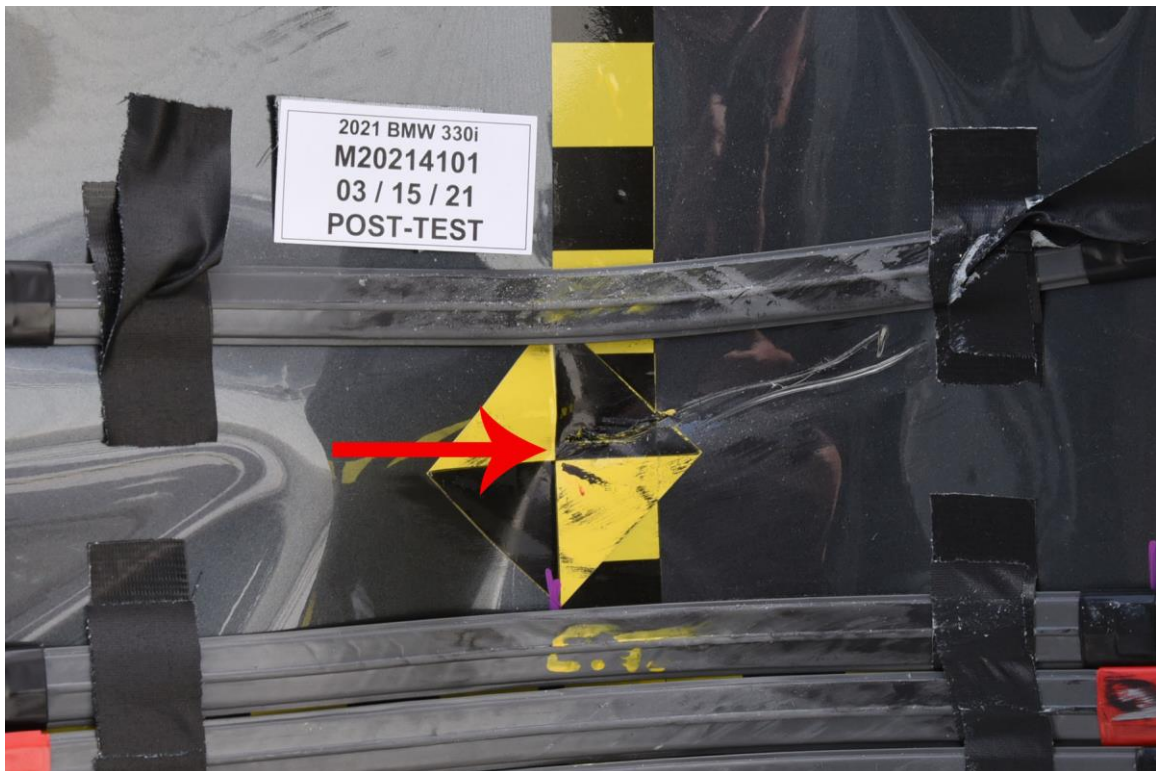
FIGURE 20. Post-Test Close-Up View of Impact Point Target Showing Impact Location

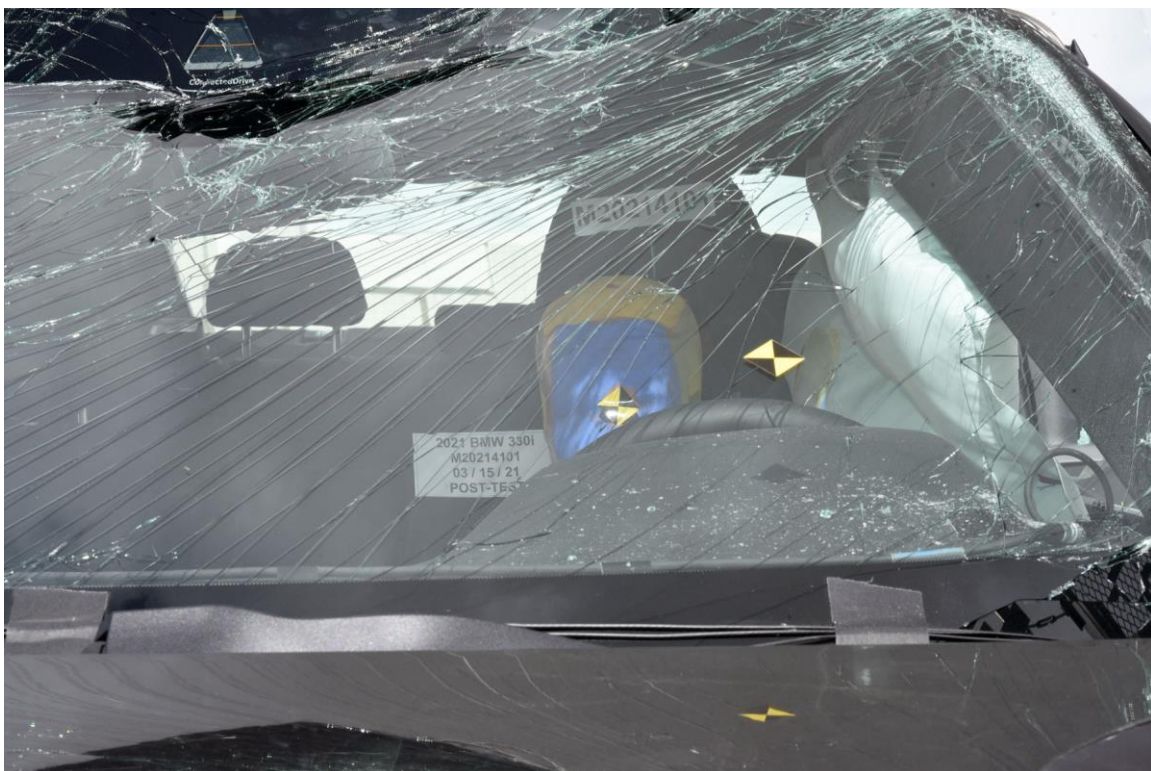
FIGURE 22. Post-Test Front Close-Up View of Dummy

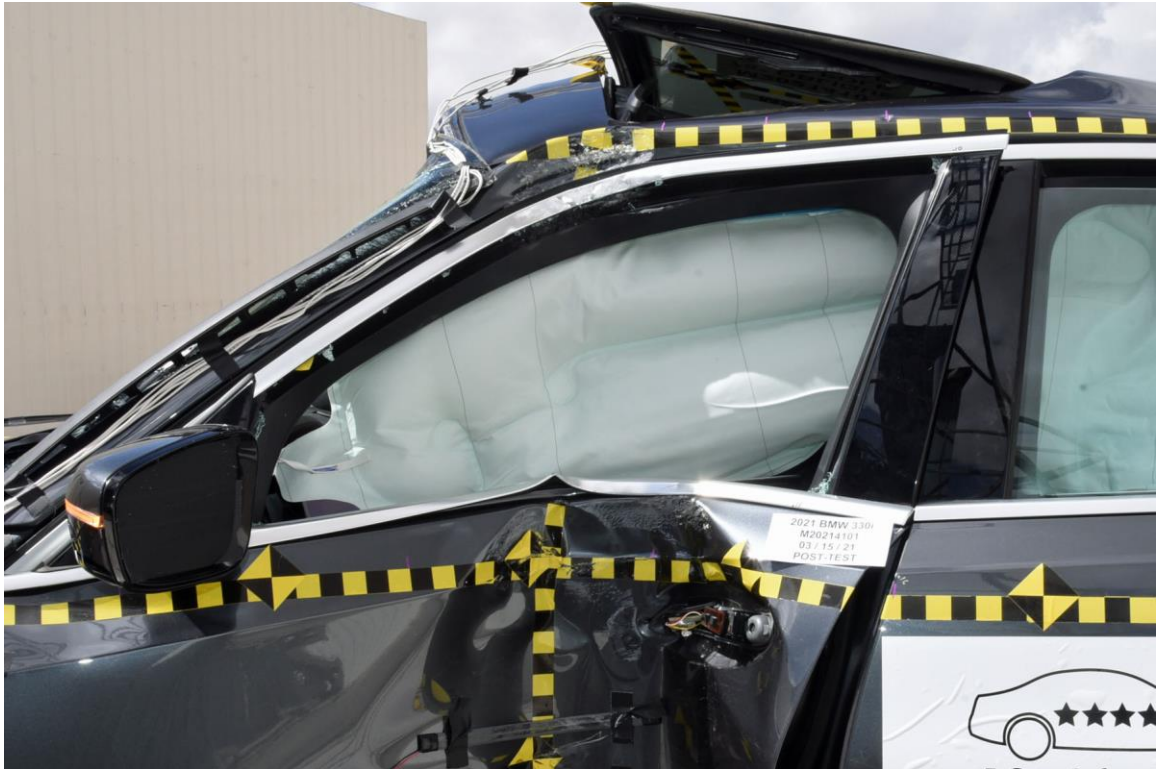
FIGURE 25. Post-Test Left Side View of Dummy Shoulder and Door Top View

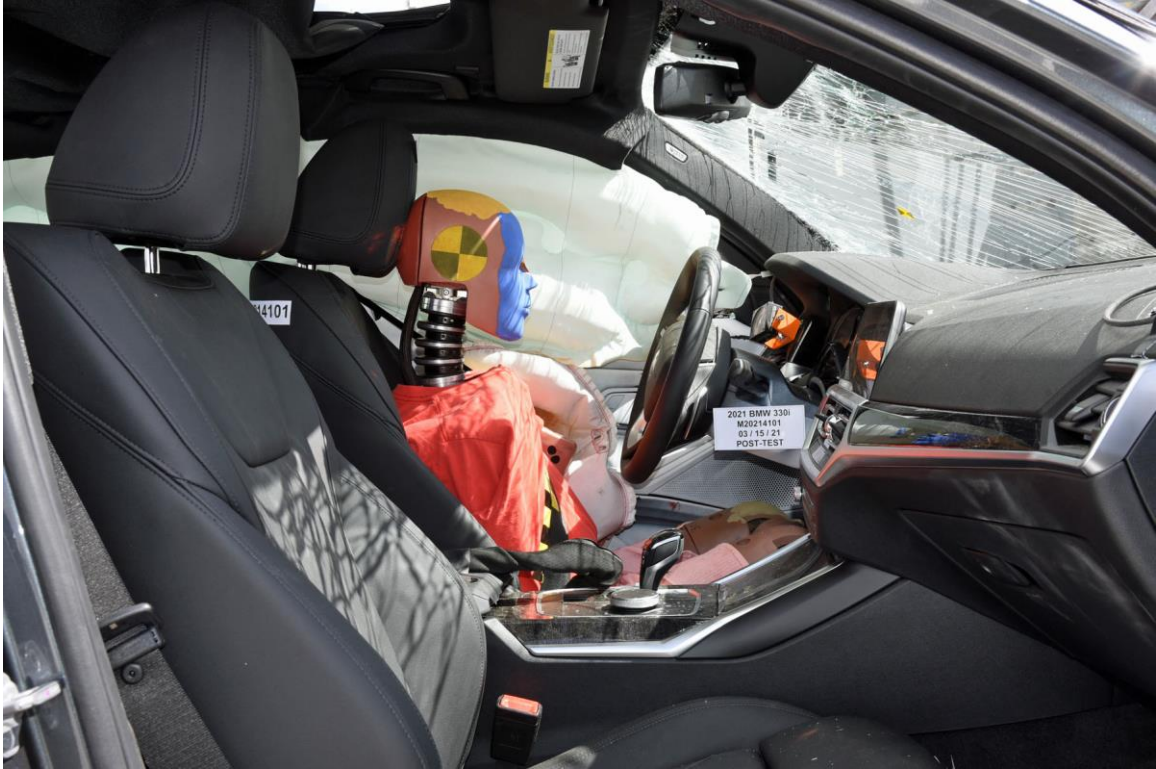
FIGURE 43. Post-Test Right Side View of Dummy and Front Seat of Occupant Compartment

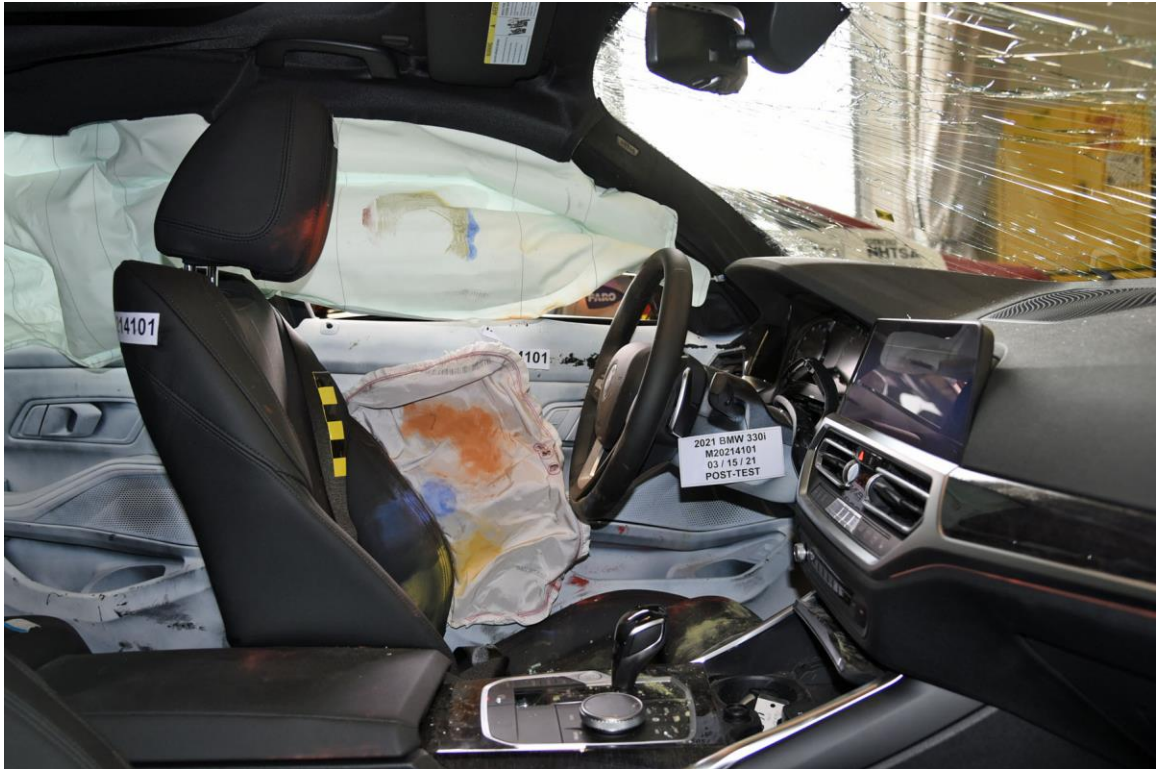
FIGURE 45. Post-Test Inner Door Panel View Showing Dummy Contact Locations

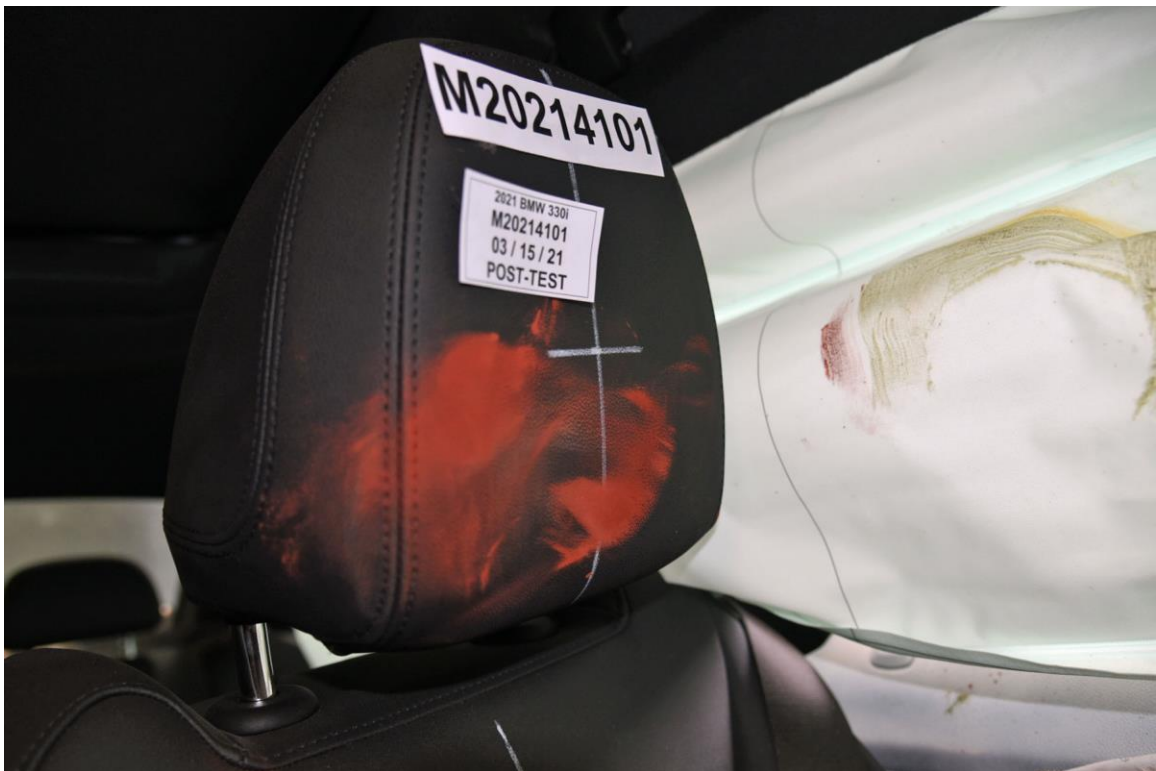
FIGURE 46. Post-Test Dummy Close-Up Head Contact with Vehicle Interior View

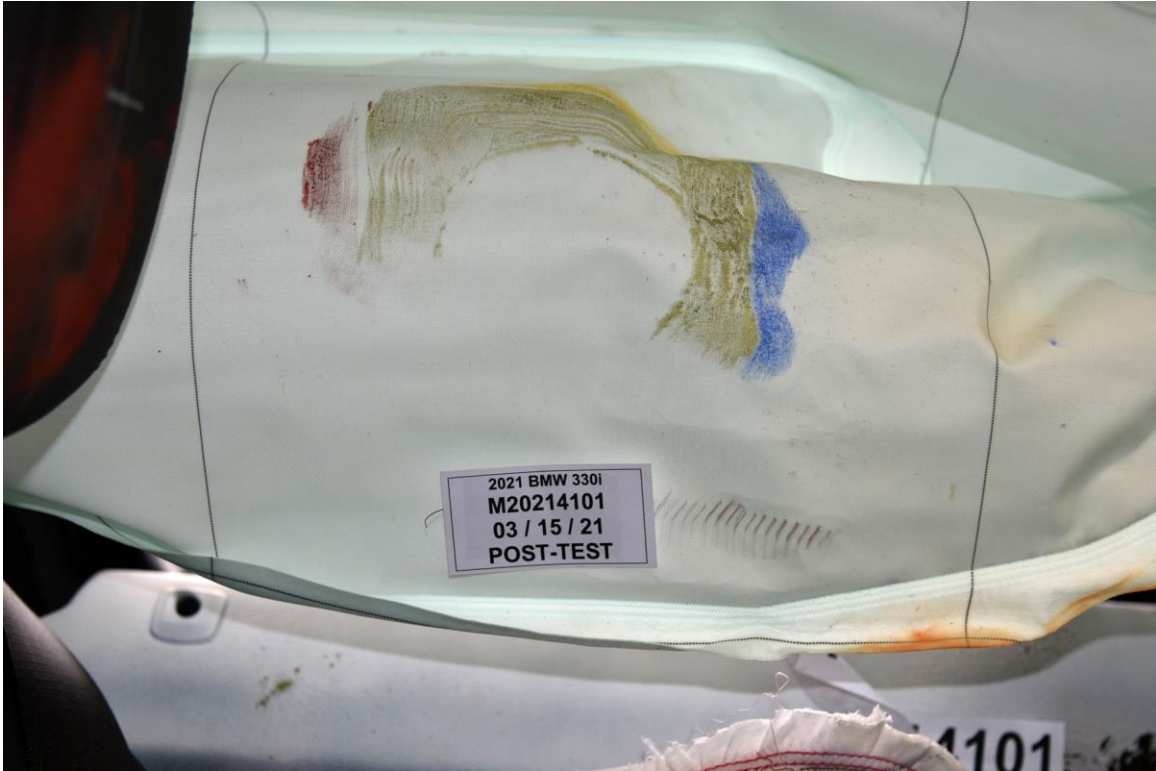
FIGURE 47. Post-Test Dummy Close-Up Head Contact With Side Airbag View

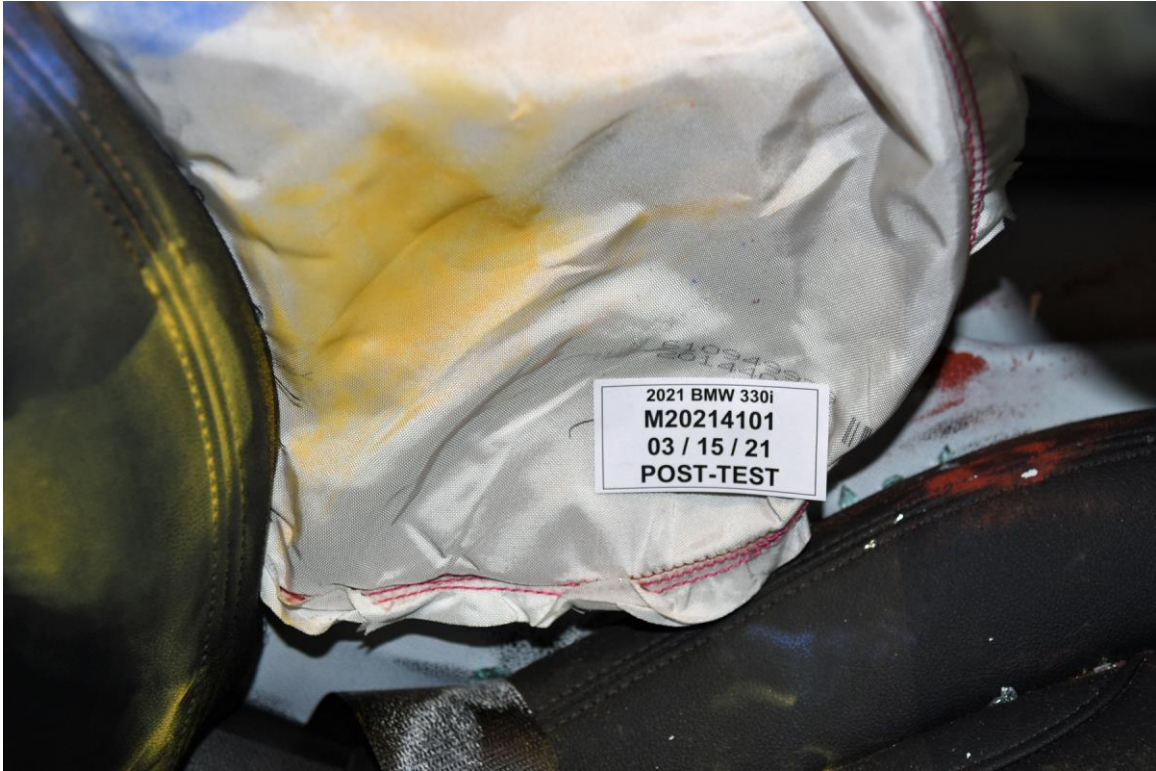
FIGURE 49. Post-Test Dummy Close-Up Torso Contact With Side Airbag View

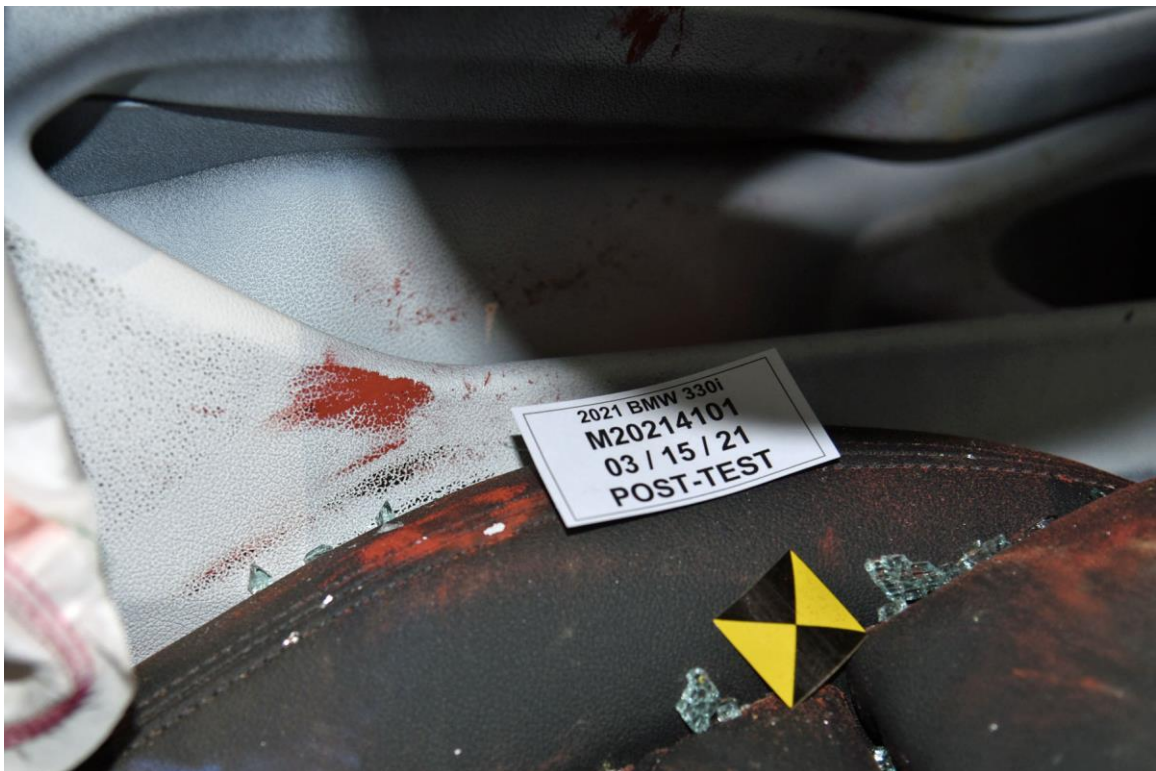
FIGURE 50. Post-Test Dummy Close-Up Pelvis Contact With Vehicle Interior View

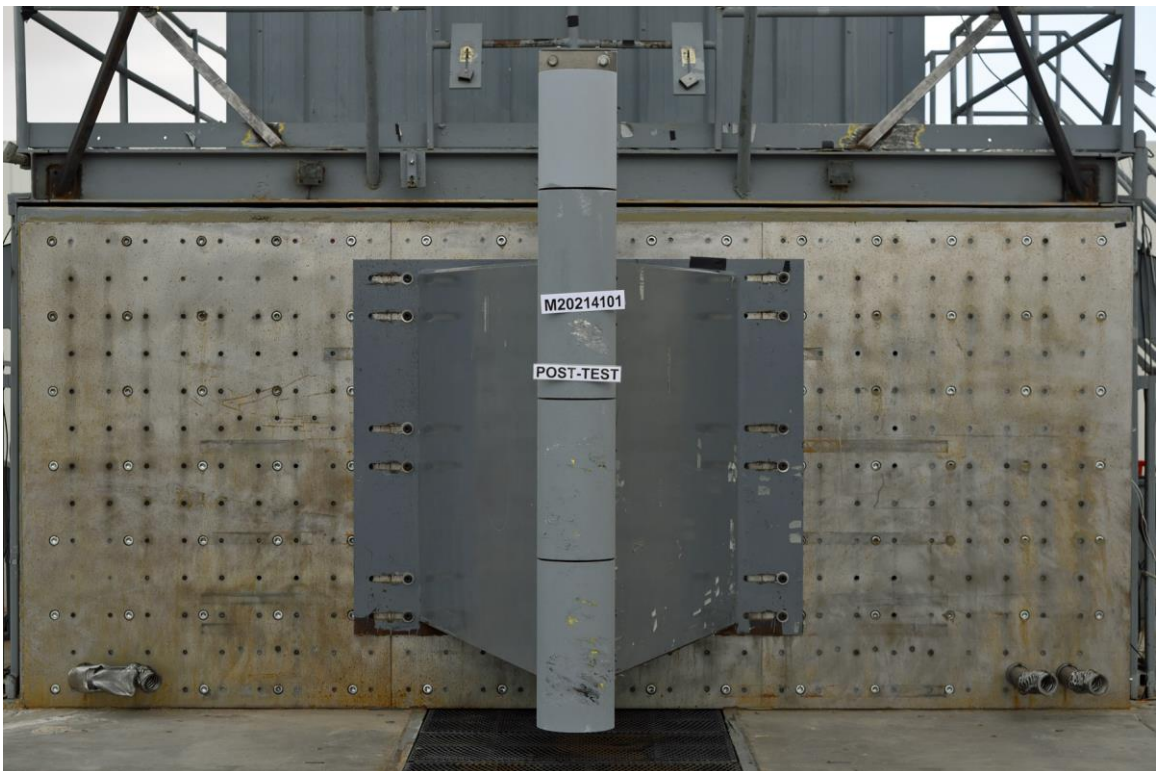
FIGURE 60. Post-Test Pole Barrier Front View

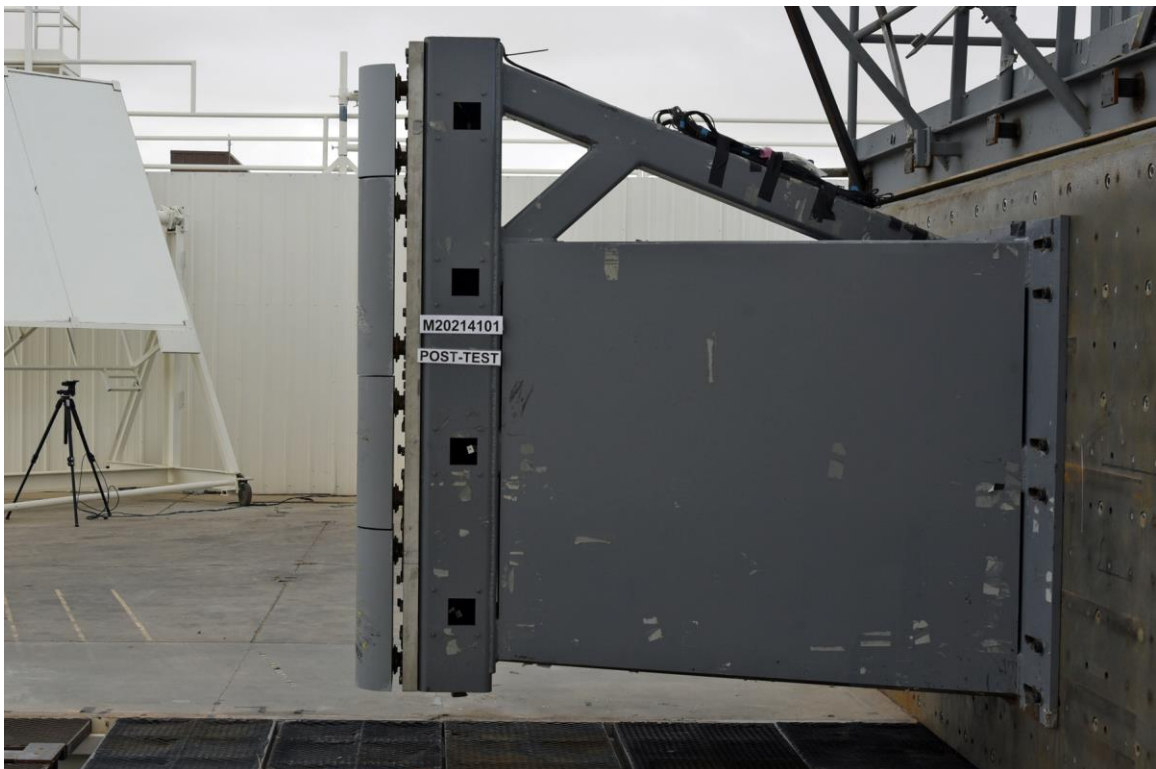
FIGURE 62. Post-Test Pole Barrier Side View

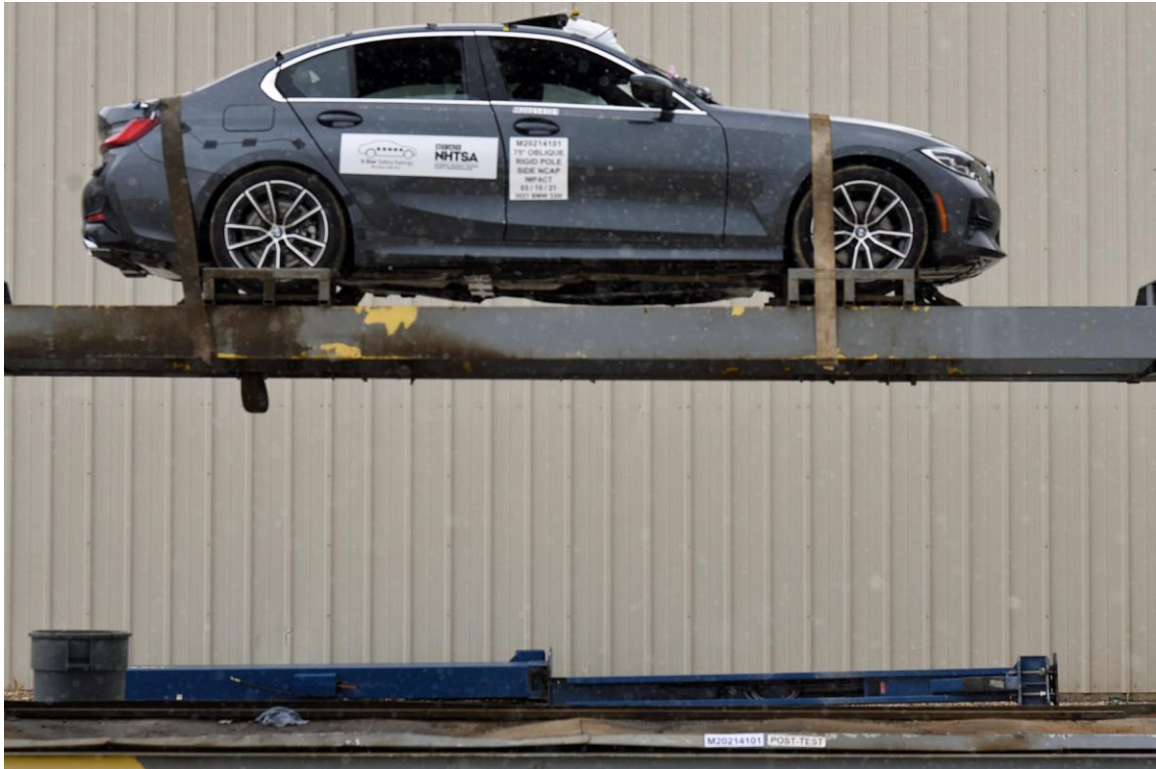
FIGURE 65. FMVSS No. 301 Static Rollover 0 Degrees

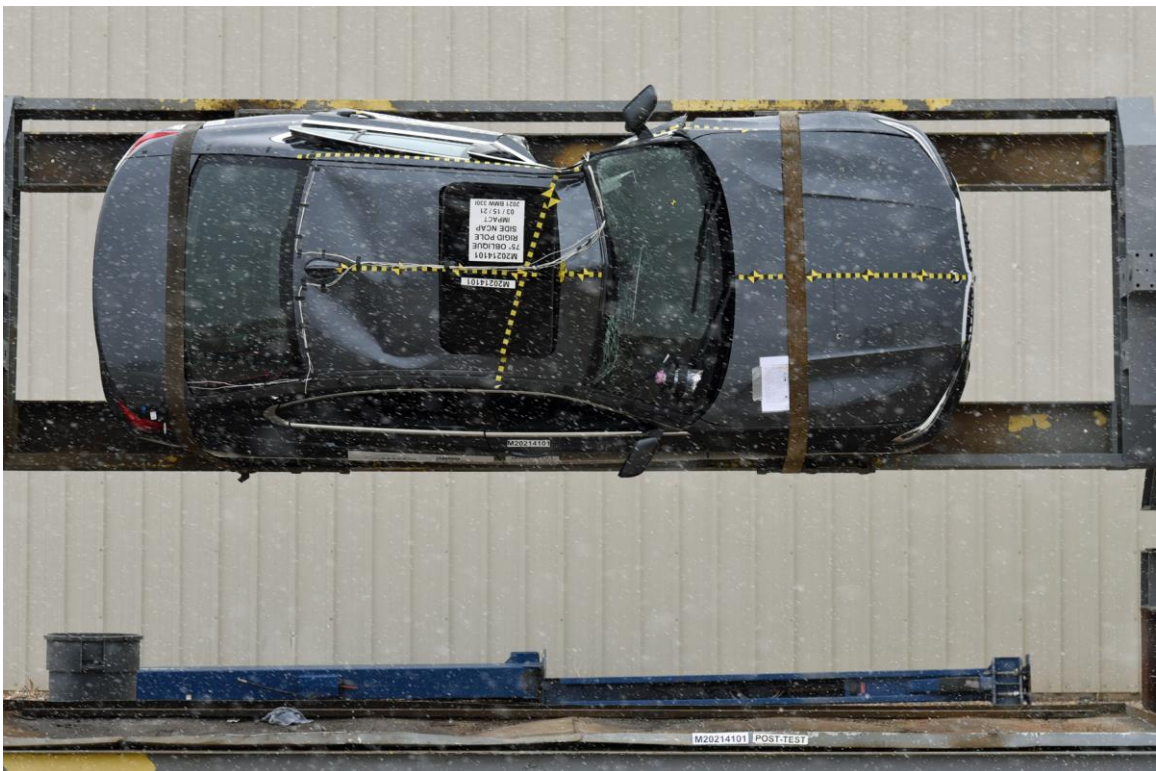
FIGURE 66. FMVSS No. 301 Static Rollover 90 Degrees

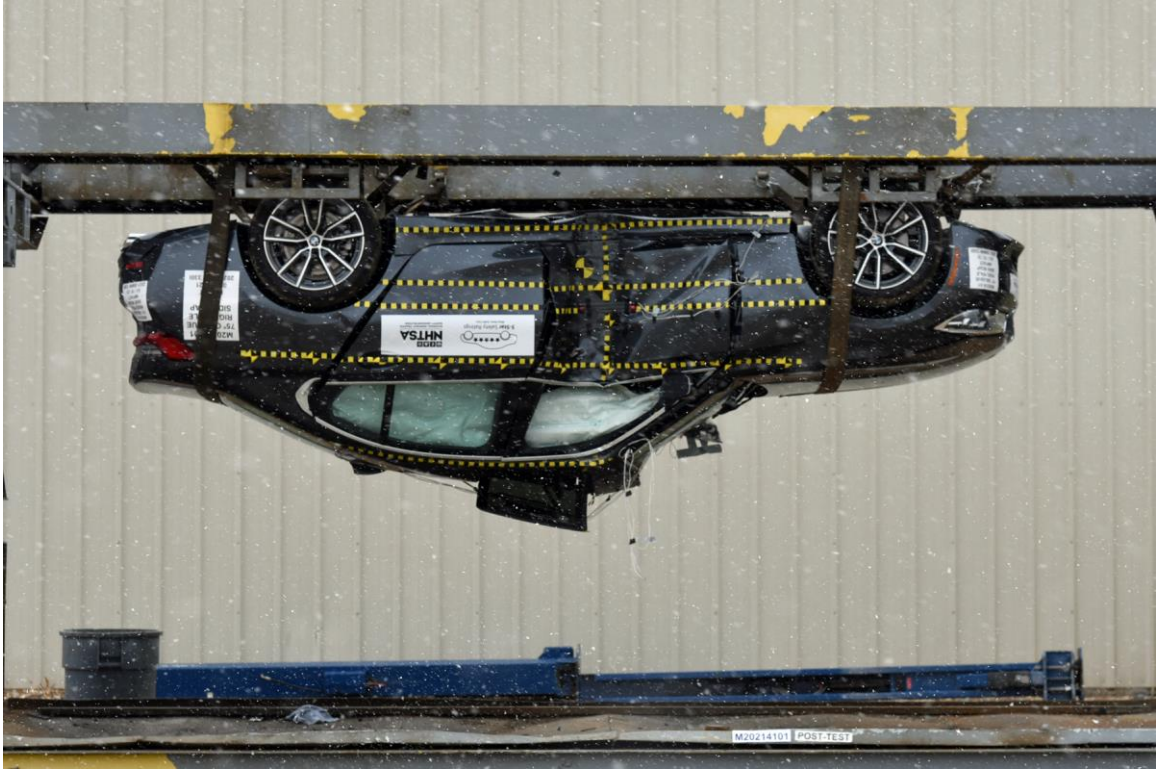
FIGURE 67. FMVSS No. 301 Static Rollover 180 Degrees

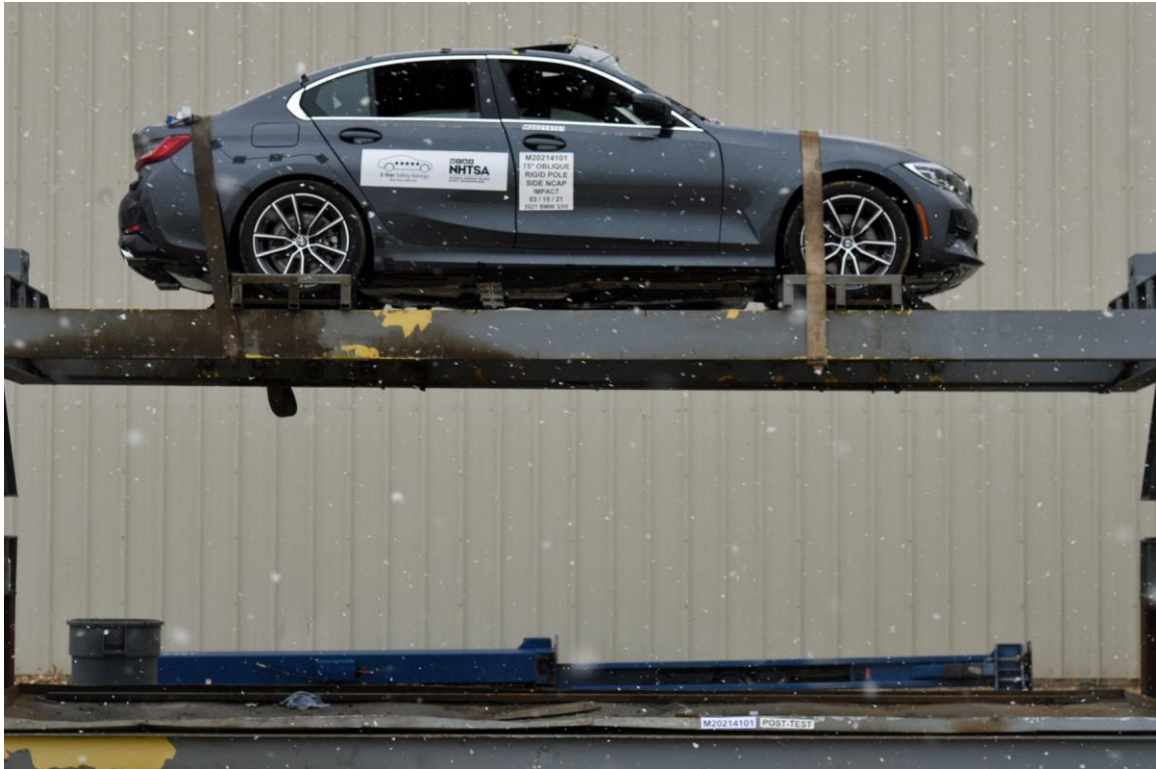
FIGURE 69. FMVSS No. 301 Static Rollover 360 Degrees

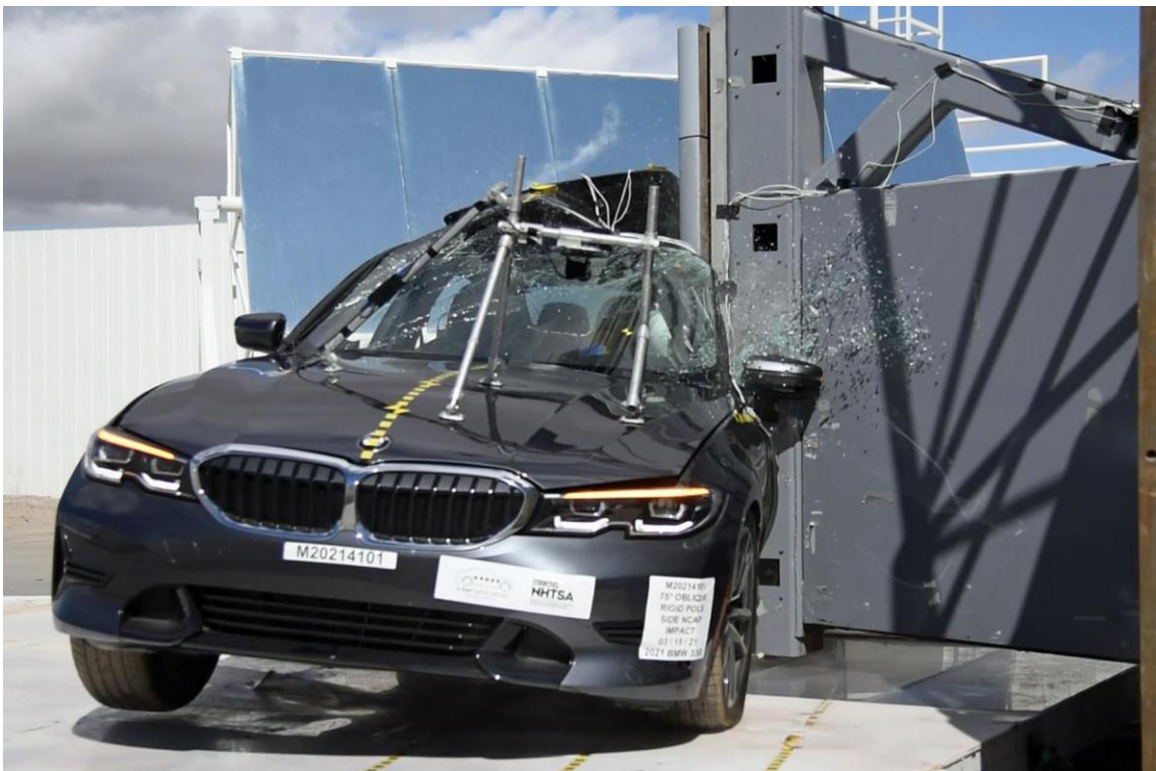
FIGURE 70. Impact Event

A rigid pole side impact test was conducted on a 2021 BMW 330i 4-door sedan. The subject vehicle was towed into the rigid pole at an angle of 74.8° and a velocity of 31.91 km/h. The test was conducted by Applus IDIADA KARCO Engineering, LLC. in Adelanto, California on March 15, 2021. Pre-test and post-test photographs of the test vehicle and side impact dummy (SID-IIs) are included in Appendix A of this report.
