REPORT NUMBER: SINCAP-CAL-21-007

NEW CAR ASSESSMENT PROGRAM (NCAP) MOVING DEFORMABLE BARRIER SIDE IMPACT TEST

Nissan Motor Co. LTD 2021 Nissan Rogue Sport Five Door SUV

NHTSA No: M20215207

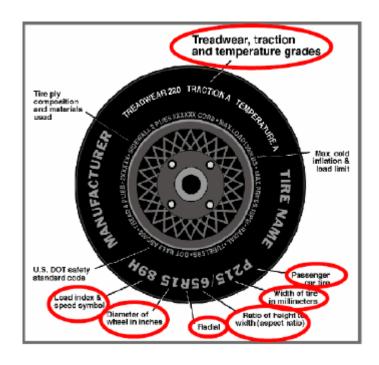
VEHICLE TIRE INFORMATION

Collected for year, make, model, & VIN, all items circled in red, tire manufacturer and tire name.

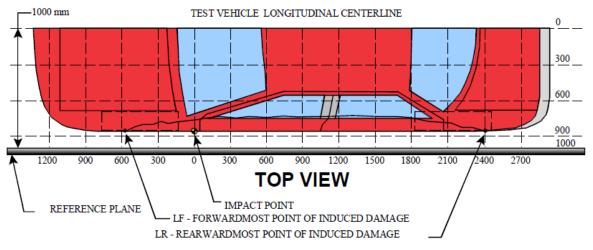
DATA SHEET NO. 13 VEHICLE AND MDB DAMAGE PROFILE DISTANCES

For guidance regarding damage profile distance measurements, please refer to the latest version of the *NHTSA Test Reference Guide. Volume 1: Vehicle Tests.*

Forward of the impact point (towards front of vehicle) is considered negative (—). Rearward of the impact point (toward rearend of vehicle) is considered positive (+).

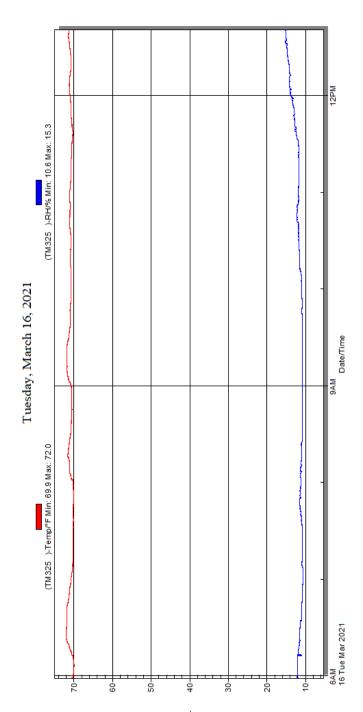
DATA SHEET NO. 15 DUMMY/VEHICLE TEMPERATURE AND HUMIDITY STABILIZATION DATA

Temperature and Humidity Stabilization Chart/Data for Dummies and Test Vehicle

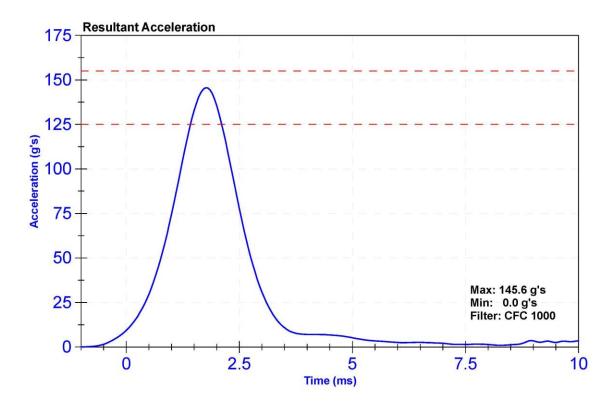
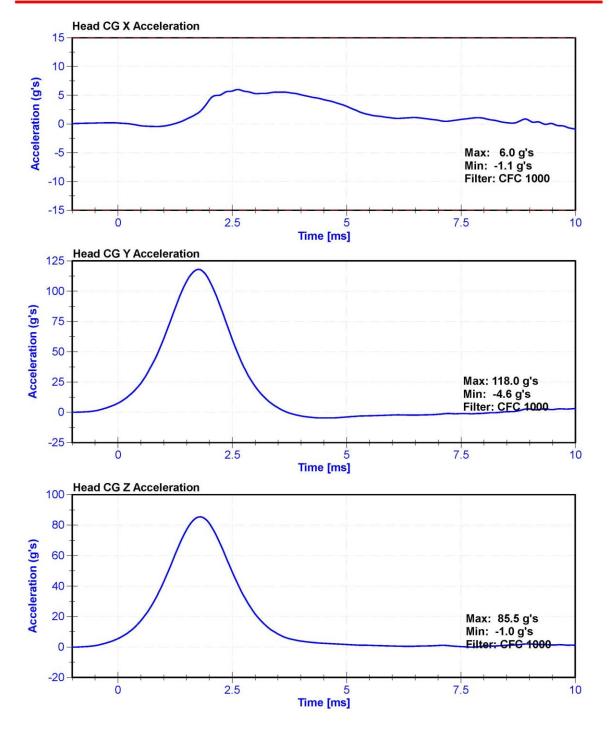
Test Parameter	Minimum Specification	Maximum Specification	Unit	Result	Pass/Fail
Temperature	20.6	22.2	°C	21.0	Pass
Humidity	10	70	%	28.0	Pass
Resultant Acceleration	125	155	g's	145.6	Pass
Oscillation	0	15	%	2.48	Pass
Fore-Aft Acceleration	-15	15	g's	6.0	Pass

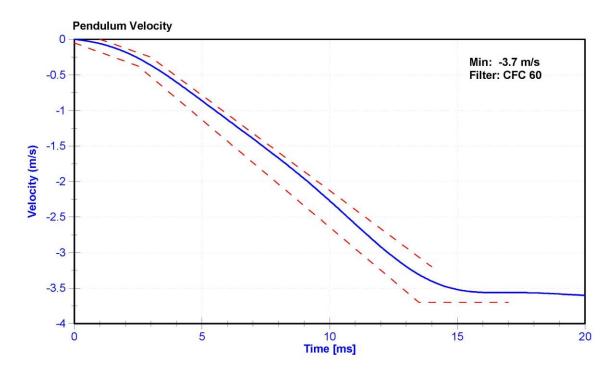
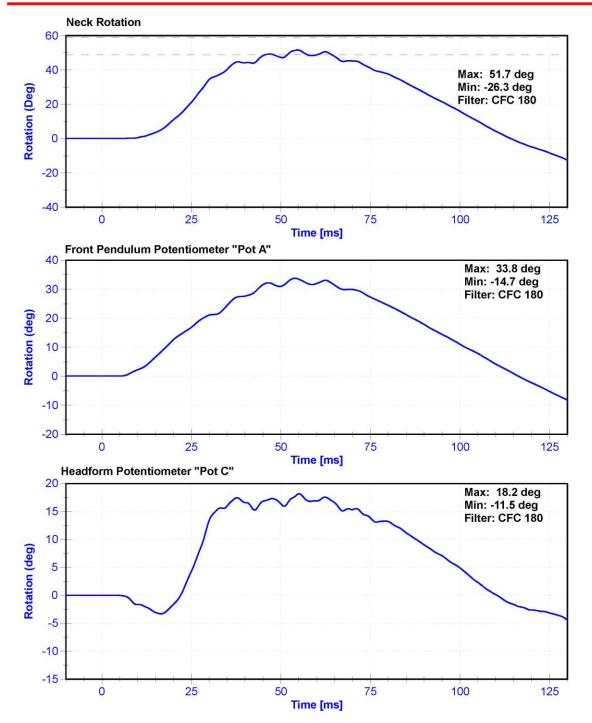
Certification Report ES-2re Neck Flexion - CFR 572

Test Parameter	Minimum Specification	Maximum Specification	Unit	Result	Pass/Fail
Temperature	20.6	22.2	°C	21.3	Pass
Humidity	10	70	%	28	Pass
Velocity	3.3	3.5	m/s	3.38	Pass
Lateral Neck Rotation	49	59	deg	51.7	Pass
Time at Maximum Rotation	54	66	ms	54.7	Pass
Time of Rotation Decay from Maximum	53	88	ms	59.6	Pass

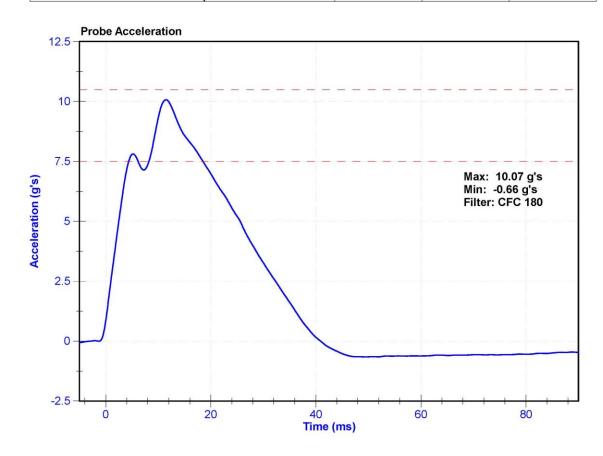
Certification Report ES-2re Shoulder Impact - CFR 572

Test Parameter	Minimum Specification	Maximum Specification	Unit	Result	Pass/Fail
Temperature	20.6	22.2	°C	20.9	Pass
Humidity	10	70	%	28.0	Pass
Velocity	4.2	4.4	m/s	4.34	Pass
Probe Acceleration	7.5	10.5	g's	10.07	Pass

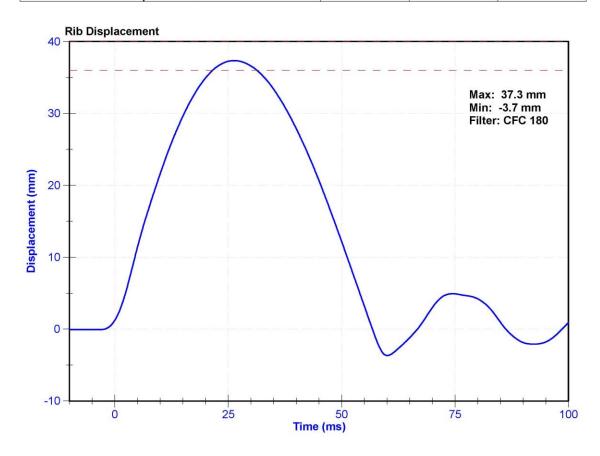
Certification Report ES-2re Upper Rib Drop 3 m/s - CFR 572

Test Parameter	Minimum Specification	Maximum Specification	Unit	Result	Pass/Fail
Temperature	20.6	22.2	°C	21.5	Pass
Humidity	10	70	%	29.0	Pass
Rib Displacement	36	40	mm	37.3	Pass

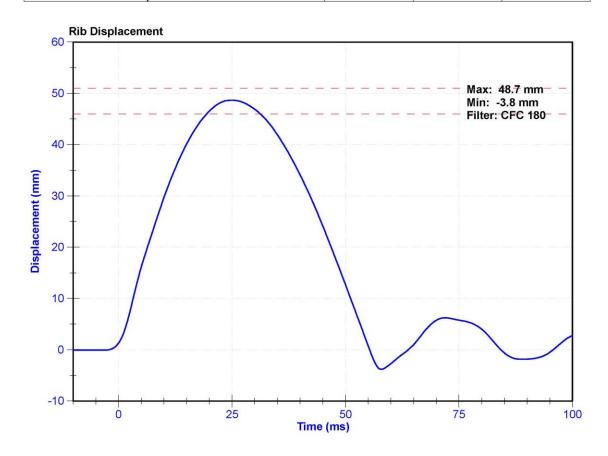
Certification Report ES-2re Upper Rib Drop 4 m/s - CFR 572

Test Parameter	Minimum Specification	Maximum Specification	Unit	Result	Pass/Fail
Temperature	20.6	22.2	°C	21.5	Pass
Humidity	10	70	%	29.0	Pass
Rib Displacement	46	51	mm	48.7	Pass

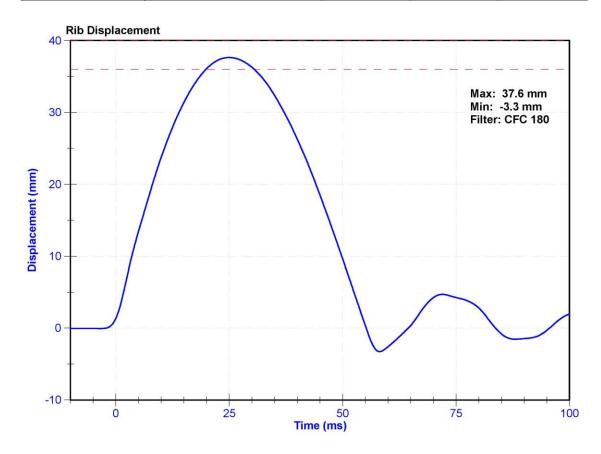
Certification Report ES-2re Middle Rib Drop 3 m/s - CFR 572

Test Parameter	Minimum Specification	Maximum Specification	Unit	Result	Pass/Fail
Temperature	20.6	22.2	°C	21.9	Pass
Humidity	10	70	%	27.0	Pass
Rib Displacement	36	40	mm	37.6	Pass

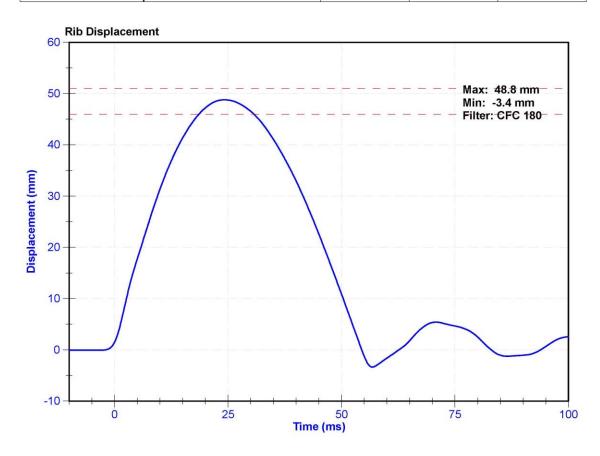
Certification Report ES-2re Middle Rib Drop 4 m/s - CFR 572

Test Parameter	Minimum Specification	Maximum Specification	Unit	Result	Pass/Fail
Temperature	20.6	22.2	°C	21.7	Pass
Humidity	10	70	%	29.0	Pass
Rib Displacement	46	51	mm	48.8	Pass

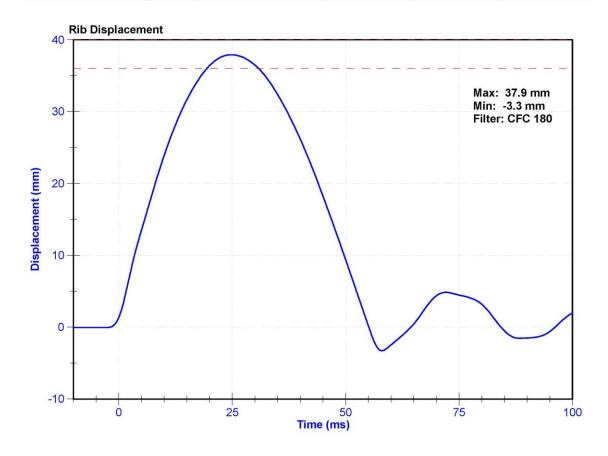
Certification Report ES-2re Lower Rib Drop 3 m/s - CFR 572

Test Parameter	Minimum Specification	Maximum Specification	Unit	Result	Pass/Fail
Temperature	20.6	22.2	°C	21.7	Pass
Humidity	10	70	%	29.0	Pass
Rib Displacement	36	40	mm	37.9	Pass

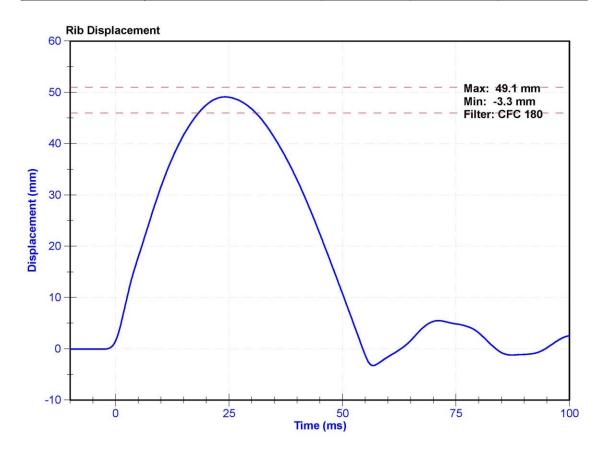
Certification Report ES-2re Lower Rib Drop 4 m/s - CFR 572

Test Parameter	Minimum Specification	Maximum Specification	Unit	Result	Pass/Fail
Temperature	20.6	22.2	°C	21.9	Pass
Humidity	10	70	%	29.0	Pass
Rib Displacement	46	51	mm	49.1	Pass

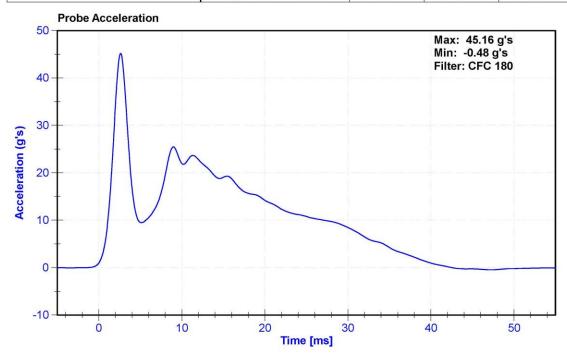
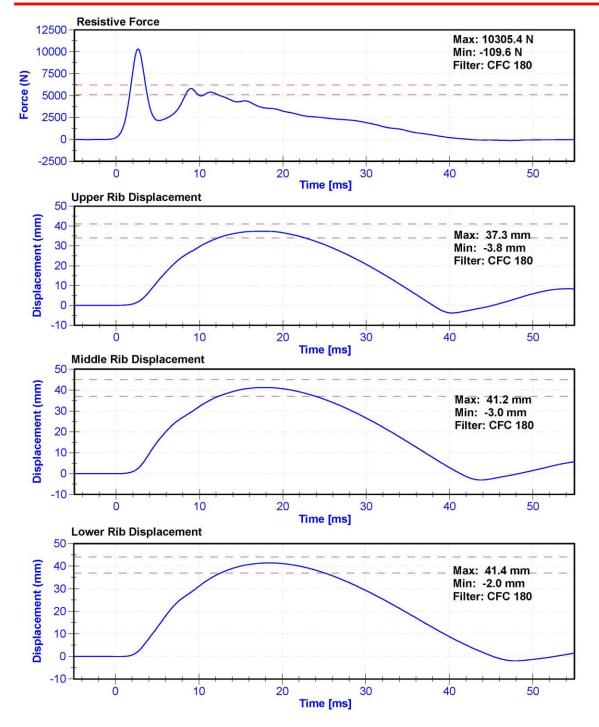
Certification Report ES-2re Thorax Impact - CFR 572

Test Parameter	Minimum Specification	Maximum Specification	Unit	Result	Pass/Fail
Temperature	20.6	22.2	°C	20.8	Pass
Humidity	10	70	%	24.0	Pass
Velocity	5.4	5.6	m/s	5.47	Pass
Resistive Force after 6ms	5100	6200	N	5809.8	Pass
Upper Thorax Rib Deflection	34	41	mm	37.3	Pass
Mid Thorax Rib Deflection	37	45	mm	41.2	Pass
Lower Thorax Rib Deflection	37	44	mm	41.4	Pass

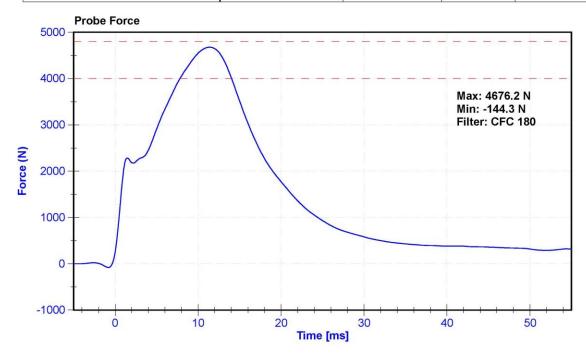
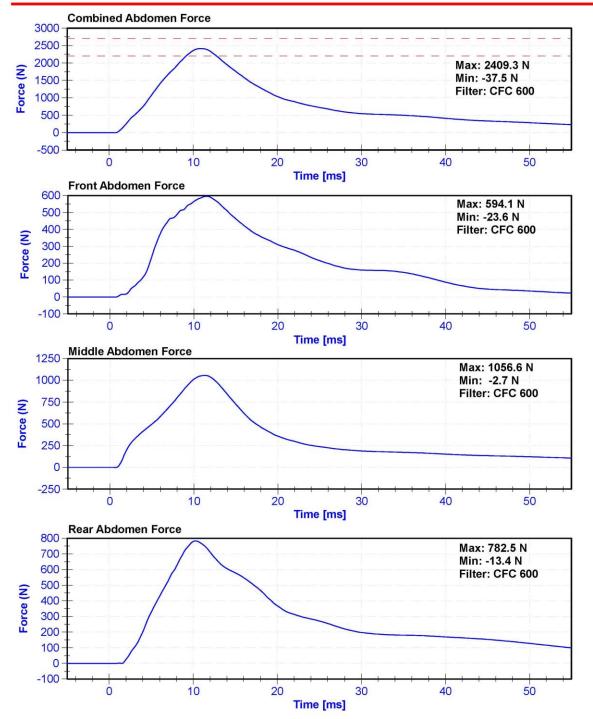
Certification Report ES-2re Abdomen Impact - CFR 572

Test Parameter	Minimum Specification	Maximum Specification	Unit	Result	Pass/Fail
Temperature	20.6	22.2	°C	20.9	Pass
Humidity	10	70	%	24	Pass
Velocity	3.9	4.1	m/s	3.97	Pass
Combined Abdomen Force	2200	2700	N	2409.3	Pass
Time at Peak Abdomen Force	10.0	12.3	ms	11.00	Pass
Resistive Probe Force	4000	4800	N	4676.2	Pass
Time at Peak Resistive Force	10.6	13.0	ms	11.40	Pass

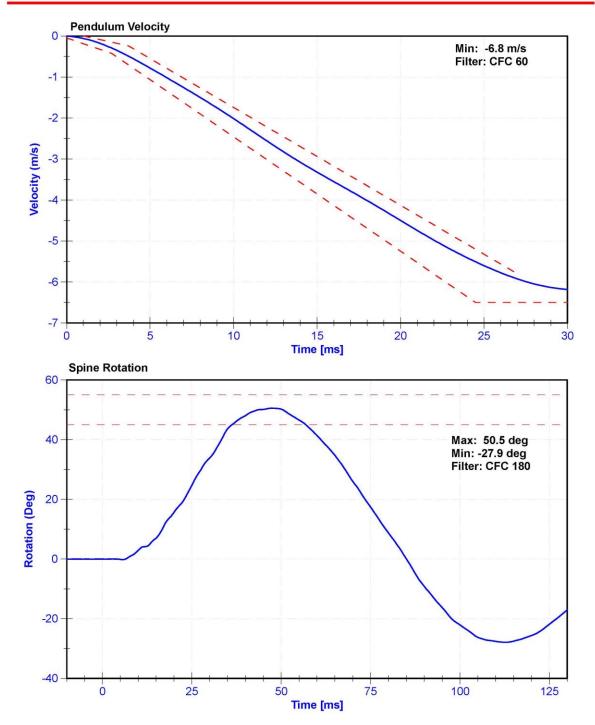
Certification Report ES-2re Spine Flexion - CFR 572

Test Parameter	Minimum Specification	Maximum Specification	Unit	Result	Pass/Fail
Temperature	20.6	22.2	°C	21.2	Pass
Humidity	10	70	%	31.0	Pass
Velocity	5.95	6.15	m/s	5.964	Pass
Lateral Spine Rotation	45	55	deg	50.5	Pass
Time at Maximum Rotation	39	53	ms	47.4	Pass
Time of Decay to Zero Degrees	37	57	ms	37.6	Pass
Pulse within Corridor?	-	-	=

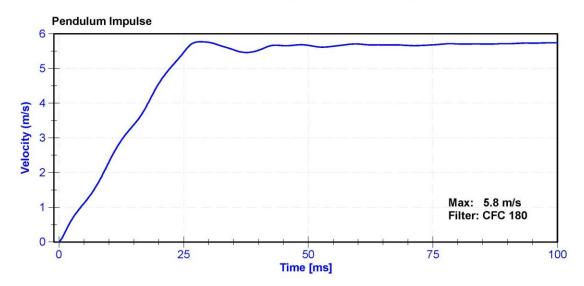
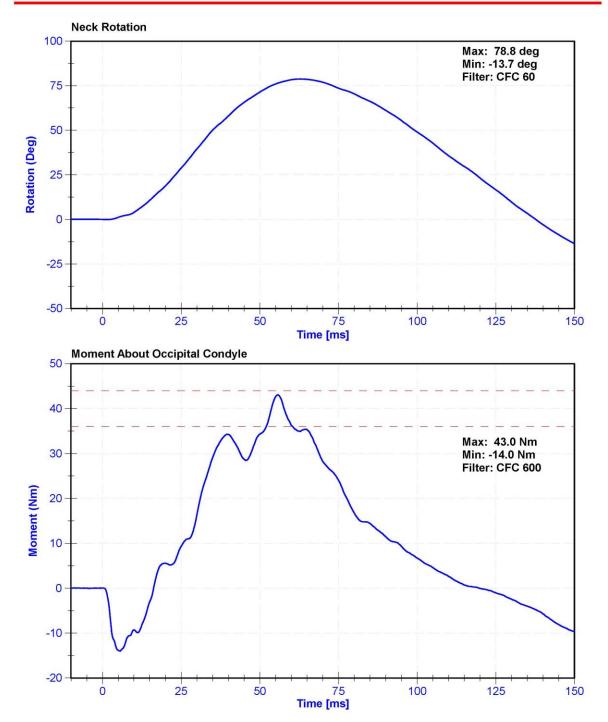
Certification Report SID-IIs Neck Flexion Left- CFR 572

Test Parameter	Minimum Specification	Maximum Specification	Unit	Result	Pass/Fail
Temperature	20.6	22.2	°C	20.9	Pass
Humidity	10	70	%	24	Pass
Velocity	5.51	5.63	m/s	5.549	Pass
Pendulum Impulse at 10ms	2.2	2.8	m/s	2.30	Pass
Pendulum Impulse at 15ms	3.3	4.1	m/s	3.38	Pass
Pendulum Impulse at 20ms	4.4	5.4	m/s	4.56	Pass
Pendulum Impulse at 25ms	5.4	6.1	m/s	5.46	Pass
Pendulum Impulse from 25 to 100ms	5.5	6.2	m/s	5.77	Pass
Neck Rotation	71	81	deg	78.8	Pass
Time at Maximum Rotation	50	70	ms	62.9	Pass
Moment about the OC	36	44	Nm	43.0	Pass
Moment Decay to 0 Nm	102	126	ms	119.9	Pass

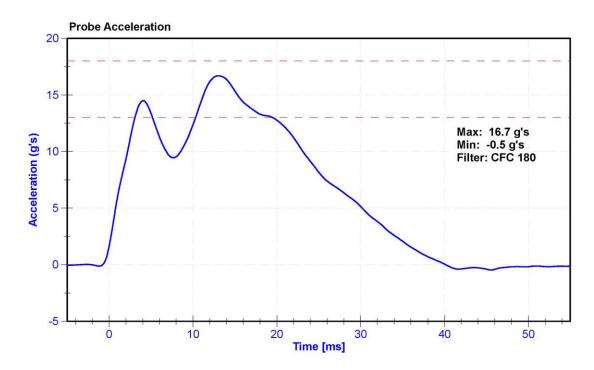
Certification Report SID-IIs Shoulder Impact - CFR 572

Test Parameter	Minimum Specification	Maximum Specification	Unit	Result	Pass/Fail
Temperature	20.6	22.2	°C	20.8	Pass
Humidity	10	70	%	22	Pass
Velocity	4.2	4.4	m/s	4.27	Pass
Probe Acceleration	13	18	g's	16.7	Pass
Shoulder Deflection	28	37	mm	30.0	Pass
Lateral Upper Spine Acceleration	17	22	g's	20.1	Pass

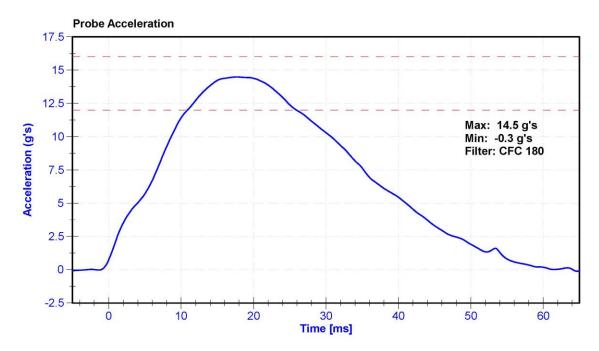
Certification Report SID-IIs Abdomen Impact - CFR 572

Test Parameter	Minimum Specification	Maximum Specification	Unit	Result	Pass/Fail
Temperature	20.6	22.2	°C	20.9	Pass
Humidity	10	70	%	29.0	Pass
Velocity	4.2	4.4	m/s	4.34	Pass
Probe Acceleration	12	16	g's	14.5	Pass
Lateral Lower Spine Acceleration	9	14	g's	11.3	Pass
Upper Abdomen Rib Deflection	36	47	mm	41.9	Pass
Lower Abdomen Rib Deflection	33	44	mm	41.1	Pass

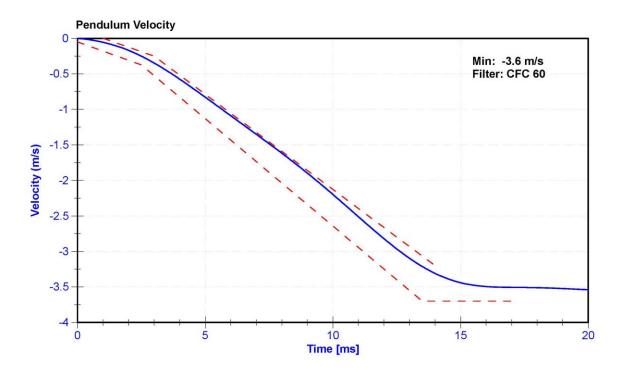
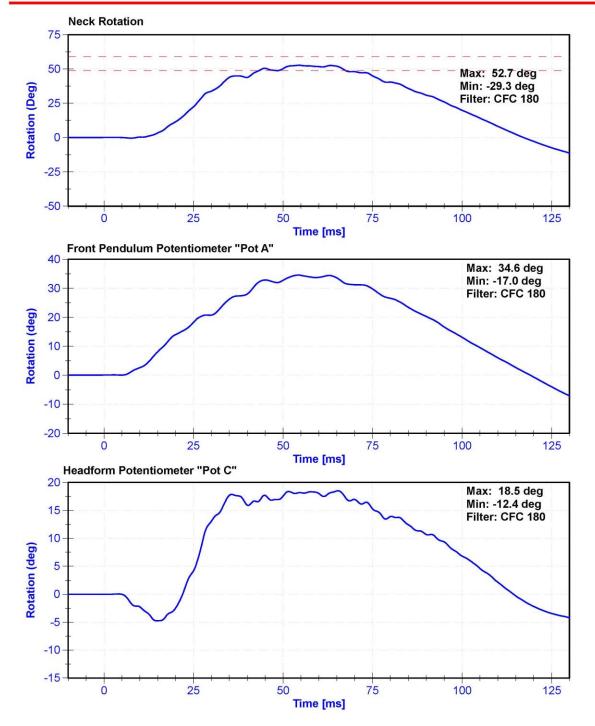
Certification Report ES-2re Neck Flexion - CFR 572

Test Parameter	Minimum Specification	Maximum Specification	Unit	Result	Pass/Fail
Temperature	20.6	22.2	°C	21.3	Pass
Humidity	10	70	%	28	Pass
Velocity	3.3	3.5	m/s	3.38	Pass
Lateral Neck Rotation	49	59	deg	52.7	Pass
Time at Maximum Rotation	54	66	ms	54.5	Pass
Time of Rotation Decay from Maximum	53	88	ms	62.7	Pass
