REPORT NUMBER: SideNCAPPole-MGA-21-035

**NEW CAR ASSESSMENT PROGRAM (NCAP)
Side Impact Pole Test**

**HYUNDAI MOTOR MANUFACTURING ALABAMA, LLC
2021 Hyundai Elantra SEL 4-Door Sedan
NHTSA No.: O20214207**

**MGA RESEARCH CORPORATION
5000 Warren Road
Burlington, WI 53105**

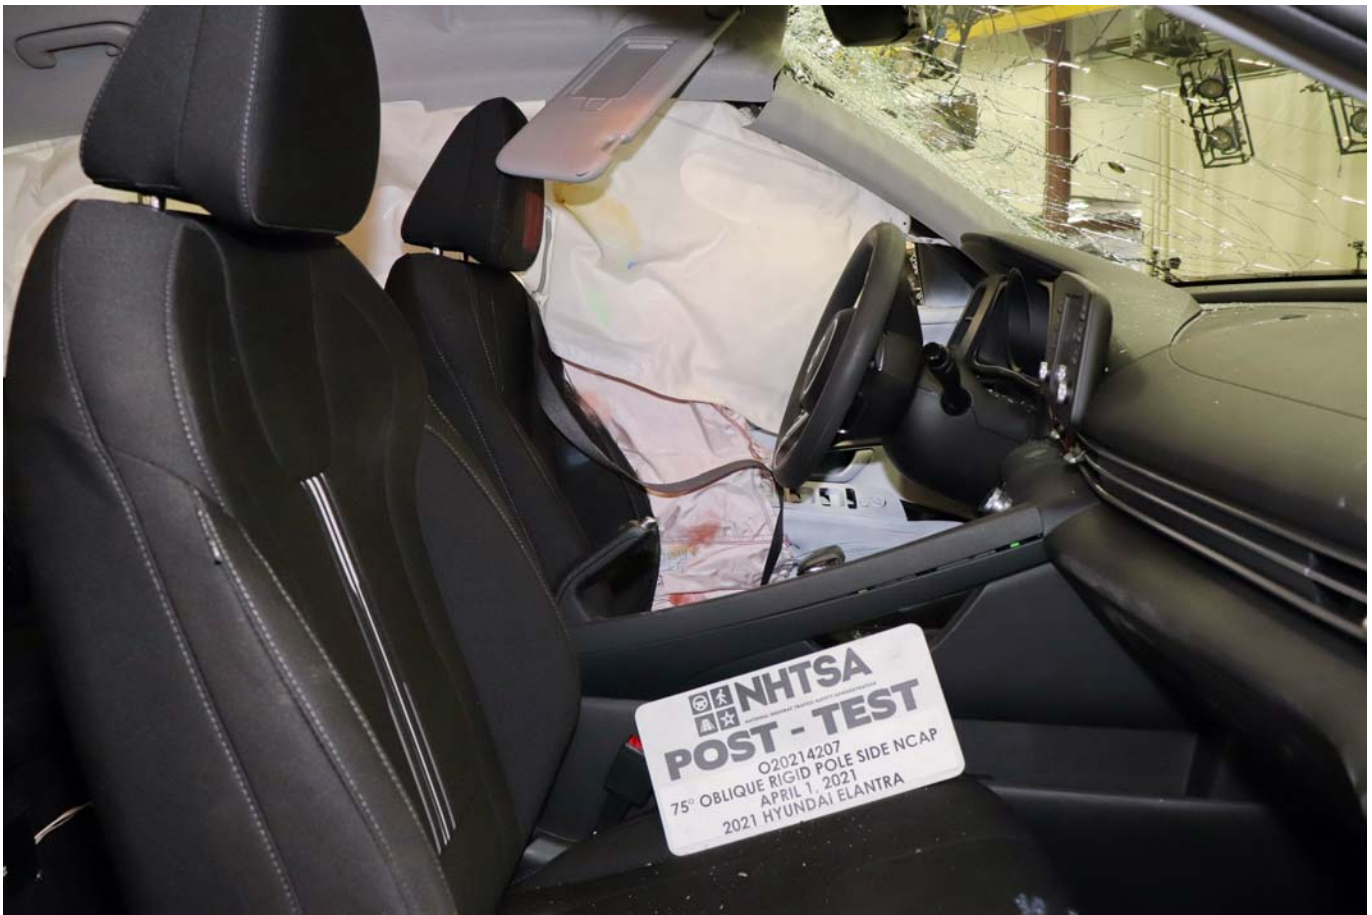
Photo No. 045 - Post-Test Inner Door Panel View Showing Dummy Contact Location

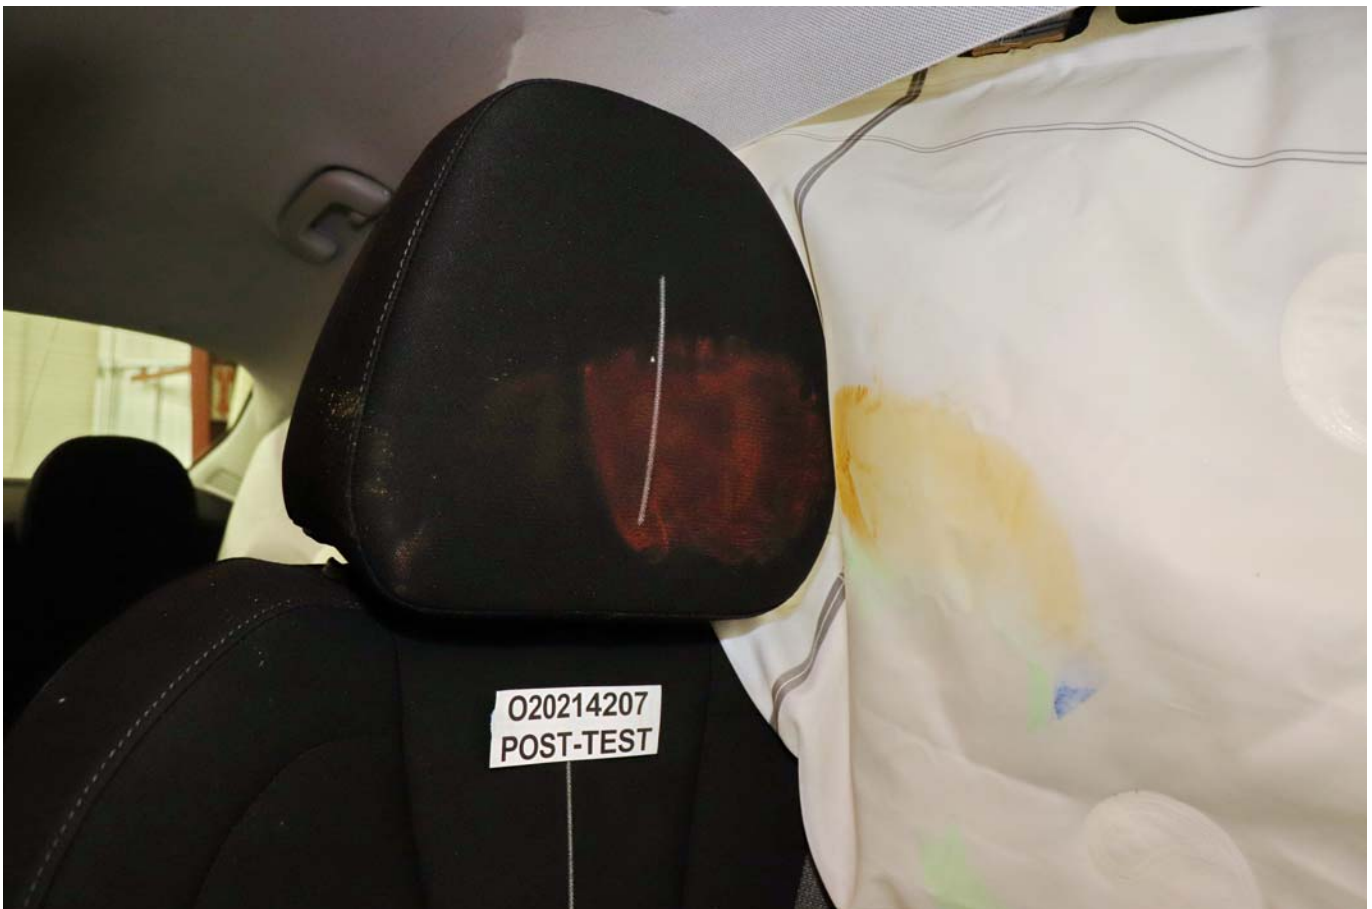
Photo No. 046 - Post-Test Dummy Close-Up Head Contact with Vehicle Interior View

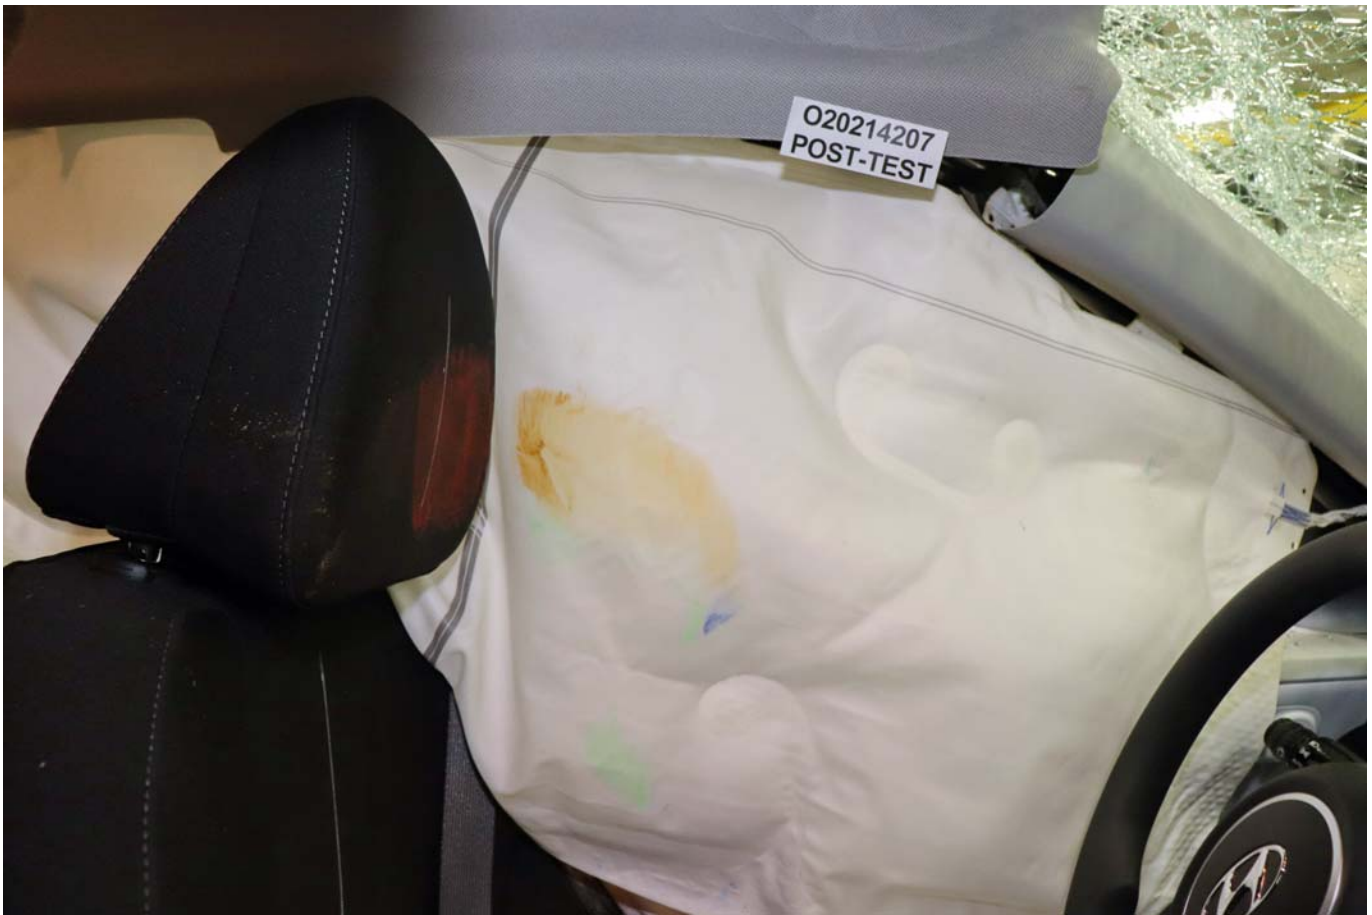
Photo No. 047 - Post-Test Dummy Close-Up Head Contact with Side Air Bag View

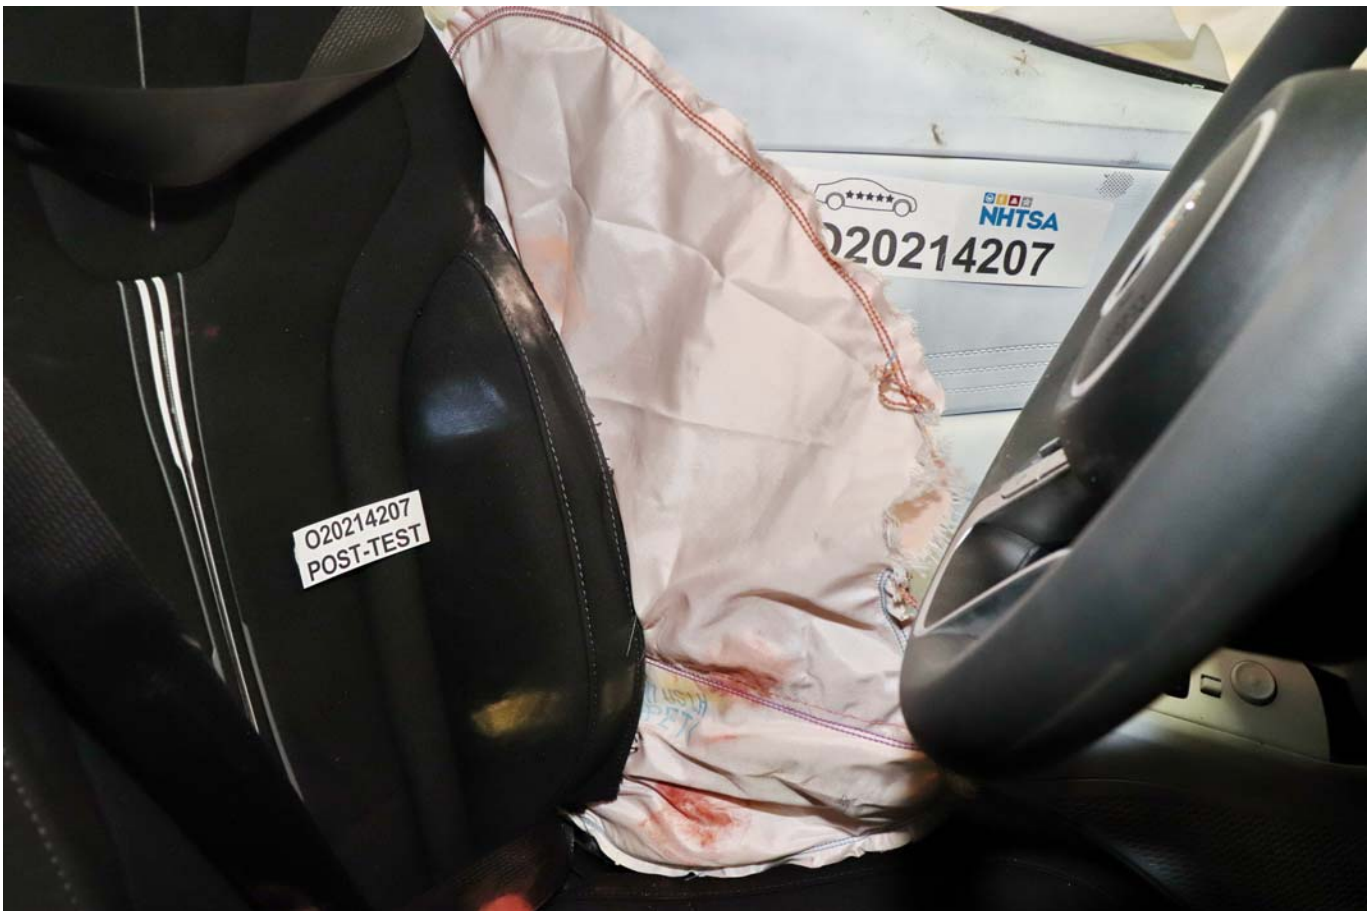
Photo No. 048 - Post-Test Dummy Close-Up Torso Contact with Vehicle Interior View

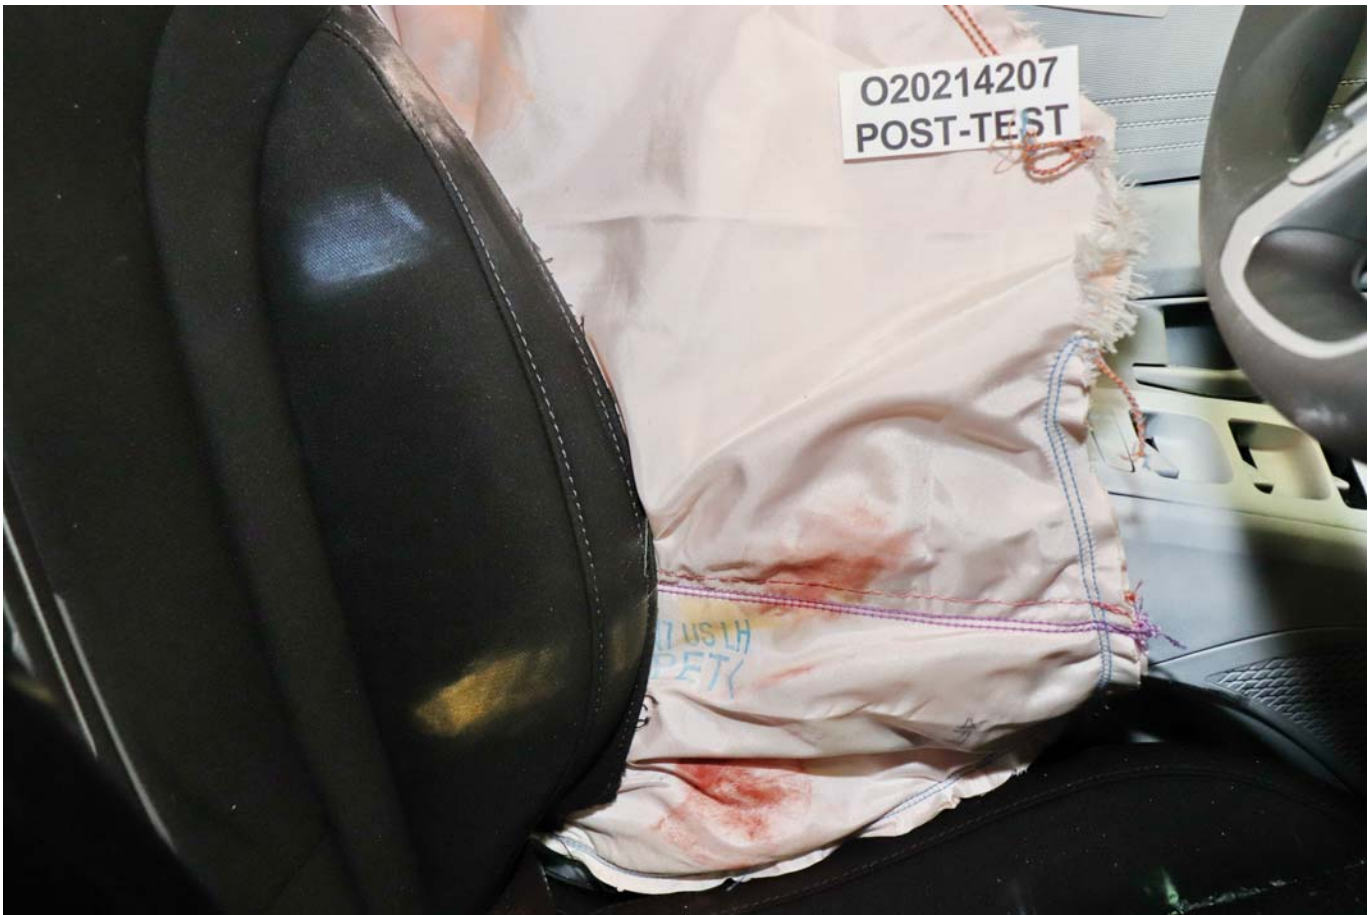
Photo No. 049 - Post-Test Dummy Close-Up Torso Contact with Side Air Bag View

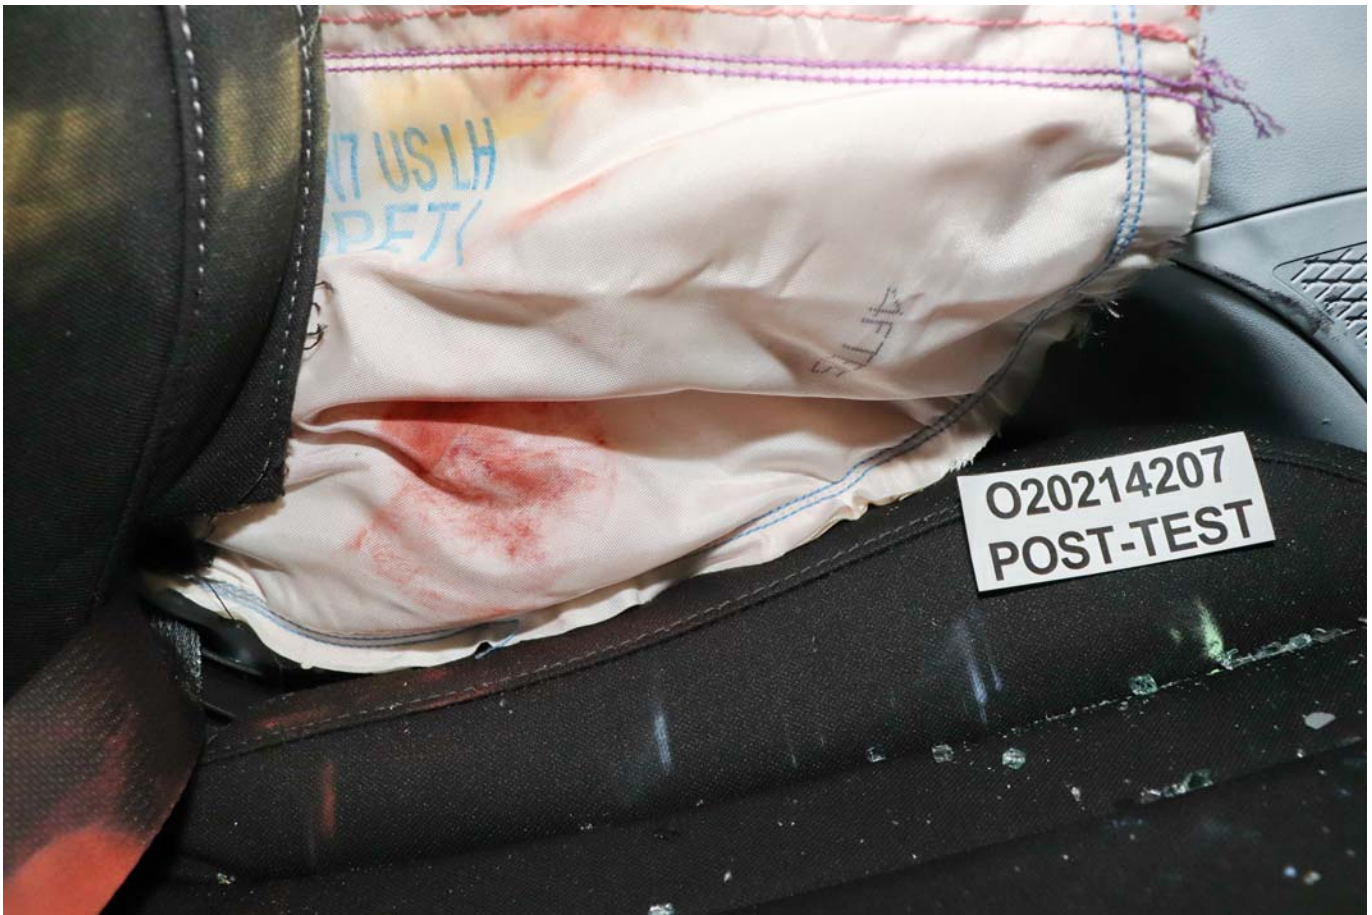
Photo No. 051 - Post-Test Dummy Close-Up Pelvis Contact with Side Air Bag View
