NEW CAR ASSESSMENT PROGRAM LANE DEPARTURE WARNING CONFIRMATION TEST NCAP-DRI-LDW-21-12

2021 Volkswagen ID.4 Pro S (Statement)

Final Report

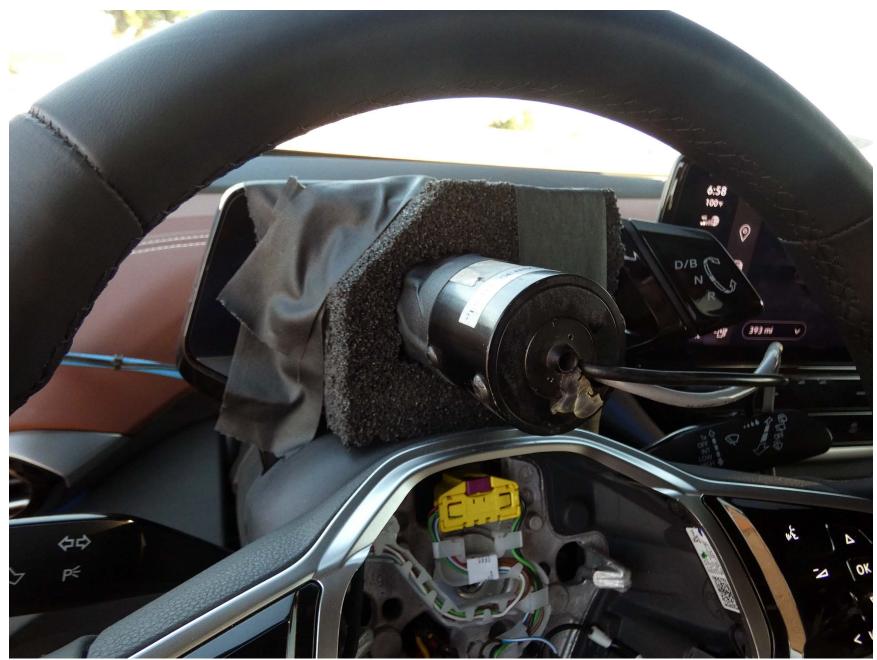
Figure A8. Sensor for Detecting Visual Alert

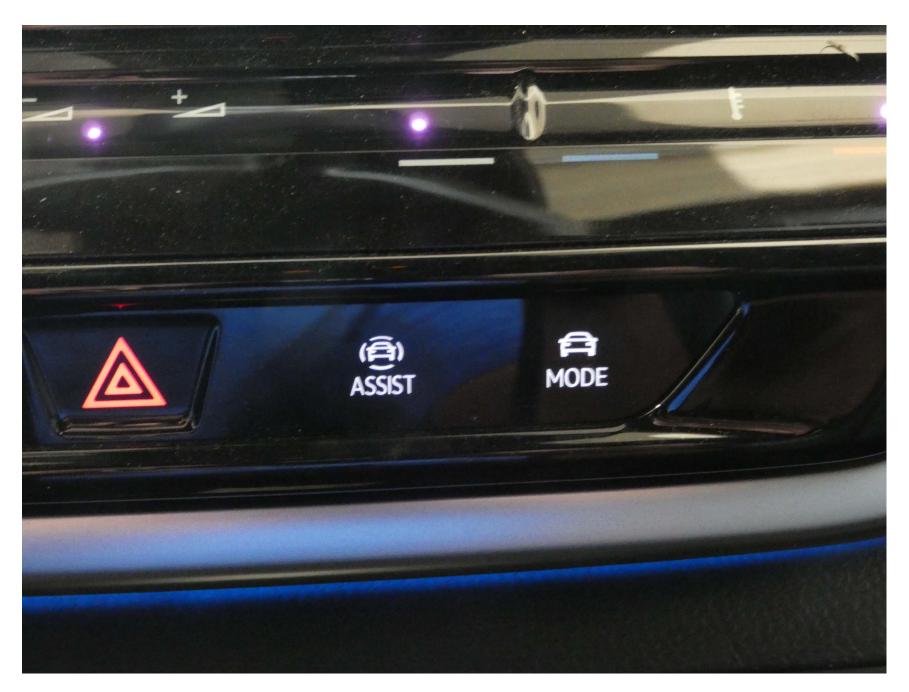
Figure A9. Button for Accessing System Menus

<u>System menus are accessed by pressing the "Assist" button in the center</u> <u>console. An image appears in the center touchscreen showing a vehicle, two</u> <u>adjacent blue vehicle and blue lane lines.</u> To disable the system: <u>Navigate to the Lane Keeping assist menu by either:</u>

See Appendix A, Figures A9 and A10.

System menus are accessed by pressing the "Assist" button in the center console. An image appears in the center touchscreen showing a vehicle, two nearby blue vehicle and blue lane lines. Navigate to the Lane Keeping assist menu by either:

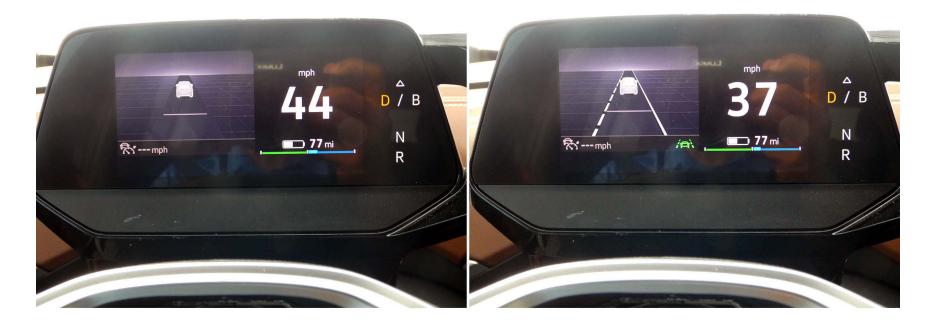
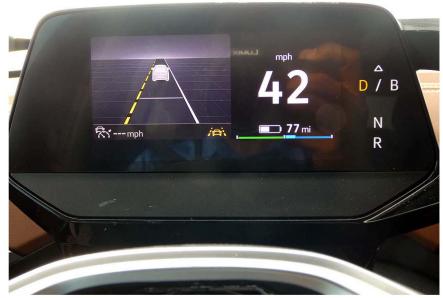
Figure A11. LDW Status Indicator and Visual Alert

The LDW status and alert indicators are shown in Appendix A, Figure A11.

Yellow line: road lane marking detected. System is actively intervening on the indicated side.

White line: road lane marking detected. The system is ready to intervene on the side shown.

Green Icon: System is active and ready to perform control intervention.

Yellow icon: System intervention (corrective steering intervention).
