REPORT NUMBER: SINCAP-CAL-20-005

**NEW CAR ASSESSMENT PROGRAM (NCAP)
MOVING DEFORMABLE BARRIER SIDE IMPACT TEST**

**Hyundai Motor Company
2021 Genesis GV80
5-door SUV**

NHTSA No: O20214217

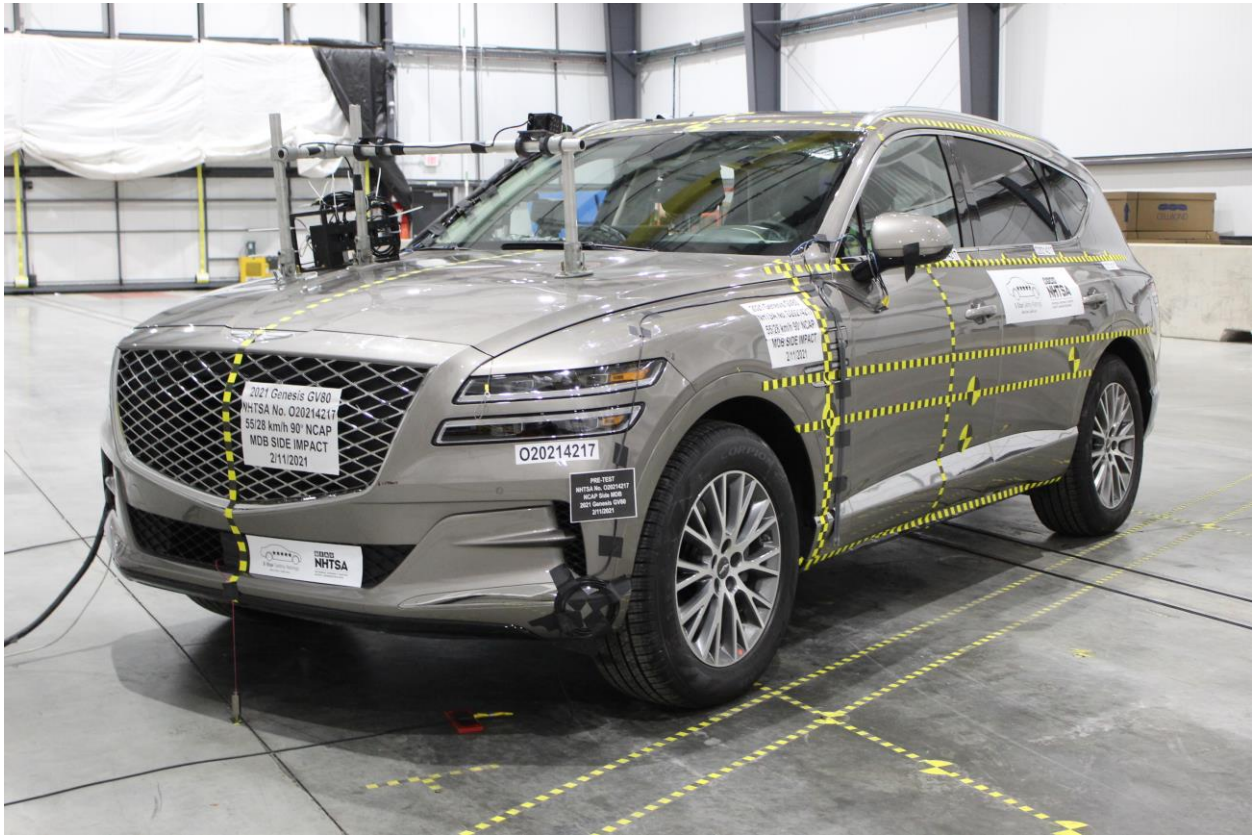
Figure A-4: Post-Test Frontal View of Test Vehicle

Critical Areas of Performance	Observations and Conclusions
Pillar Performance	B-Pillar & C-Pillar Buckled
Sill Separation	None
Windshield Damage	None
Side Window Damage	None
Other Notable Effects	None

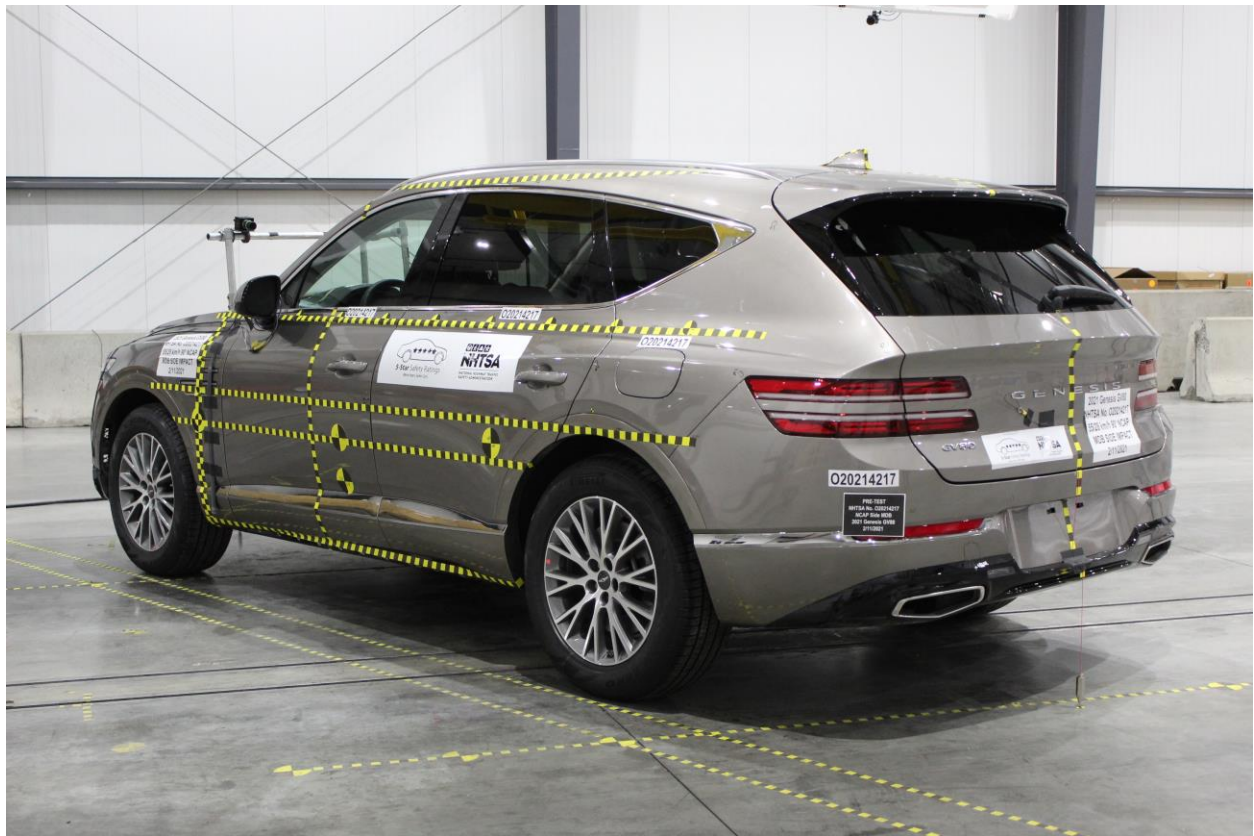
Figure A-8: Post-Test Left Side View of Test Vehicle

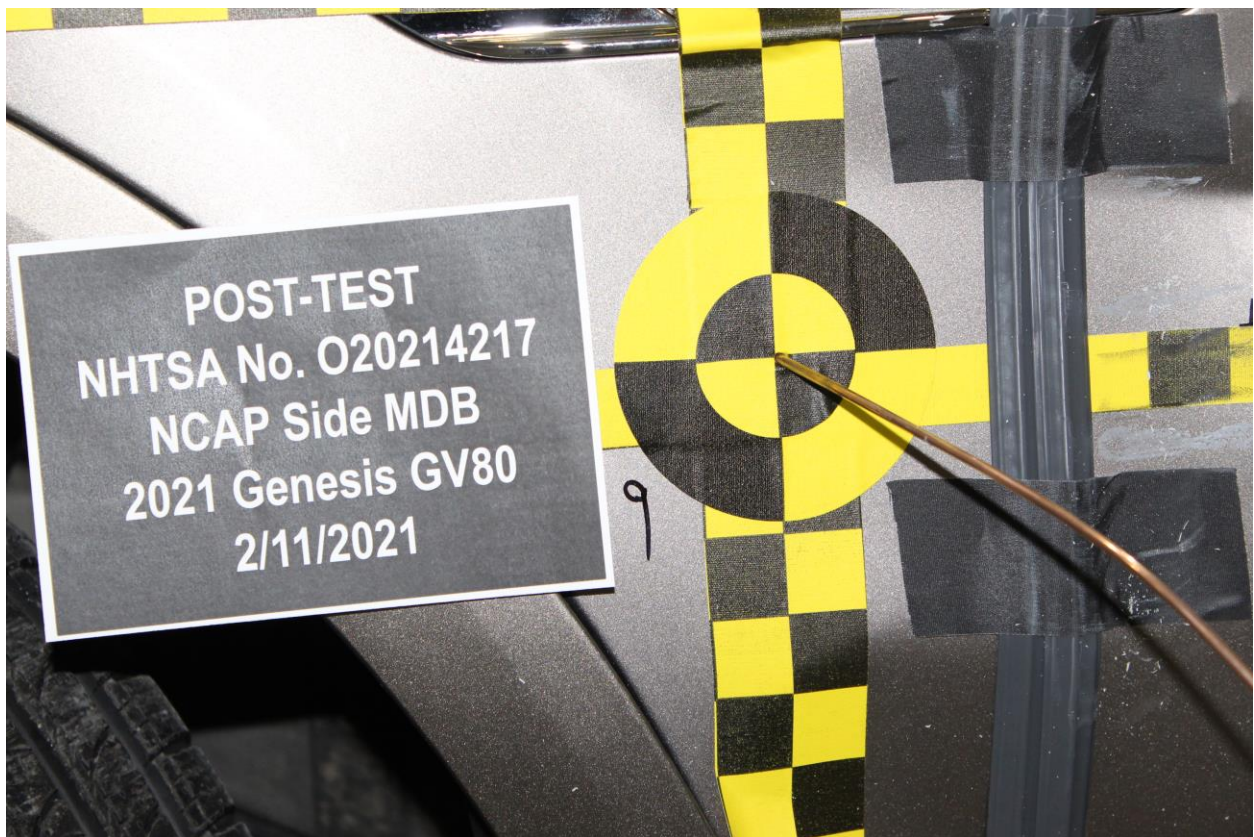
Figure A-20: Post-Test Close-up View of Impact Point Target

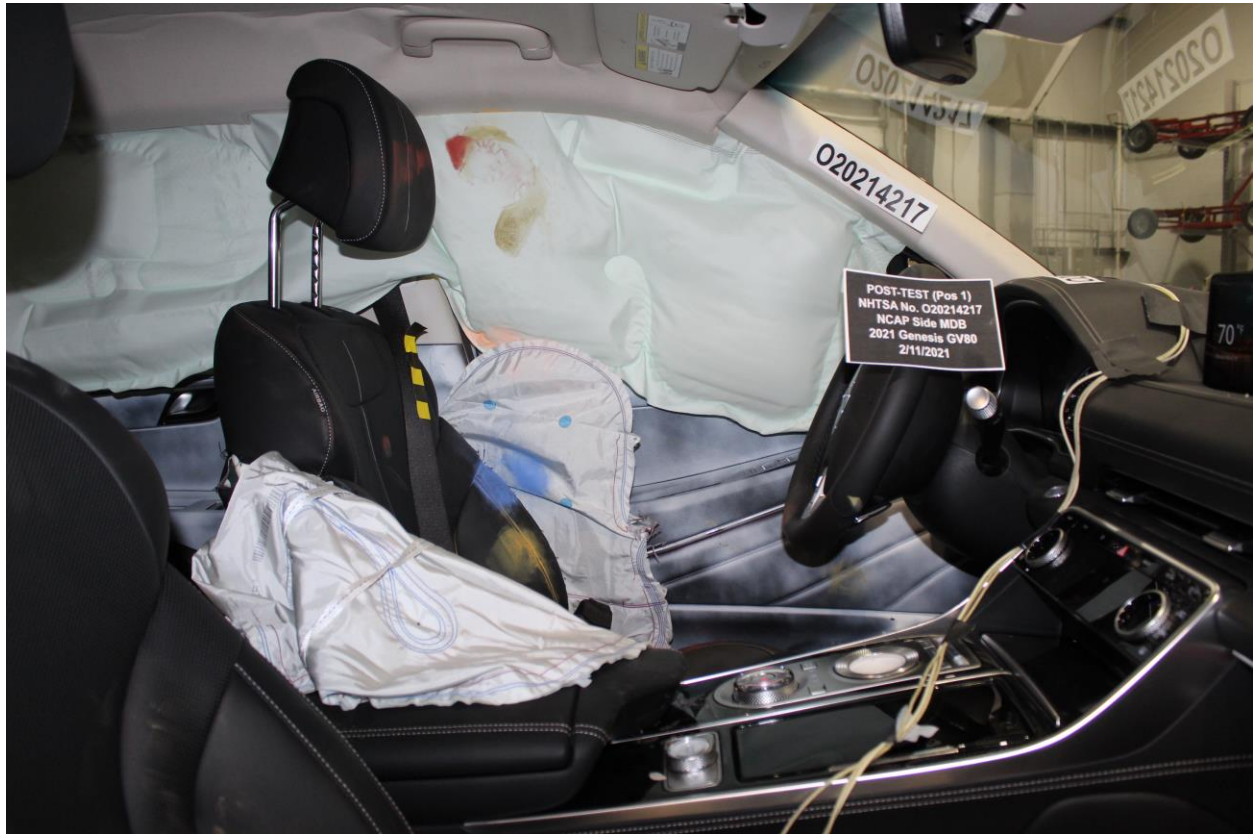
Figure A-47: Post-Test Driver Inner Door Panel View Showing Driver Dummy Contact Locations

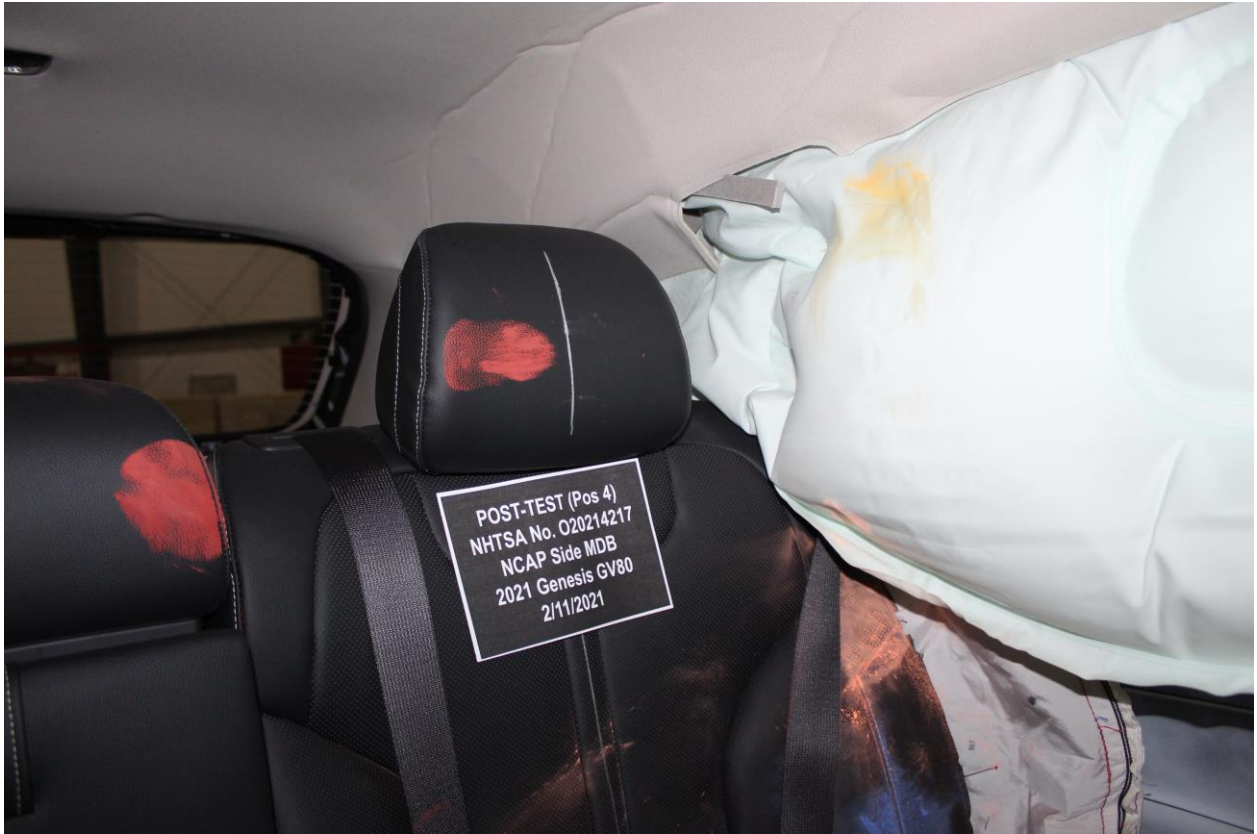
Figure A-75: Post-Test Rear Passenger Dummy Close-Up Head Contact with Vehicle View
