REPORT NUMBER: SideNCAPPole-KAR-21-006
NEW CAR ASSESSMENT PROGRAM (NCAP)
SIDE IMPACT POLE TEST

MERCEDES-BENZ AG STUTTGART
2021 MERCEDES-BENZ GLB250 5-DOOR SUV

NHTSA No: M20214304

FINAL REPORT

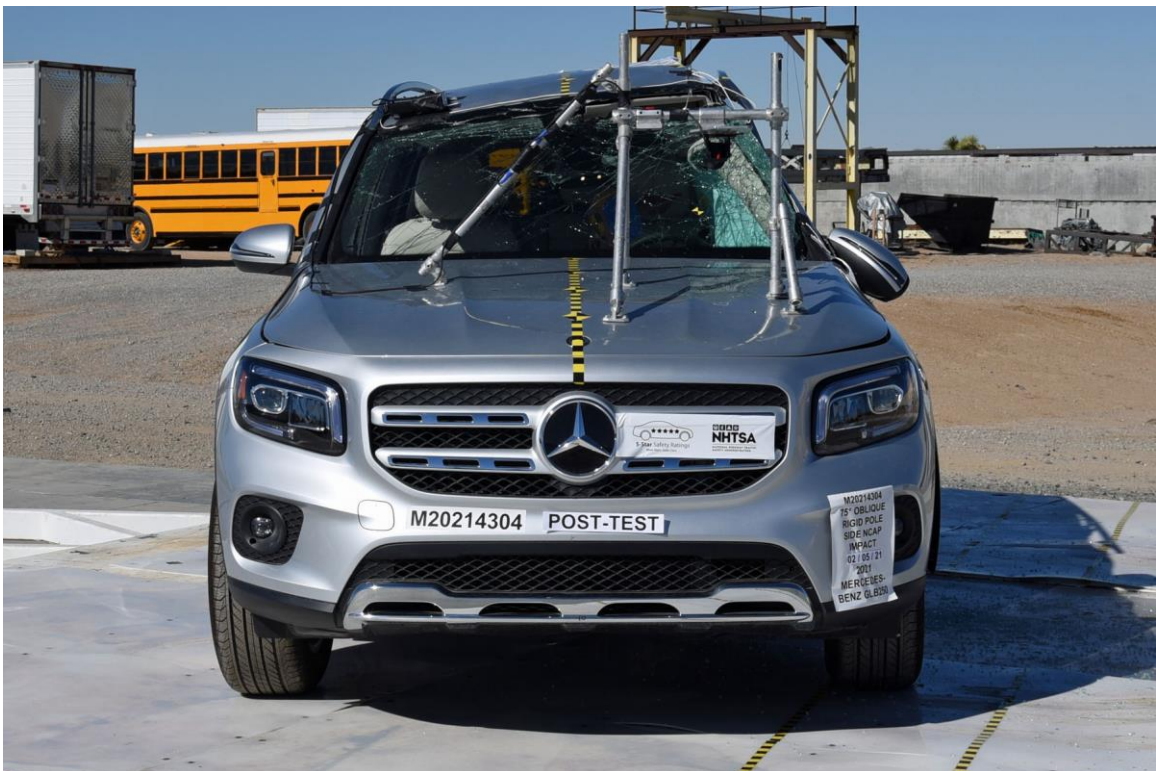
FIGURE 4. Post-Test Frontal View of Test Vehicle

<p>The struck side doors at the front and rear of the vehicle was jammed shut and did not separate from the hinges. There was no separation of the latches.</p>				Measurement Description	Driver ATD (SID-IIs)			Units	Threshold	Result	Head Injury Criteria (HIC ₃₆)		1000	467.7	Resultant Lower Spine Acceleration	g	82	57	Total Pelvic Force (Sum of Acetabular and Iliac Forces)	N	5525	3813	Maximum Thoracic Rib Deflection	mm	38	38	Maximum Abdominal Rib Deflection	mm	45	32
Measurement Description	Driver ATD (SID-IIs)																													
	Units	Threshold	Result																											
Head Injury Criteria (HIC ₃₆)		1000	467.7																											
Resultant Lower Spine Acceleration	g	82	57																											
Total Pelvic Force (Sum of Acetabular and Iliac Forces)	N	5525	3813																											
Maximum Thoracic Rib Deflection	mm	38	38																											
Maximum Abdominal Rib Deflection	mm	45	32																											
17. Key Words New Car Assessment Program (NCAP) Side Impact Pole Part 572V SID-IIs		18. Distribution Statement National Highway Traffic Safety Admin. Technical Information Services Division 1200 New Jersey Ave., SE Washington, DC 20590																												
19. Security Classification of this report UNCLASSIFIED	20. Security Classification of this page UNCLASSIFIED	21. No. of Pages 104	22. Price

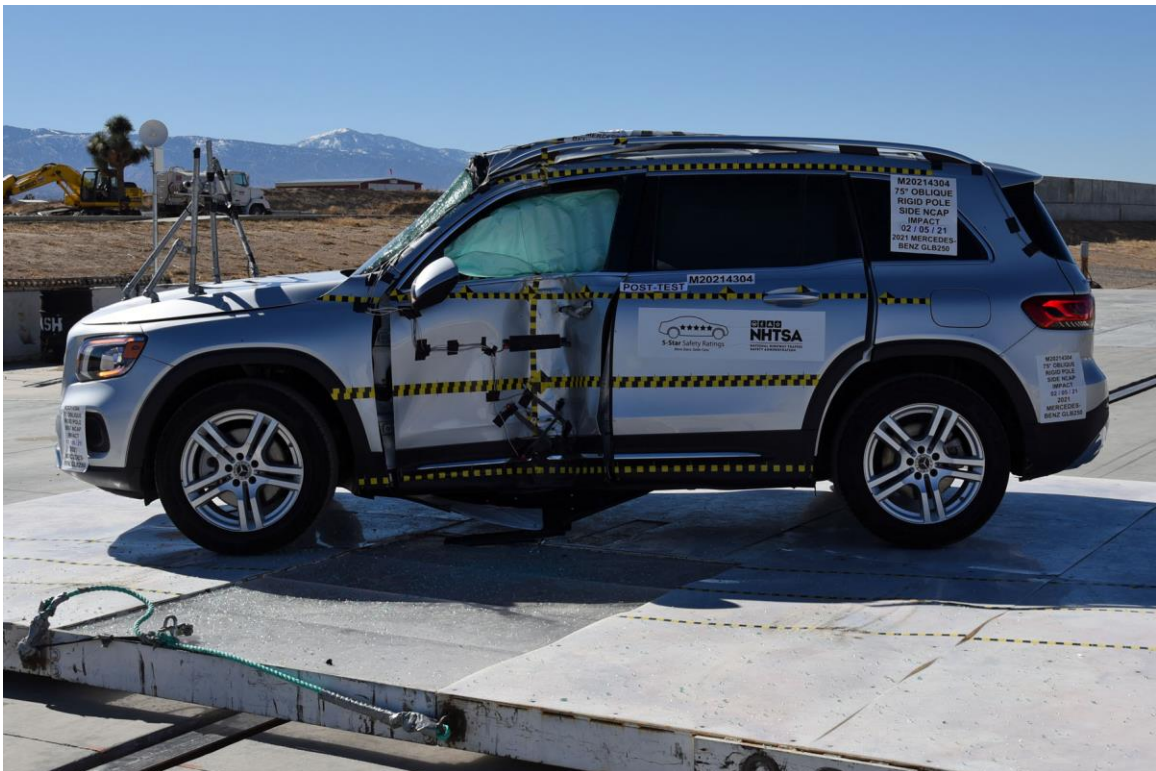
FIGURE 8. Post-Test Left Side View of Test Vehicle

Critical Areas of Performance	Observations and Conclusions
Pillar Performance	No separation occurred
Sill Separation	No separation occurred
Windshield Damage	Broken
Side Window Damage	Left front window broken
Other Notable Effects

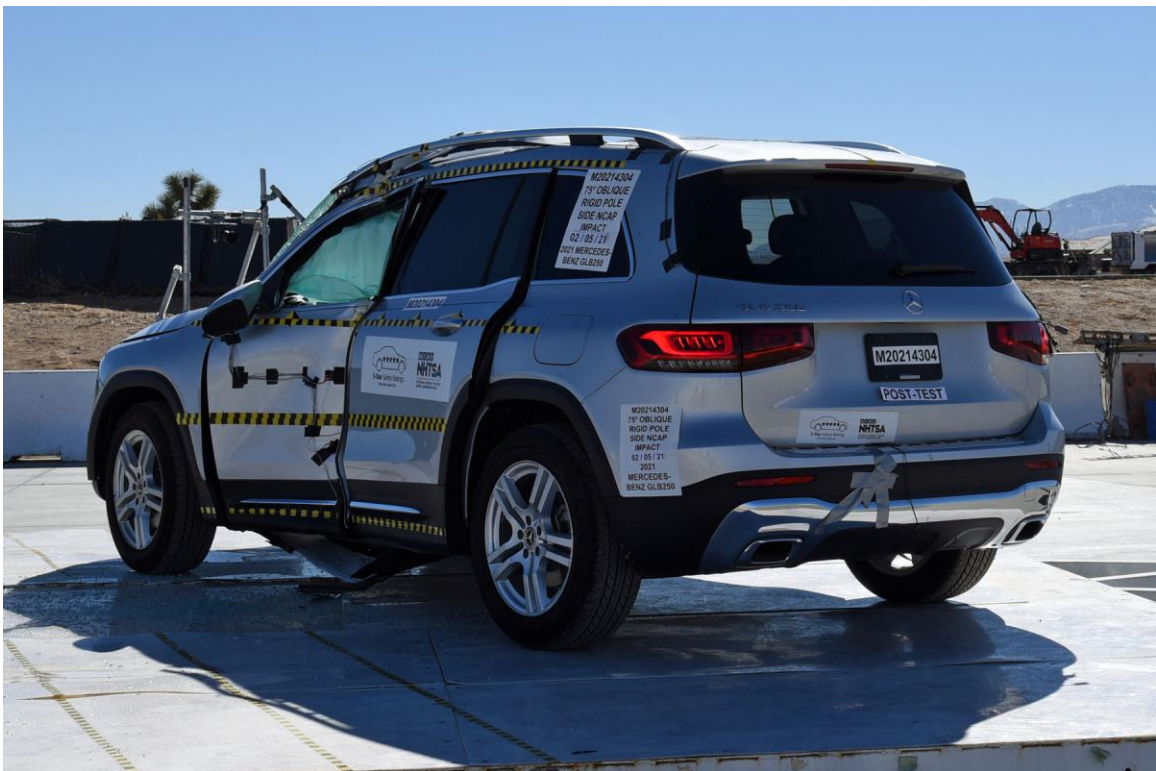
FIGURE 10. Post-Test Left Rear $\frac{3}{4}$ View of Test Vehicle

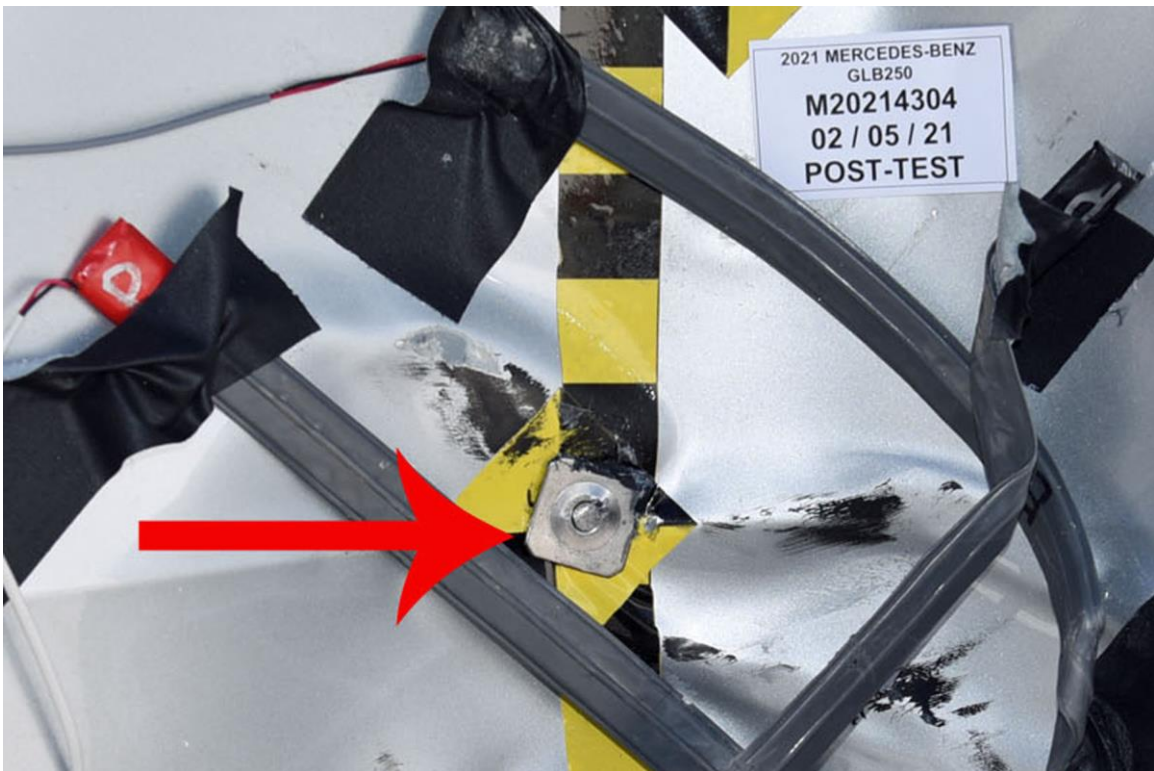
FIGURE 20. Post-Test Close-Up View of Impact Point Target Showing Impact Location

Distance from 75° Impact Location Line (mm)
Fore 25 mm target	70
Aft 25 mm target	71

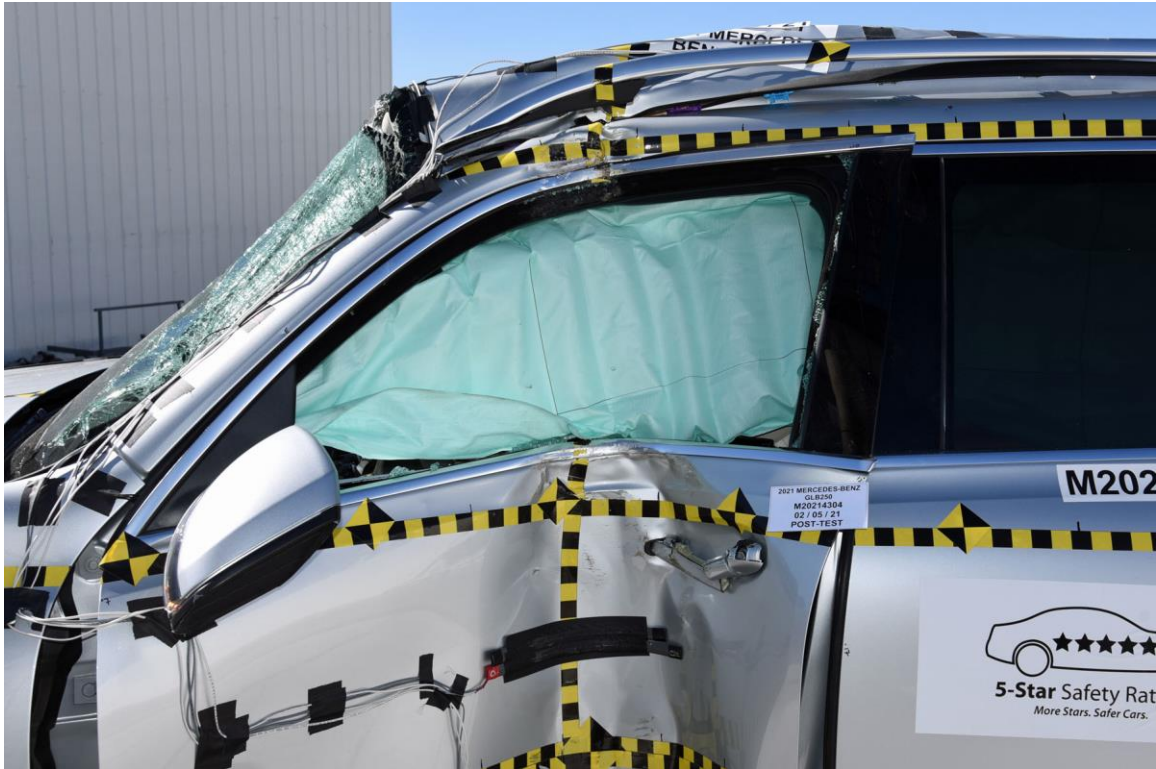
FIGURE 25. Post-Test Left Side View of Dummy Shoulder and Door Top View

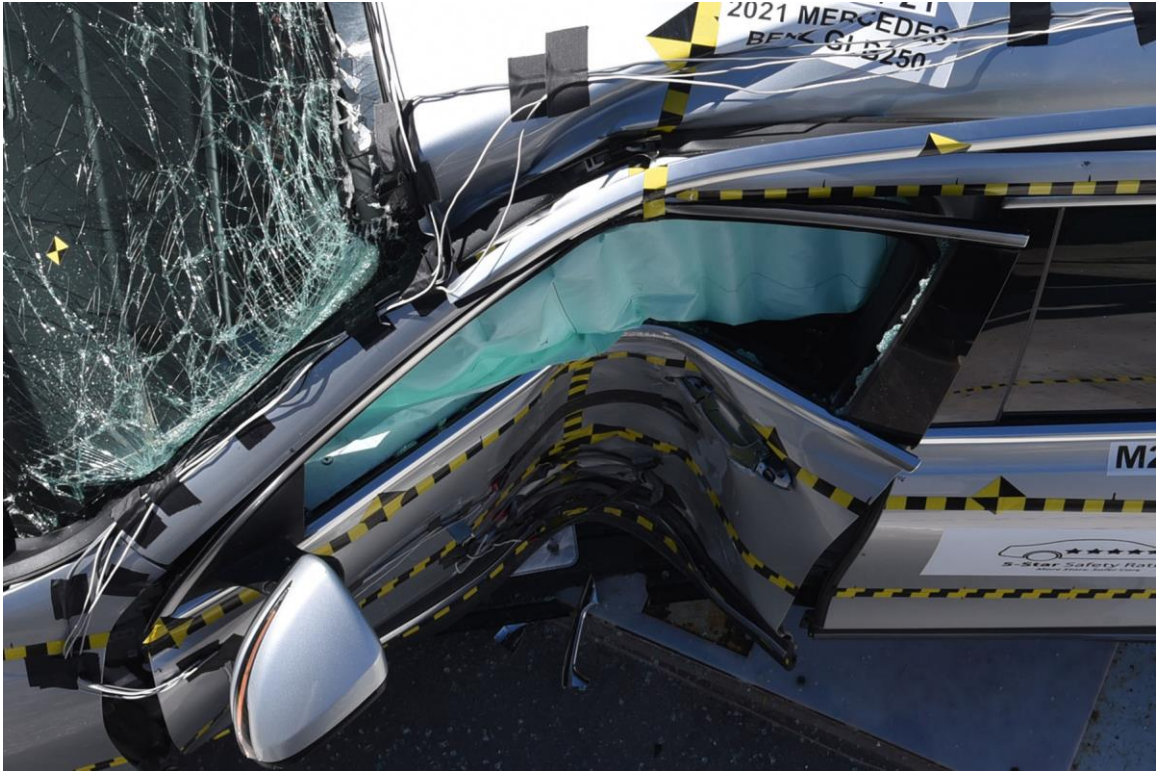
FIGURE 41. Post-Test Dummy and Door Clearance View

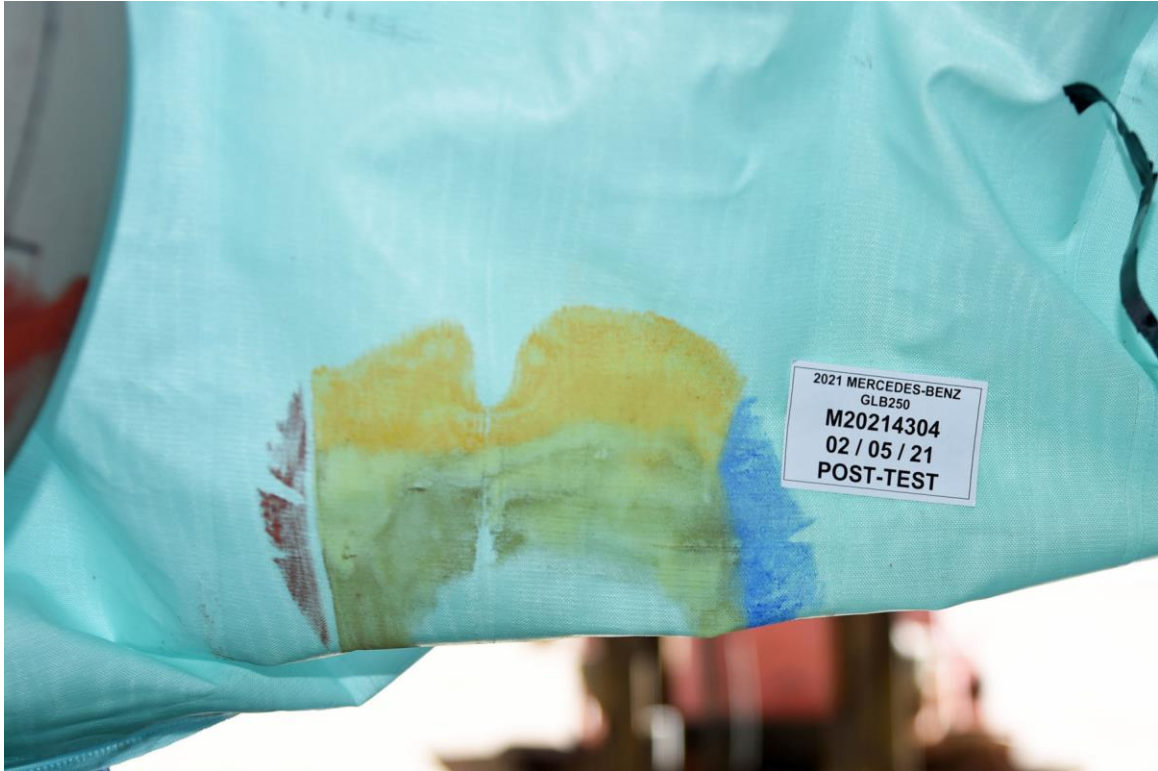
FIGURE 47. Post-Test Dummy Close-Up Head Contact With Side Airbag View

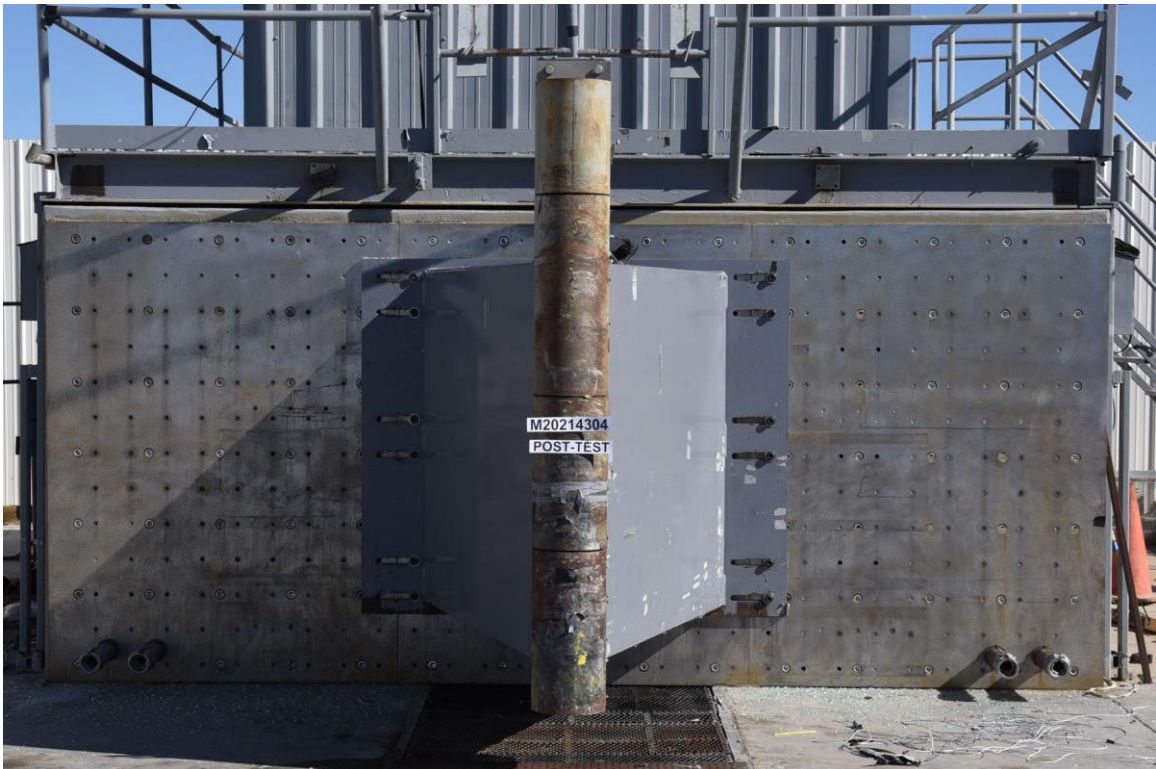
FIGURE 60. Post-Test Pole Barrier Front View
