**REPORT NUMBER: SideNCAPPole-MGA-21-038**

**NEW CAR ASSESSMENT PROGRAM (NCAP)  
Side Impact Pole Test**

**KIA MOTORS MANUFACTURING GEORGIA, INC.  
2021 Kia Sorento LX 5-Door SUV  
NHTSA No.: O20214210**

**FINAL REPORT**

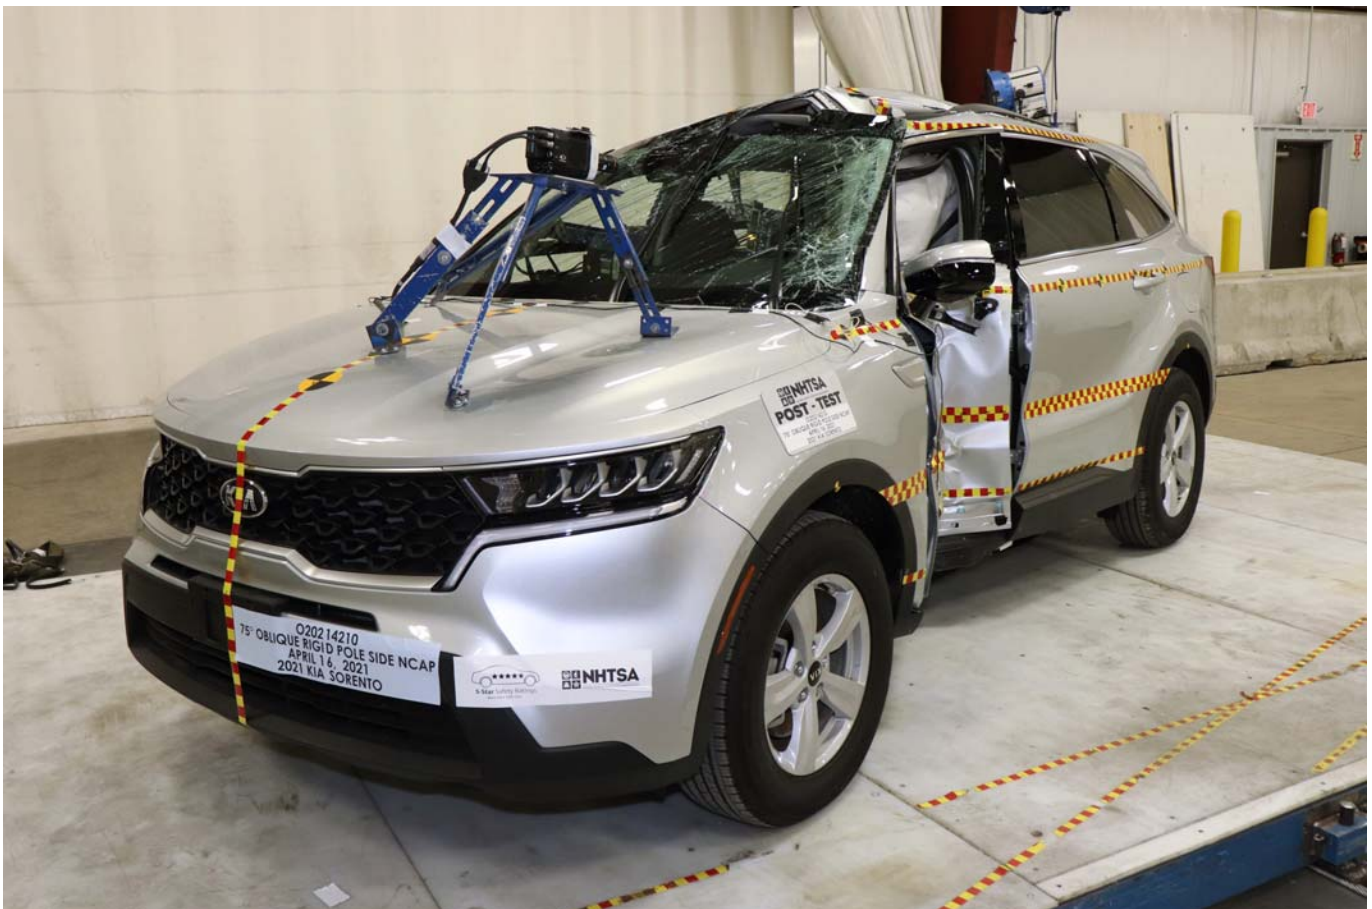
Photo No. 006 - Post-Test Left Front Three-Quarter View of Test Vehicle

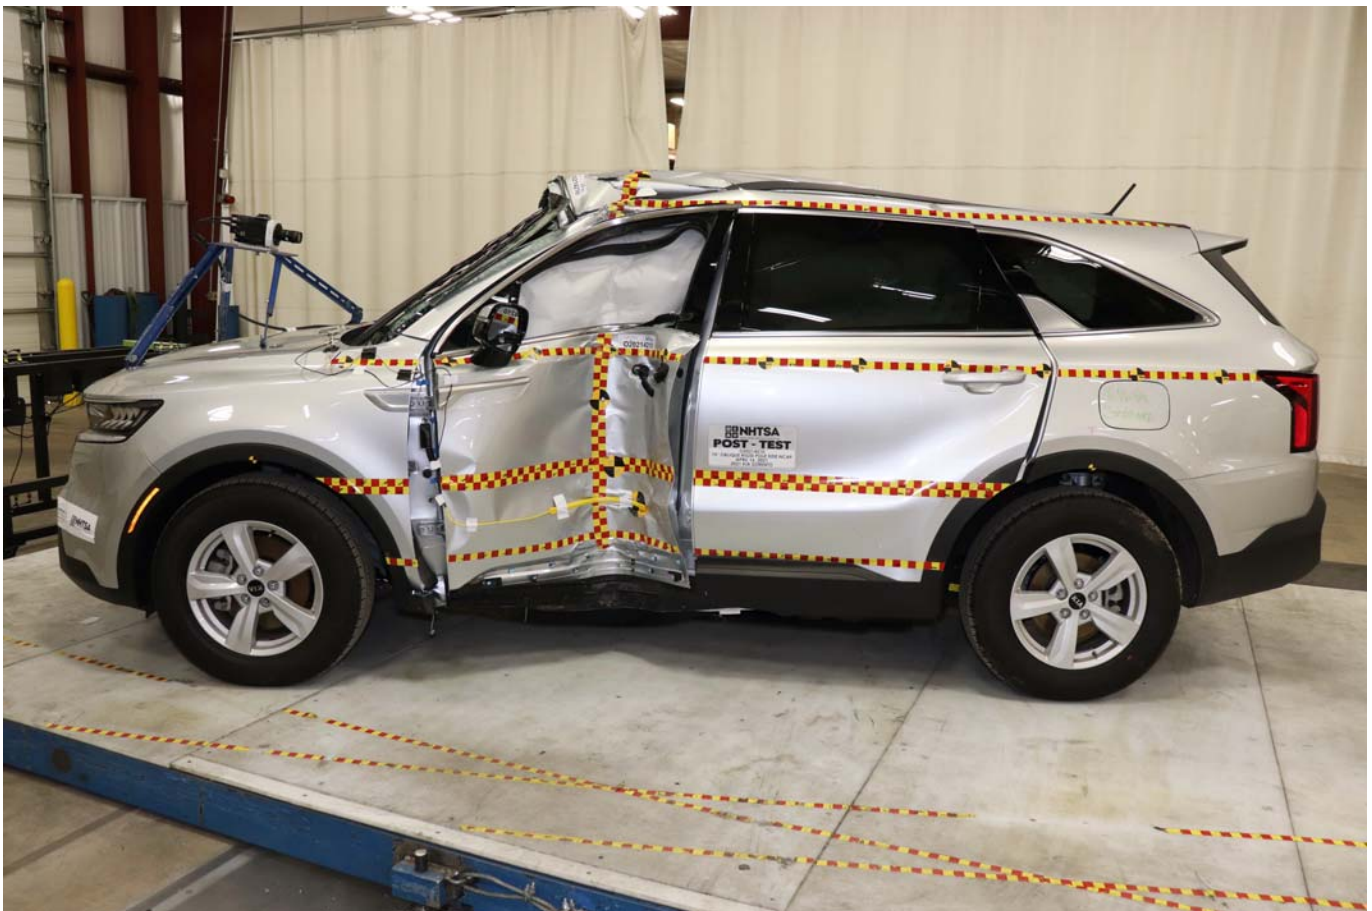
Photo No. 008 - Post-Test Left Side View of Test Vehicle

| Critical Areas of Performance | Observations and Conclusions |
|---|---|
| Side Window Damage | LF window broken |

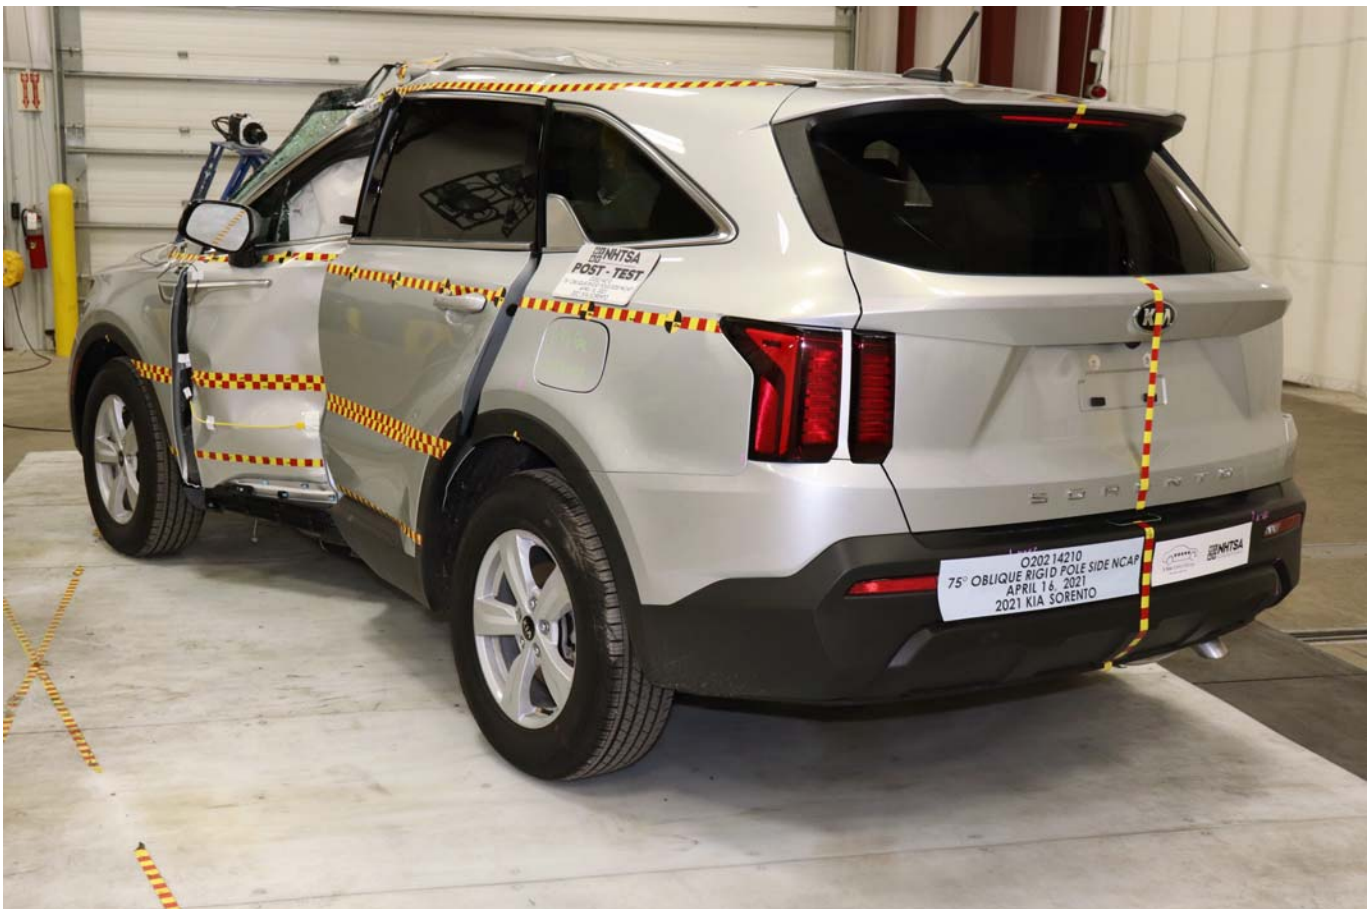
Photo No. 010 - Post-Test Left Rear Three-Quarter View of Test Vehicle

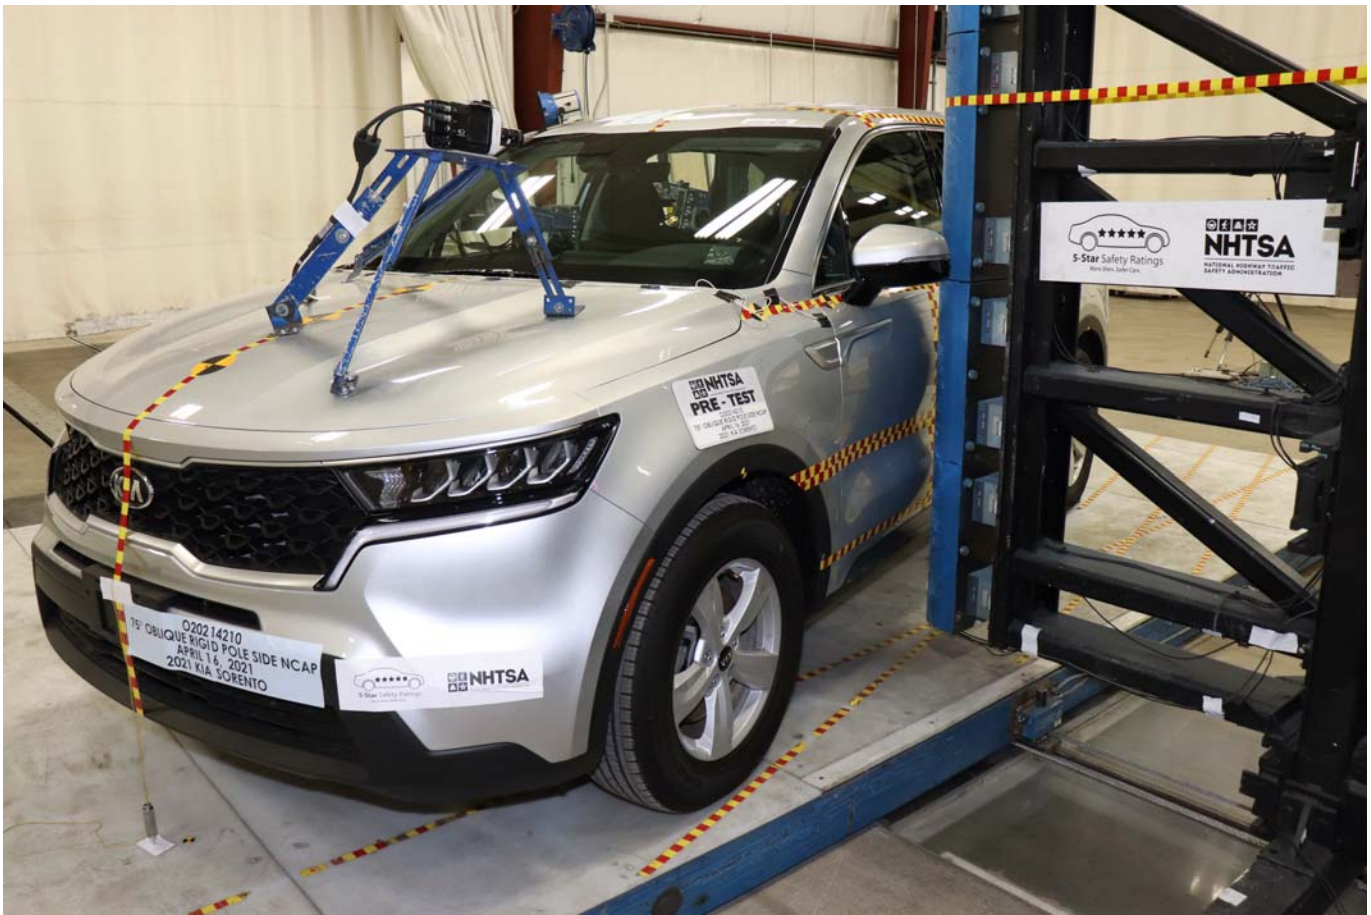
Photo No. 017 - Pre-Test Left Side View of Pole Positioned Against Side of Vehicle

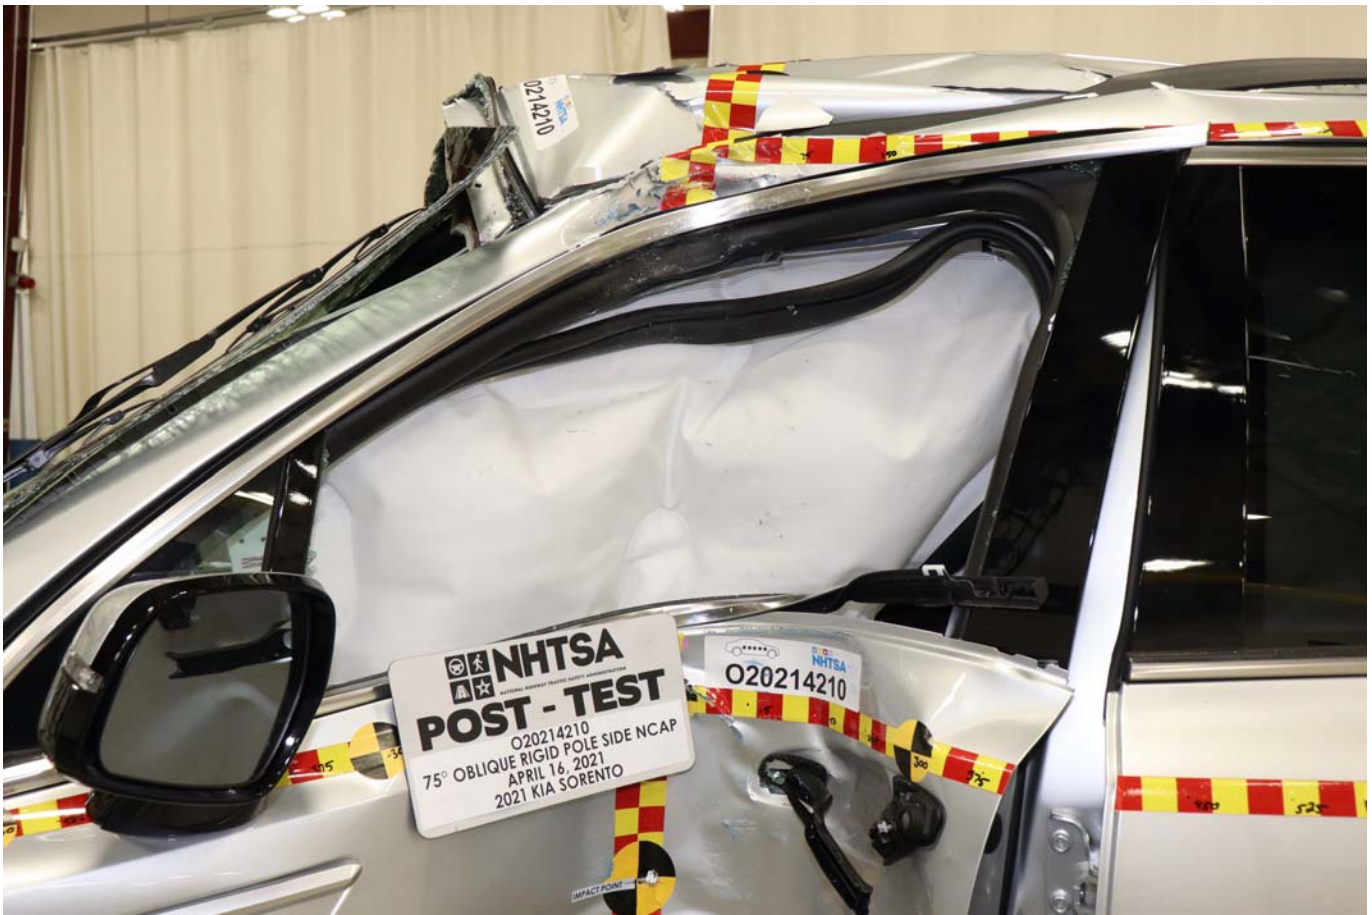
Photo No. 025 - Post-Test Left Side View of Dummy Shoulder and Door Top View

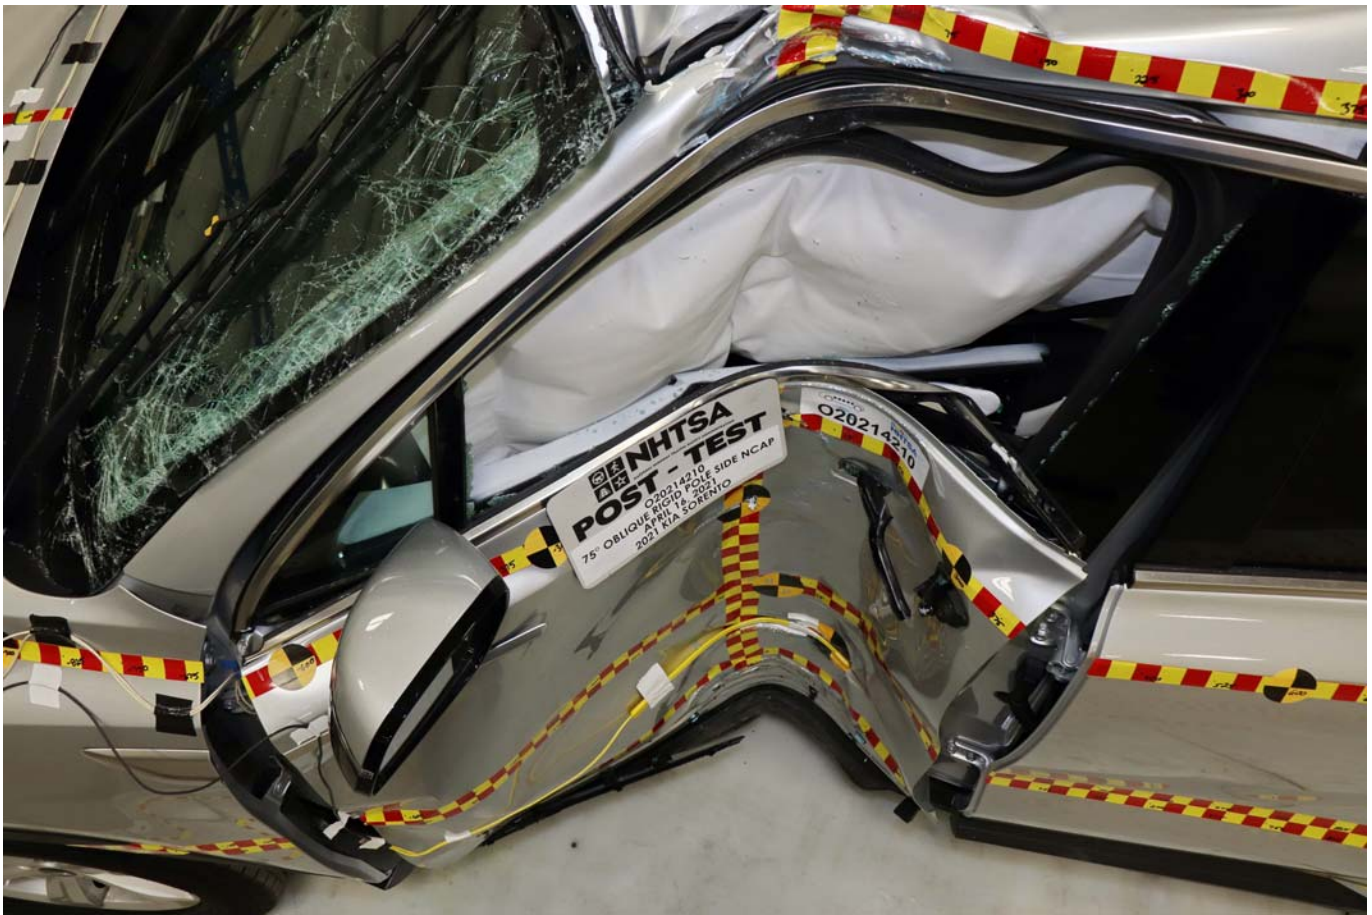
Photo No. 041 - Post-Test Dummy and Door Clearance View

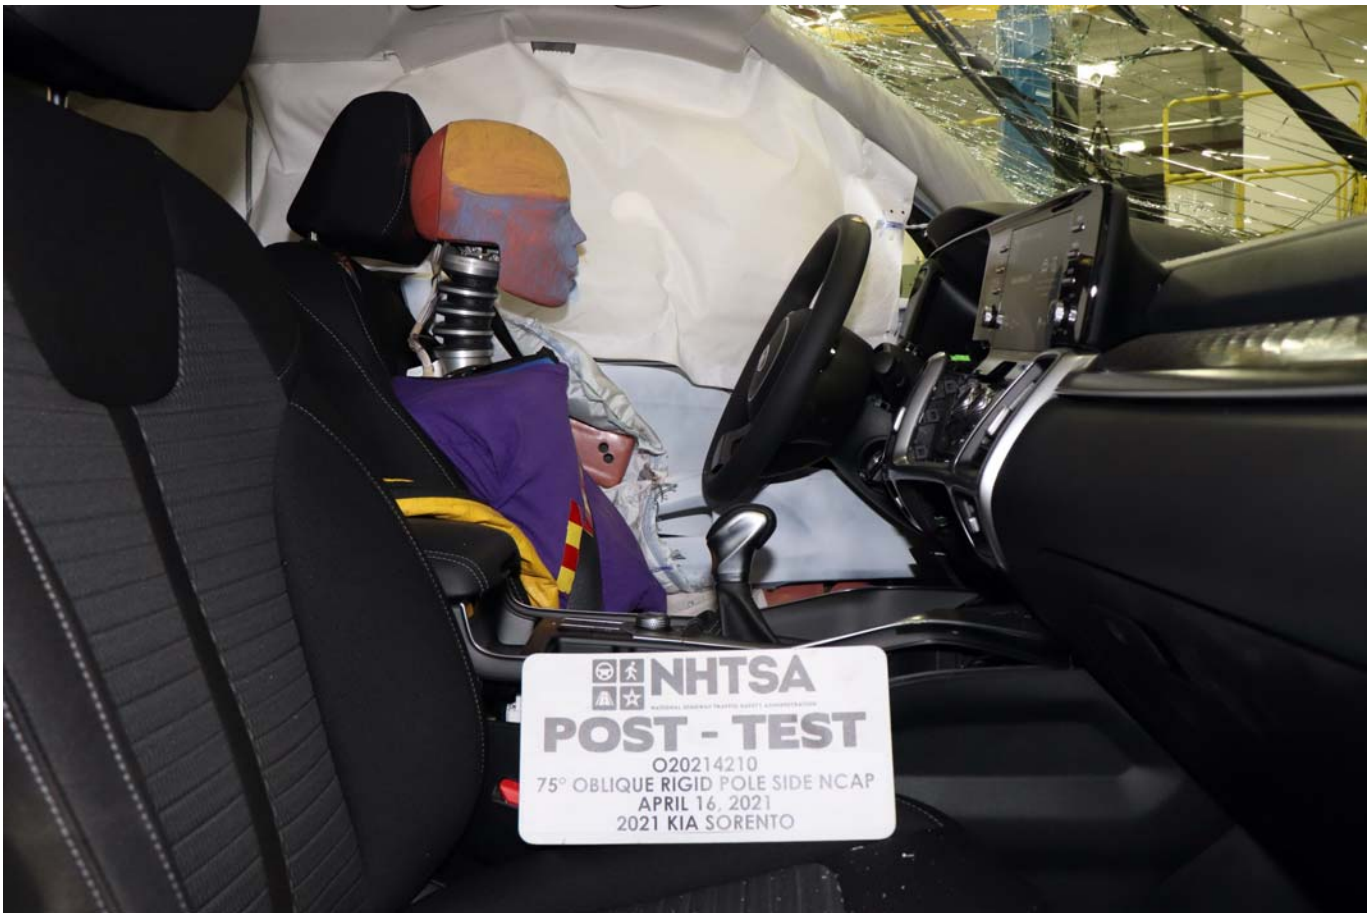
Photo No. 043 - Post-Test Right Side View of Dummy and Front Seat of Occupant Compartment

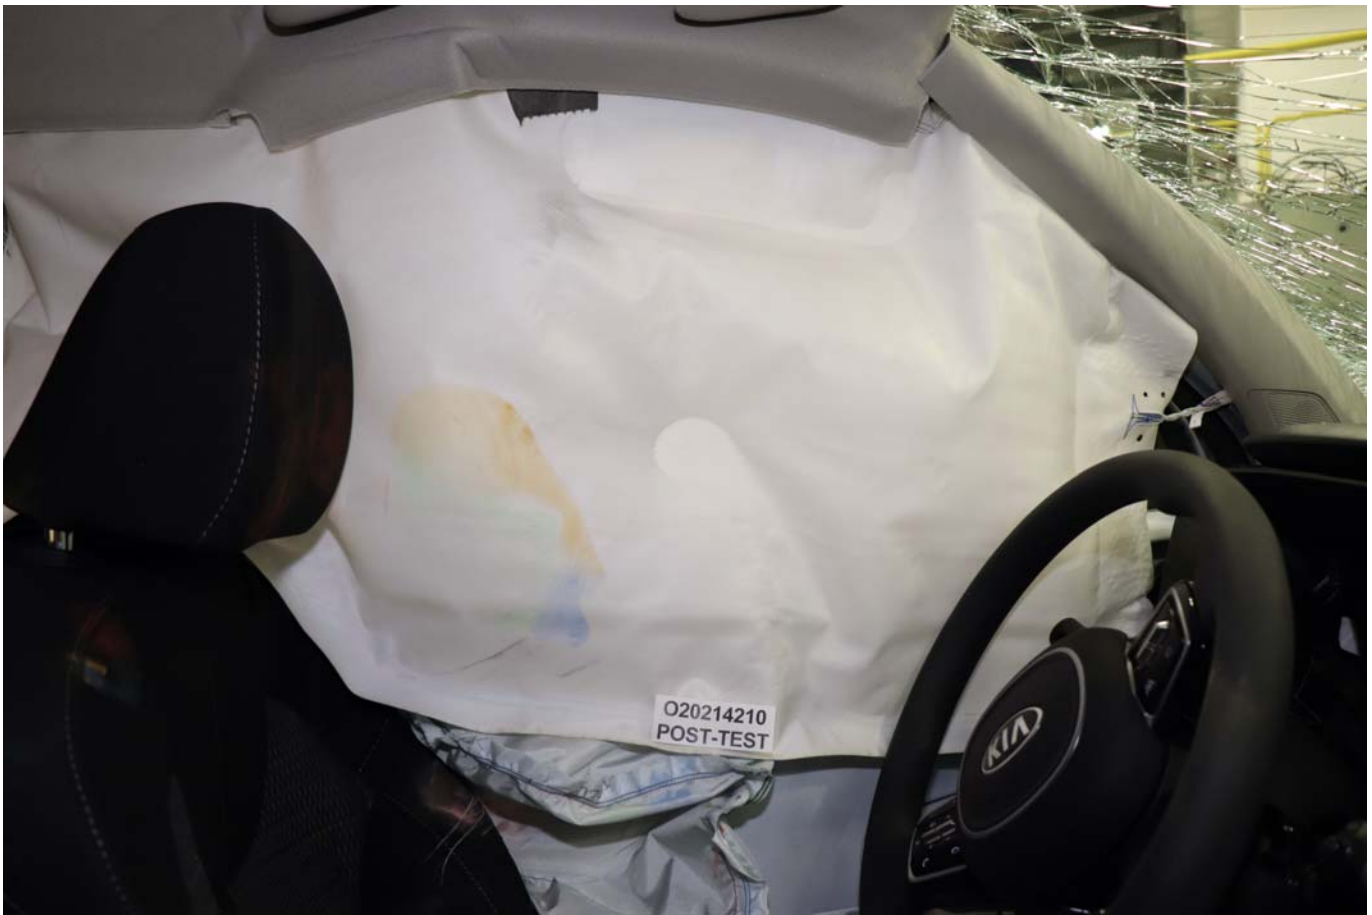
Photo No. 047 - Post-Test Dummy Close-Up Head Contact with Side Air Bag View

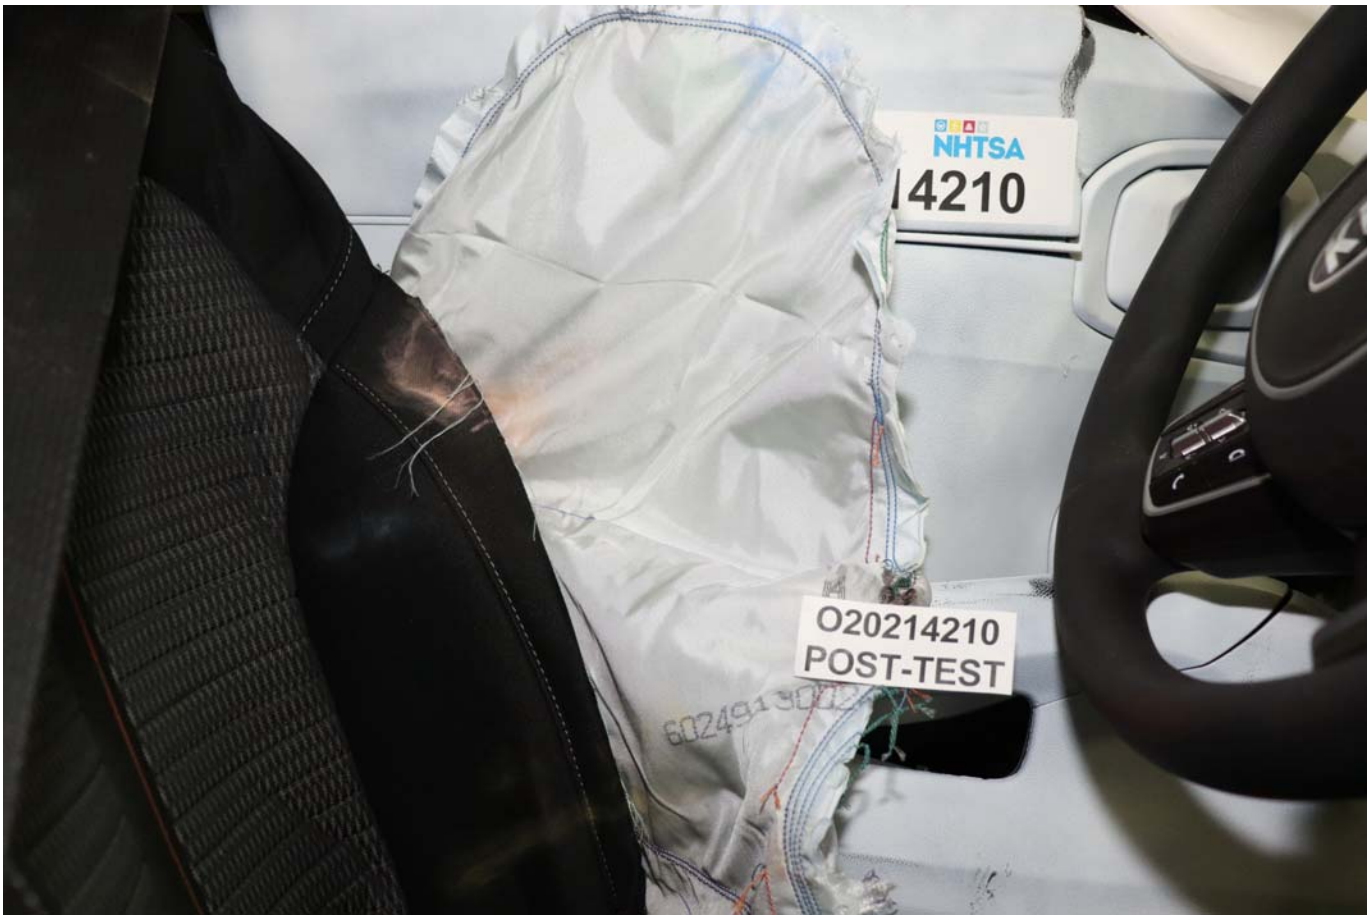
Photo No. 049 - Post-Test Dummy Close-Up Torso Contact with Side Air Bag View

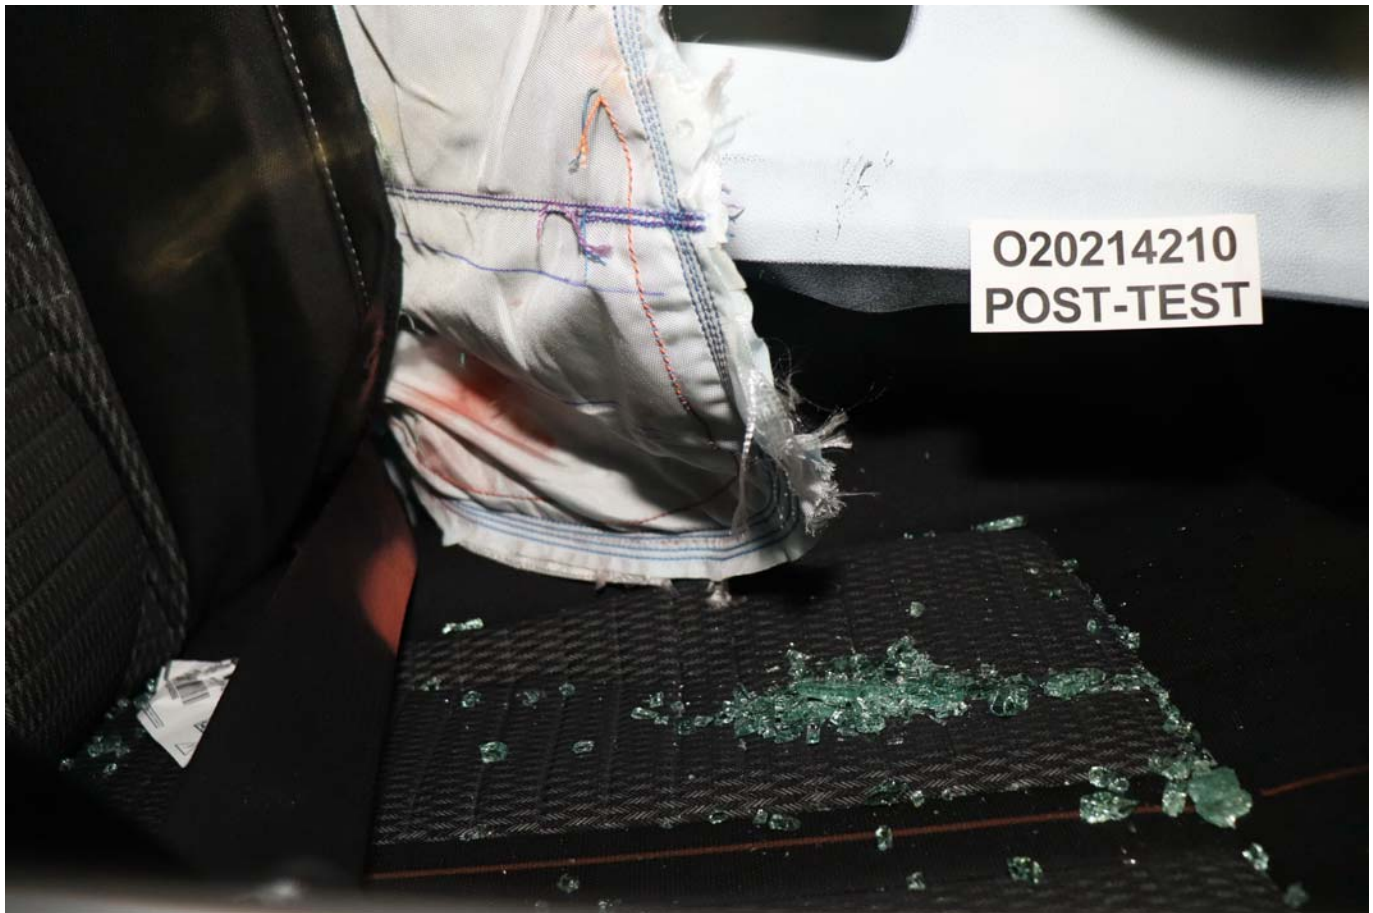
Photo No. 051 - Post-Test Dummy Close-Up Pelvis Contact with Side Air Bag View

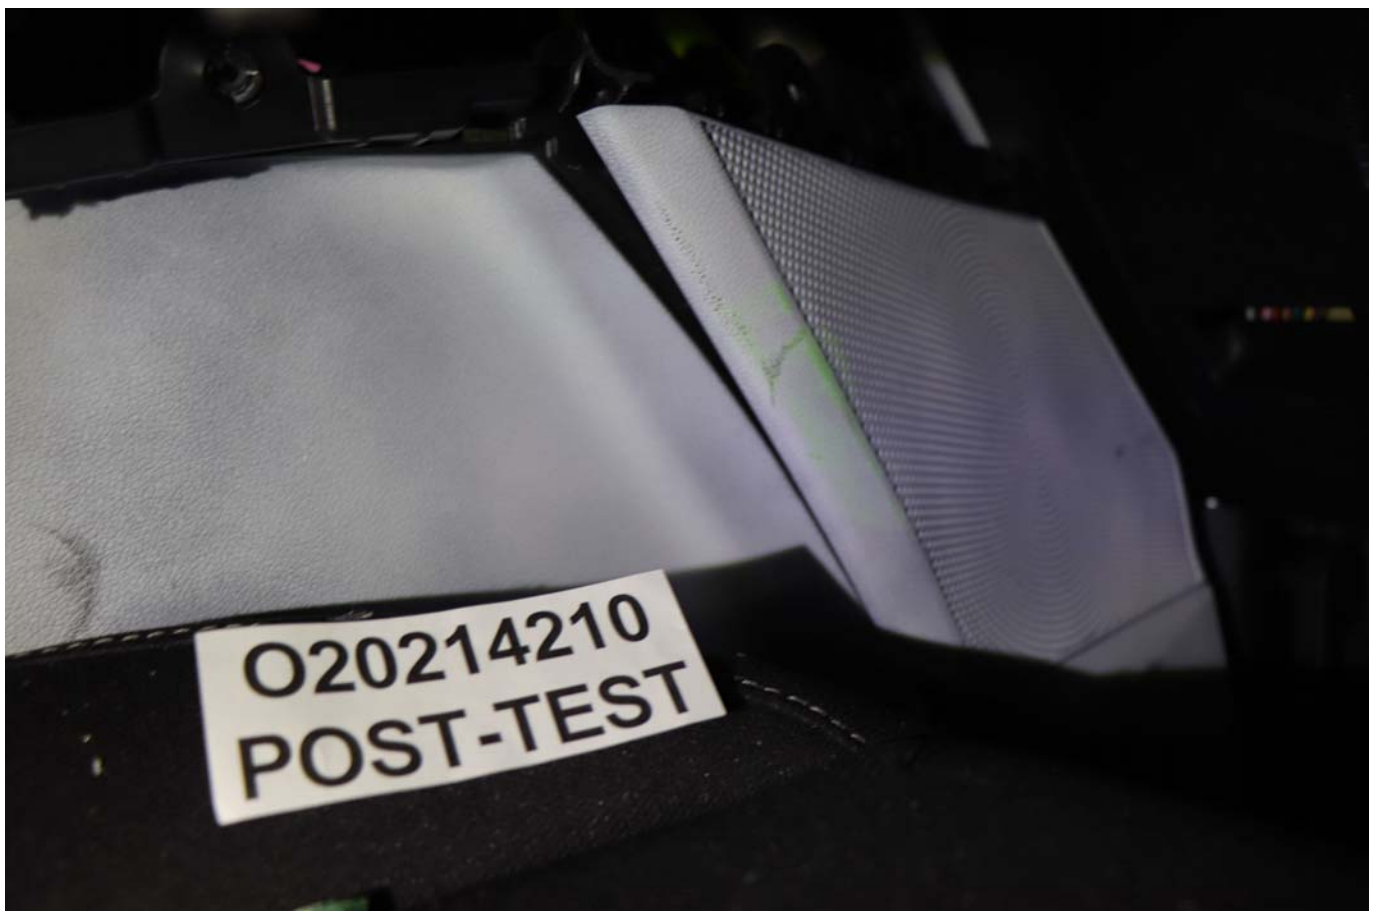
Photo No. 052 - Post-Test Dummy Close-Up Knee Contact with Vehicle Interior View

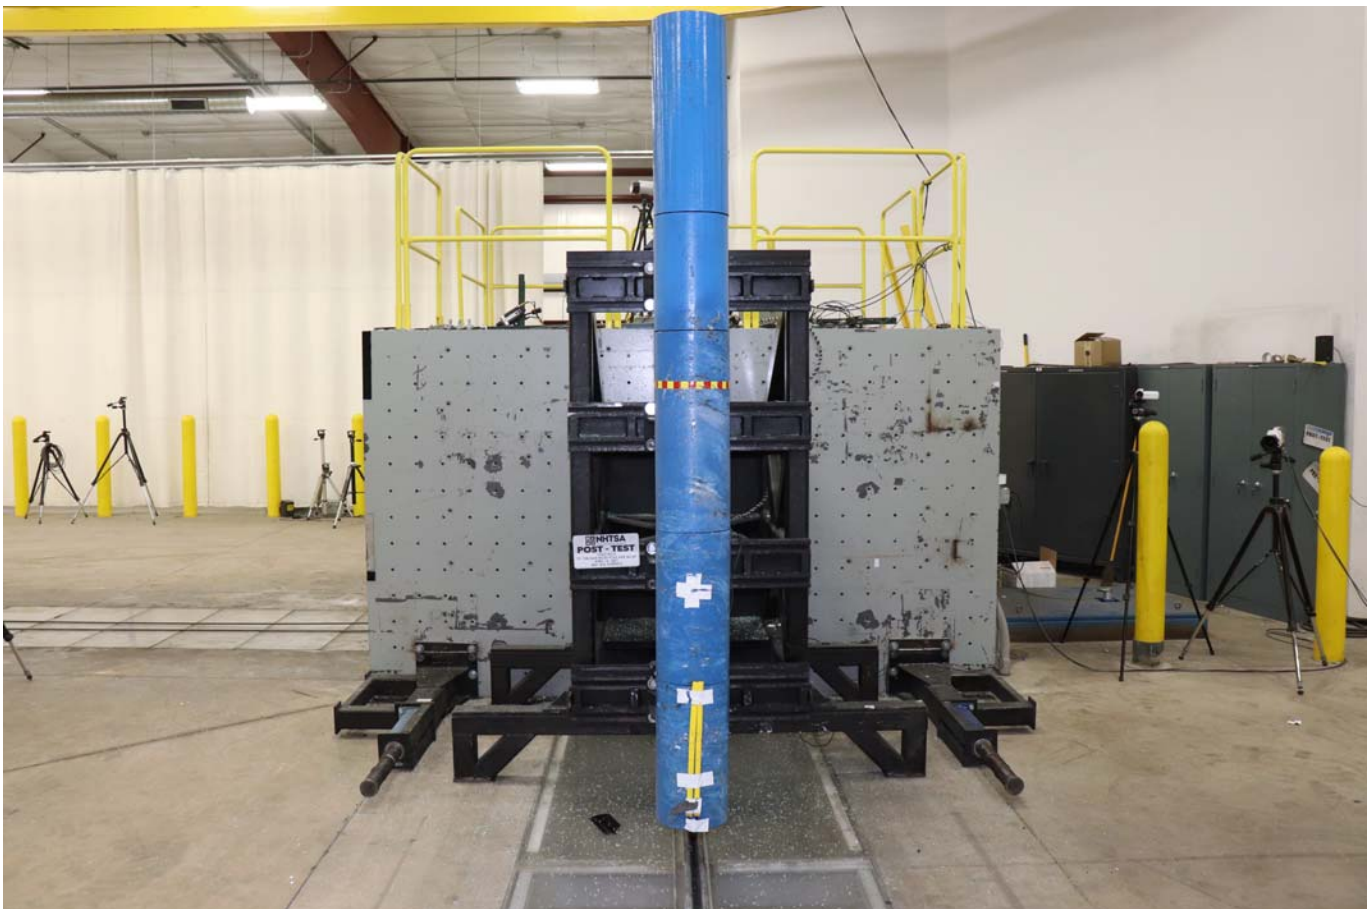
Photo No. 060 - Post-Test Pole Barrier Front View

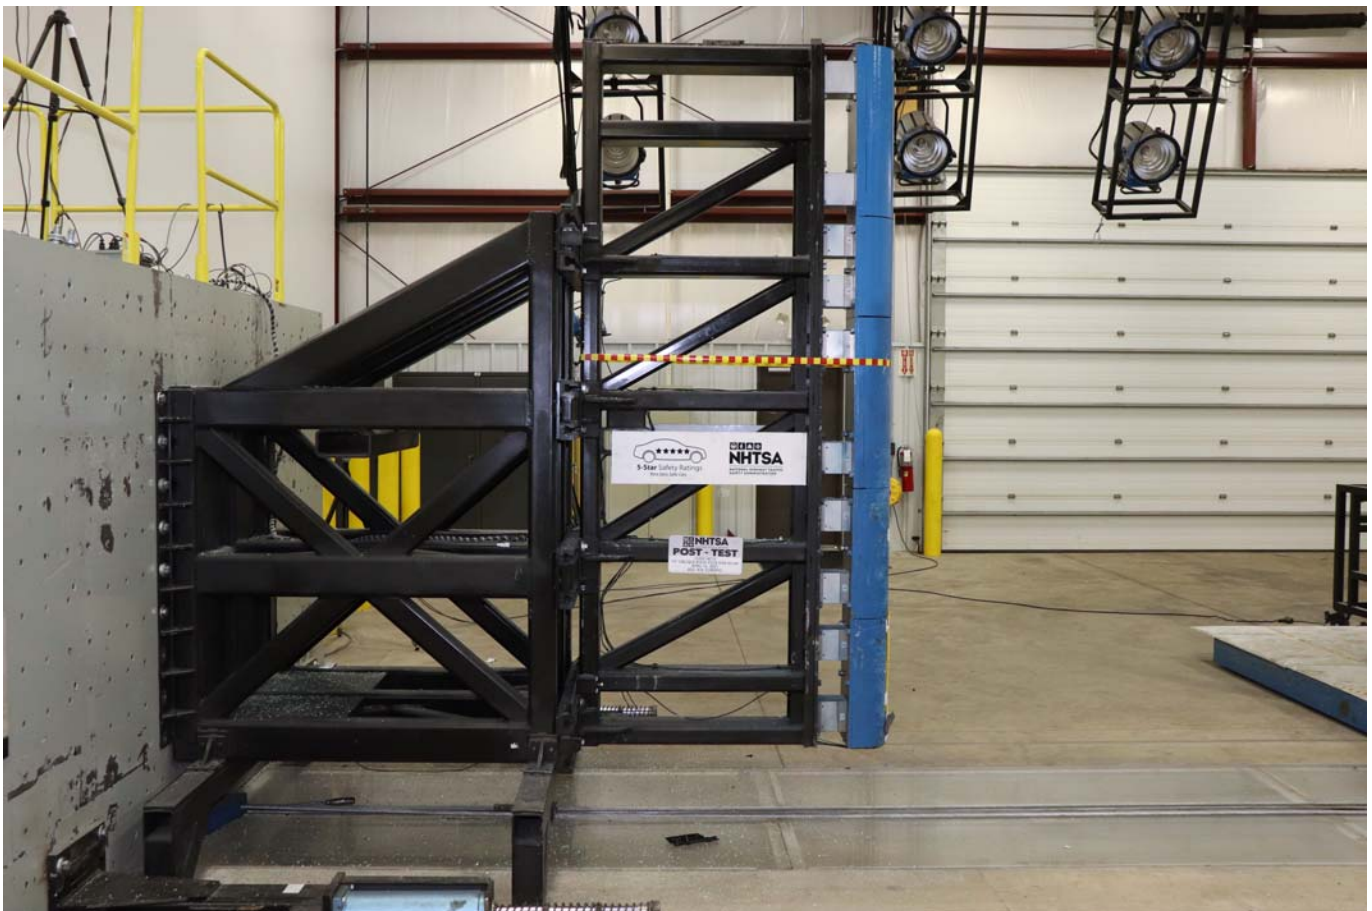
Photo No. 062 - Post-Test Pole Barrier Side View

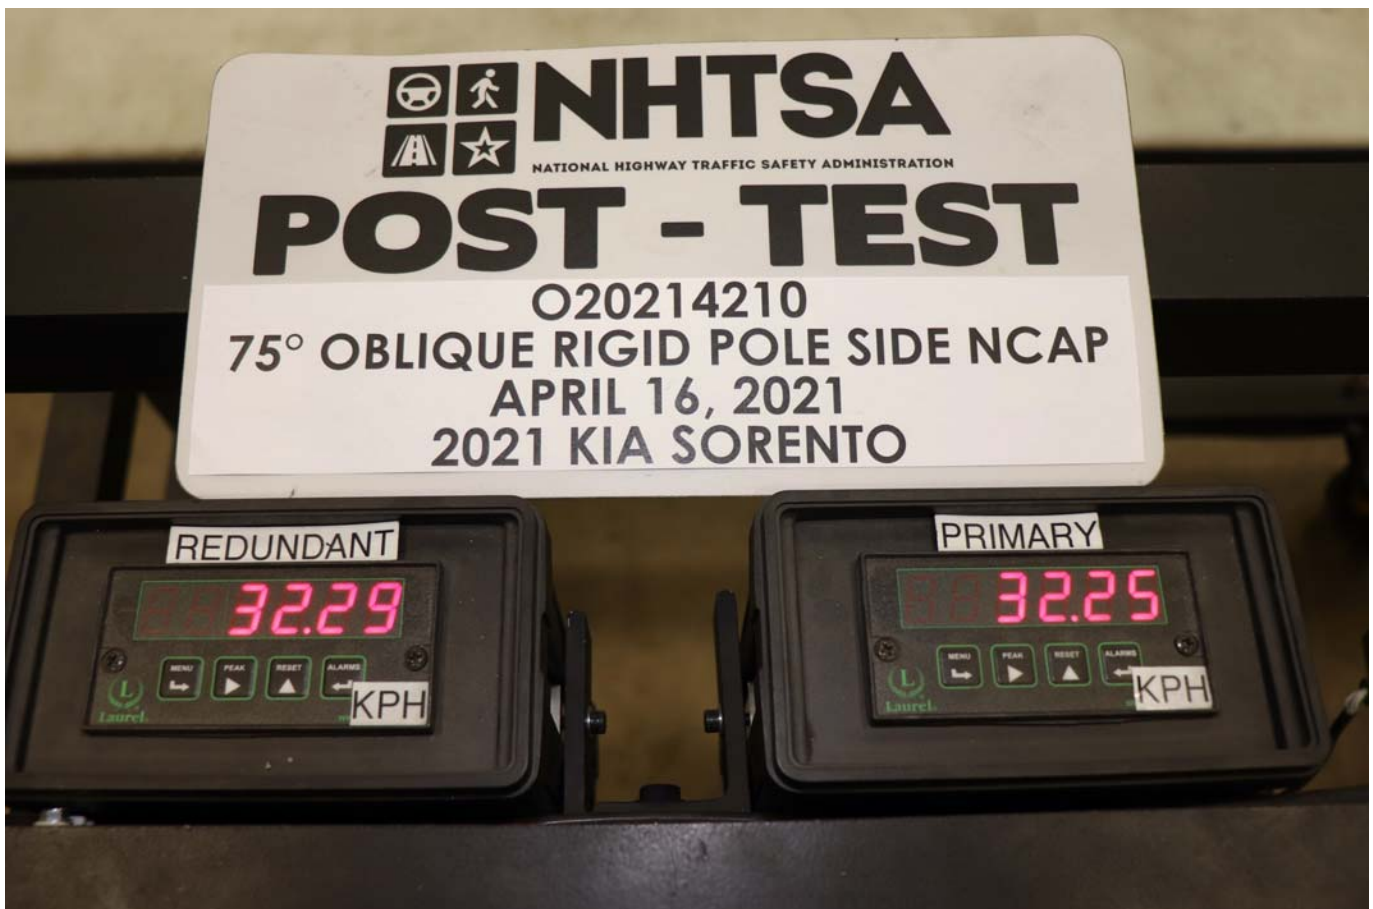
Photo No. 064 - Post-Test Primary and Redundant Speed Trap Read-Out

A rigid pole side impact test was conducted on a 2021 Kia Sorento LX 5-Door SUV. The subject vehicle was towed into the rigid pole at an angle of 75° and a velocity of 32.25 km/h. The test was conducted by MGA Research Corporation in Burlington, Wisconsin on April 16, 2021. Pre-test and post-test photographs of the test vehicle and side impact dummy (SID-IIs) are included in Appendix A of this report.

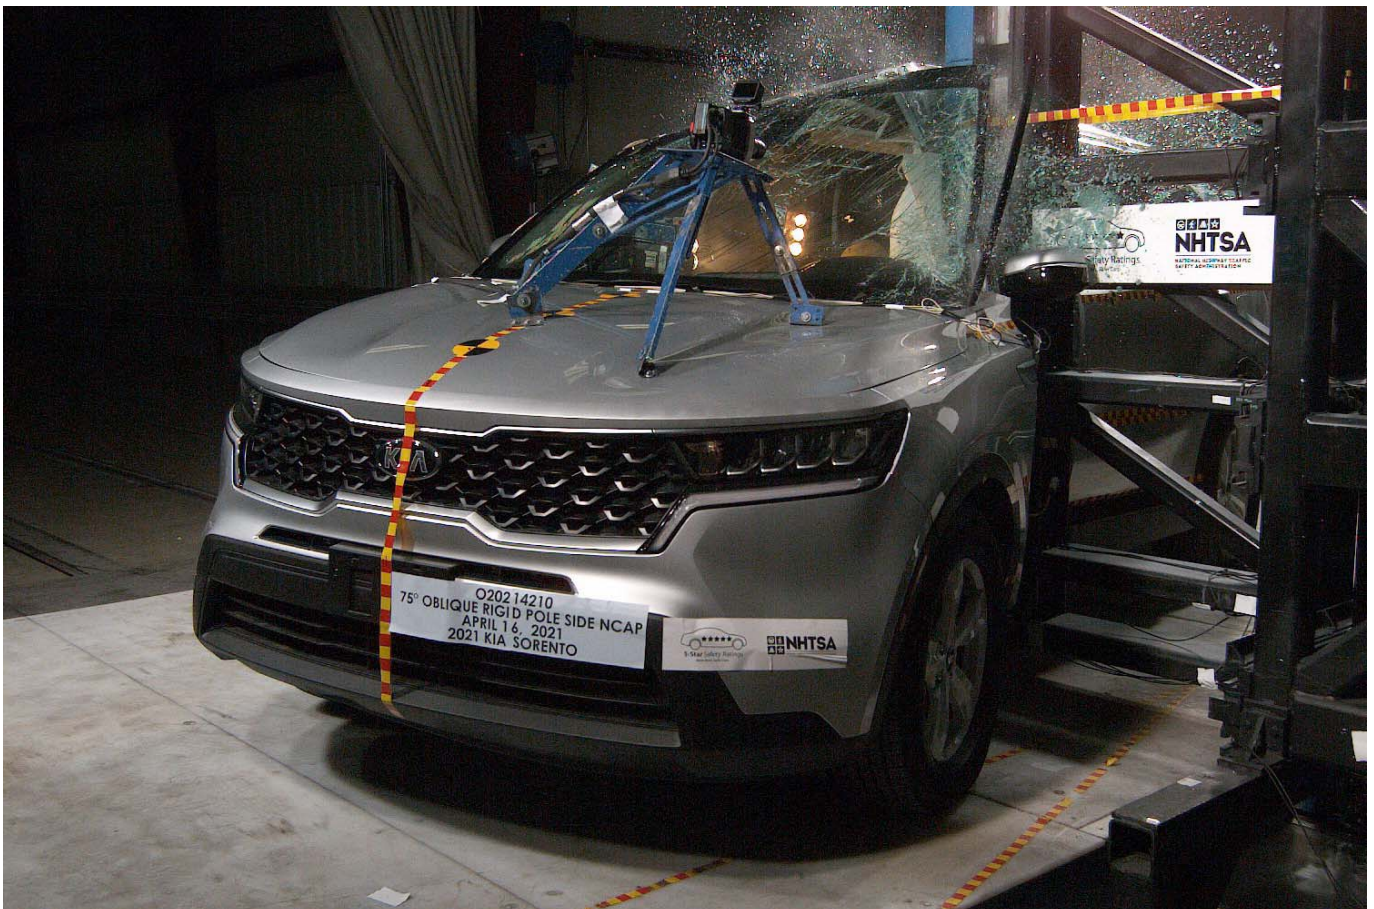
Photo No. 070 - Impact Event

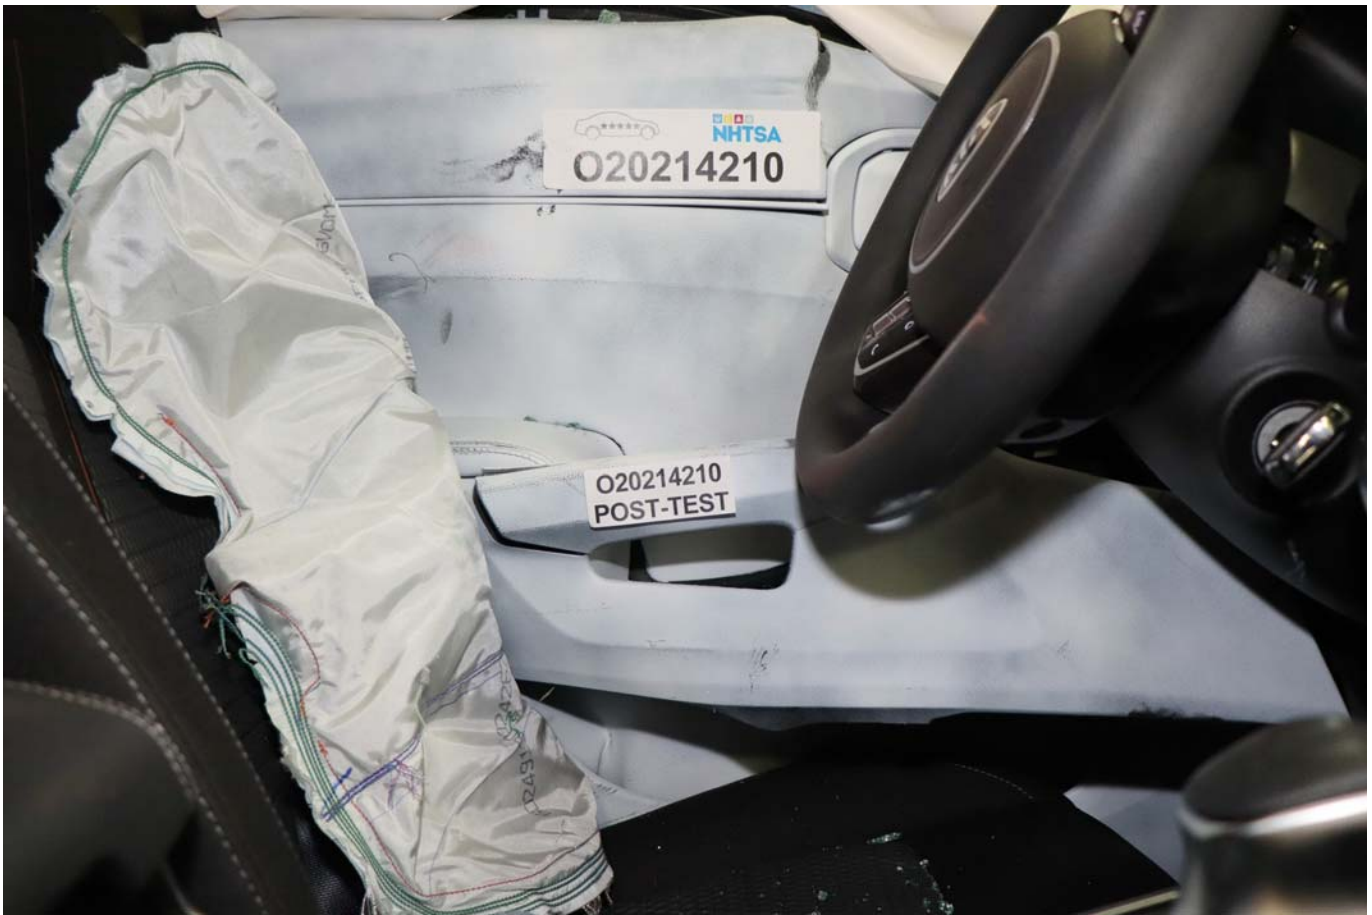
Photo No. 073 - Post-Test View of Shattered Vehicle Inner Door Panel
