**NEW CAR ASSESSMENT PROGRAM (NCAP)  
Side Impact Pole Test**

**FORD MOTOR CO.  
2021 Ford F-150 4x2 SuperCab  
NHTSA No.: M20210205**

**MGA RESEARCH CORPORATION  
5000 Warren Road  
Burlington, WI 53105**

**FINAL REPORT**

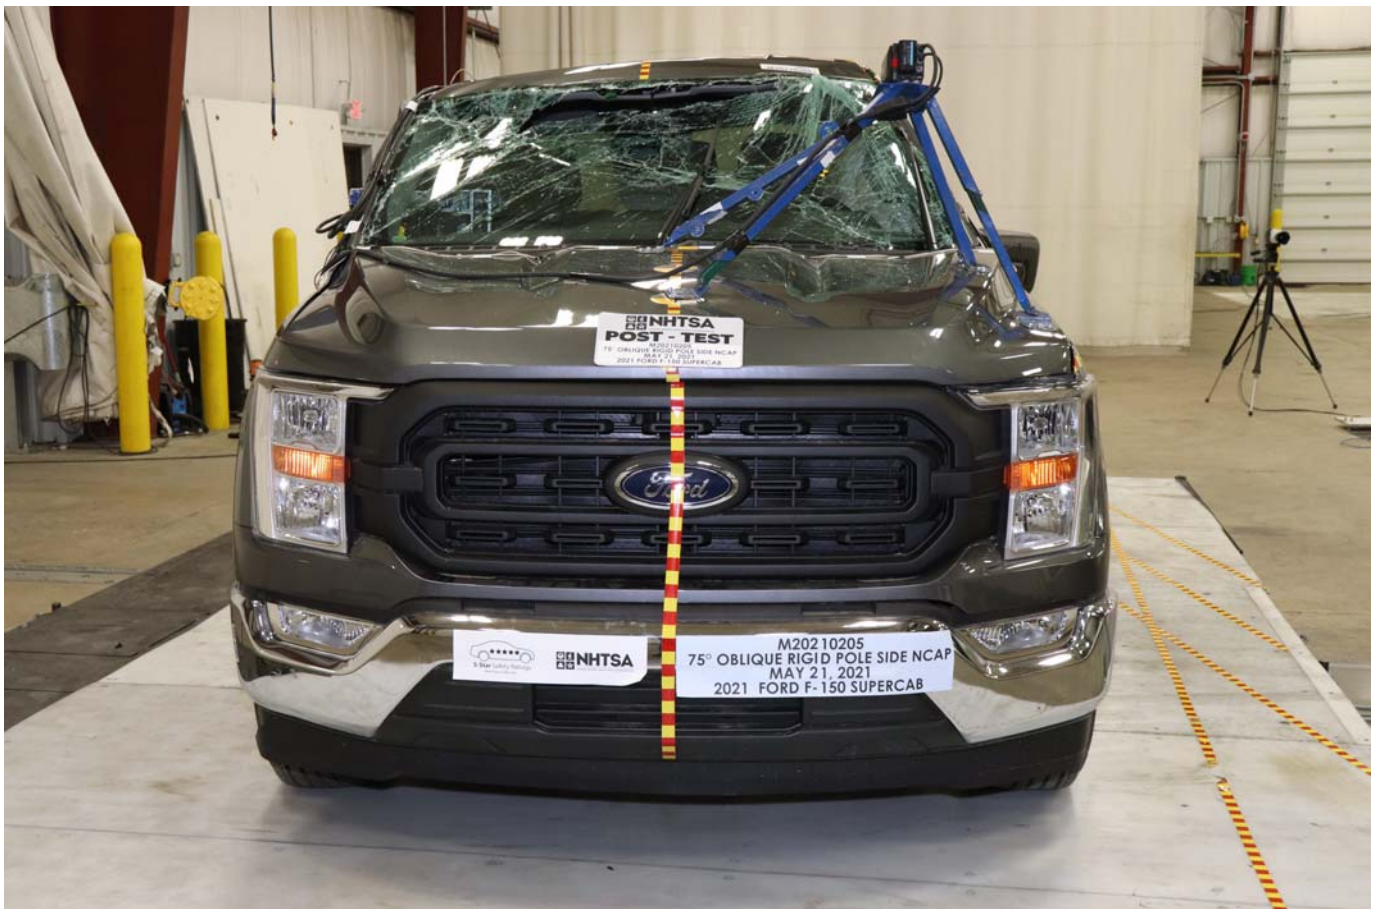
Photo No. 004 - Post-Test Frontal View of Test Vehicle

| Critical Areas of Performance | Observations and Conclusions |
|---|---|
| Windshield Damage | Cracked |

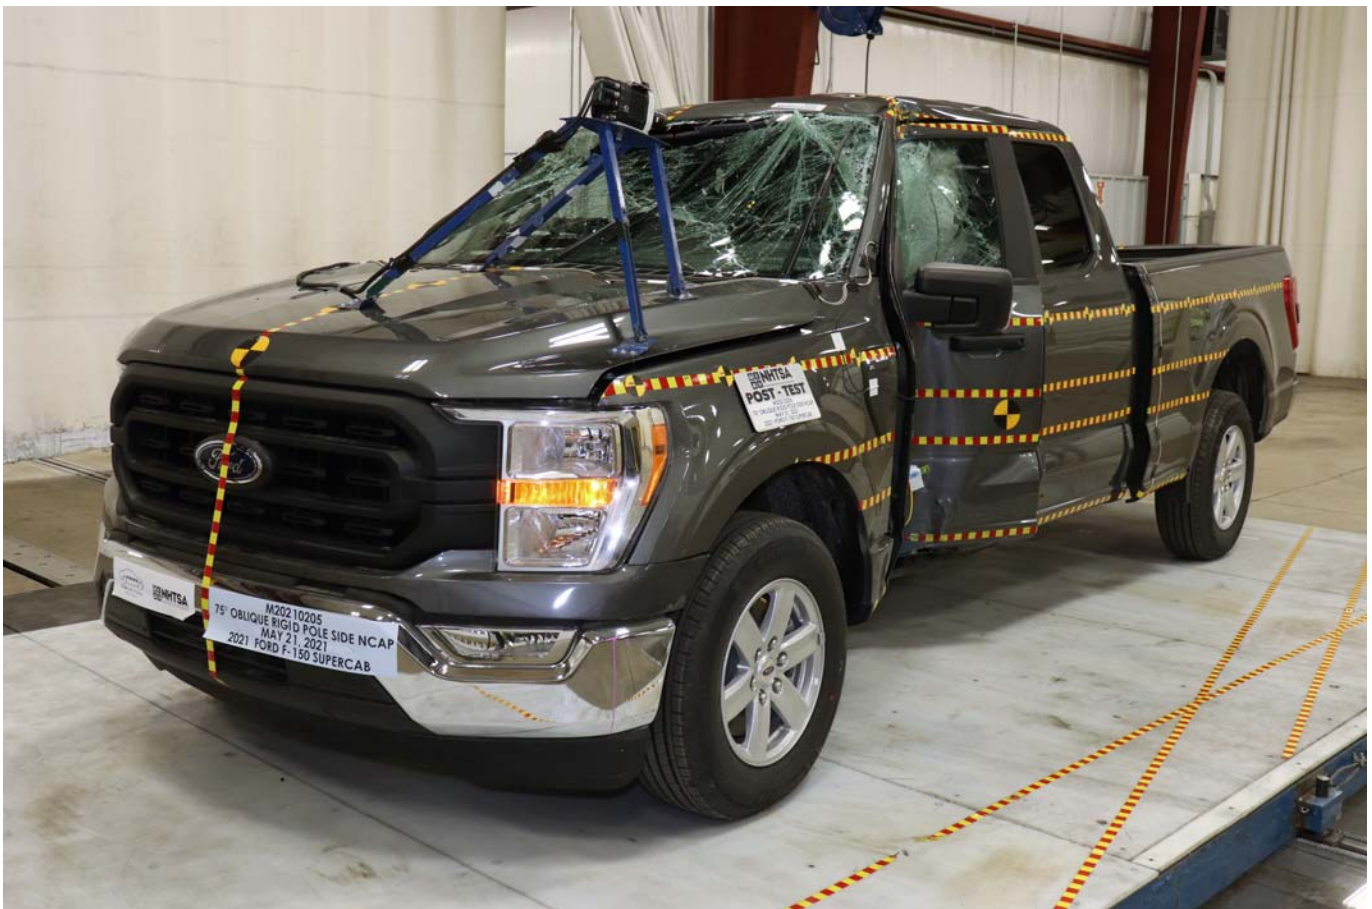
Photo No. 006 - Post-Test Left Front Three-Quarter View of Test Vehicle

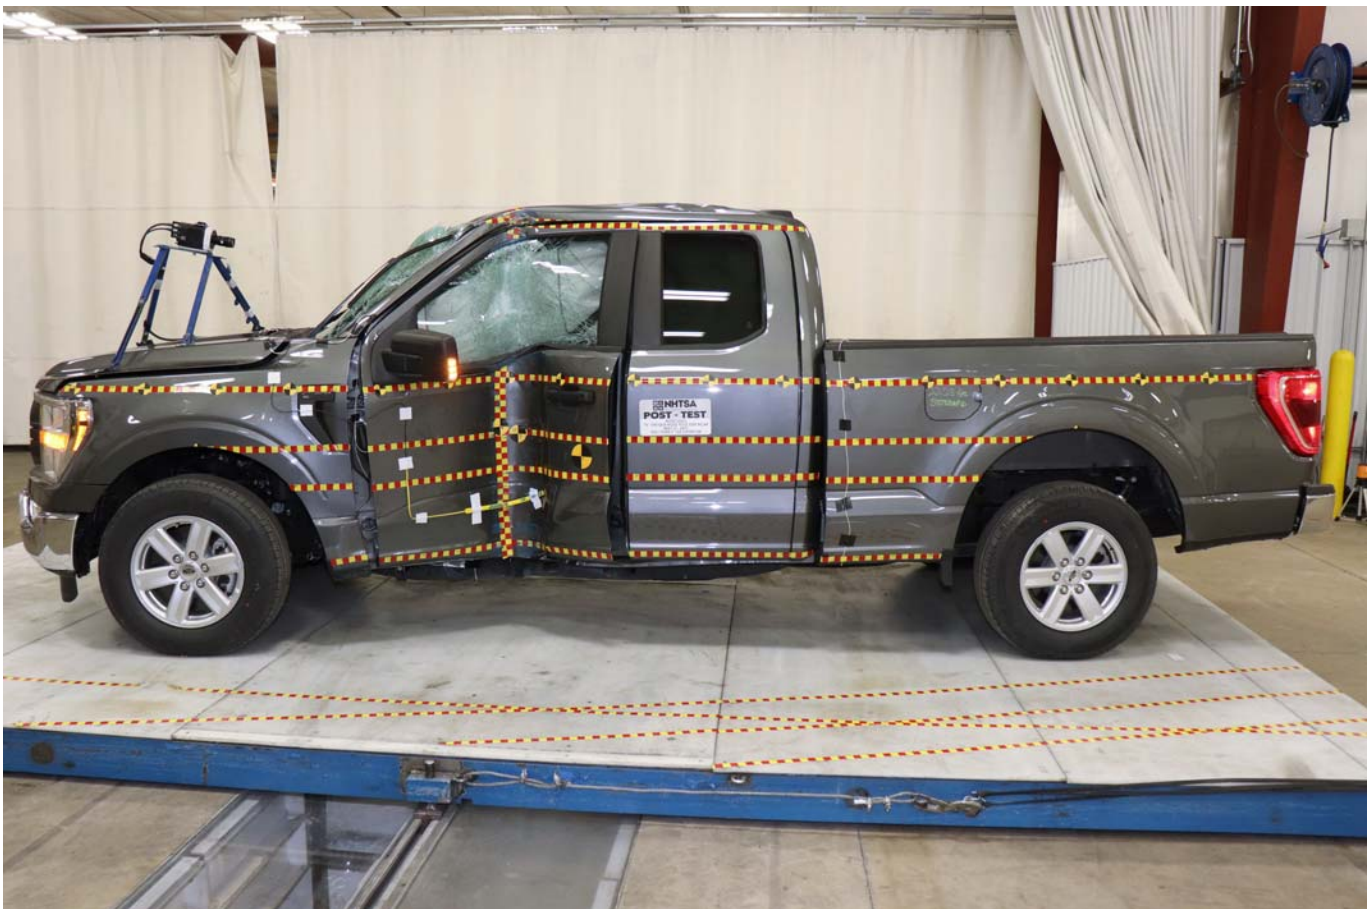
Photo No. 008 - Post-Test Left Side View of Test Vehicle

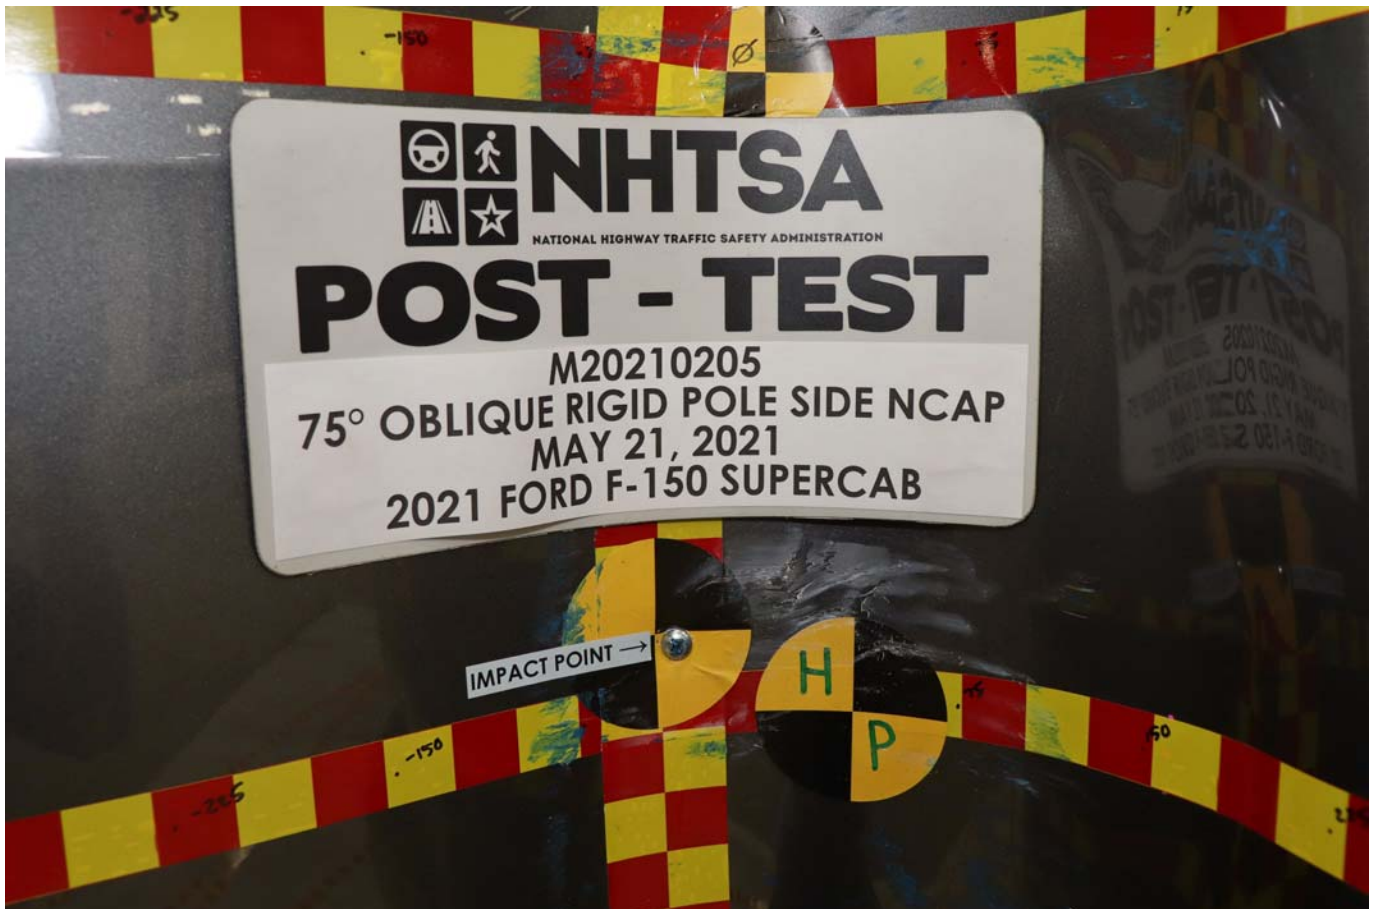
Photo No. 020 - Post-Test Close-Up View of Impact Point Target Showing Impact Location

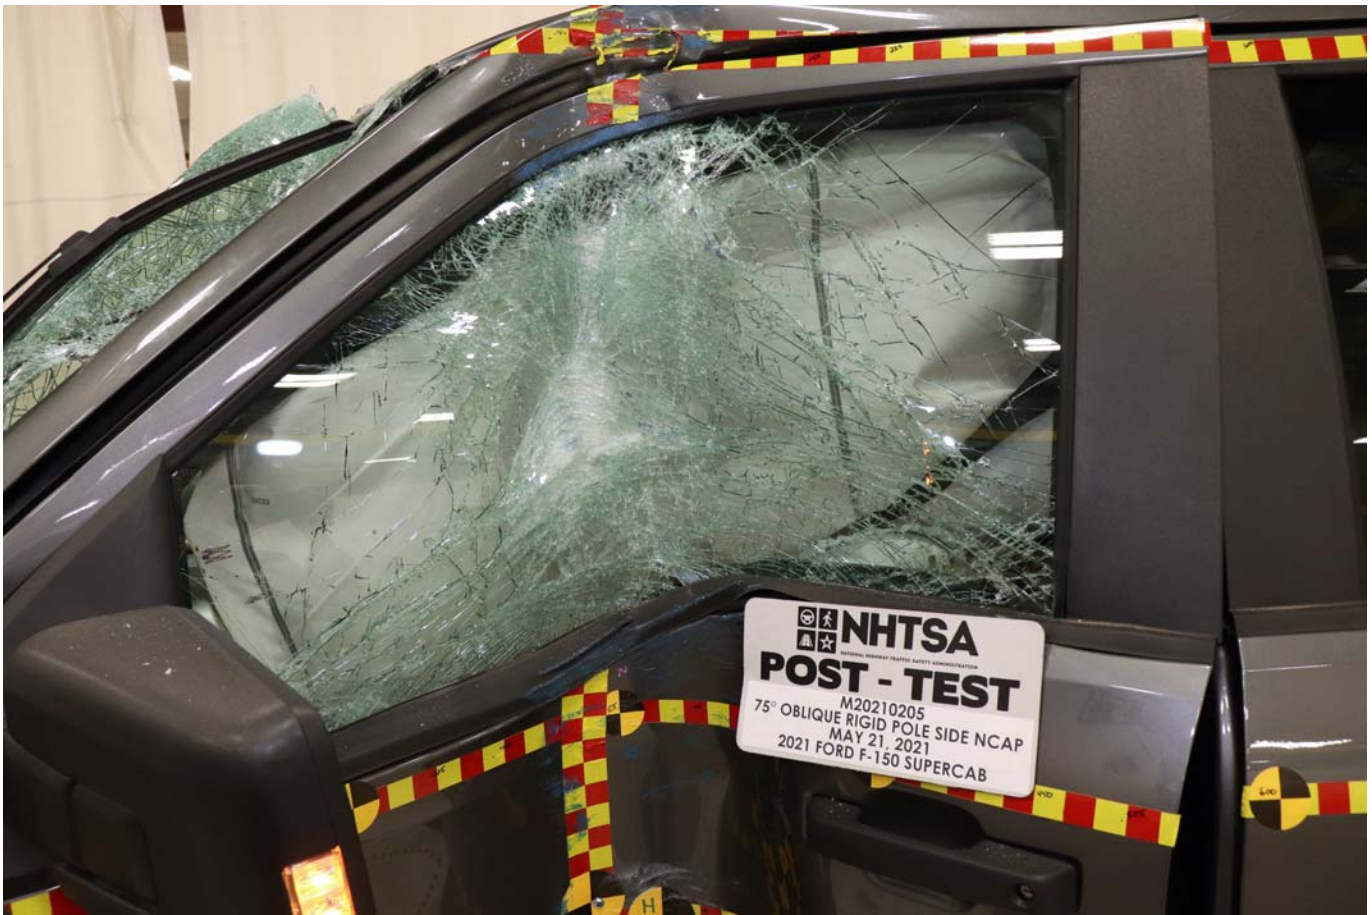
Photo No. 025 - Post-Test Left Side View of Dummy Shoulder and Door Top View

| Critical Areas of Performance | Observations and Conclusions |
|---|---|
| Side Window Damage | LF window cracked |

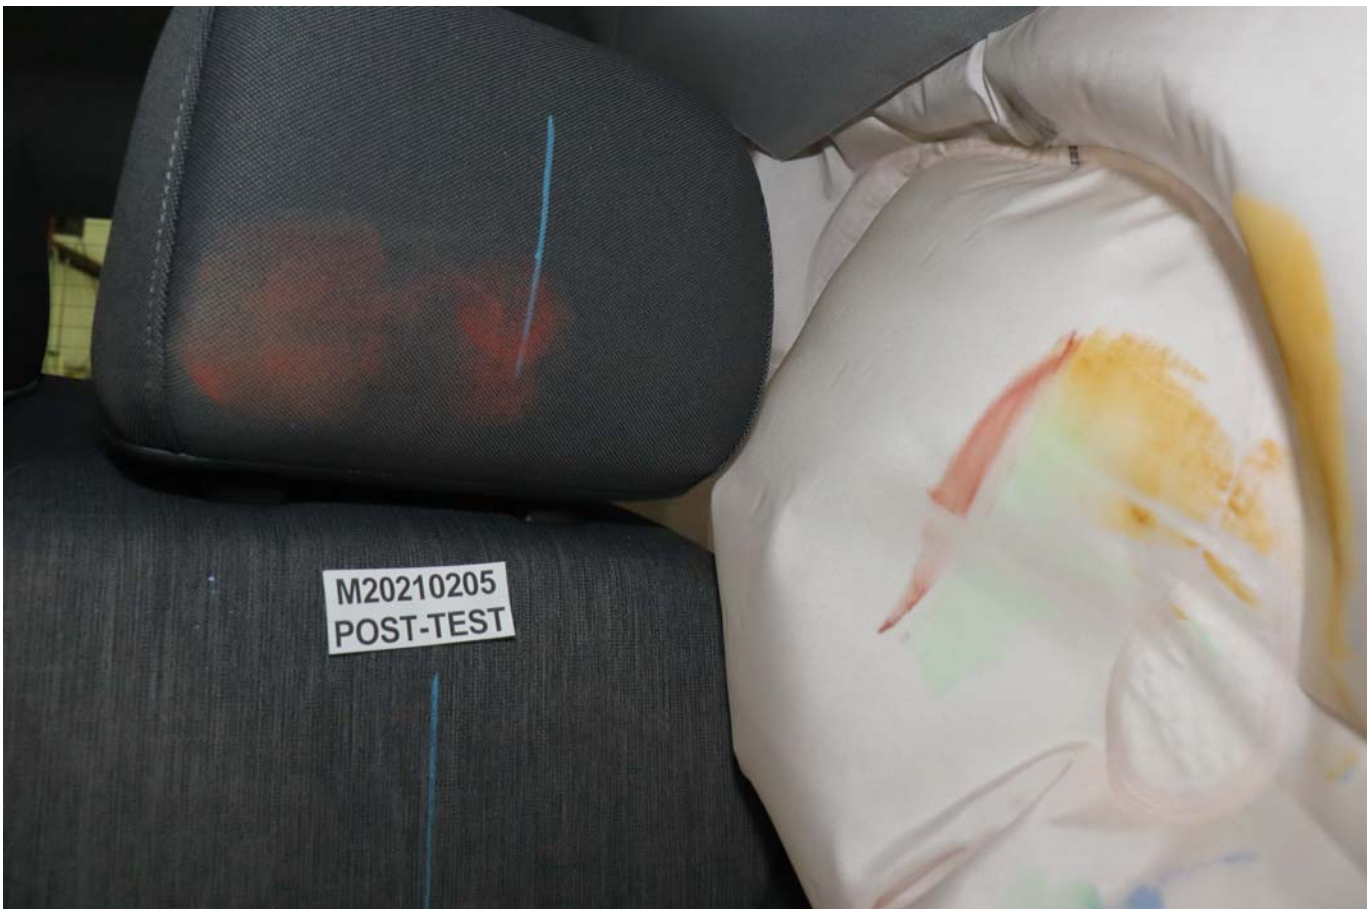
Photo No. 046 - Post-Test Dummy Close-Up Head Contact with Vehicle Interior View

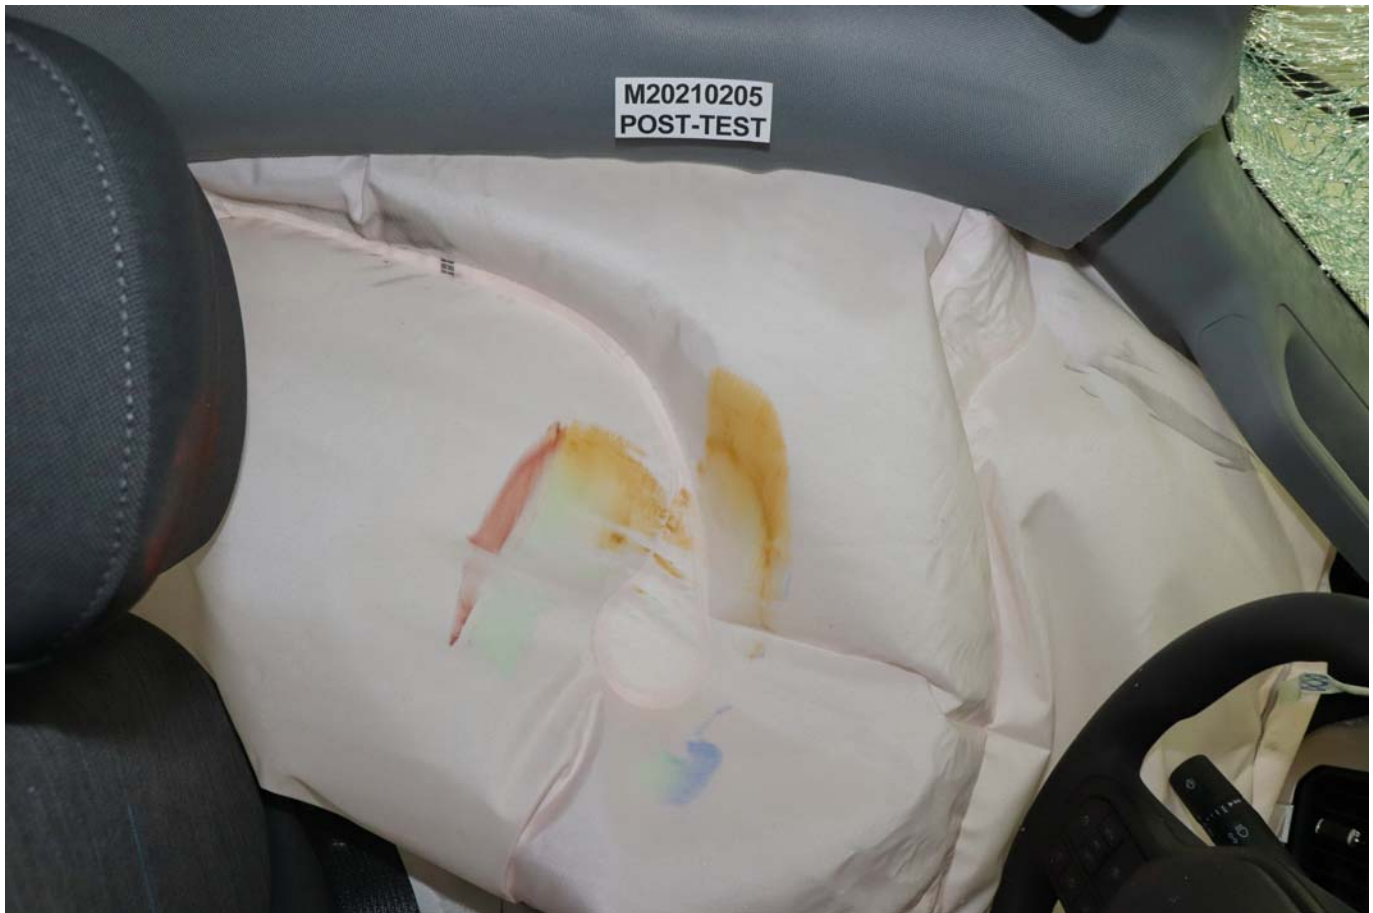
Photo No. 047 - Post-Test Dummy Close-Up Head Contact with Side Air Bag View

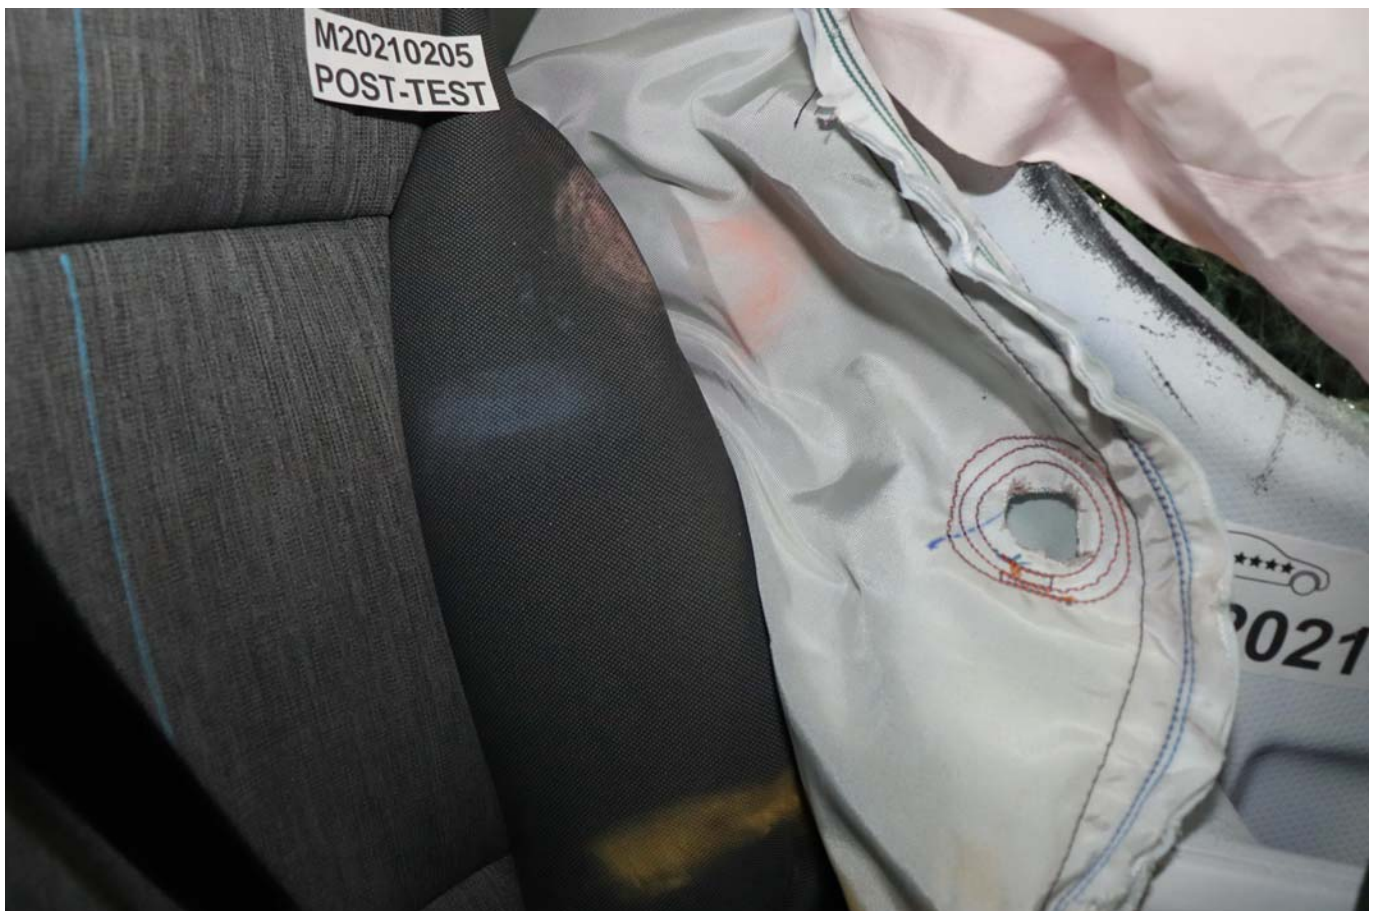
Photo No. 048 - Post-Test Dummy Close-Up Torso Contact with Vehicle Interior View

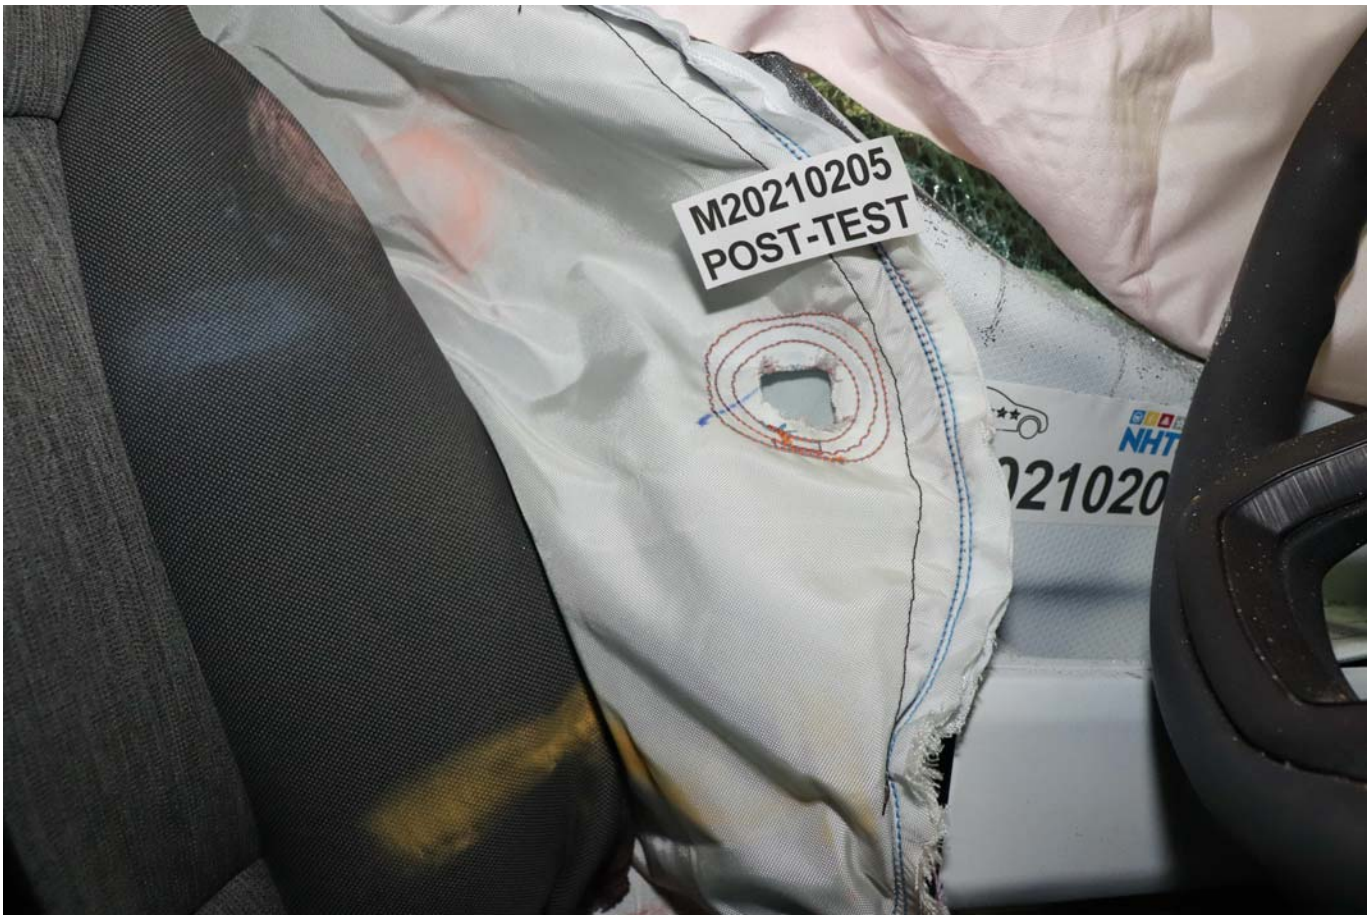
Photo No. 049 - Post-Test Dummy Close-Up Torso Contact with Side Air Bag View

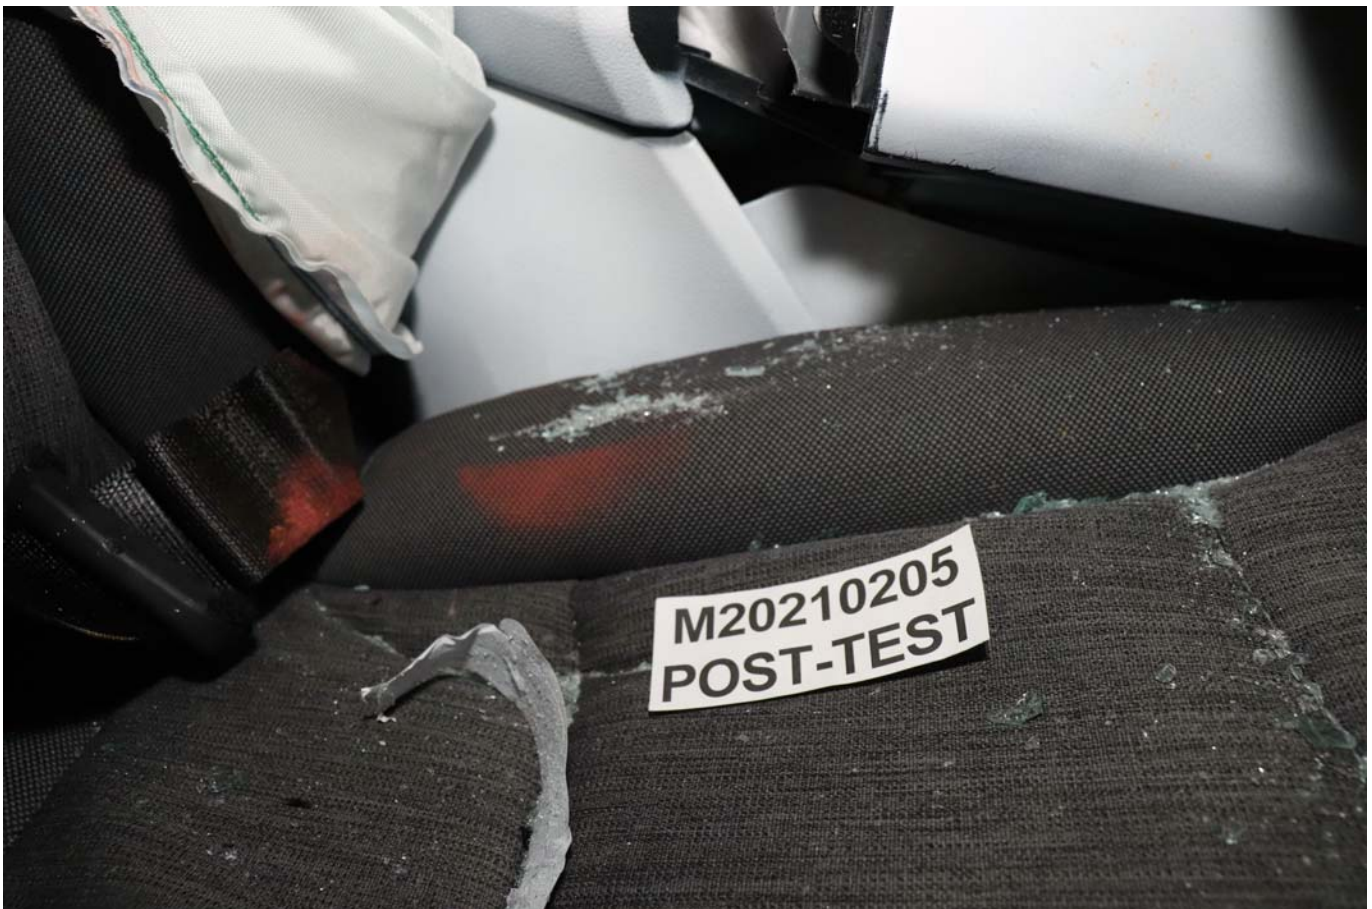
Photo No. 050 - Post-Test Dummy Close-Up Pelvis Contact with Vehicle Interior View

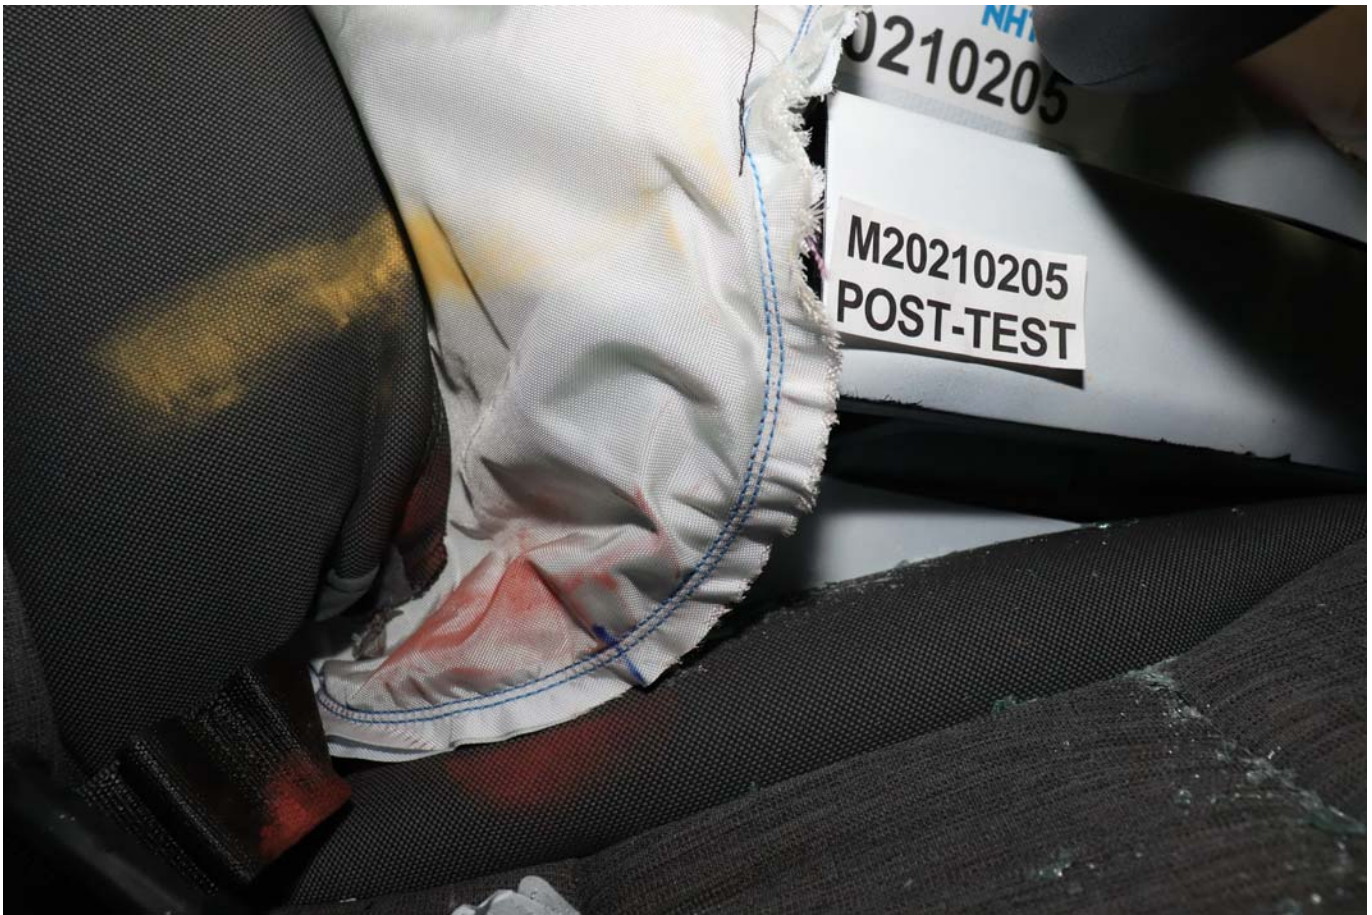
Photo No. 051 - Post-Test Dummy Close-Up Pelvis Contact with Side Air Bag View

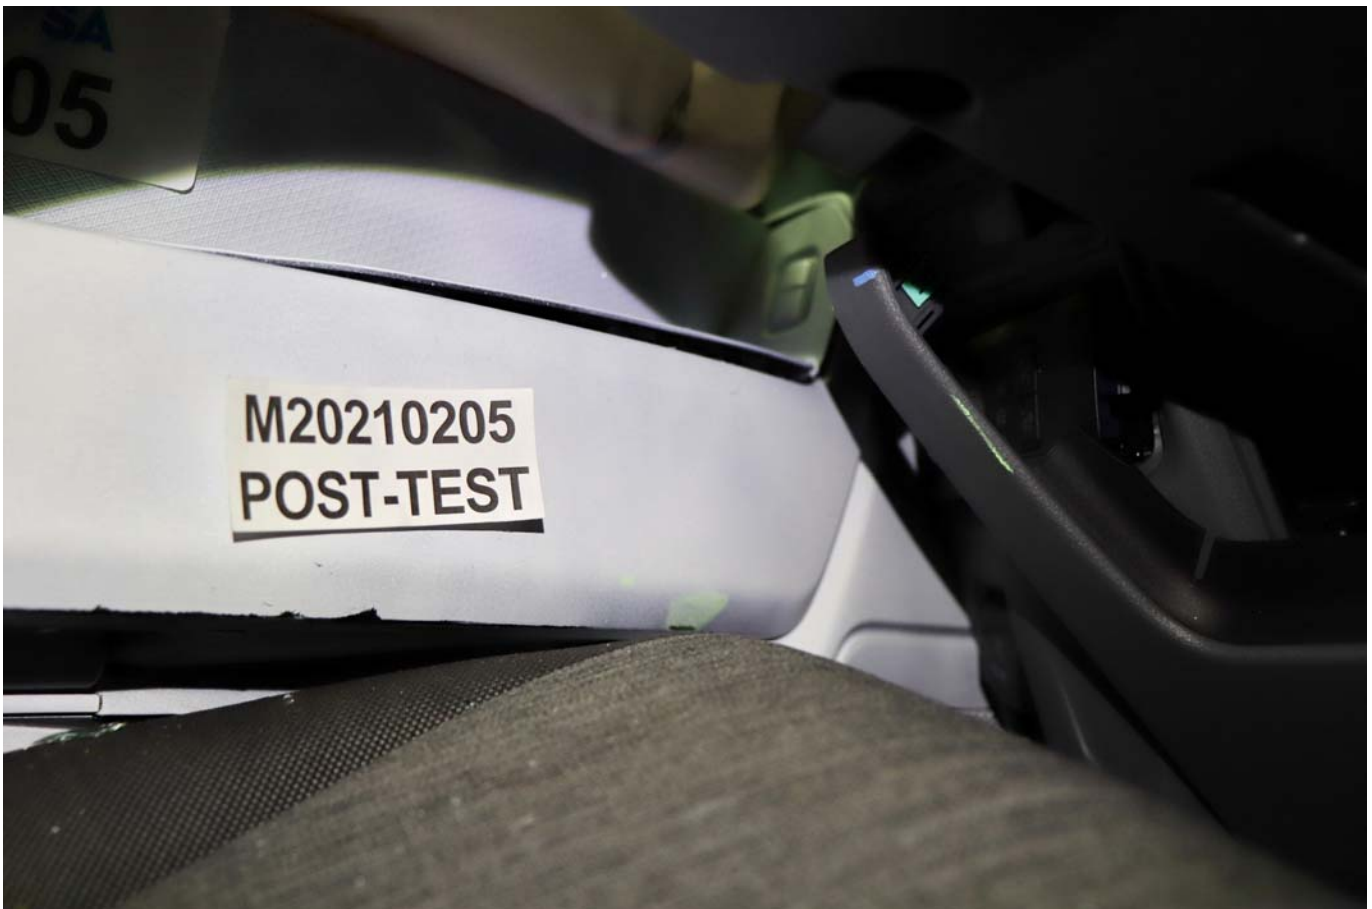
Photo No. 052 - Post-Test Dummy Close-Up Knee Contact with Vehicle Interior View

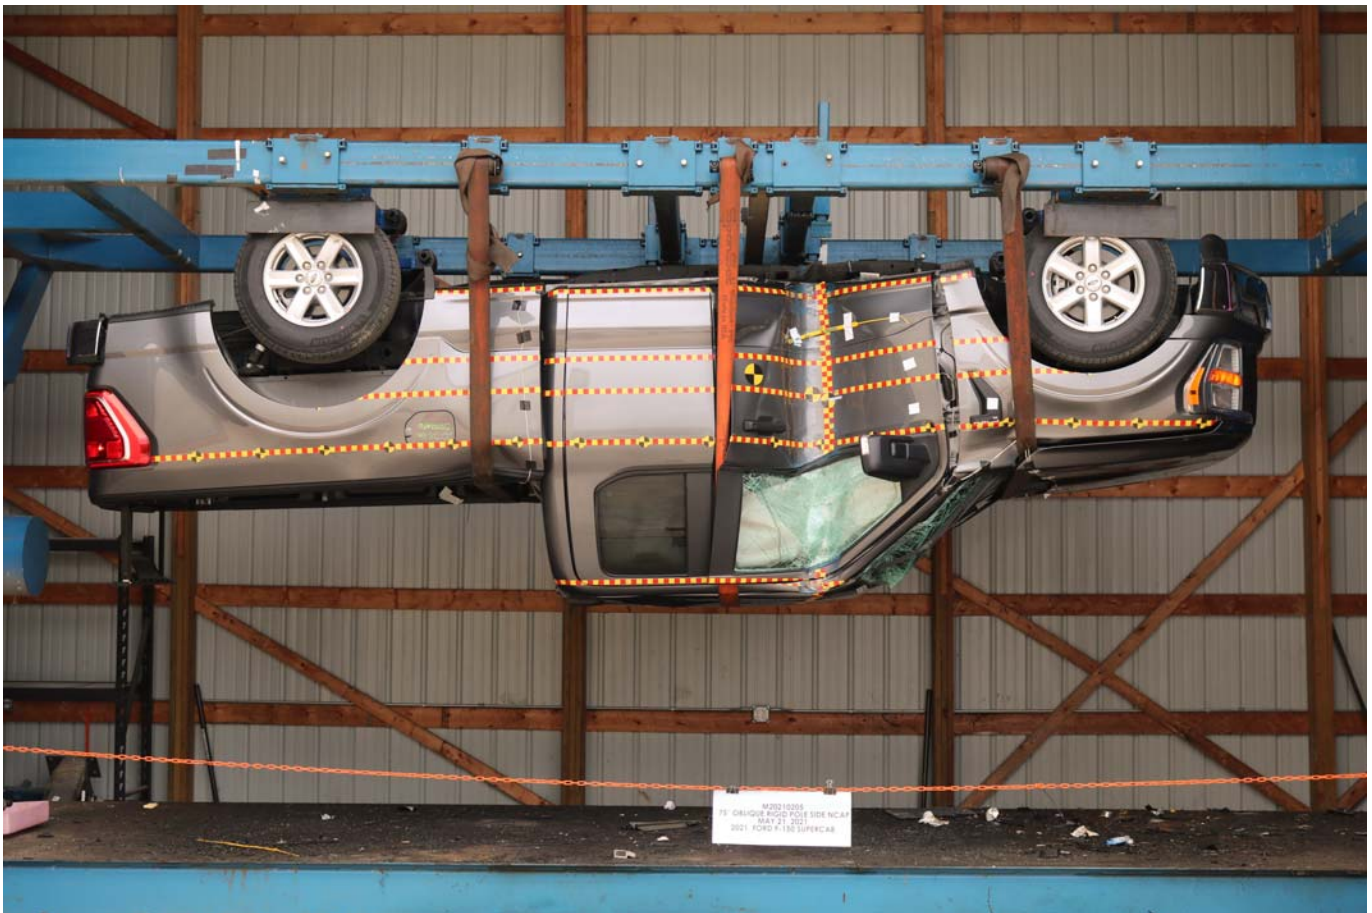
Photo No. 067 - FMVSS Photo No. 301 Static Rollover 180 Degrees

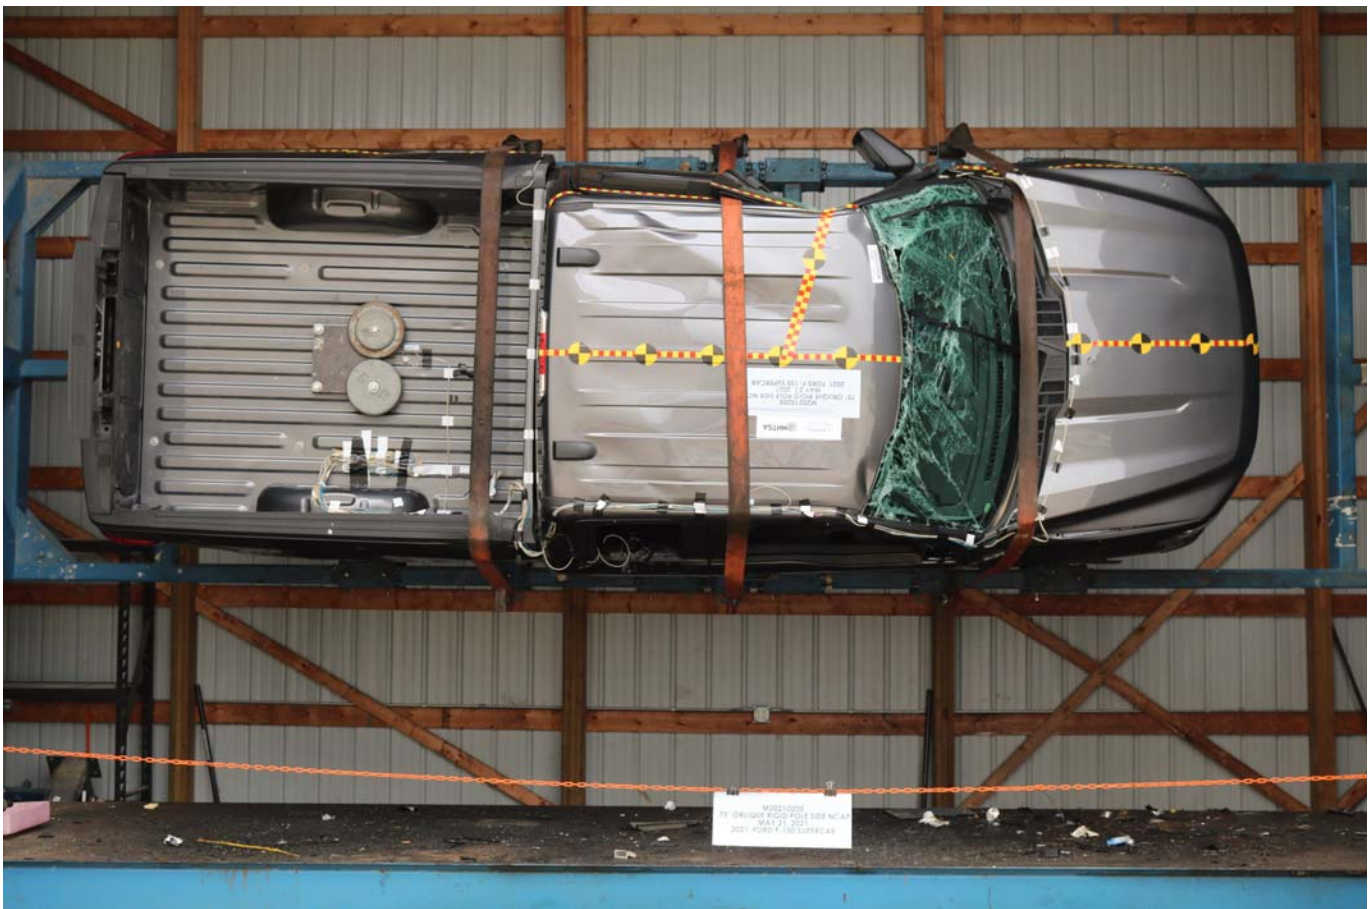
Photo No. 068 - FMVSS Photo No. 301 Static Rollover 270 Degrees

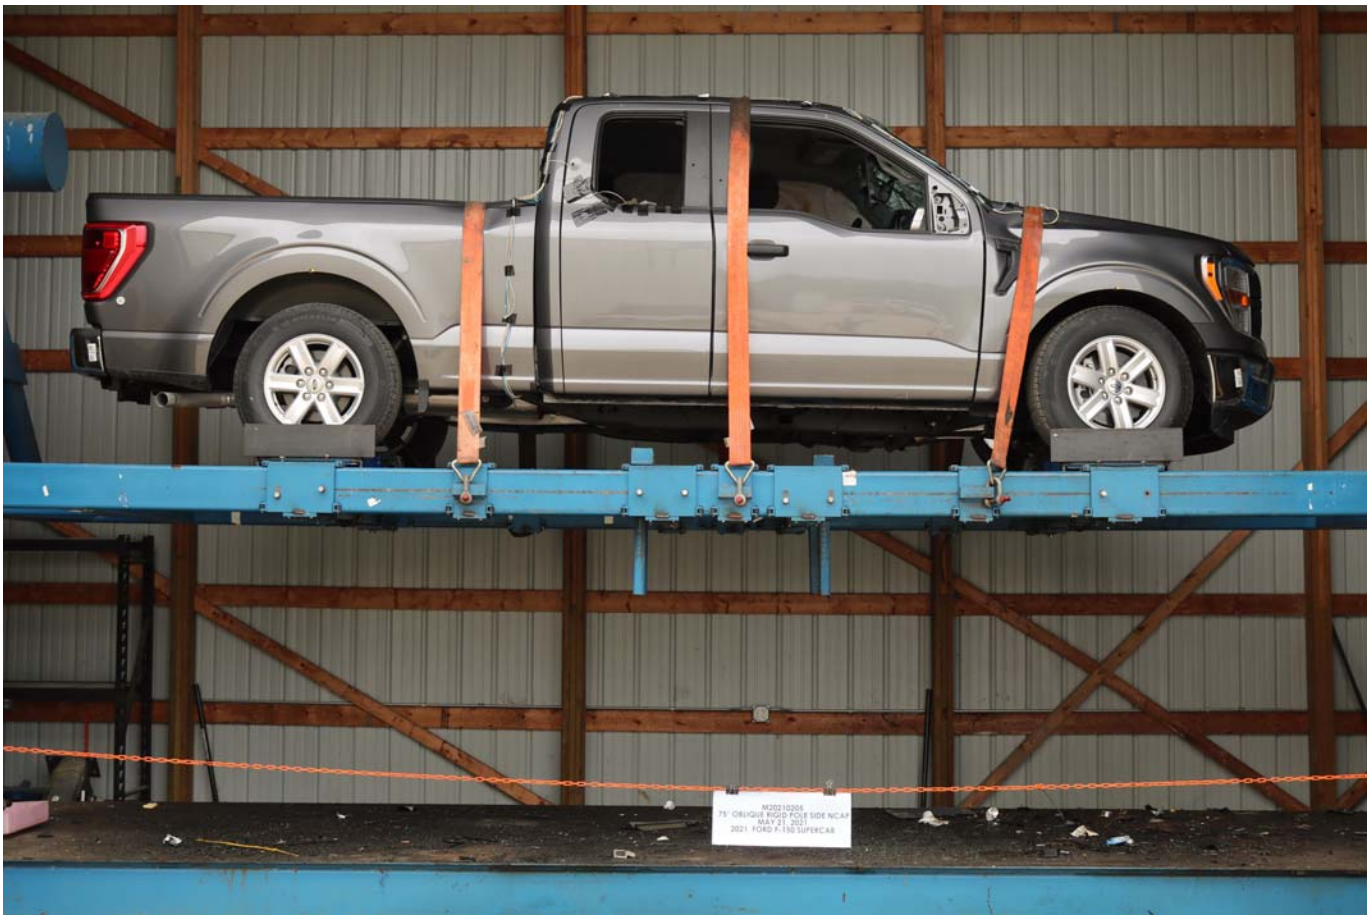
Photo No. 069 - FMVSS Photo No. 301 Static Rollover 360 Degrees
