REPORT NUMBER: NCAP-MGA-21-042

**NEW CAR ASSESSMENT PROGRAM (NCAP)
Frontal Barrier Impact Test**

**HYUNDAI MOTOR MANUFACTURING ALABAMA, LLC
2021 Hyundai Santa Fe SEL AWD 5-Door SUV
NHTSA No.: O20214218**

**MGA RESEARCH CORPORATION
5000 Warren Road
Burlington, WI 53105**

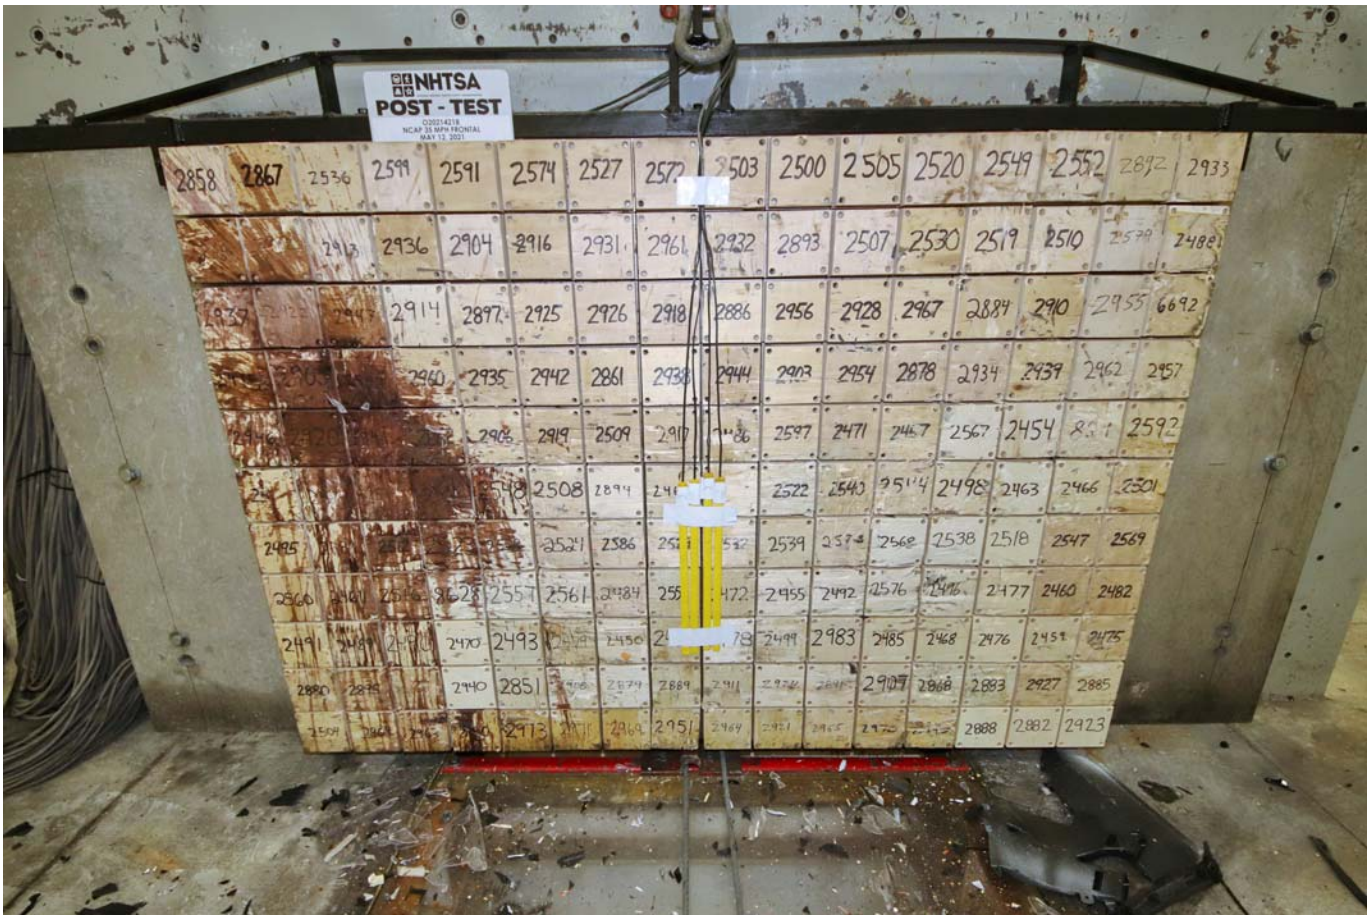
Photo No. 003 - Post-Test Load Cell Wall

A load cell barrier consisting of 176 load cells was impacted by a 2021 Hyundai Santa Fe SEL AWD 5-Door SUV at a velocity of 56.42 km/h. The test was performed at MGA Research Corporation on May 12, 2021. Pre-test and post-test photographs of the vehicle and dummies can be found in Appendix A.

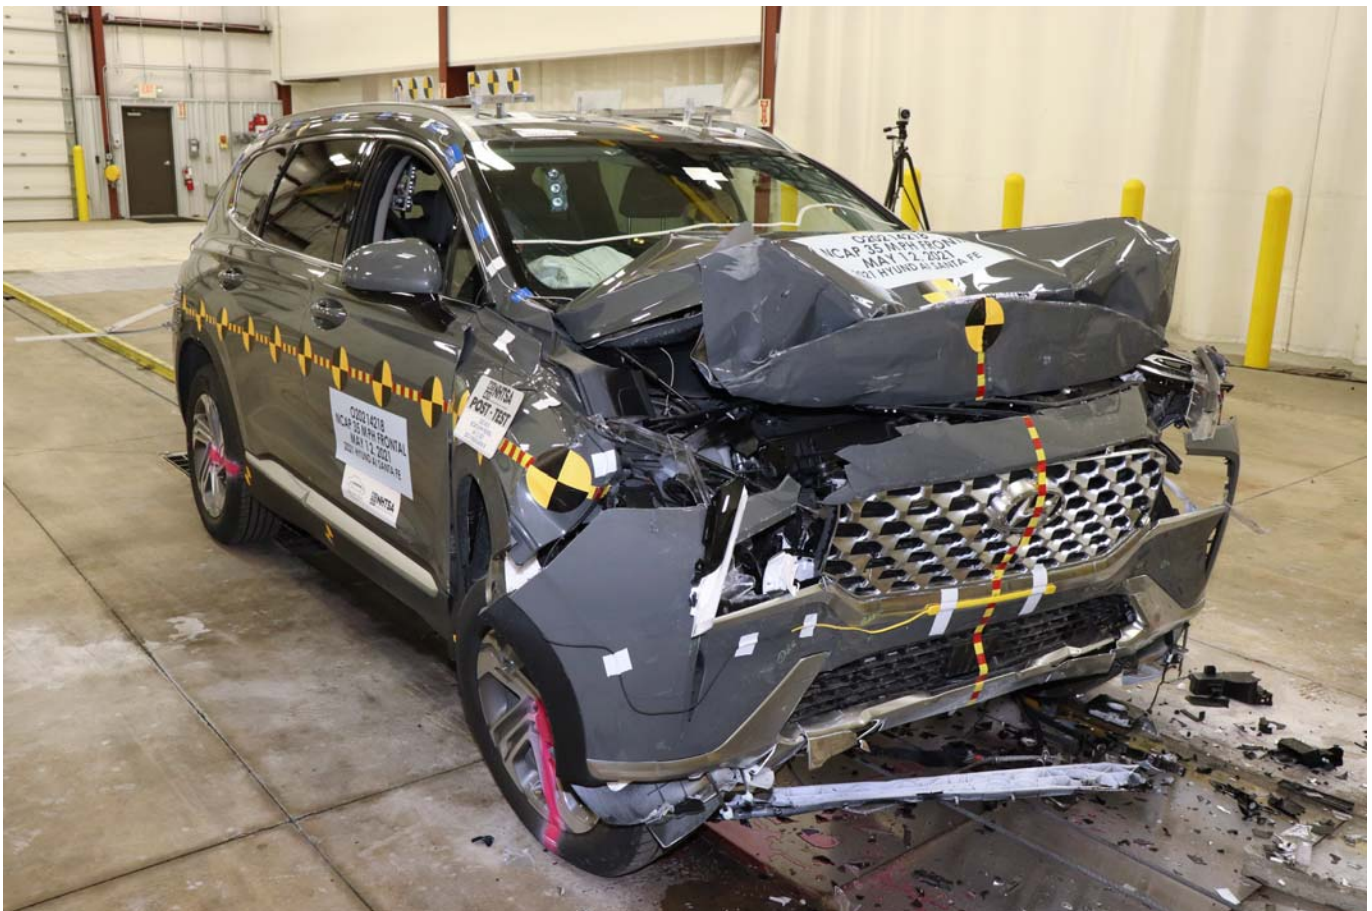
Photo No. 015 - Post-Test Right Front 3-4 View

The maximum static crush of the vehicle was 548 mm located to the right of the vehicle centerline and both the driver and passenger side doors remained closed during the impact event and were operable after the impact.

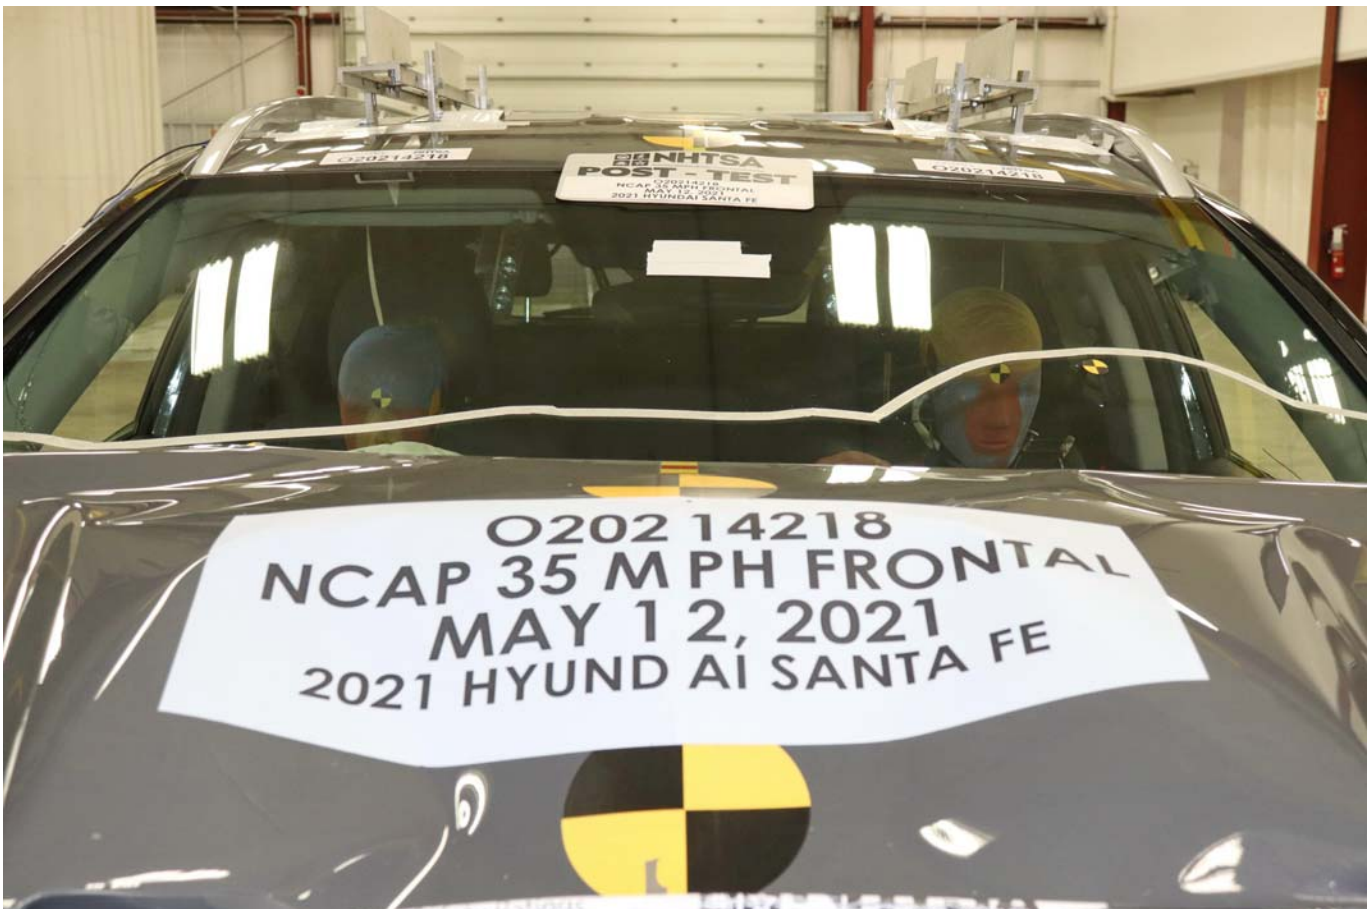
Photo No. 019 - Post-Test Windshield View

There was 100 percent windshield retention and no intrusion into the protected zone of the windshield during the event. There was no Stoddard Solvent leakage after the event or during any phase of the static rollover.

Critical Areas of Performance	Observations and Conclusions
Windshield Damage	Cracked at lower corner by hood on passenger side
Window Damage	None
Other Notable Effects	None

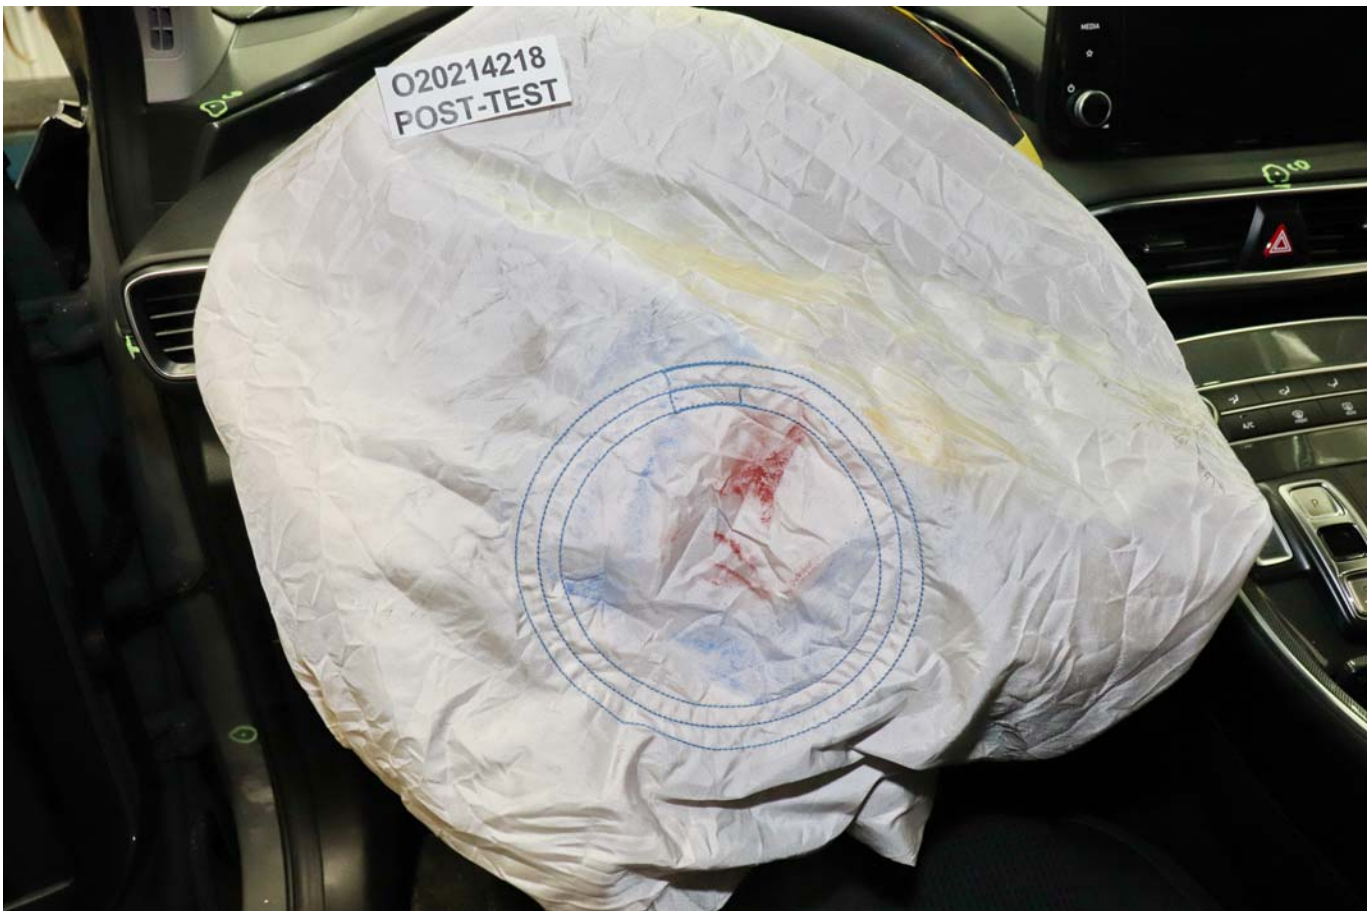
Photo No. 049 - Post-Test Driver Dummy Contact with Airbag

The driver's visible contact points were as follows: The driver's head contacted the airbag. The driver's head also contacted the headrest.

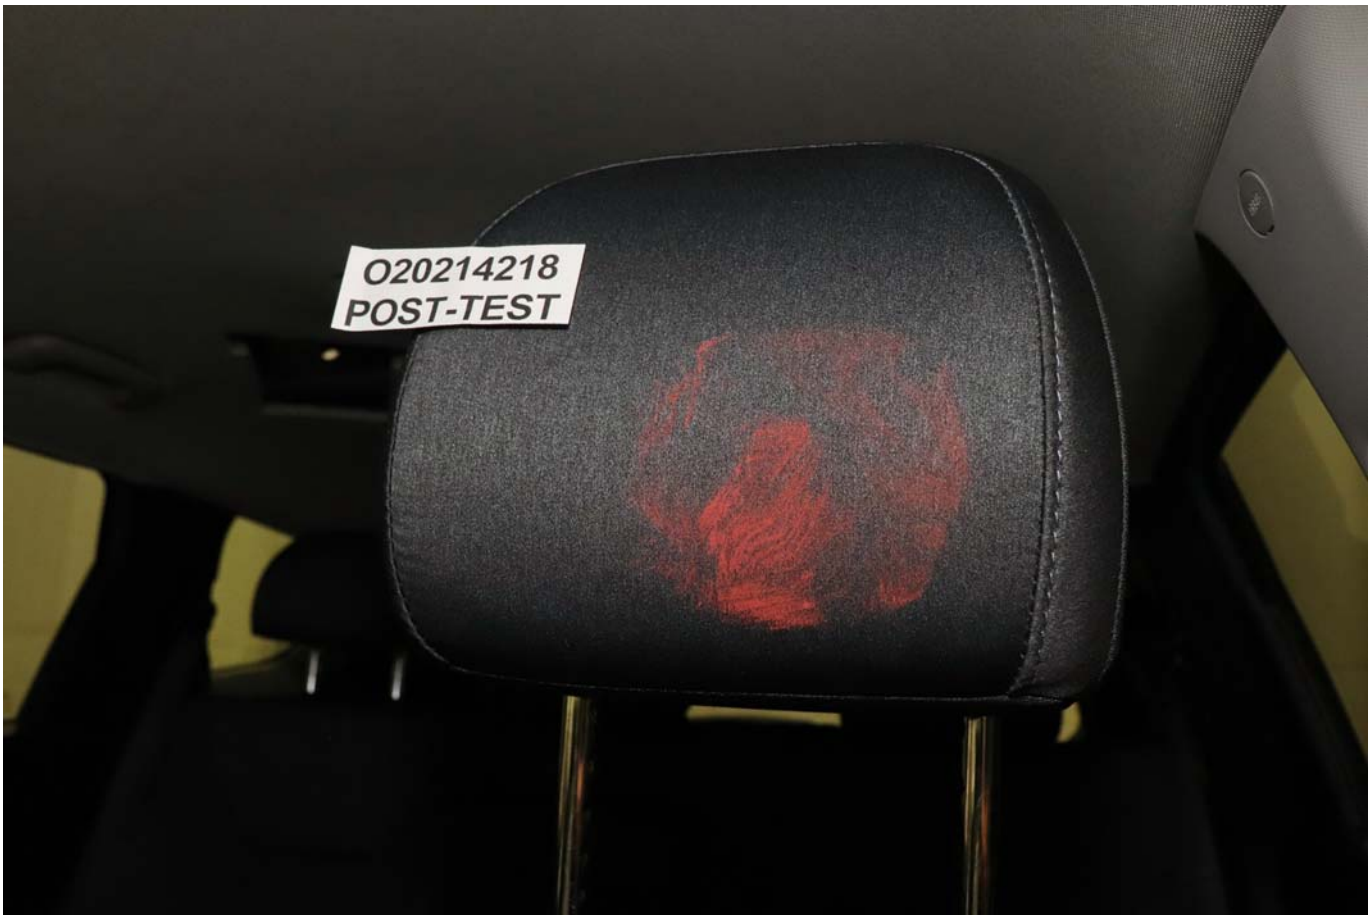
Photo No. 050 - Post-Test Driver Dummy Contact with Headrest

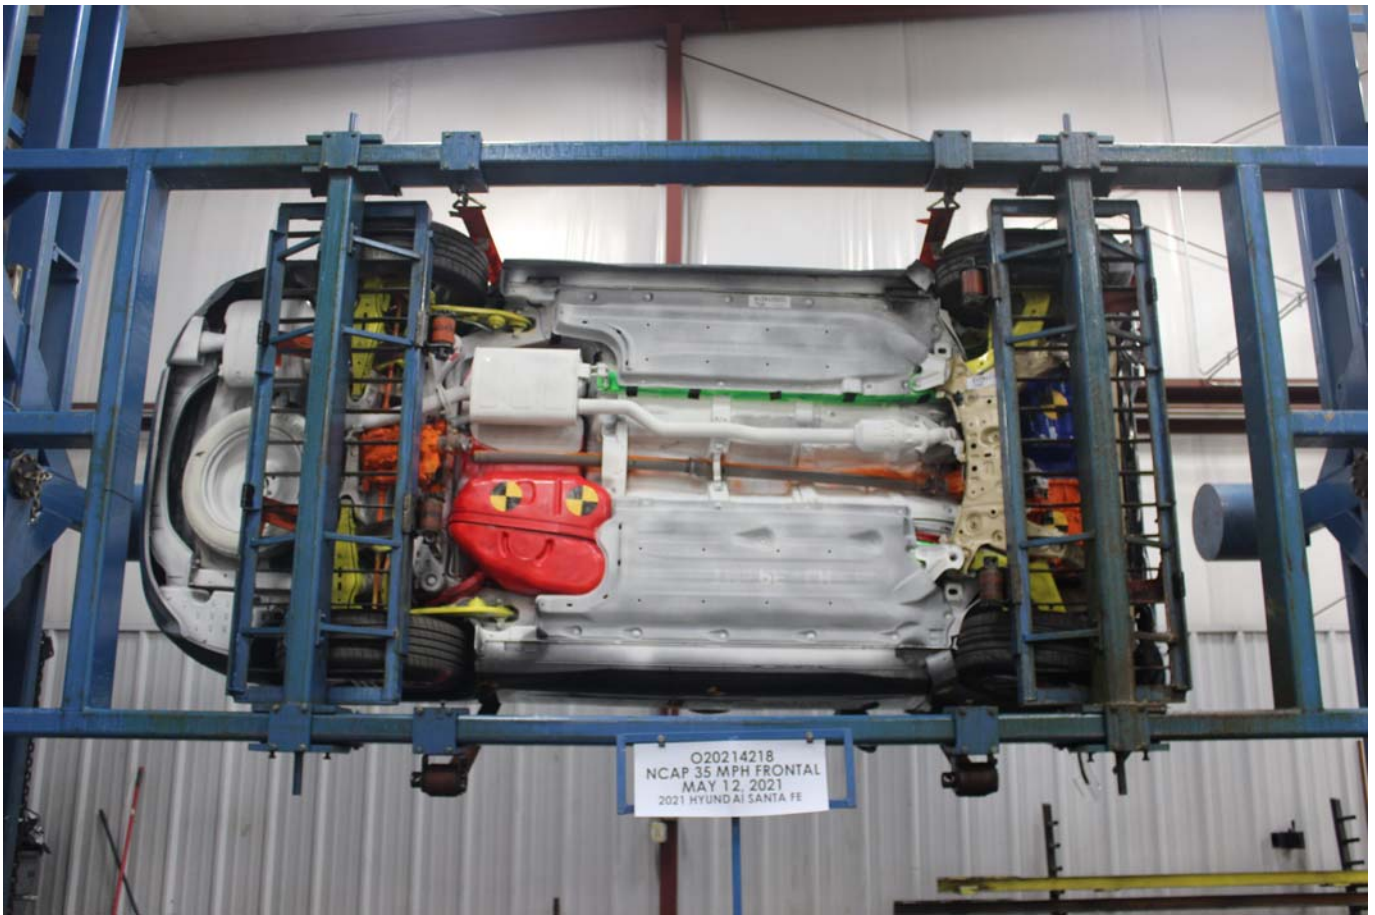
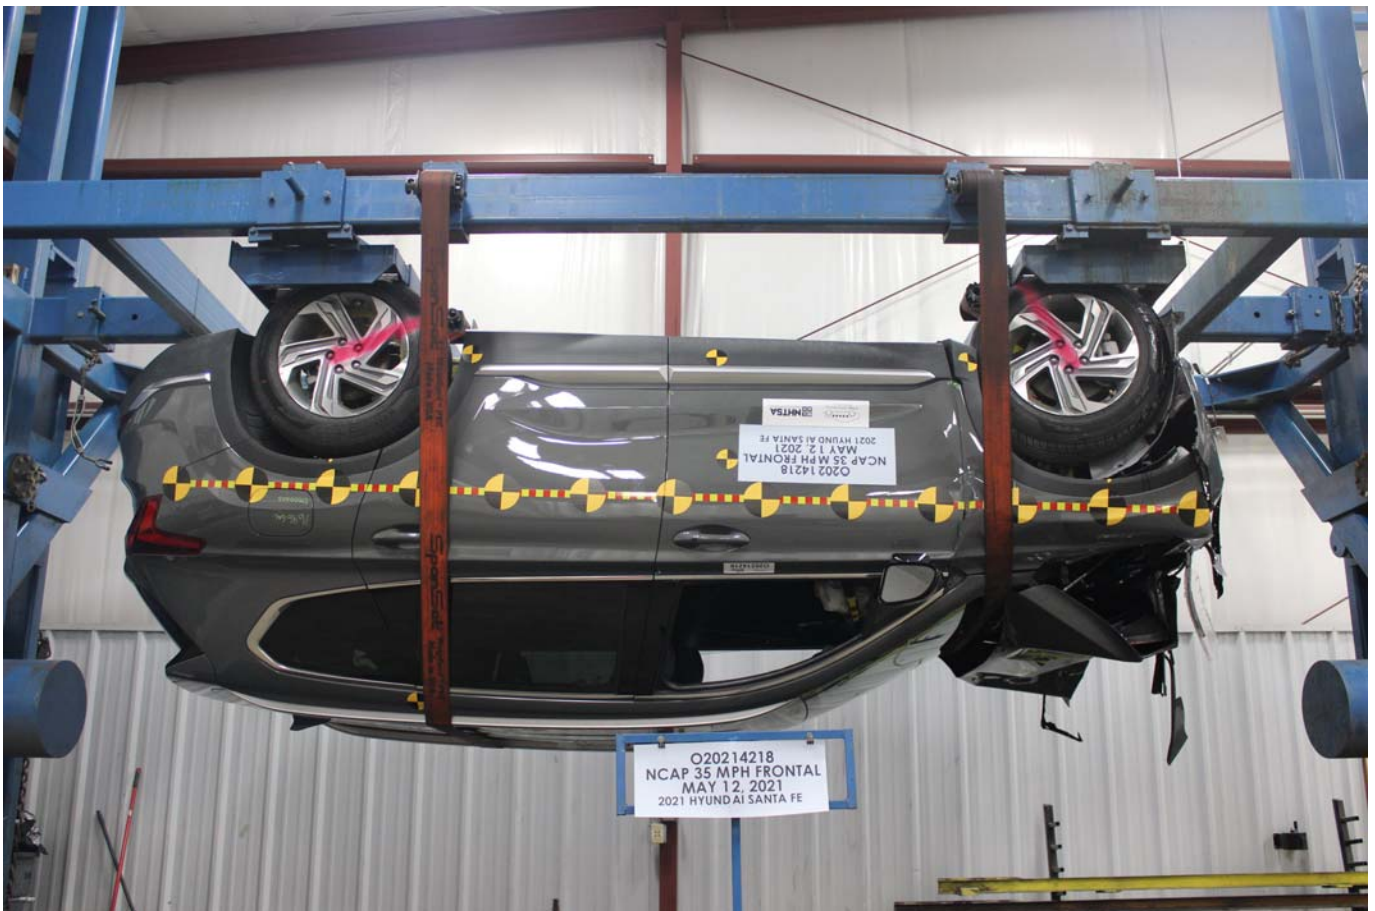
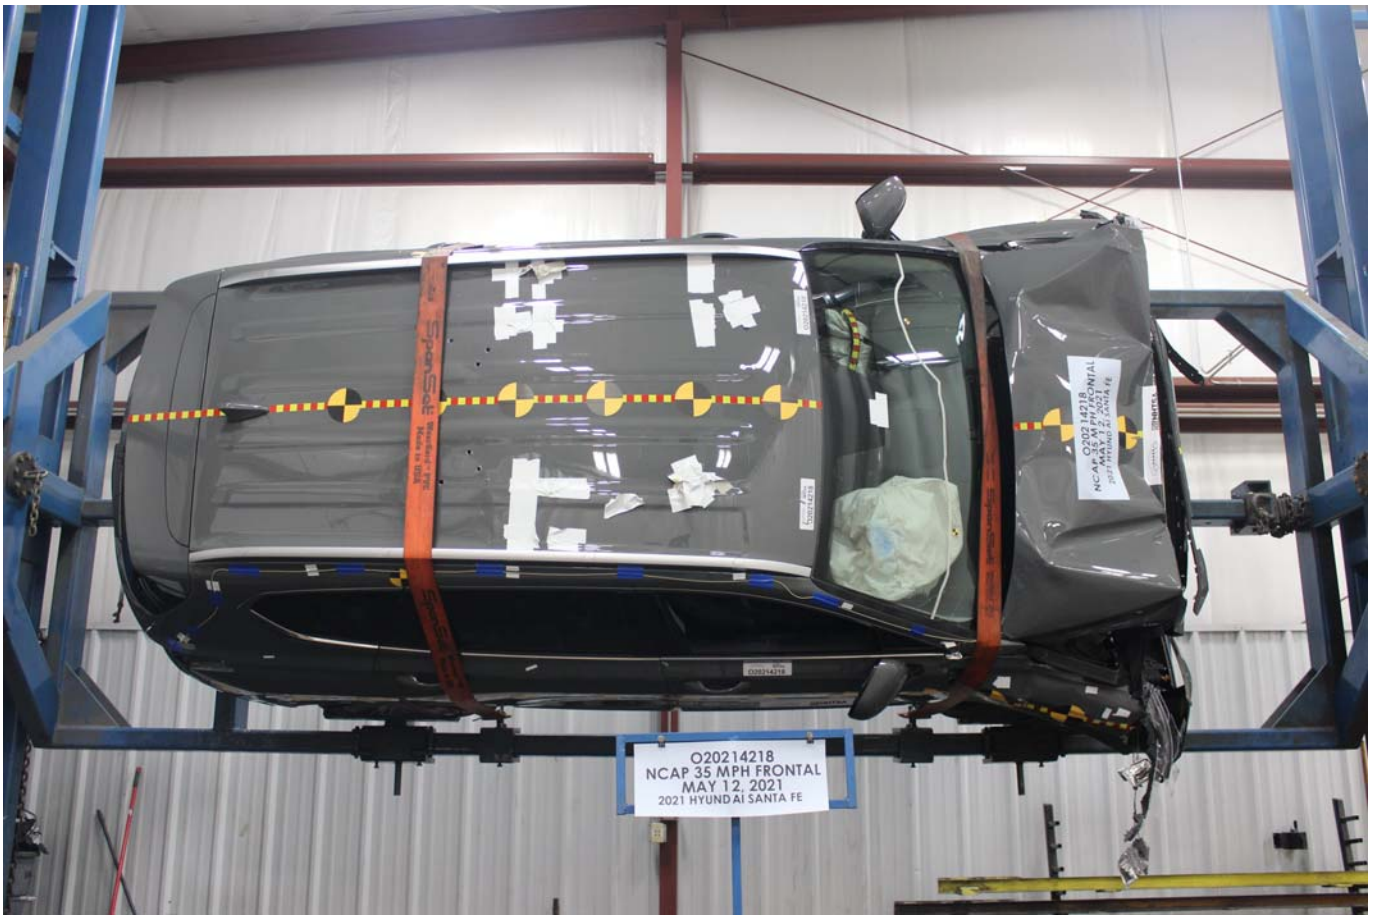
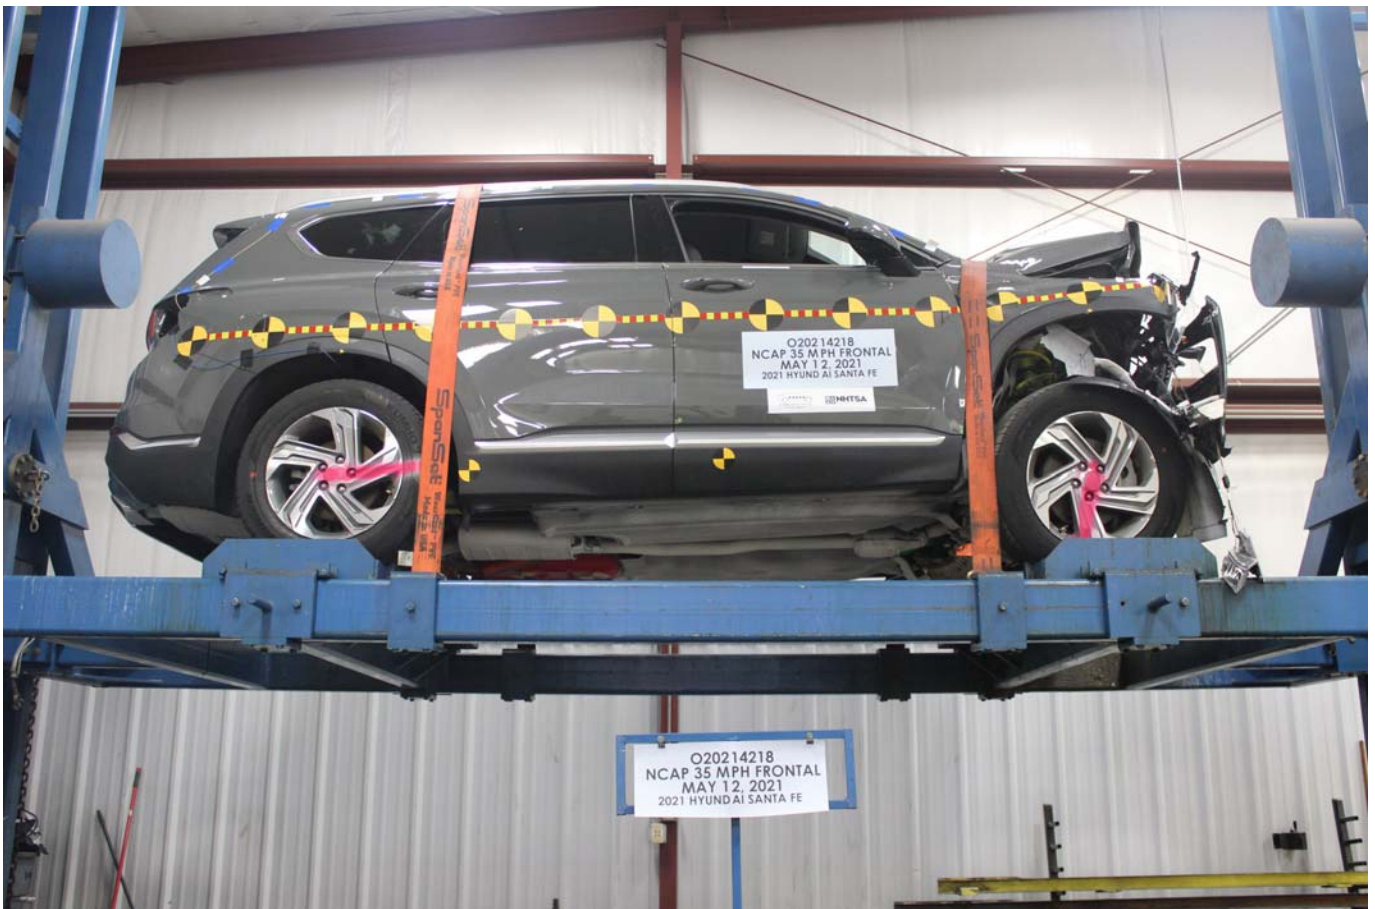
Photo No. 078 - Vehicle at 90 Degrees on Static Rollover Device

Photo No. 079 - Vehicle at 180 Degrees on Static Rollover Device

Photo No. 080 - Vehicle at 270 Degrees on Static Rollover Device

Photo No. 081 - Vehicle at 360 Degrees on Static Rollover Device

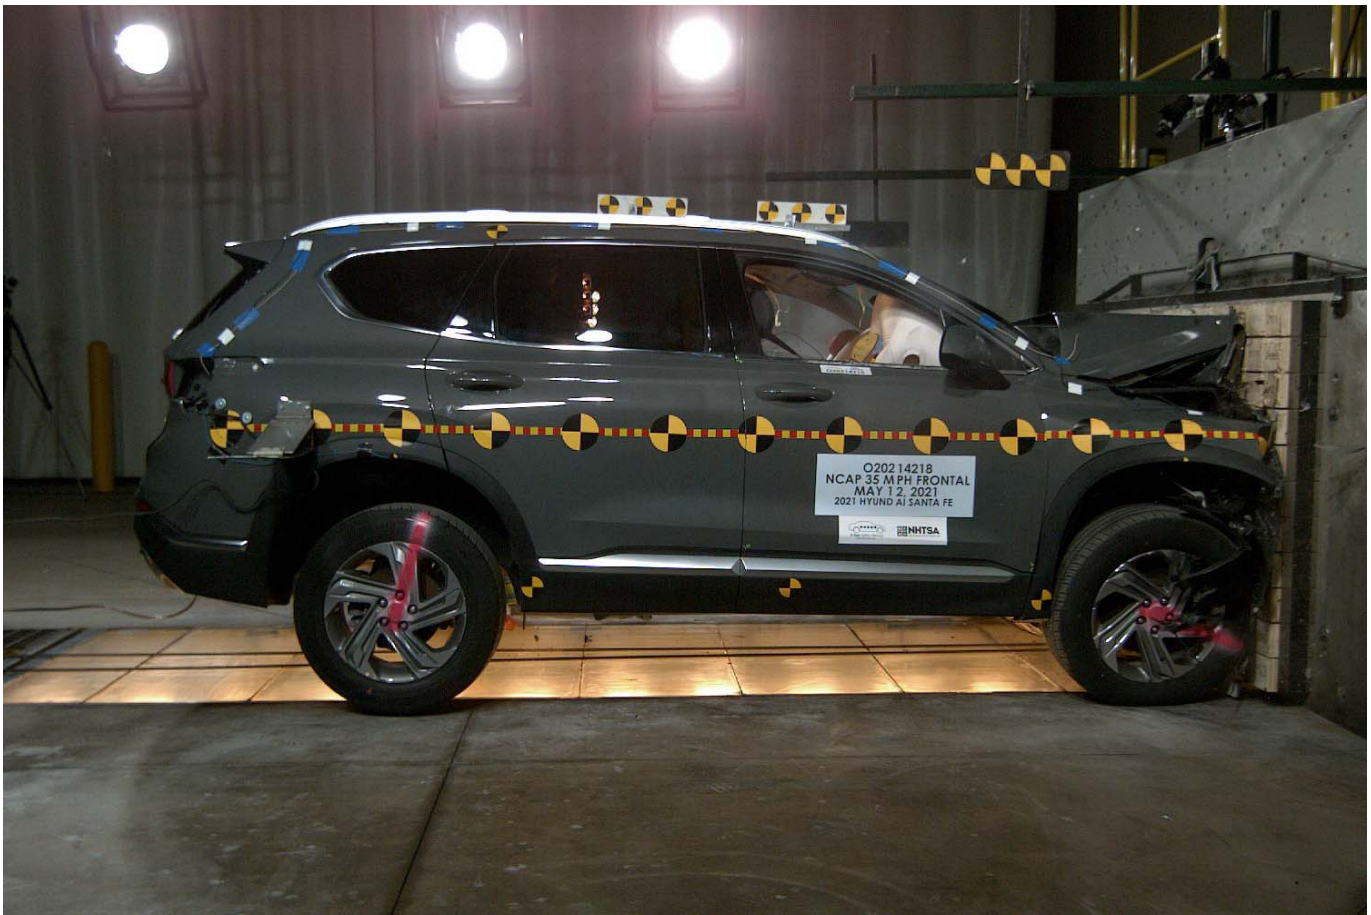
Photo No. 082 - 2021 Hyundai Santa Fe SEL AWD 5-Door SUV Frontal Impact Event
