**REPORT NUMBER: SideNCAPPole-MGA-21-044**

**NEW CAR ASSESSMENT PROGRAM (NCAP)  
Side Impact Pole Test**

**HYUNDAI MOTOR MANUFACTURING ALABAMA, LLC  
2021 Hyundai Santa Fe SEL 5-Door SUV  
NHTSA No.: O20214219**

**FINAL REPORT**

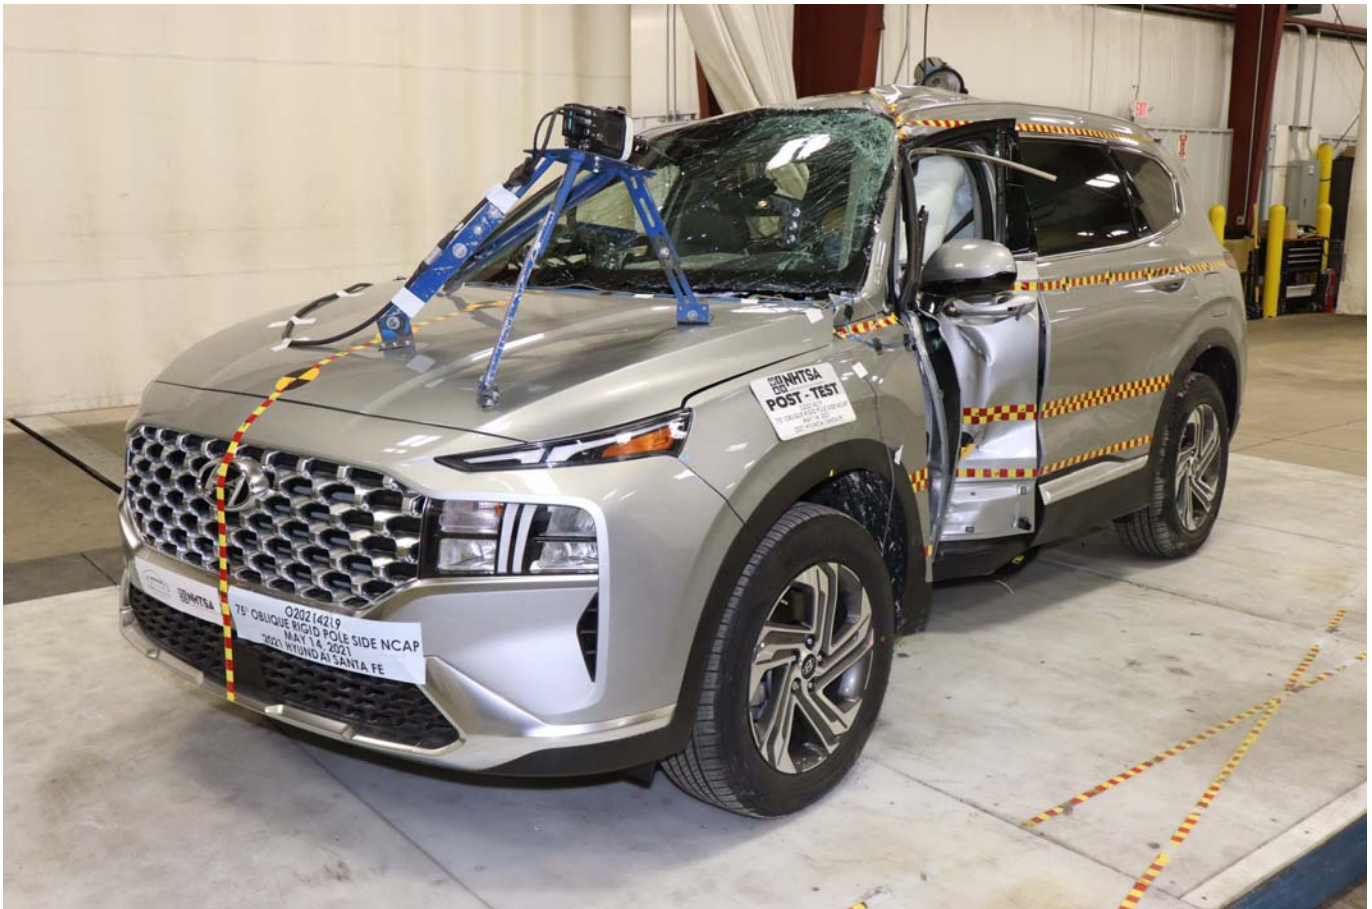
Photo No. 006 - Post-Test Left Front Three-Quarter View of Test Vehicle

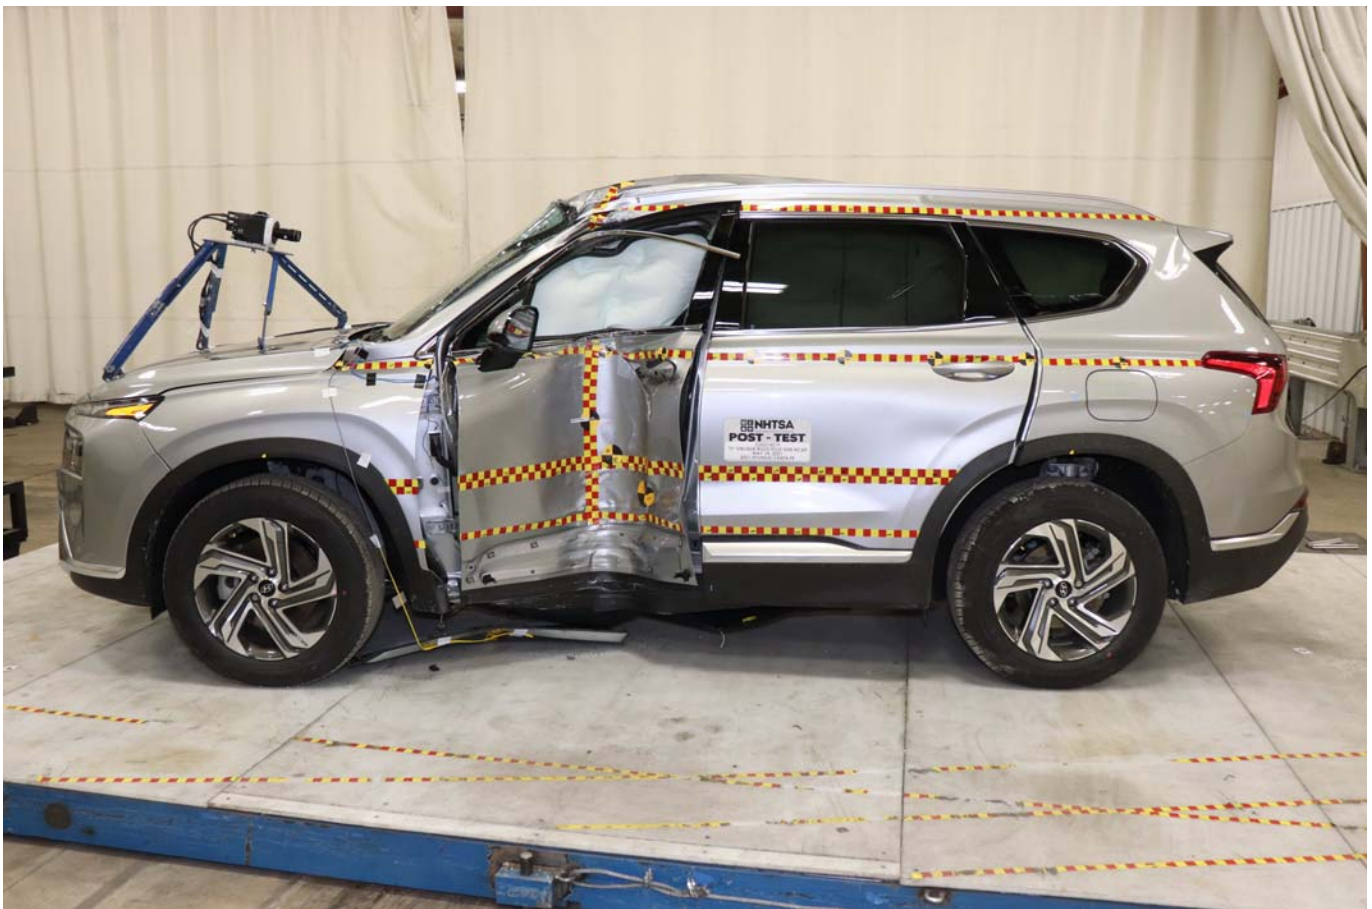
Photo No. 008 - Post-Test Left Side View of Test Vehicle

Critical Areas of Performance	Observations and Conclusions
Pillar Performance	No Separation
Sill Separation	None
Windshield Damage	Cracked
Side Window Damage	LF window broken
Other Notable Effects	None

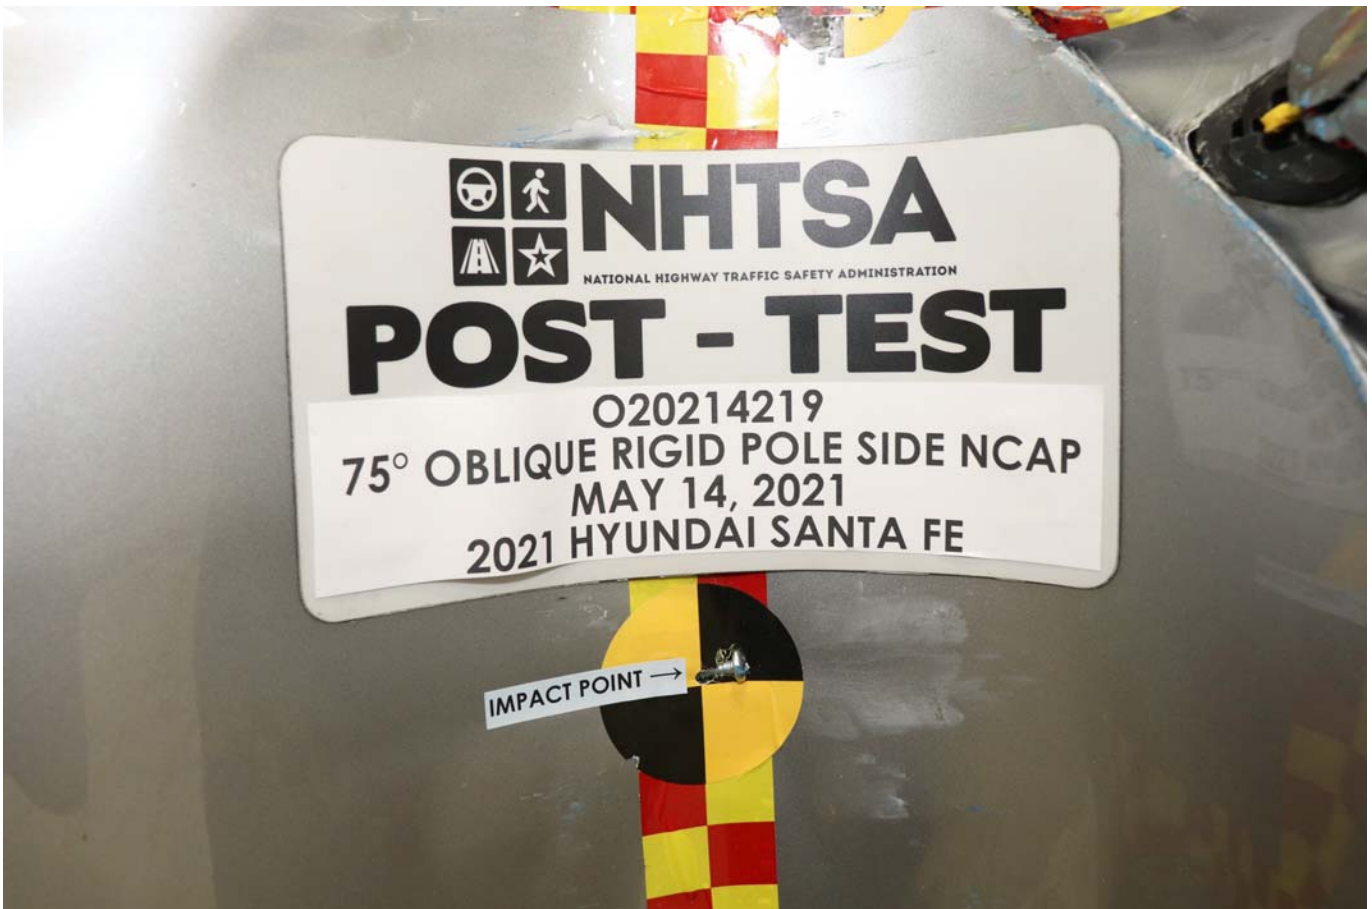
Photo No. 020 - Post-Test Close-Up View of Impact Point Target Showing Impact Location

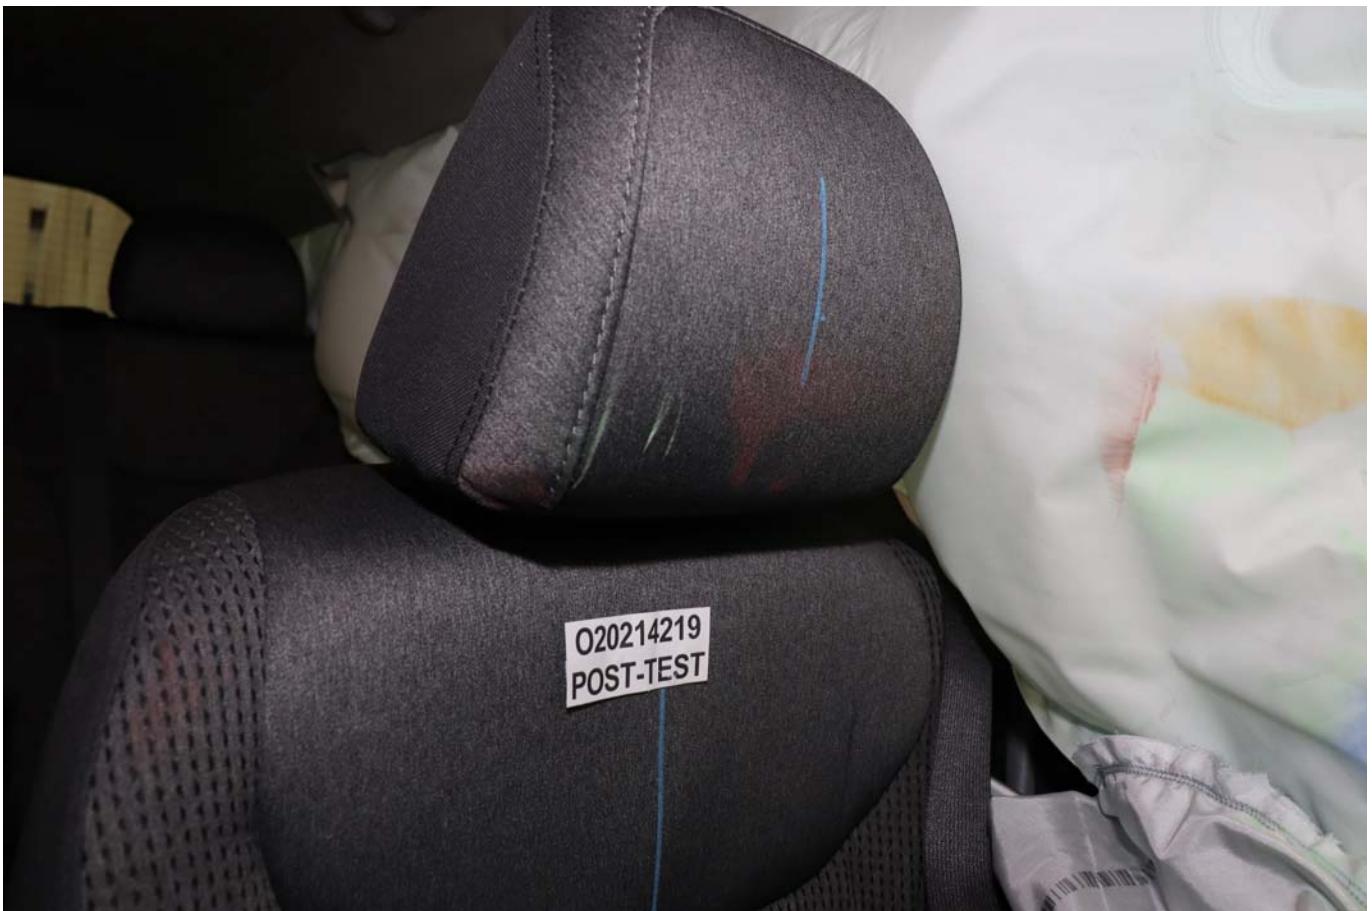
Photo No. 046 - Post-Test Dummy Close-Up Head Contact with Vehicle Interior View

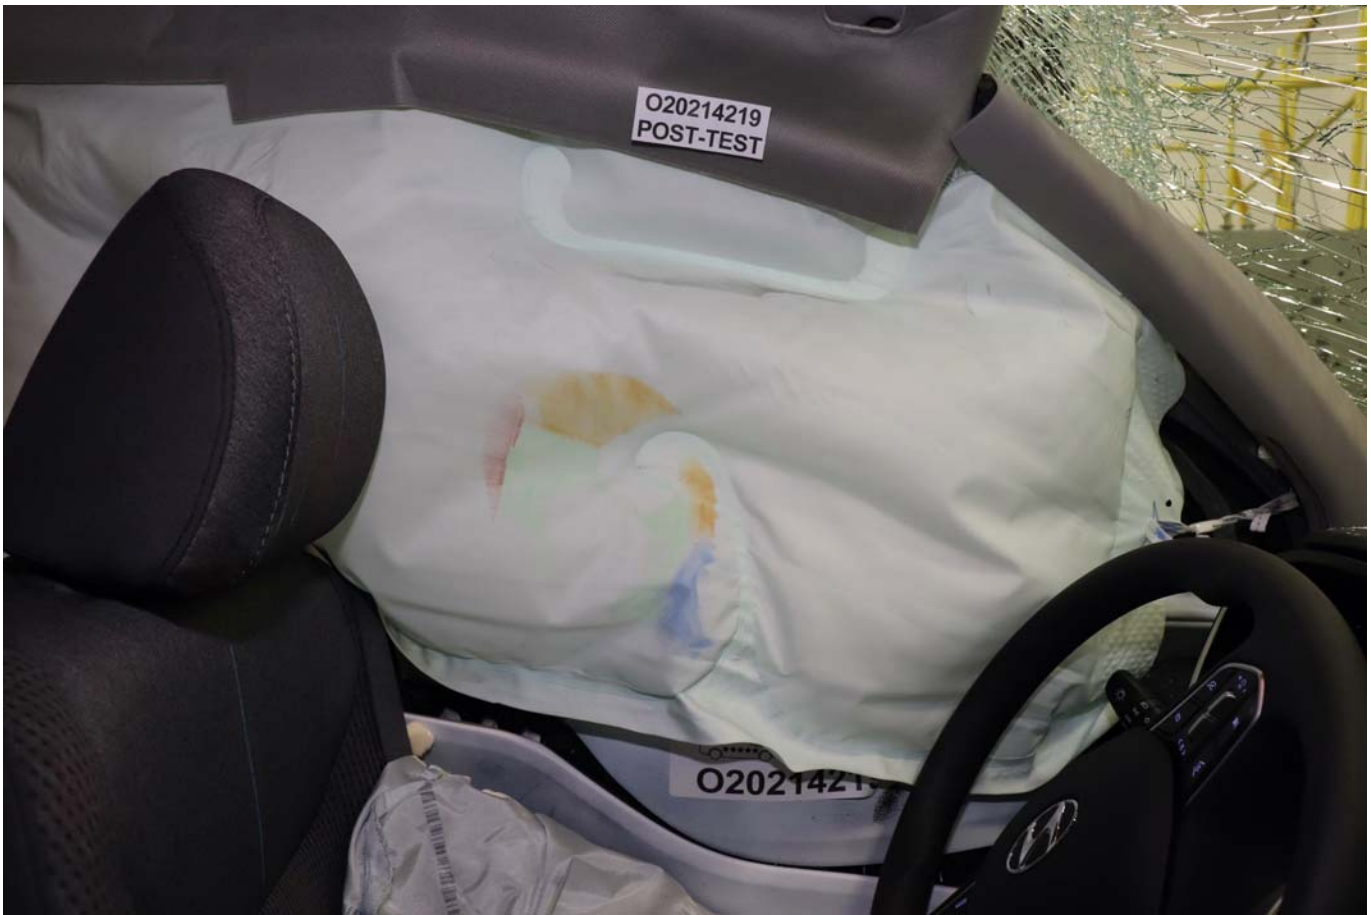
Photo No. 047 - Post-Test Dummy Close-Up Head Contact with Side Air Bag View

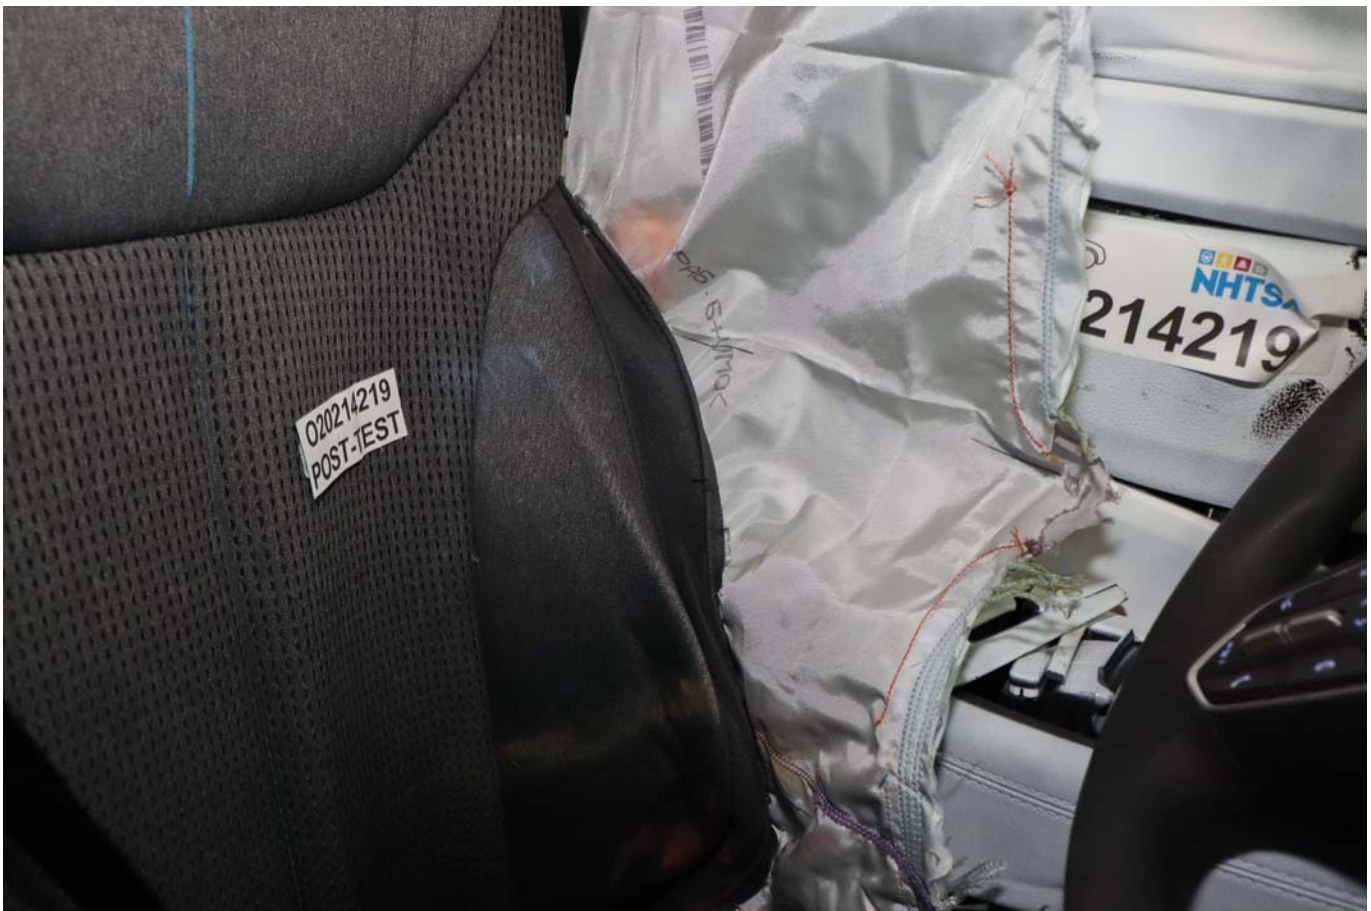
Photo No. 048 - Post-Test Dummy Close-Up Torso Contact with Vehicle Interior View

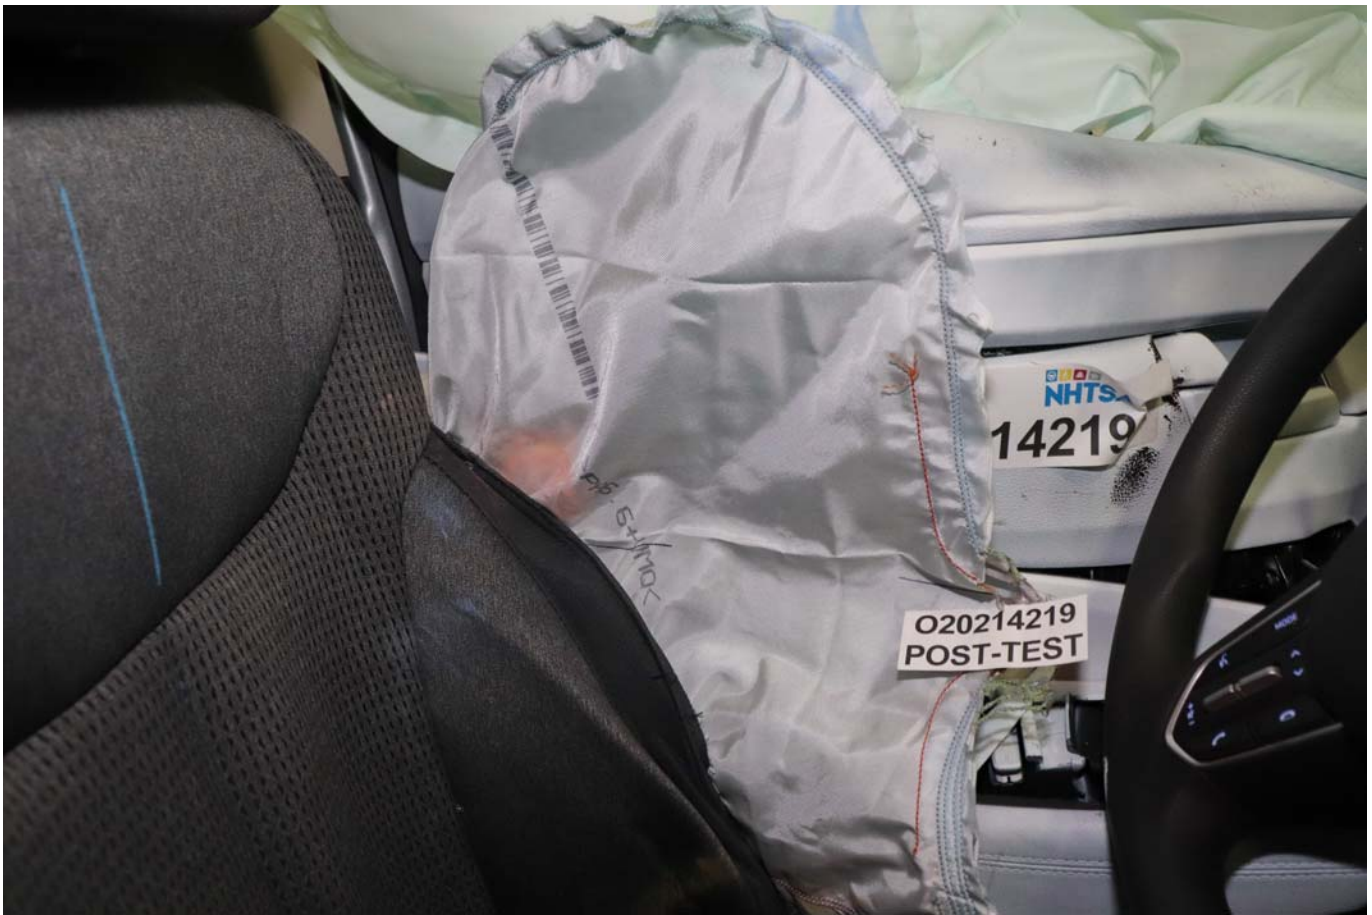
Photo No. 049 - Post-Test Dummy Close-Up Torso Contact with Side Air Bag View

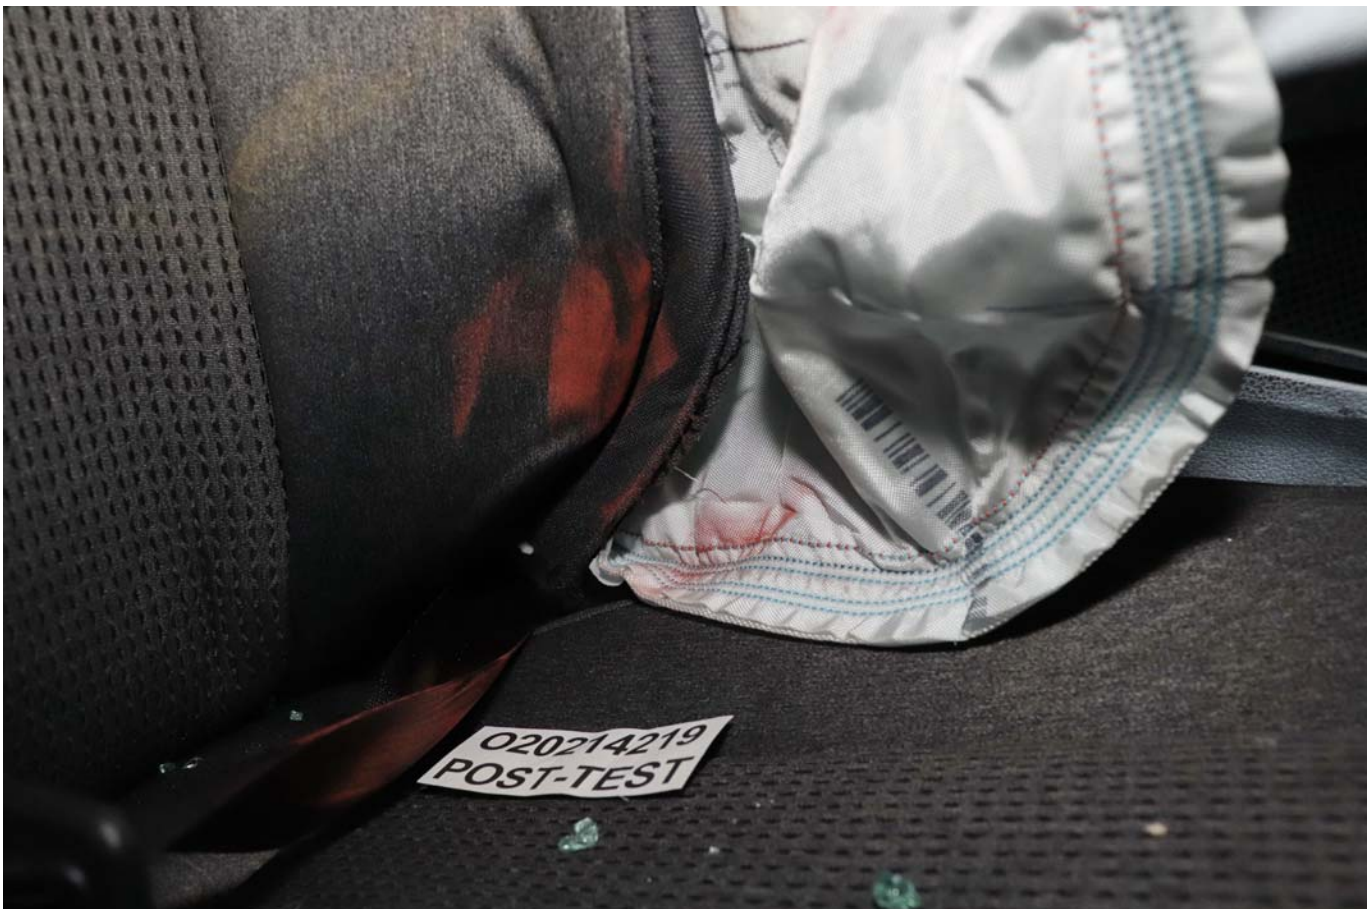
Photo No. 050 - Post-Test Dummy Close-Up Pelvis Contact with Vehicle Interior View

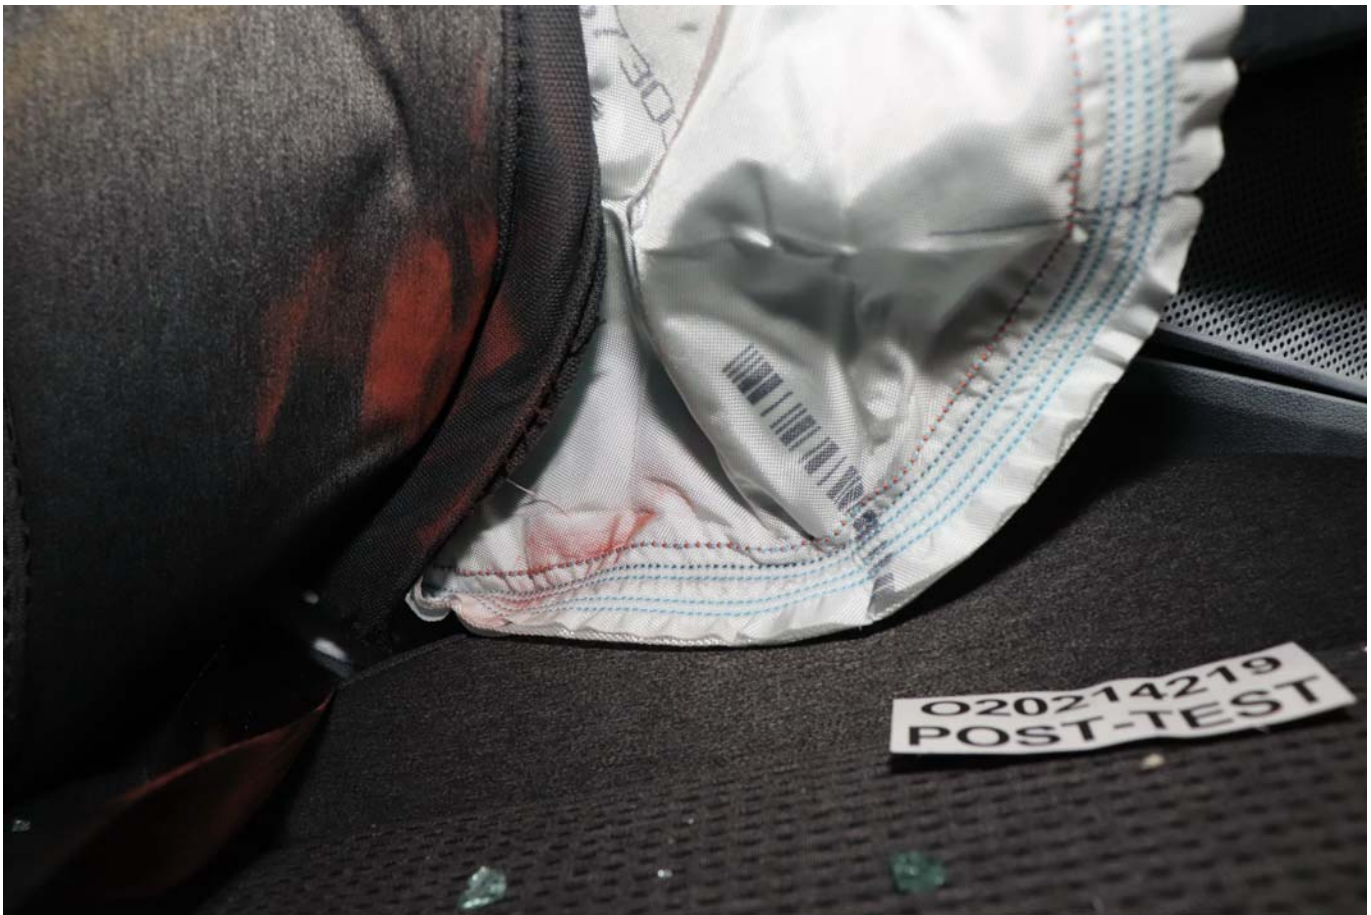
Photo No. 051 - Post-Test Dummy Close-Up Pelvis Contact with Side Air Bag View

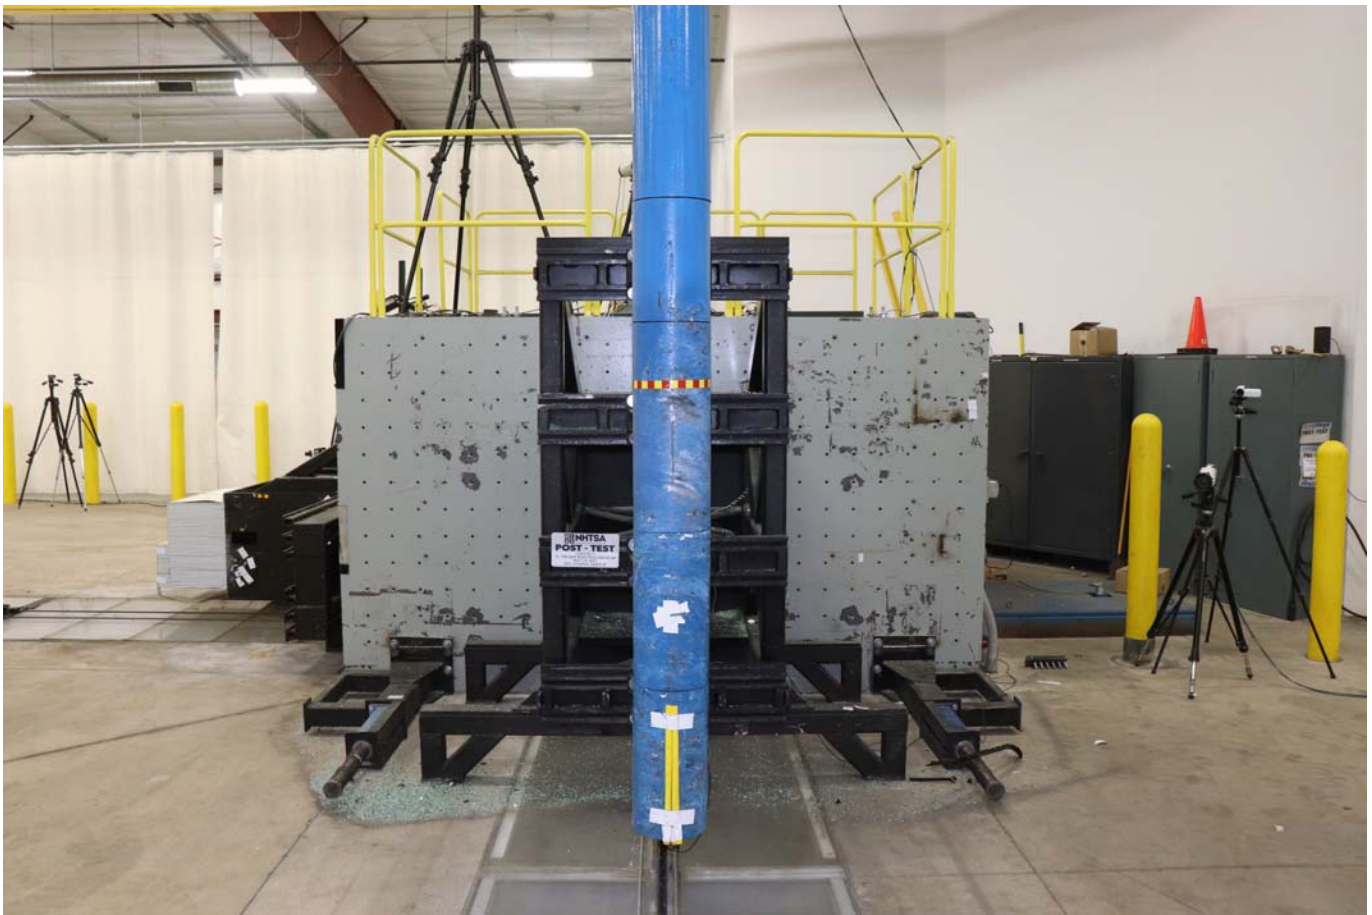
Photo No. 060 - Post-Test Pole Barrier Front View

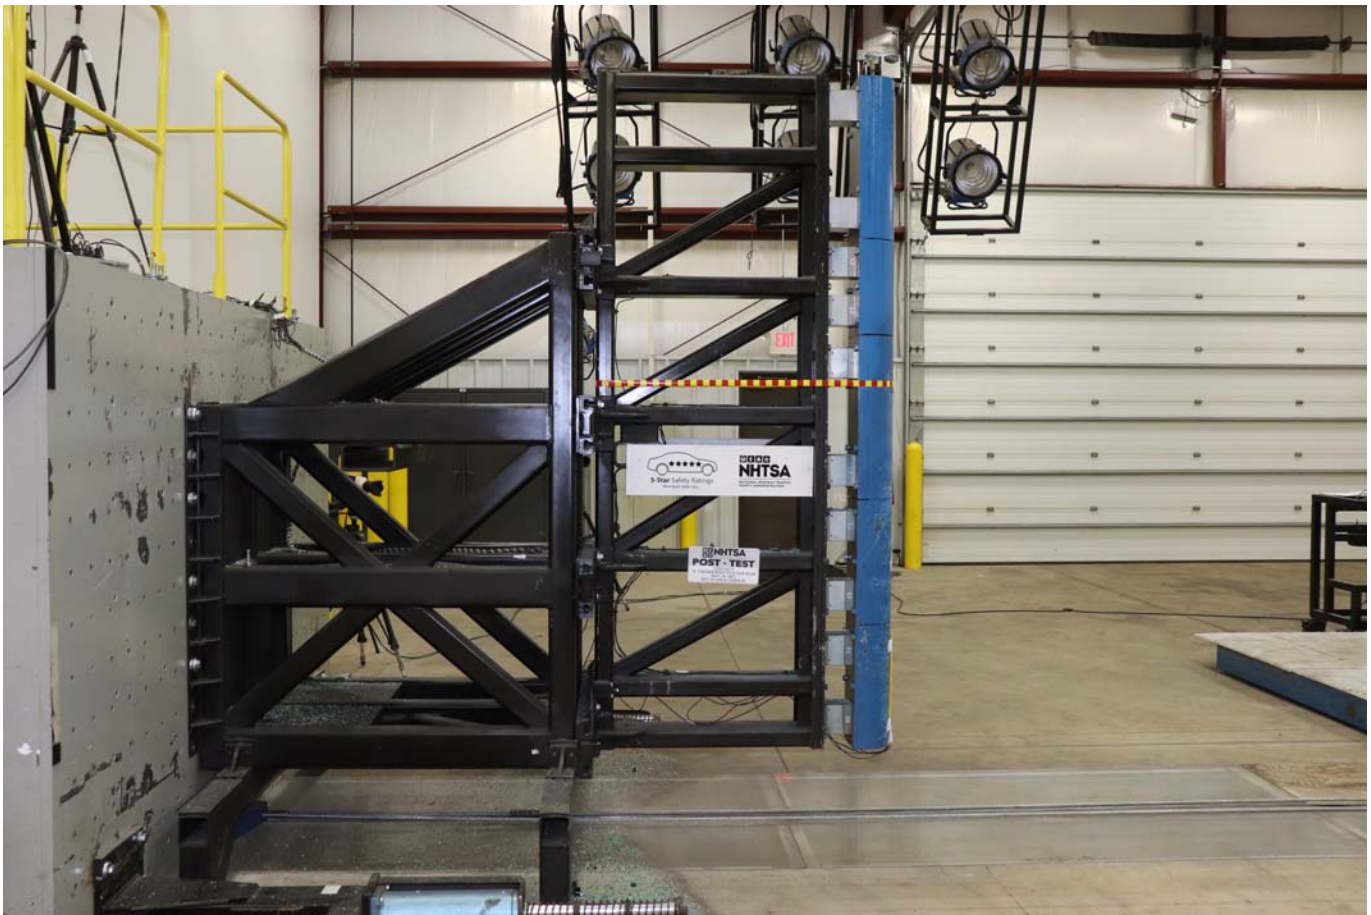
Photo No. 062 - Post-Test Pole Barrier Side View

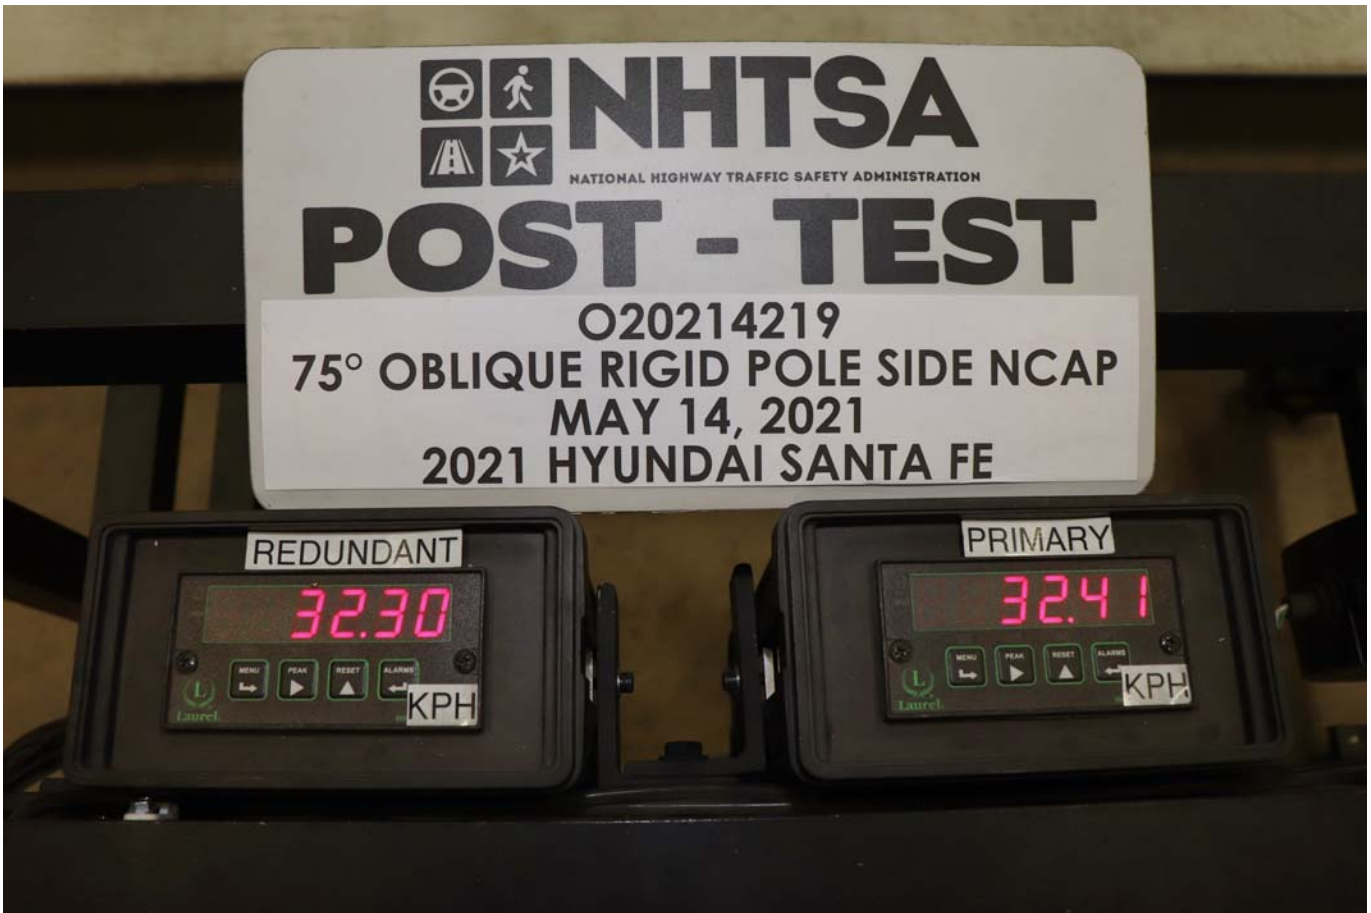
Photo No. 064 - Post-Test Primary and Redundant Speed Trap Read-Out

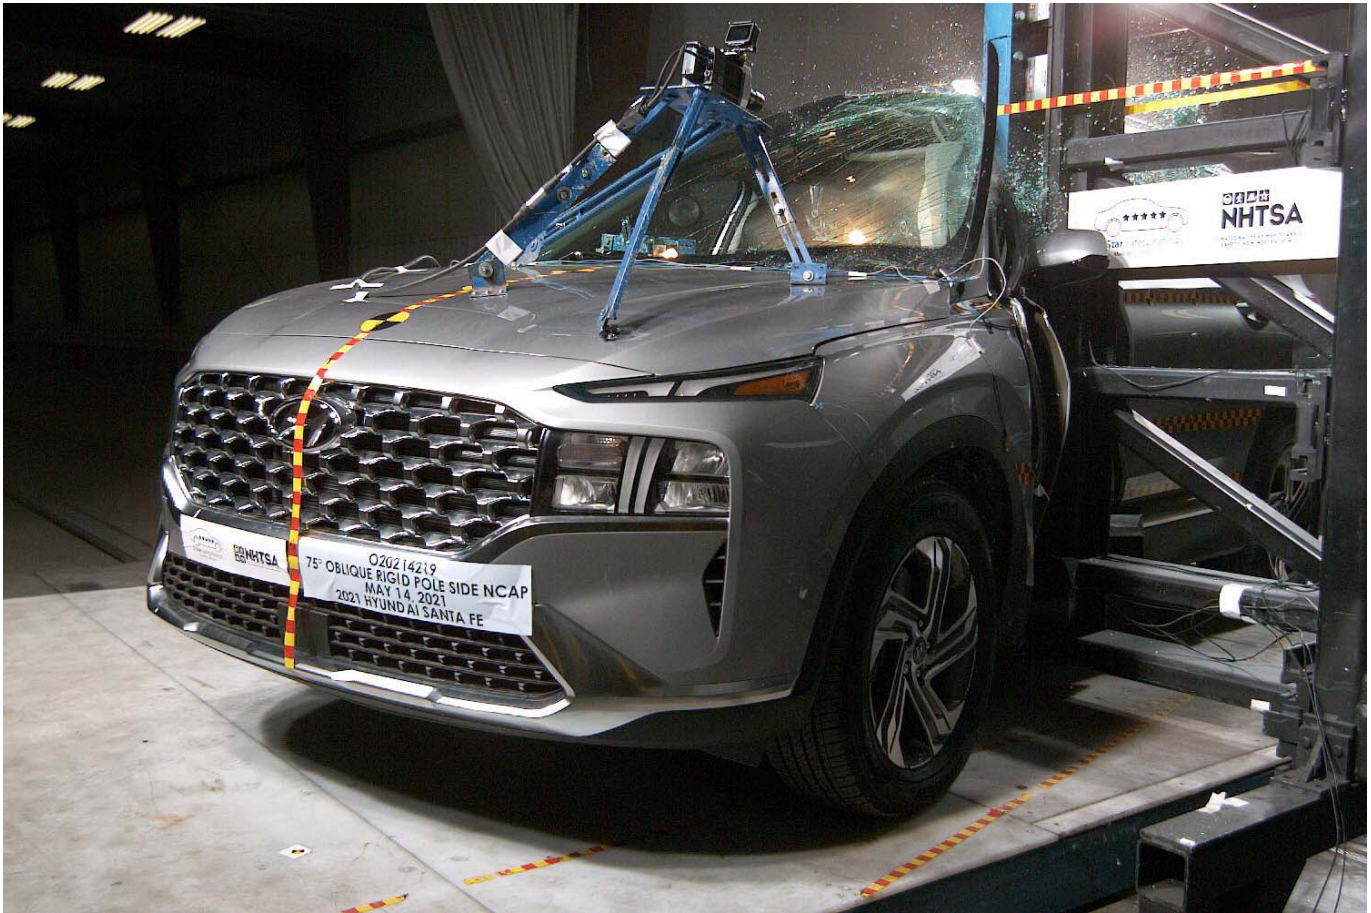
Photo No. 070 - Impact Event
