REPORT NUMBER: SideNCAPMDB-MGA-21-043

**NEW CAR ASSESSMENT PROGRAM (NCAP)
Moving Deformable Barrier Side Impact Test**

**HYUNDAI MOTOR MANUFACTURING ALABAMA, LLC
Hyundai Santa Fe SEL 5-Door SUV
NHTSA No.: O20214220**

FINAL REPORT

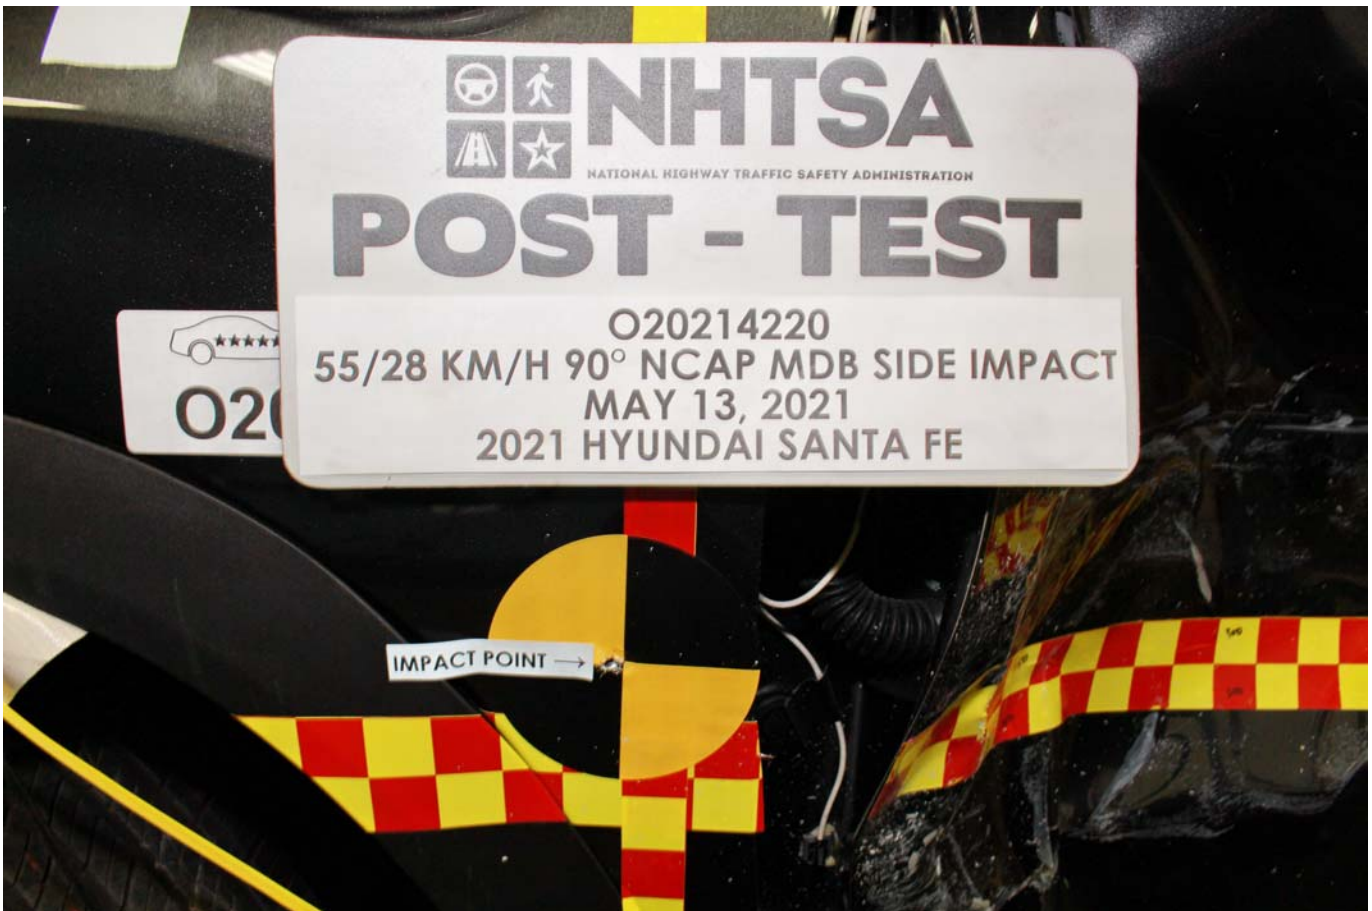
Photo No. 020 - Post-Test Close-Up View of Impact Point Target

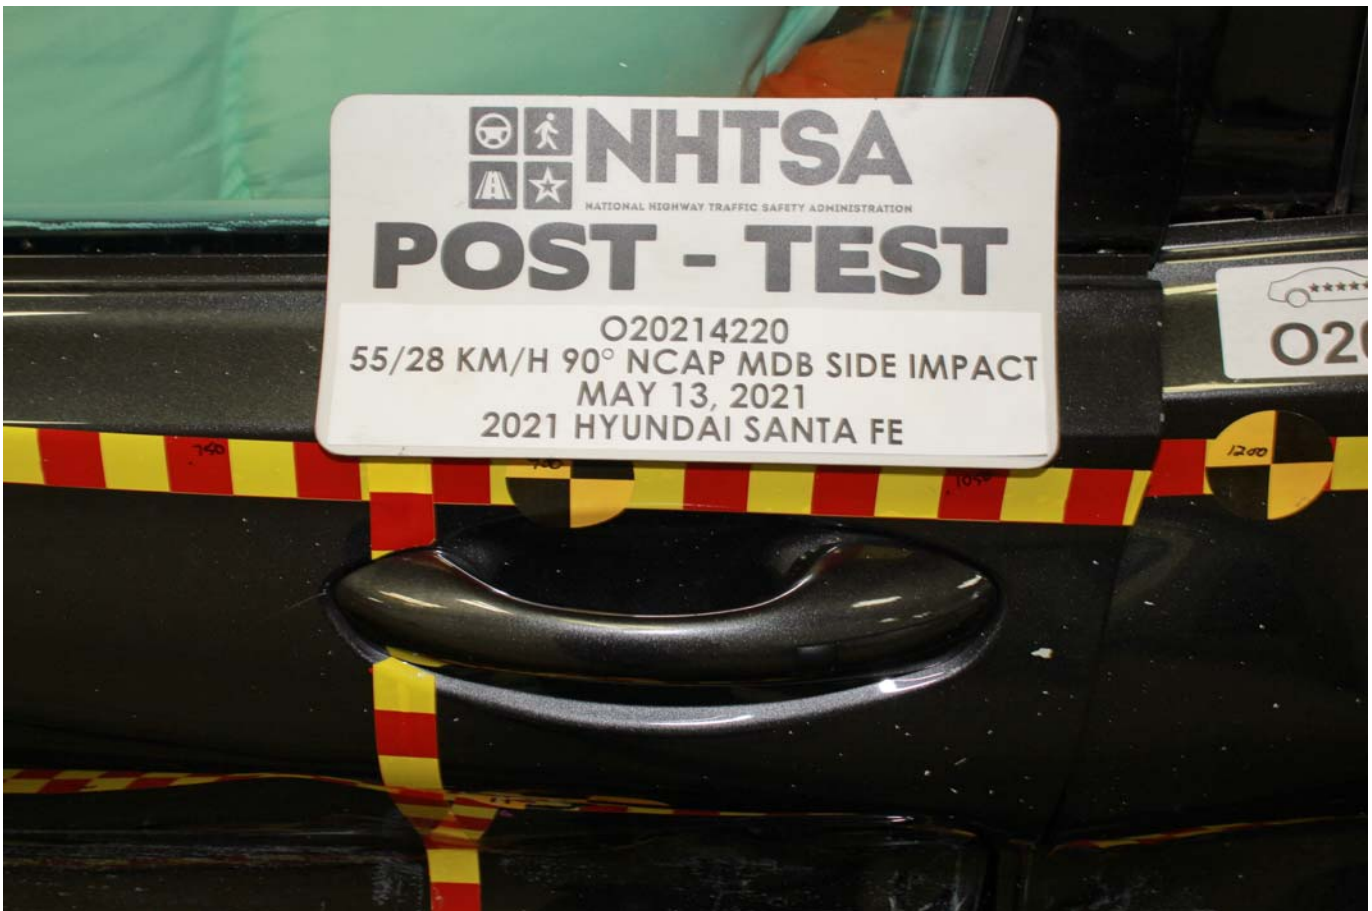
Photo No. 022 - Post-Test Left Front Door Latch Close-Up

The two doors on the struck side of the vehicle did not separate from the body at the hinges or latches and the opposite door(s) did not open during the side impact event.

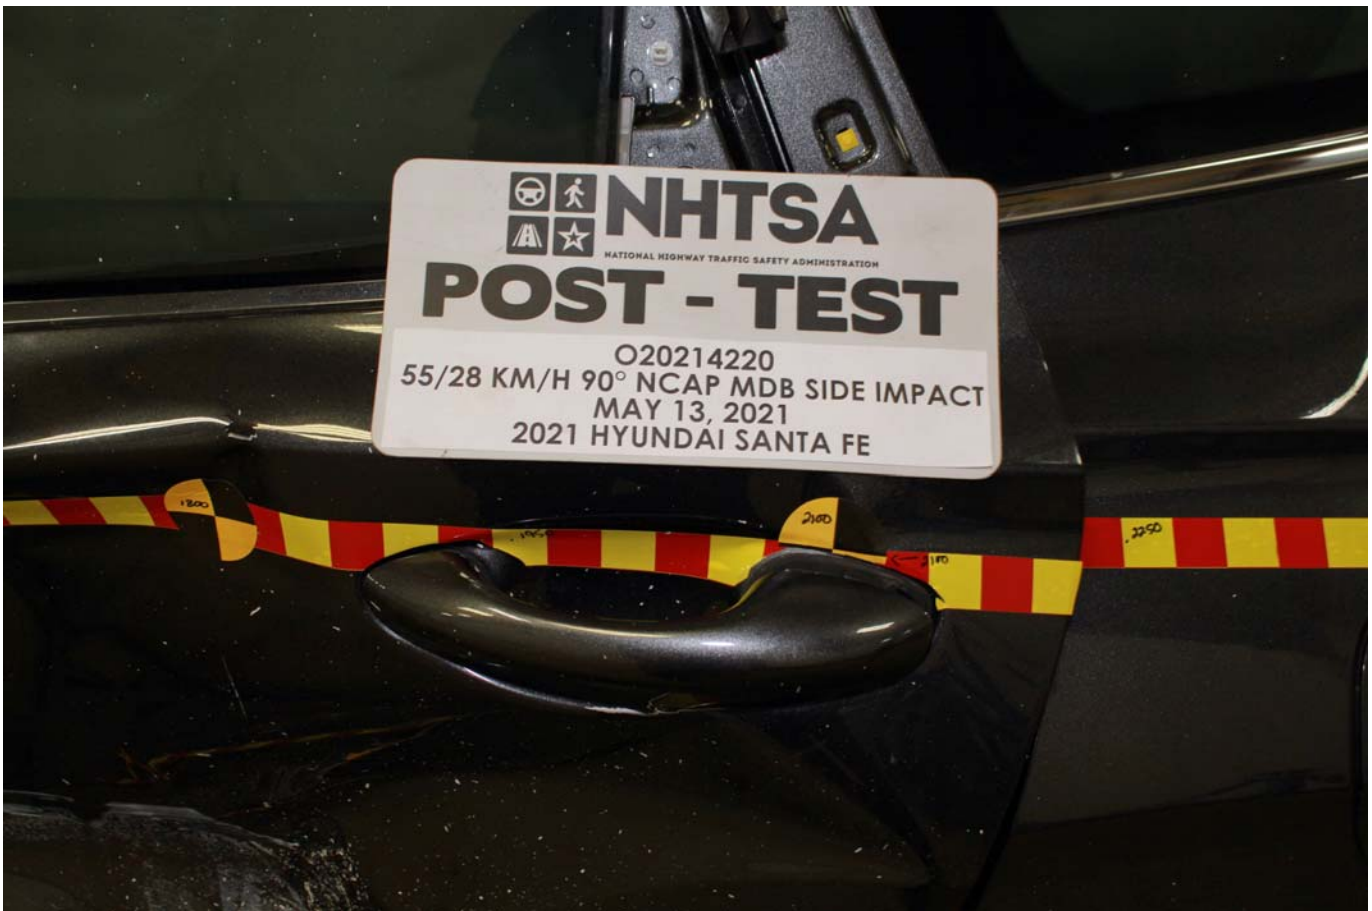
Photo No. 024 - Post-Test Left Rear Door Latch Close-Up

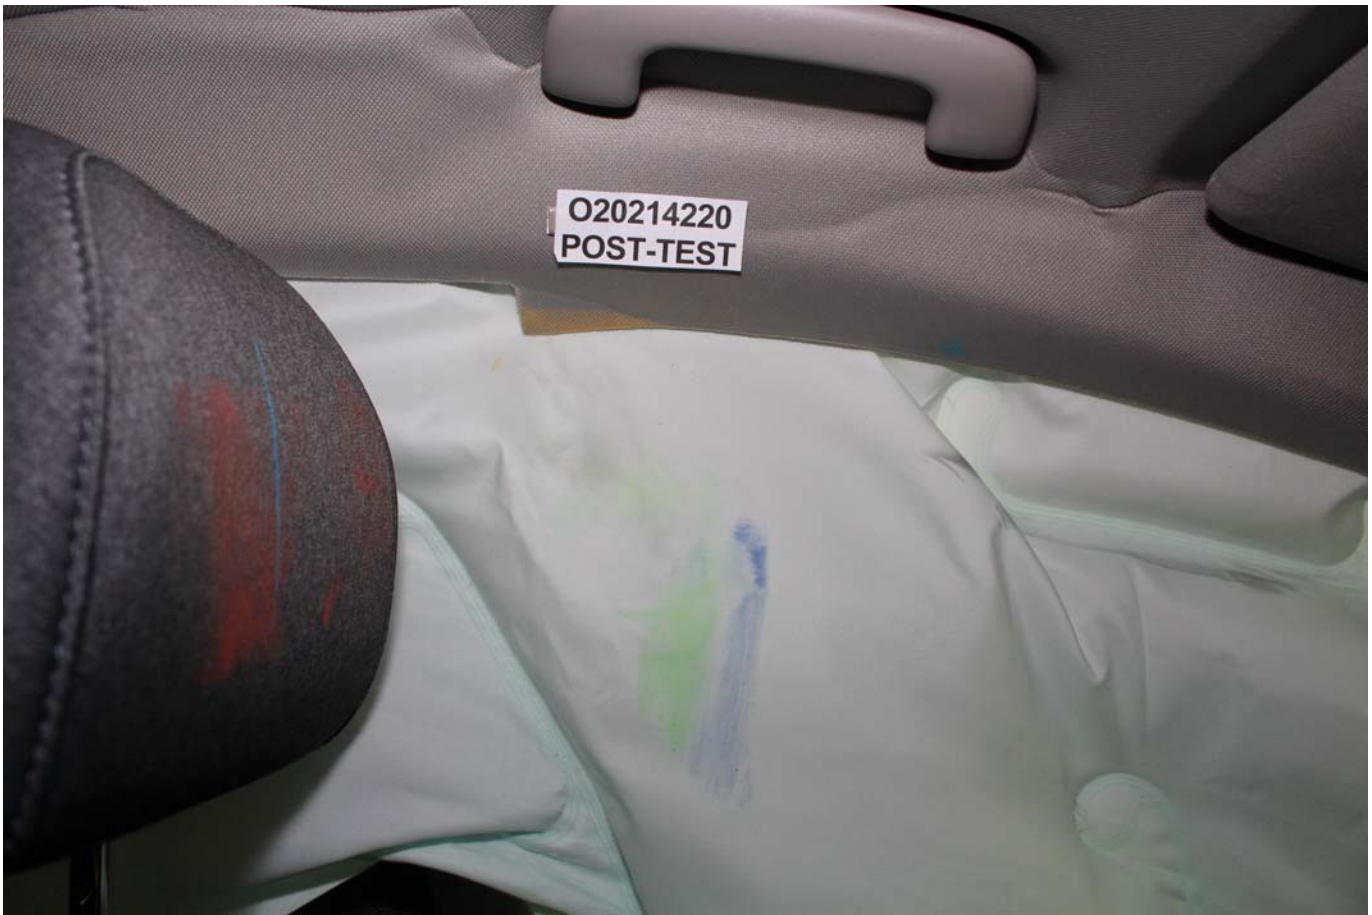
Photo No. 049 - Post-Test Driver Dummy Close-up Head Contact with Side Airbag View

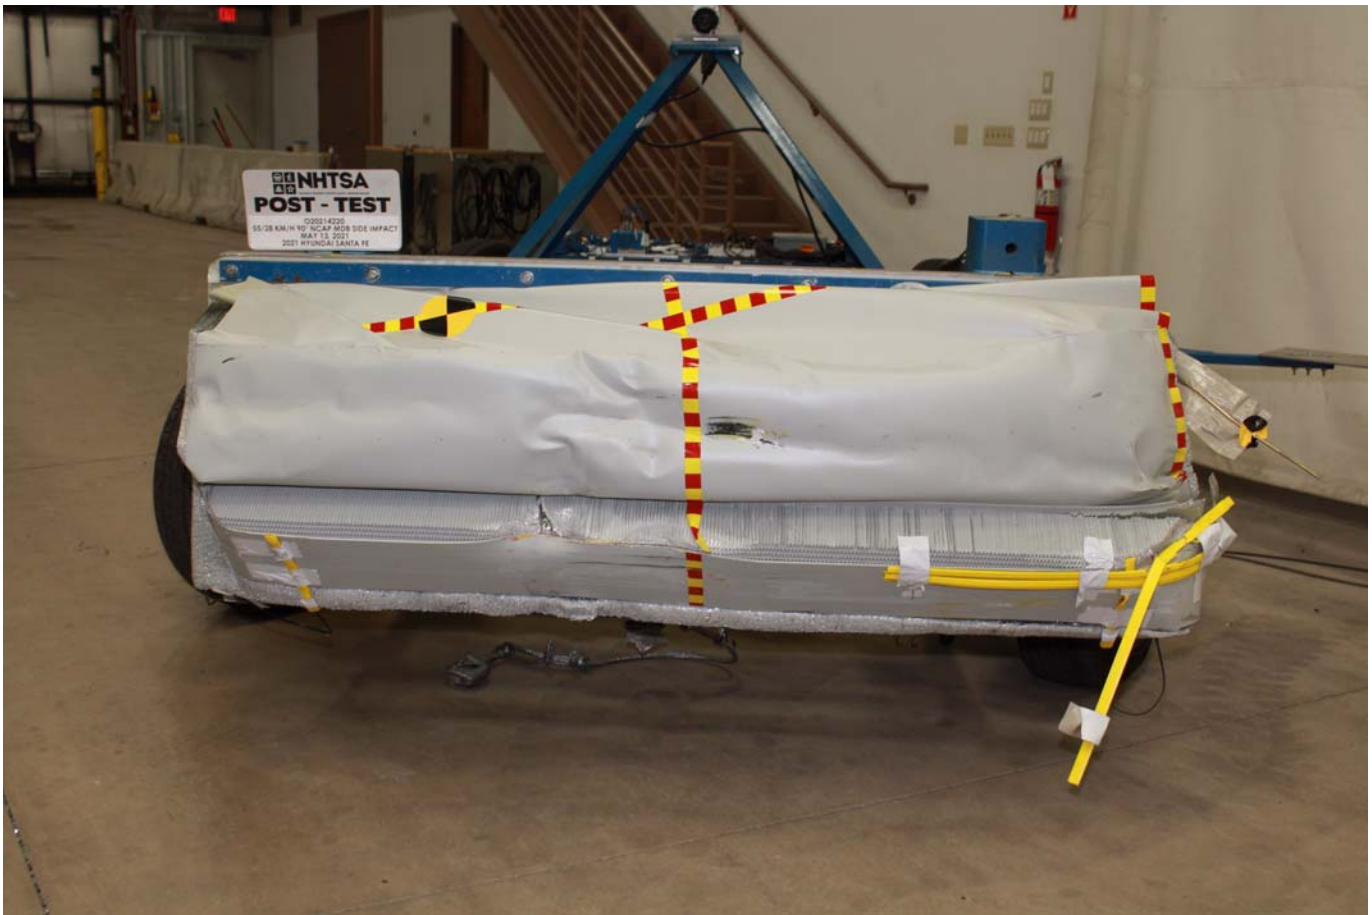
Photo No. 085 - Post-Test Front View of MDB Impactor Face

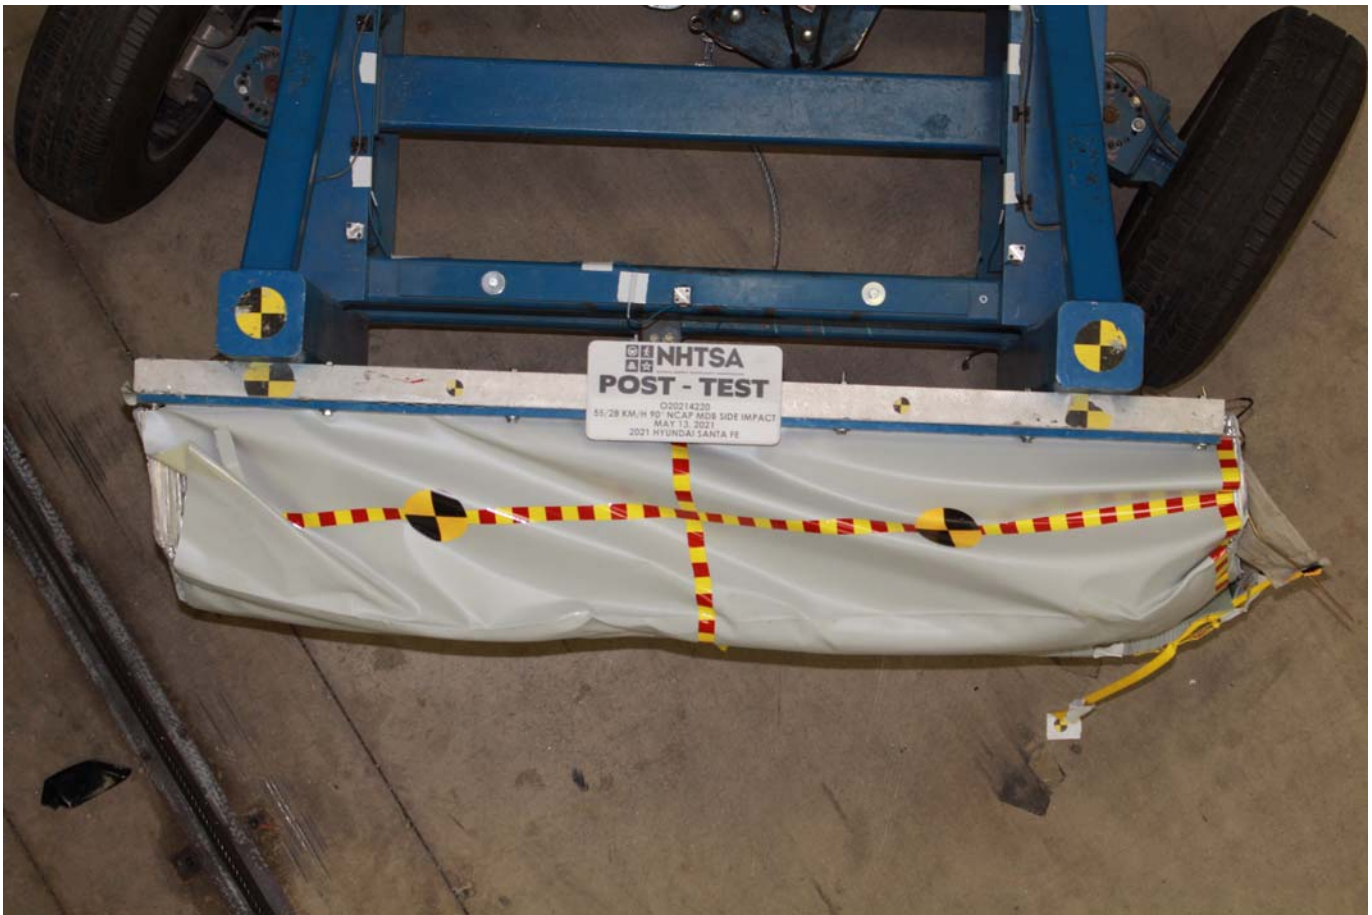
Photo No. 087 - Post-Test Top View of MDB Impactor Face
