**REPORT NUMBER: SideNCAPPole-KAR-21-013
NEW CAR ASSESSMENT PROGRAM (NCAP)
SIDE IMPACT POLE TEST**

**HYUNDAI MOTOR COMPANY
2021 GENESIS G80 4-DOOR SEDAN**

**PREPARED BY:
APPLUS IDIADA KARCO ENGINEERING, LLC.
9270 HOLLY ROAD
ADELANTO, CA 92301**

FINAL REPORT

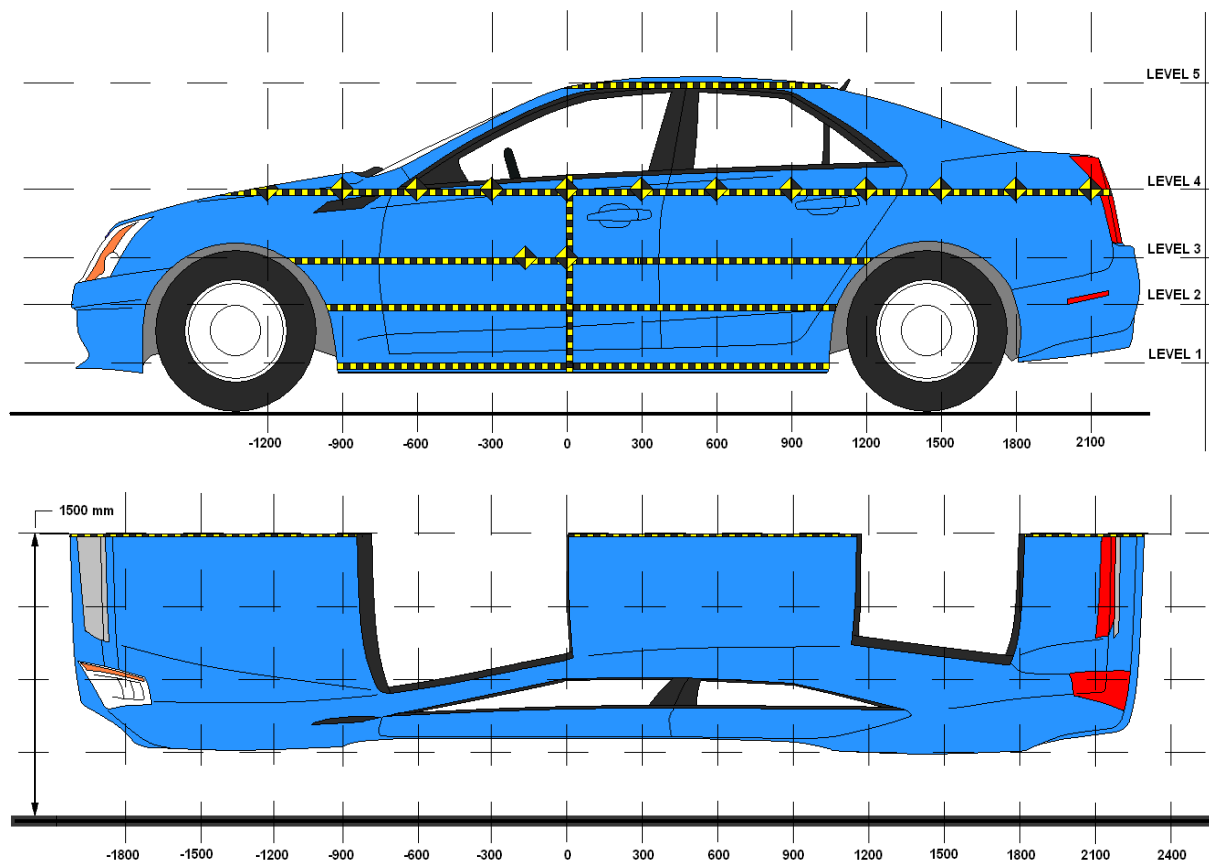
TEST VEHICLE EXTERIOR CRUSH MEASUREMENTS

NOTE: All measurements in mm with tolerance of $\pm 3\text{mm}$

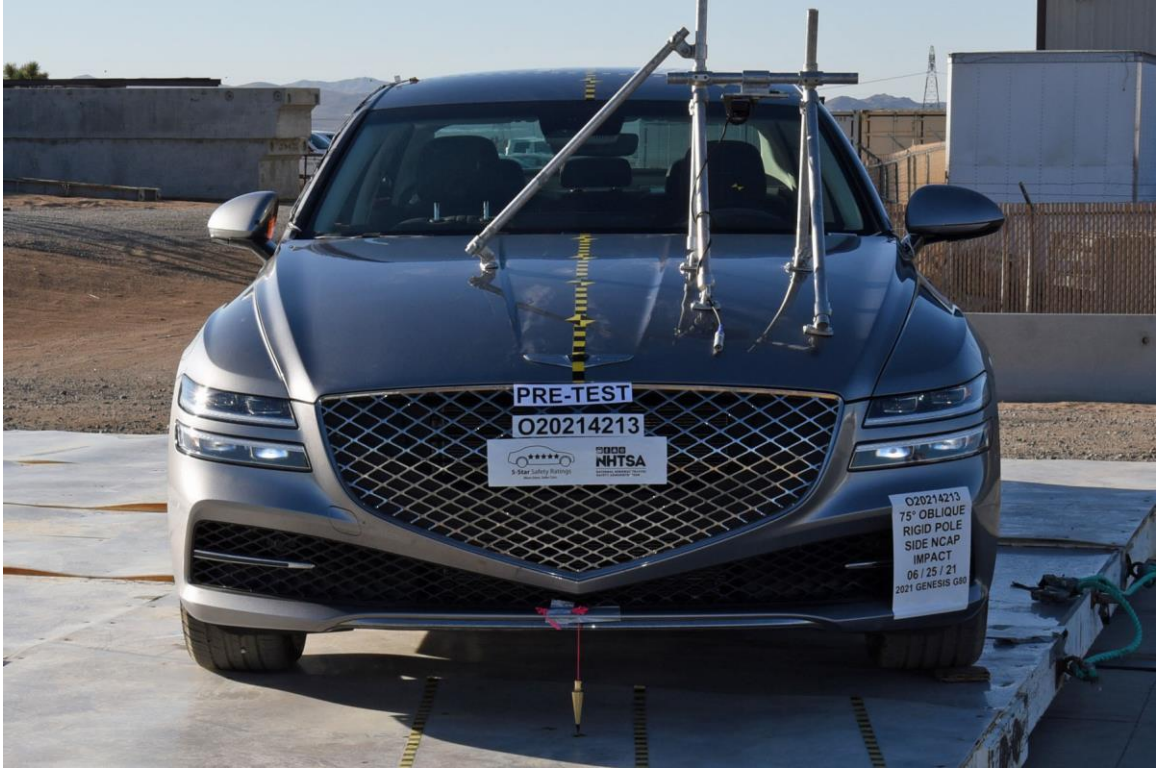
FIGURE 3. Pre-Test Frontal View of Test Vehicle

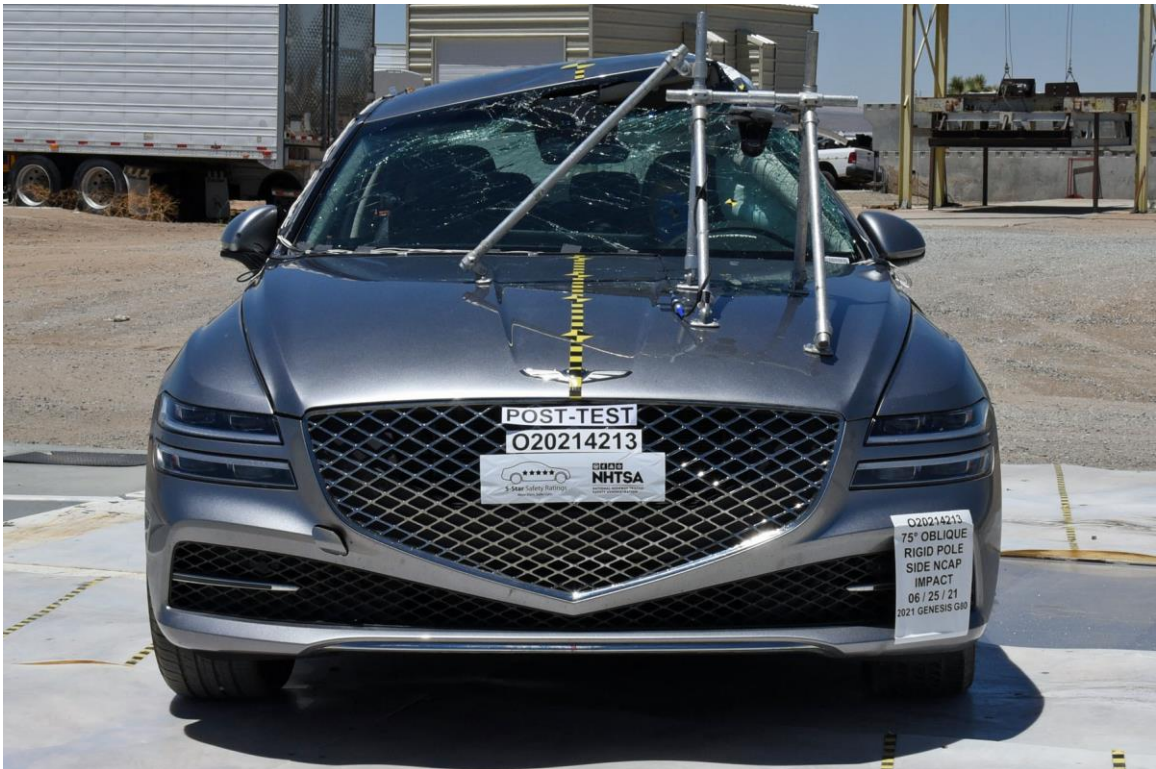
FIGURE 4. Post-Test Frontal View of Test Vehicle

Critical Areas of Performance	Observations and Conclusions
Pillar Performance	No separation occurred
Sill Separation	No separation occurred
Windshield Damage	Broken
Side Window Damage	Broken
Other Notable Effects	Windshield Separation

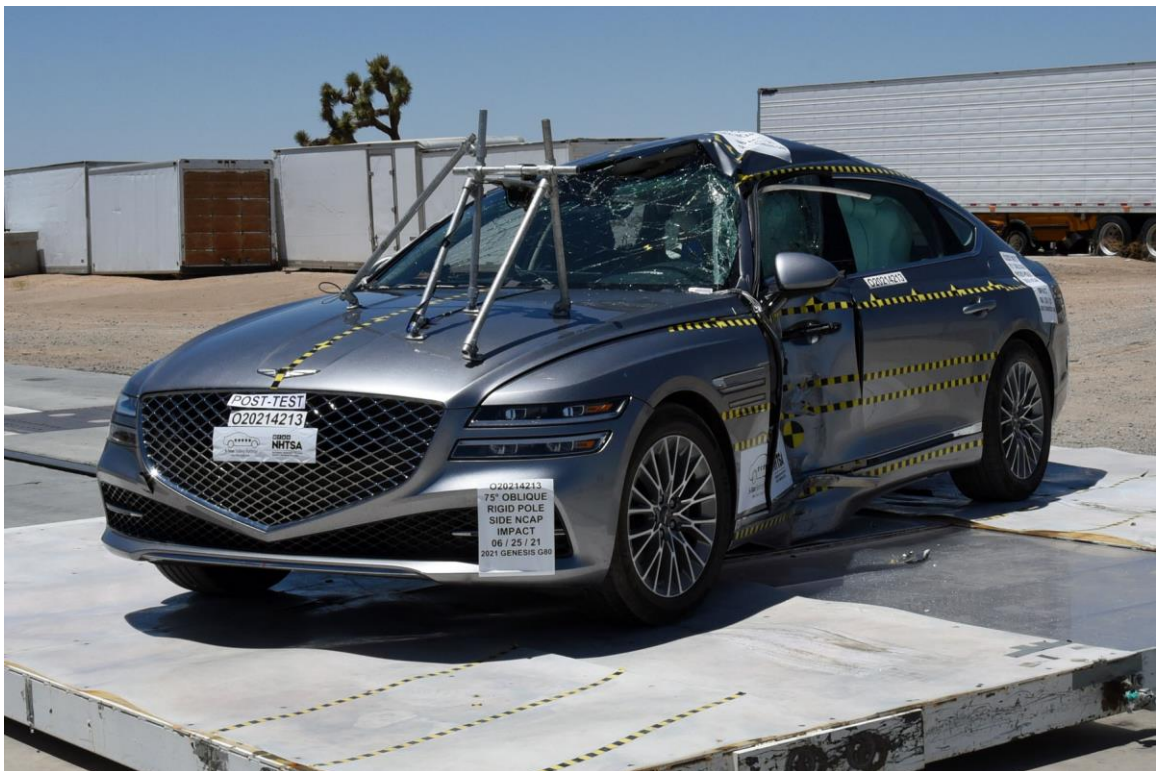
FIGURE 6. Post-Test Left Front 3/4 View of Test Vehicle

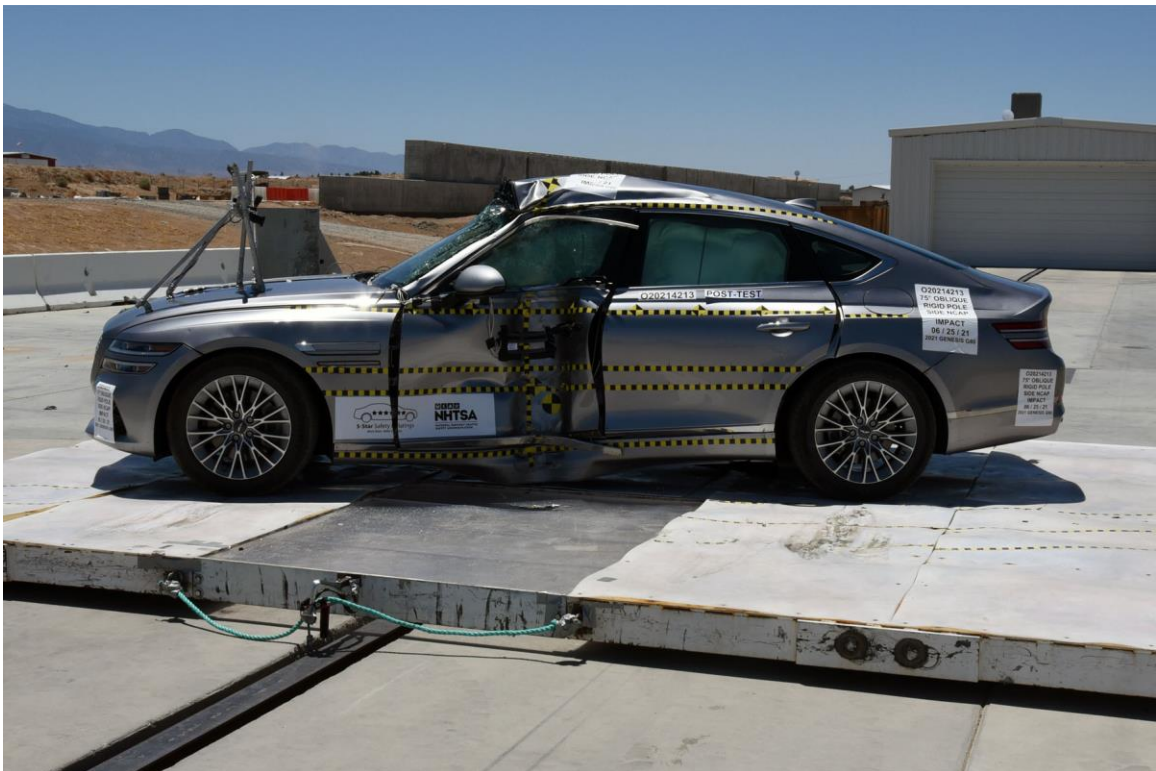
FIGURE 8. Post-Test Left Side View of Test Vehicle

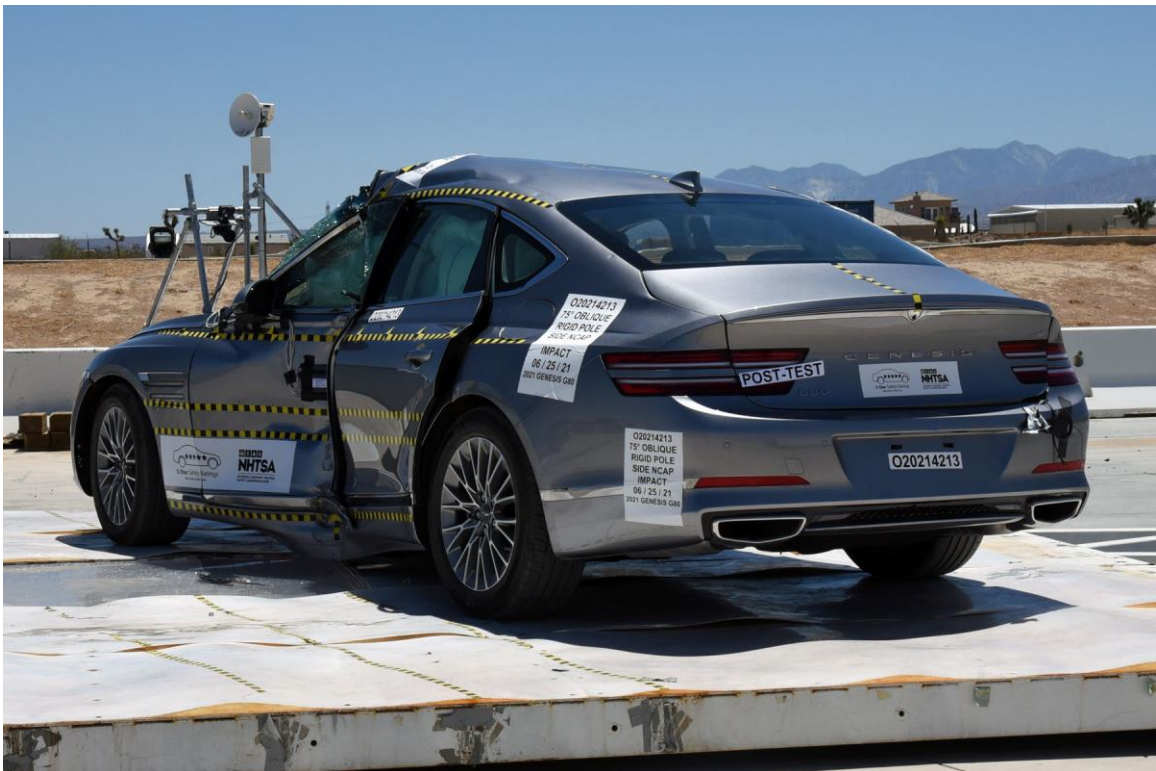
FIGURE 10. Post-Test Left Rear $\frac{3}{4}$ View of Test Vehicle

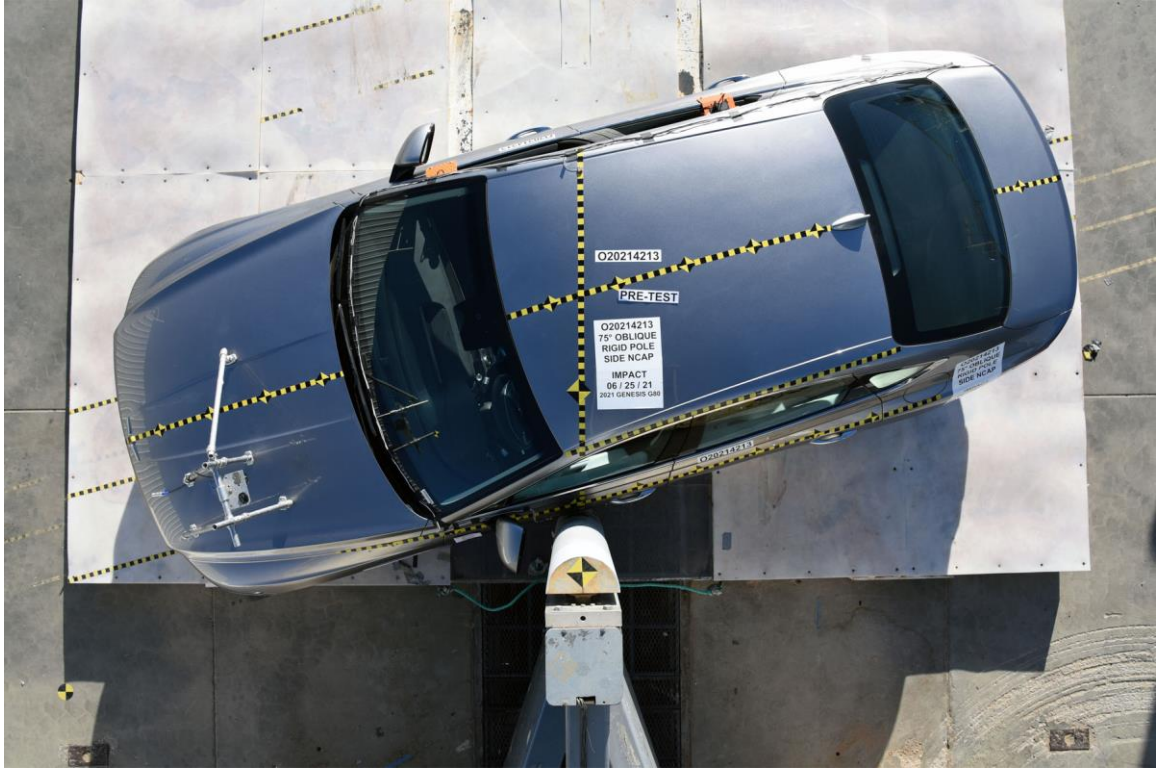
FIGURE 15. Pre-Test Overhead View of Test Area

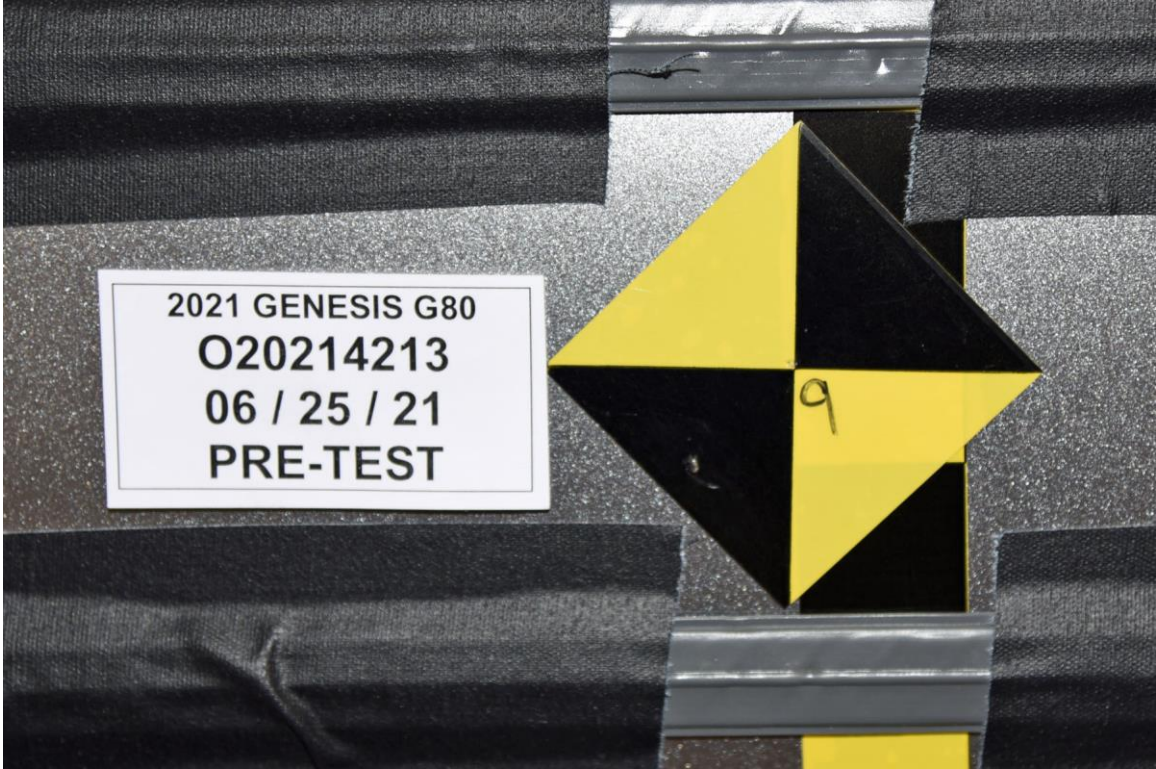
FIGURE 19. Pre-Test Close-Up View of Impact Point Target

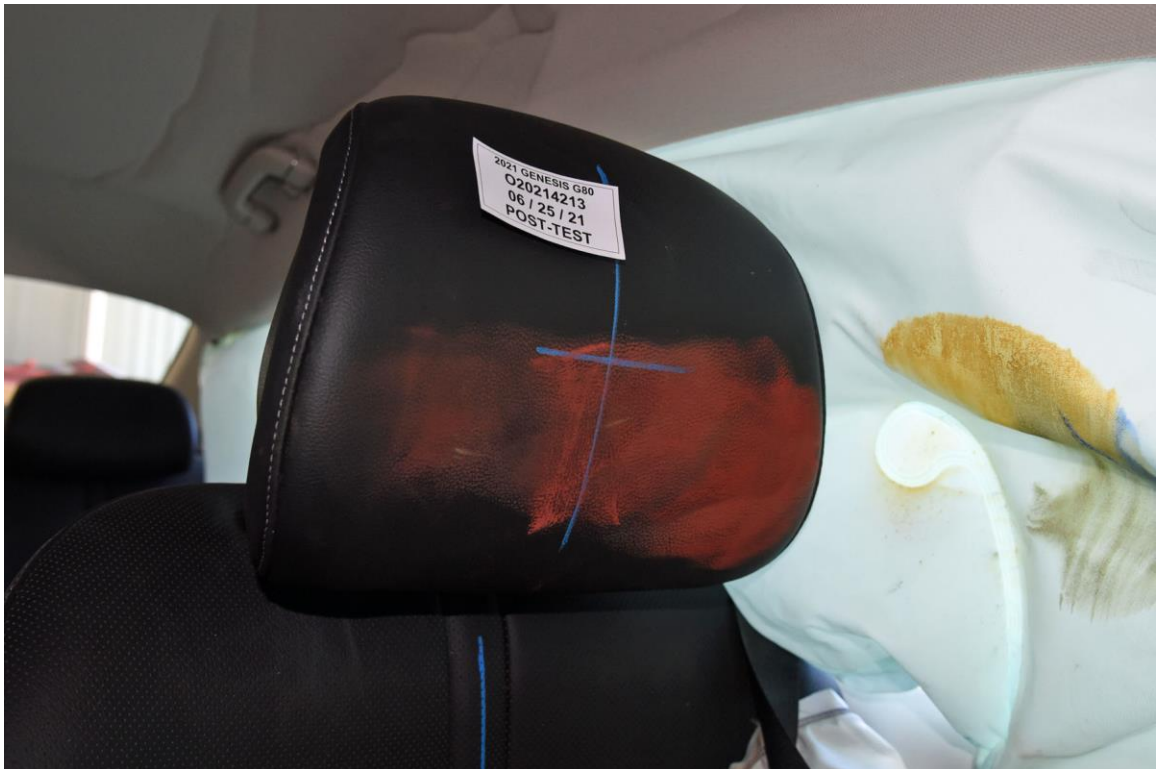
FIGURE 46. Post-Test Dummy Close-Up Head Contact with Vehicle Interior View

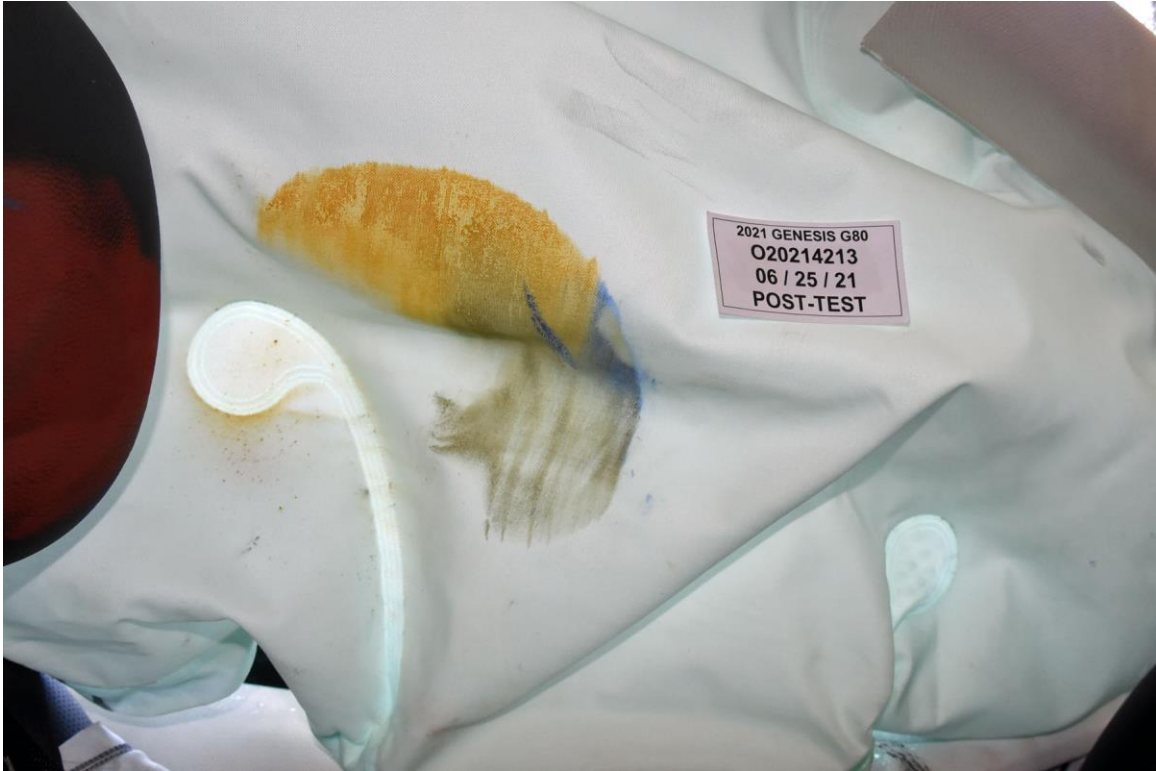
FIGURE 47. Post-Test Dummy Close-Up Head Contact With Side Airbag View

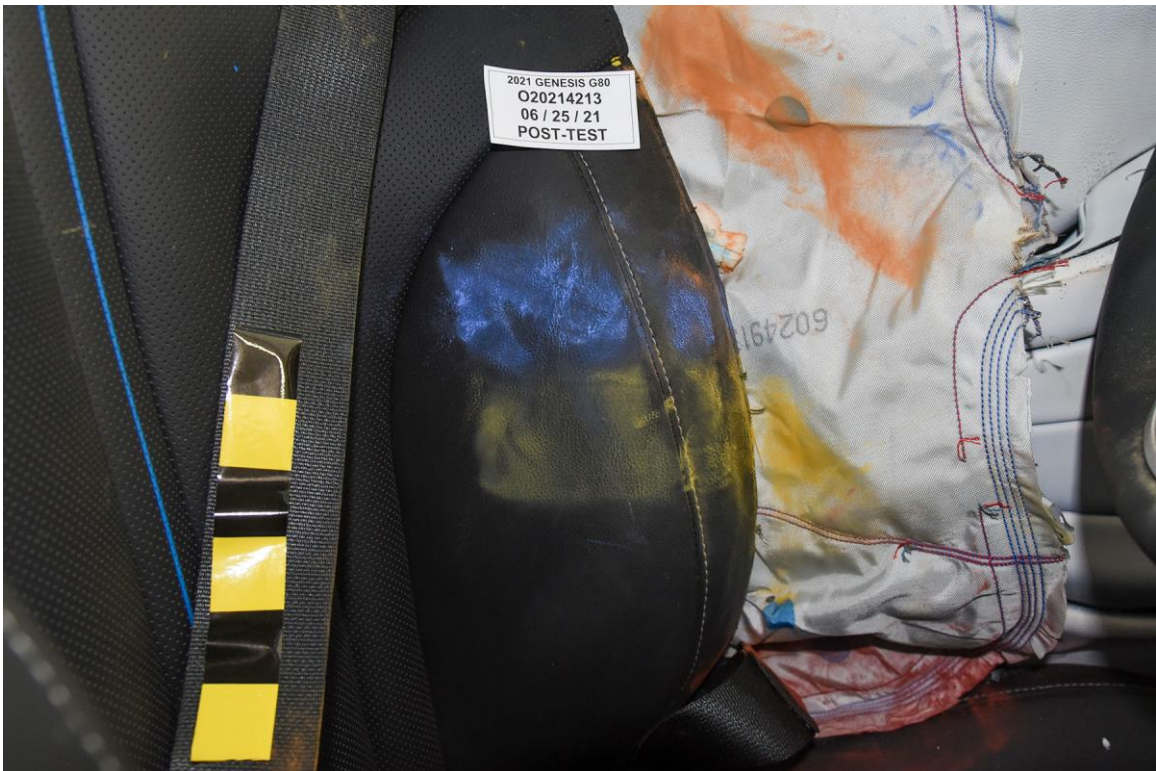
FIGURE 48. Post-Test Dummy Close-Up Torso Contact With Vehicle Interior View

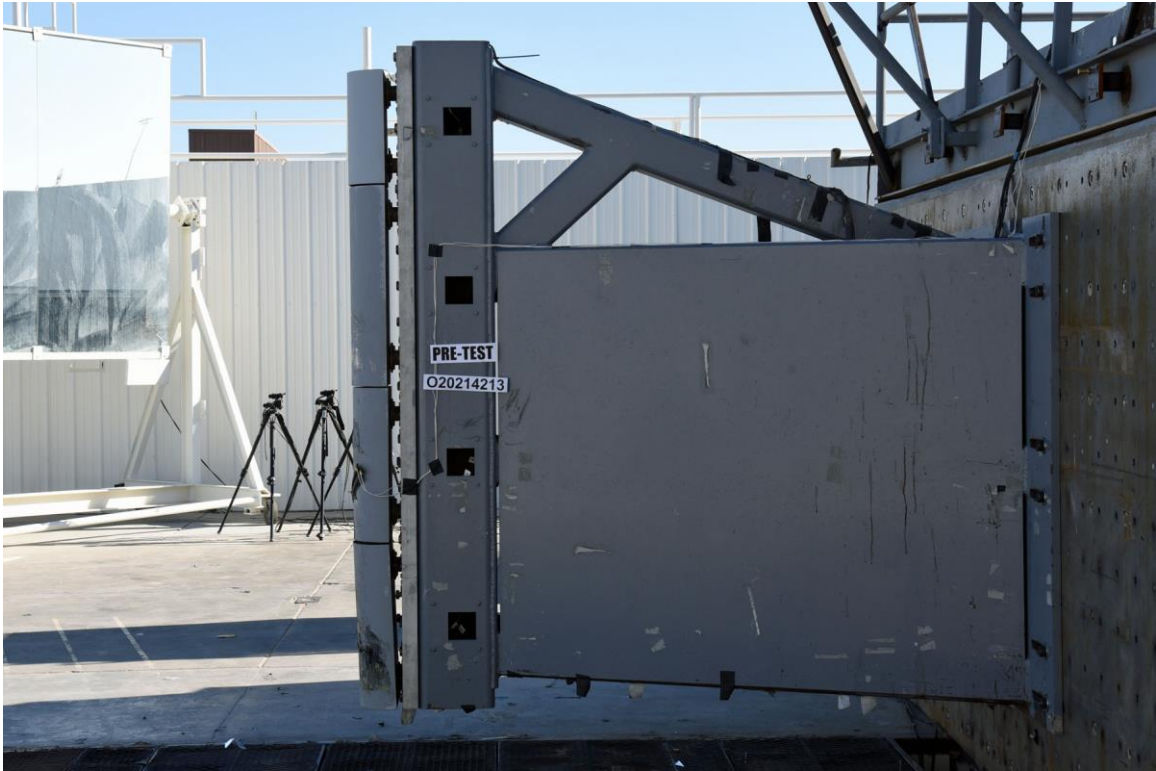
FIGURE 61. Pre-Test Pole Barrier Side View
