REPORT NUMBER: SideNCAPPole-MGA-21-048

**NEW CAR ASSESSMENT PROGRAM (NCAP)
Side Impact Pole Test**

**NISSAN MOTOR CO., LTD.
2021 Infiniti QX50 LUXE 5-Door SUV
NHTSA No.: O20215202**

**MGA RESEARCH CORPORATION
5000 Warren Road
Burlington, WI 53105**

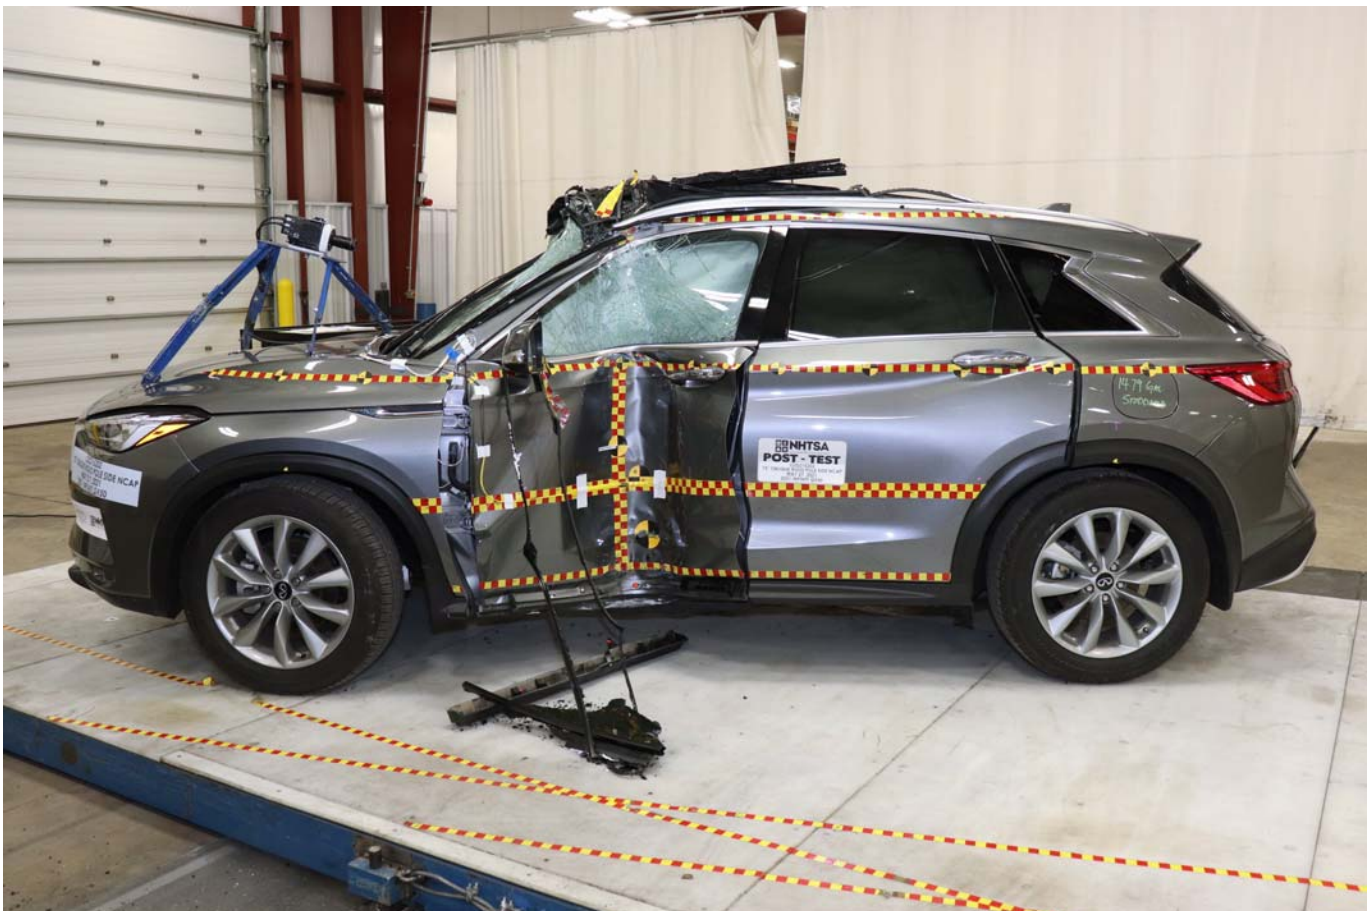
Photo No. 008 - Post-Test Left Side View of Test Vehicle

Critical Areas of Performance	Observations and Conclusions
Pillar Performance	No Separation
Sill Separation	No Separation
Windshield Damage	Broken
Side Window Damage	LF window cracked
Other Notable Effects	Large opening at top of windshield, glass shards in passenger compartment.

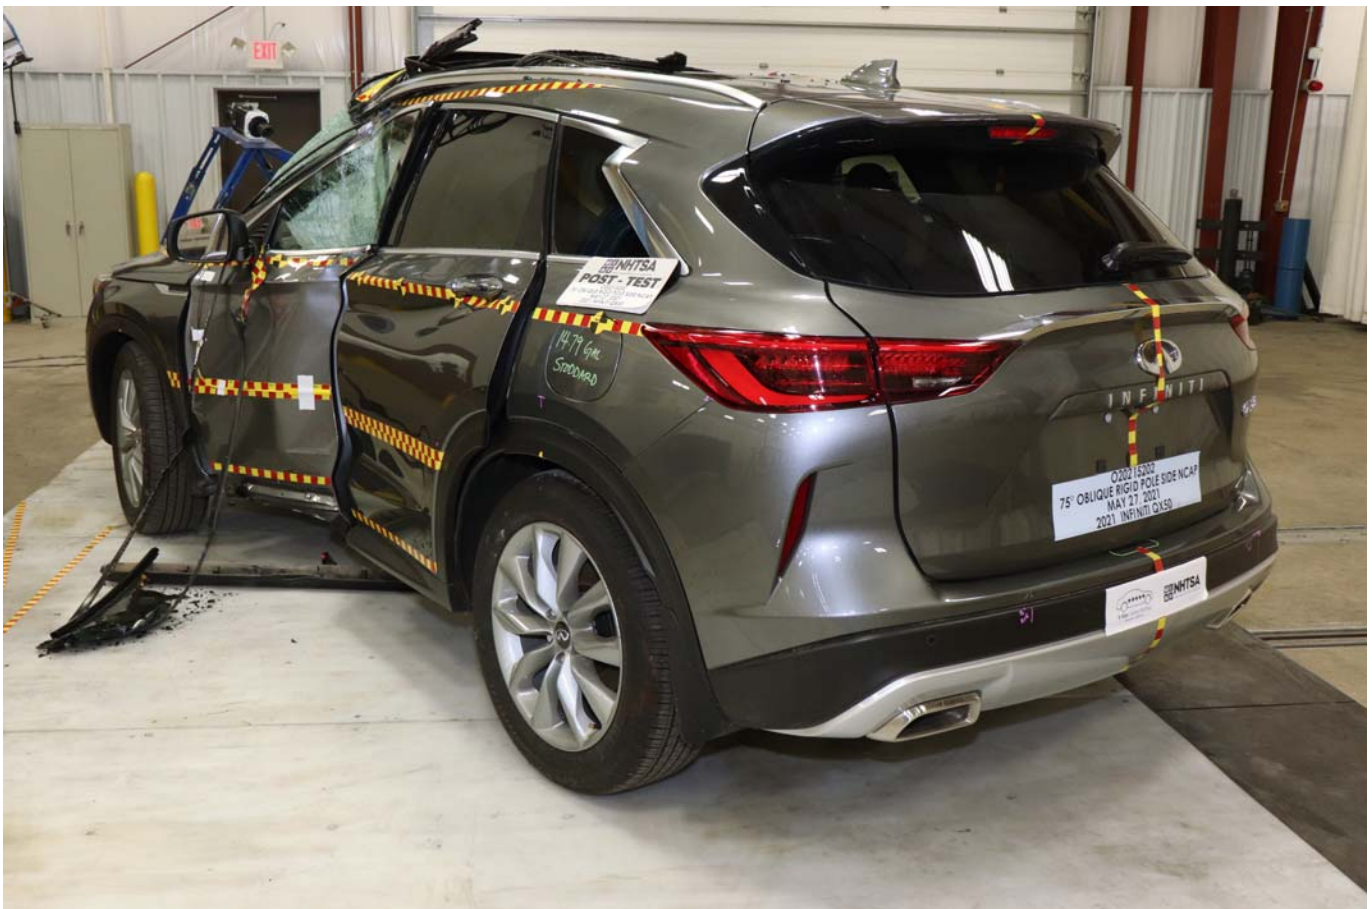
Photo No. 010 - Post-Test Left Rear Three-Quarter View of Test Vehicle

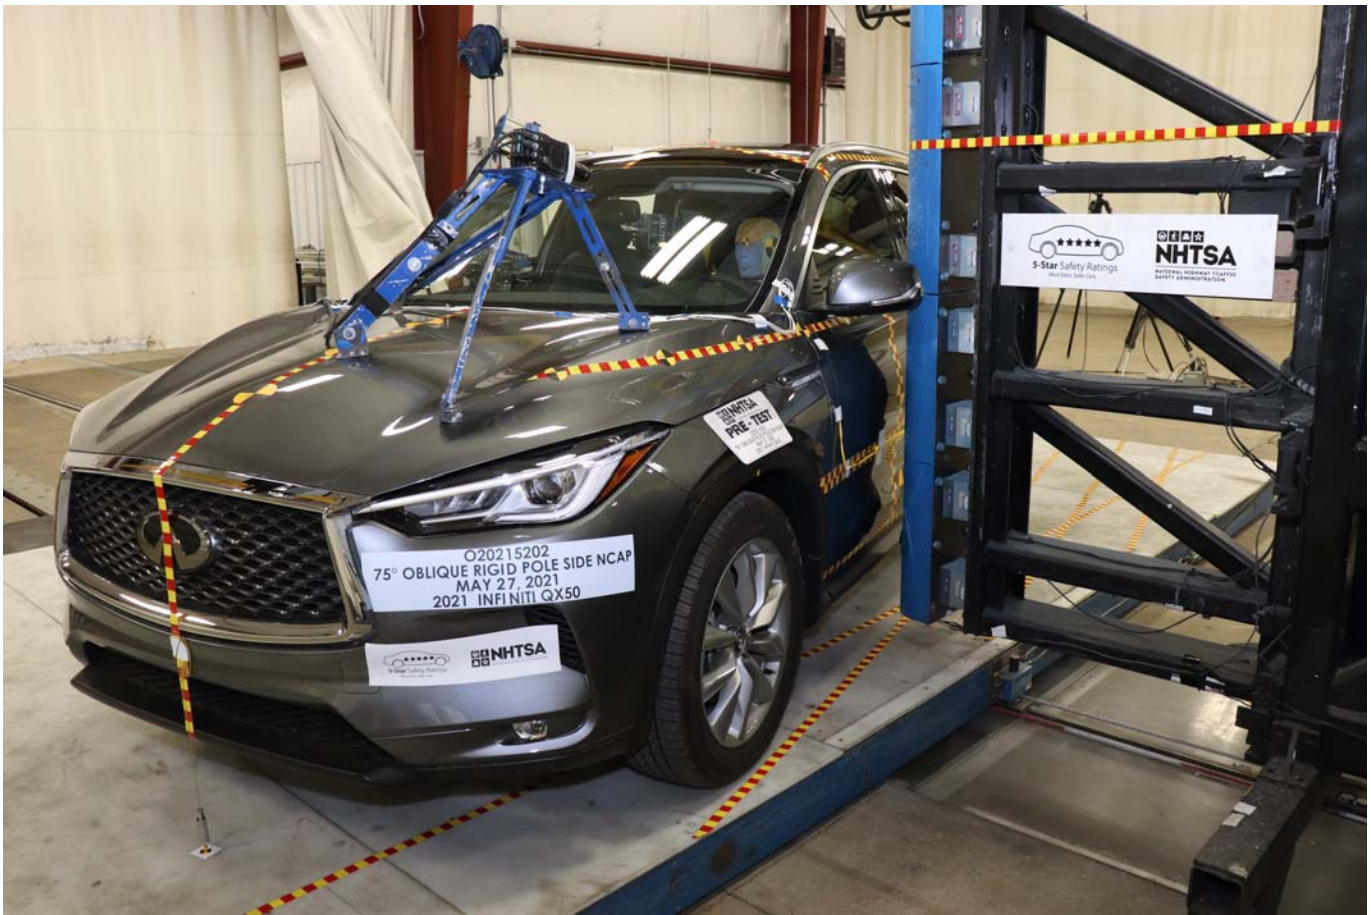
Photo No. 017 - Pre-Test Left Side View of Pole Positioned Against Side of Vehicle

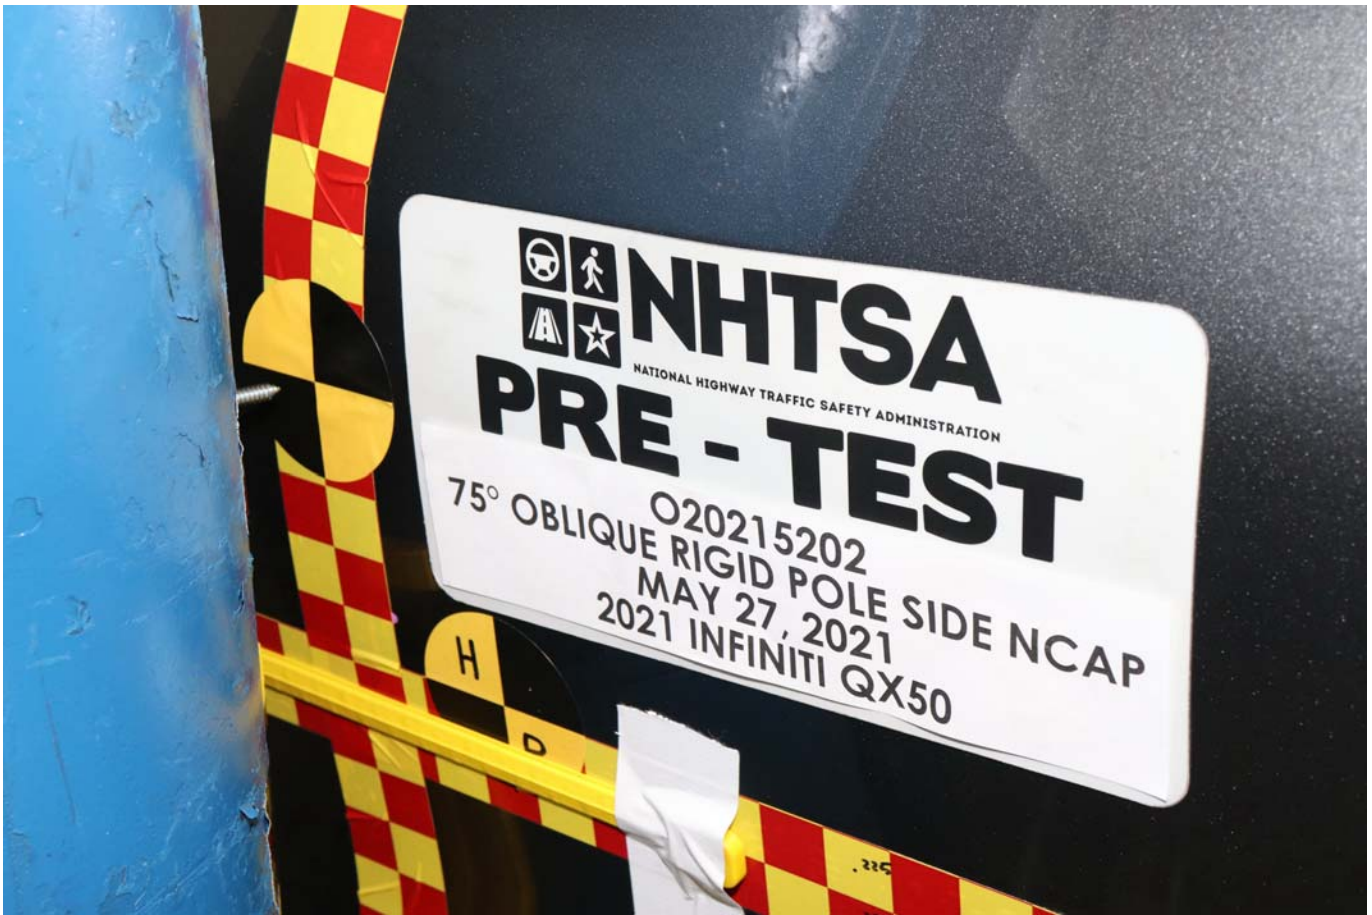
Photo No. 019 - Pre-Test Close-Up View of Impact Point Target

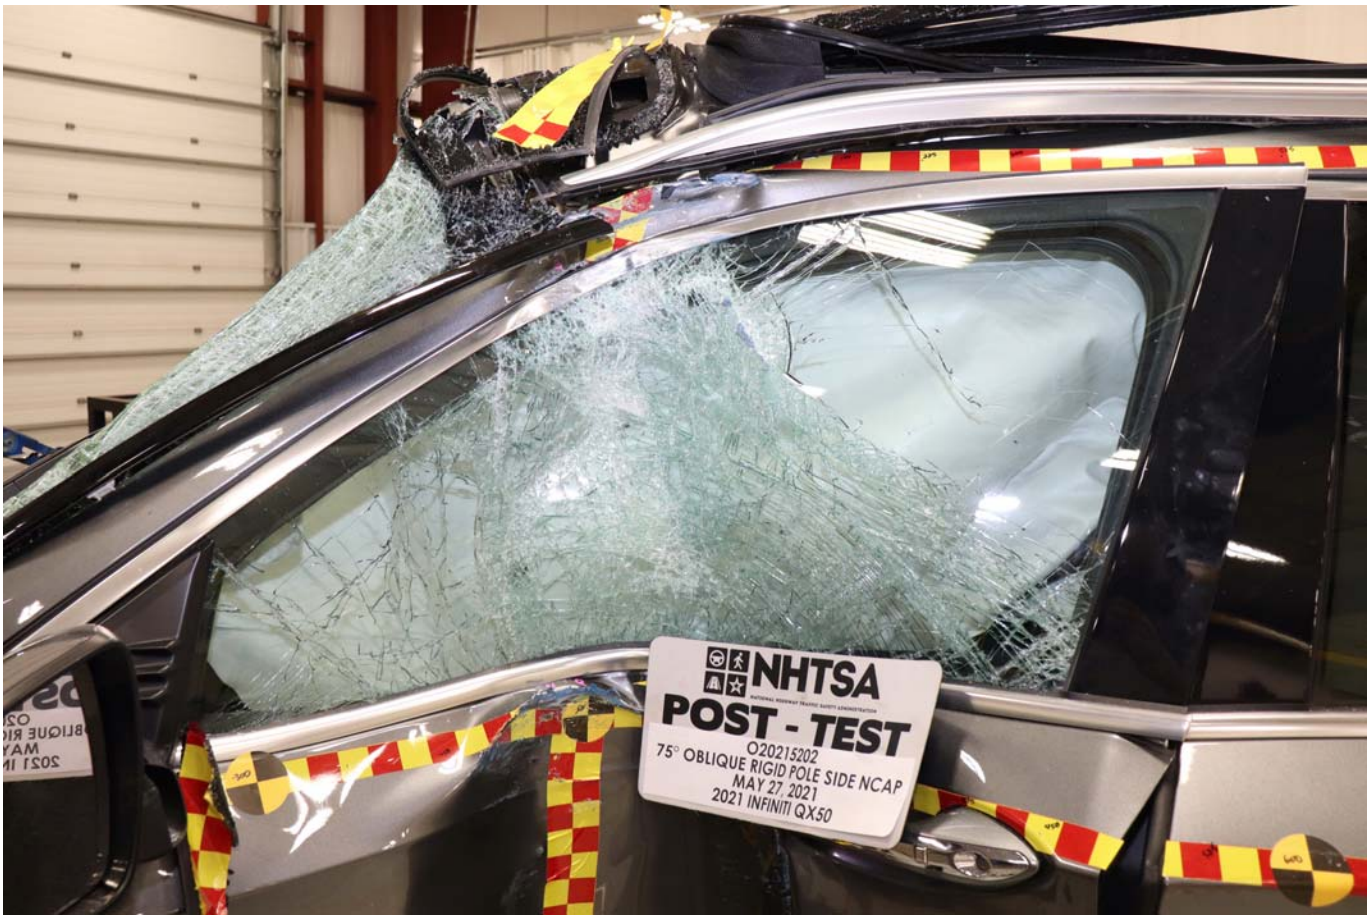
Photo No. 025 - Post-Test Left Side View of Dummy Shoulder and Door Top View

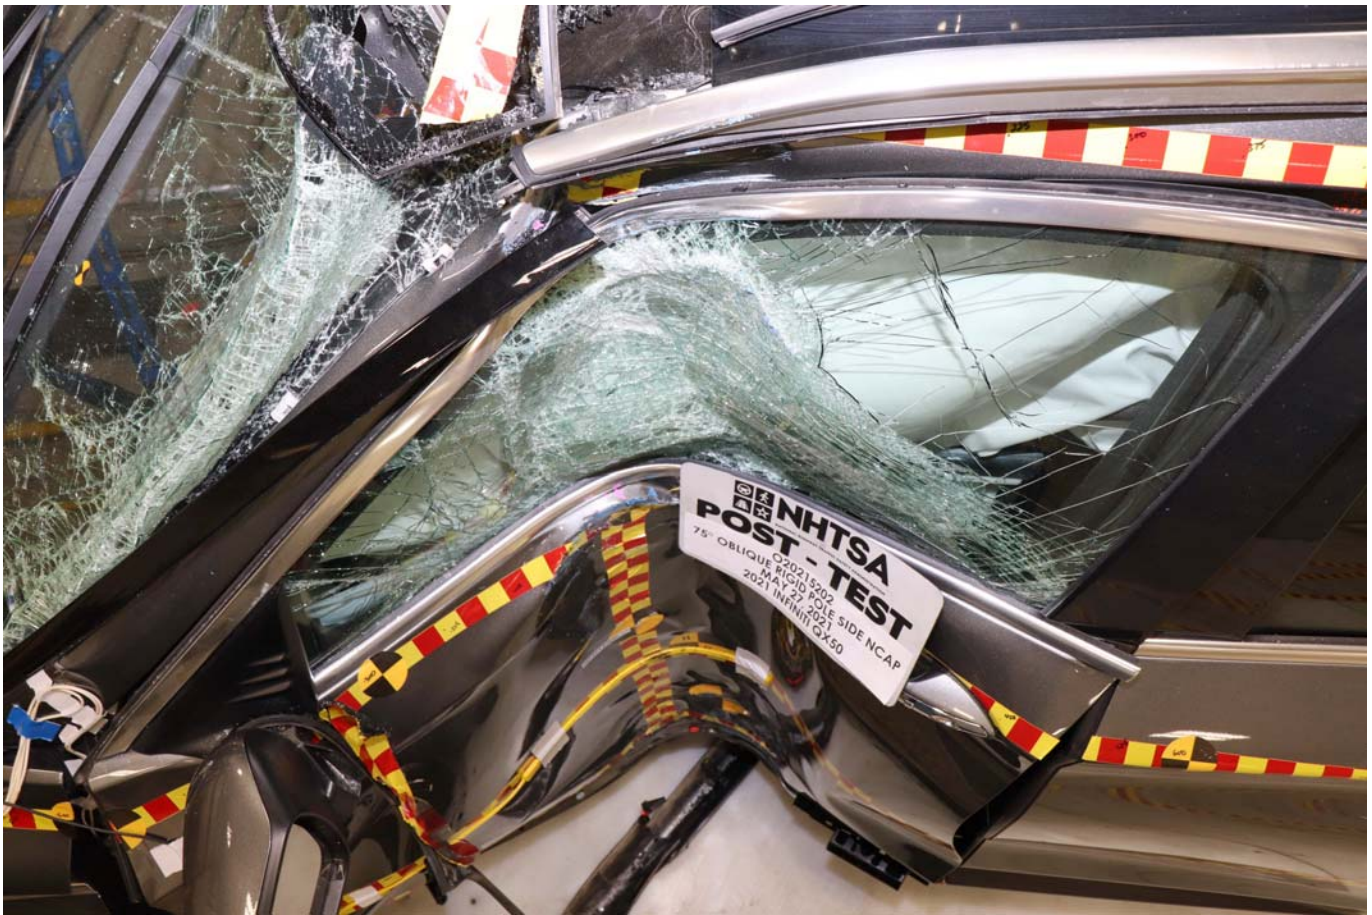
Photo No. 041 - Post-Test Dummy and Door Clearance View

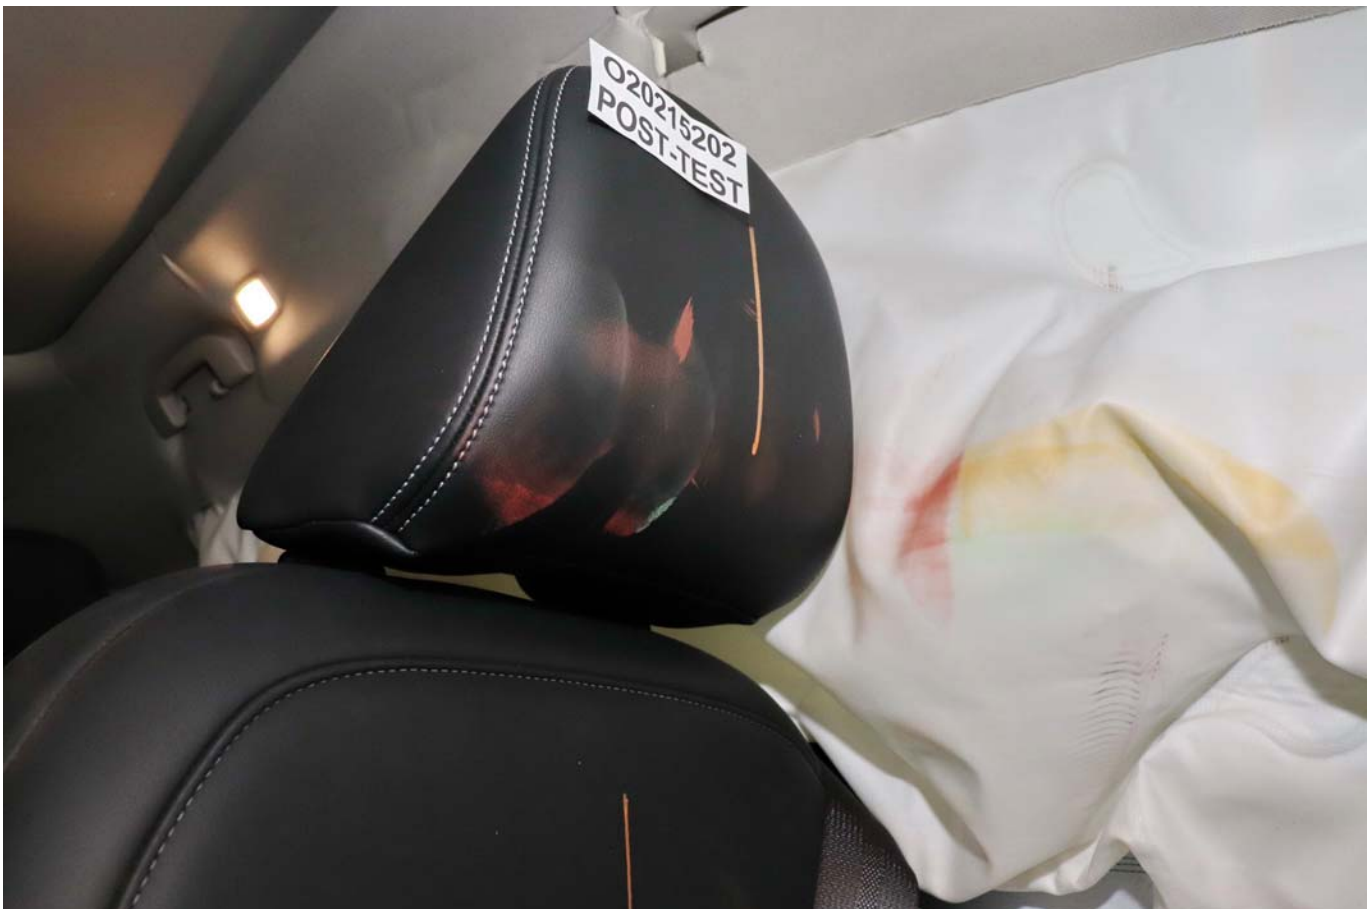
Photo No. 046 - Post-Test Dummy Close-Up Head Contact with Vehicle Interior View

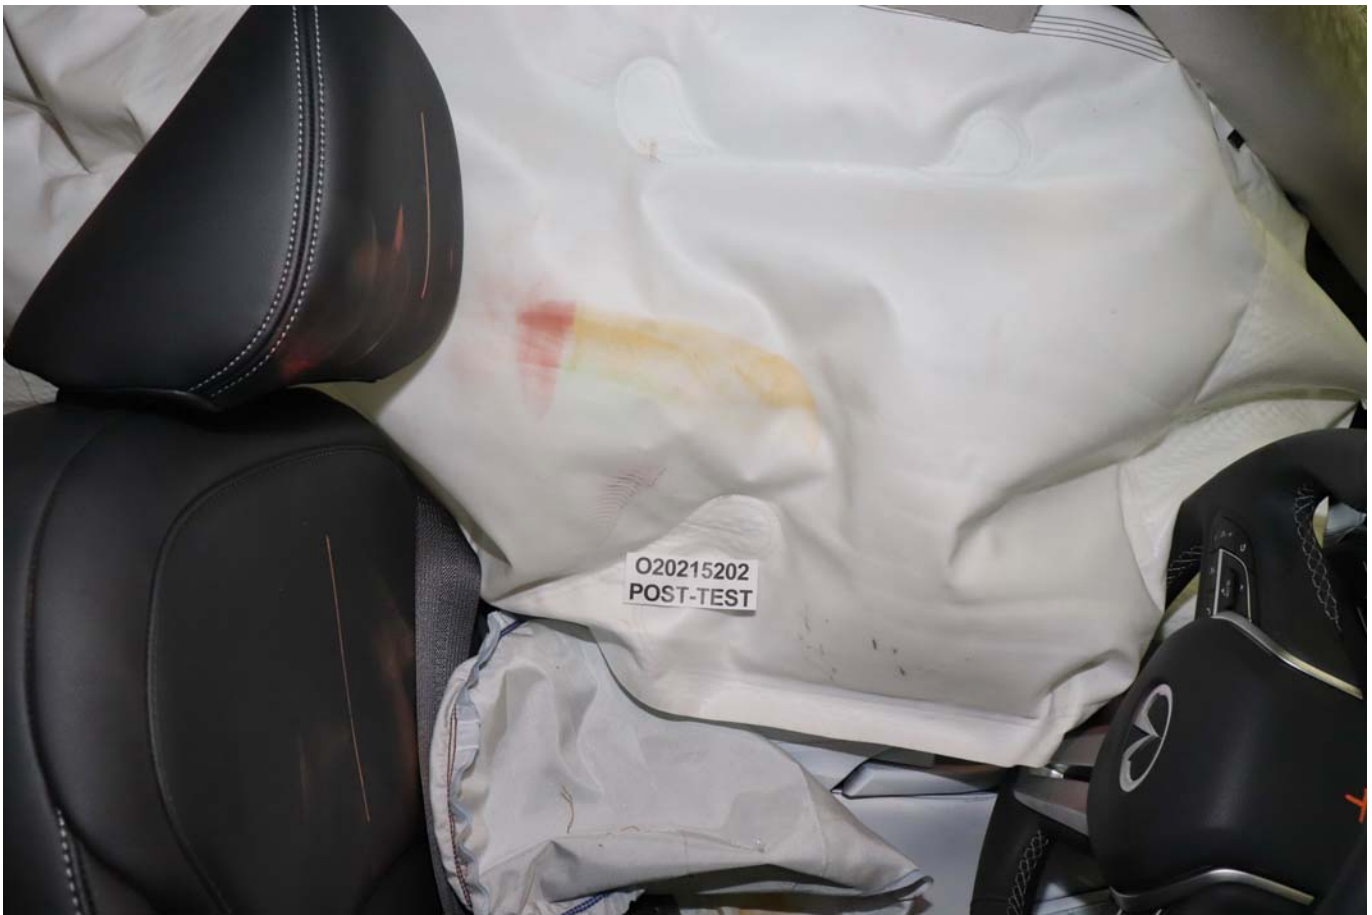
Photo No. 047 - Post-Test Dummy Close-Up Head Contact with Side Air Bag View

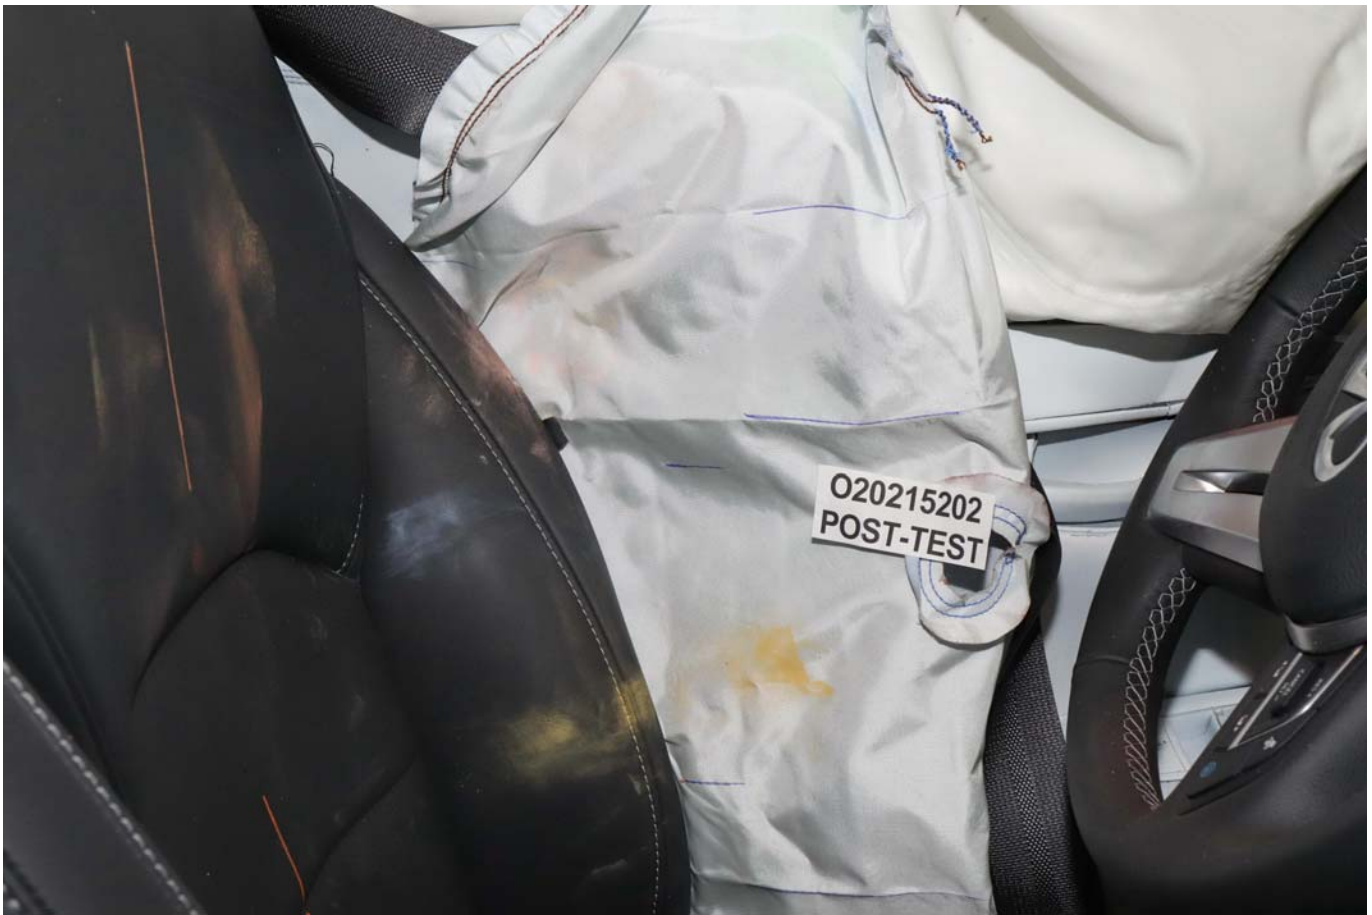
Photo No. 049 - Post-Test Dummy Close-Up Torso Contact with Side Air Bag View

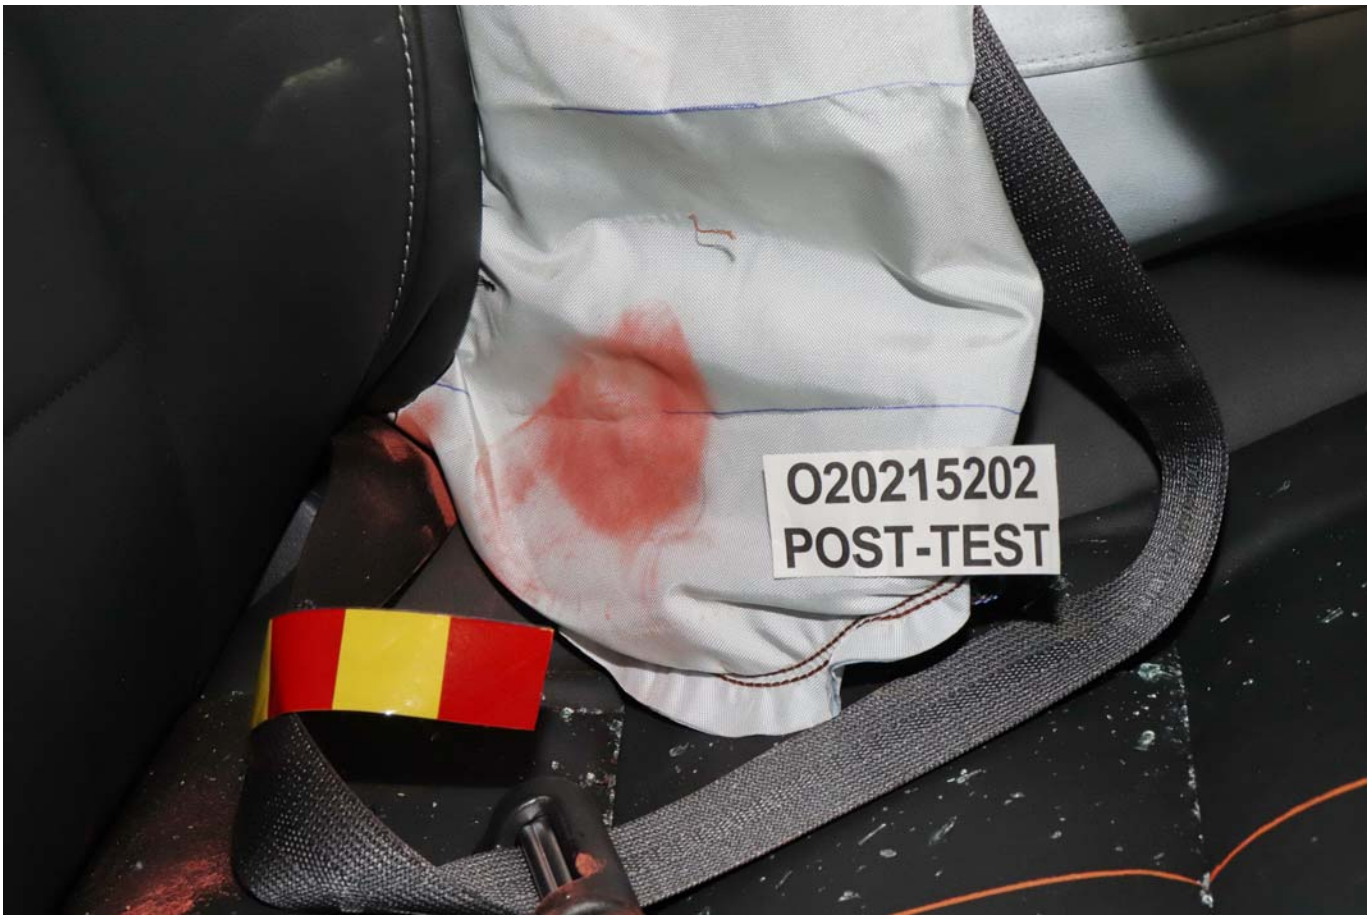
Photo No. 051 - Post-Test Dummy Close-Up Pelvis Contact with Side Air Bag View

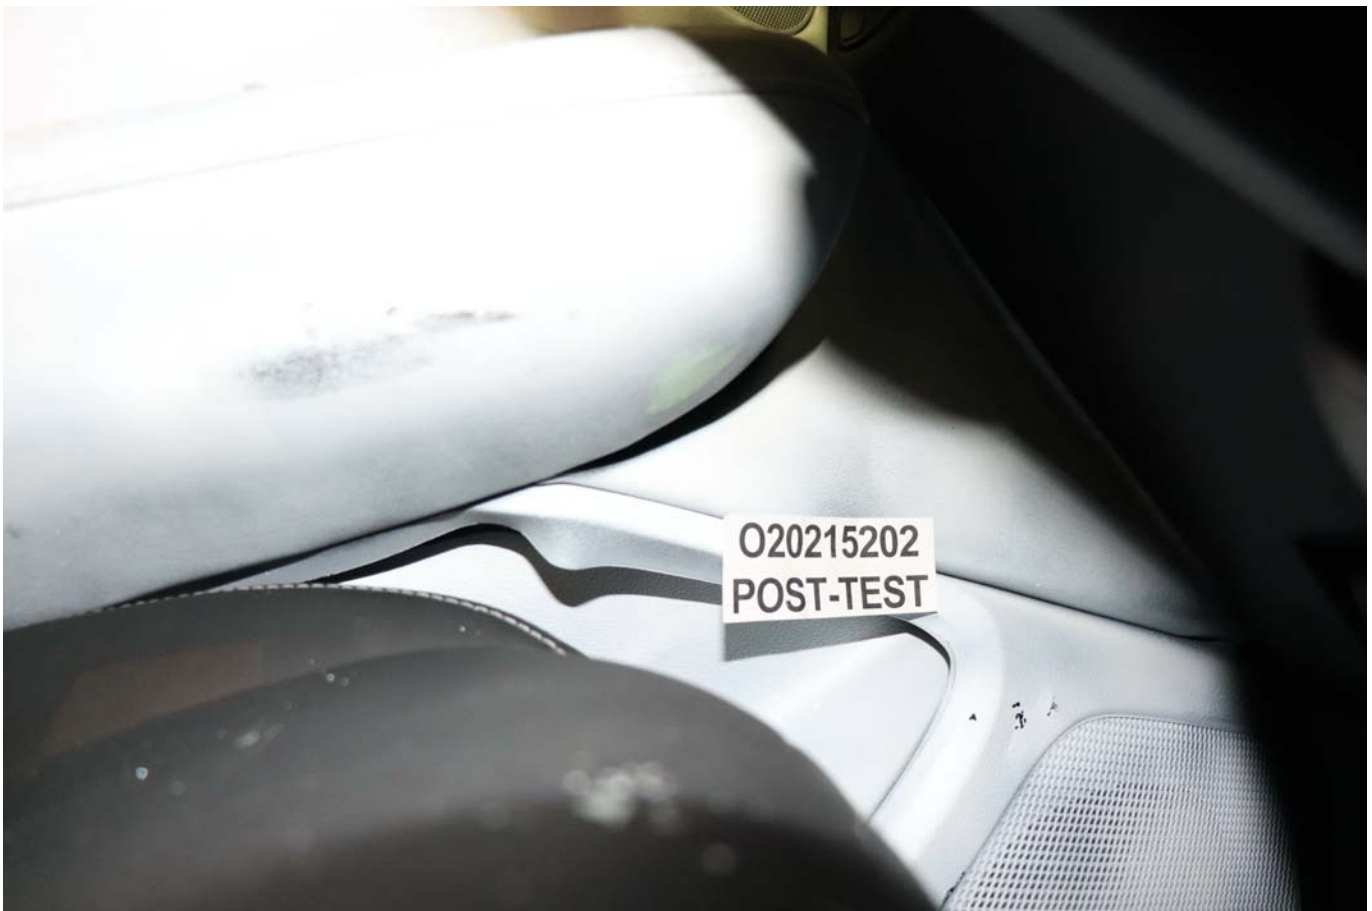
Photo No. 052 - Post-Test Dummy Close-Up Knee Contact with Vehicle Interior View

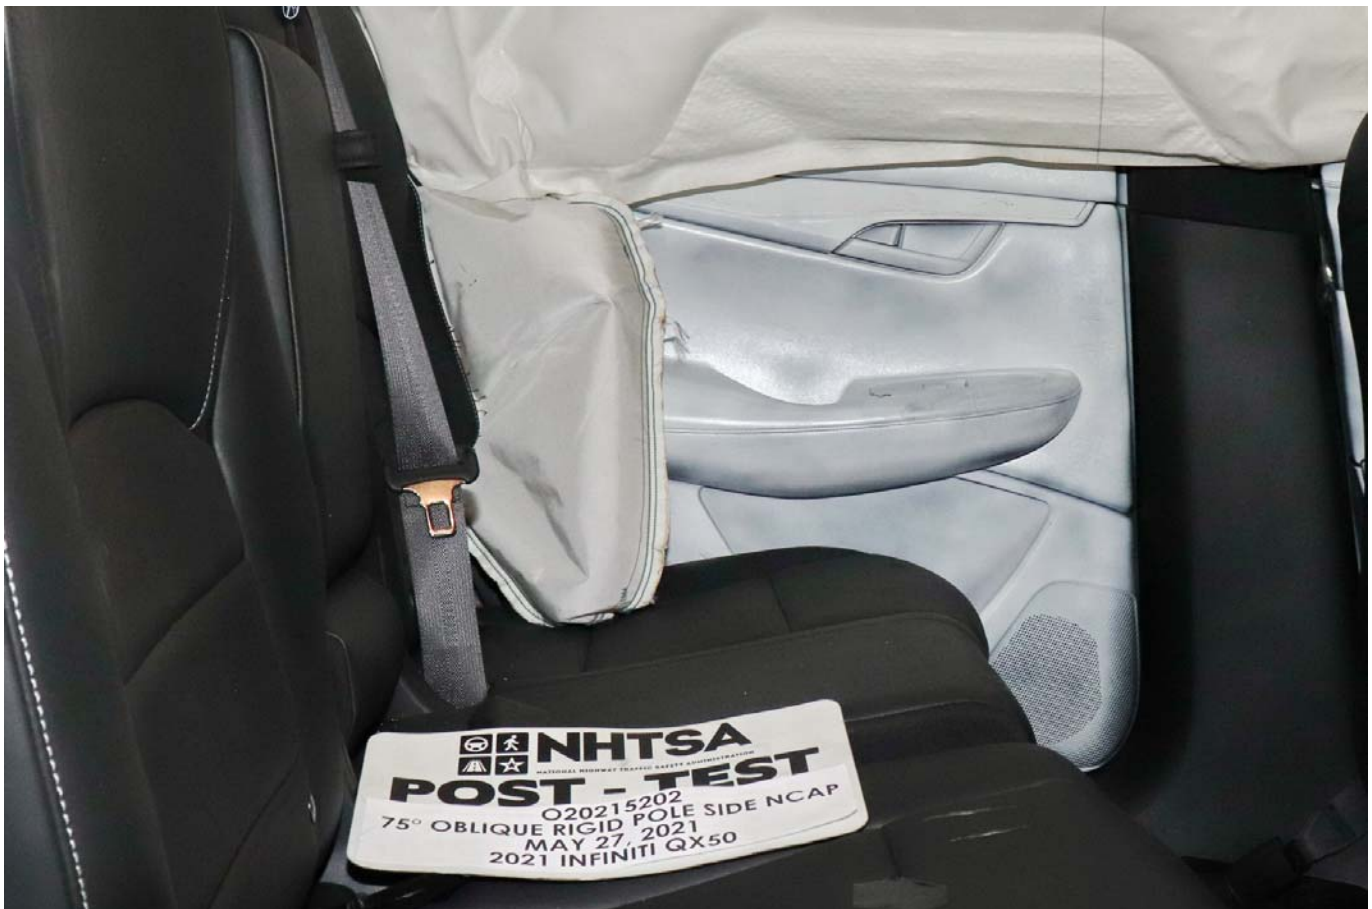
Photo No. 054 - Post-Test Inner Rear Passenger Torso Air Bag Deployment View

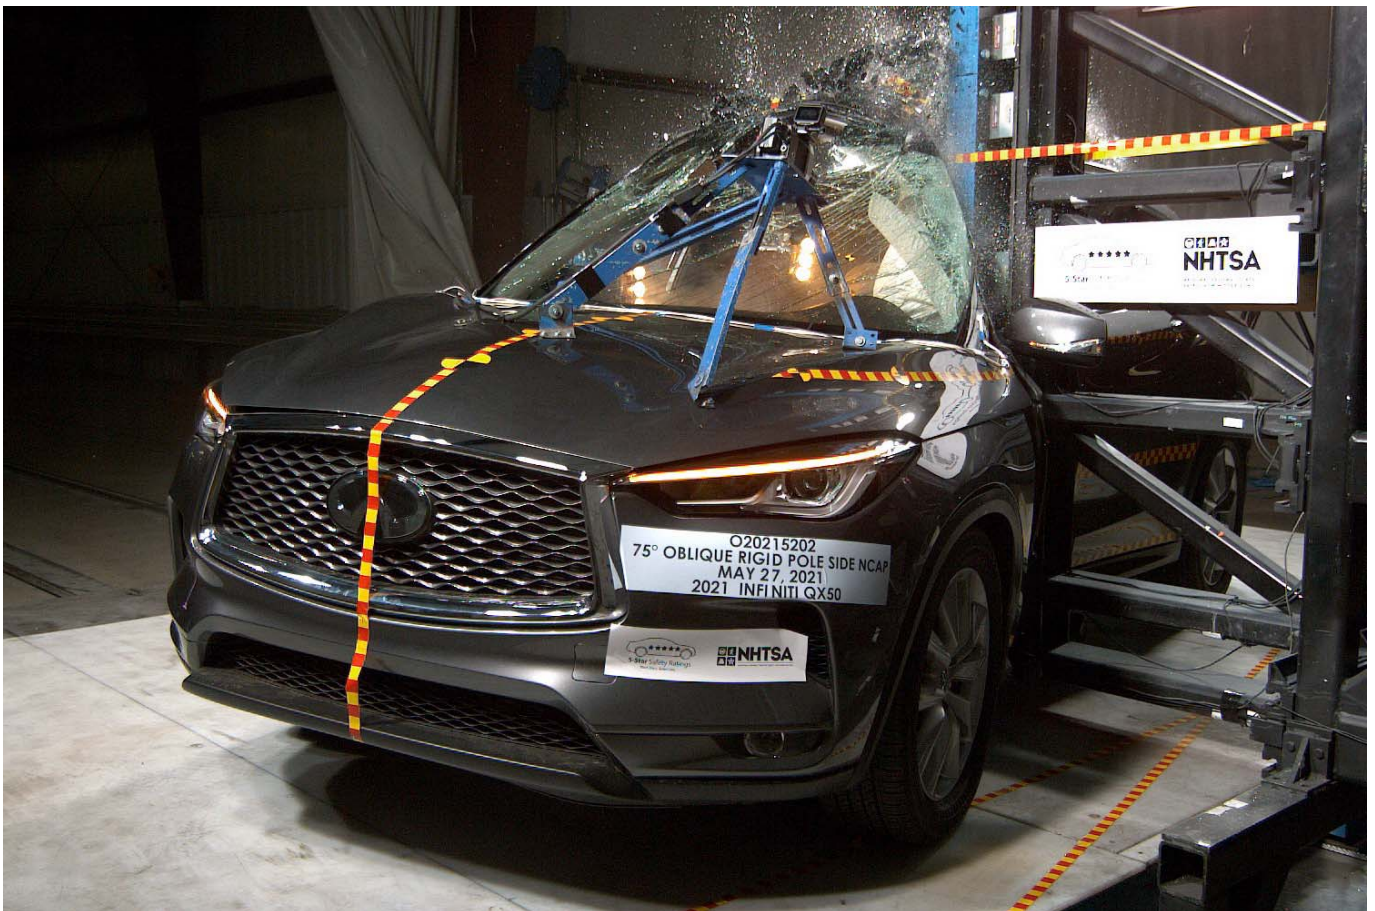
Photo No. 070 - Impact Event

A rigid pole side impact test was conducted on a 2021 Infiniti QX50 LUXE 5-Door SUV. The subject vehicle was towed into the rigid pole at an angle of 75° and a velocity of 32.27 km/h. The test was conducted by MGA Research Corporation in Burlington, Wisconsin on May 27, 2021. Pre-test and post-test photographs of the test vehicle and side impact dummy (SID-IIs) are included in Appendix A of this report.
