REPORT NUMBER: SideNCAPMDB-KAR-21-012

**NEW CAR ASSESSMENT PROGRAM (NCAP)
MOVING DEFORMABLE BARRIER SIDE IMPACT TEST**

**HYUNDAI MOTOR COMPANY
2021 GENESIS G80 4-DOOR SEDAN**

NHTSA No: O20214214

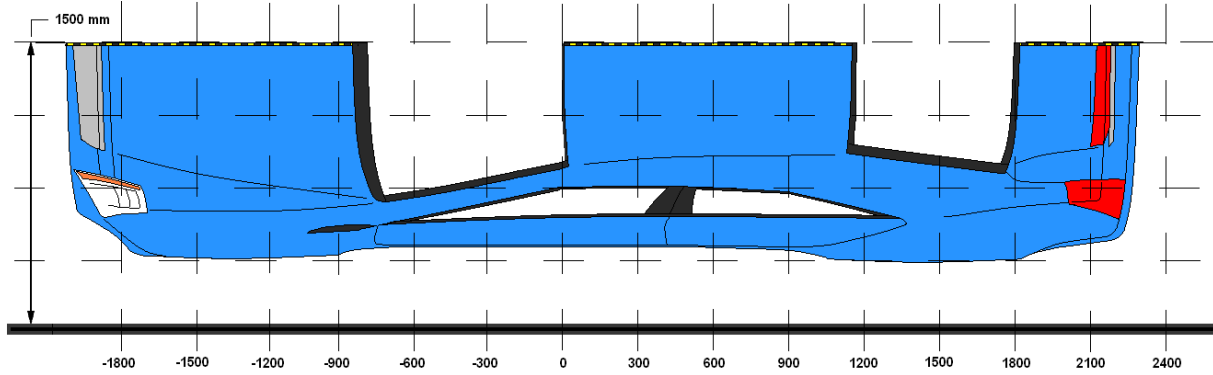
VEHICLE AND MDB DAMAGE PROFILE DISTANCES

VEHICLE DAMAGE PROFILE DISTANCES

DPD	Distance From Impact Point (mm)	Level	Pre-Test (mm)	Post-Test (mm)	Crush (mm)
1	2700	4	595	599	4
2	2100	4	592	616	24
3	1500	2	584	712	128
4	1050	3	561	665	104
5	450	2	581	670	89
6	-150	3	551	554	3

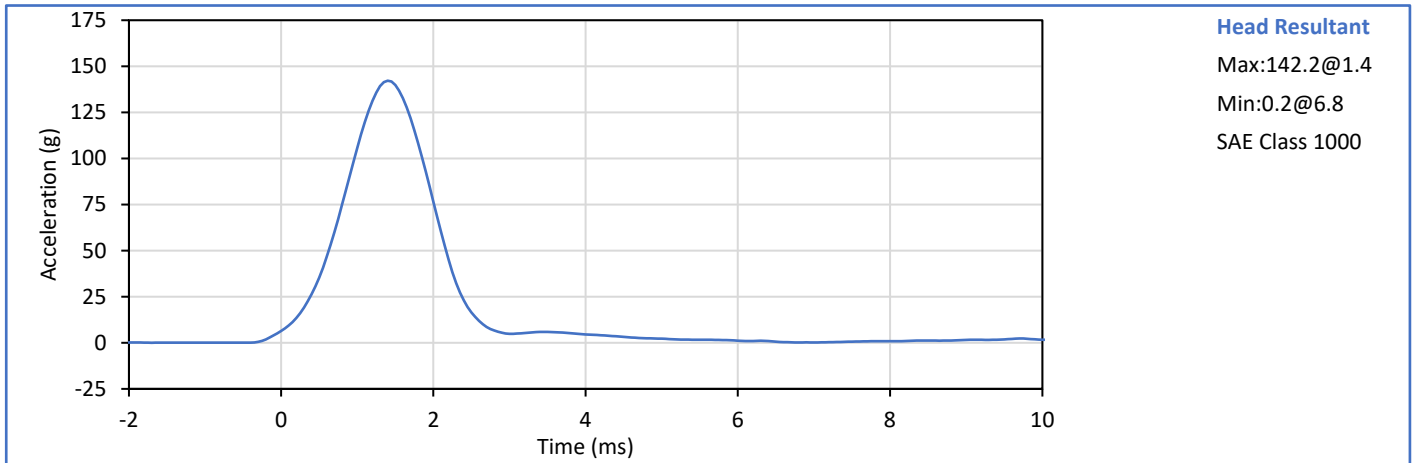
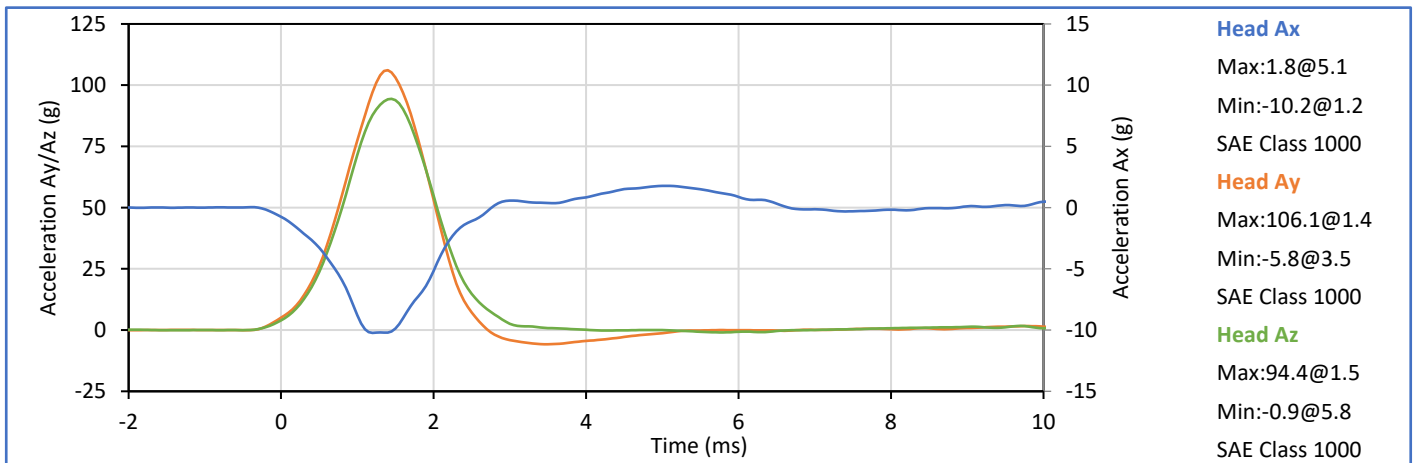
Tested Parameter	Units	Spec. Low	Spec. High	Result	Pass/Fail
Laboratory Temperature	°C	18.9	25.6	21.1	Pass
Laboratory Relative Humidity	%	10	70	44	Pass
Peak Resultant Acceleration	g	125.0	155.0	142.2	Pass
Peak Head Ax	g	-15.0	15.0	1.8	Pass
Oscillations After Main Pulse	%	0.0	15.0	1.6	Pass
Is Acceleration Unimodal?	Yes/No	Yes		Yes	Pass
Overall Test Results					Pass

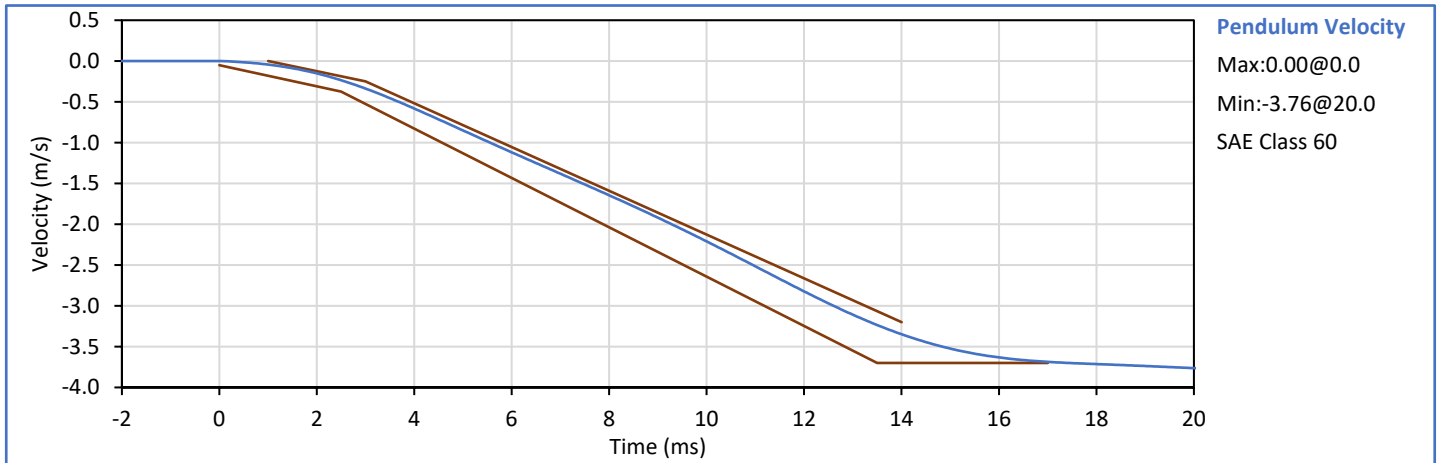
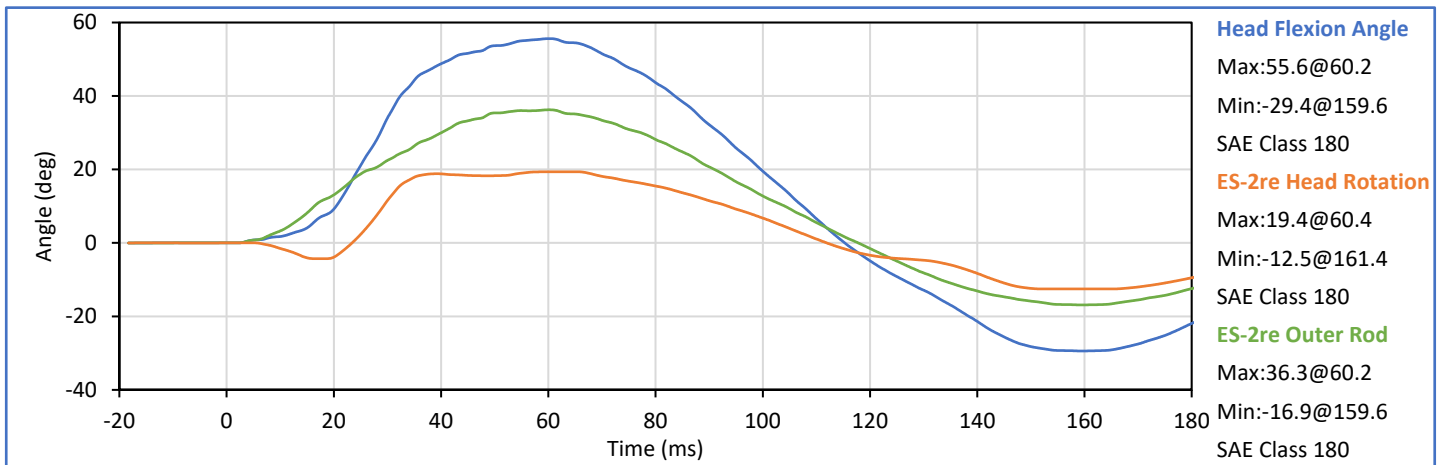
Tested Parameter	Units	Spec. Low	Spec. High	Result	Pass/Fail
Laboratory Temperature	°C	20.6	22.2	21.1	Pass
Laboratory Relative Humidity	%	10	70	43	Pass
Pendulum Velocity	m/s	3.30	3.50	3.49	Pass
Peak Headform Flexion	deg	49.0	59.0	55.6	Pass
Time of Peak Headform Flexion	ms	54.0	66.0	60.2	Pass
Flexion Decay (Peak to zero)	ms	53.0	88.0	55.1	Pass
Overall Test Results					Pass

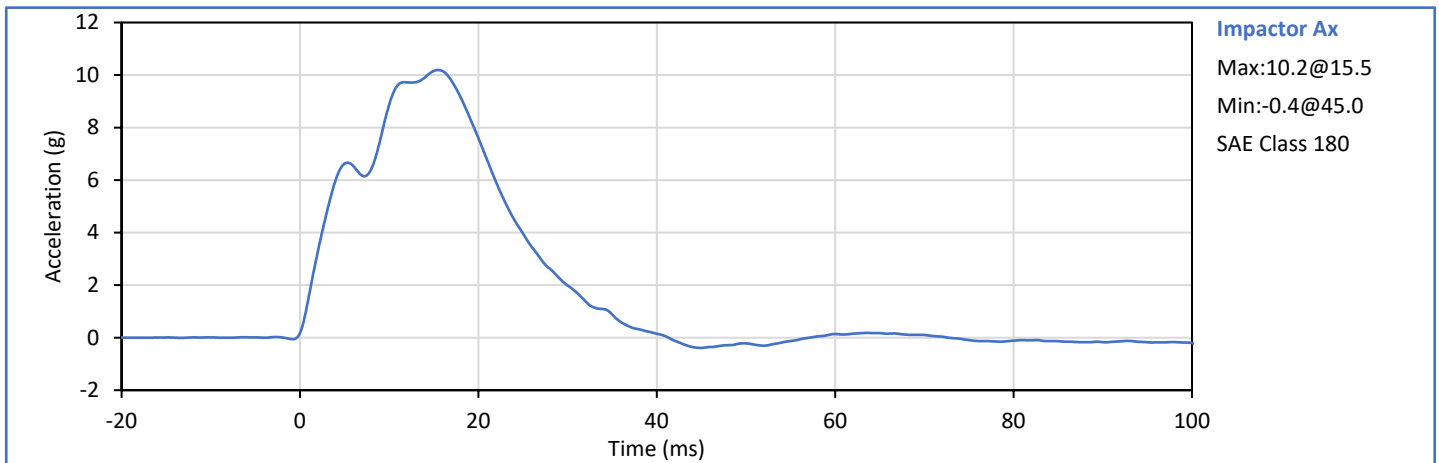
Tested Parameter	Units	Spec. Low	Spec. High	Result	Pass/Fail
Laboratory Temperature	°C	20.6	22.2	21.1	Pass
Laboratory Relative Humidity	%	10	70	32	Pass
Impactor Velocity	m/s	4.20	4.40	4.33	Pass
Peak Impactor Ax	g	7.5	10.5	10.2	Pass
Overall Test Results					Pass

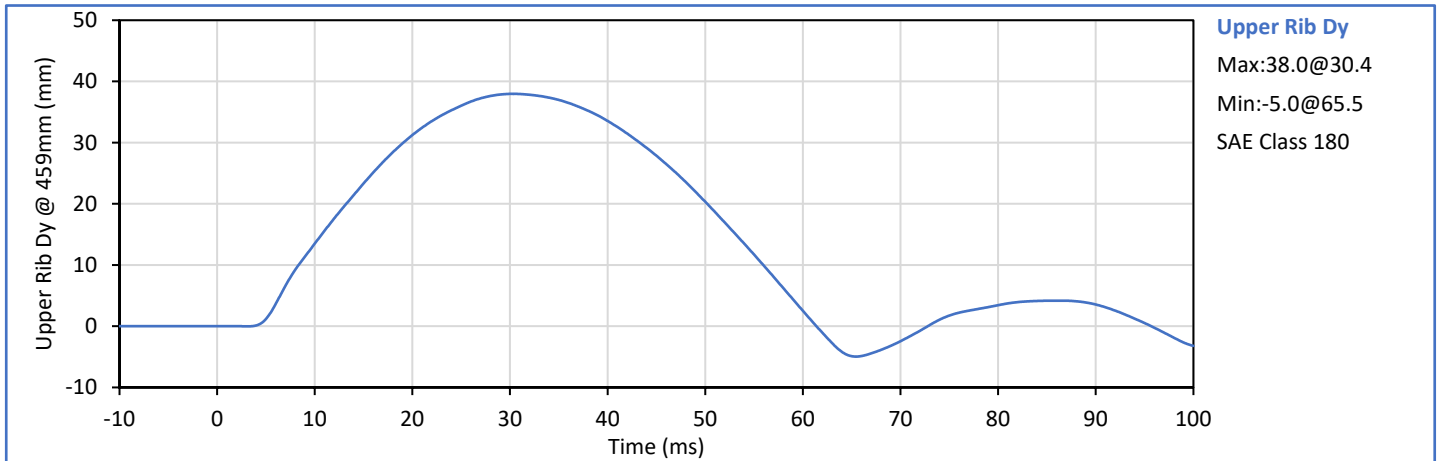
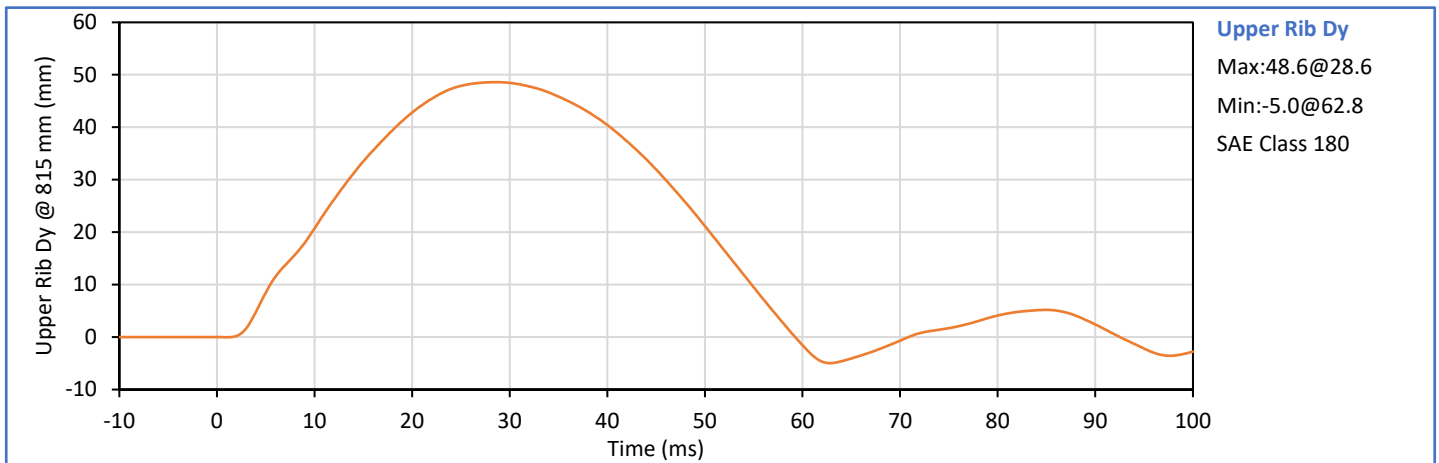
Tested Parameter	Units	Spec. Low	Spec. High	Result	Pass/Fail
Laboratory Temperature	°C	20.6	22.2	21.1	Pass
Laboratory Relative Humidity	%	10	70	34	Pass
Upper Rib Dy @ 459mm	mm	36.0	40.0	38.0	Pass
Upper Rib Dy @ 815mm	mm	46.0	51.0	48.6	Pass
Overall Test Results					Pass

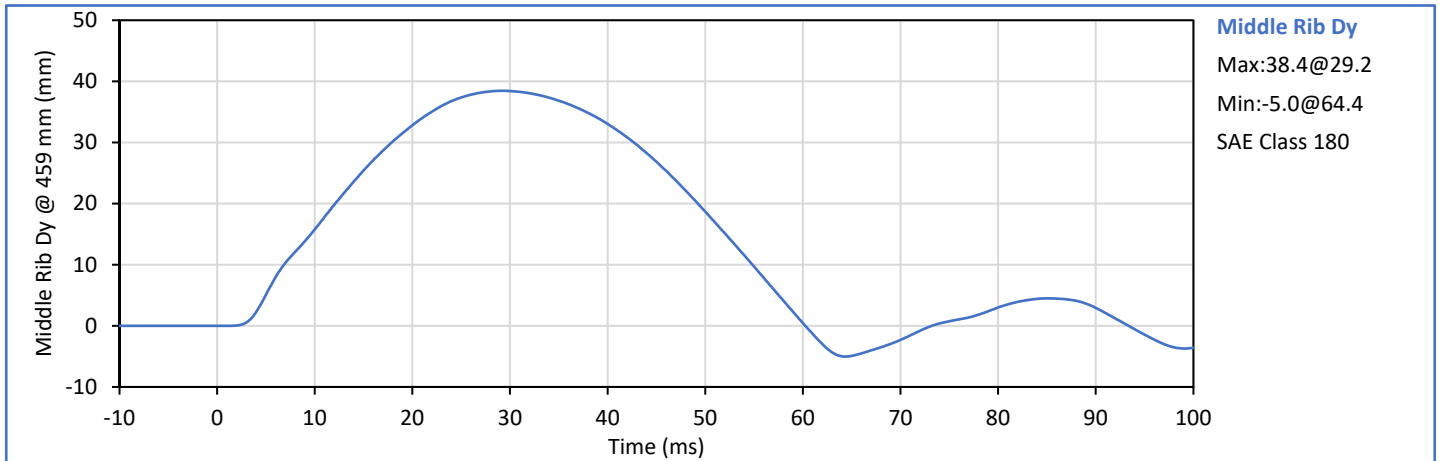
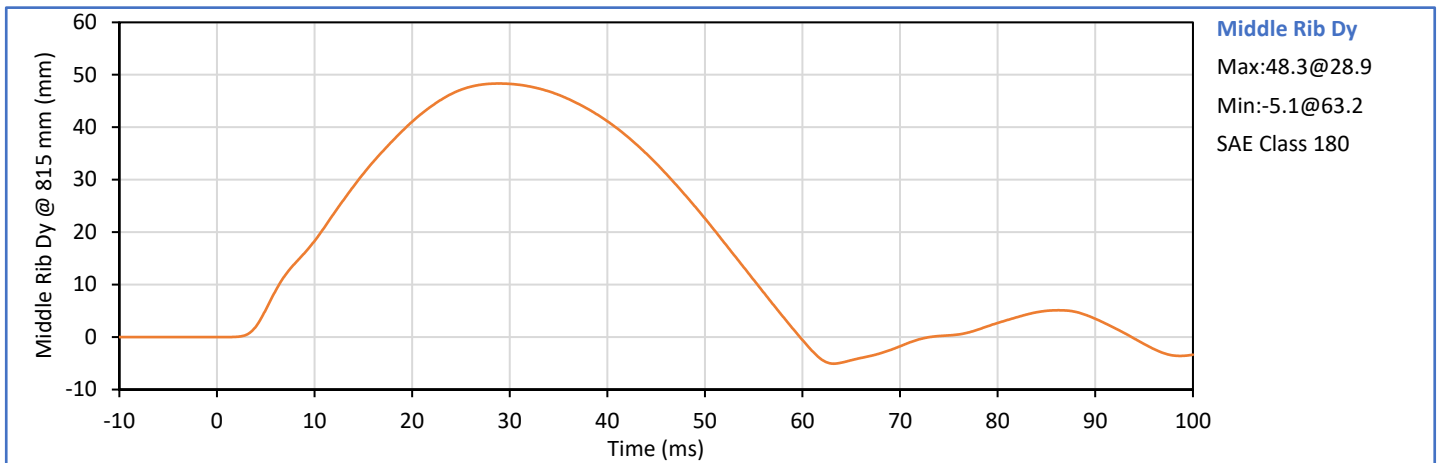
Tested Parameter	Units	Spec. Low	Spec. High	Result	Pass/Fail
Laboratory Temperature	°C	20.6	22.2	21.1	Pass
Laboratory Relative Humidity	%	10	70	34	Pass
Middle Rib Dy @ 459mm	mm	36.0	40.0	38.4	Pass
Middle Rib Dy @ 815mm	mm	46.0	51.0	48.3	Pass
Overall Test Results					Pass

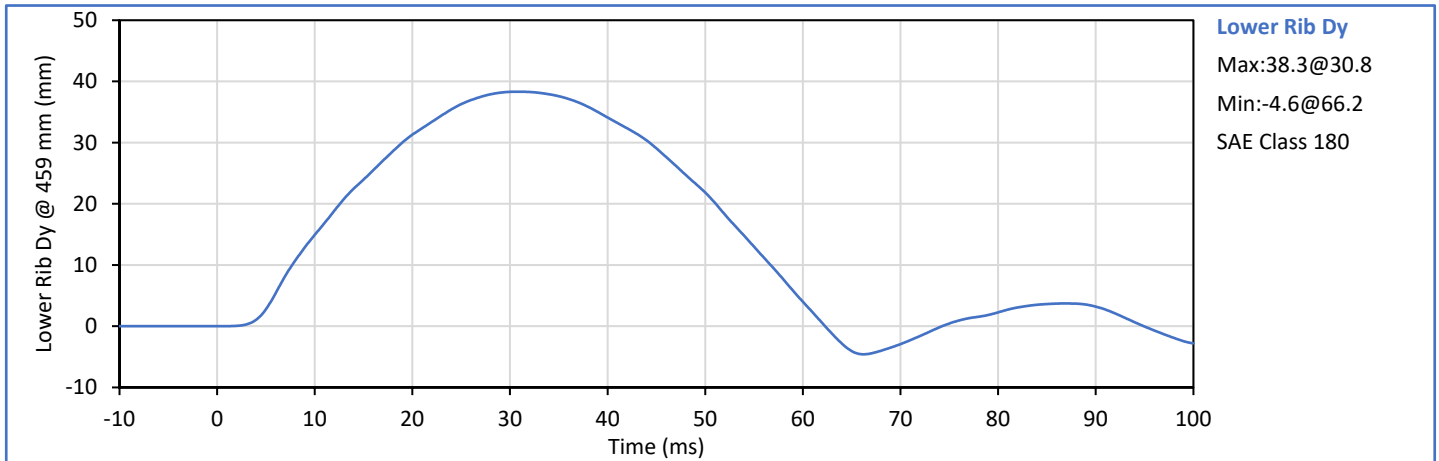
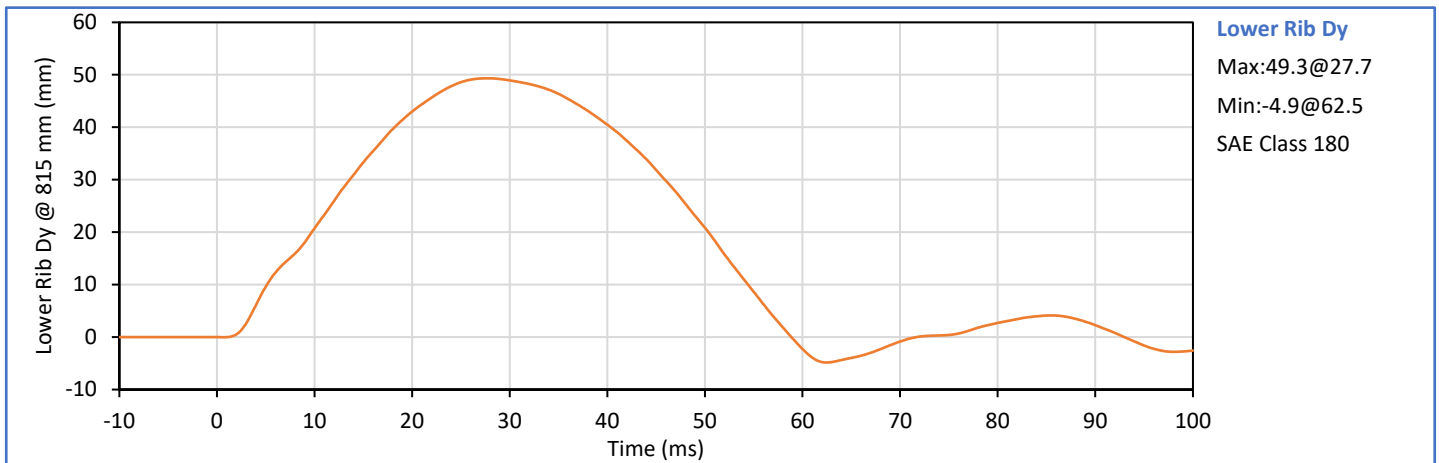
Tested Parameter	Units	Spec. Low	Spec. High	Result	Pass/Fail
Laboratory Temperature	°C	20.6	22.2	21.1	Pass
Laboratory Relative Humidity	%	10	70	34	Pass
Lower Rib Dy @ 459mm	mm	36.0	40.0	38.3	Pass
Lower Rib Dy @ 815mm	mm	46.0	51.0	49.3	Pass
Overall Test Results					Pass

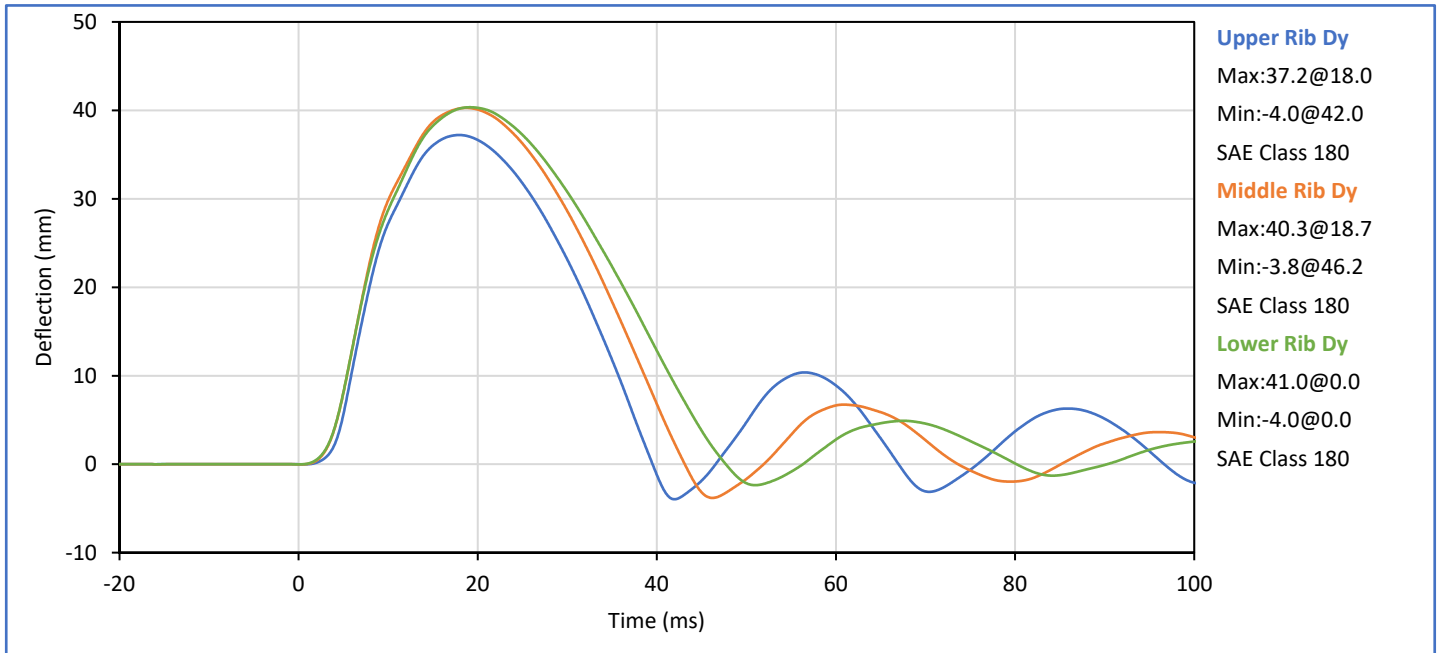
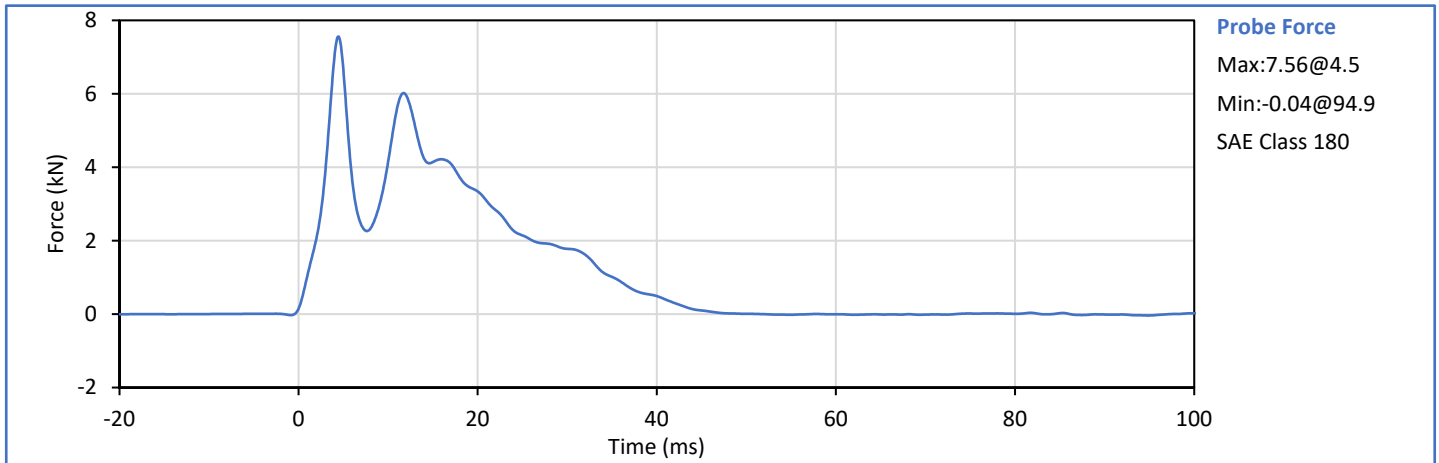
Tested Parameter	Units	Spec. Low	Spec. High	Result	Pass/Fail
Laboratory Temperature	°C	20.6	22.2	21.7	Pass
Laboratory Relative Humidity	%	10	70	32	Pass
Impactor Velocity	m/s	5.40	5.60	5.52	Pass
Peak Upper Rib Dy	mm	34.0	41.0	37.2	Pass
Peak Middle Rib Dy	mm	37.0	45.0	40.3	Pass
Peak Lower Rib Dy	mm	37.0	44.0	40.4	Pass
Peak Impactor Force After 6 ms	kN	5.10	6.20	6.02	Pass
Overall Test Results					Pass

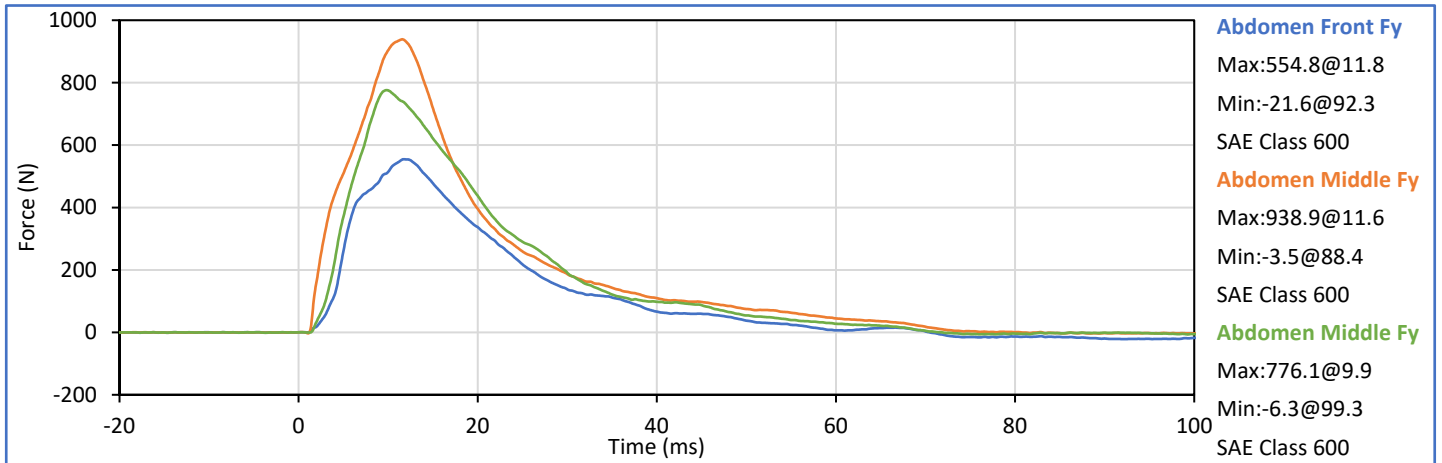
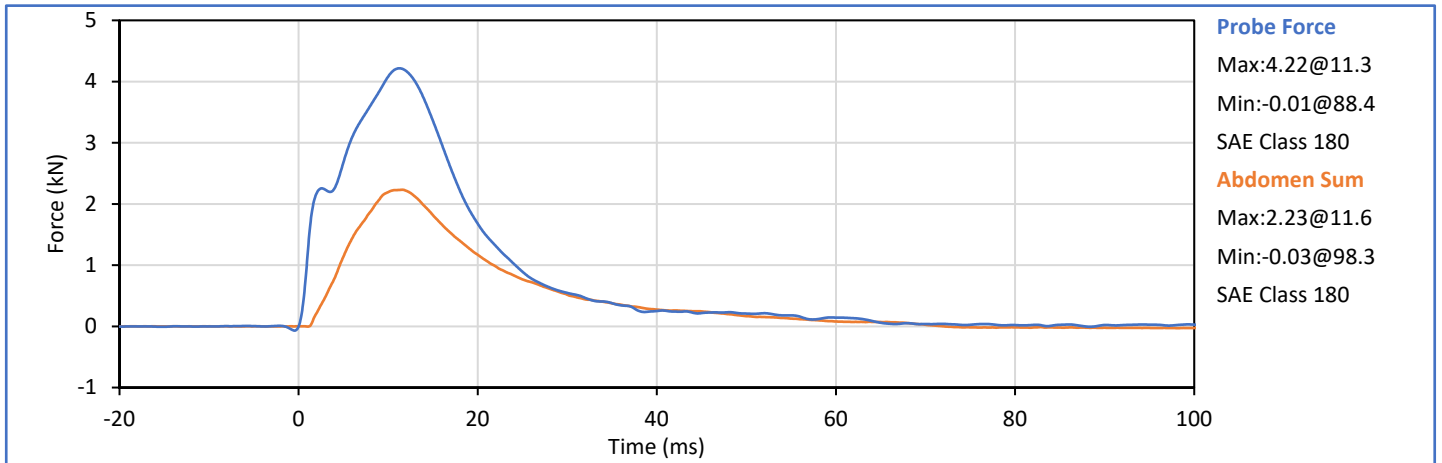
Tested Parameter	Units	Spec. Low	Spec. High	Result	Pass/Fail
Laboratory Temperature	°C	20.6	22.2	21.1	Pass
Laboratory Relative Humidity	%	10	70	33	Pass
Impactor Velocity	m/s	3.90	4.10	4.01	Pass
Peak Impactor Force	kN	4.00	4.80	4.22	Pass
Time of Peak Impactor Force	ms	10.6	13.0	11.3	Pass
Sum of Abdomen Forces	kN	2.20	2.70	2.23	Pass
Time of Peak Sum Abdomen Force	ms	10.0	12.3	11.6	Pass
Overall Test Results					Pass

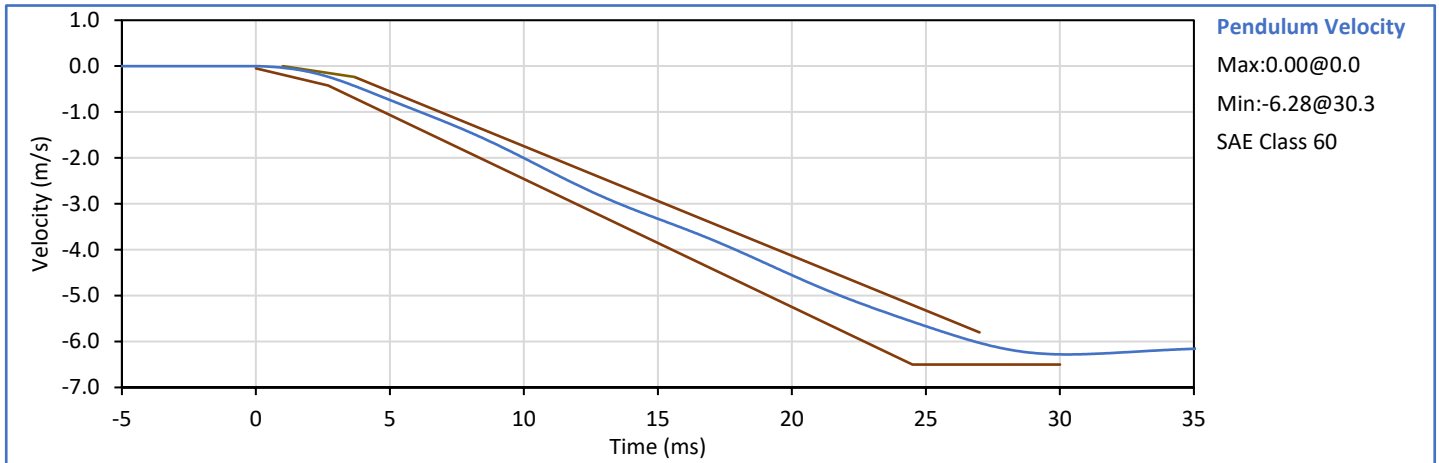
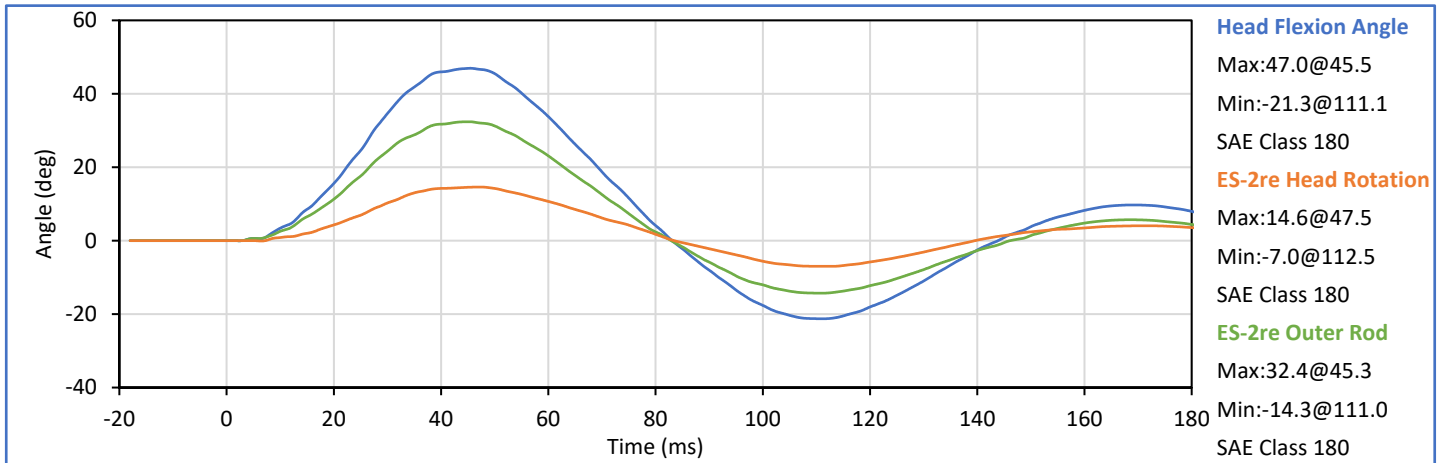
Tested Parameter	Units	Spec. Low	Spec. High	Result	Pass/Fail
Laboratory Temperature	°C	20.6	22.2	21.1	Pass
Laboratory Relative Humidity	%	10	70	43	Pass
Pendulum Velocity	m/s	5.95	6.15	6.08	Pass
Peak Headform Flexion	deg	45.0	55.0	47.0	Pass
Time of Peak Headform Flexion	ms	39.0	53.0	45.5	Pass
Flexion Decay (Peak to zero)	ms	37.0	57.0	37.7	Pass
Overall Test Results					Pass

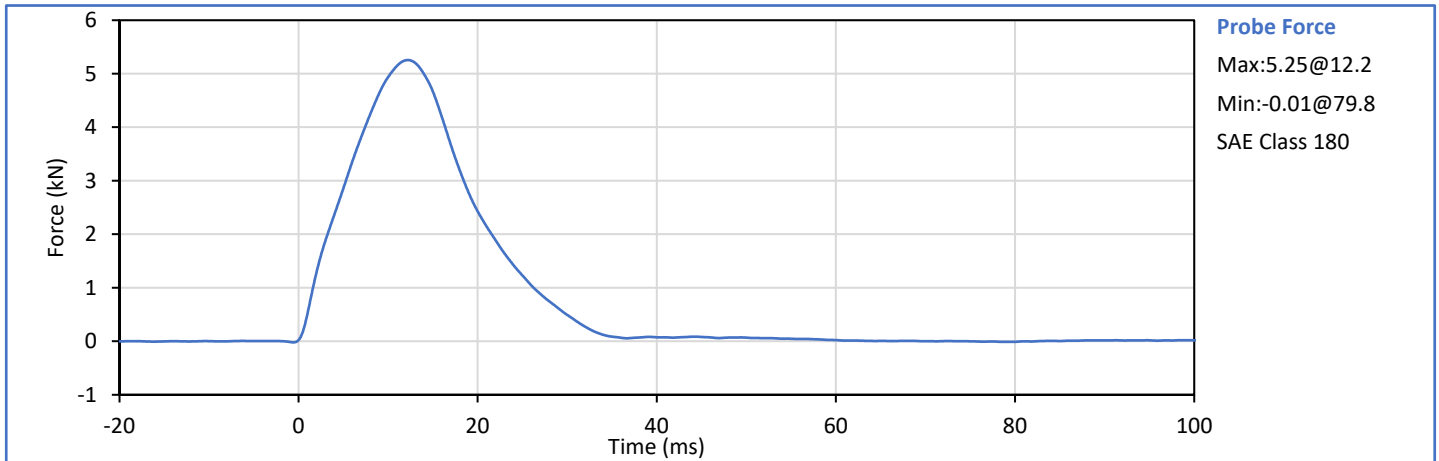
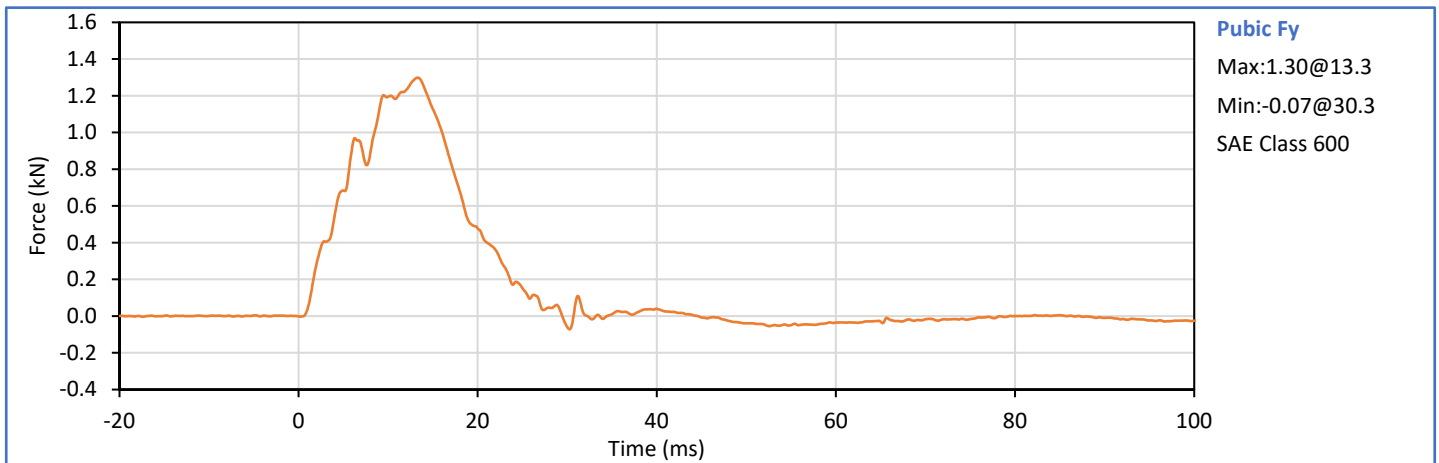
Tested Parameter	Units	Spec. Low	Spec. High	Result	Pass/Fail
Laboratory Temperature	°C	20.6	22.2	21.7	Pass
Laboratory Relative Humidity	%	10	70	33	Pass
Impactor Velocity	m/s	4.20	4.40	4.32	Pass
Peak Impactor Force	kN	4.70	5.40	5.25	Pass
Time of Peak Impactor Force	ms	11.8	16.1	12.2	Pass
Pubic Symphysis Fy	kN	1.23	1.59	1.30	Pass
Time of Peak Pubic Symphysis Fy	ms	12.2	17.0	13.3	Pass
Overall Test Results					Pass

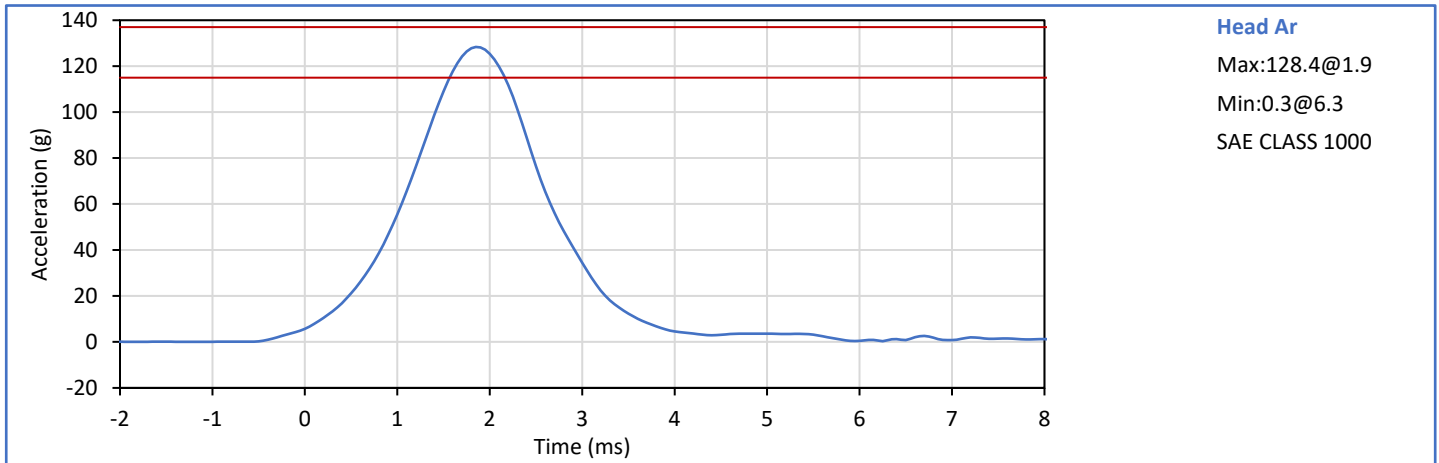
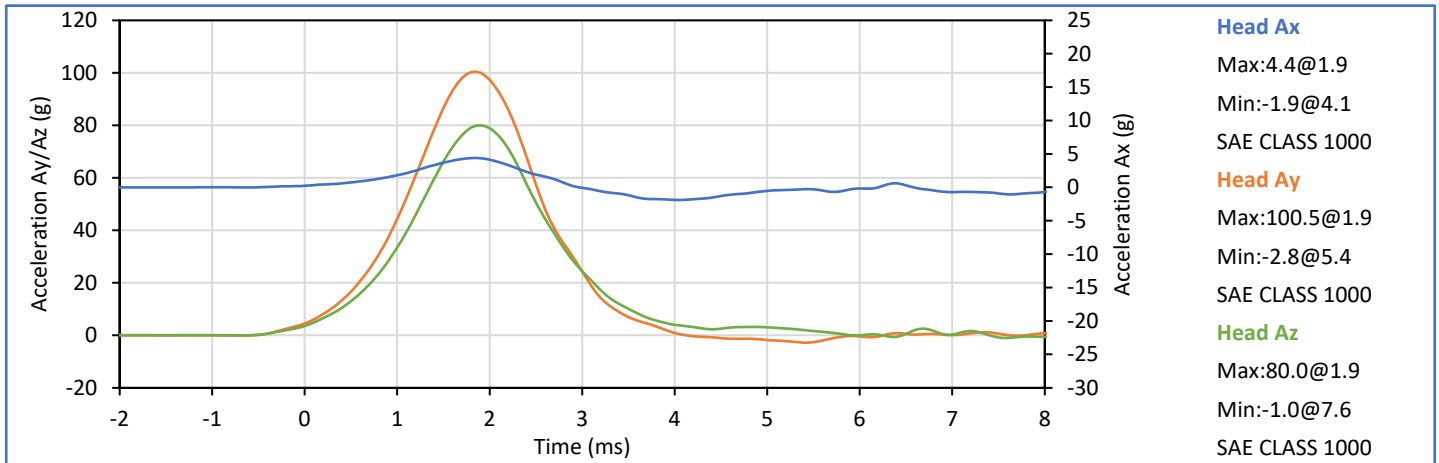
Tested Parameter	Units	Spec. Low	Spec. High	Result	Pass/Fail
Laboratory Temperature	°C	18.9	25.6	21.7	Pass
Laboratory Relative Humidity	%	10	70	43	Pass
Peak Resultant Acceleration	g	115.0	137.0	128.4	Pass
Peak Head Ax	g	-15.0	15.0	4.4	Pass
Oscillations After Main Pulse	%	0.0	15.0	2.0	Pass
Is Acceleration Unimodal?	Yes/No	Yes		Yes	Pass
Overall Test Results					Pass

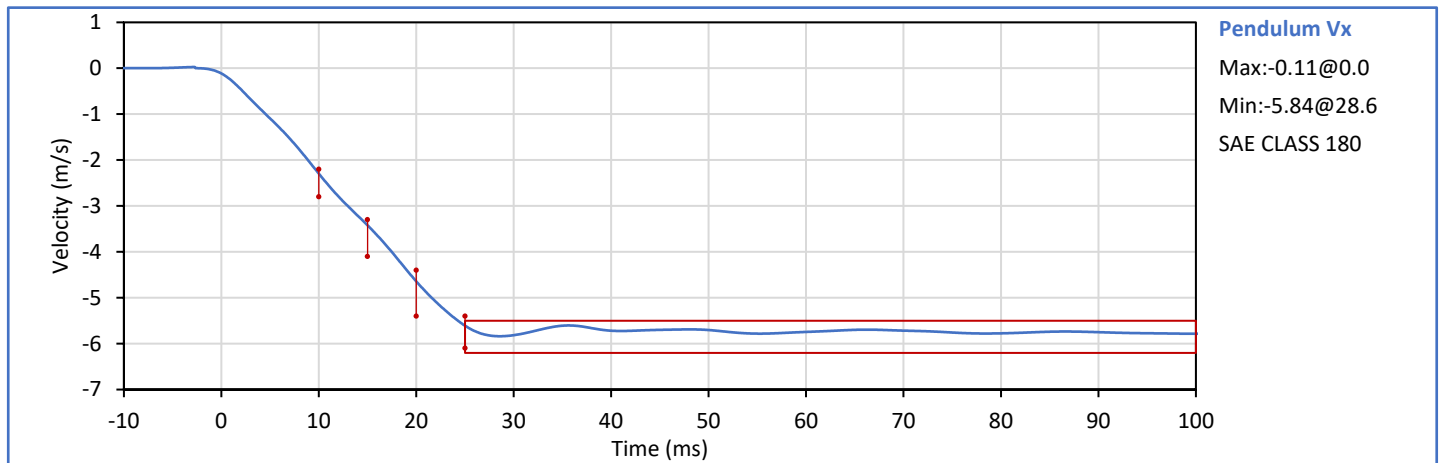
Tested Parameter	Units	Spec. Low	Spec. High	Result	Pass/Fail
Laboratory Temperature	°C	20.6	22.2	21.1	Pass
Laboratory Relative Humidity	%	10	70	30	Pass
Pendulum Velocity	m/s	5.51	5.63	5.59	Pass
Pendulum Decel at 10 ms	m/s	-2.80	-2.20	-2.30	Pass
Pendulum Decel at 15 ms	m/s	-4.10	-3.30	-3.42	Pass
Pendulum Decel at 20 ms	m/s	-5.40	-4.40	-4.64	Pass
Pendulum Decel at 25 ms	m/s	-6.10	-5.40	-5.61	Pass
Pendulum Decel from 25-100 ms	m/s	-6.20	-5.50	-5.84/-5.61	Pass
Peak "D" Plane Rotation	deg	-81.0	-71.0	-73.5	Pass
Time of Peak "D" Plane Rotation	ms	50.0	70.0	62.2	Pass
Peak Occ. Condyle Moment	Nm	36.0	44.0	41.2	Pass
Time of Moment Decay to 0 Nm	ms	102.0	126.0	113.0	Pass
Overall Test Results					Pass

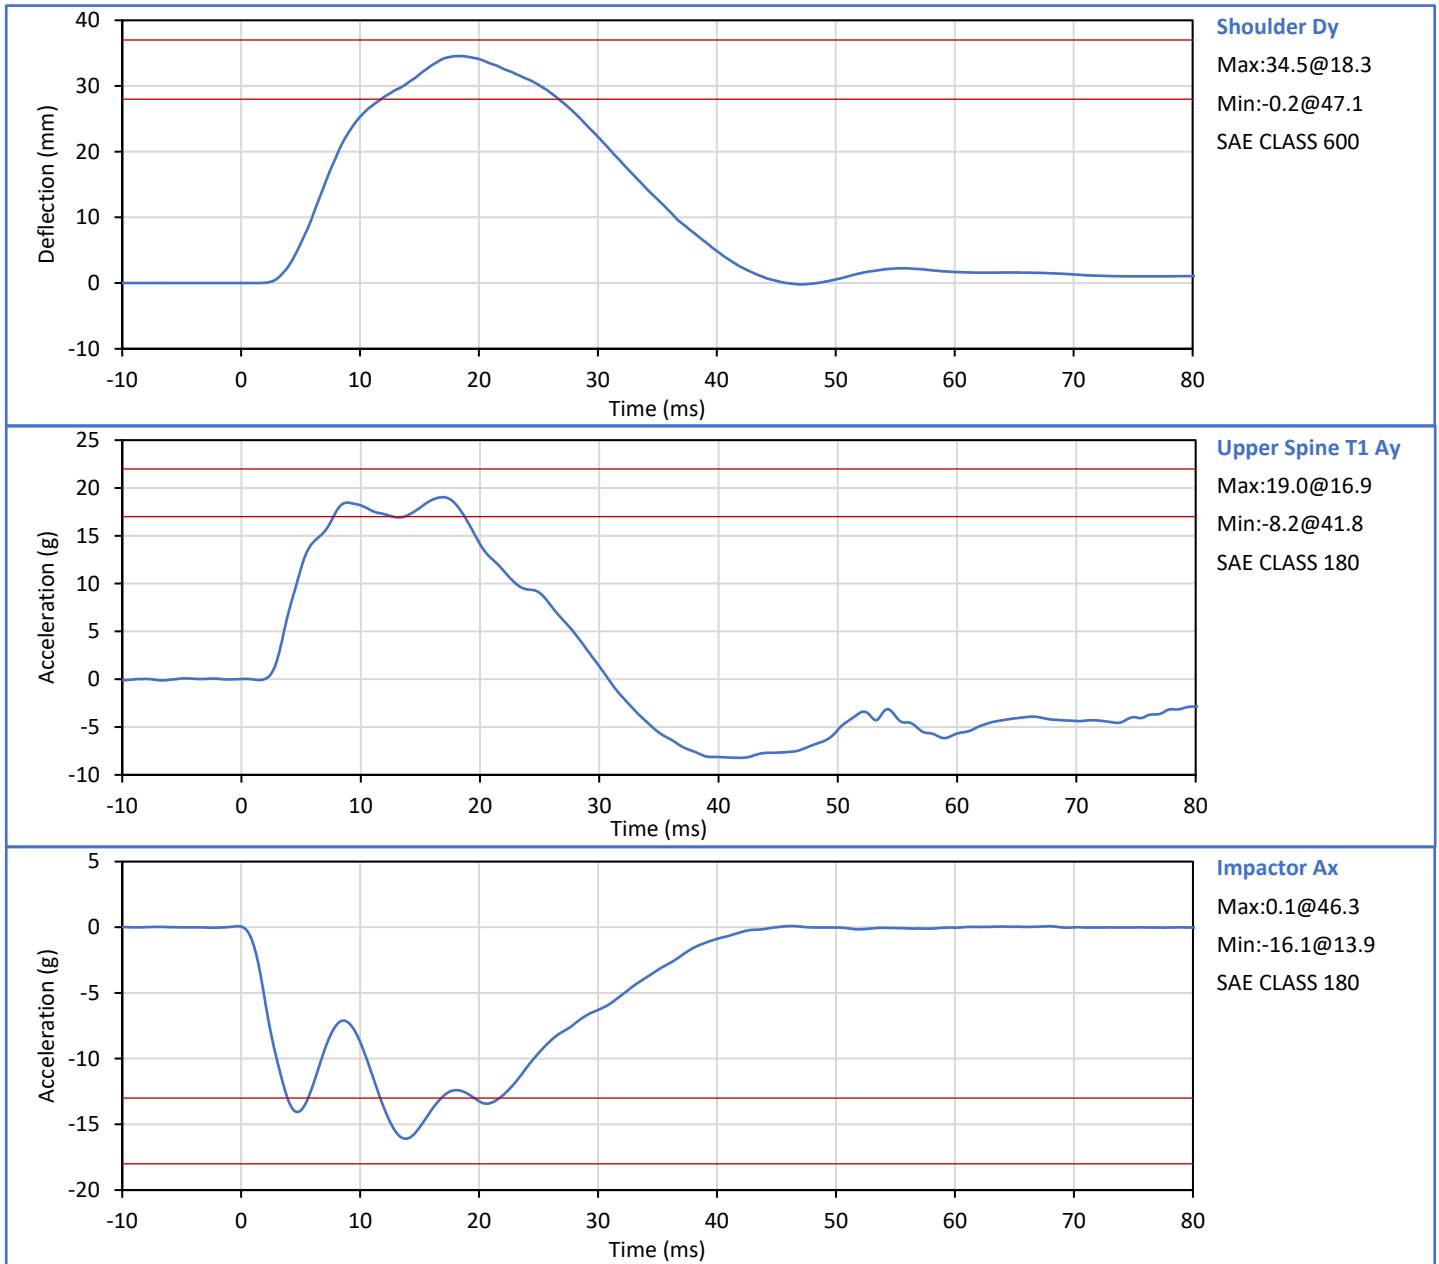
Tested Parameter	Units	Spec. Low	Spec. High	Result	Pass/Fail
Laboratory Temperature	°C	20.6	22.2	21.1	Pass
Laboratory Relative Humidity	%	10	70	34	Pass
Impactor Velocity	m/s	4.20	4.40	4.32	Pass
Peak Shoulder Dy	mm	28.0	37.0	34.5	Pass
Peak Upper Spine (T1) Ay	g	17.0	22.0	19.0	Pass
Peak Impactor Ax	g	-18.0	-13.0	-16.1	Pass
Overall Test Results					Pass

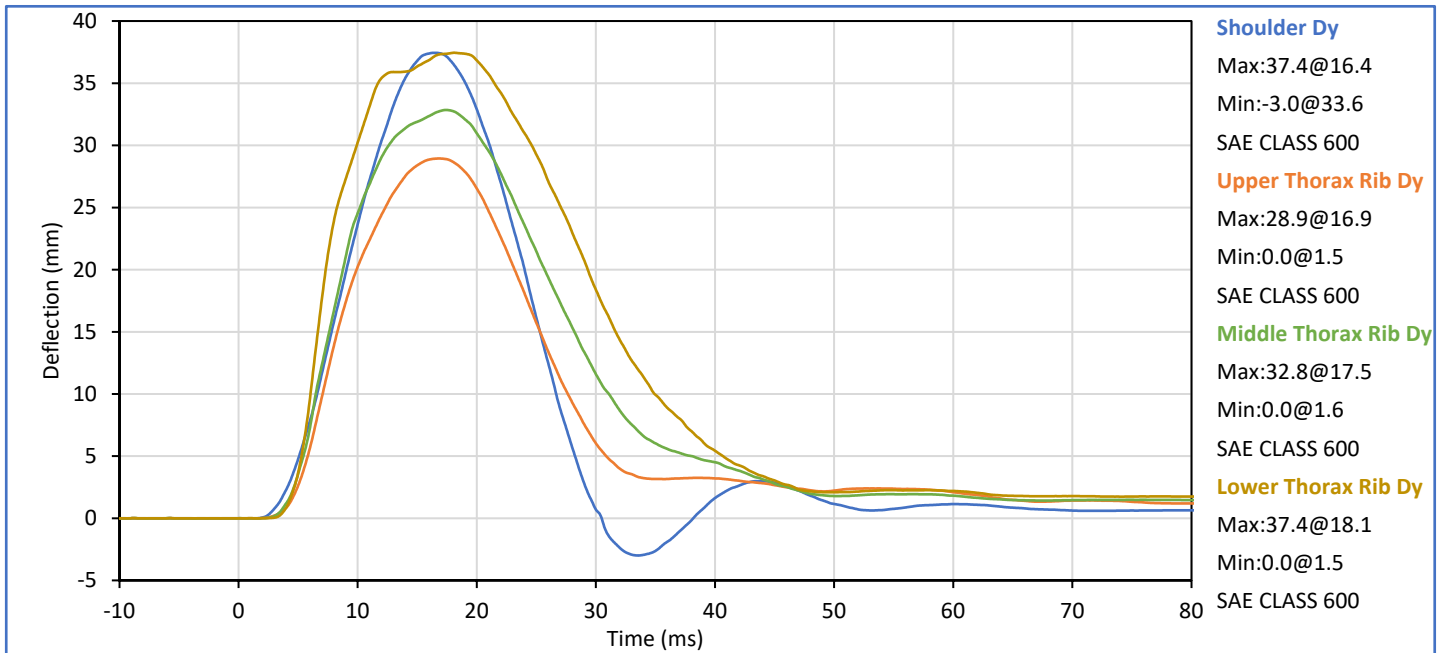
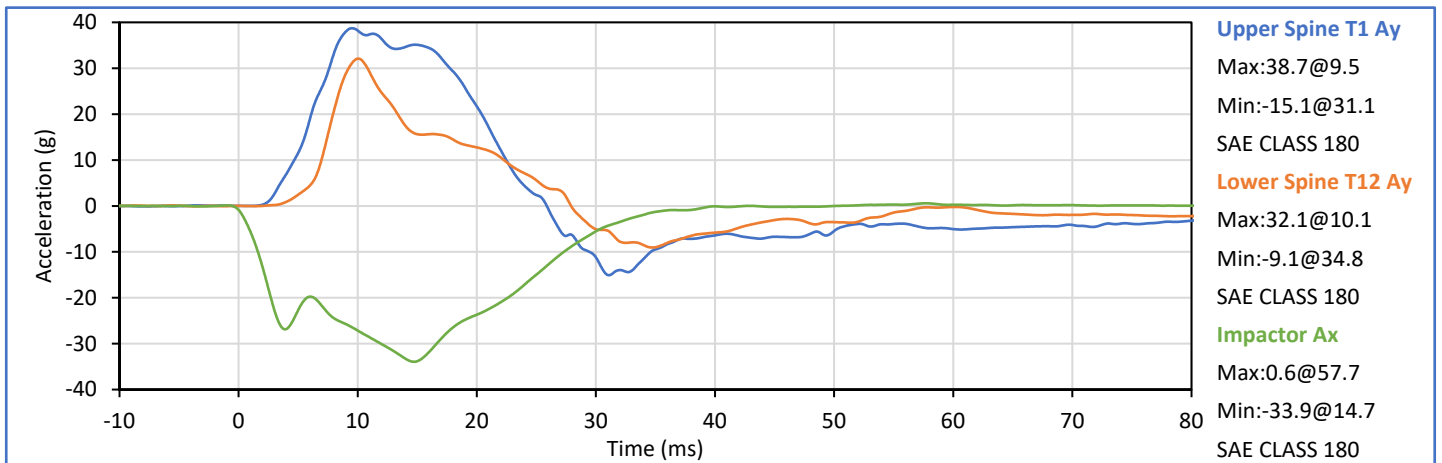
Tested Parameter	Units	Spec. Low	Spec. High	Result	Pass/Fail
Laboratory Temperature	°C	20.6	22.2	21.1	Pass
Laboratory Relative Humidity	%	10	70	34	Pass
Impactor Velocity	m/s	6.60	6.80	6.71	Pass
Peak Shoulder Dy	mm	31.0	40.0	37.4	Pass
Peak Upper Rib Dy	mm	25.0	32.0	28.9	Pass
Peak Middle Rib Dy	mm	30.0	36.0	32.8	Pass
Peak Lower Rib Dy	mm	32.0	38.0	37.4	Pass
Peak Upper Spine (T1) Ay	g	34.0	43.0	38.7	Pass
Peak Lower Spine (T12) Ay	g	29.0	37.0	32.1	Pass
Peak Impactor Ax	g	-36.0	-30.0	-33.9	Pass
Overall Test Results					Pass

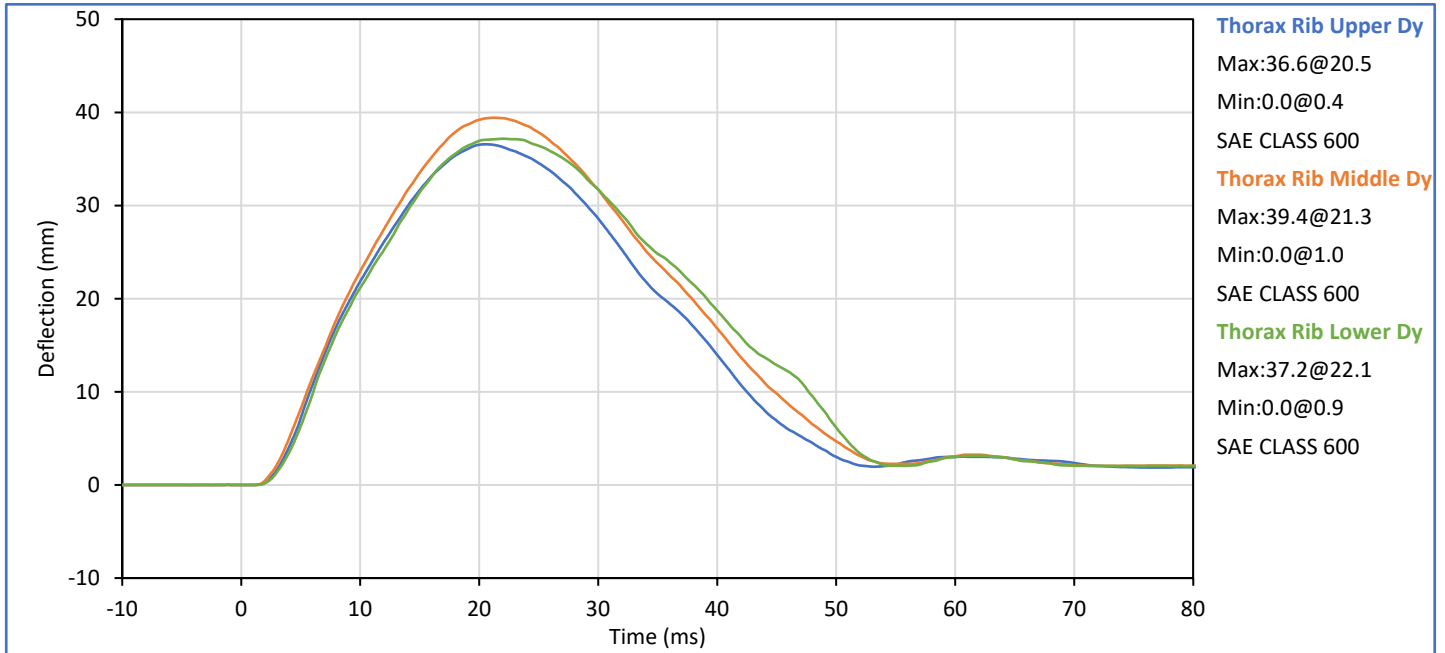
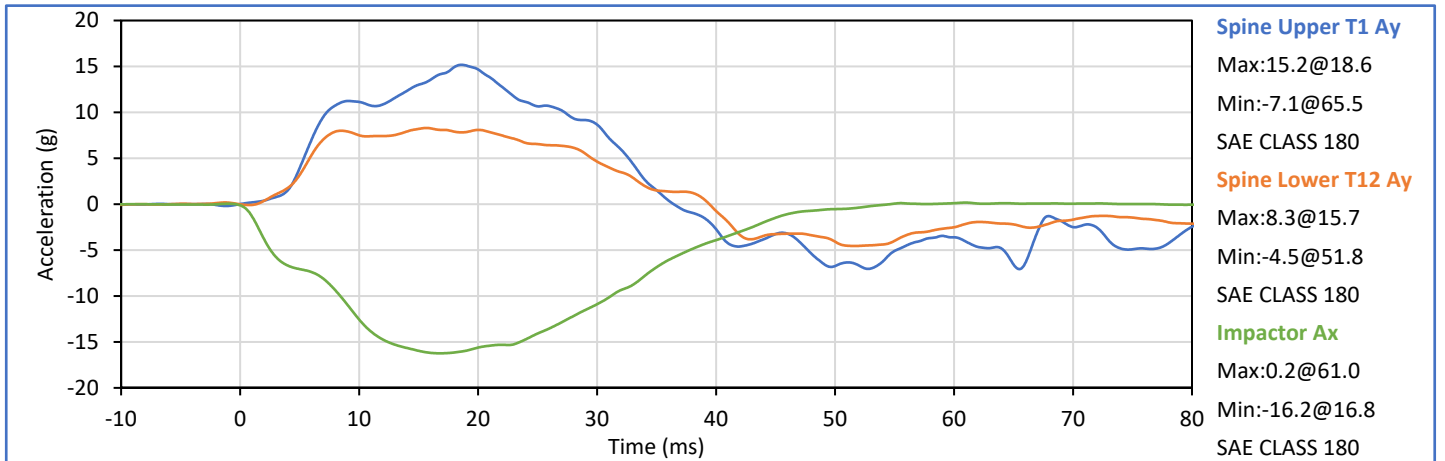
Tested Parameter	Units	Spec. Low	Spec. High	Result	Pass/Fail
Laboratory Temperature	°C	20.6	22.2	21.1	Pass
Laboratory Relative Humidity	%	10	70	34	Pass
Impactor Velocity	m/s	4.20	4.40	4.32	Pass
Peak Thorax Rib Upper Dy	mm	32.0	40.0	36.6	Pass
Peak Thorax Rib Middle Dy	mm	39.0	45.0	39.4	Pass
Peak Thorax Rib Lower Dy	mm	35.0	43.0	37.2	Pass
Peak Spine Upper T1 Ay	g	13.0	17.0	15.2	Pass
Peak Spine Lower T12 Ay	g	7.0	11.0	8.3	Pass
Peak Impactor Ax	g	-18.0	-14.0	-16.2	Pass
Overall Test Results					Pass
