REPORT NUMBER: SideNCAPMDB-KAR-21-012

**NEW CAR ASSESSMENT PROGRAM (NCAP)
MOVING DEFORMABLE BARRIER SIDE IMPACT TEST**

**HYUNDAI MOTOR COMPANY
2021 GENESIS G80 4-DOOR SEDAN**

NHTSA No: O20214214

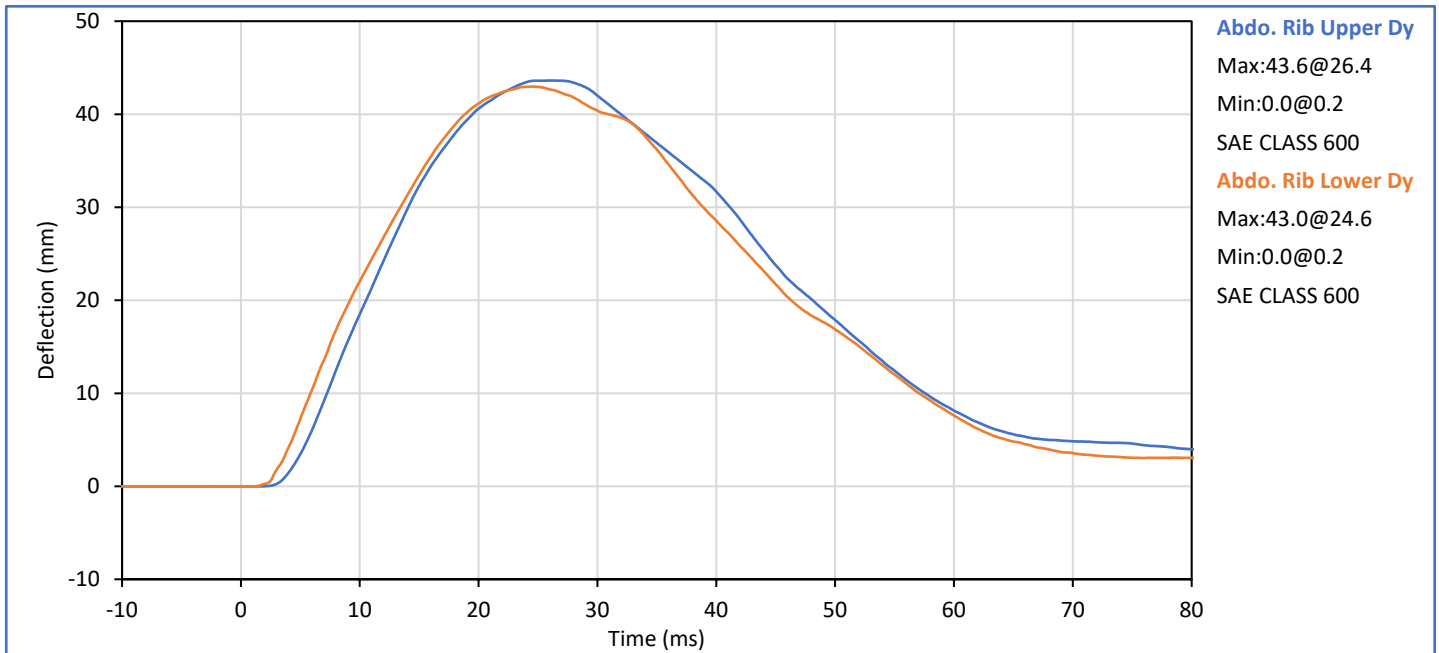
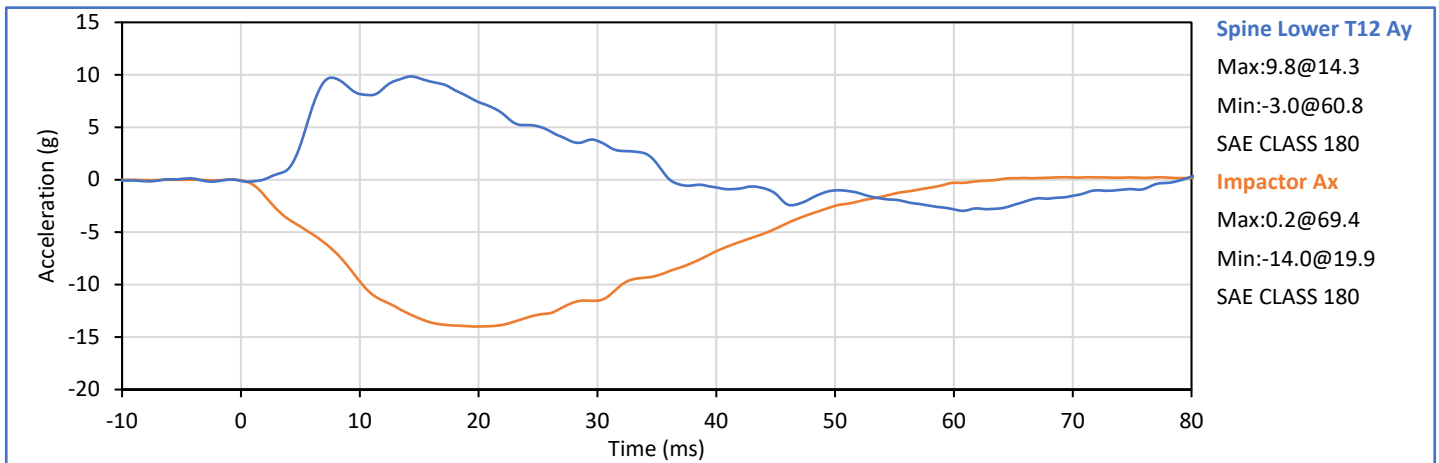
Tested Parameter	Units	Spec. Low	Spec. High	Result	Pass/Fail
Laboratory Temperature	°C	20.6	22.2	21.1	Pass
Laboratory Relative Humidity	%	10	70	34	Pass
Impactor Velocity	m/s	4.20	4.40	4.32	Pass
Peak Upper Abdomen Rib Dy	mm	36.0	47.0	43.6	Pass
Peak Lower Abdomen Rib Dy	mm	33.0	44.0	43.0	Pass
Peak Lower Spine T12 Ay	mm	9.0	14.0	9.8	Pass
Peak Impactor Ax	g	-16.0	-12.0	-14.0	Pass
Overall Test Results					Pass

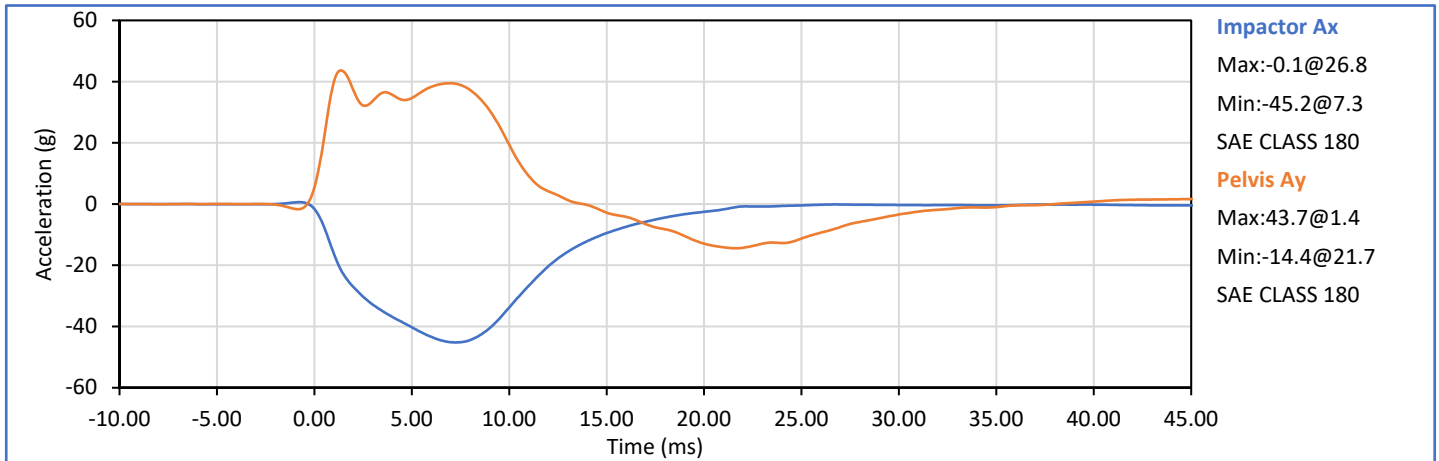
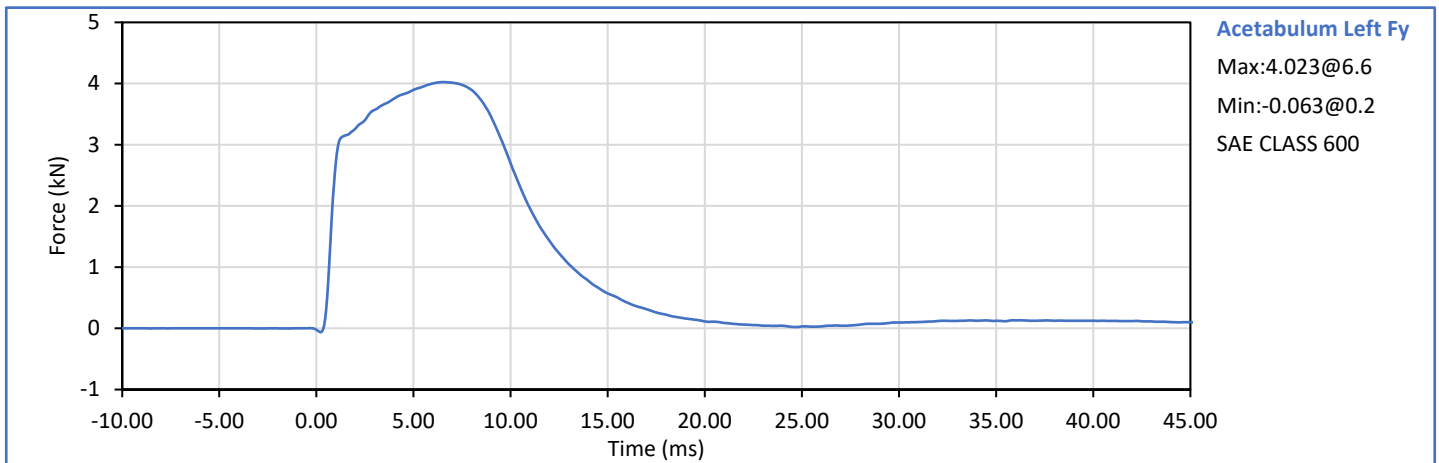
Tested Parameter	Units	Spec. Low	Spec. High	Result	Pass/Fail
Laboratory Temperature	°C	20.6	22.2	21.1	Pass
Laboratory Relative Humidity	%	10	70	33	Pass
Impactor Velocity	m/s	6.60	6.80	6.72	Pass
Peak Acetabulum Fy	kN	3.60	4.30	4.02	Pass
Pelvis Ay after 6ms	g	34.0	42.0	39.5	Pass
Peak Impactor Ax	g	-47.0	-38.0	-45.2	Pass
Overall Test Results					Pass

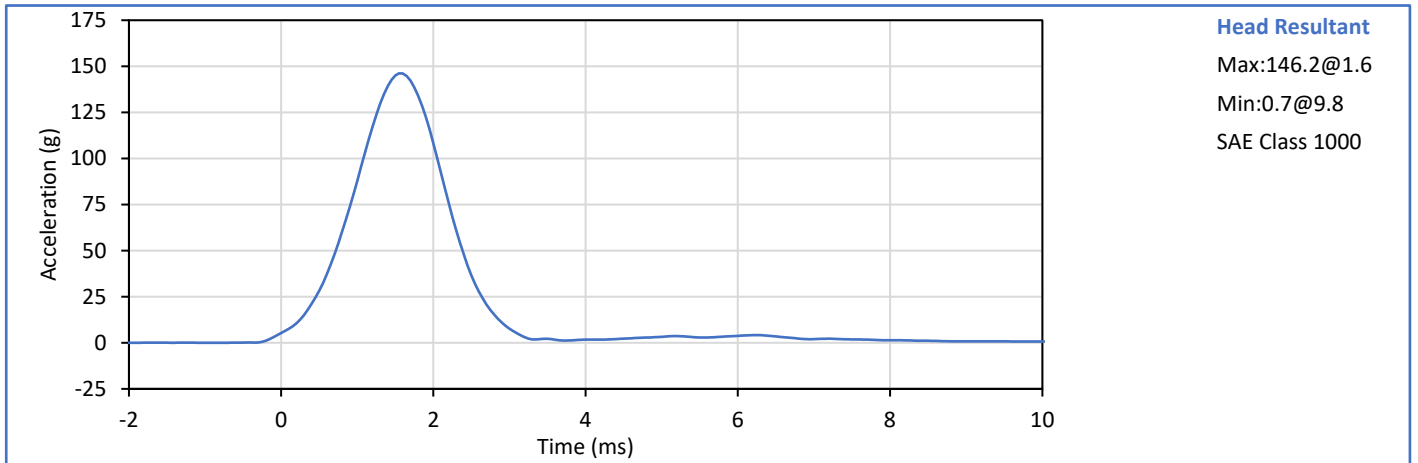
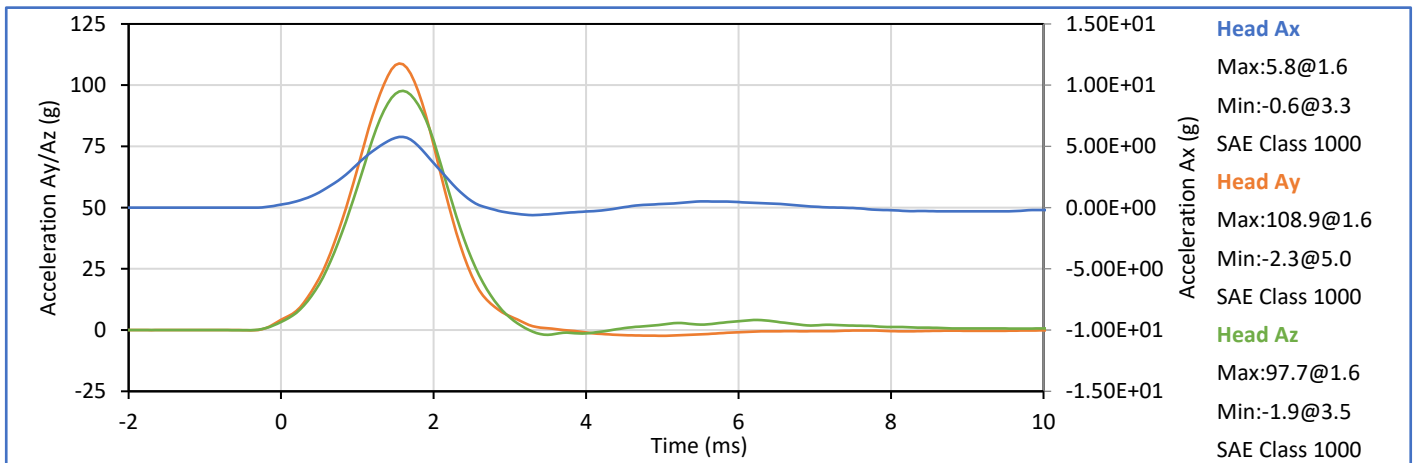
Tested Parameter	Units	Spec. Low	Spec. High	Result	Pass/Fail
Laboratory Temperature	°C	18.9	25.6	21.7	Pass
Laboratory Relative Humidity	%	10	70	45	Pass
Peak Resultant Acceleration	g	125.0	155.0	146.2	Pass
Peak Head Ax	g	-15.0	15.0	5.8	Pass
Oscillations After Main Pulse	%	0.0	15.0	2.8	Pass
Is Acceleration Unimodal?	Yes/No	Yes		Yes	Pass
Overall Test Results					Pass

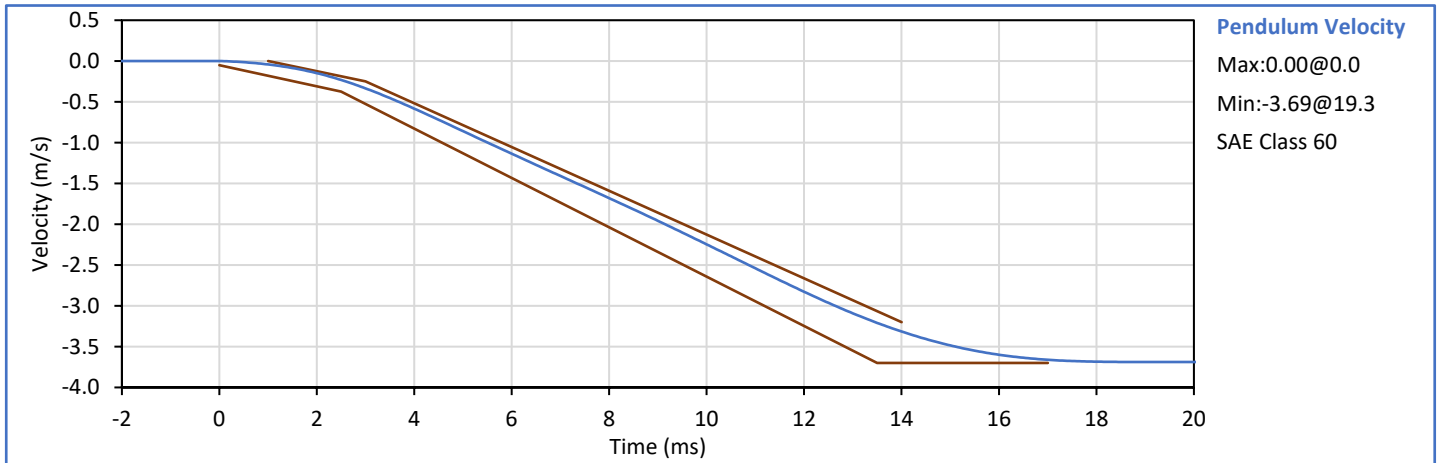
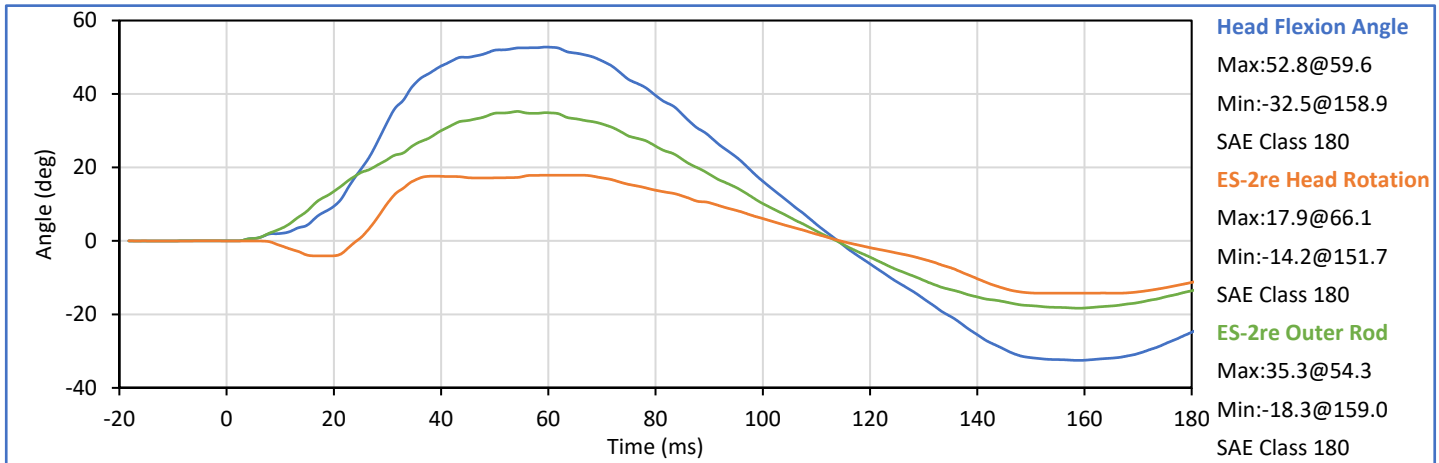
Tested Parameter	Units	Spec. Low	Spec. High	Result	Pass/Fail
Laboratory Temperature	°C	20.6	22.2	21.7	Pass
Laboratory Relative Humidity	%	10	70	45	Pass
Pendulum Velocity	m/s	3.30	3.50	3.46	Pass
Peak Headform Flexion	deg	49.0	59.0	52.8	Pass
Time of Peak Headform Flexion	ms	54.0	66.0	59.6	Pass
Flexion Decay (Peak to zero)	ms	53.0	88.0	54.4	Pass
Overall Test Results					Pass

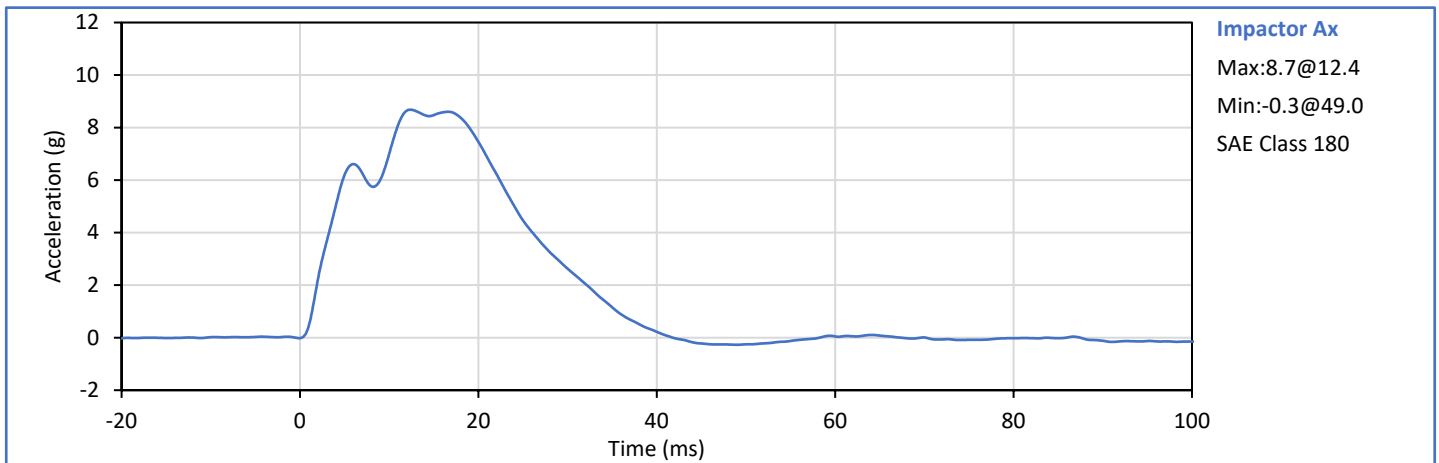
Tested Parameter	Units	Spec. Low	Spec. High	Result	Pass/Fail
Laboratory Temperature	°C	20.6	22.2	21.1	Pass
Laboratory Relative Humidity	%	10	70	39	Pass
Impactor Velocity	m/s	4.20	4.40	4.35	Pass
Peak Impactor Ax	g	7.5	10.5	8.7	Pass
Overall Test Results					Pass

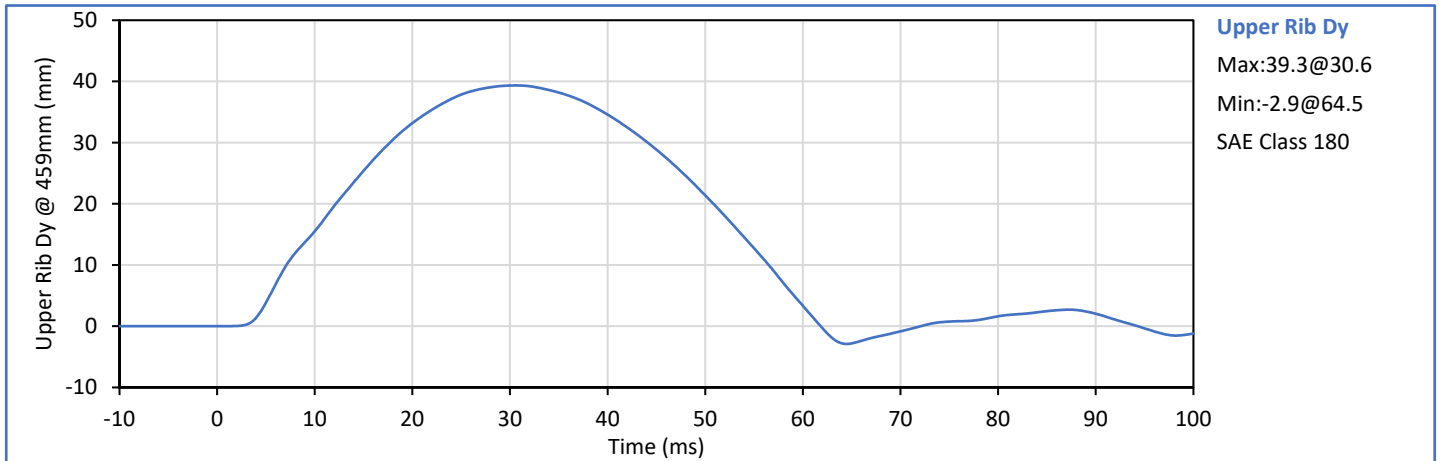
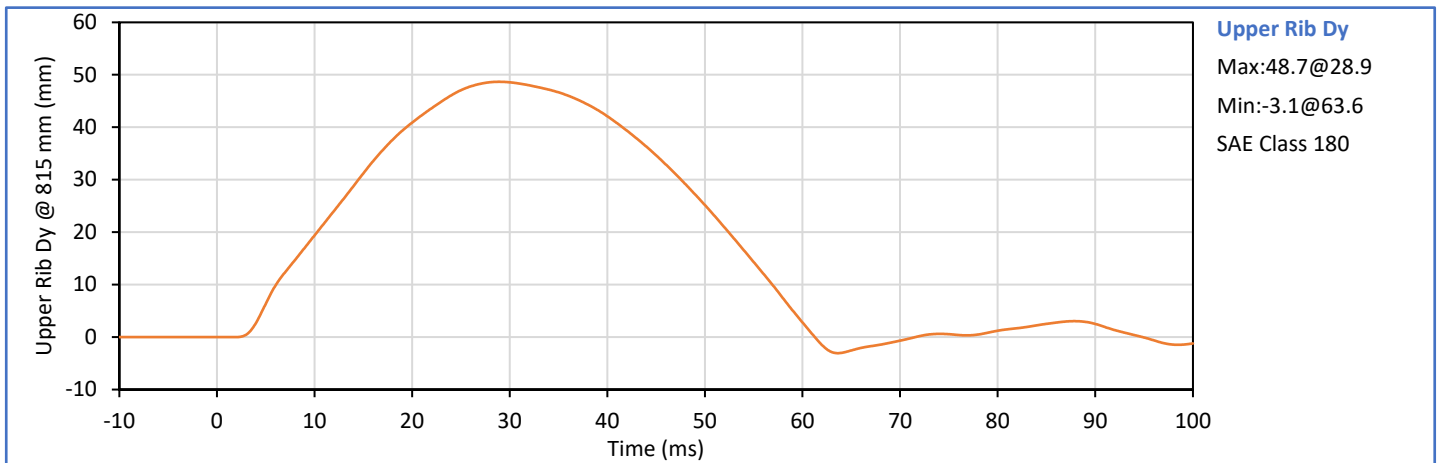
Tested Parameter	Units	Spec. Low	Spec. High	Result	Pass/Fail
Laboratory Temperature	°C	20.6	22.2	21.7	Pass
Laboratory Relative Humidity	%	10	70	40	Pass
Upper Rib Dy @ 459mm	mm	36.0	40.0	39.3	Pass
Upper Rib Dy @ 815mm	mm	46.0	51.0	48.7	Pass
Overall Test Results					Pass

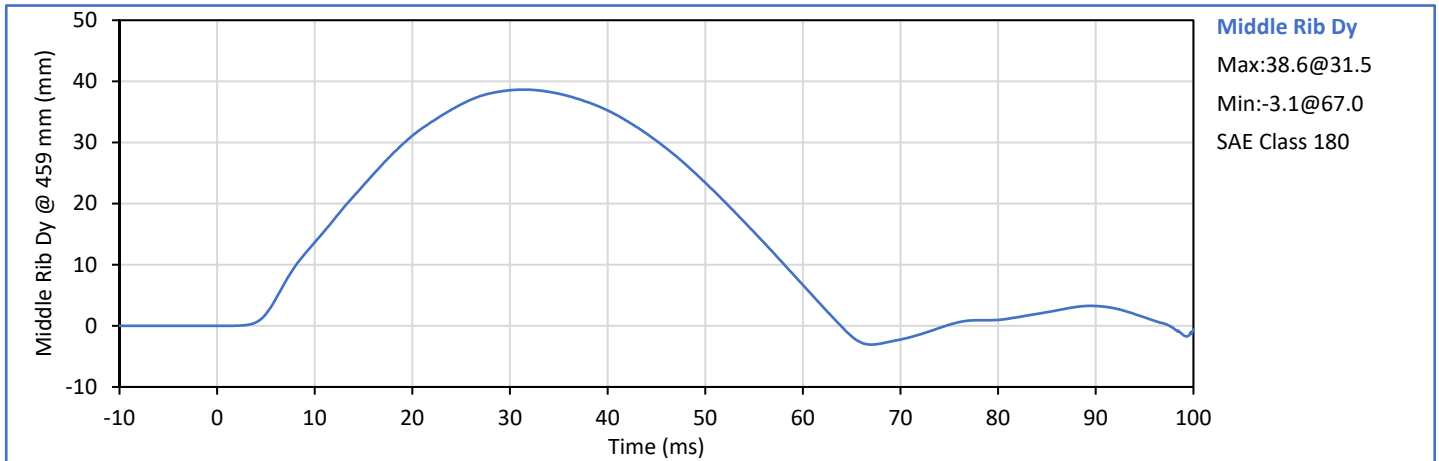
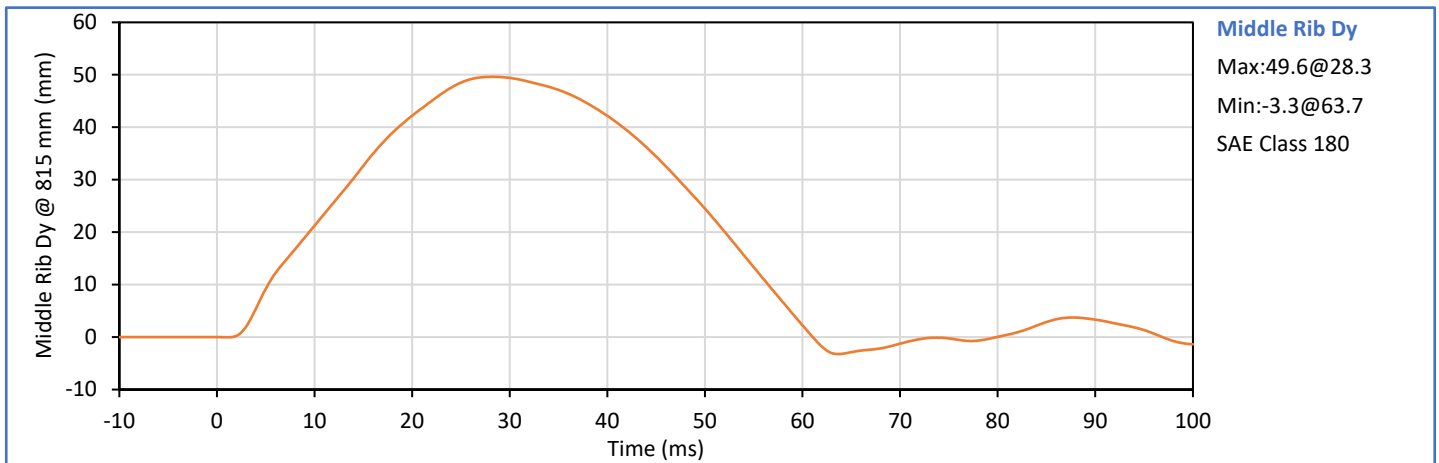
Tested Parameter	Units	Spec. Low	Spec. High	Result	Pass/Fail
Laboratory Temperature	°C	20.6	22.2	21.1	Pass
Laboratory Relative Humidity	%	10	70	42	Pass
Middle Rib Dy @ 459mm	mm	36.0	40.0	38.6	Pass
Middle Rib Dy @ 815mm	mm	46.0	51.0	49.6	Pass
Overall Test Results					Pass

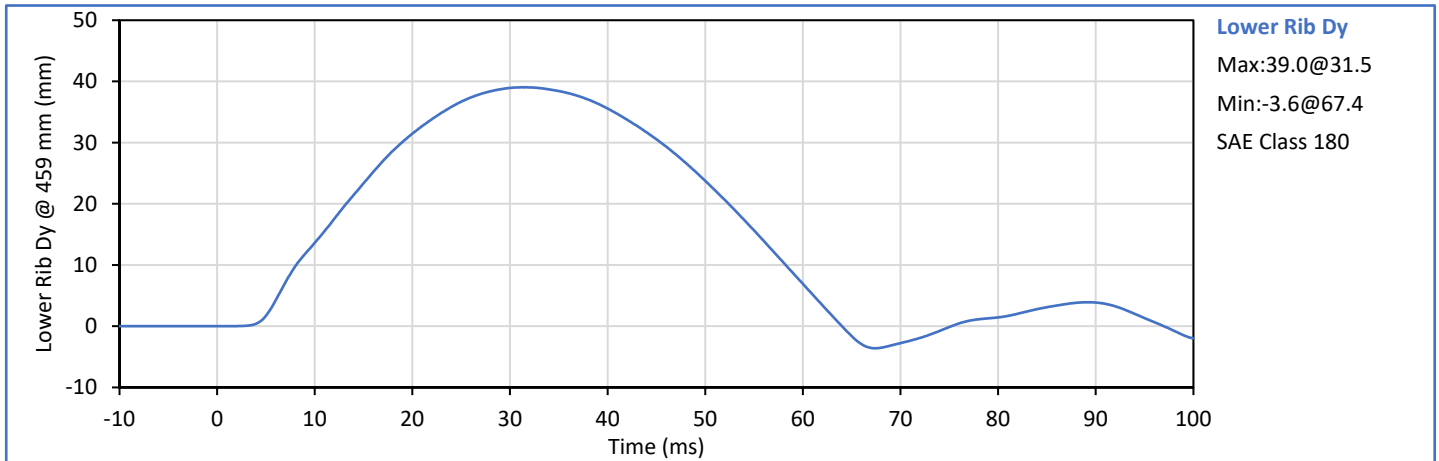
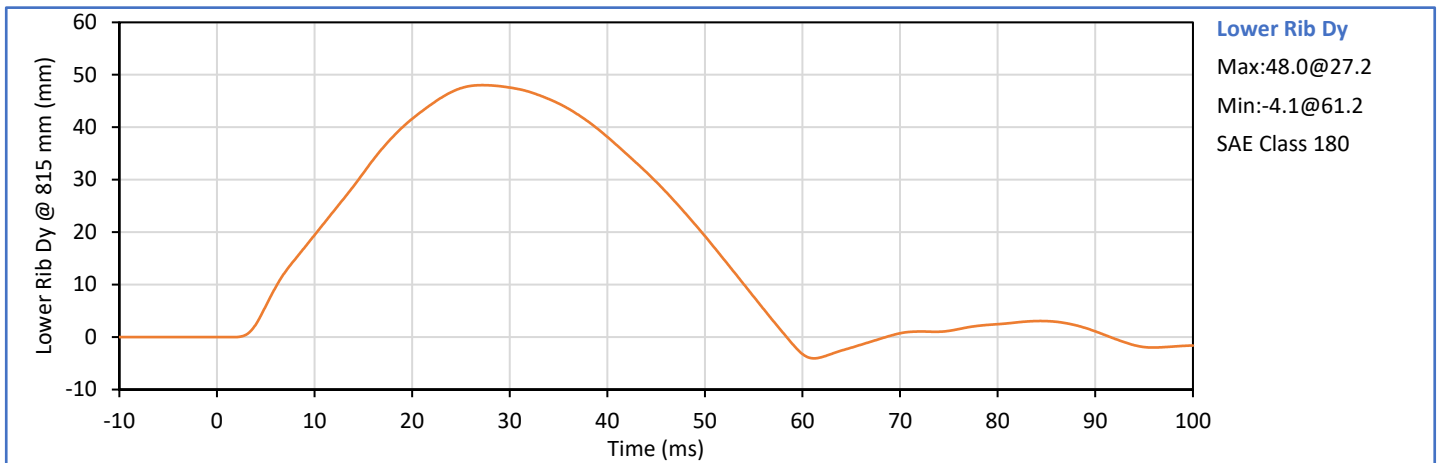
Tested Parameter	Units	Spec. Low	Spec. High	Result	Pass/Fail
Laboratory Temperature	°C	20.6	22.2	21.1	Pass
Laboratory Relative Humidity	%	10	70	44	Pass
Lower Rib Dy @ 459mm	mm	36.0	40.0	39.0	Pass
Lower Rib Dy @ 815mm	mm	46.0	51.0	48.0	Pass
Overall Test Results					Pass

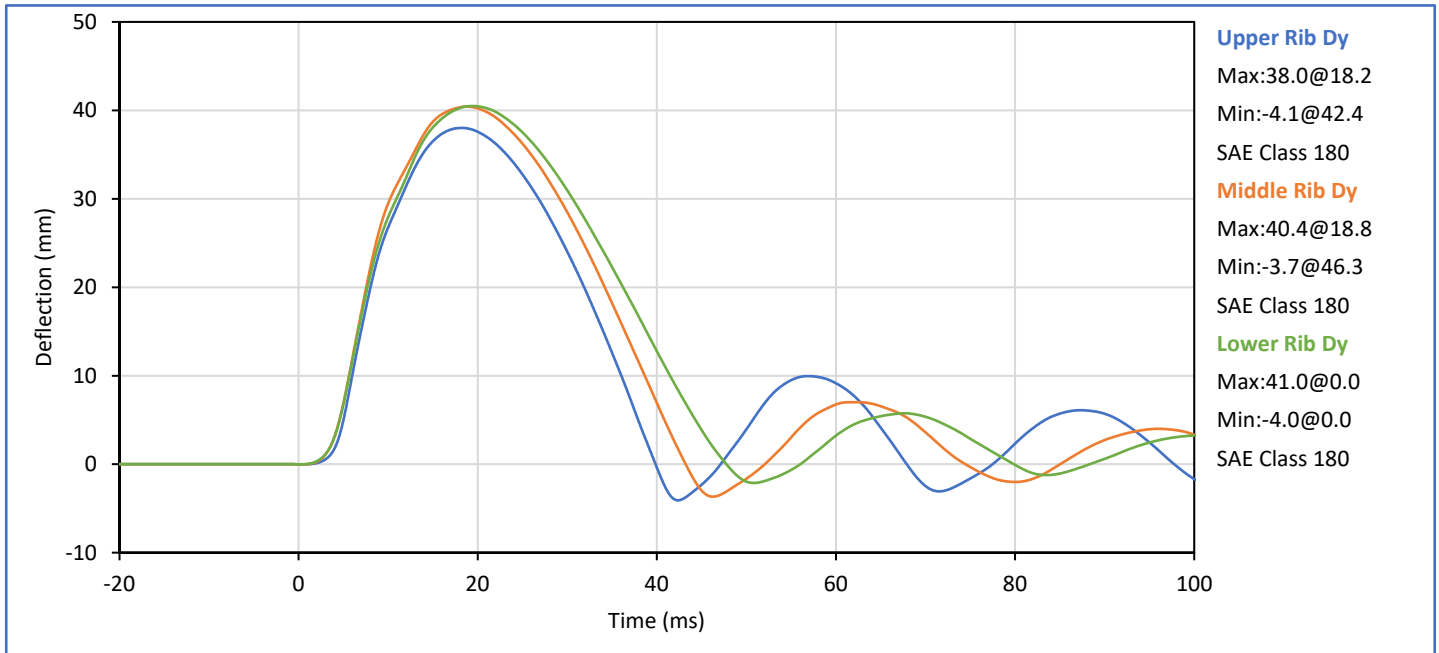
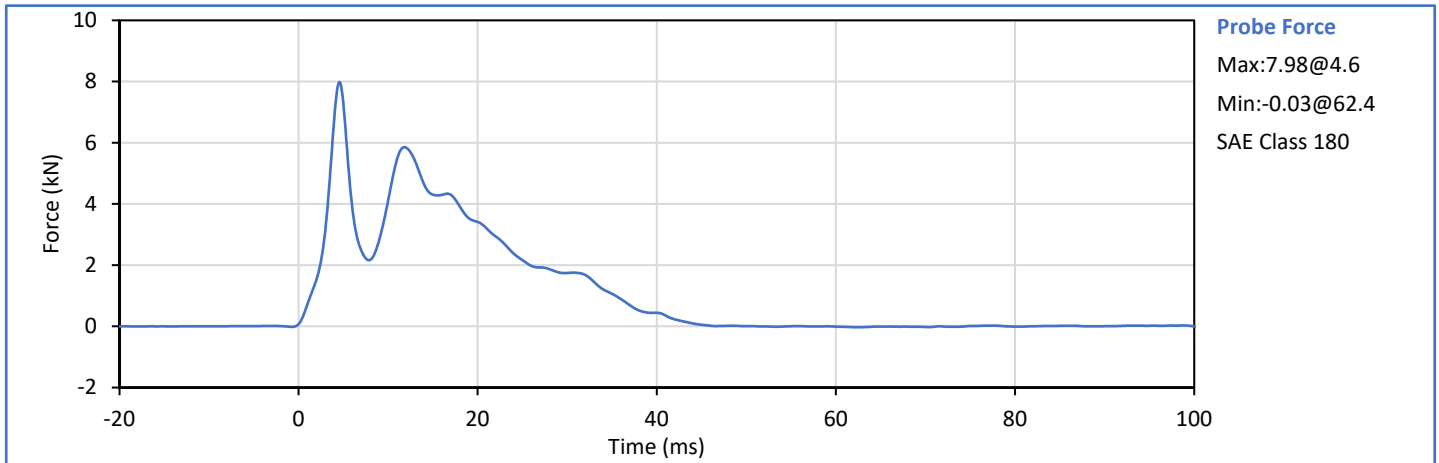
Tested Parameter	Units	Spec. Low	Spec. High	Result	Pass/Fail
Laboratory Temperature	°C	20.6	22.2	21.1	Pass
Laboratory Relative Humidity	%	10	70	39	Pass
Impactor Velocity	m/s	5.40	5.60	5.51	Pass
Peak Upper Rib Dy	mm	34.0	41.0	38.0	Pass
Peak Middle Rib Dy	mm	37.0	45.0	40.4	Pass
Peak Lower Rib Dy	mm	37.0	44.0	40.5	Pass
Peak Impactor Force After 6 ms	kN	5.10	6.20	5.85	Pass
Overall Test Results					Pass

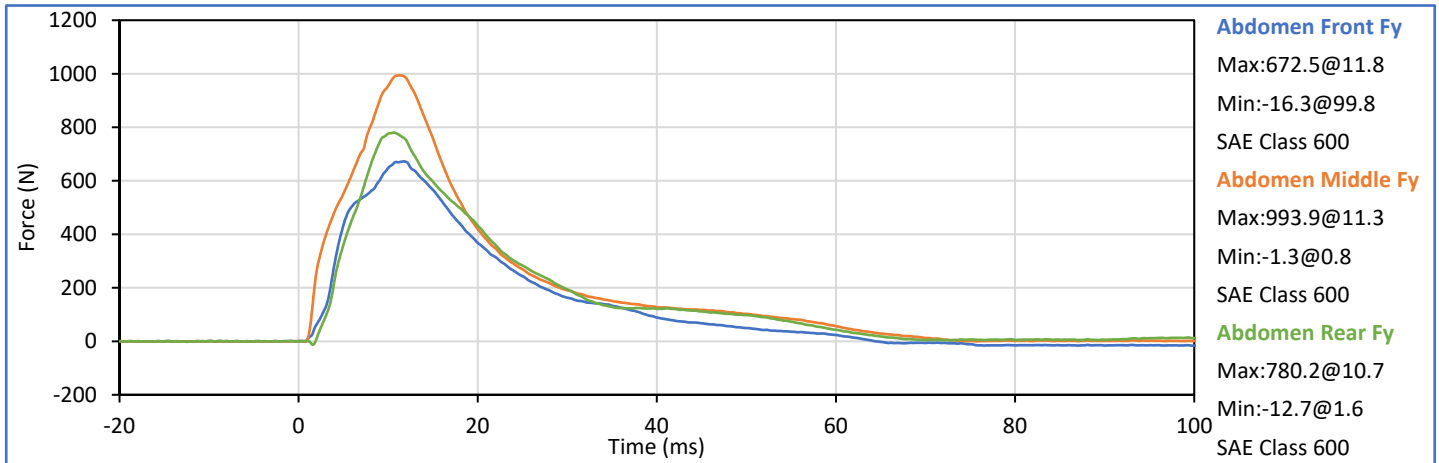
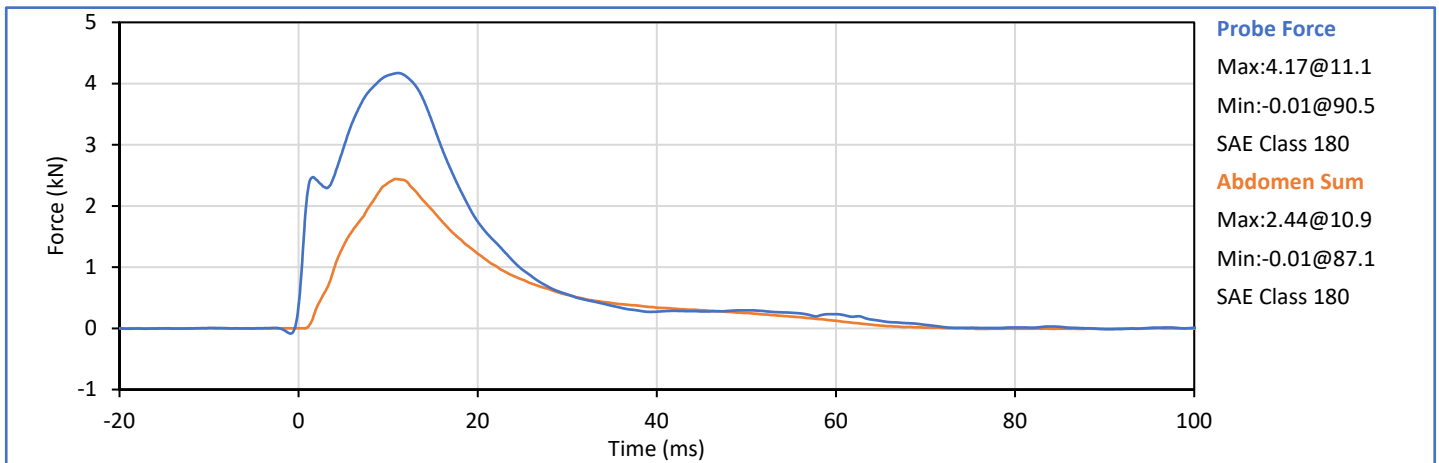
Tested Parameter	Units	Spec. Low	Spec. High	Result	Pass/Fail
Laboratory Temperature	°C	20.6	22.2	21.1	Pass
Laboratory Relative Humidity	%	10	70	39	Pass
Impactor Velocity	m/s	3.90	4.10	4.03	Pass
Peak Impactor Force	kN	4.00	4.80	4.17	Pass
Time of Peak Impactor Force	ms	10.6	13.0	11.1	Pass
Sum of Abdomen Forces	kN	2.20	2.70	2.44	Pass
Time of Peak Sum Abdomen Force	ms	10.0	12.3	10.9	Pass
Overall Test Results					Pass

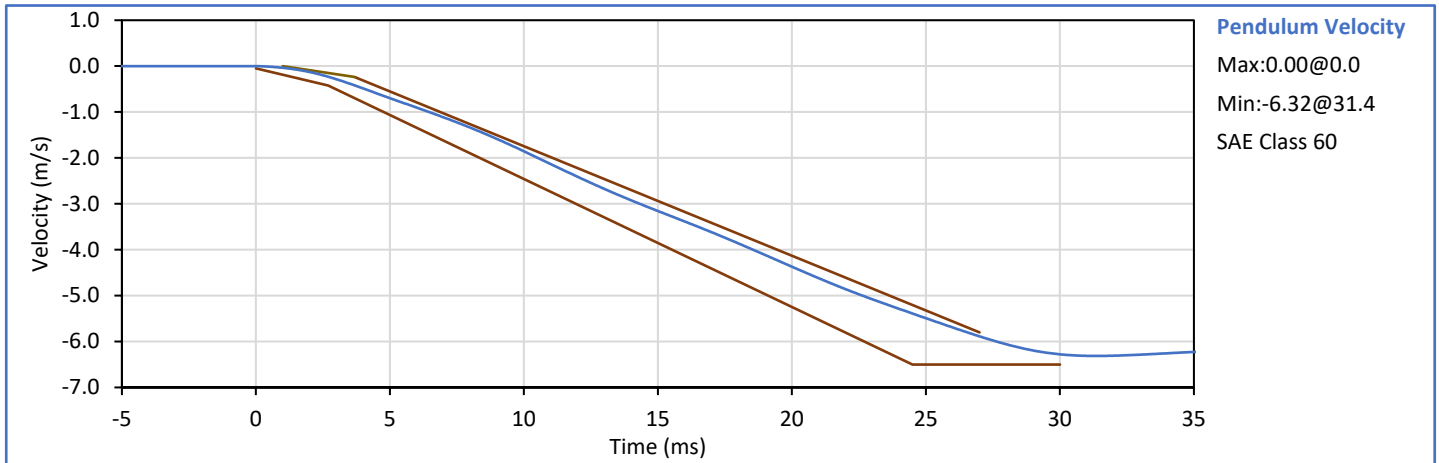
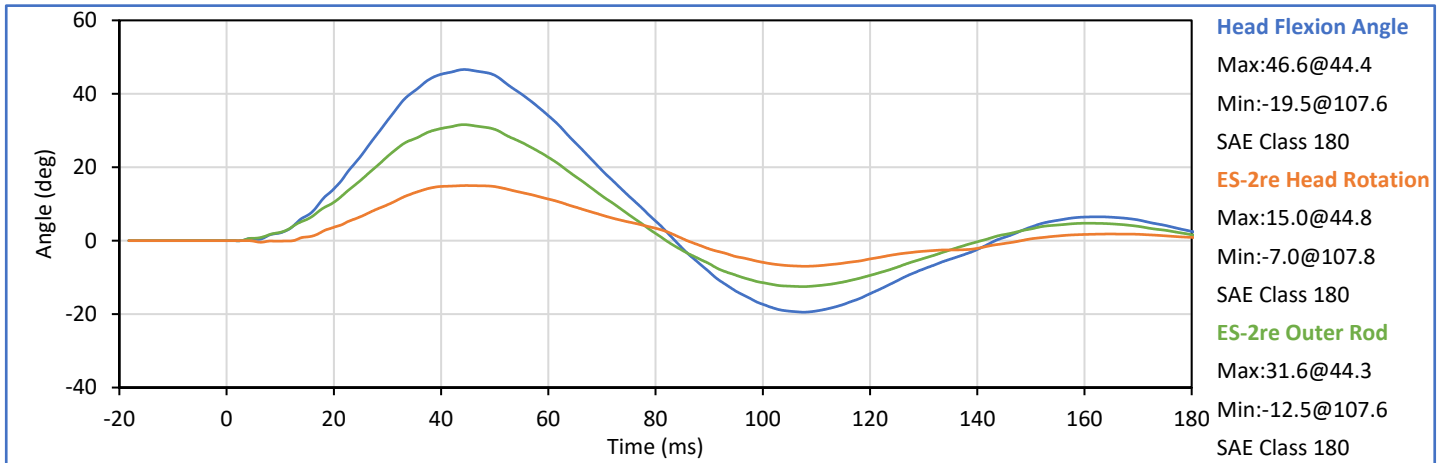
Tested Parameter	Units	Spec. Low	Spec. High	Result	Pass/Fail
Laboratory Temperature	°C	20.6	22.2	21.7	Pass
Laboratory Relative Humidity	%	10	70	46	Pass
Pendulum Velocity	m/s	5.95	6.15	6.09	Pass
Peak Headform Flexion	deg	45.0	55.0	46.6	Pass
Time of Peak Headform Flexion	ms	39.0	53.0	44.4	Pass
Flexion Decay (Peak to zero)	ms	37.0	57.0	39.3	Pass
Overall Test Results					Pass

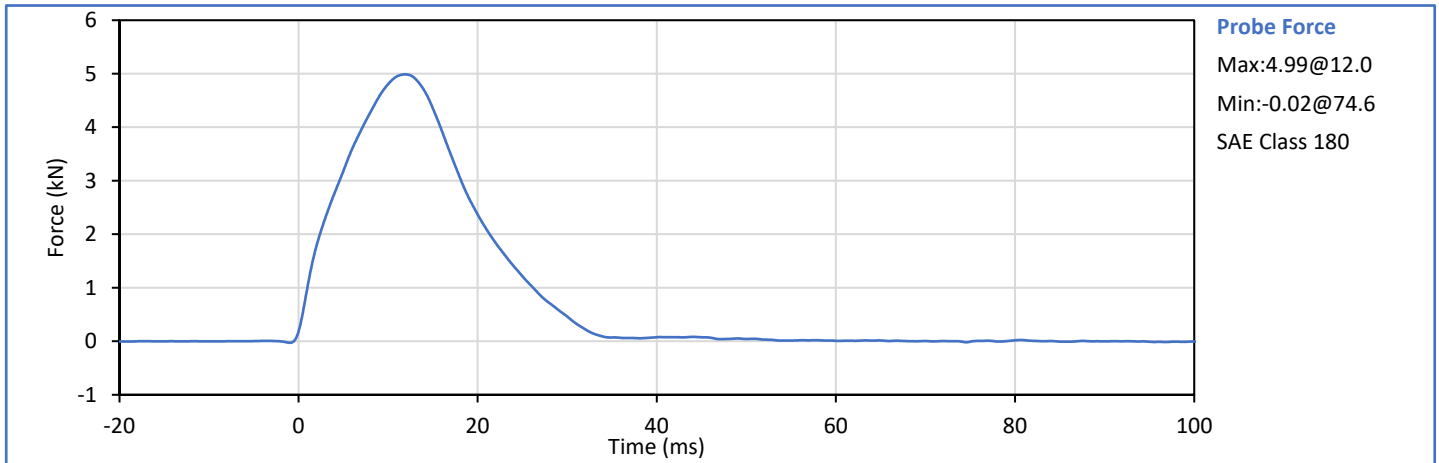
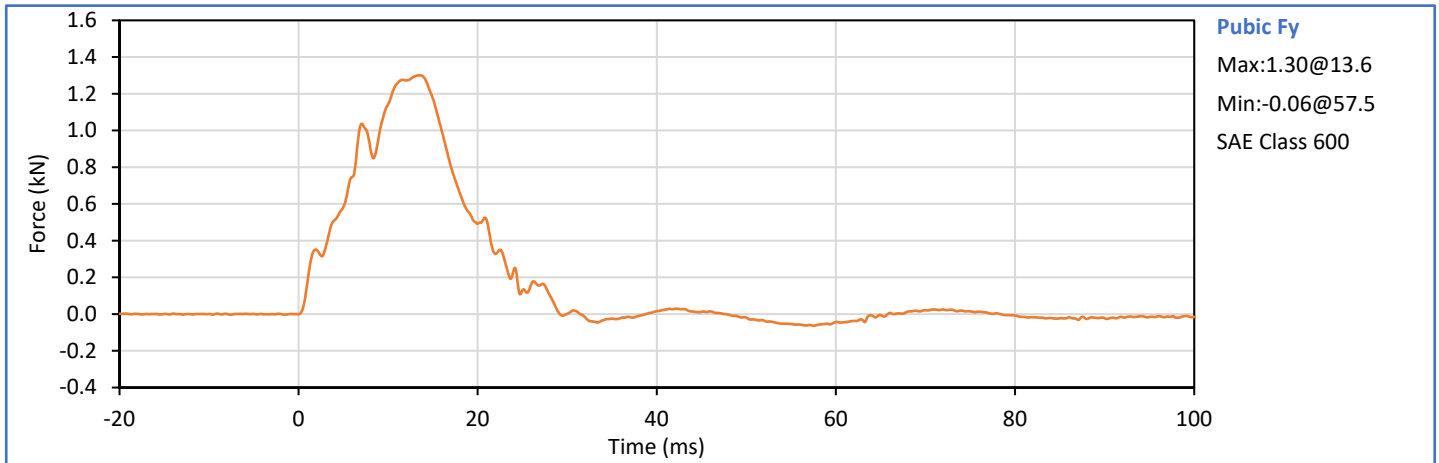
Tested Parameter	Units	Spec. Low	Spec. High	Result	Pass/Fail
Laboratory Temperature	°C	20.6	22.2	21.1	Pass
Laboratory Relative Humidity	%	10	70	39	Pass
Impactor Velocity	m/s	4.20	4.40	4.33	Pass
Peak Impactor Force	kN	4.70	5.40	4.99	Pass
Time of Peak Impactor Force	ms	11.8	16.1	12.0	Pass
Pubic Symphysis Fy	kN	1.23	1.59	1.30	Pass
Time of Peak Pubic Symphysis Fy	ms	12.2	17.0	13.6	Pass
Overall Test Results					Pass

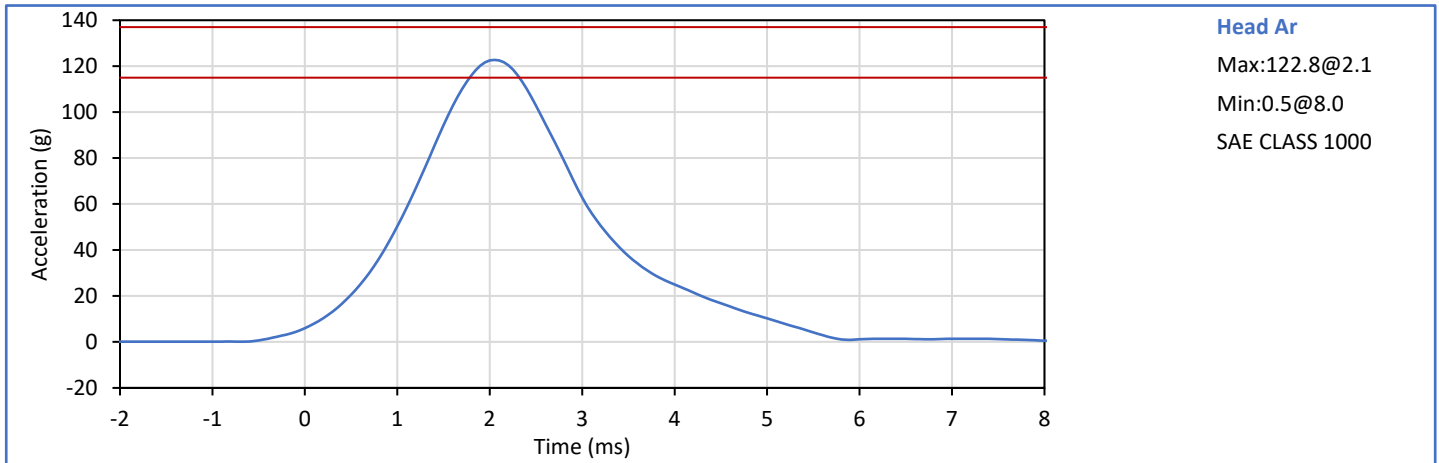
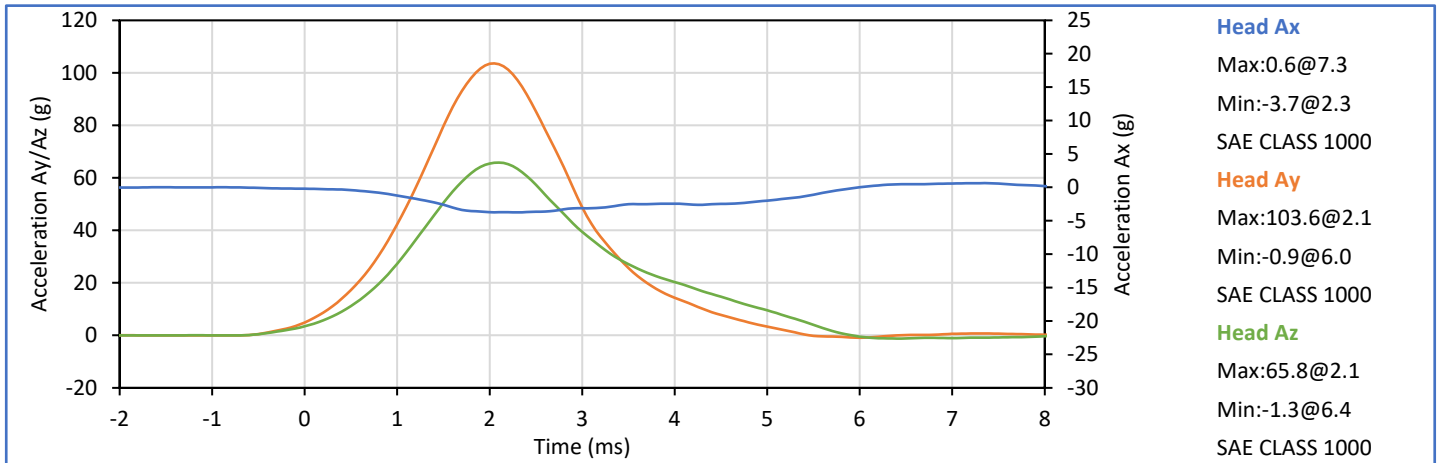
Tested Parameter	Units	Spec. Low	Spec. High	Result	Pass/Fail
Laboratory Temperature	°C	18.9	25.6	21.1	Pass
Laboratory Relative Humidity	%	10	70	26	Pass
Peak Resultant Acceleration	g	115.0	137.0	122.8	Pass
Peak Head Ax	g	-15.0	15.0	-3.7	Pass
Oscillations After Main Pulse	%	0.0	15.0	1.1	Pass
Is Acceleration Unimodal?	Yes/No	Yes		Yes	Pass
Overall Test Results					Pass

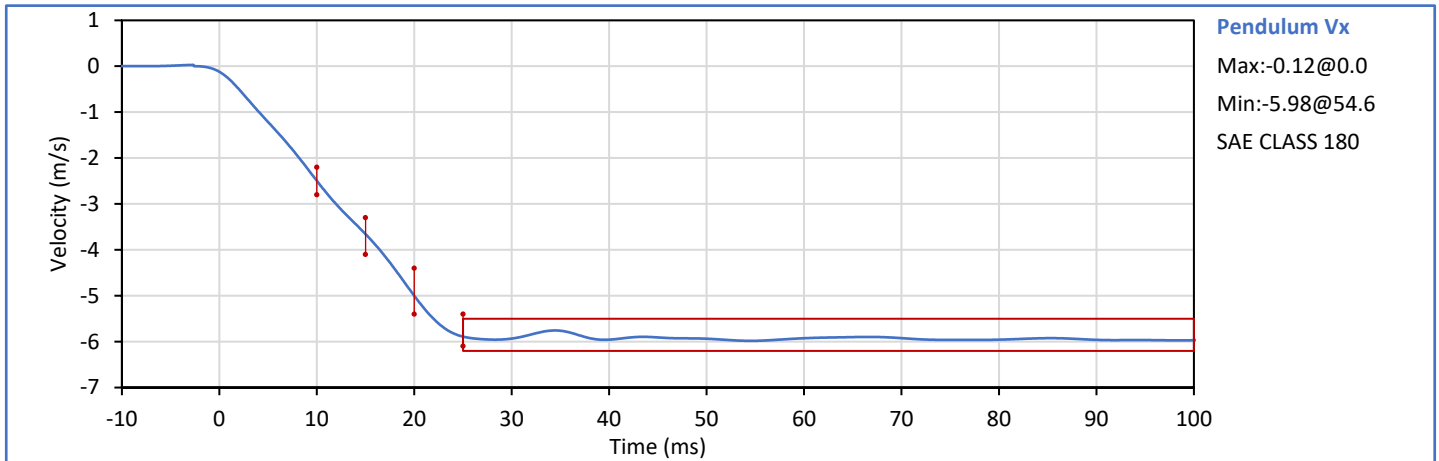
Tested Parameter	Units	Spec. Low	Spec. High	Result	Pass/Fail
Laboratory Temperature	°C	20.6	22.2	21.1	Pass
Laboratory Relative Humidity	%	10	70	30	Pass
Pendulum Velocity	m/s	5.51	5.63	5.59	Pass
Pendulum Decel at 10 ms	m/s	-2.80	-2.20	-2.50	Pass
Pendulum Decel at 15 ms	m/s	-4.10	-3.30	-3.66	Pass
Pendulum Decel at 20 ms	m/s	-5.40	-4.40	-5.00	Pass
Pendulum Decel at 25 ms	m/s	-6.10	-5.40	-5.89	Pass
Pendulum Decel from 25-100 ms	m/s	-6.20	-5.50	-5.98/-5.76	Pass
Peak "D" Plane Rotation	deg	-81.0	-71.0	-75.2	Pass
Time of Peak "D" Plane Rotation	ms	50.0	70.0	60.4	Pass
Peak Occ. Condyle Moment	Nm	36.0	44.0	40.6	Pass
Time of Moment Decay to 0 Nm	ms	102.0	126.0	109.0	Pass
Overall Test Results					Pass

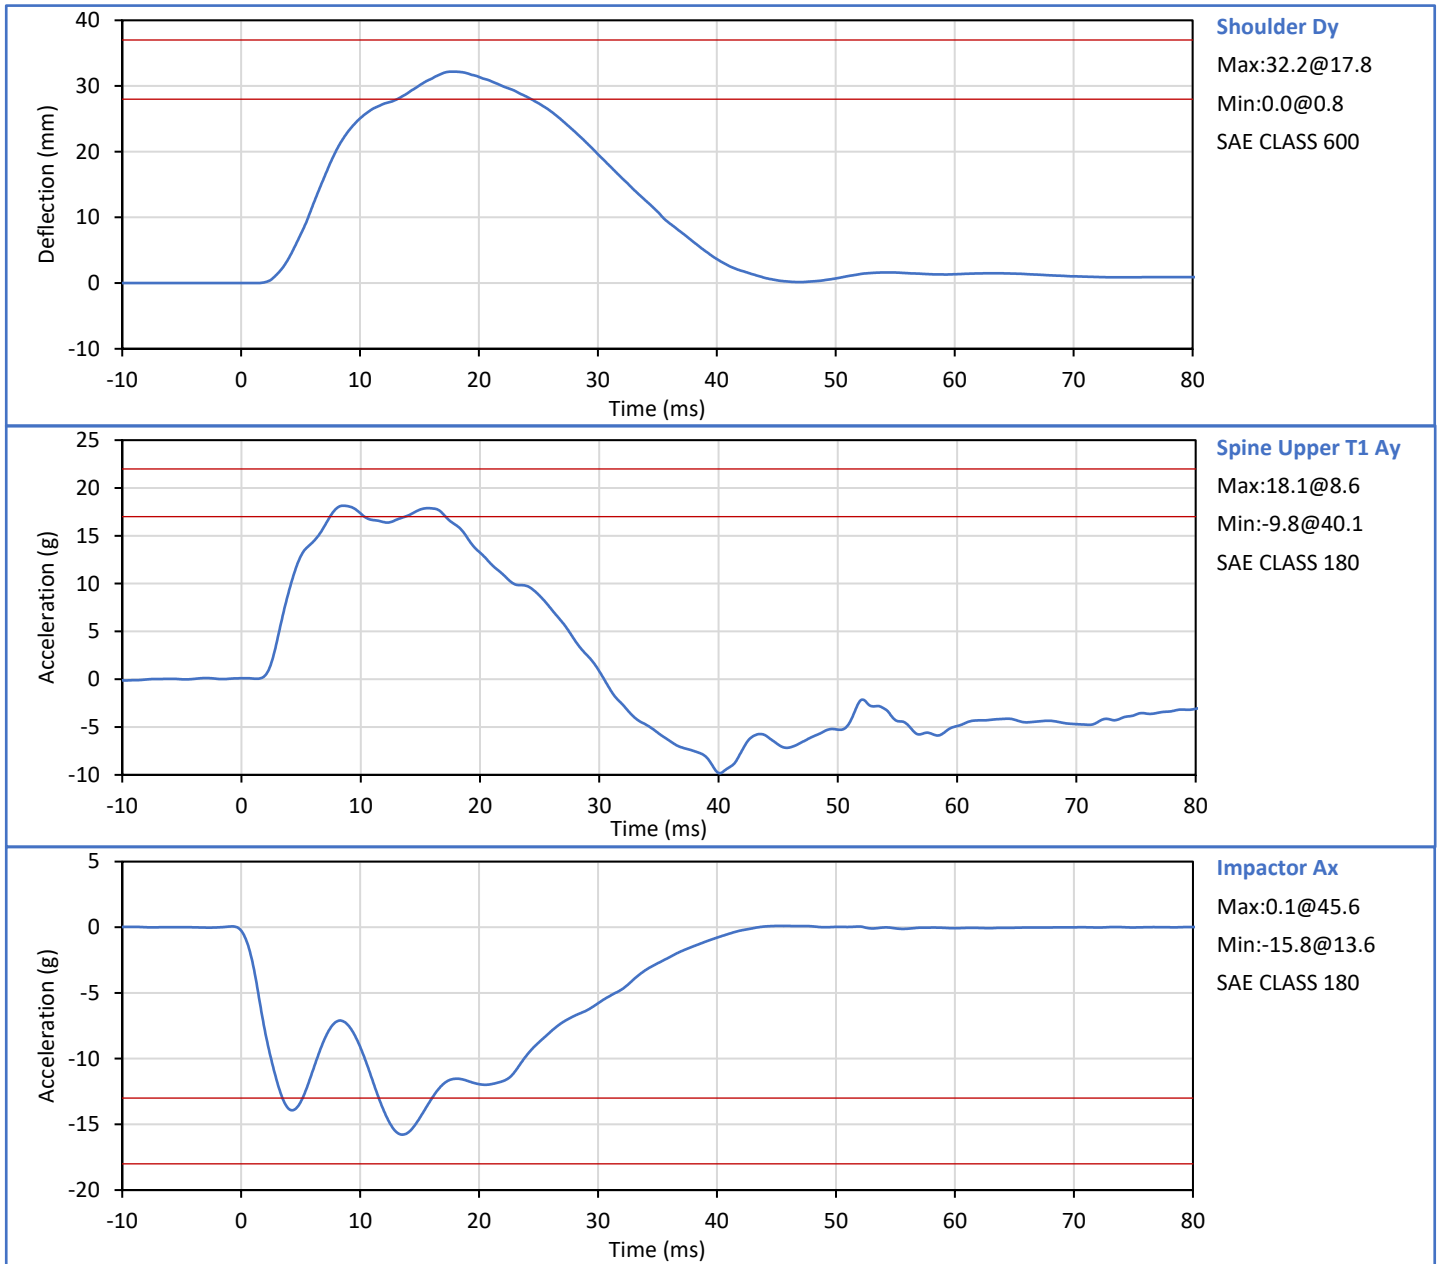
Tested Parameter	Units	Spec. Low	Spec. High	Result	Pass/Fail
Laboratory Temperature	°C	20.6	22.2	21.7	Pass
Laboratory Relative Humidity	%	10	70	47	Pass
Impactor Velocity	m/s	4.20	4.40	4.33	Pass
Peak Shoulder Dy	mm	28.0	37.0	32.2	Pass
Peak Upper Spine (T1) Ay	g	17.0	22.0	18.1	Pass
Peak Impactor Ax	g	-18.0	-13.0	-15.8	Pass
Overall Test Results					Pass

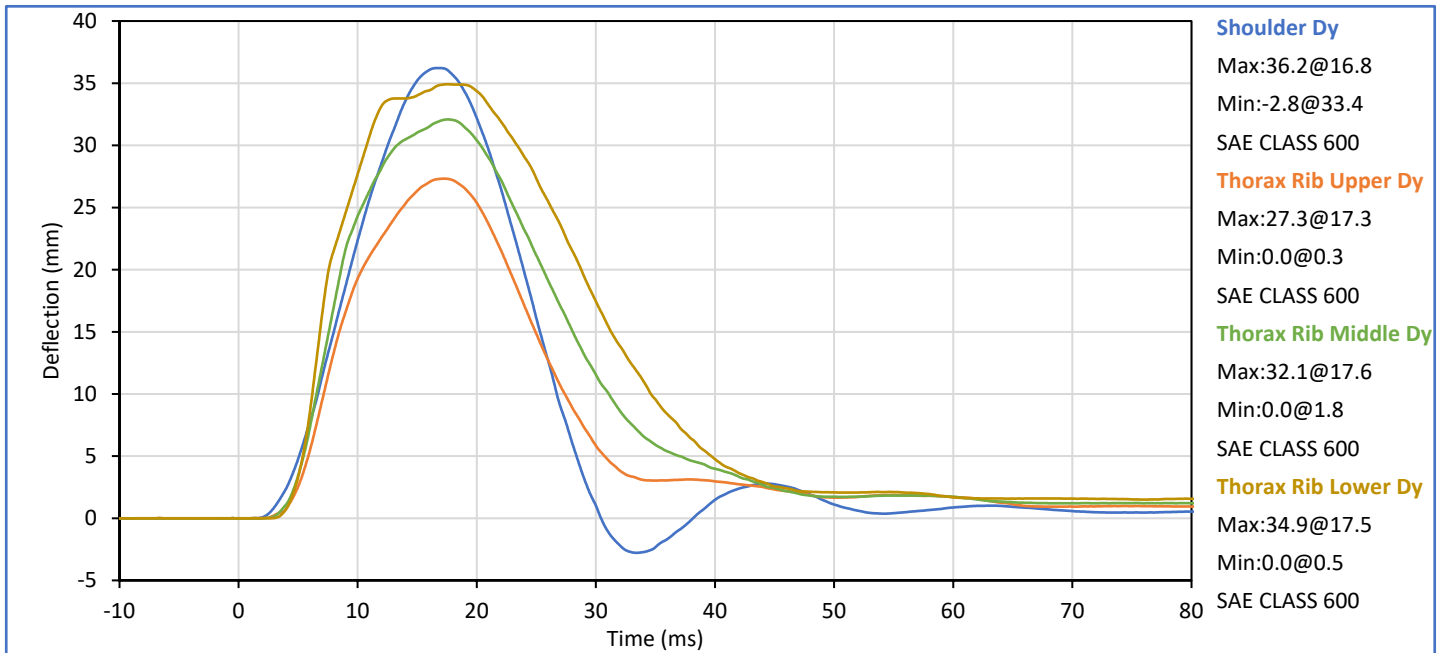
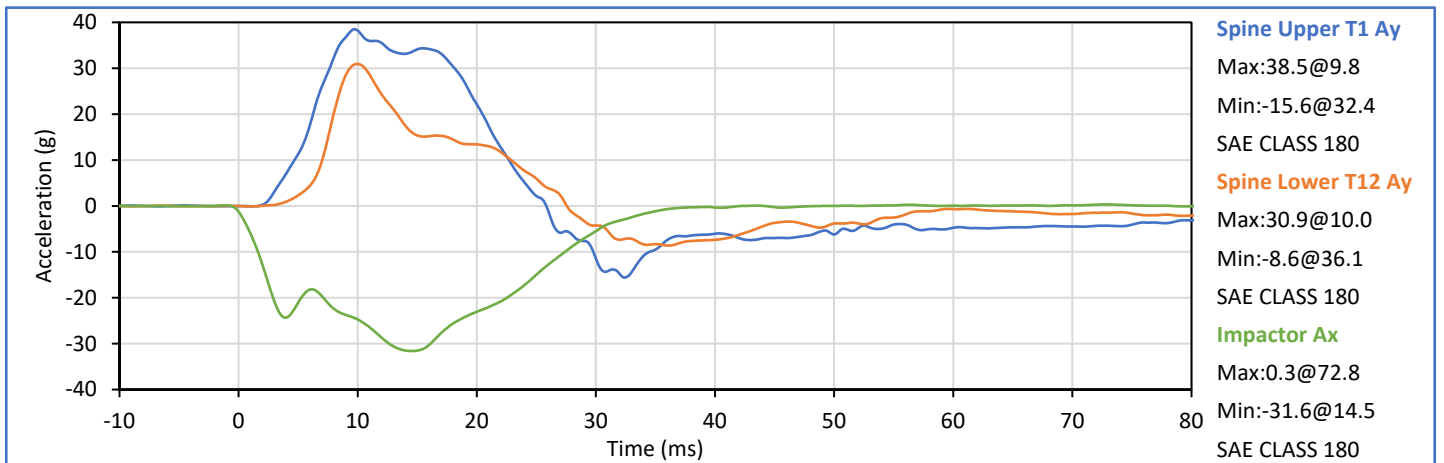
Tested Parameter	Units	Spec. Low	Spec. High	Result	Pass/Fail
Laboratory Temperature	°C	20.6	22.2	21.7	Pass
Laboratory Relative Humidity	%	10	70	47	Pass
Impactor Velocity	m/s	6.60	6.80	6.74	Pass
Peak Shoulder Dy	mm	31.0	40.0	36.2	Pass
Peak Upper Rib Dy	mm	25.0	32.0	27.3	Pass
Peak Middle Rib Dy	mm	30.0	36.0	32.1	Pass
Peak Lower Rib Dy	mm	32.0	38.0	34.9	Pass
Peak Upper Spine (T1) Ay	g	34.0	43.0	38.5	Pass
Peak Lower Spine (T12) Ay	g	29.0	37.0	30.9	Pass
Peak Impactor Ax	g	-36.0	-30.0	-31.6	Pass
Overall Test Results					Pass
