REPORT NUMBER: SideNCAPMDB-KAR-21-012

**NEW CAR ASSESSMENT PROGRAM (NCAP)
MOVING DEFORMABLE BARRIER SIDE IMPACT TEST**

**HYUNDAI MOTOR COMPANY
2021 GENESIS G80 4-DOOR SEDAN**

NHTSA No: O20214214

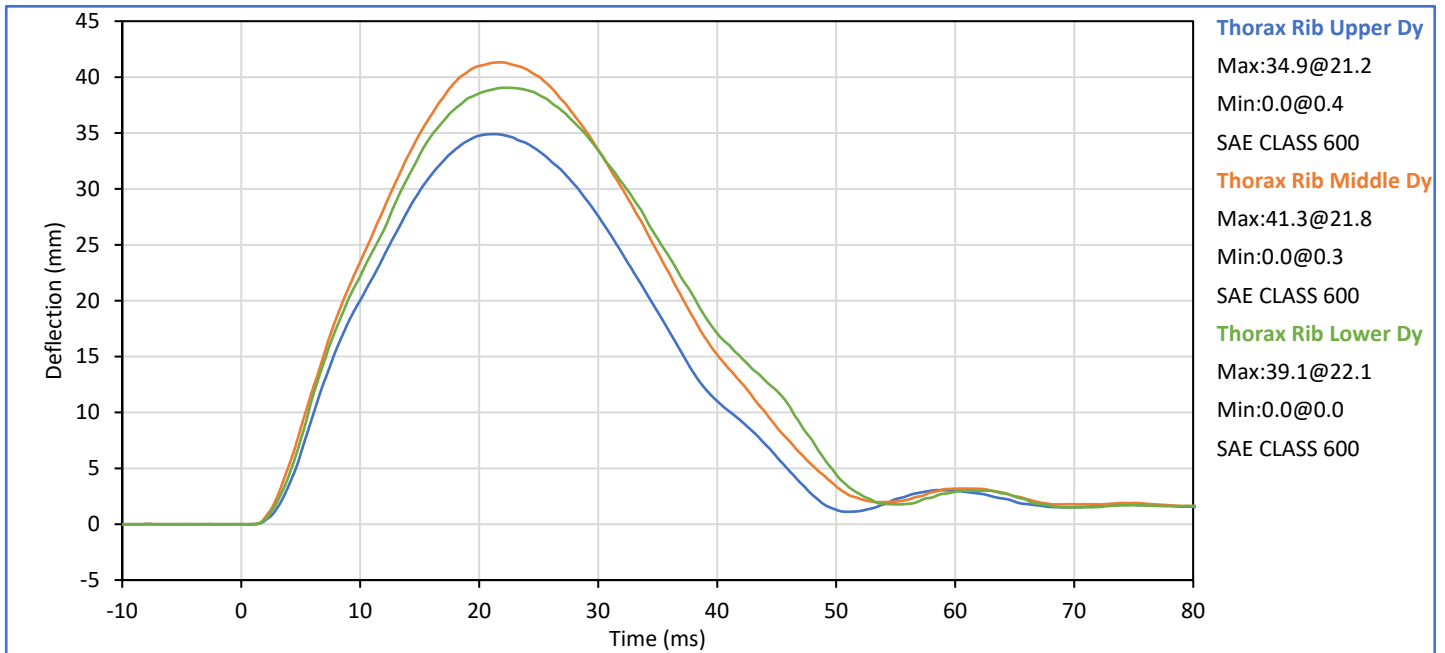
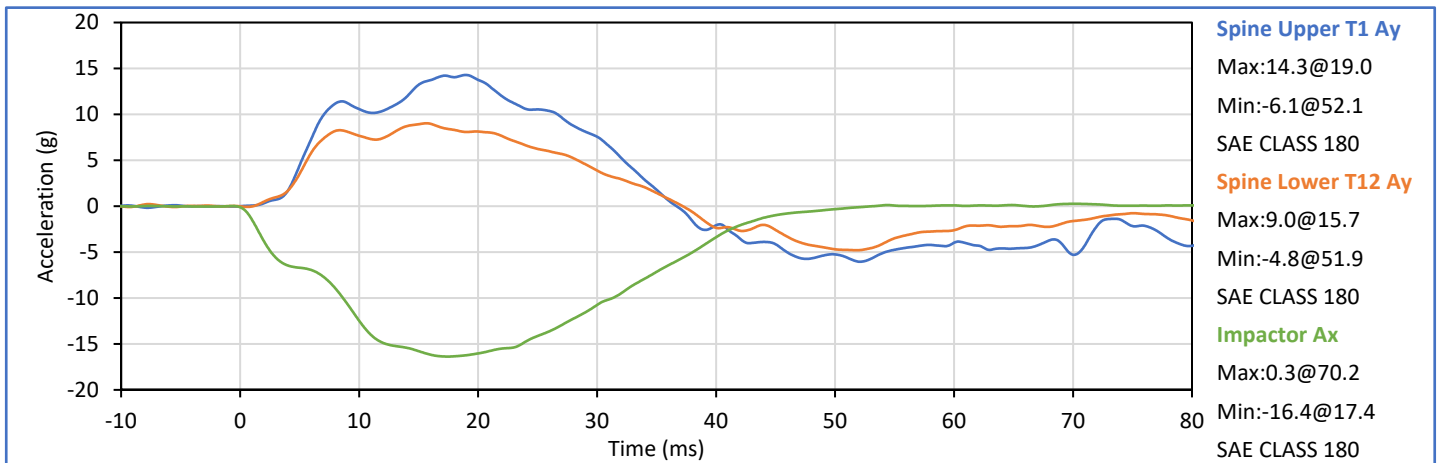
Tested Parameter	Units	Spec. Low	Spec. High	Result	Pass/Fail
Laboratory Temperature	°C	20.6	22.2	21.7	Pass
Laboratory Relative Humidity	%	10	70	47	Pass
Impactor Velocity	m/s	4.20	4.40	4.31	Pass
Peak Thorax Rib Upper Dy	mm	32.0	40.0	34.9	Pass
Peak Thorax Rib Middle Dy	mm	39.0	45.0	41.3	Pass
Peak Thorax Rib Lower Dy	mm	35.0	43.0	39.1	Pass
Peak Spine Upper T1 Ay	g	13.0	17.0	14.3	Pass
Peak Spine Lower T12 Ay	g	7.0	11.0	9.0	Pass
Peak Impactor Ax	g	-18.0	-14.0	-16.4	Pass
Overall Test Results					Pass

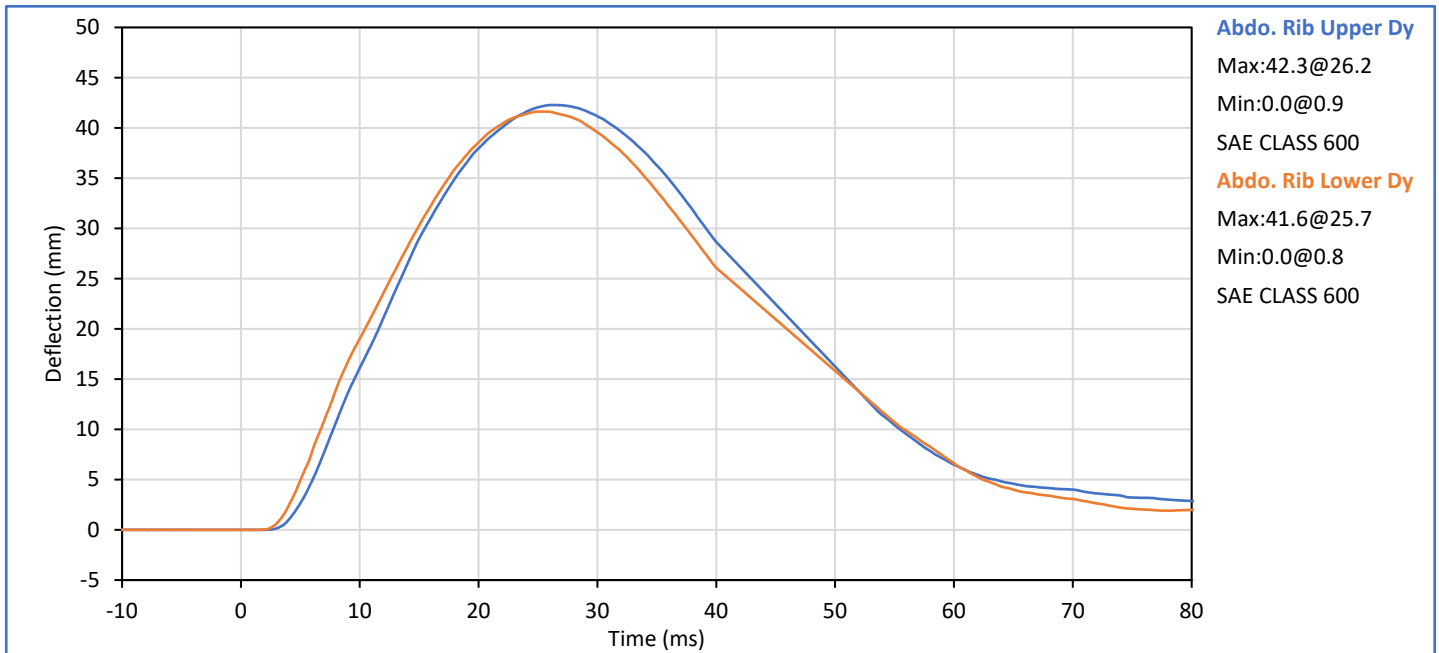
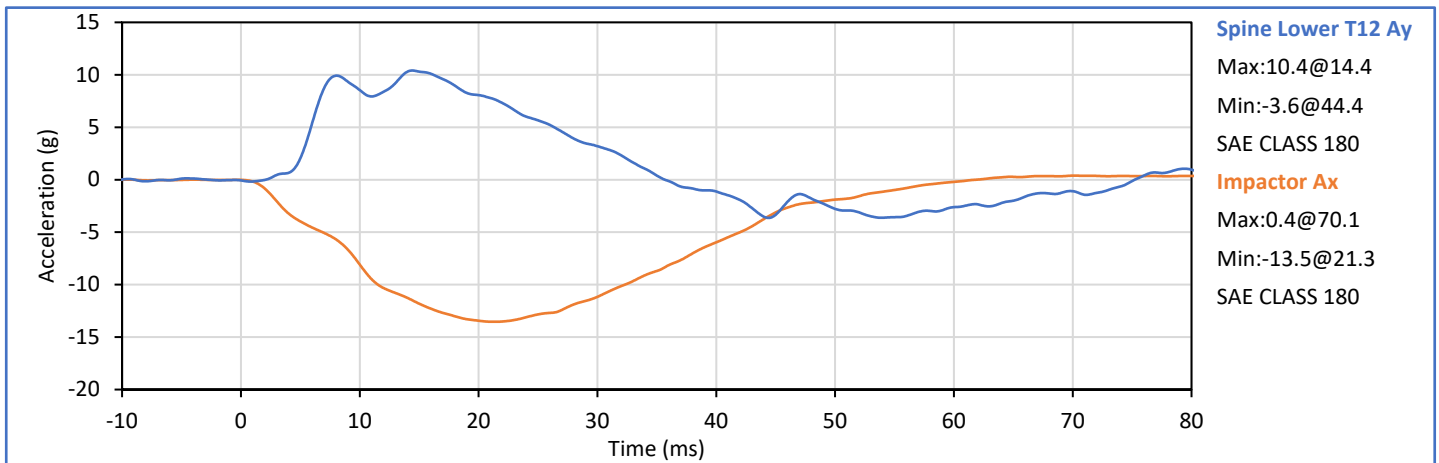
Tested Parameter	Units	Spec. Low	Spec. High	Result	Pass/Fail
Laboratory Temperature	°C	20.6	22.2	21.7	Pass
Laboratory Relative Humidity	%	10	70	47	Pass
Impactor Velocity	m/s	4.20	4.40	4.34	Pass
Peak Upper Abdomen Rib Dy	mm	36.0	47.0	42.3	Pass
Peak Lower Abdomen Rib Dy	mm	33.0	44.0	41.6	Pass
Peak Lower Spine T12 Ay	mm	9.0	14.0	10.4	Pass
Peak Impactor Ax	g	-16.0	-12.0	-13.5	Pass
Overall Test Results					Pass

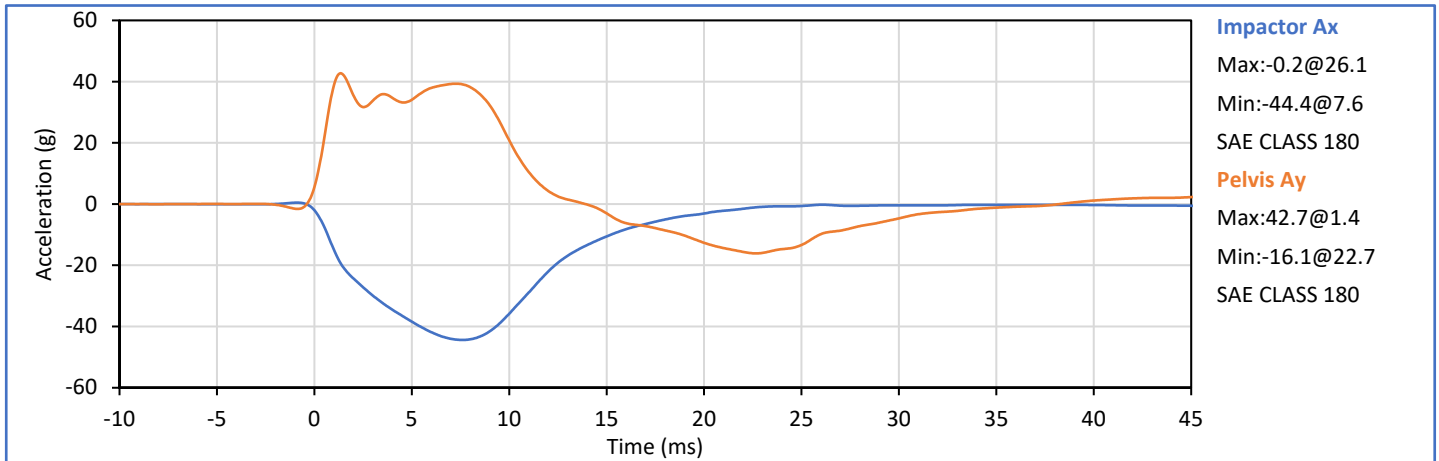
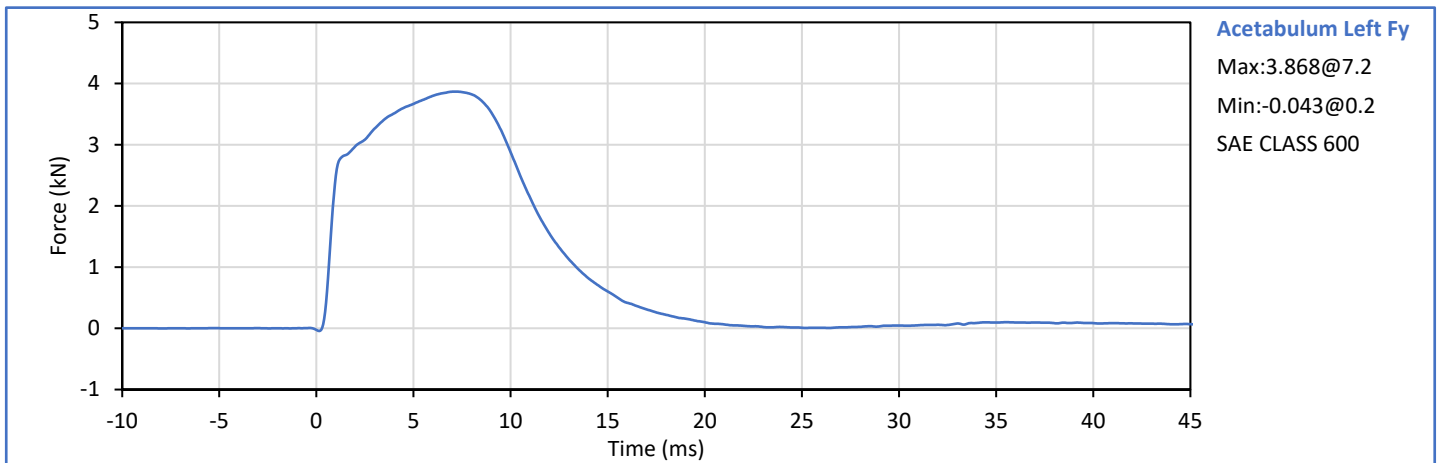
Tested Parameter	Units	Spec. Low	Spec. High	Result	Pass/Fail
Laboratory Temperature	°C	20.6	22.2	21.7	Pass
Laboratory Relative Humidity	%	10	70	47	Pass
Impactor Velocity	m/s	6.60	6.80	6.72	Pass
Peak Acetabulum Fy	kN	3.60	4.30	3.87	Pass
Pelvis Ay after 6ms	g	34.0	42.0	39.3	Pass
Peak Impactor Ax	g	-47.0	-38.0	-44.4	Pass
Overall Test Results					Pass
