REPORT NUMBER: TWG-MGA-20-003

**SIDE AIRBAG OUT-OF-POSITION INJURY
TECHNICAL WORKING GROUP**

**NISSAN MOTOR CO., LTD.
2020 Nissan Titan SV 4x4 Crew Cab Truck
NHTSA No.: M20205212TWG2**

FINAL REPORT

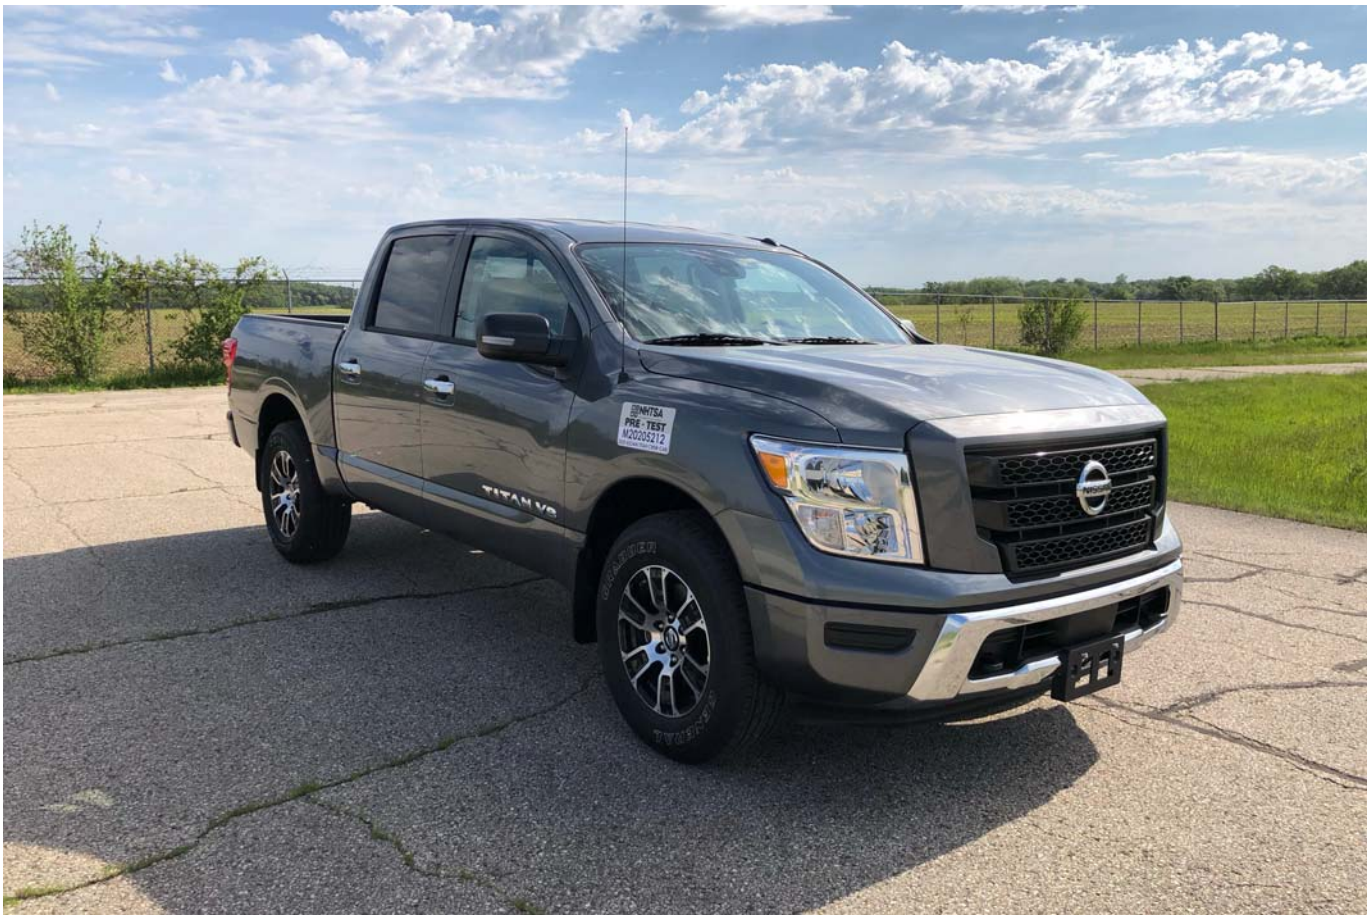
Photo No. 001 - Right Three-Quarter Front View of Vehicle, As Received

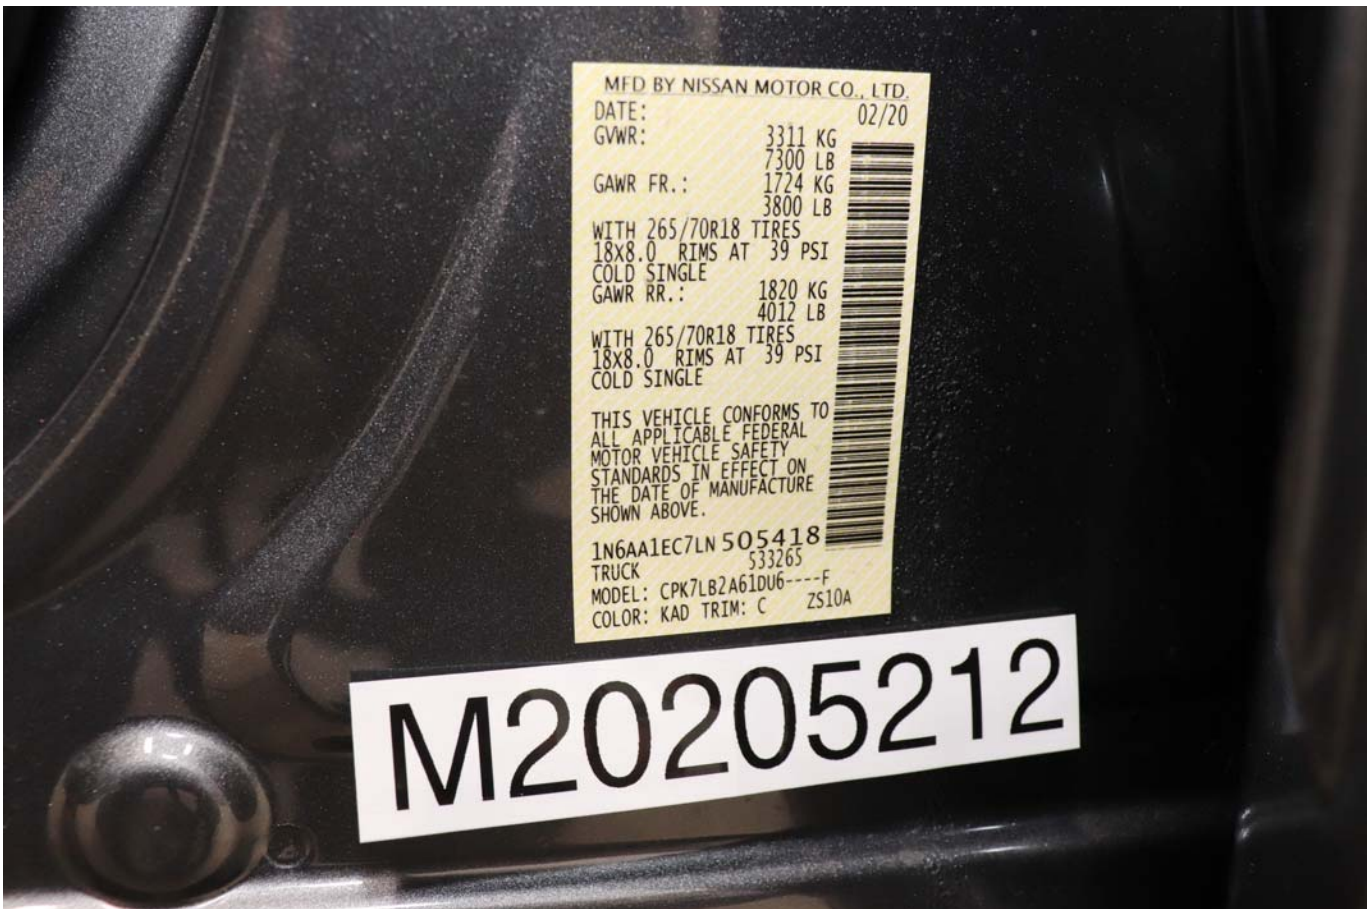
Photo No. 002 - Vehicle Certification Placard

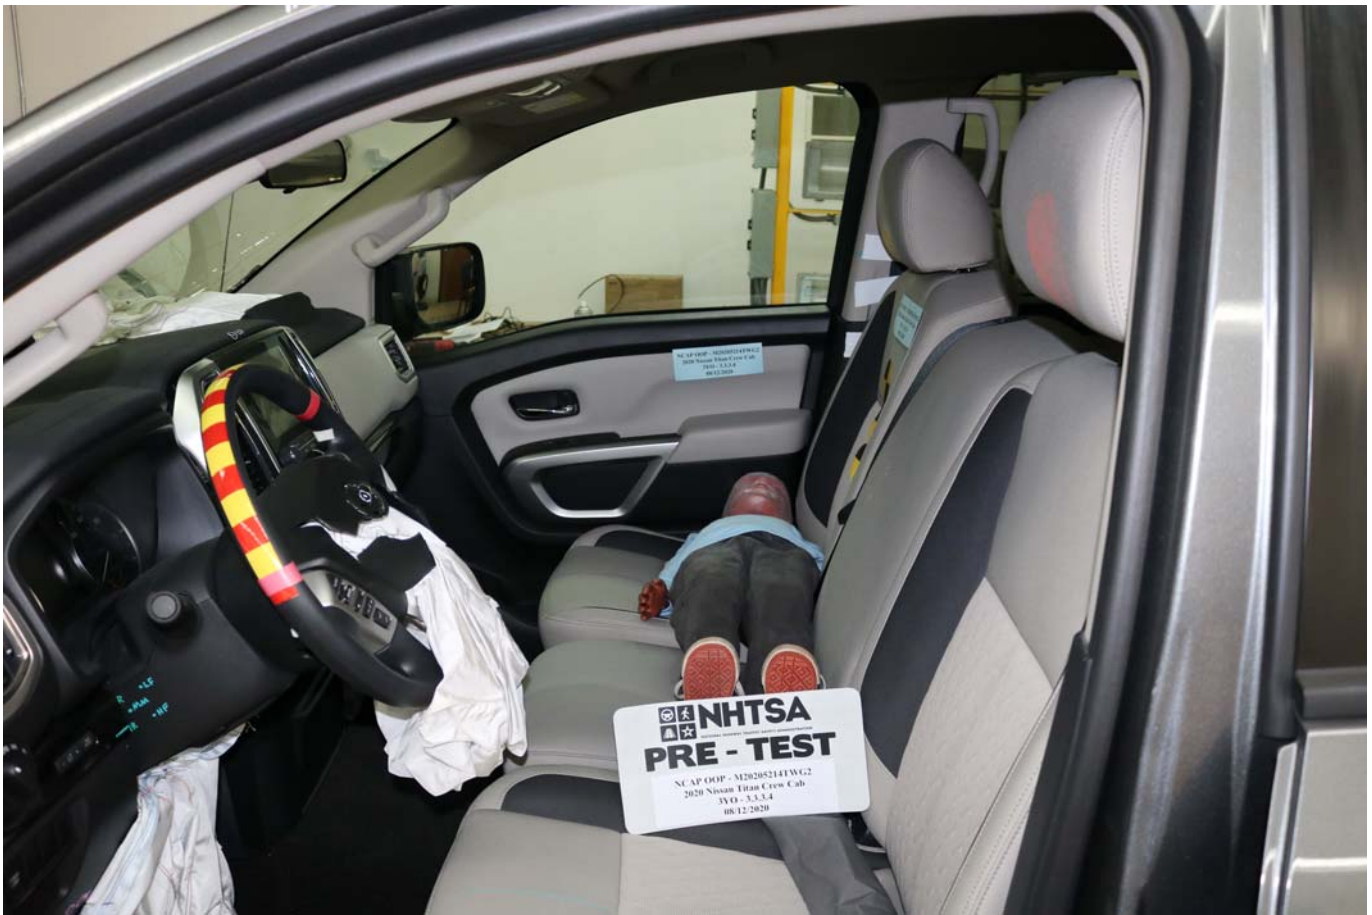
Photo No. 005 - Pre-Test Dummy Left Side View

The Hybrid III 3-Year-Old child dummy was placed in the right front passenger seat. The dummy was placed on the seat, lying on its back with its arms at its sides so that its rearmost arm contacts the seatback. The dummy was slid outboard until the CG of the head is aligned with the vertical centerline of the airbag module. The dummy's legs were supported by the center seat cushion. Clearance between the dummy's head and the right front passenger door panel was minimized while avoiding contact.

The dummy's skullcap seam was covered with 4mm electrical tape to prevent the airbag from getting caught in the seam. The dummy's head skin was cleaned with alcohol and dusted with baby powder to achieve acceptable frictional characteristics.

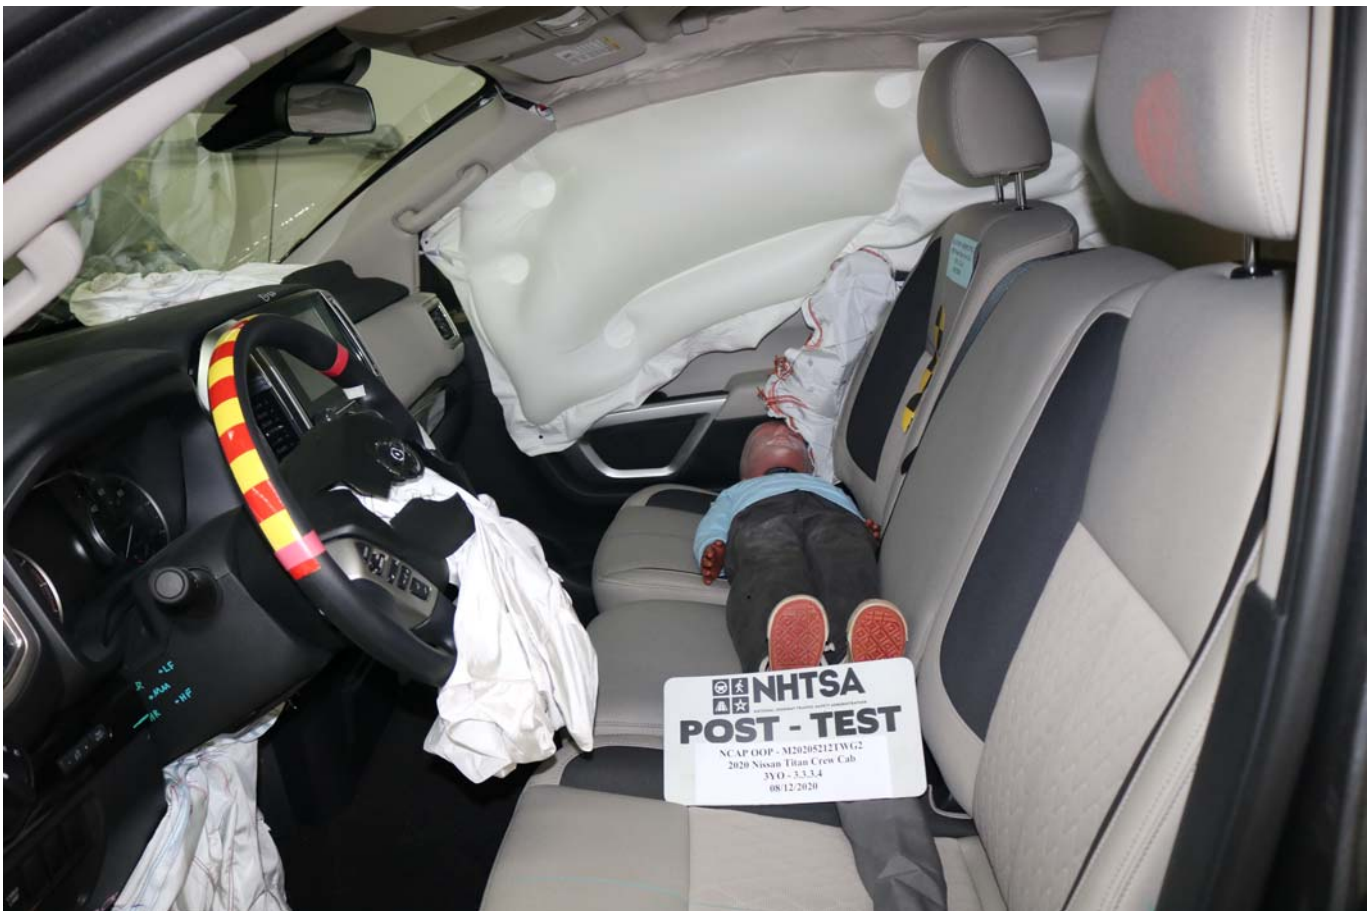
Photo No. 006 - Post-Test Dummy Left Side View

- Side torso/pelvis airbag to side of head

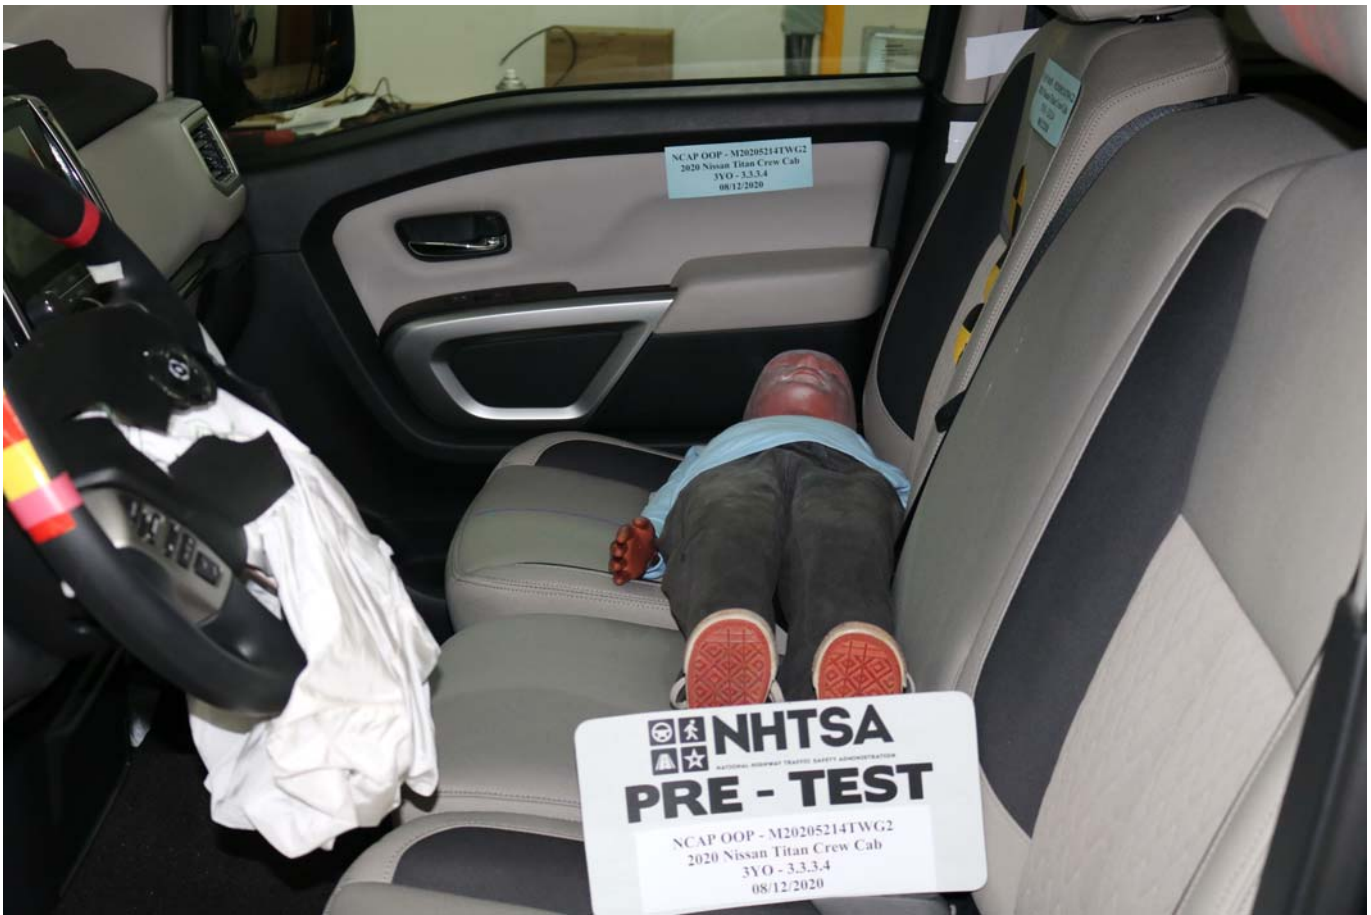
Photo No. 007 - Pre-Test Dummy Left Side Close-Up View

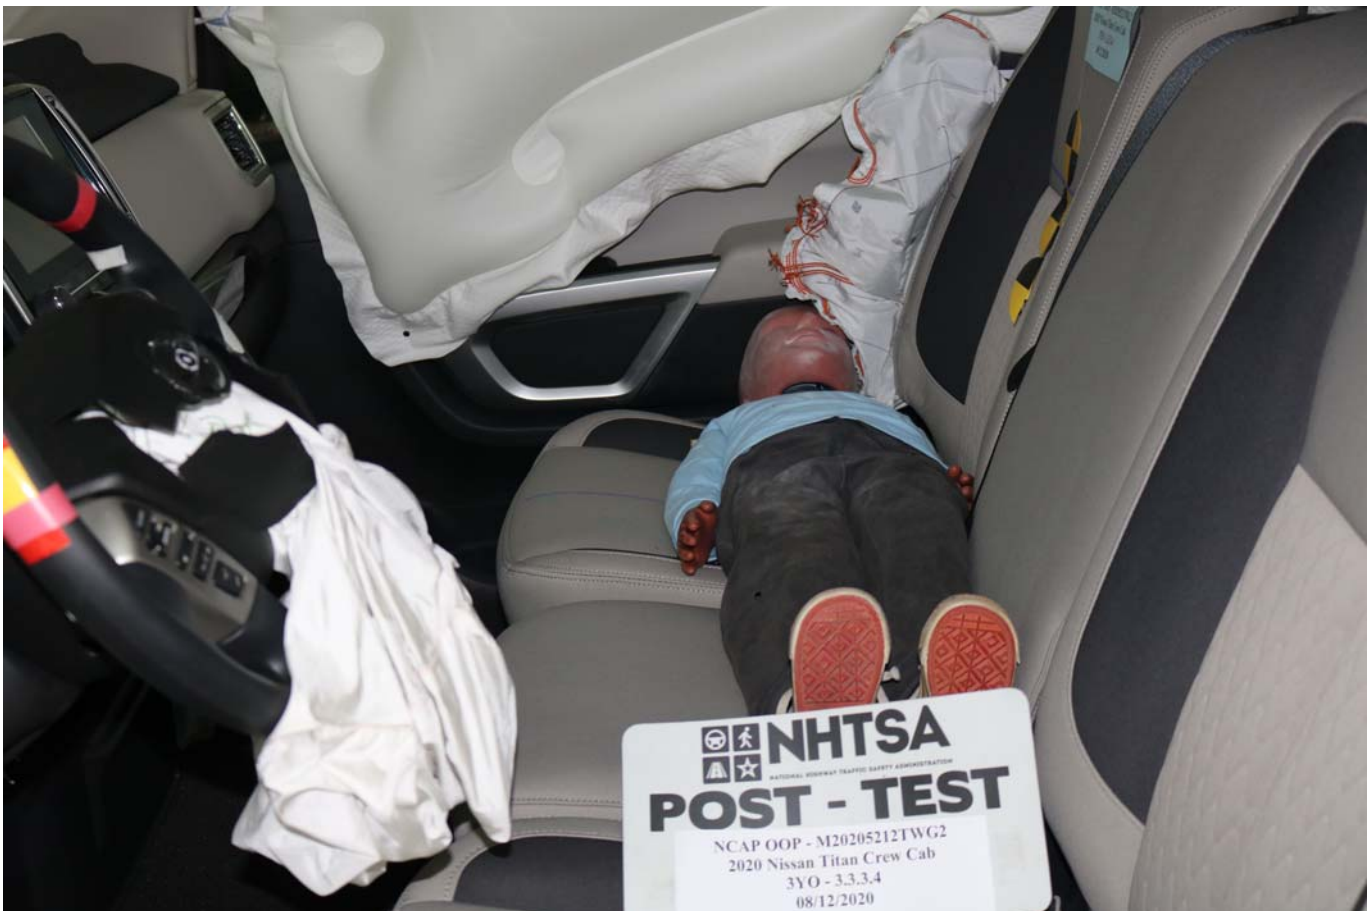
Photo No. 008 - Post-Test Dummy Left Side Close-Up View

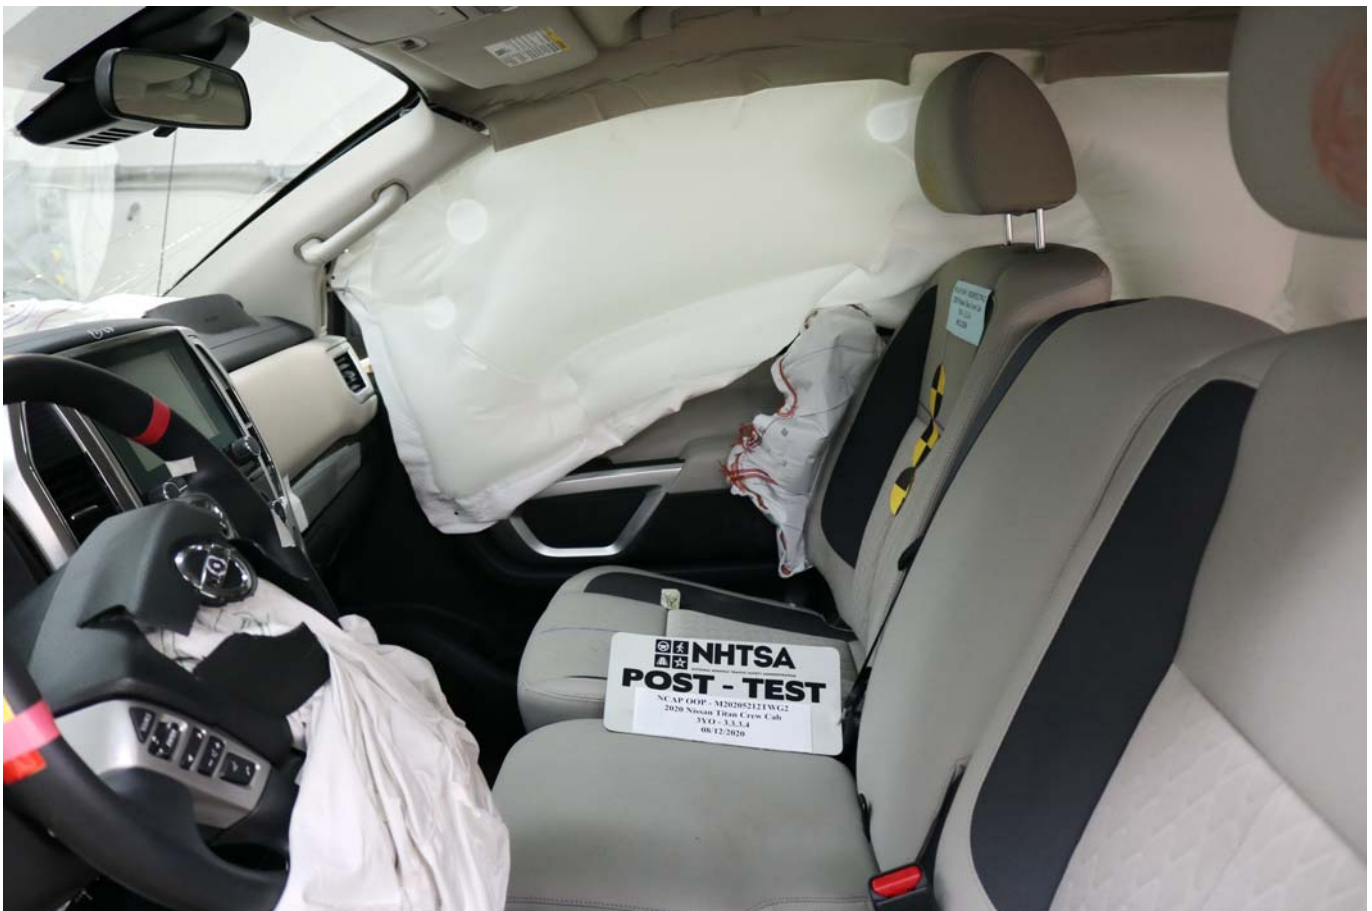
Photo No. 022 - Post-Test Curtain Airbag Left Side View

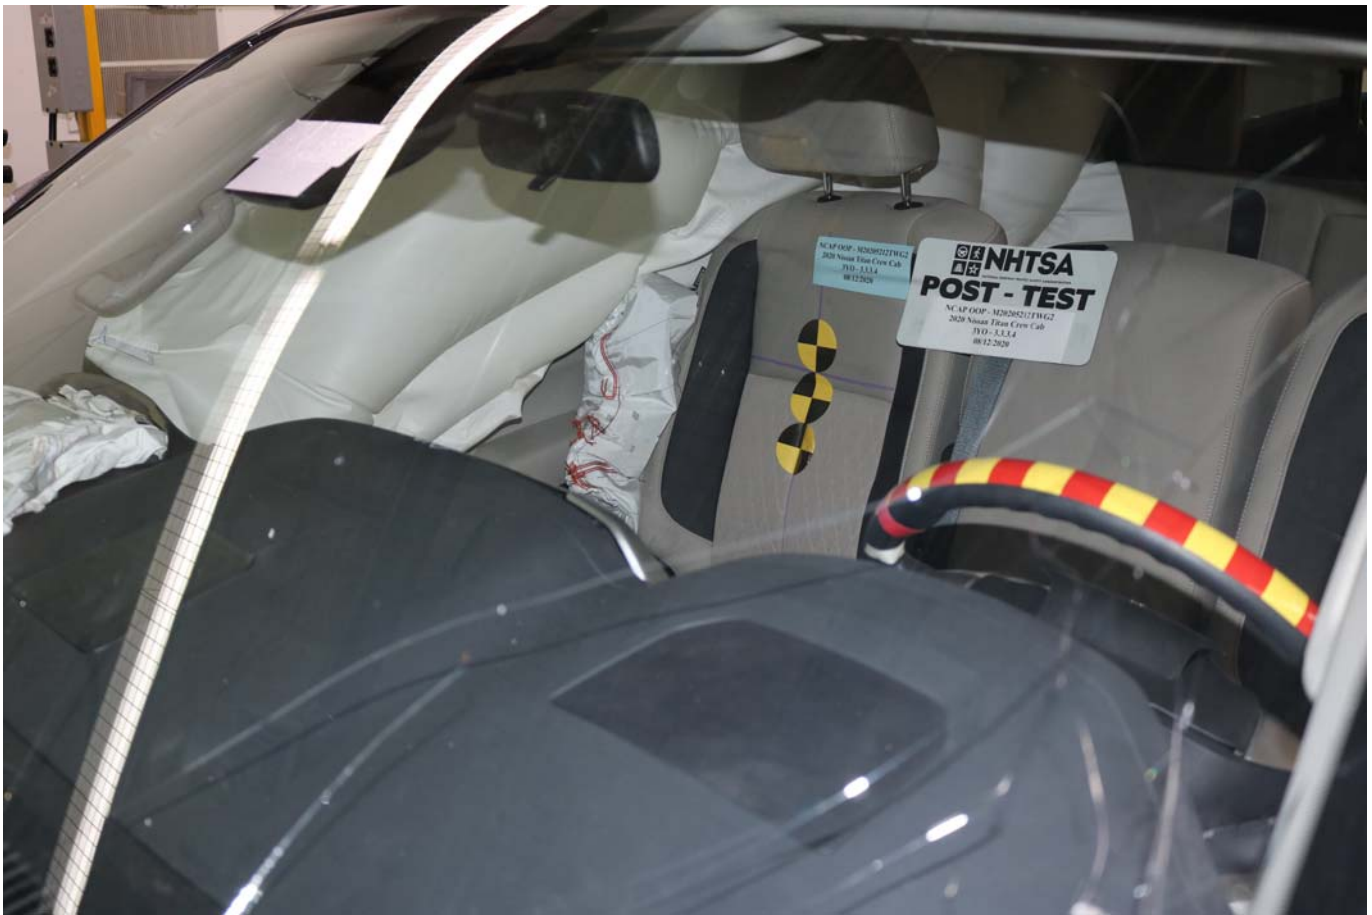
Photo No. 023 - Post-Test Curtain Airbag Left Three-Quarter Front View

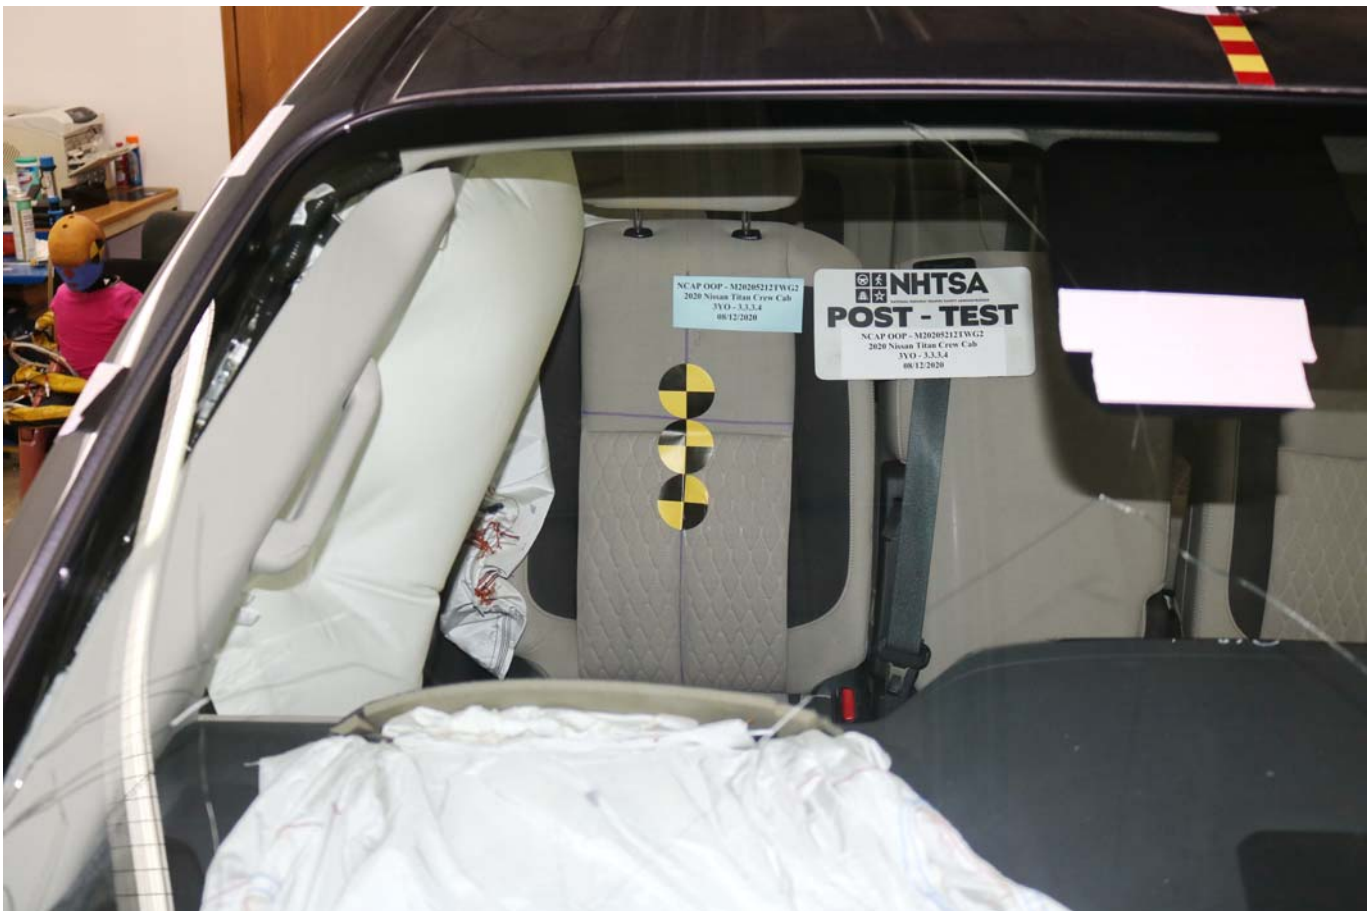
Photo No. 024 - Post-Test Curtain Airbag Front View

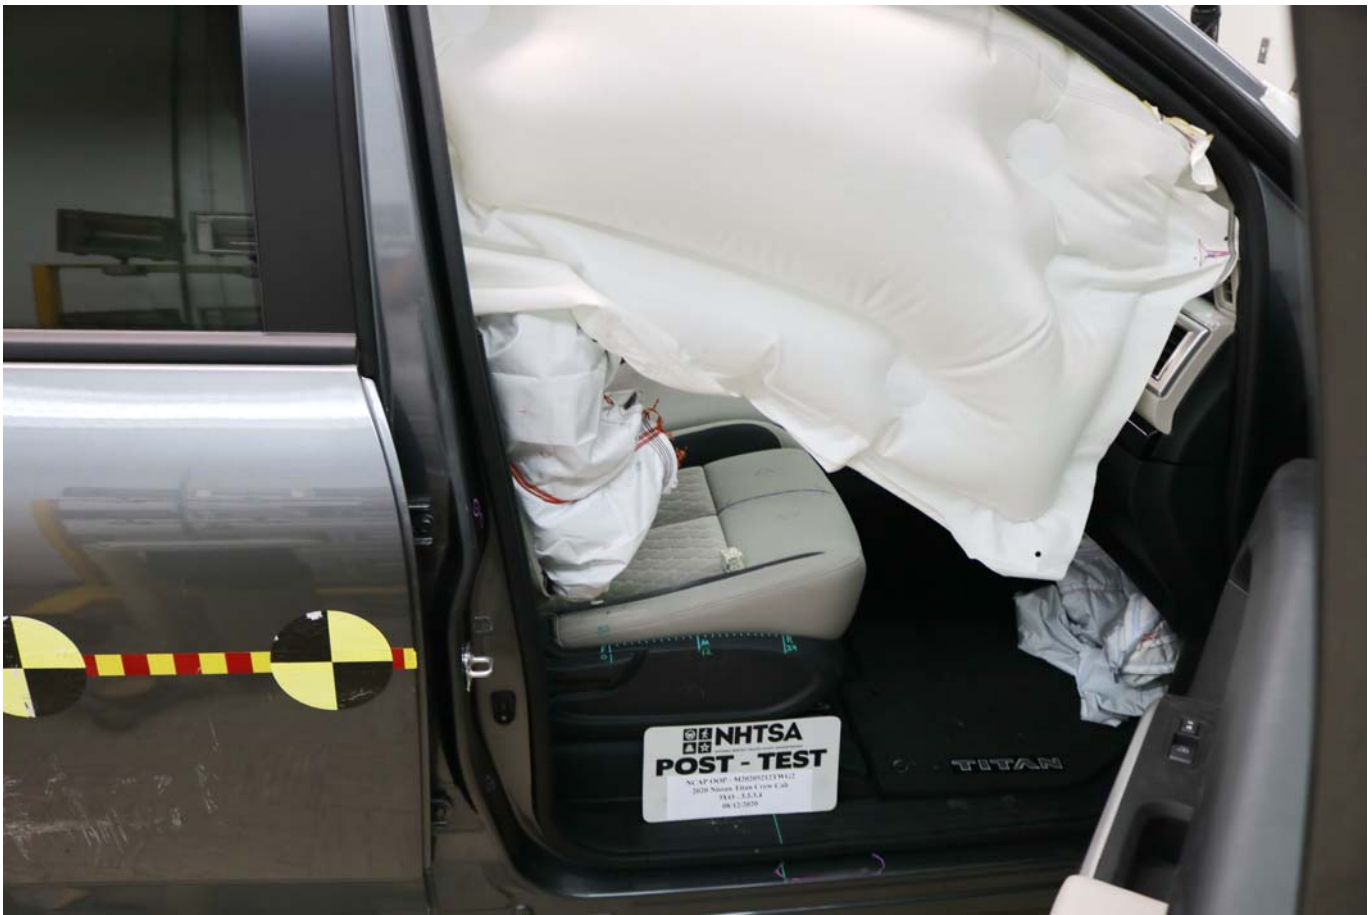
Photo No. 025 - Post-Test Curtain Airbag Right Side View (Door Open)

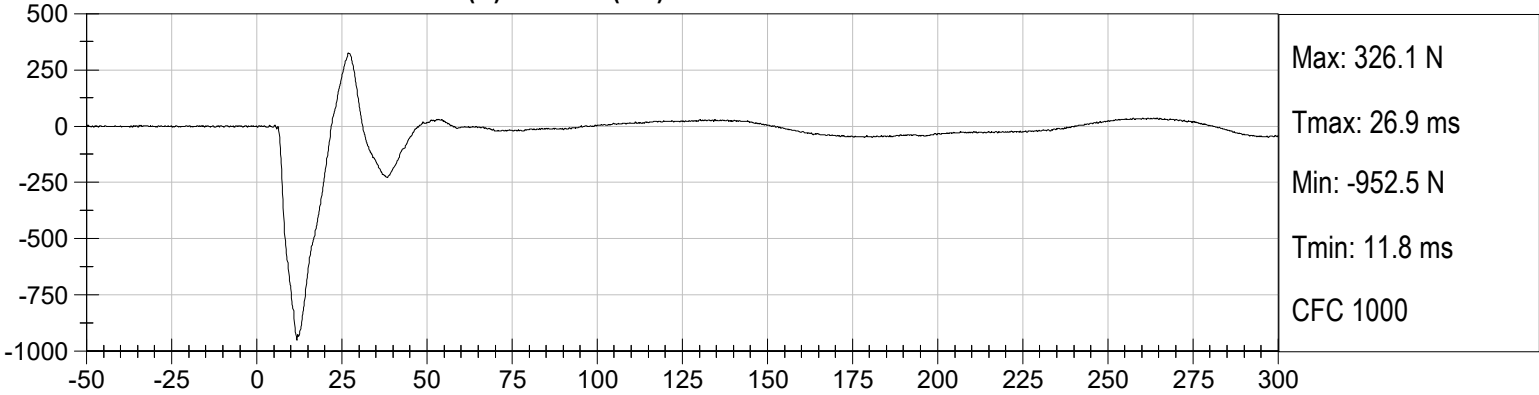
PASSENGER UPPER NECK FResultant (N) vs Time (ms)

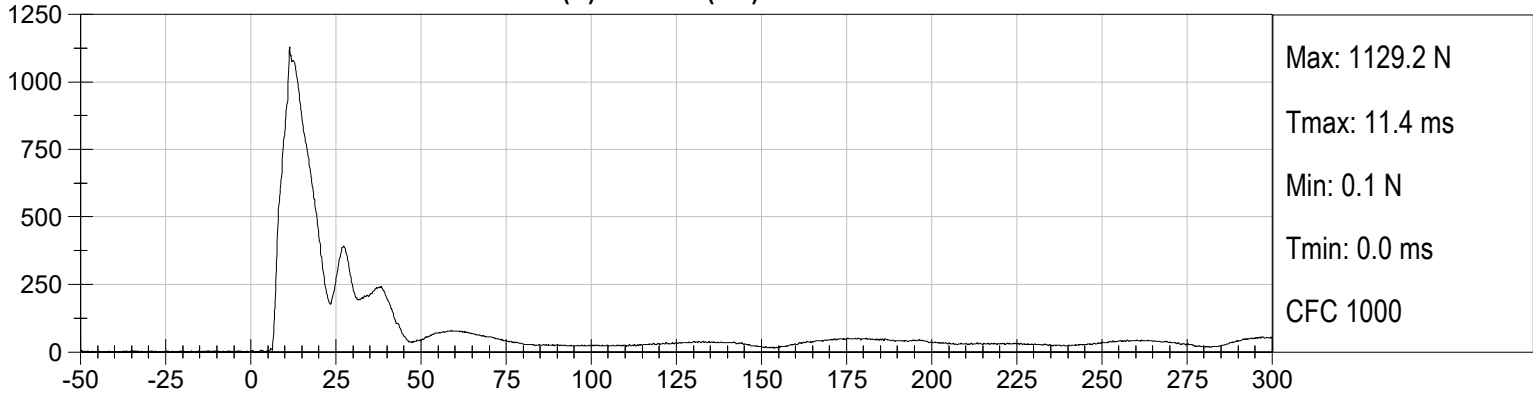
PASSENGER UPPER NECK MX (Nm) vs Time (ms)

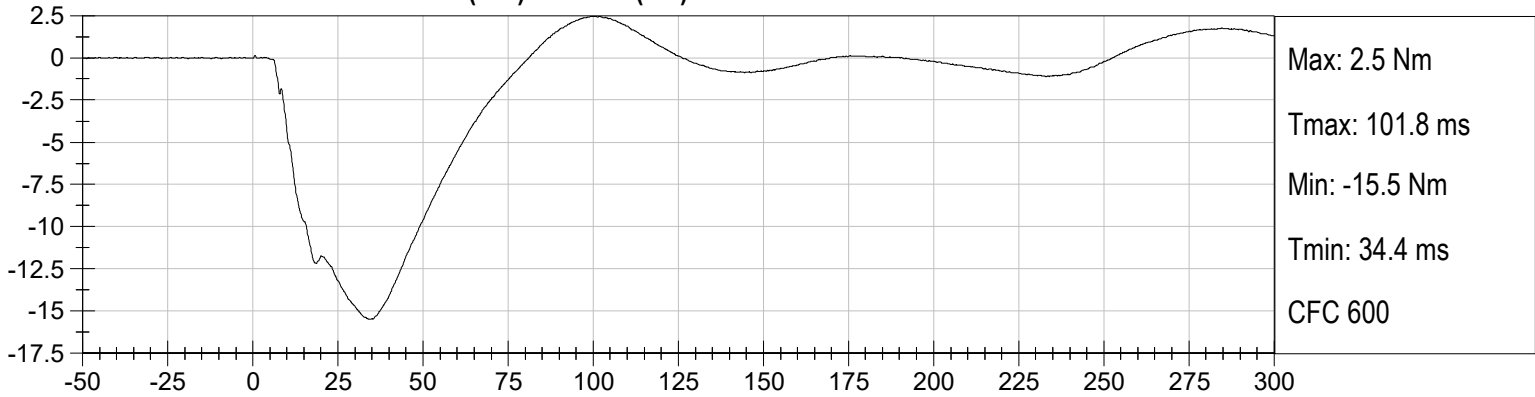
PASSENGER UPPER NECK MResultant (Nm) vs Time (ms)

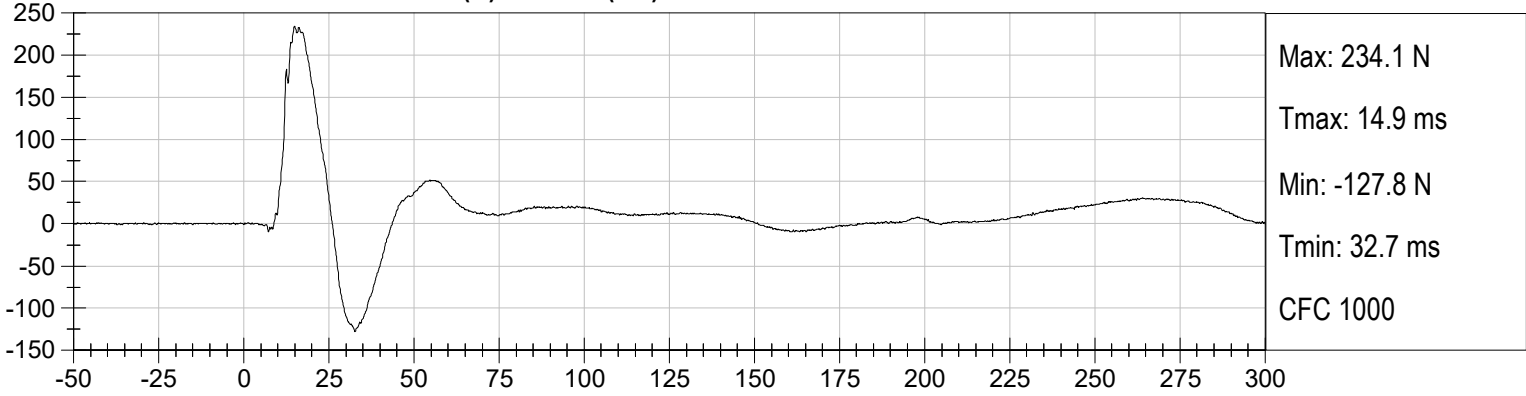
PASSENGER LOWER NECK FY (N) vs Time (ms)

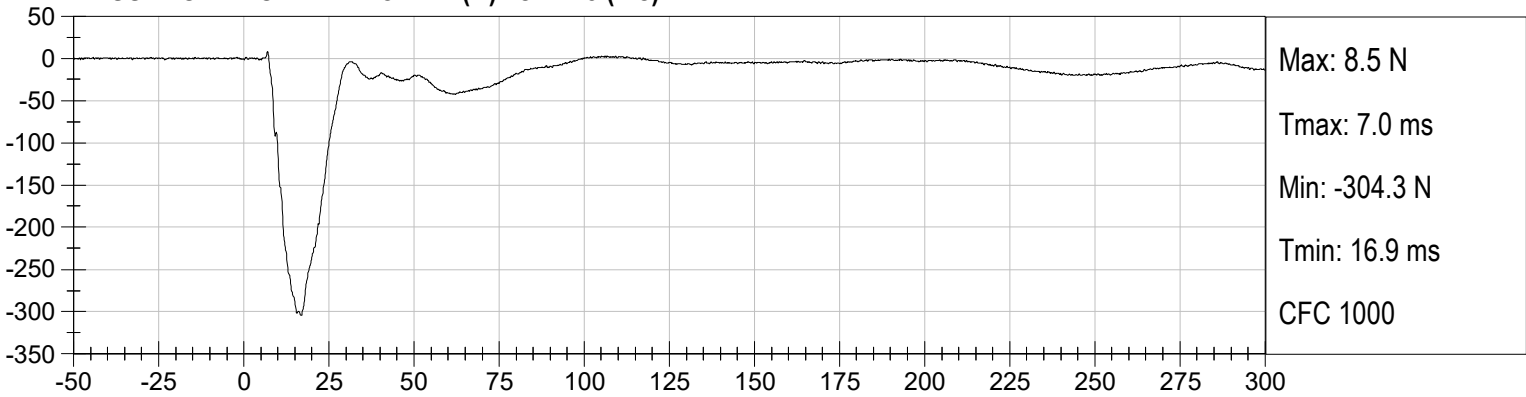
PASSENGER LOWER NECK FZ (N) vs Time (ms)

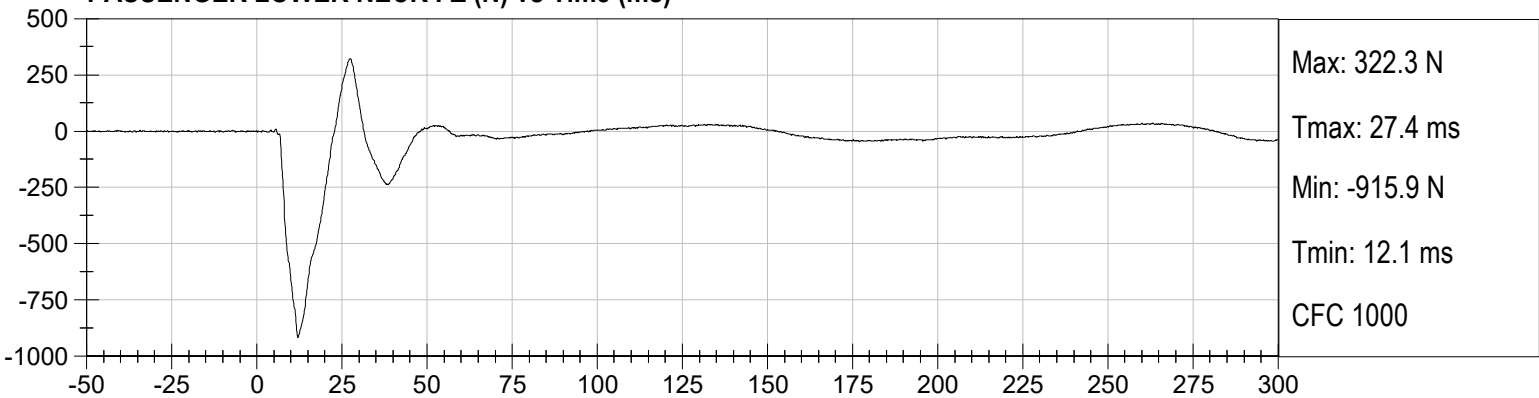
PASSENGER LOWER NECK FResultant (N) vs Time (ms)

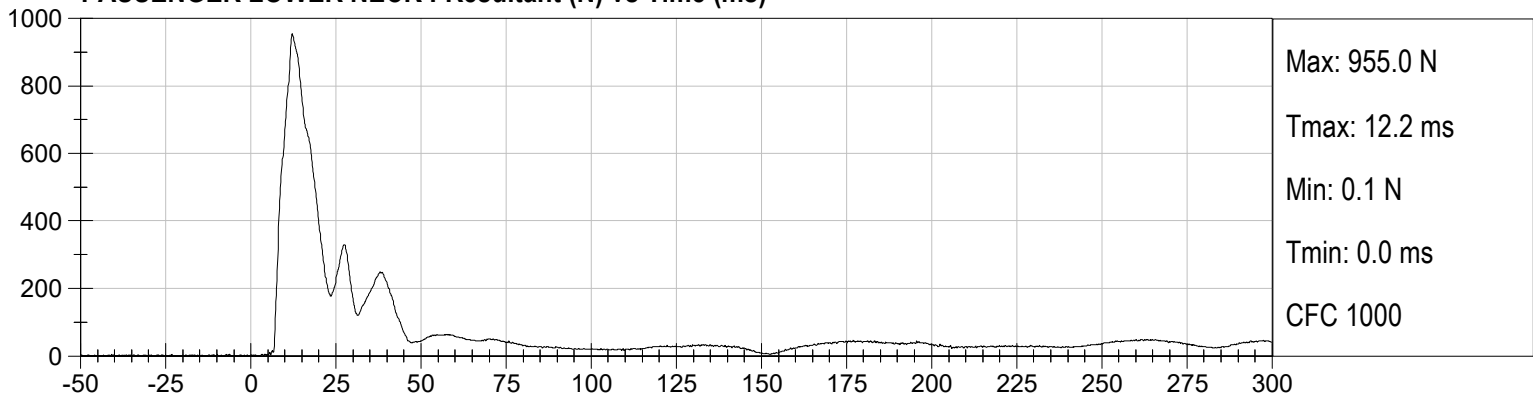
PASSENGER LOWER NECK MX (Nm) vs Time (ms)

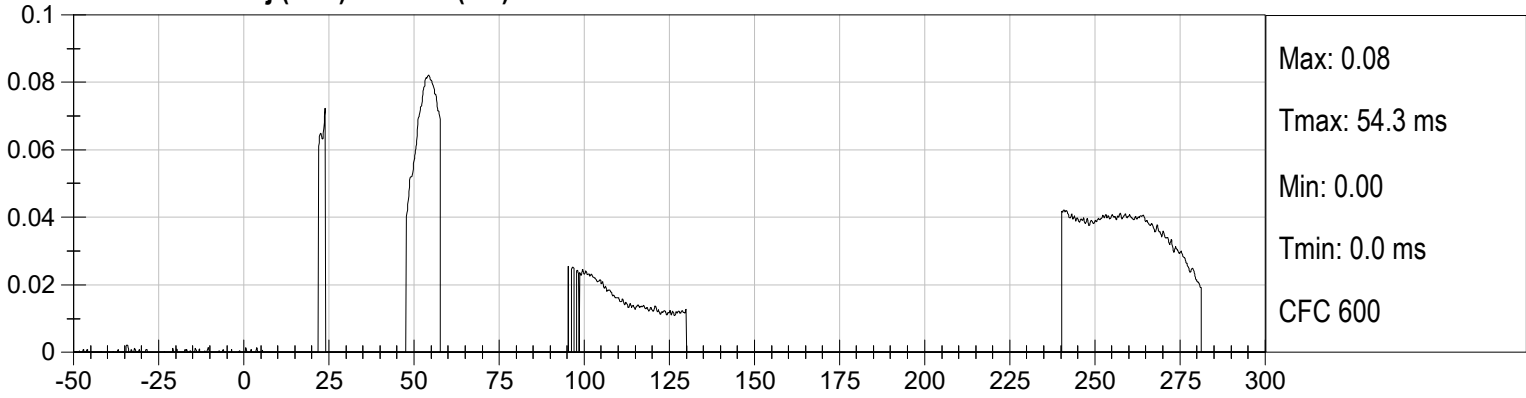
PASSENGER Nij (NTE) vs Time (ms)

Injury Criteria	Unit	Value	Time (ms)
Upper Neck NTF		0.08	54.3
Upper Neck NTE		0.39	28.1
Upper Neck NCF		0.67	12.9
Upper Neck NCE		0.32	33.4
Peak Tension	N	326.1	26.9
Peak Compression	N	952.5	11.8

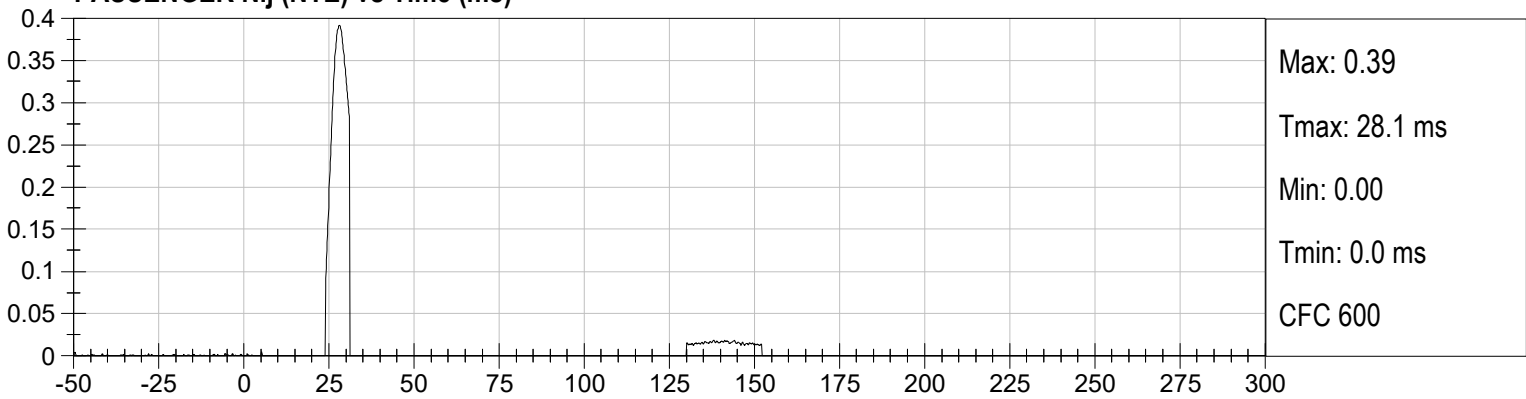
PASSENGER Nij (NCF) vs Time (ms)

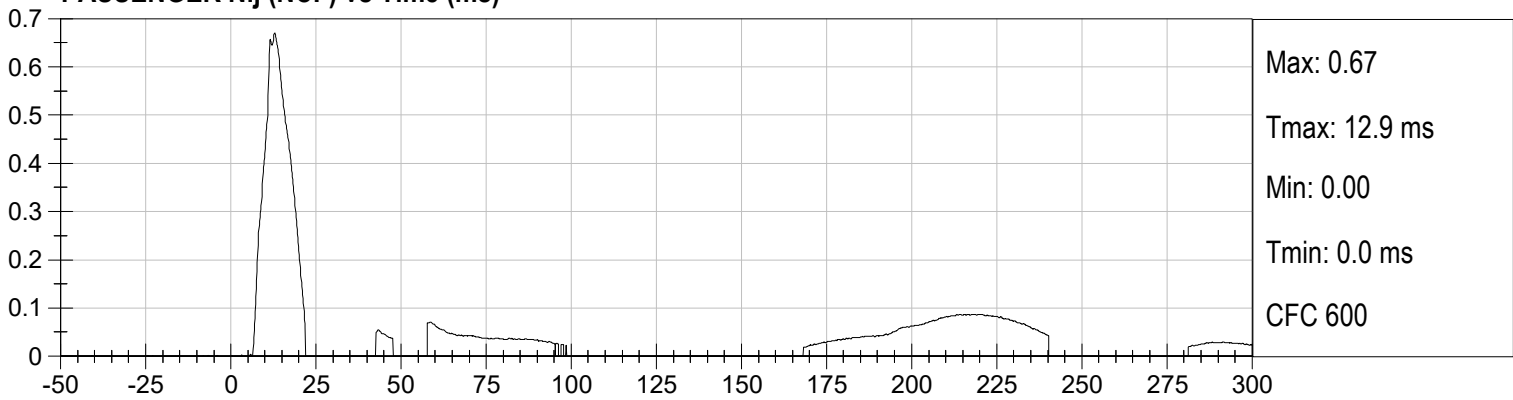
PASSENGER Nij (NCE) vs Time (ms)

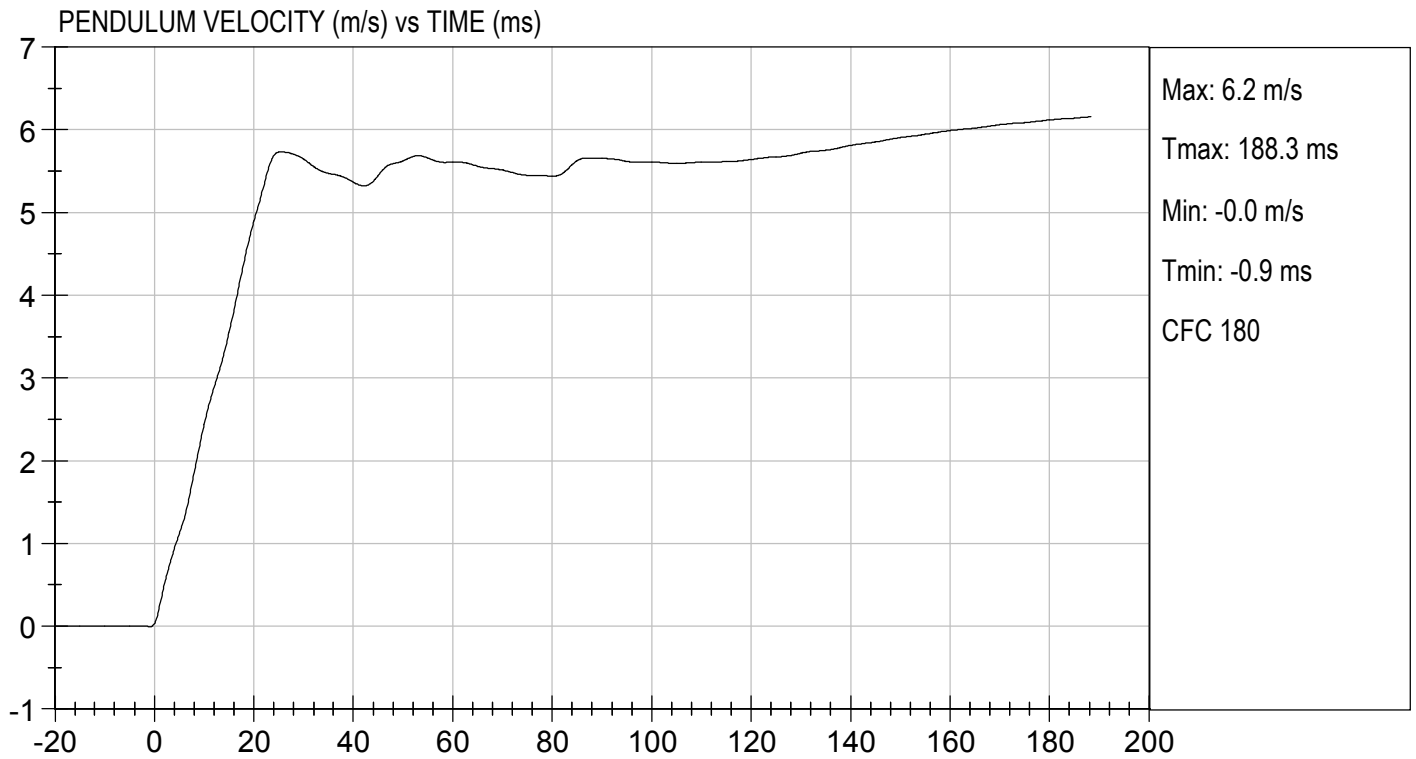
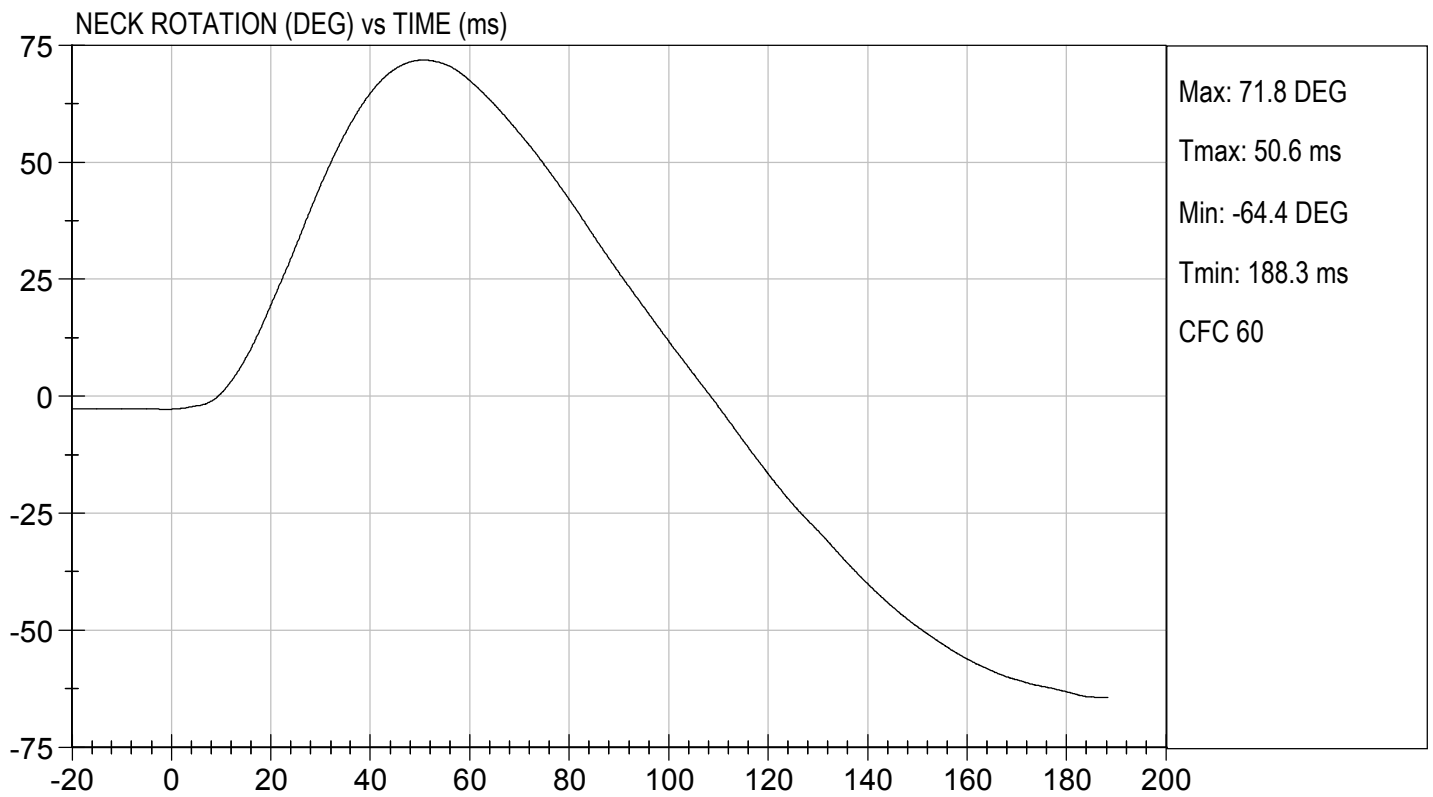
TEST DESC: NECK FLEXION
VELOCITY: 17.92 ft/s, 5.46 m/s

TEST DATE: 07/29/2020
TEST #: D201752
