REPORT NUMBER: TWG-MGA-20-003

**SIDE AIRBAG OUT-OF-POSITION INJURY
TECHNICAL WORKING GROUP**

**NISSAN MOTOR CO., LTD.
2020 Nissan Titan SV 4x4 Crew Cab Truck
NHTSA No.: M20205212TWG2**

FINAL REPORT

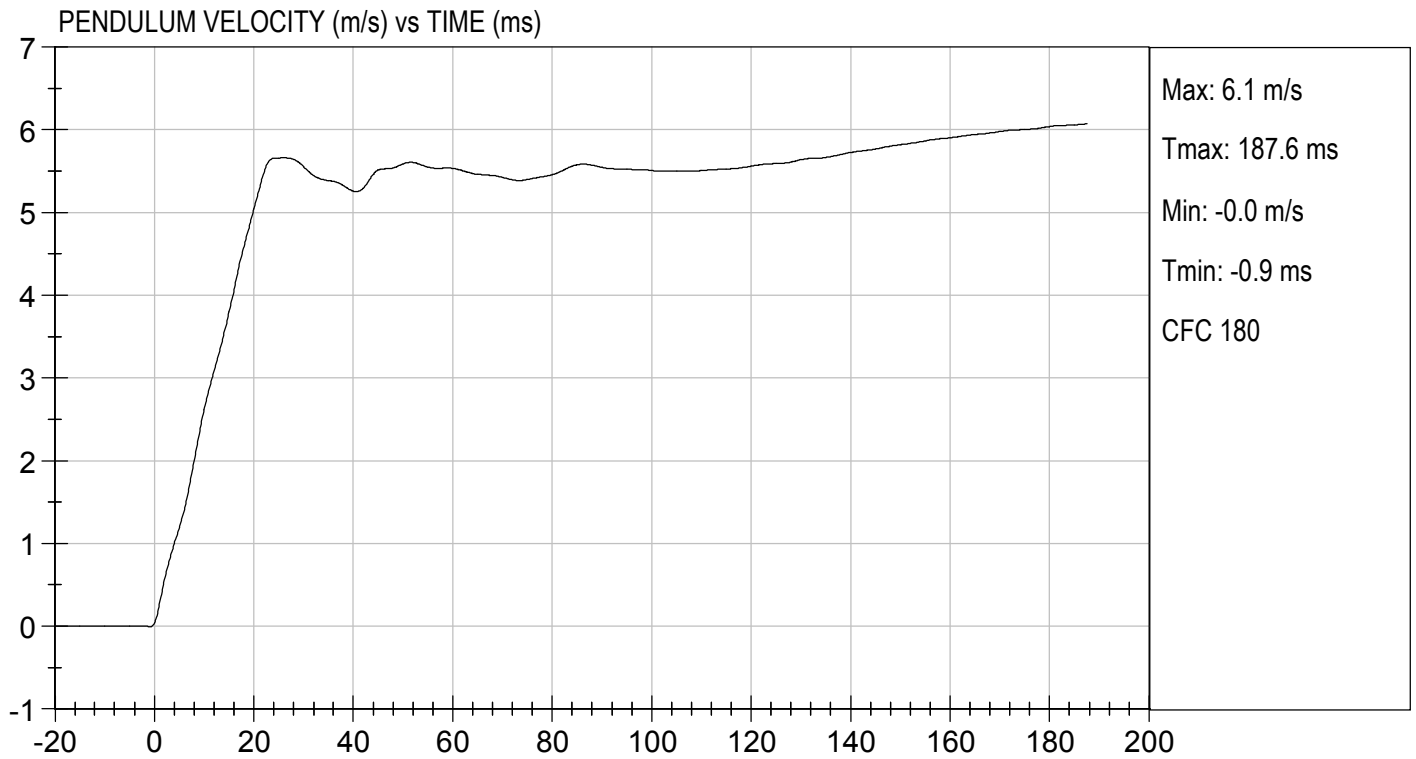
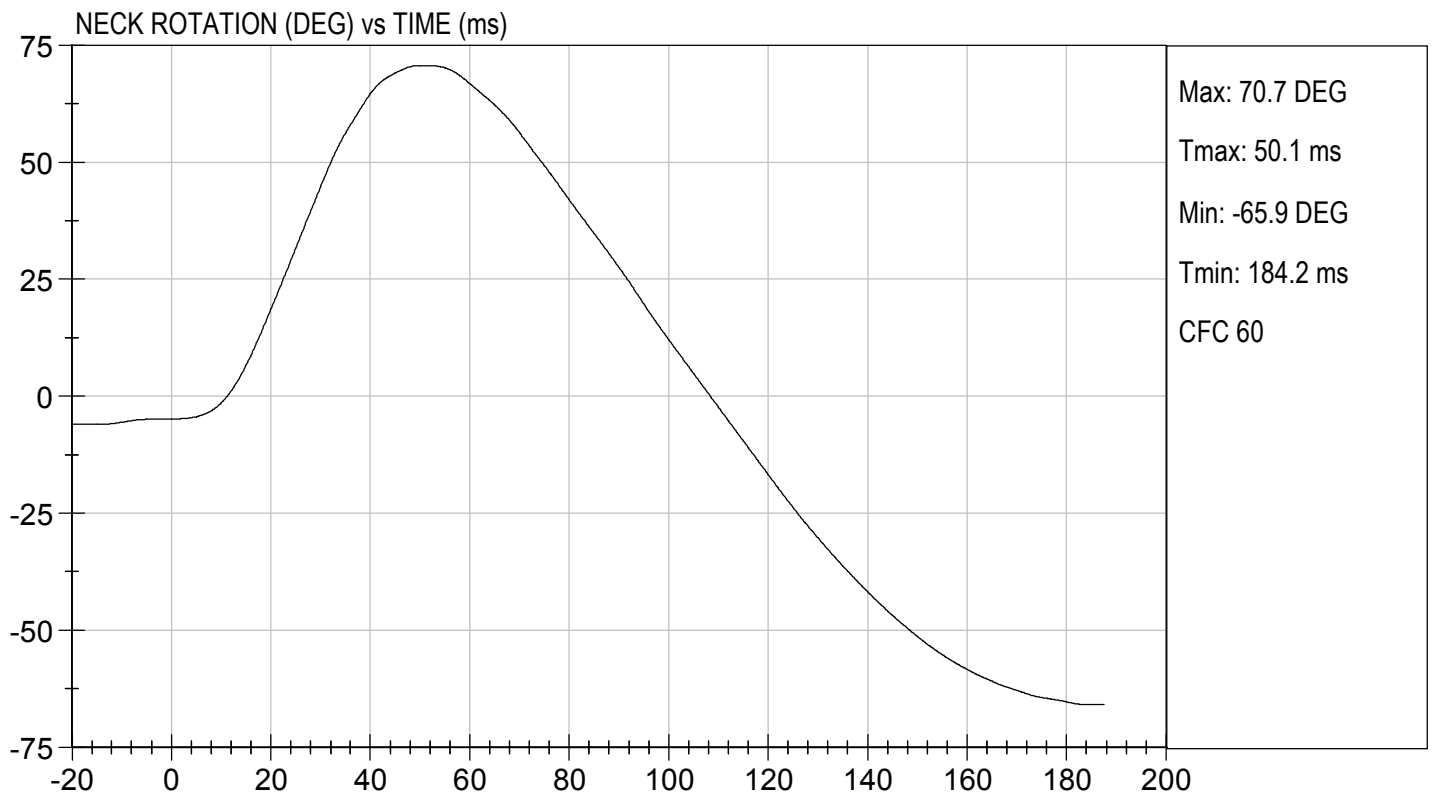
TEST DESC: NECK FLEXION
VELOCITY: 18.31 ft/s, 5.58 m/s

TEST DATE: 09/21/2020
TEST #: D202362

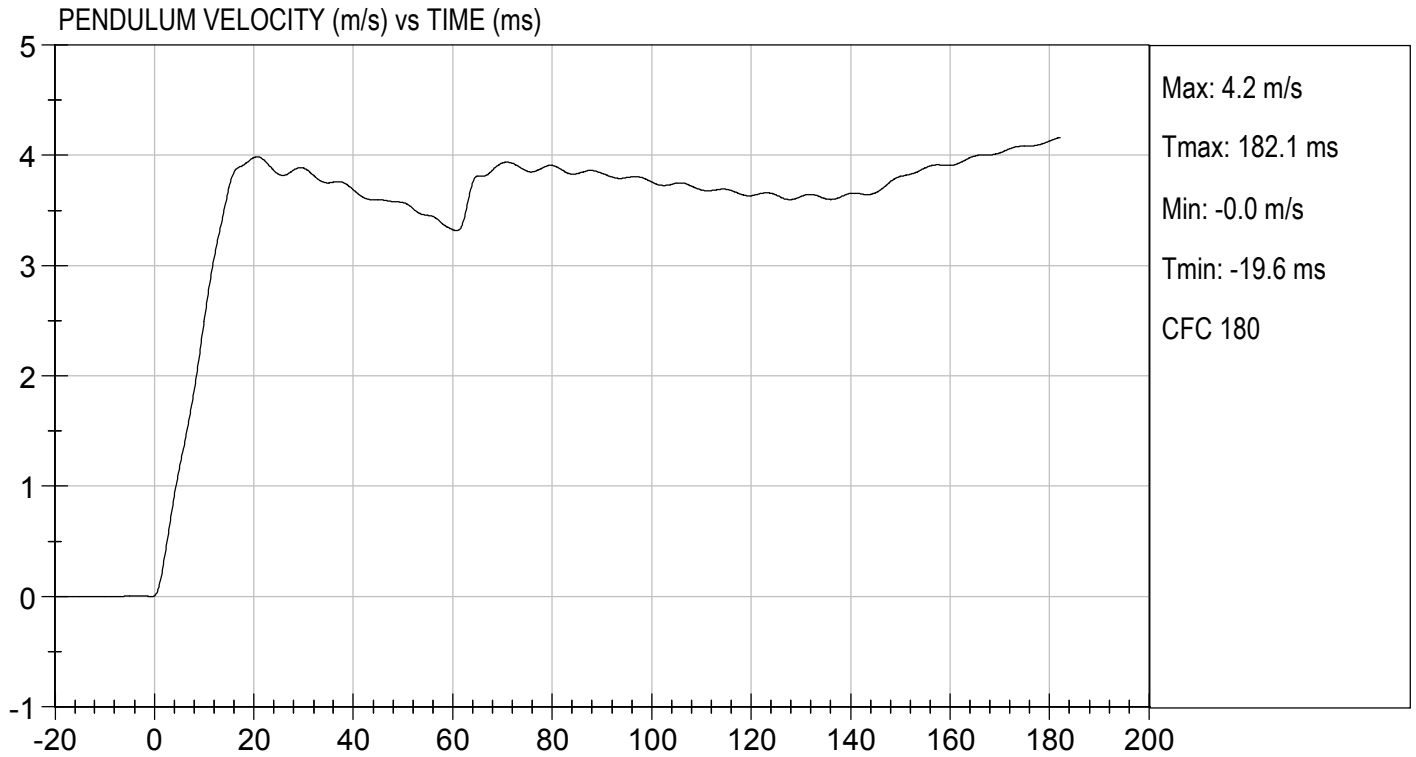
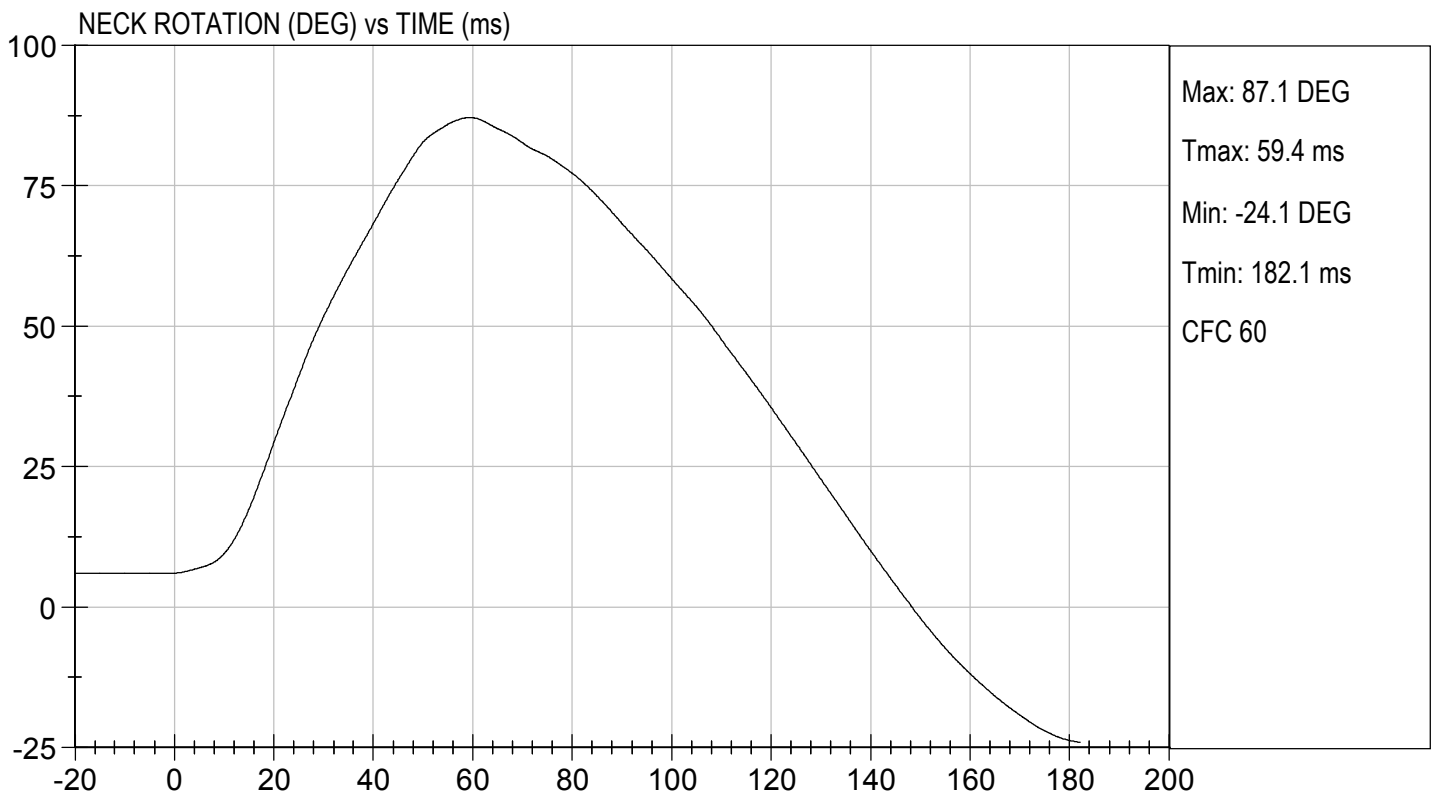
TEST DESC: NECK EXTENSION
VELOCITY: 12.25 ft/s, 3.73 m/s

TEST DATE: 09/21/2020
TEST #: D202363
