**REPORT NUMBER: TWG-MGA-20-002**

**SIDE AIRBAG OUT-OF-POSITION INJURY  
TECHNICAL WORKING GROUP**

**KIA MOTORS MANUFACTURING GEORGIA, INC.  
2020 Kia Telluride S 5-Door SUV  
NHTSA No.: M20204220TWG2**

**FINAL REPORT**

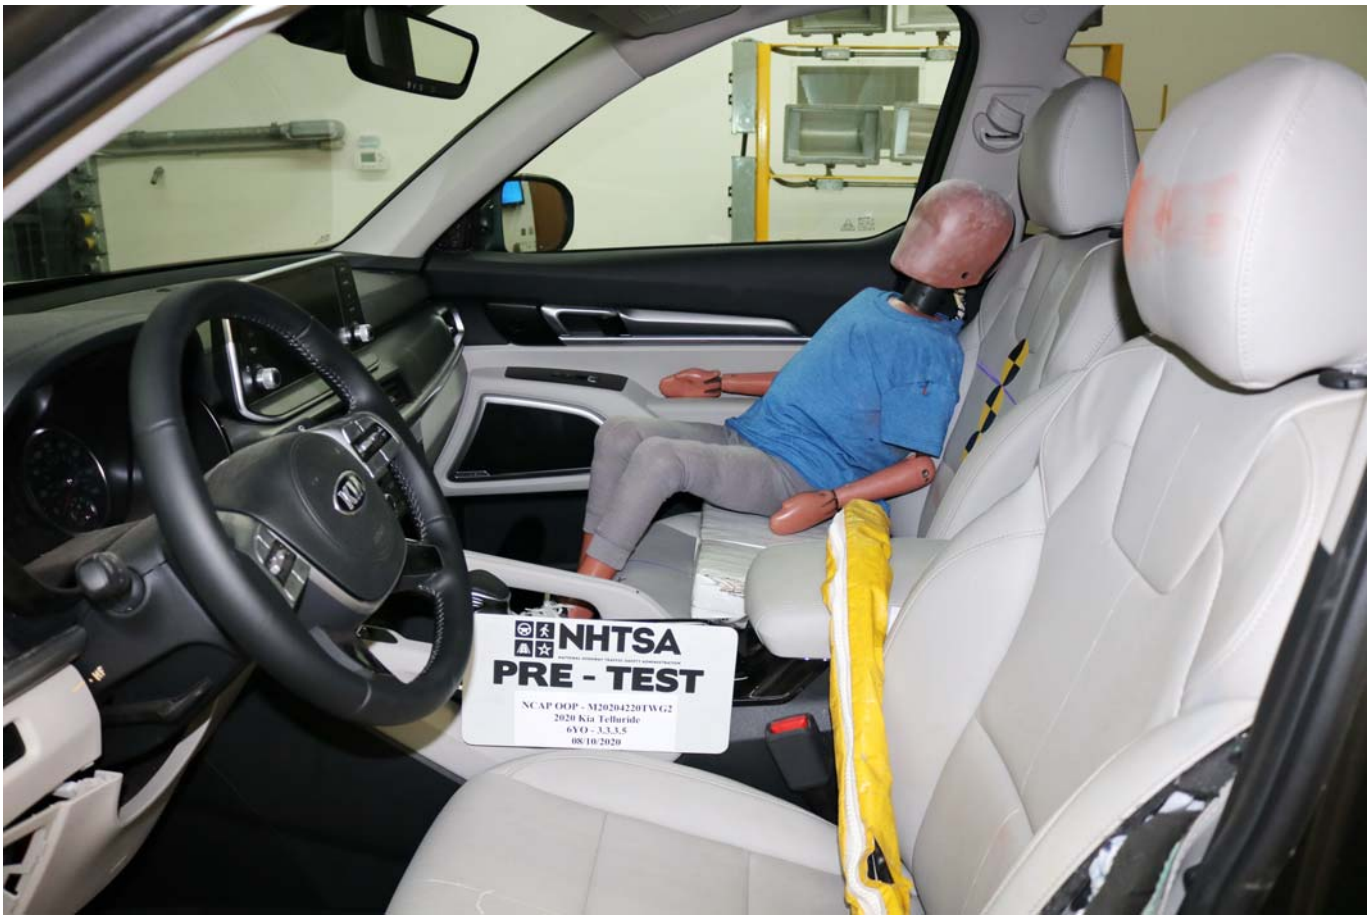
Photo No. 005 - Pre-Test Dummy Left Side View

The Hybrid III 6-Year-Old child dummy was placed in the right front passenger seat. The dummy was seated on the outboard edge of a foam block aligning the upper spine with the deployment trajectory of the airbag. The head was placed between the seat bolster and pillar/side trim to minimize the fore-aft clearance between the neck and seatback. Legs were aligned such that they cross the heel placement points on the seat cushion. The dummy's pelvis was slid forward (parallel to the centerline of the vehicle) until the neck/torso junction was aligned vertically with the top edge of the airbag module. The dummy's outboard arm was raised to clear the vehicle armrest. The pelvis/torso of the dummy was in contact with the door.

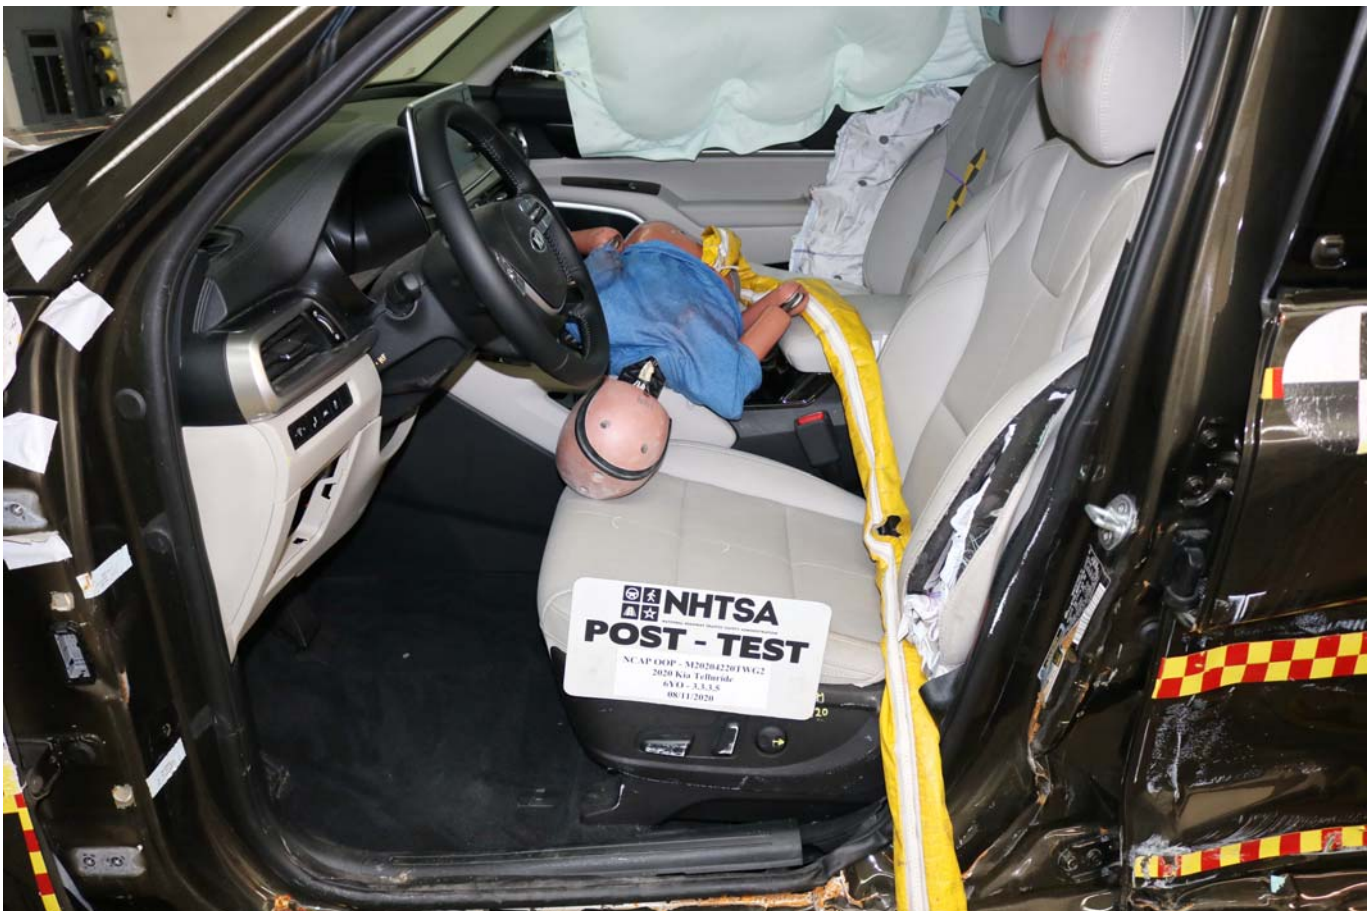
Photo No. 006 - Post-Test Dummy Left Side View

- Side curtain airbag to top of head
- Side torso/pelvis airbag to right side of torso and pelvis

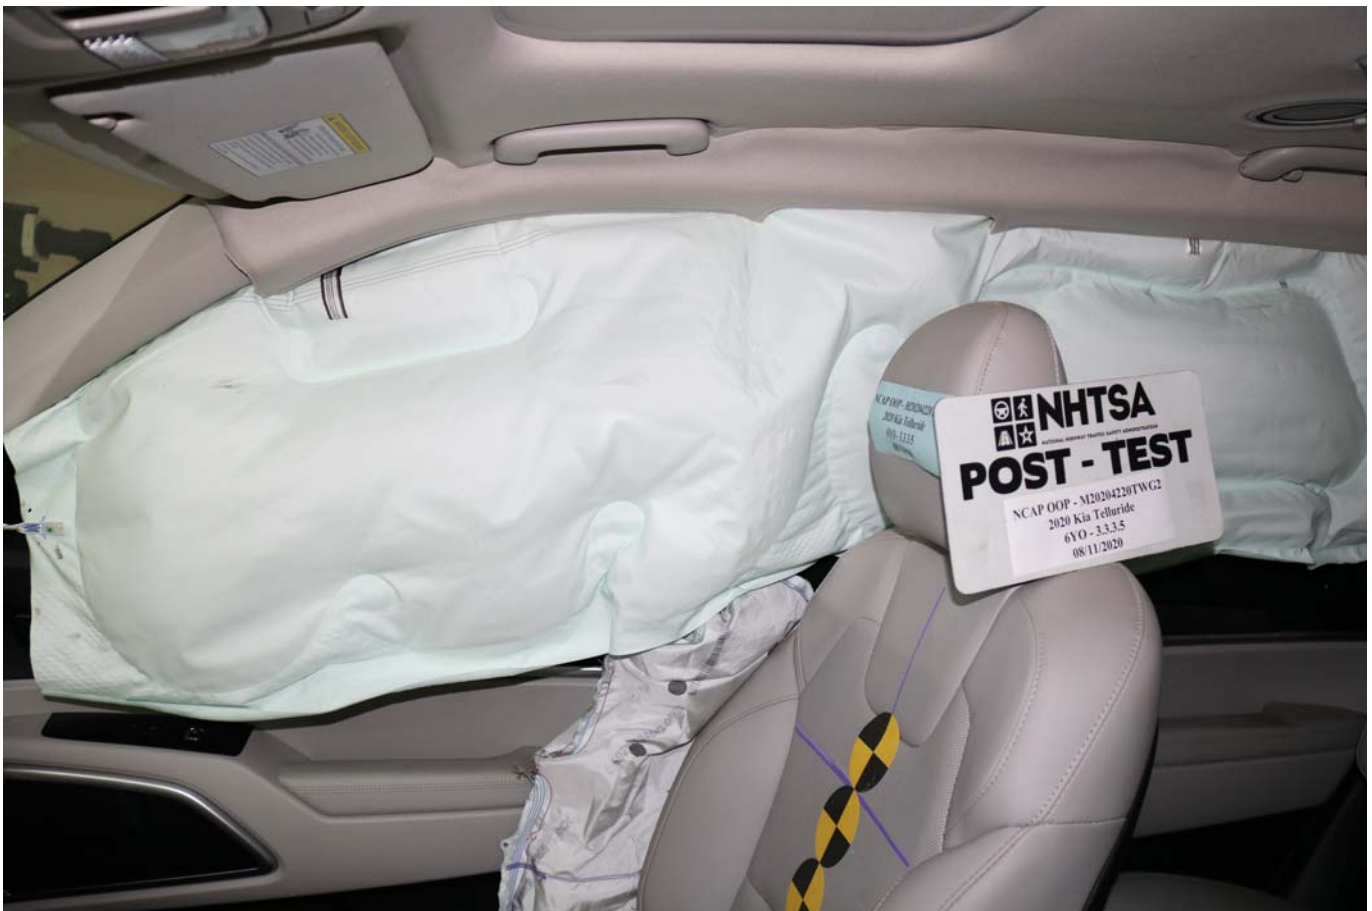
Photo No. 022 - Post-Test Curtain Airbag Left Side View

Head	Side curtain airbag to top of head
Upper Torso	Side torso/pelvis airbag
Lower Torso	Side torso/pelvis airbag
Knee	None

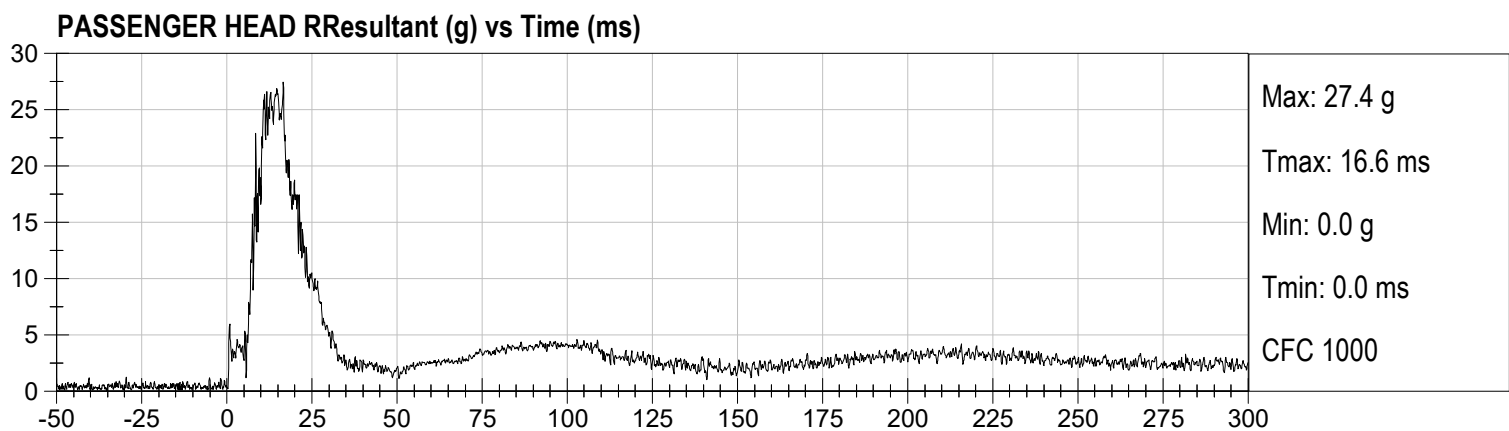
**PASSENGER HEAD X (g) vs Time (ms)**

**PASSENGER HEAD Y (g) vs Time (ms)**

**PASSENGER HEAD Z (g) vs Time (ms)**

**PASSENGER HEAD Resultant (g) vs Time (ms)**

HIC <sub>15</sub>	T <sub>1</sub> (ms)	T <sub>2</sub> (ms)	HIC <sub>36</sub>	T <sub>1</sub> (ms)	T <sub>2</sub> (ms)
30	7.0	22.0	30	7.0	22.0
