**REPORT NUMBER: TWG-MGA-20-007**

**SIDE AIRBAG OUT-OF-POSITION INJURY  
TECHNICAL WORKING GROUP**

**NISSAN MOTOR CO., LTD.  
2020 Nissan Leaf S 5-Door Hatchback  
NHTSA No.: M20205205TWG2**

**FINAL REPORT**

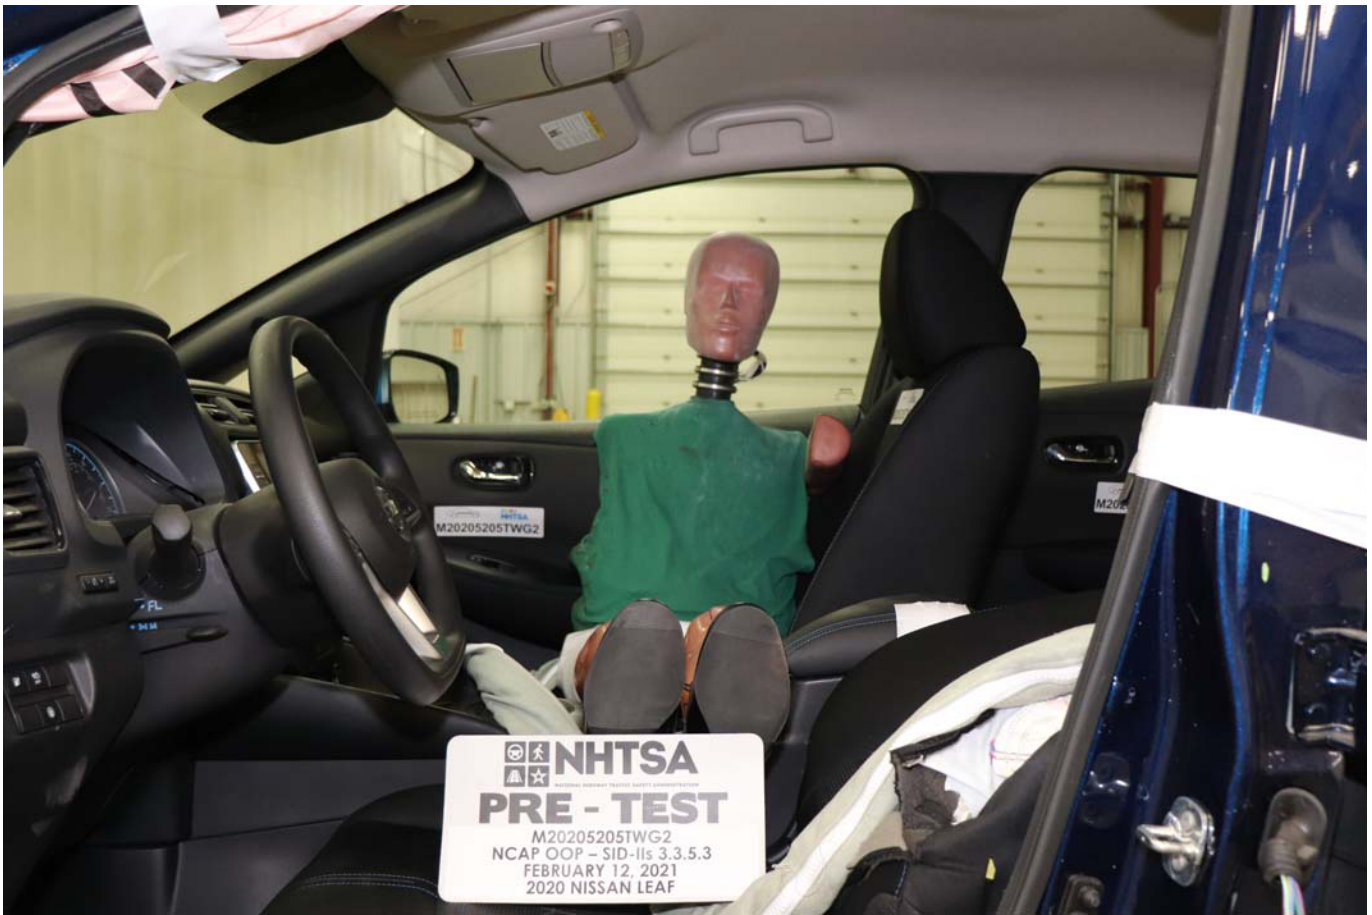
Photo No. 005 - Pre-Test Dummy Left Side View

The SID-IIs Build Level D 5<sup>th</sup>-percentile female dummy was placed in the right front passenger seat facing toward the center of the vehicle with its arm against the seatback. The arm was rotated horizontally in the forward direction with respect to the dummy. The seat track was adjusted forward to minimize the vertical distance between the dummy's head and curtain airbag. The dummy's pelvis was slid outboard until the dummy's back contacted the door trim panel or armrest and the CG of the head was centered in the deployment trajectory of the airbag. The vertical plane through the centerline of the dummy's rib-stiffener and shoulder bolt was parallel to the centerline of the vehicle.

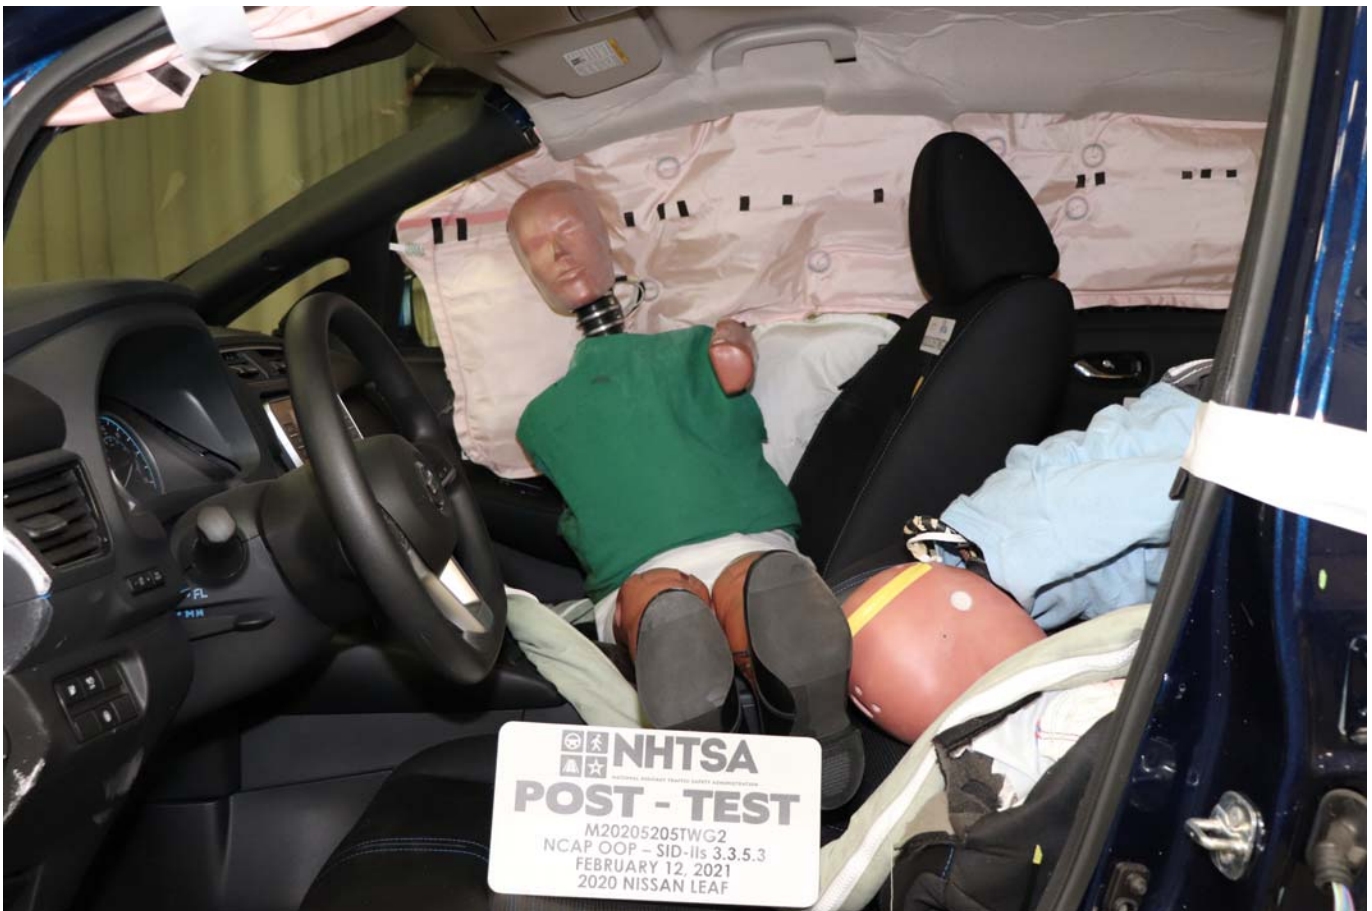
Photo No. 006 - Post-Test Dummy Left Side View

The SID-IIs Build Level D 5<sup>th</sup>-percentile female dummy's visible contact points were as follows:

- Side curtain airbag to top of head
- Side torso/pelvis airbag to left side of torso and pelvis
