REPORT NUMBER: TWG-CAL-20-04

**NEW CAR ASSESSMENT PROGRAM (NCAP)
SIDE AIRBAG OUT-OF-POSITION TEST**

**GM Korea Company
2020 Buick Encore GX
SUV**

NHTSA NUMBER: M20200101TWG2

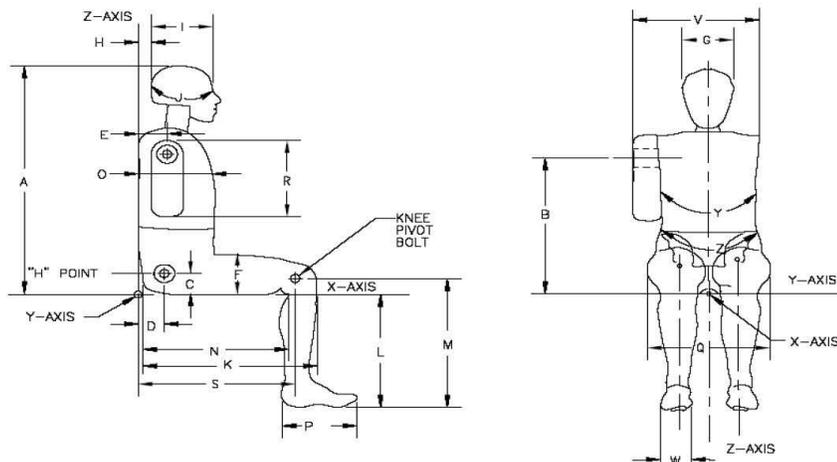
External Measurements - SID-IIs

Symbol	Description	Specification (mm)		Result (mm)	Pass/Fail
A	Sitting Height	772	788	779	Pass
B	Shoulder Pivot Height	437	453	446	Pass
C	H-point Height	79	89	84	Pass
D	H-point from seatback	141	151	146	Pass
E	Shoulder Pivot from Backline	97	107	104	Pass
F	Thigh Clearance	119	135	127	Pass
G	Head Breadth	140	148	144	Pass
H	Head Back from Backline	40	46	44	Pass
I	Head Depth	178	188	183	Pass
J	Head Circumference	541	551	547	Pass
K	Buttock to Knee Length	514	540	537	Pass
L	Popliteal Height	343	369	357	Pass
M	Knee Pivot to floor height	392	409	403	Pass
N	Buttock Popliteal Length	416	442	433	Pass
O	Chest Depth w/o jacket	195	211	205	Pass
P	Foot Length	216	232	224	Pass
Q	Hip Breadth (w/pelvic plugs)	313	323	319	Pass
R	Arm Length	249	259	255	Pass
S	Knee Joint to seatback	477	493	487	Pass
V	Shoulder Width	341	357	346	Pass
W	Foot Width	78	94	85	Pass
Y	Chest Circumference w/jacket	851	881	867	Pass
Z	Waist Circumference	761	791	781	Pass
