REPORT NUMBER: TWG-MGA-20-005

**SIDE AIRBAG OUT-OF-POSITION INJURY
TECHNICAL WORKING GROUP**

**GENERAL MOTORS LLC
2020 GMC Acadia SLE 5-Door SUV
NHTSA No.: M20200113TWG2**

FINAL REPORT

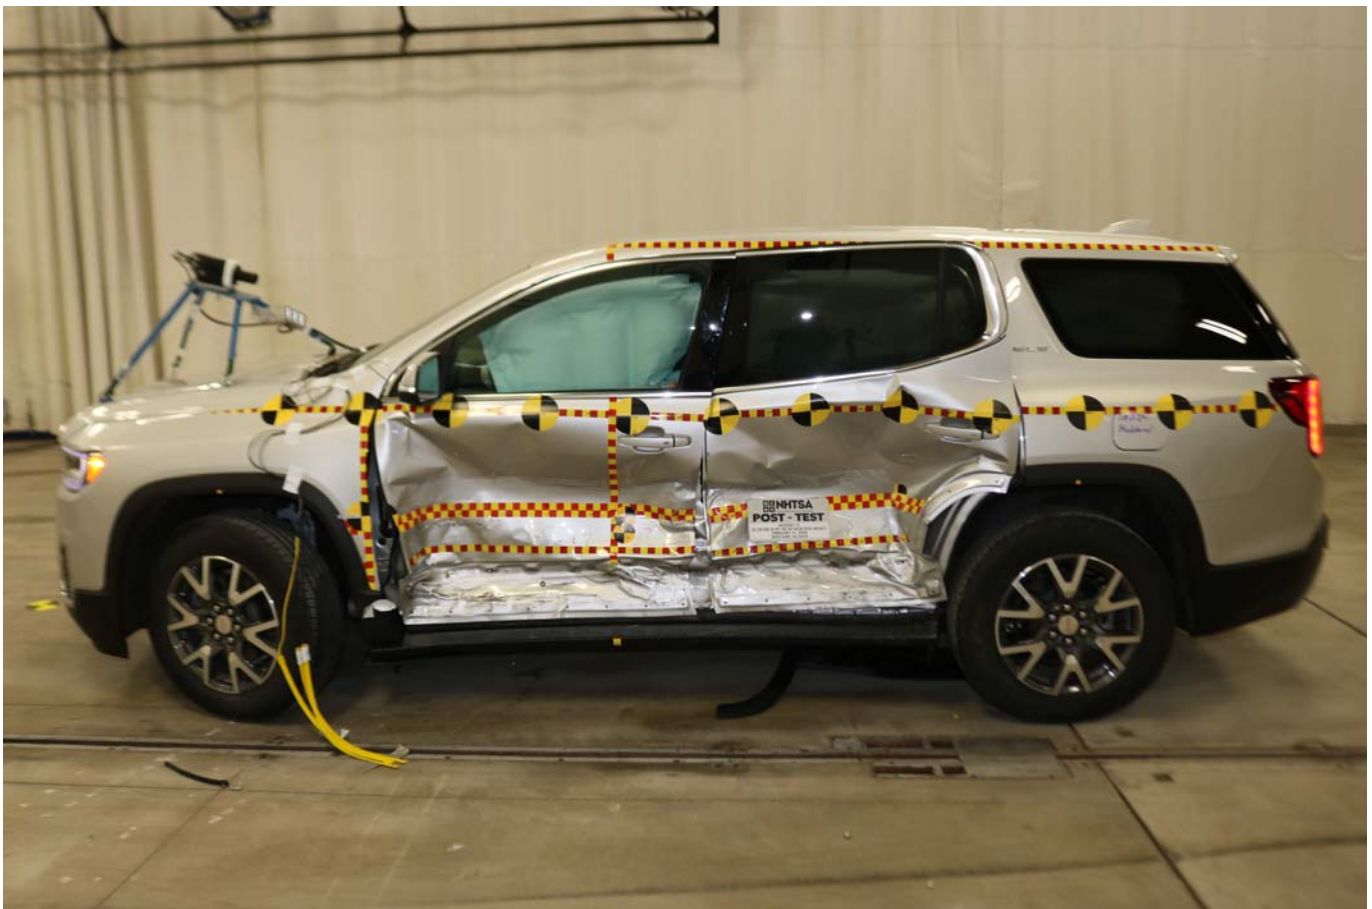
Photo No. 004 - Post-Test Vehicle Left Side View

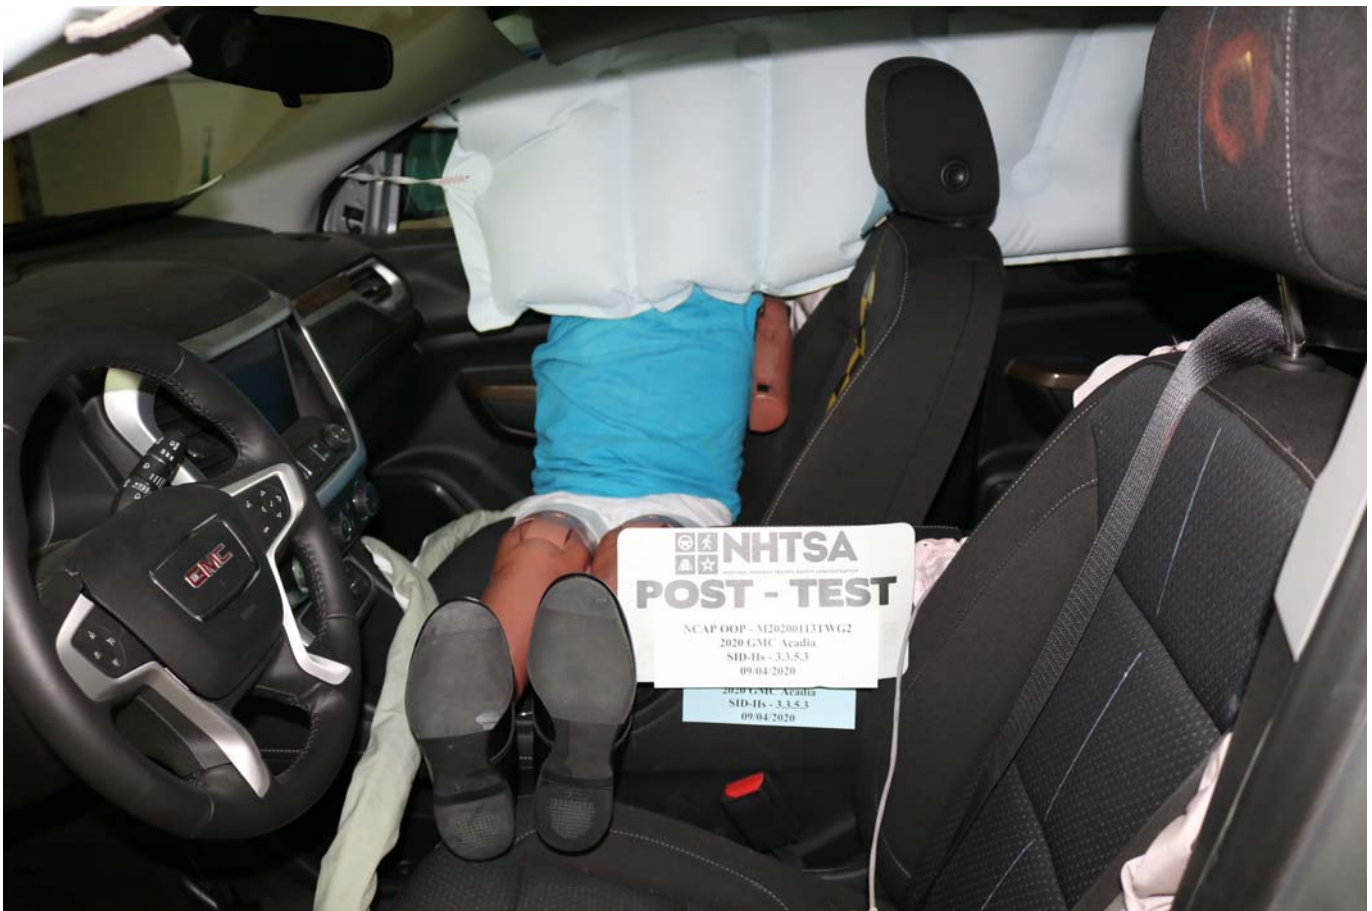
Photo No. 006 - Post-Test Dummy Left Side View

- Side curtain airbag to top and back of head
- Side torso/pelvis airbag to left side of torso and pelvis

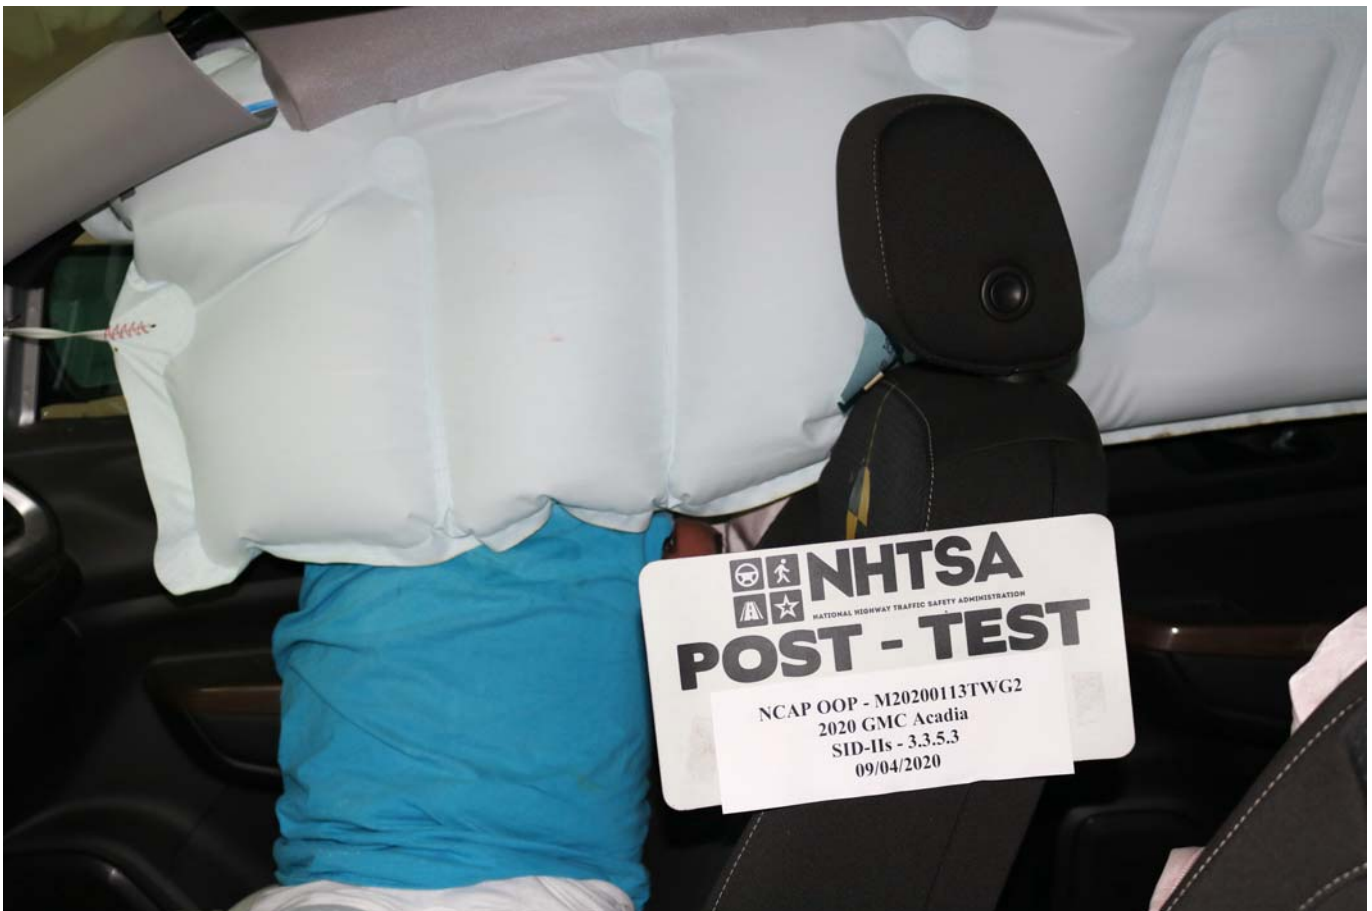
Photo No. 008 - Post-Test Dummy Left Side Close-Up View

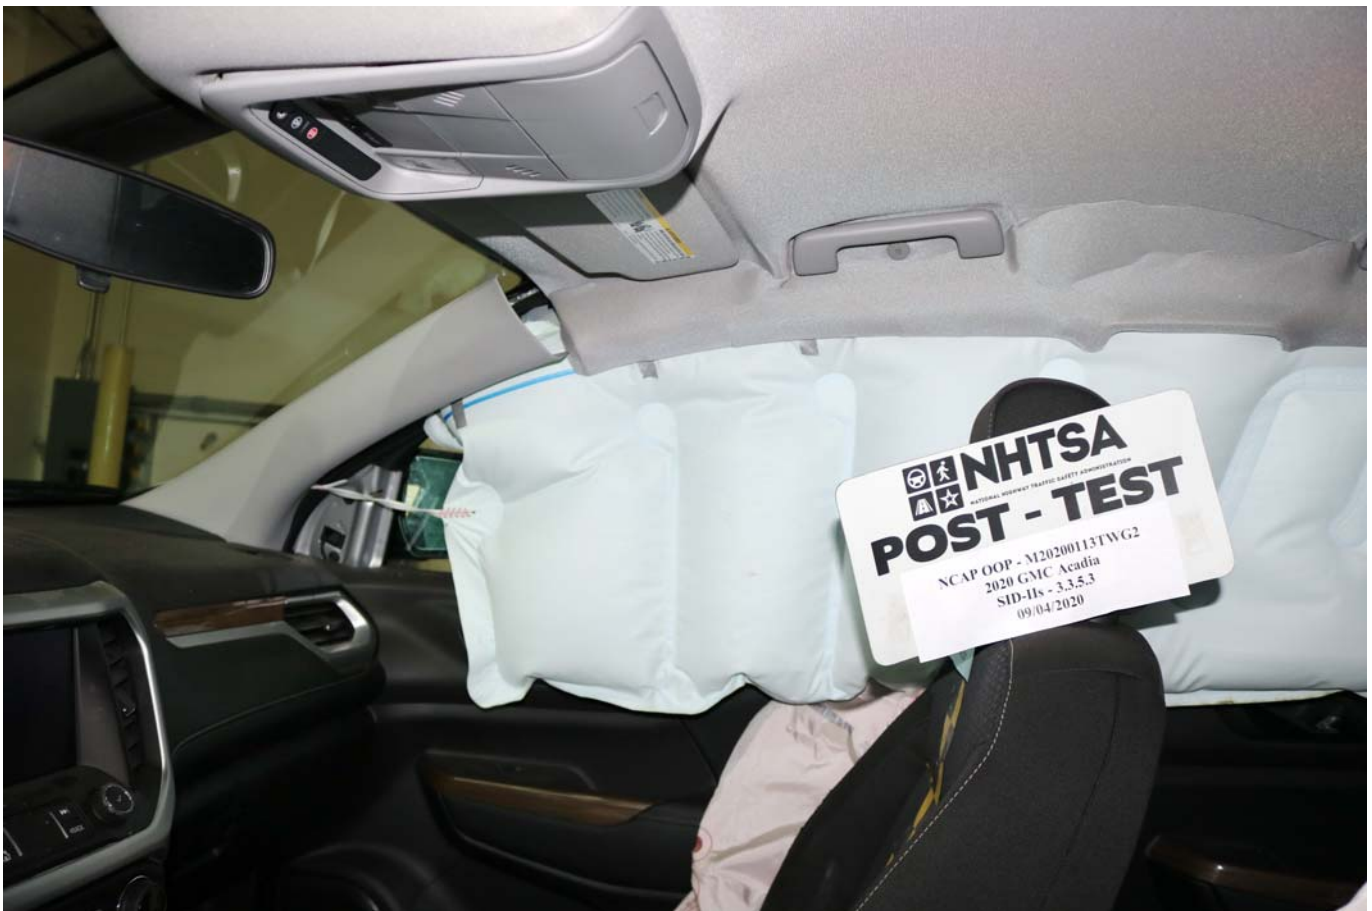
Photo No. 022 - Post-Test Curtain Airbag Left Side View

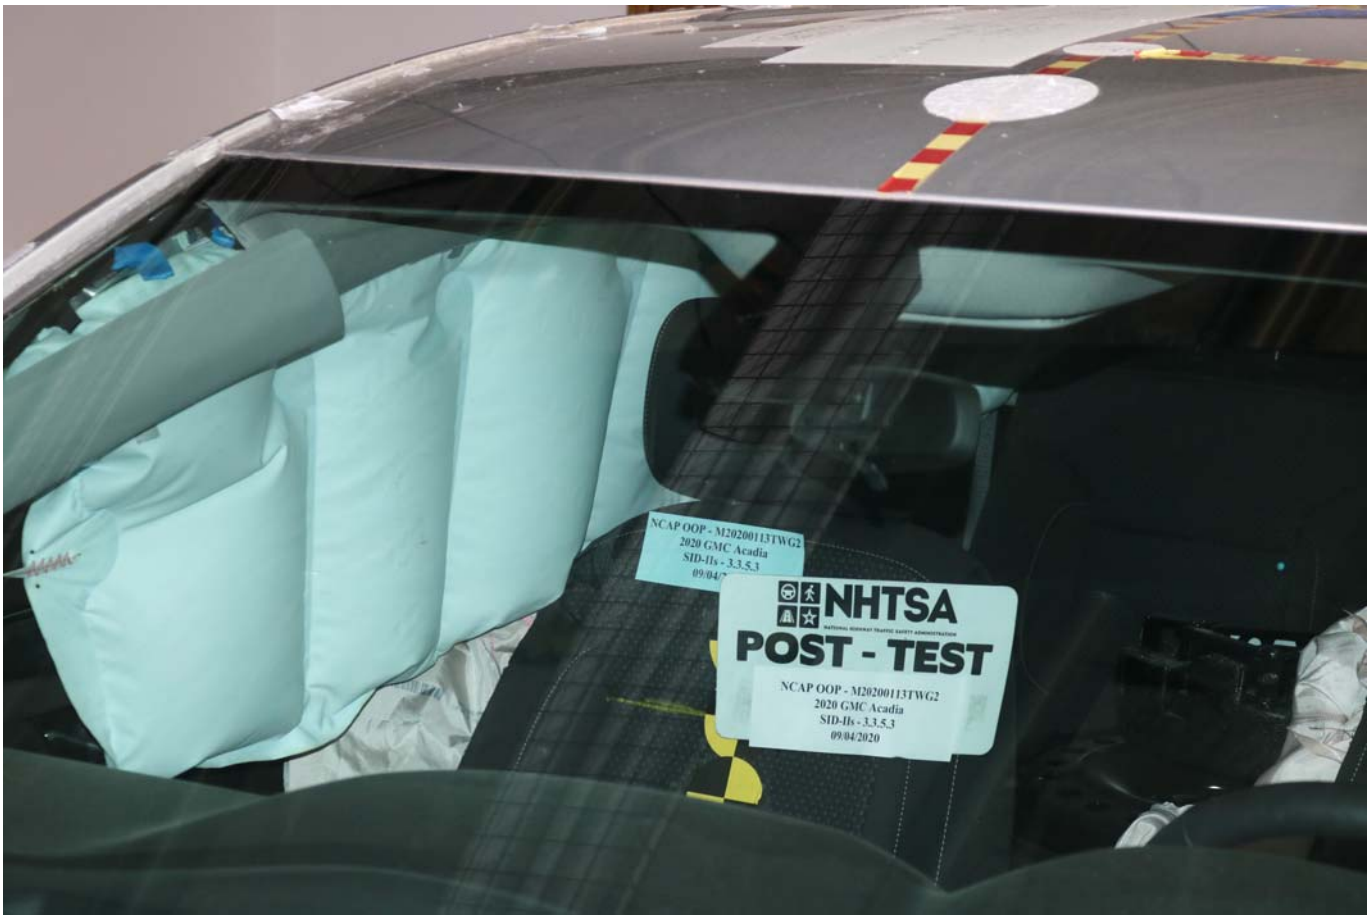
Photo No. 023 - Post-Test Curtain Airbag Left Three-Quarter Front View

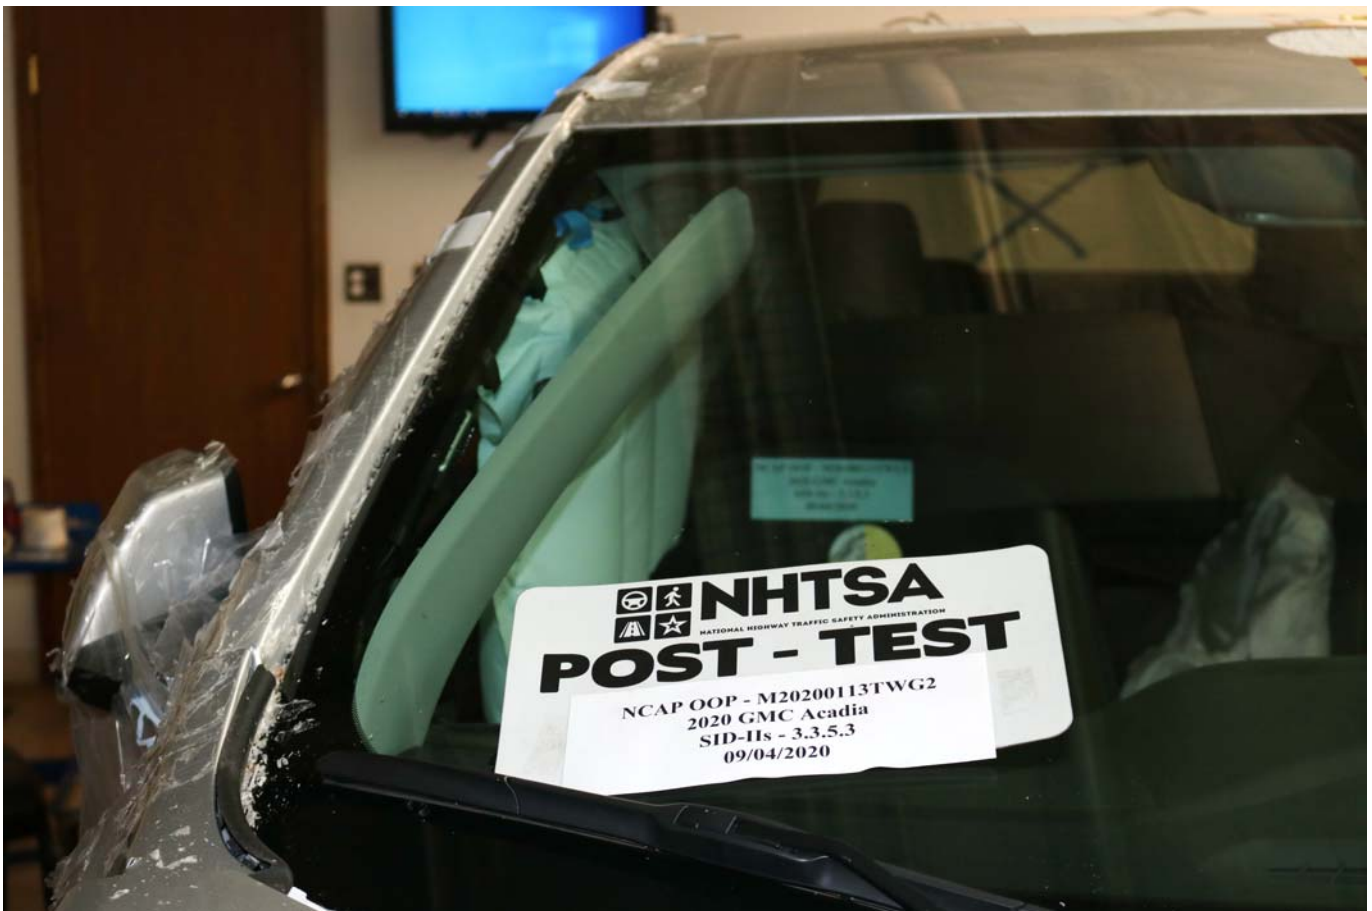
Photo No. 024 - Post-Test Curtain Airbag Front View

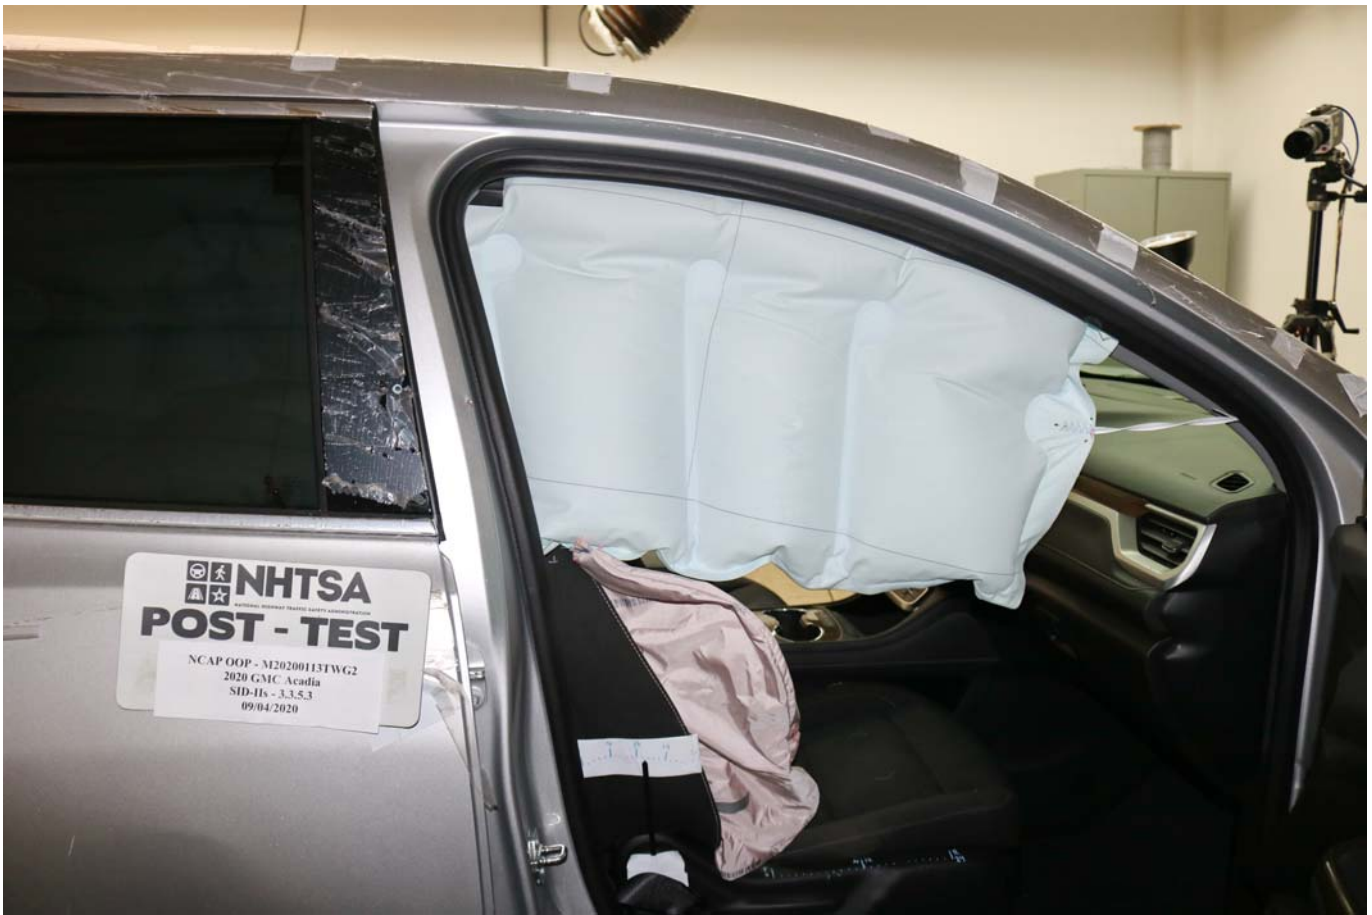
Photo No. 025 - Post-Test Curtain Airbag Right Side View (Door Open)
