Final Report Number: NCAP-TRC-21-004

New Car Assessment Program (NCAP) Frontal Barrier Impact Test

> FORD MOTOR CO. 2021 Ford Bronco Sport NHTSA Number: M20210221

PREPARED BY: Transportation Research Center Inc. 10820 State Route 347 P. O. Box B-67 East Liberty, OH 43319

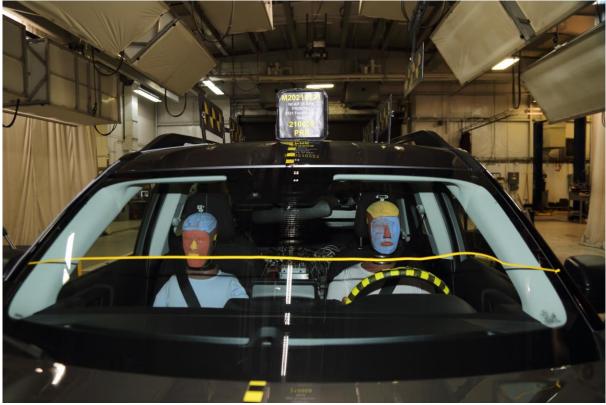
019 Post-Test Windshield View

Critical Areas of Performance Observations	
Windshield Damage	Passenger side mostly cracked
Window Damage	None
Other Notable Effects	None
